M1 Junction 15 West – Extended Development Site

Supplementary Geotechnical & Geoenvironmental Investigation

313582-02 (00)

Title: Supplementary ground investigation interpretive report: M1 Junction 15 West – Extended Development Site

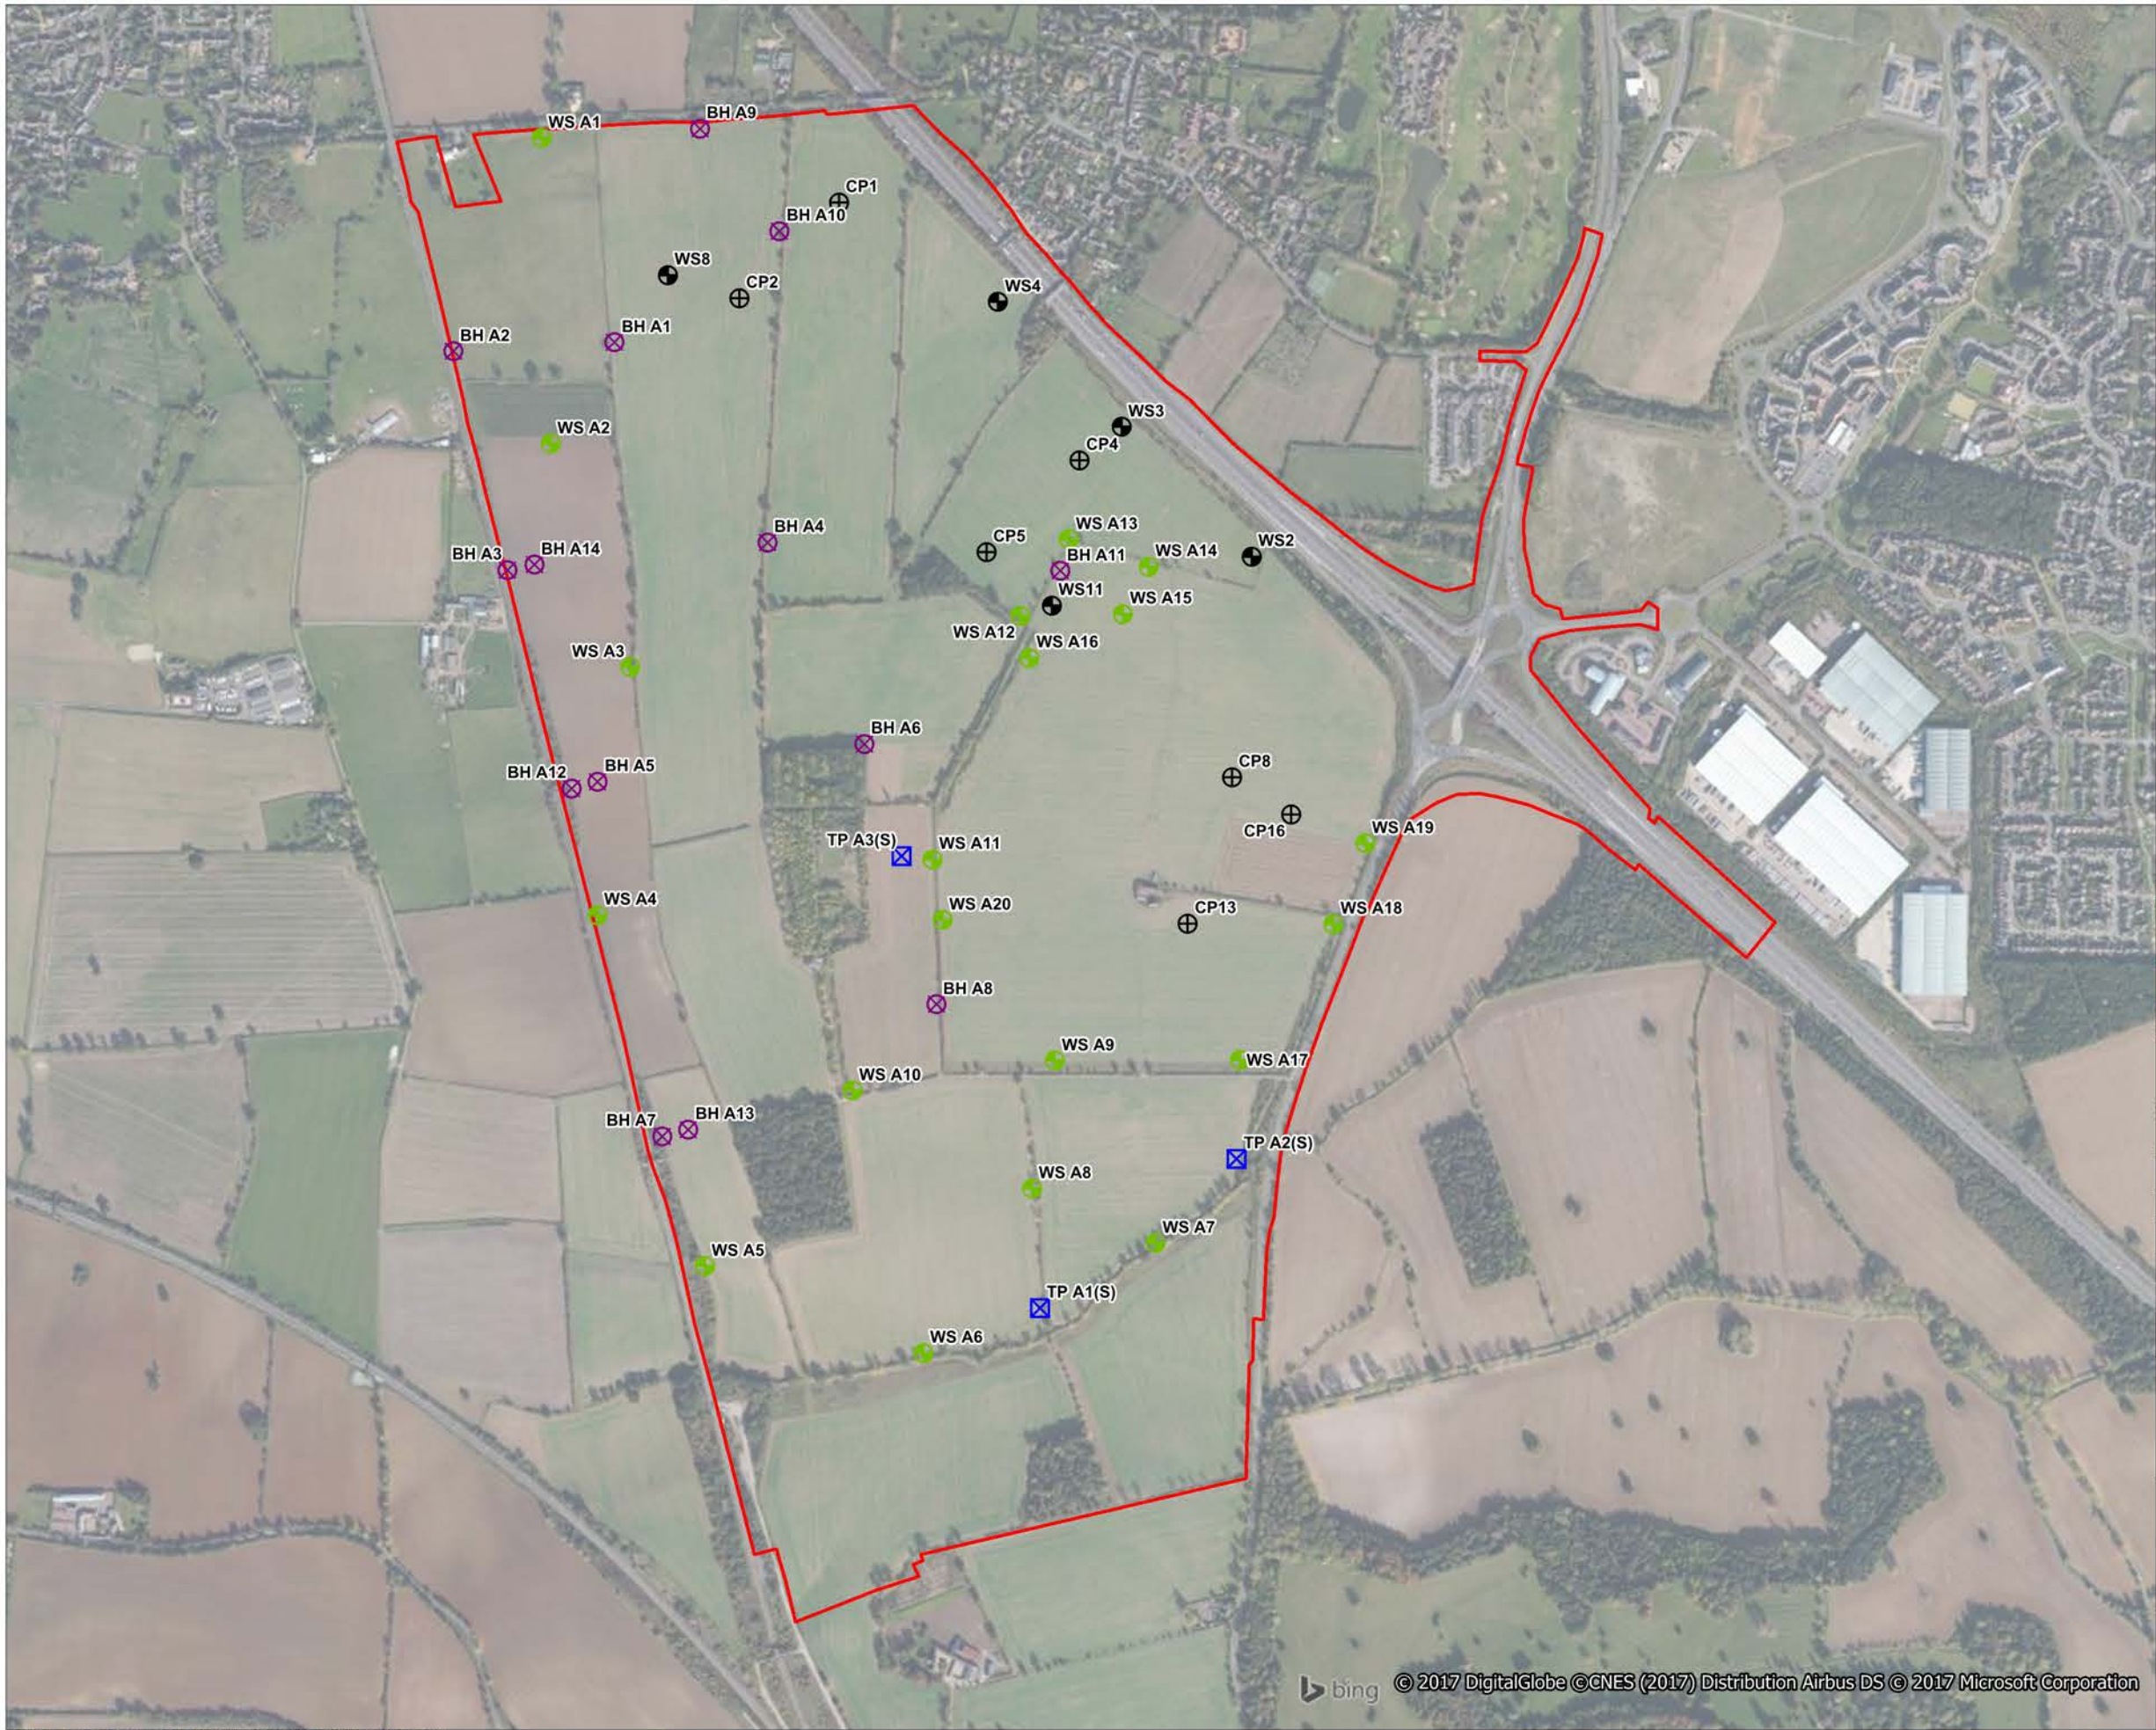
- Site boundary (Feb 2017)
- Borehole (BH A)
- Trial Pit (TP) with Soakaway (S)
- Window Sample (WS A)
- Boreholes to be re-activated
 - Cable Percussion borehole (CP)
 - Window Sample (WS)

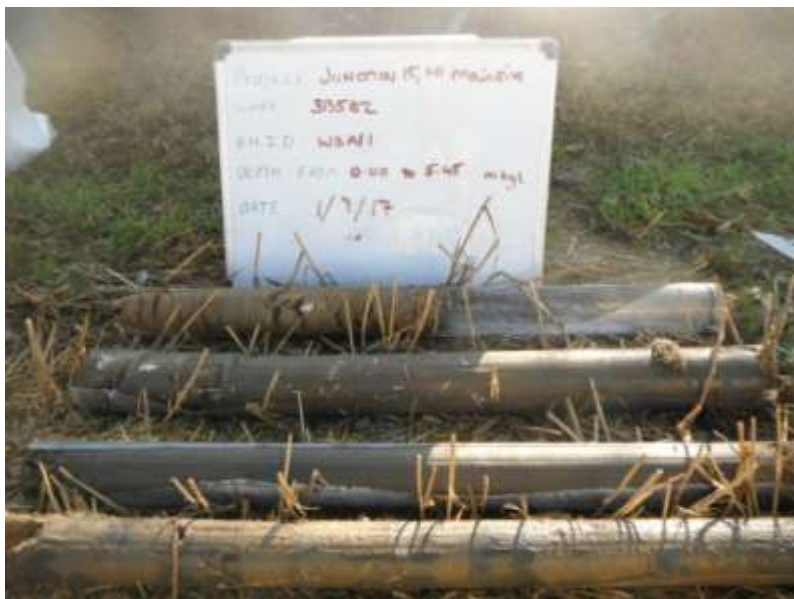
Photo No. 12	Date: 01/09/2017

Exploratory hole number: Window sample borehole A11		
Description: WSA11 was advanced to 5.45m bgl.

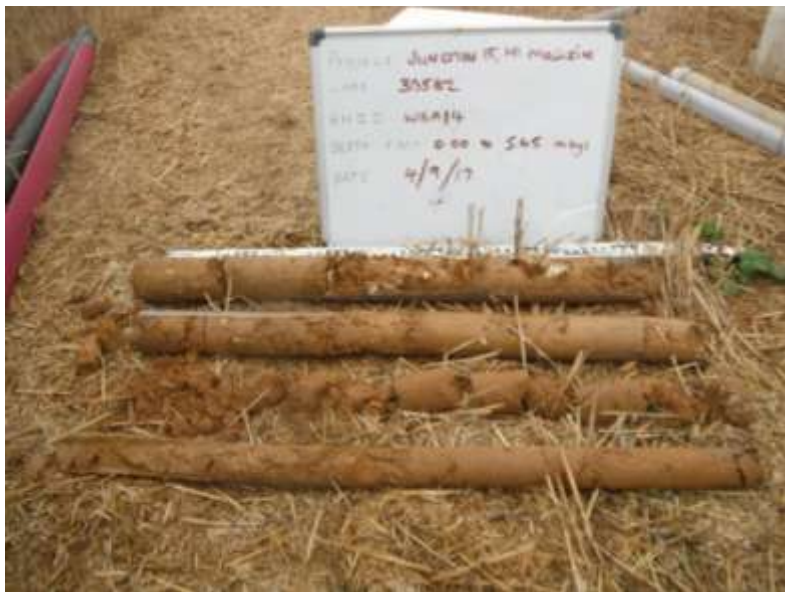
Photo No. 15	Date: 04/09/2017

Exploratory hole number: Window sample borehole A14		
Description: WSA14 was advanced to 5.45m bgl.

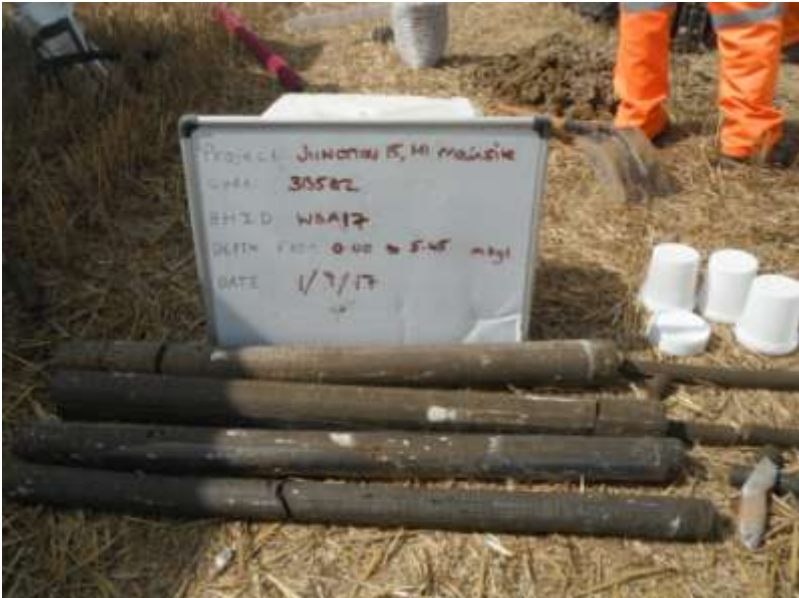
Photo No. 18	Date: 01/09/2017

Exploratory hole number: Window sample borehole A17		
Description: WSA17 was advanced to 5.45m bgl.

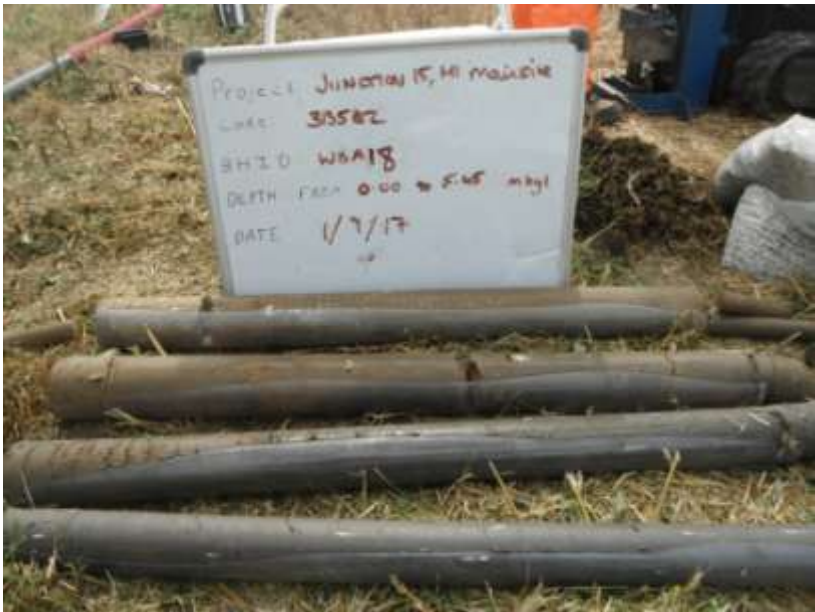
Photo No. 19	Date: 01/09/2017

Exploratory hole number: Window sample borehole A18		
Description: WSA18 was advanced to 5.45m bgl.

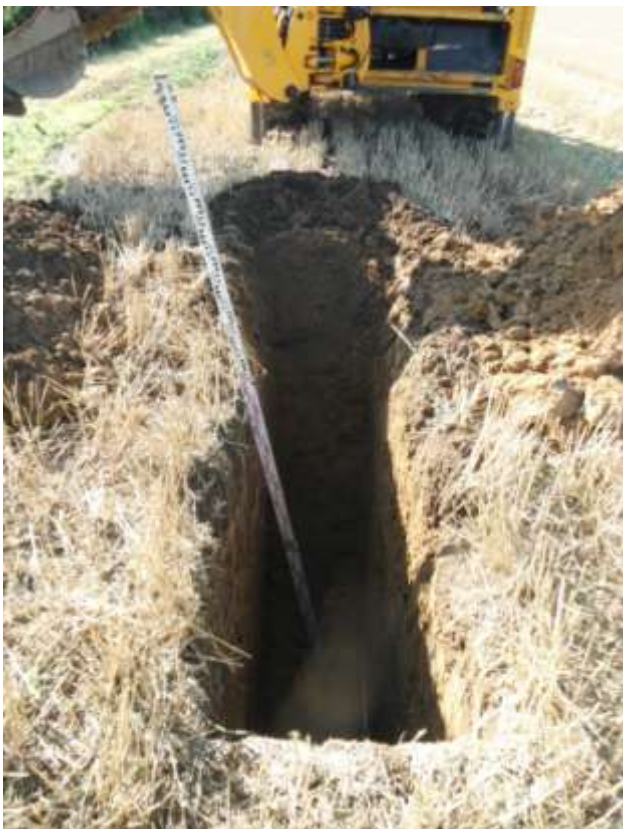
Photo no. 27	Date: 12/09/2017

Exploratory hole number: Trial pit A3		
Description: Trial pit A3 excavated to a maximum depth of 2.20m upon completion of the excavation a soakaway test was undertaken.

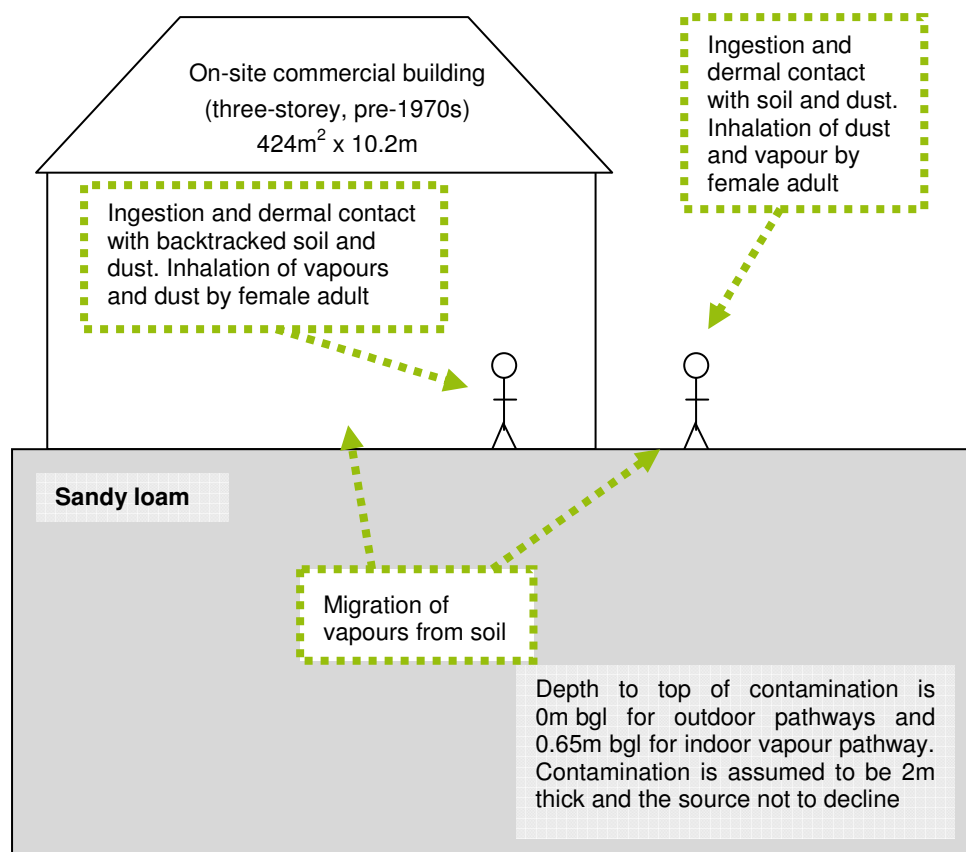
Figure 1: Conceptual model for CLEA commercial scenario

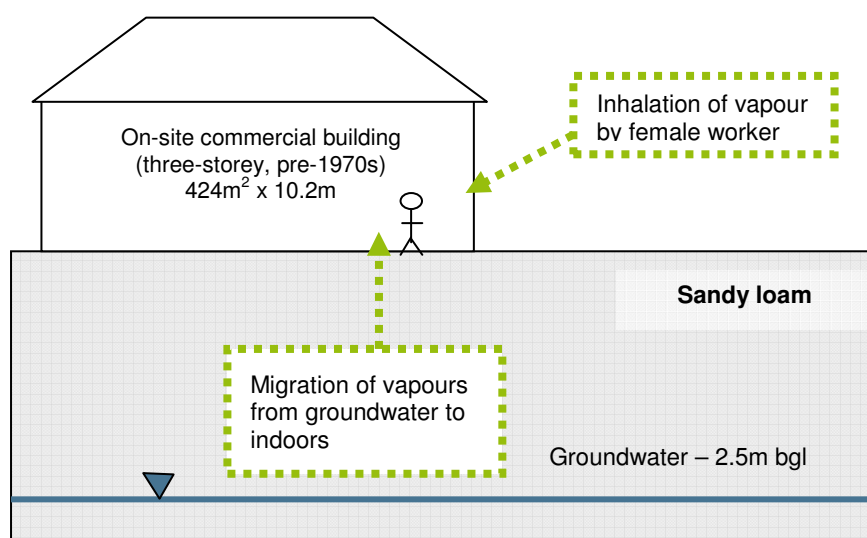
Figure 2: GrAC conceptual model for RBCA commercial scenario

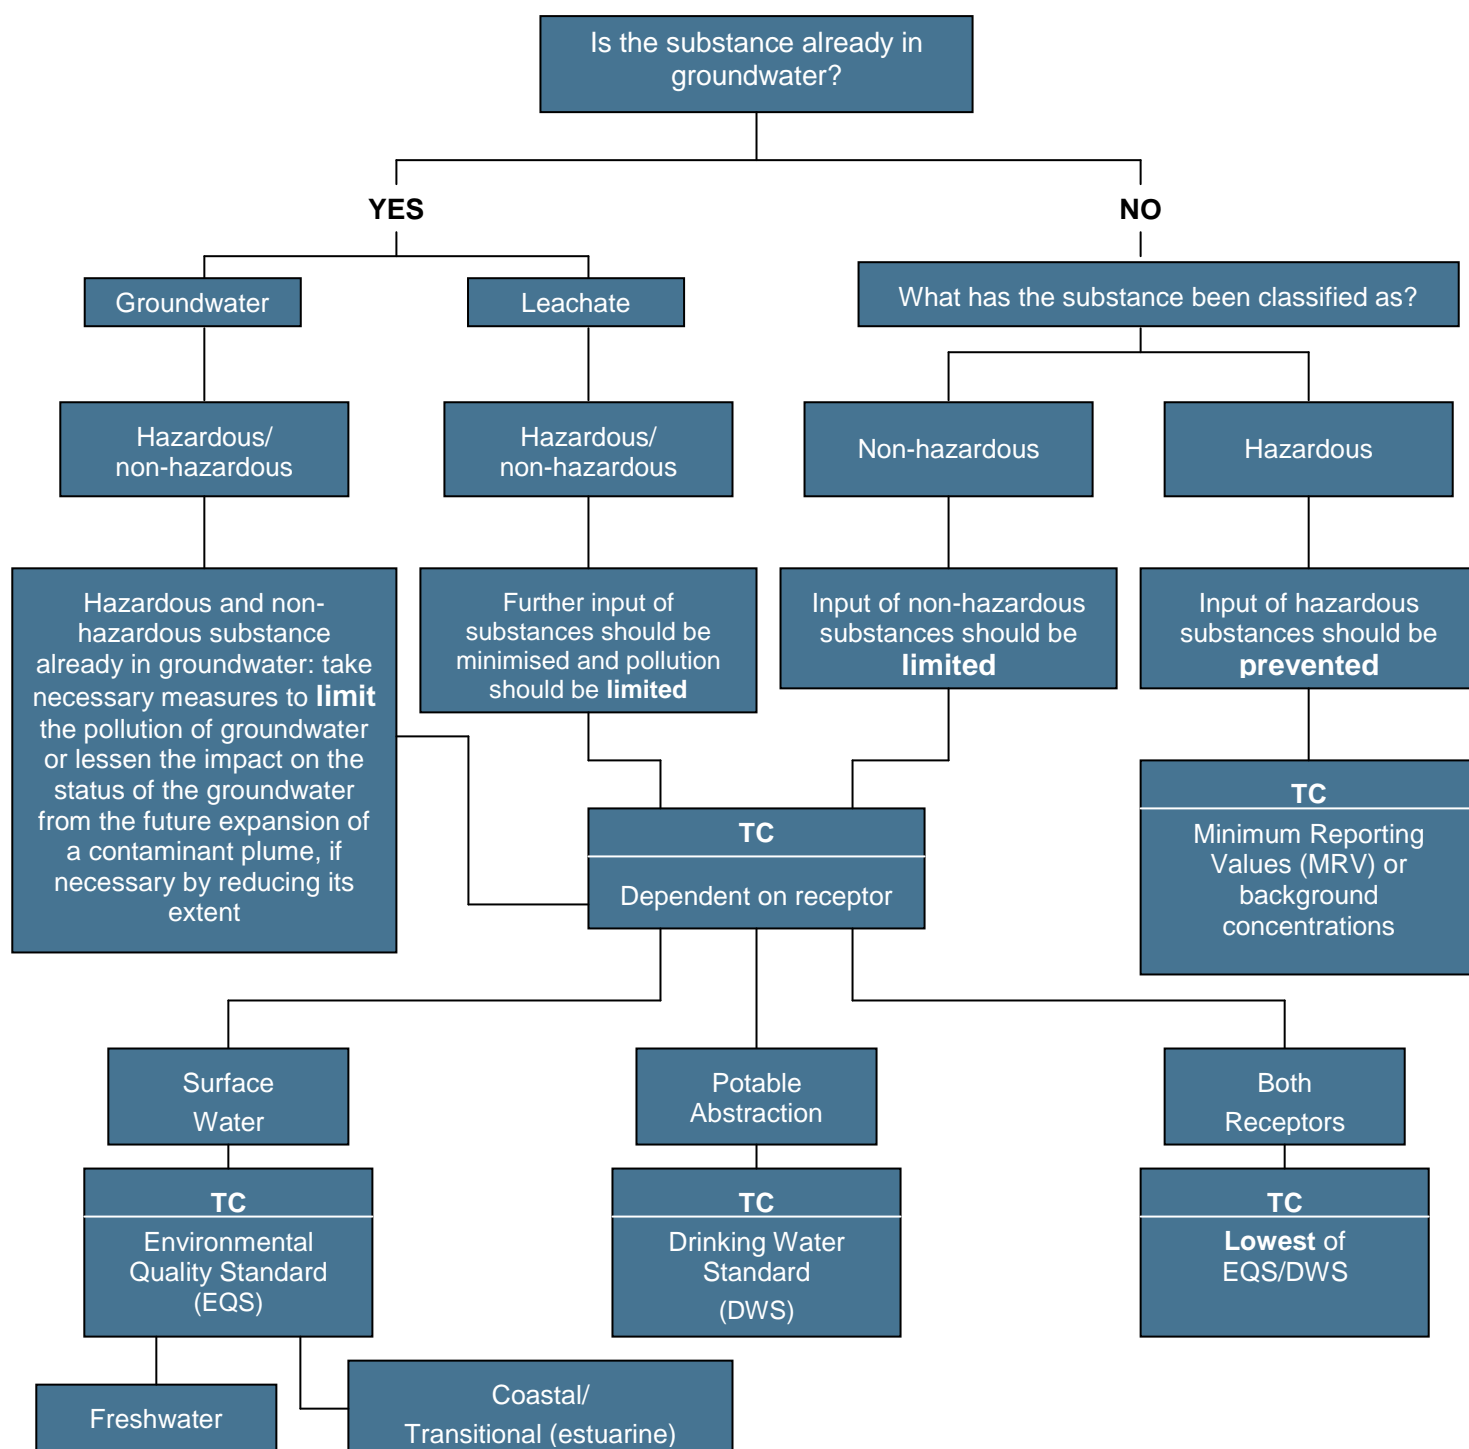
FLOW CHART TO ASSIST WITH SELECTION OF TARGET CONCENTRATIONS

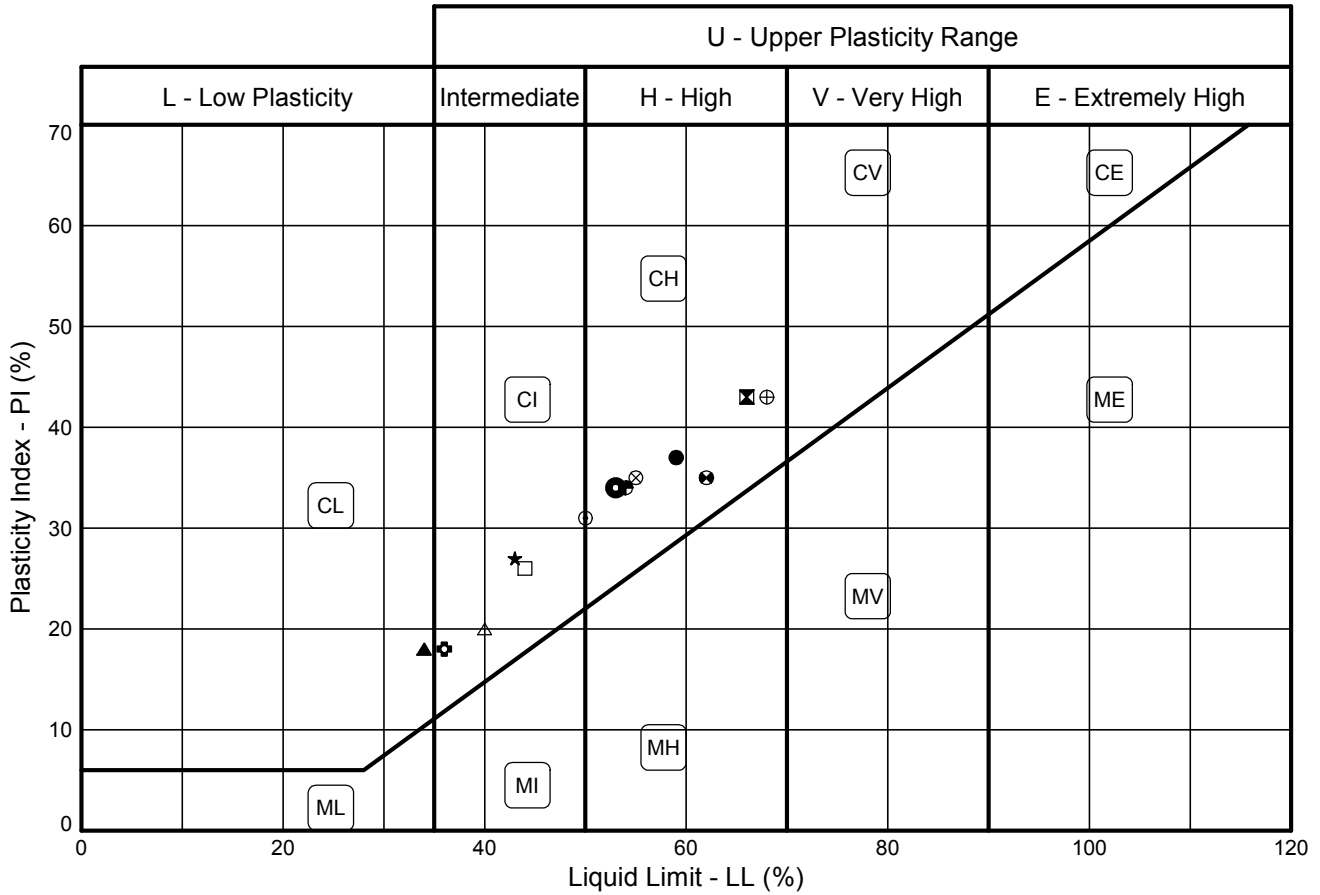
Sample Identification				BS Test Method #	Preparation Method +	MC %	LL %	PL %	PI %	<425um %	Lab location
Exploratory Position ID	Sample	Depth (m)									
●	BHA1	4D	3.00	3.2/4.4/5.3/5.4	4.2.4	20	59	22	37	99	C
⊠	BHA2	1D	1.20	3.2/4.4/5.3/5.4	4.2.3	19	66	23	43	100	C
▲	BHA6	1B	0.60	3.2/4.4/5.3/5.4	4.2.4	23	34	16	18	83	C
★	BHA6	2B	2.50	3.2/4.4/5.3/5.4	4.2.3	25	43	16	27	100	C
⊙	BHA8	1B	0.50	3.2/4.4/5.3/5.4	4.2.4	25	50	19	31	92	C
⊕	BHA8	2U	2.50	3.2/4.4/5.3/5.4	4.2.4	17	36	18	18	84	C
⊙	BHA10	1B	0.50	3.2/4.4/5.3/5.4	4.2.4	24	53	19	34	91	C
△	BHA10	4B	3.50	3.2/4.4/5.3/5.4	4.2.3	24	40	20	20	100	C
⊗	BHA10	6B	5.50	3.2/4.4/5.3/5.4	4.2.3	24	55	20	35	100	C
⊕	BHA10	10U	9.50	3.2/4.4/5.3/5.4	4.2.3	25	68	25	43	100	C
□	BHA12	1U	2.50	3.2/4.4/5.3/5.4	4.2.4	19	44	18	26	77	C
⊗	BHA13	1U	2.50	3.2/4.4/5.3/5.4	4.2.4	27	62	27	35	87	C
⊕	BHA14	3U	6.50	3.2/4.4/5.3/5.4	4.2.4	21	54	20	34	98	C

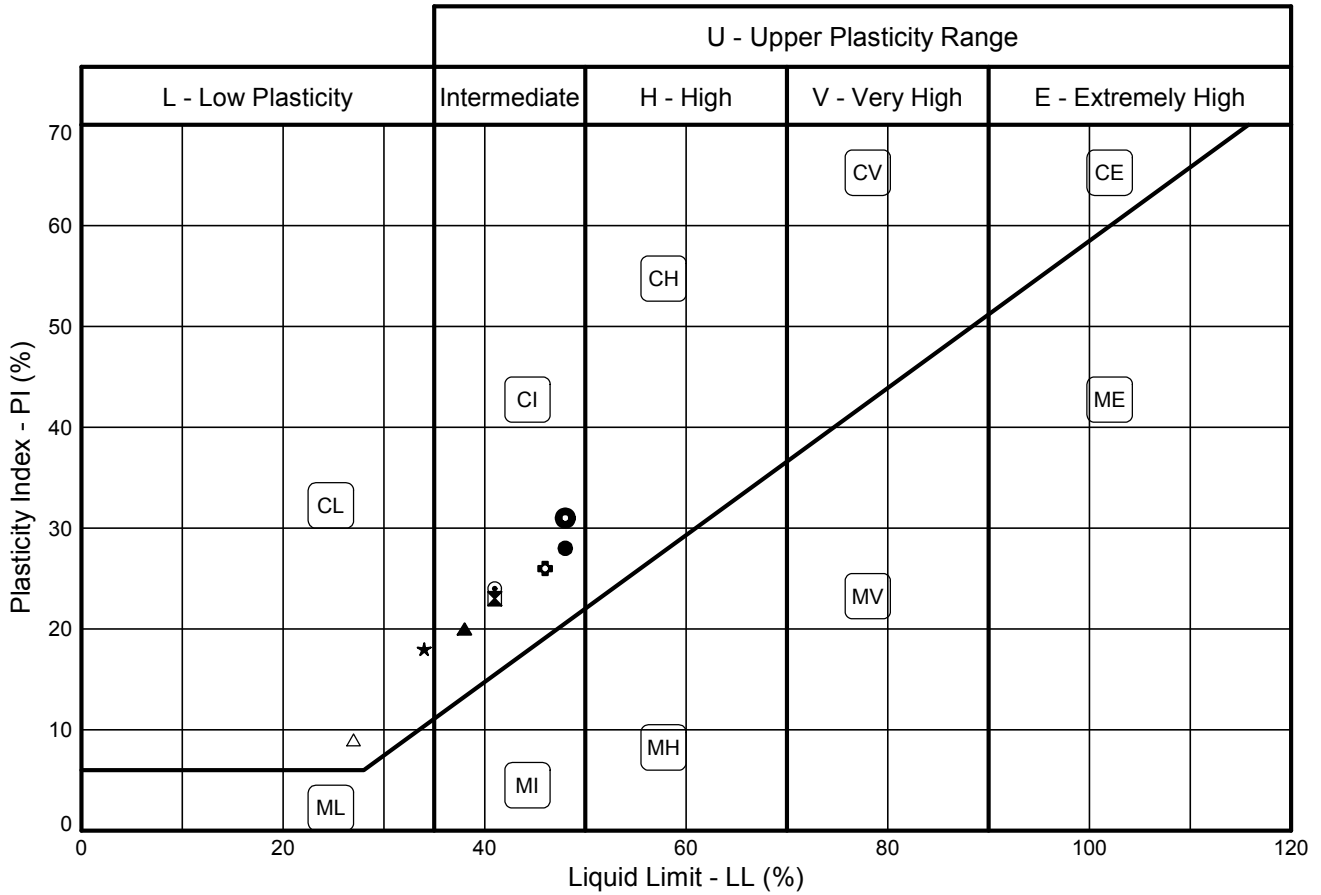
Sample Identification				BS Test Method #	Preparation Method +	MC %	LL %	PL %	PI %	<425um %	Lab location
Exploratory Position ID	Sample	Depth (m)									
●	TPA1	1B	0.80	3.2/4.4/5.3/5.4	4.2.4	25	48	20	28	96	C
⊠	TPA2	1B	1.50	3.2/4.4/5.3/5.4	4.2.4	20	41	18	23	94	C
▲	TPA2	2B	2.50	3.2/4.4/5.3/5.4	4.2.4	19	38	18	20	94	C
★	TPA3	1B	1.00	3.2/4.4/5.3/5.4	4.2.4	20	34	16	18	85	C
⊙	WSA12	1B	1.00	3.2/4.4/5.3/5.4	4.2.4	18	41	17	24	65	C
⊕	WSA12	2B	3.00	3.2/4.4/5.3/5.4	4.2.4	24	46	20	26	92	C
⦿	WSA13	1B	1.00	3.2/4.4/5.3/5.4	4.2.4	21	48	17	31	72	C
△	WSA15	1B	2.00	3.2/4.4/5.3/5.4	4.2.4	22	27	18	9	89	C

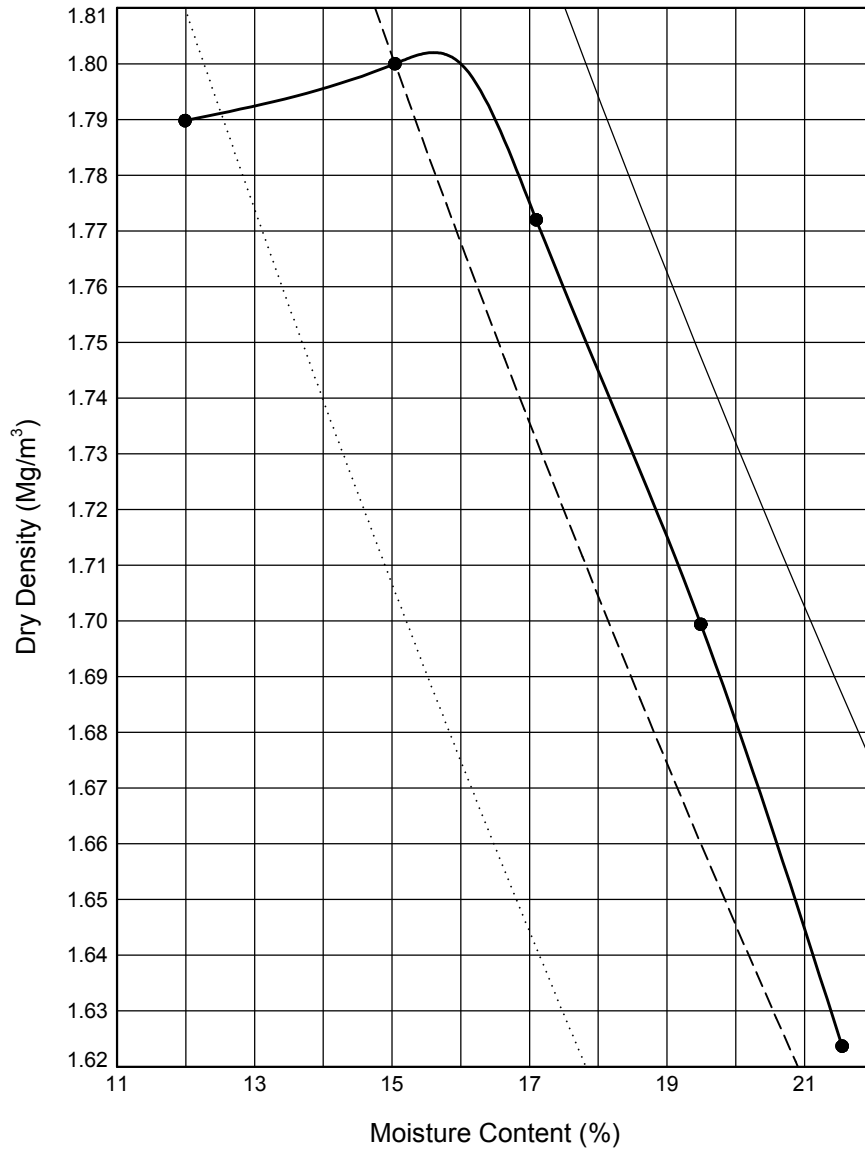
Trial Pit: **TPA2** Sample Ref: **2** Sample Type: **B** Depth (m): **2.50**

Initial Sample Conditions		Test Details		Test Results	
Initial Moisture Content (%)	: 19	Compaction Type	: Heavy	Maximum Dry Density (Mg/m³)	: 1.80
% Retained on 37.5mm BS Sieve	: 0	Mass of Rammer (kg):	4.5	Optimum Moisture Content (%)	: 16
% Retained on 20.0mm BS Sieve	: 0	Type of Mould	: Proctor	Method Used:	Clause 3.5
Particle Density - assumed (Mg/m³)	: 2.65	Remarks:			
Size of Soil Pieces	: <20mm				
Sample Description			Key to Air Voids Lines		
Brown slightly sandy slightly gravelly CLAY			———— 0%	----- 5% 10%

Only one compaction test was undertaken on the Oadby Member, and this indicates an optimum moisture content of 16% however, the sample tested had a natural moisture content exceeding this suggesting that these materials are wet of optimum for reuse.

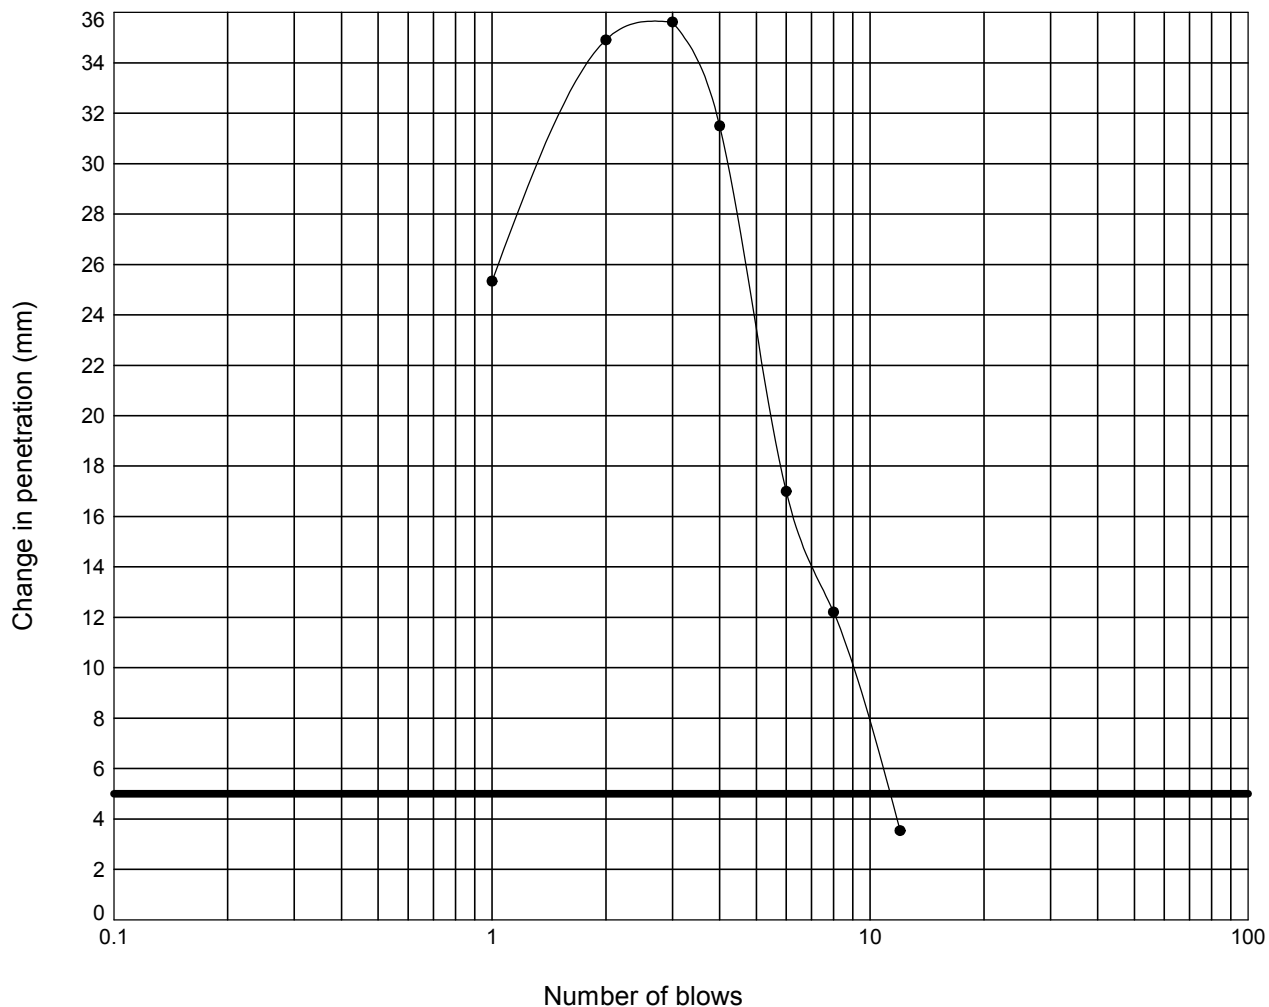
Description : **Brown slightly sandy slightly gravelly CLAY**

Moisture Content :	= 25	%
Percentage retained on 20 mm sieve :	= 0	%
Moisture Condition Value :	= 9.2	
Interpretation of curve:	= Steepest straight line - Fig 9

MCV single point testing carried out on a 5 typical samples at natural moisture content, suggests that the 5 samples tested at as dug moisture contents fall within a suitable envelope for MCV and moisture content and should therefore be compactable.

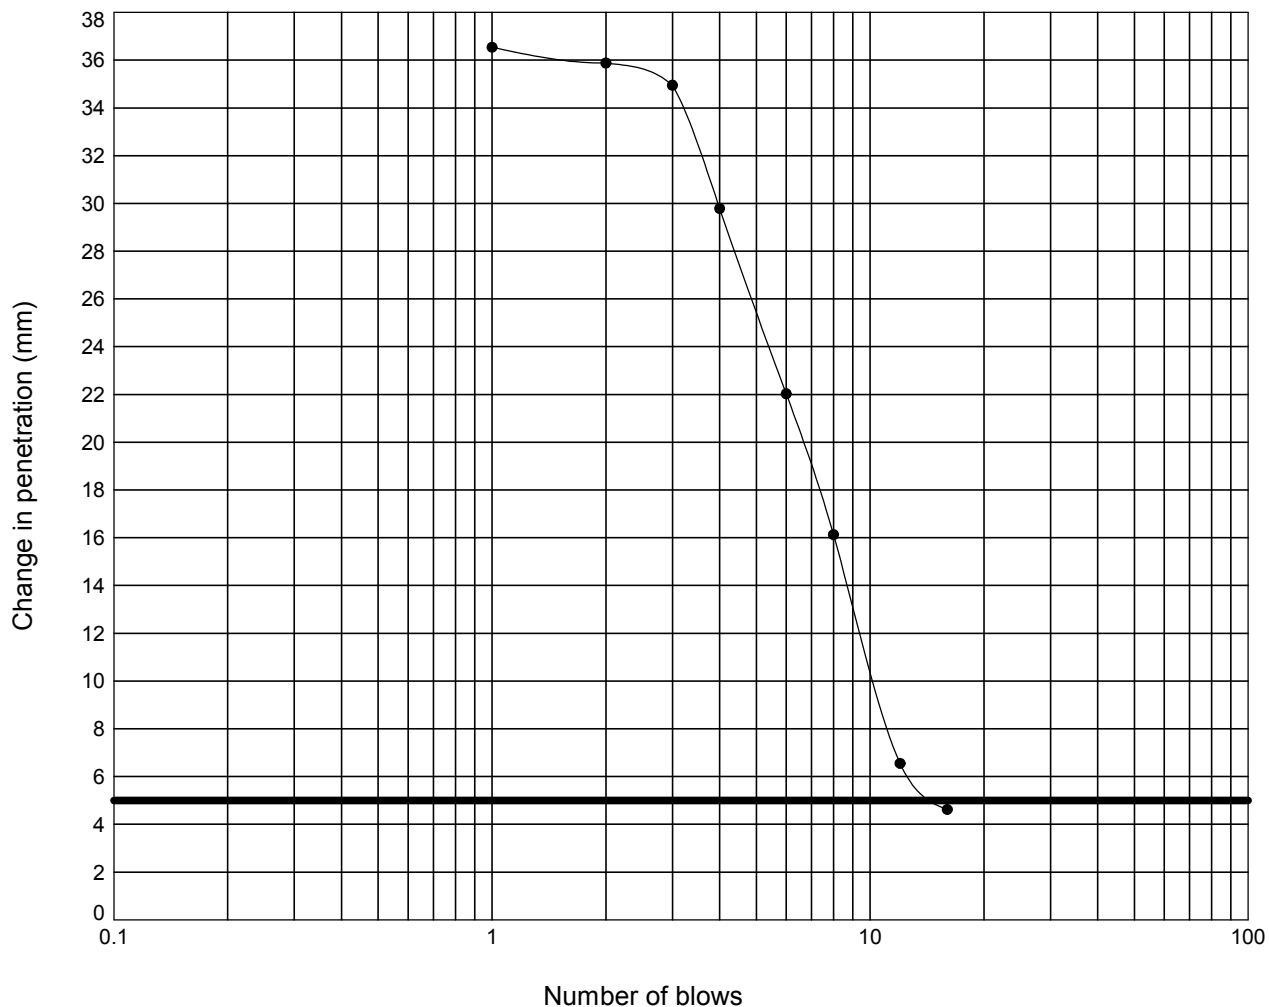
Description : **Dark grey slightly sandy CLAY**

Moisture Content :	= 22	%
Percentage retained on 20 mm sieve :	= 0	%
Moisture Condition Value :	= 11.1	
Interpretation of curve:	= Steepest straight line - Fig 9

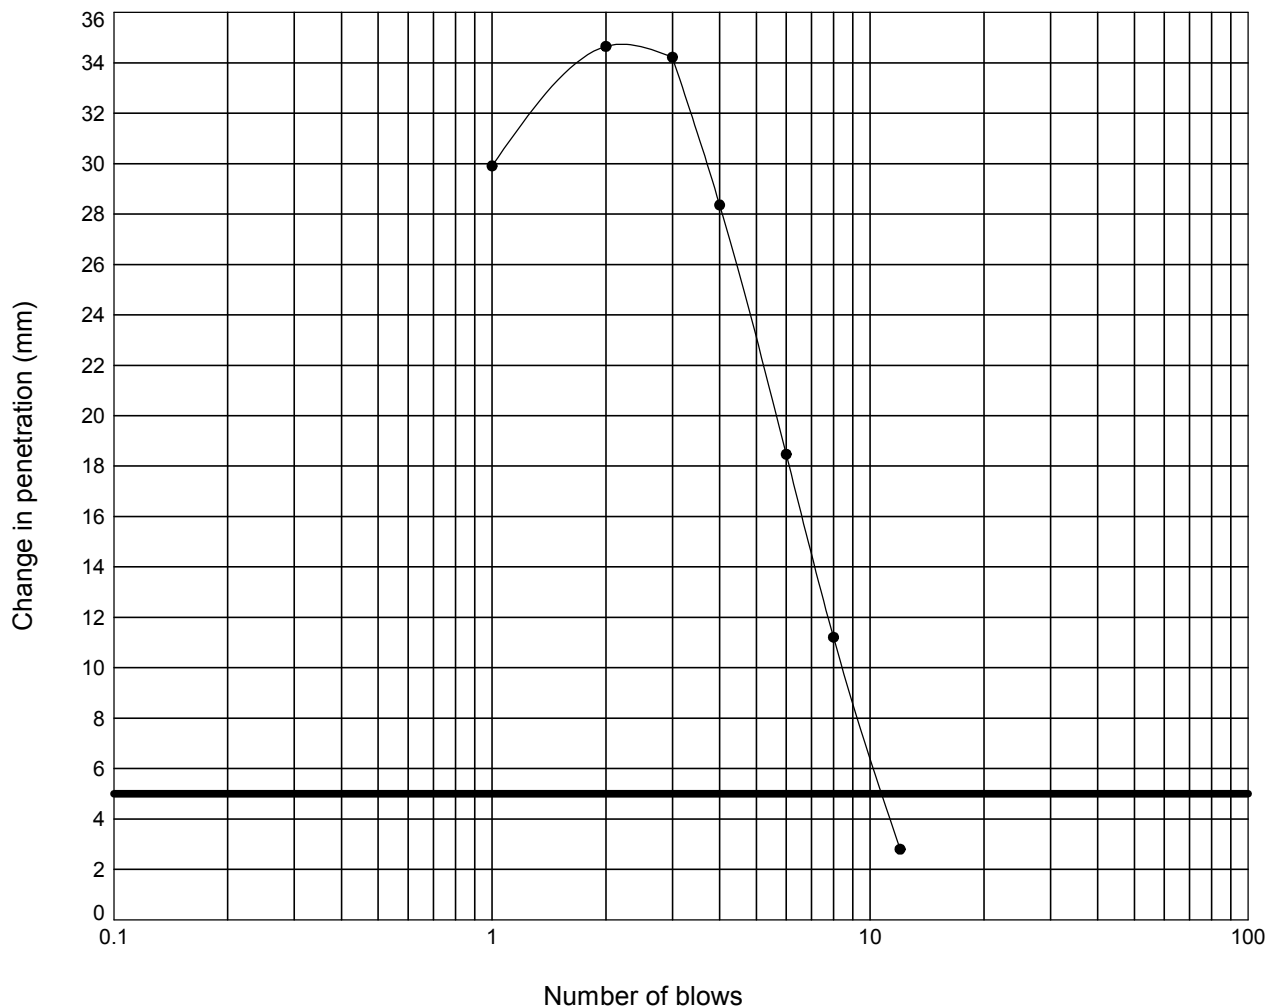
Description : **Grey slightly gravelly CLAY**

Moisture Content :	=	31	%
Percentage retained on 20 mm sieve :	=	0	%
Moisture Condition Value :	=	10.1	
Interpretation of curve:	=	Steepest straight line - Fig 9

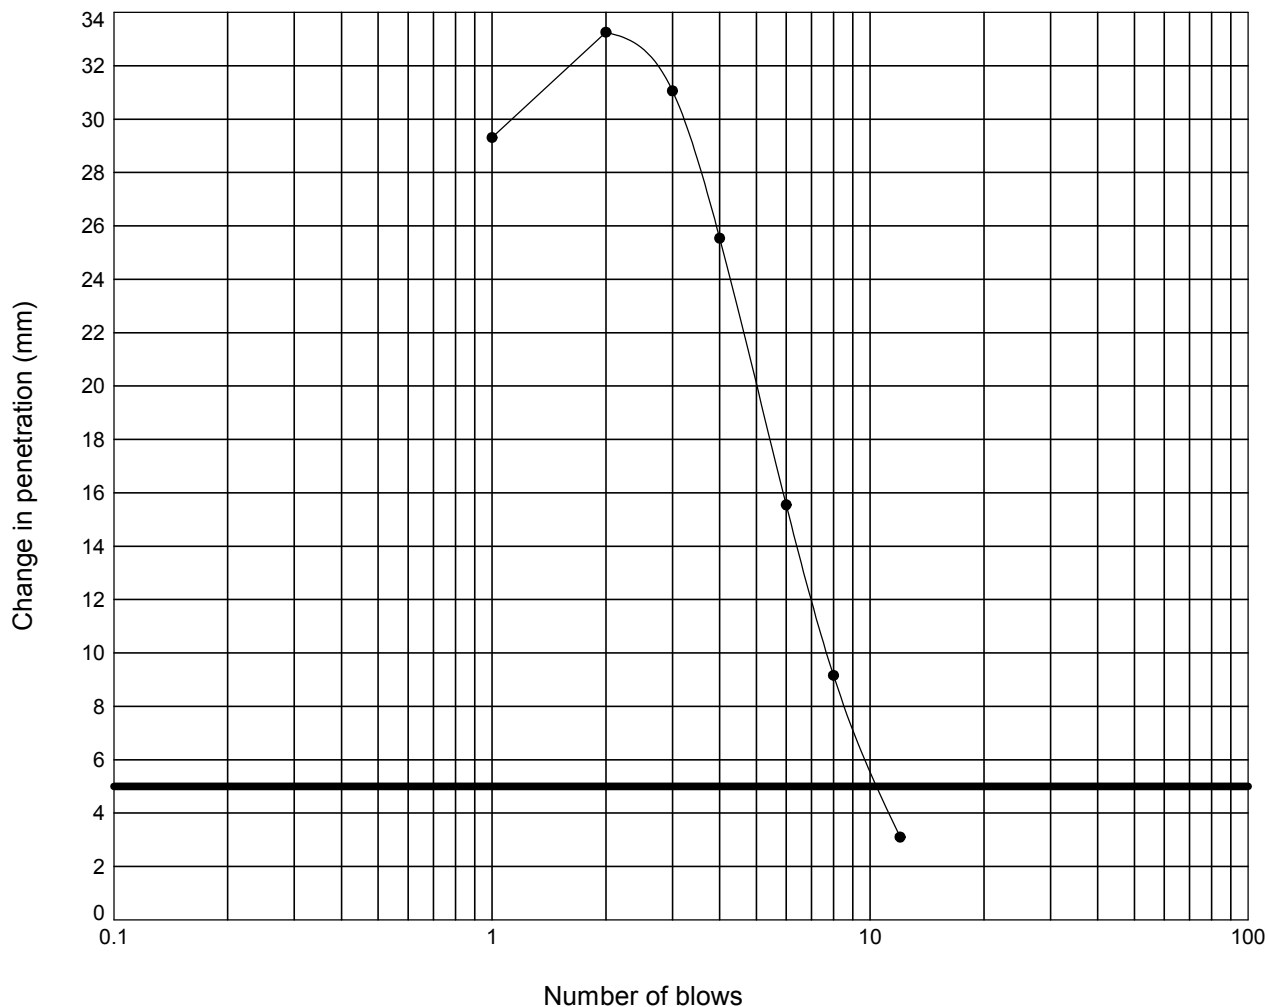
Description : **Grey slightly gravelly CLAY**

Moisture Content :	= 29	%
Percentage retained on 20 mm sieve :	= 0	%
Moisture Condition Value :	= 9.6	
Interpretation of curve:	= Steepest straight line - Fig 9

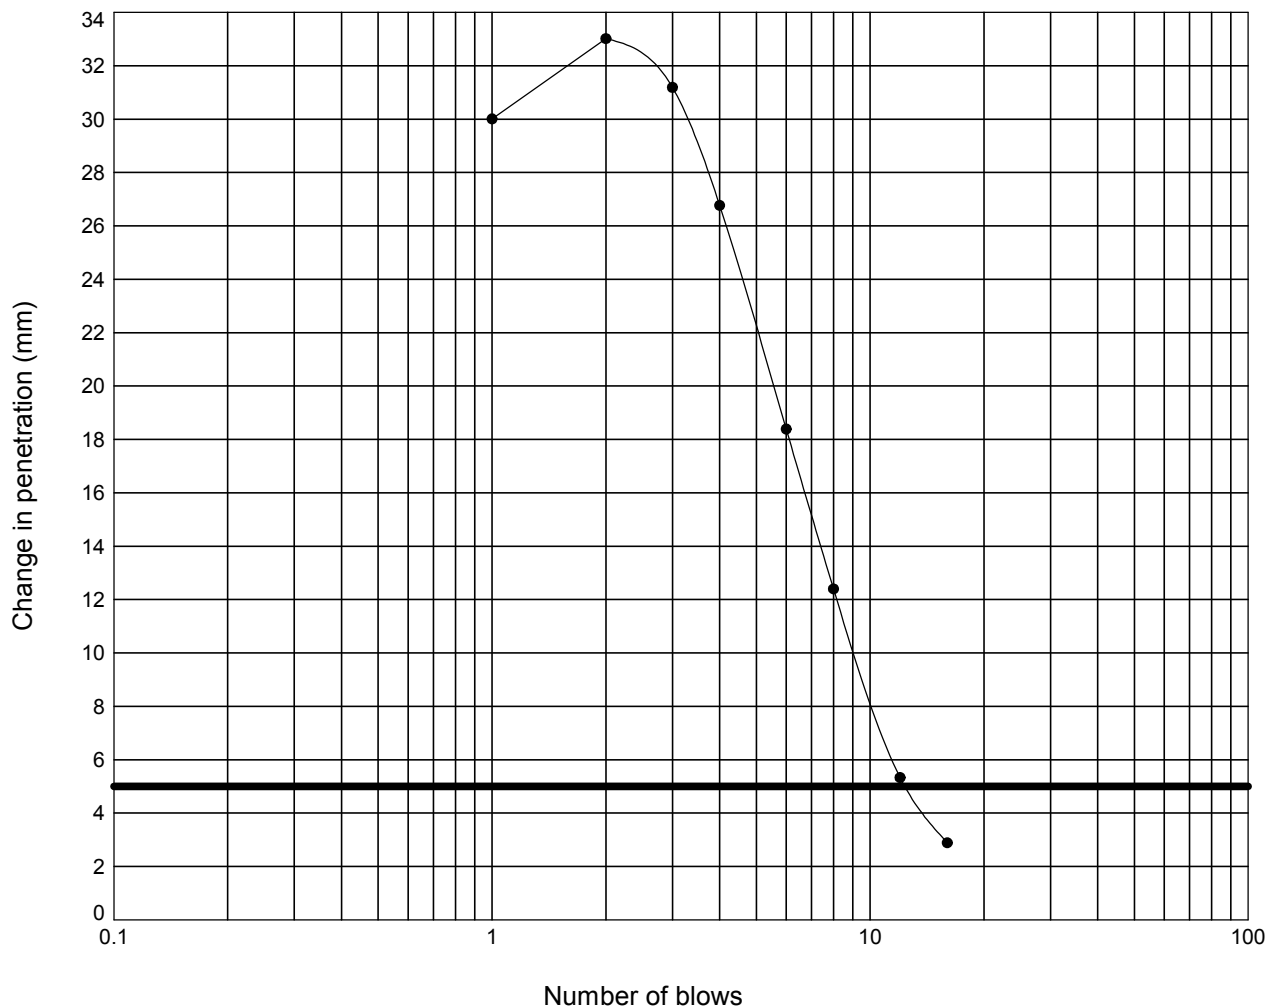
Description : **Brown slightly sandy slightly gravelly CLAY**

Moisture Content :	= 20	%
Percentage retained on 20 mm sieve :	= 0	%
Moisture Condition Value :	= 10.6	
Interpretation of curve:	= Steepest straight line - Fig 9

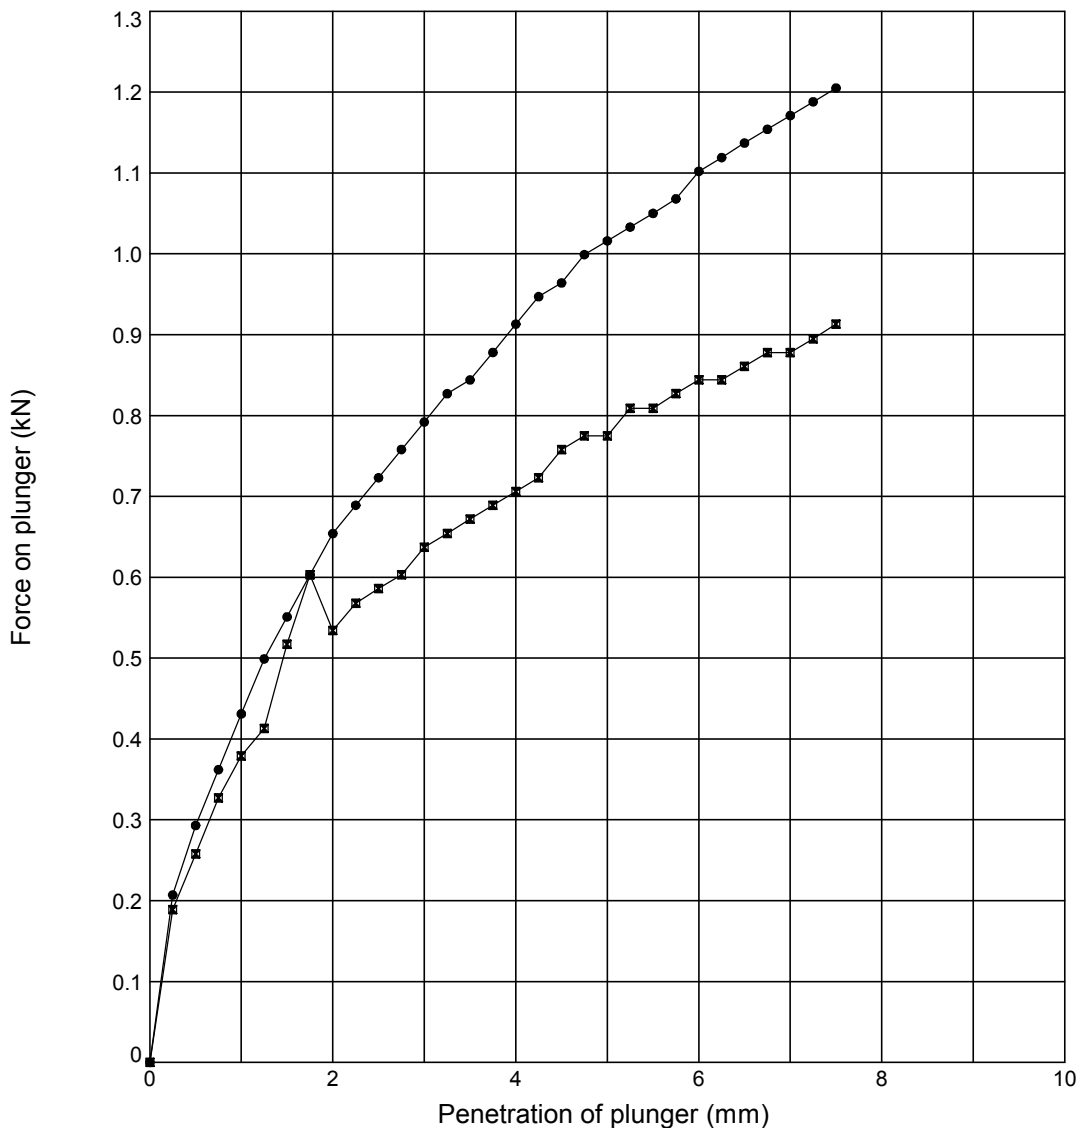
Borehole: **BHA10** Sample Ref: **2** Sample Type: **B** Depth (m): **1.00**

Initial Sample Conditions		Test Details		Test Results	Top	Base
Initial Moisture Content (%)	: 15	Compaction Type	: 4.5 kg Dynamic	Moisture Content (%)	15	16
Initial Bulk Density (Mg/m ³)	: 2.05	Surcharge (kg)	: 4.0	CBR value (%)	5.5	4.4
Initial Dry Density (Mg/m ³)	: 1.79	Soaking Time (hrs)	: -	Remarks: None		
% retained on 20mm sieve	: 0	Swelling (mm)	: -			
Sample Description				Key		
Grey slightly sandy CLAY				● Top ⊠ Base
