M1 Junction 15 West – Extended Development Site

Supplementary Geotechnical & Geoenvironmental Investigation

313582-02 (00)

Title: Supplementary ground investigation interpretive report: M1 Junction 15 West – Extended Development Site

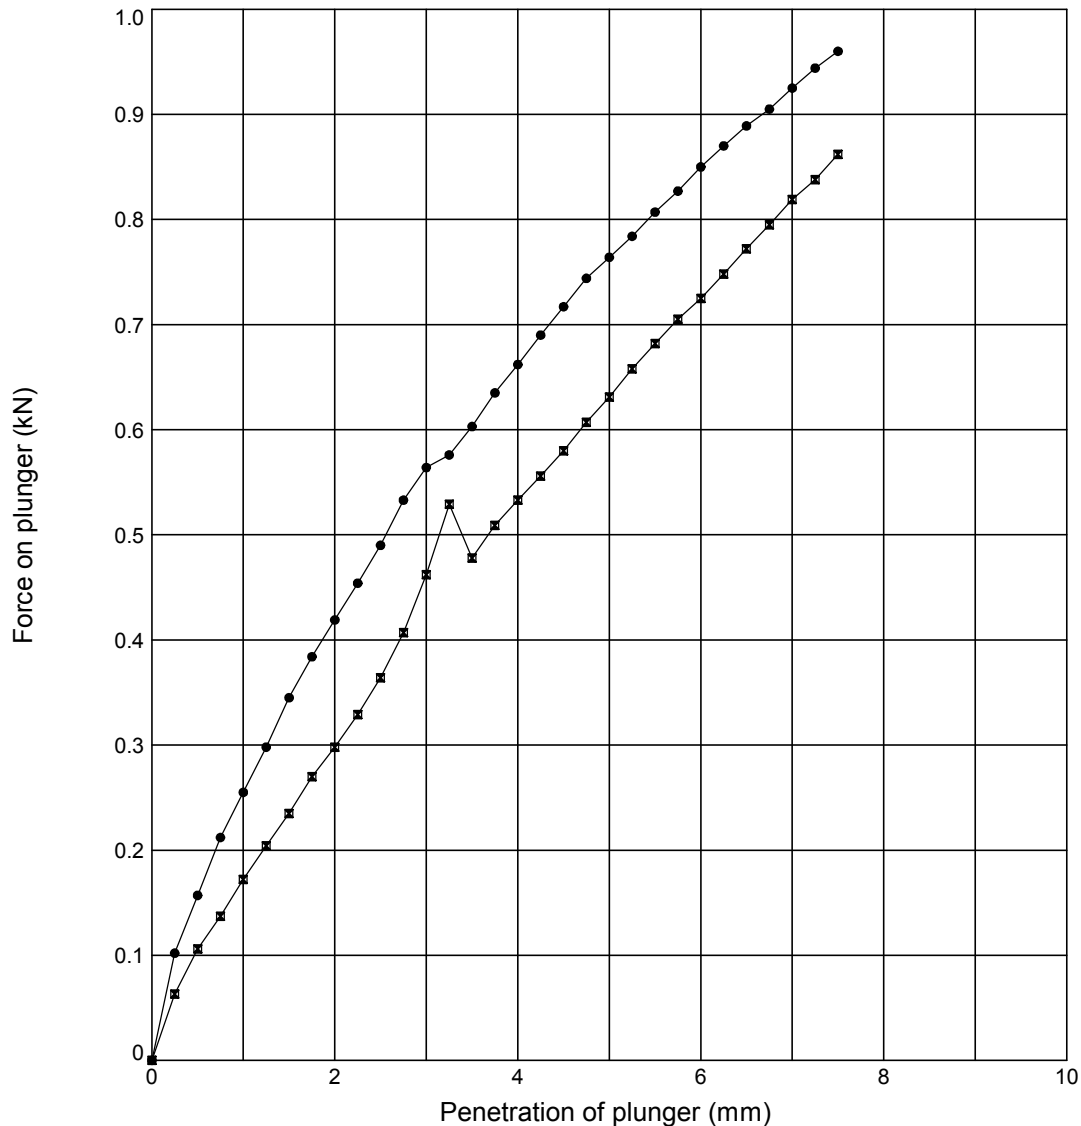
Trial Pit: **TPA2** Sample Ref: **2** Sample Type: **B** Depth (m): **2.50**

Initial Sample Conditions		Test Details		Test Results	Top	Base
Initial Moisture Content (%)	: 20	Compaction Type	: 4.5 kg Dynamic	Moisture Content (%)	20	20
Initial Bulk Density (Mg/m ³)	: 2.08	Surcharge (kg)	: 4.0	CBR value (%)	3.8	3.2
Initial Dry Density (Mg/m ³)	: 1.73	Soaking Time (hrs)	: -	Remarks: None		
% retained on 20mm sieve	: 0	Swelling (mm)	: -			
Sample Description				Key		
Brown slightly sandy slightly gravelly CLAY				● Top ⊠ Base
