Roxhill Developments Limited

M1 Junction 15 West - Roade Bypass

Interpretative Ground Investigation Report

313583-02 (00)

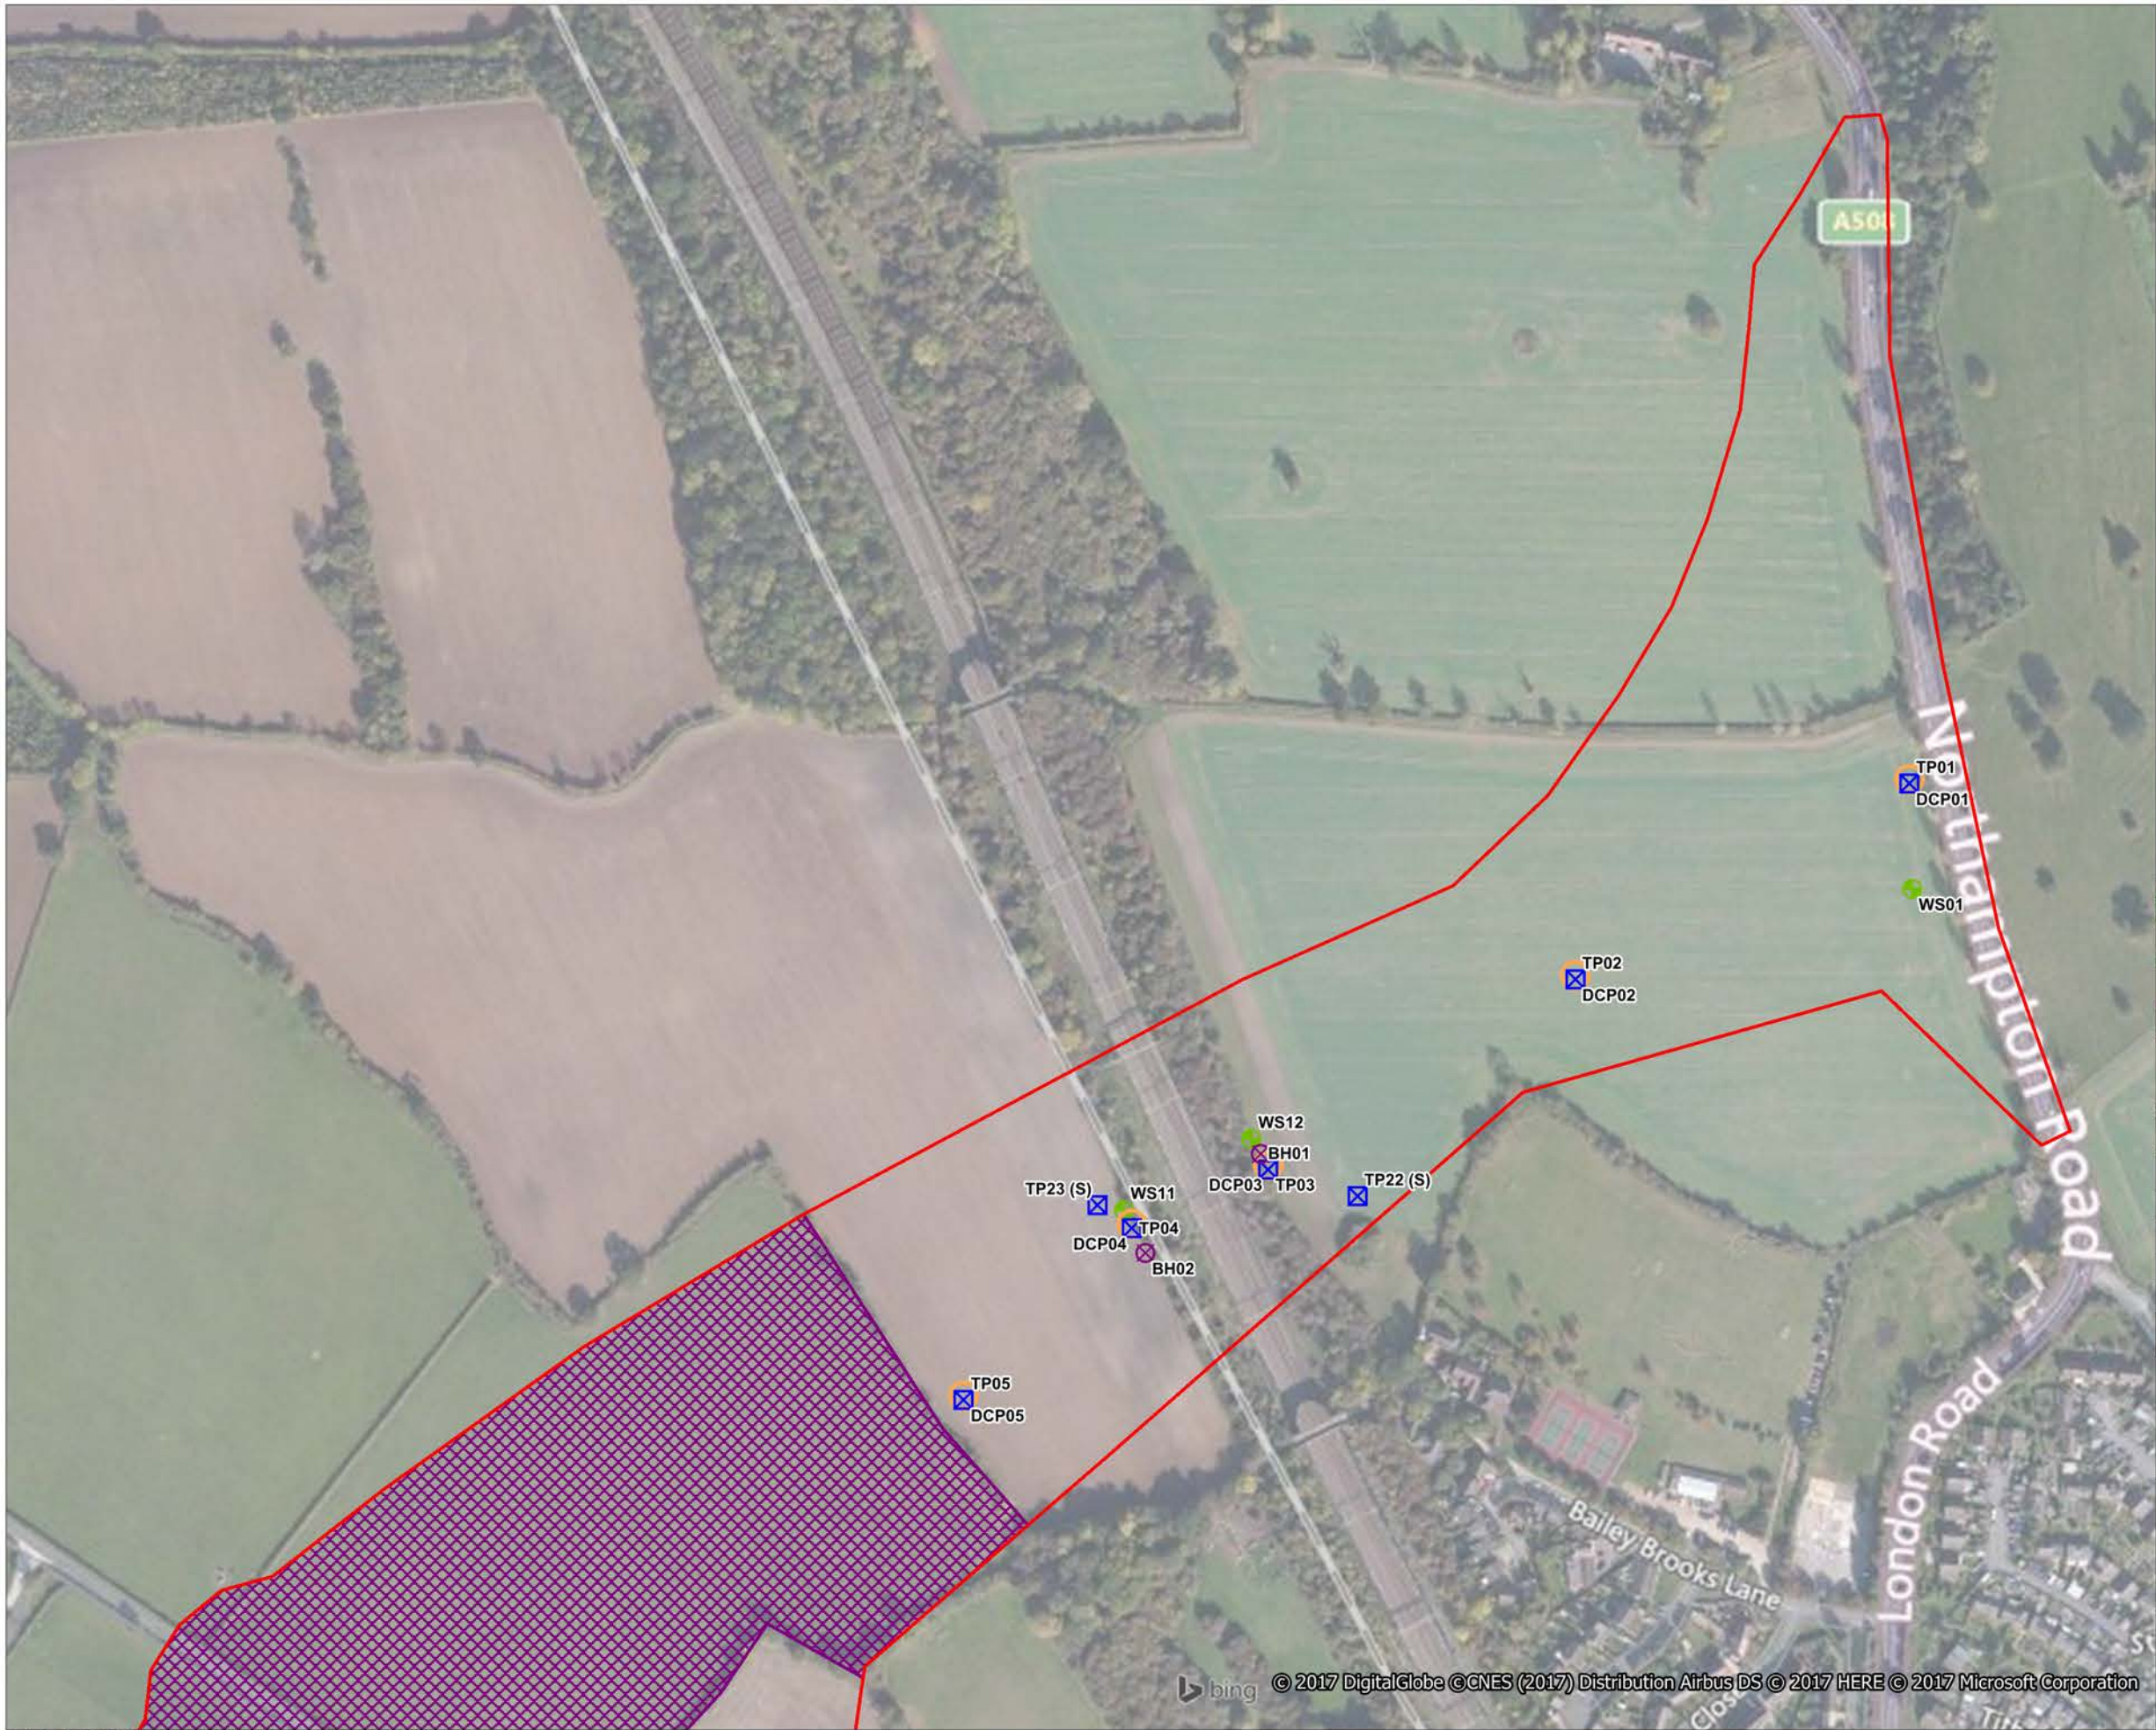
Figure 2
As Built Exploratory Hole Location Plan
Map 1 of 3

Trial pits 6, 8, 9, 10, 11, 19, 21, 24 and 25 were not excavated as access permissions were not in place at the time of works

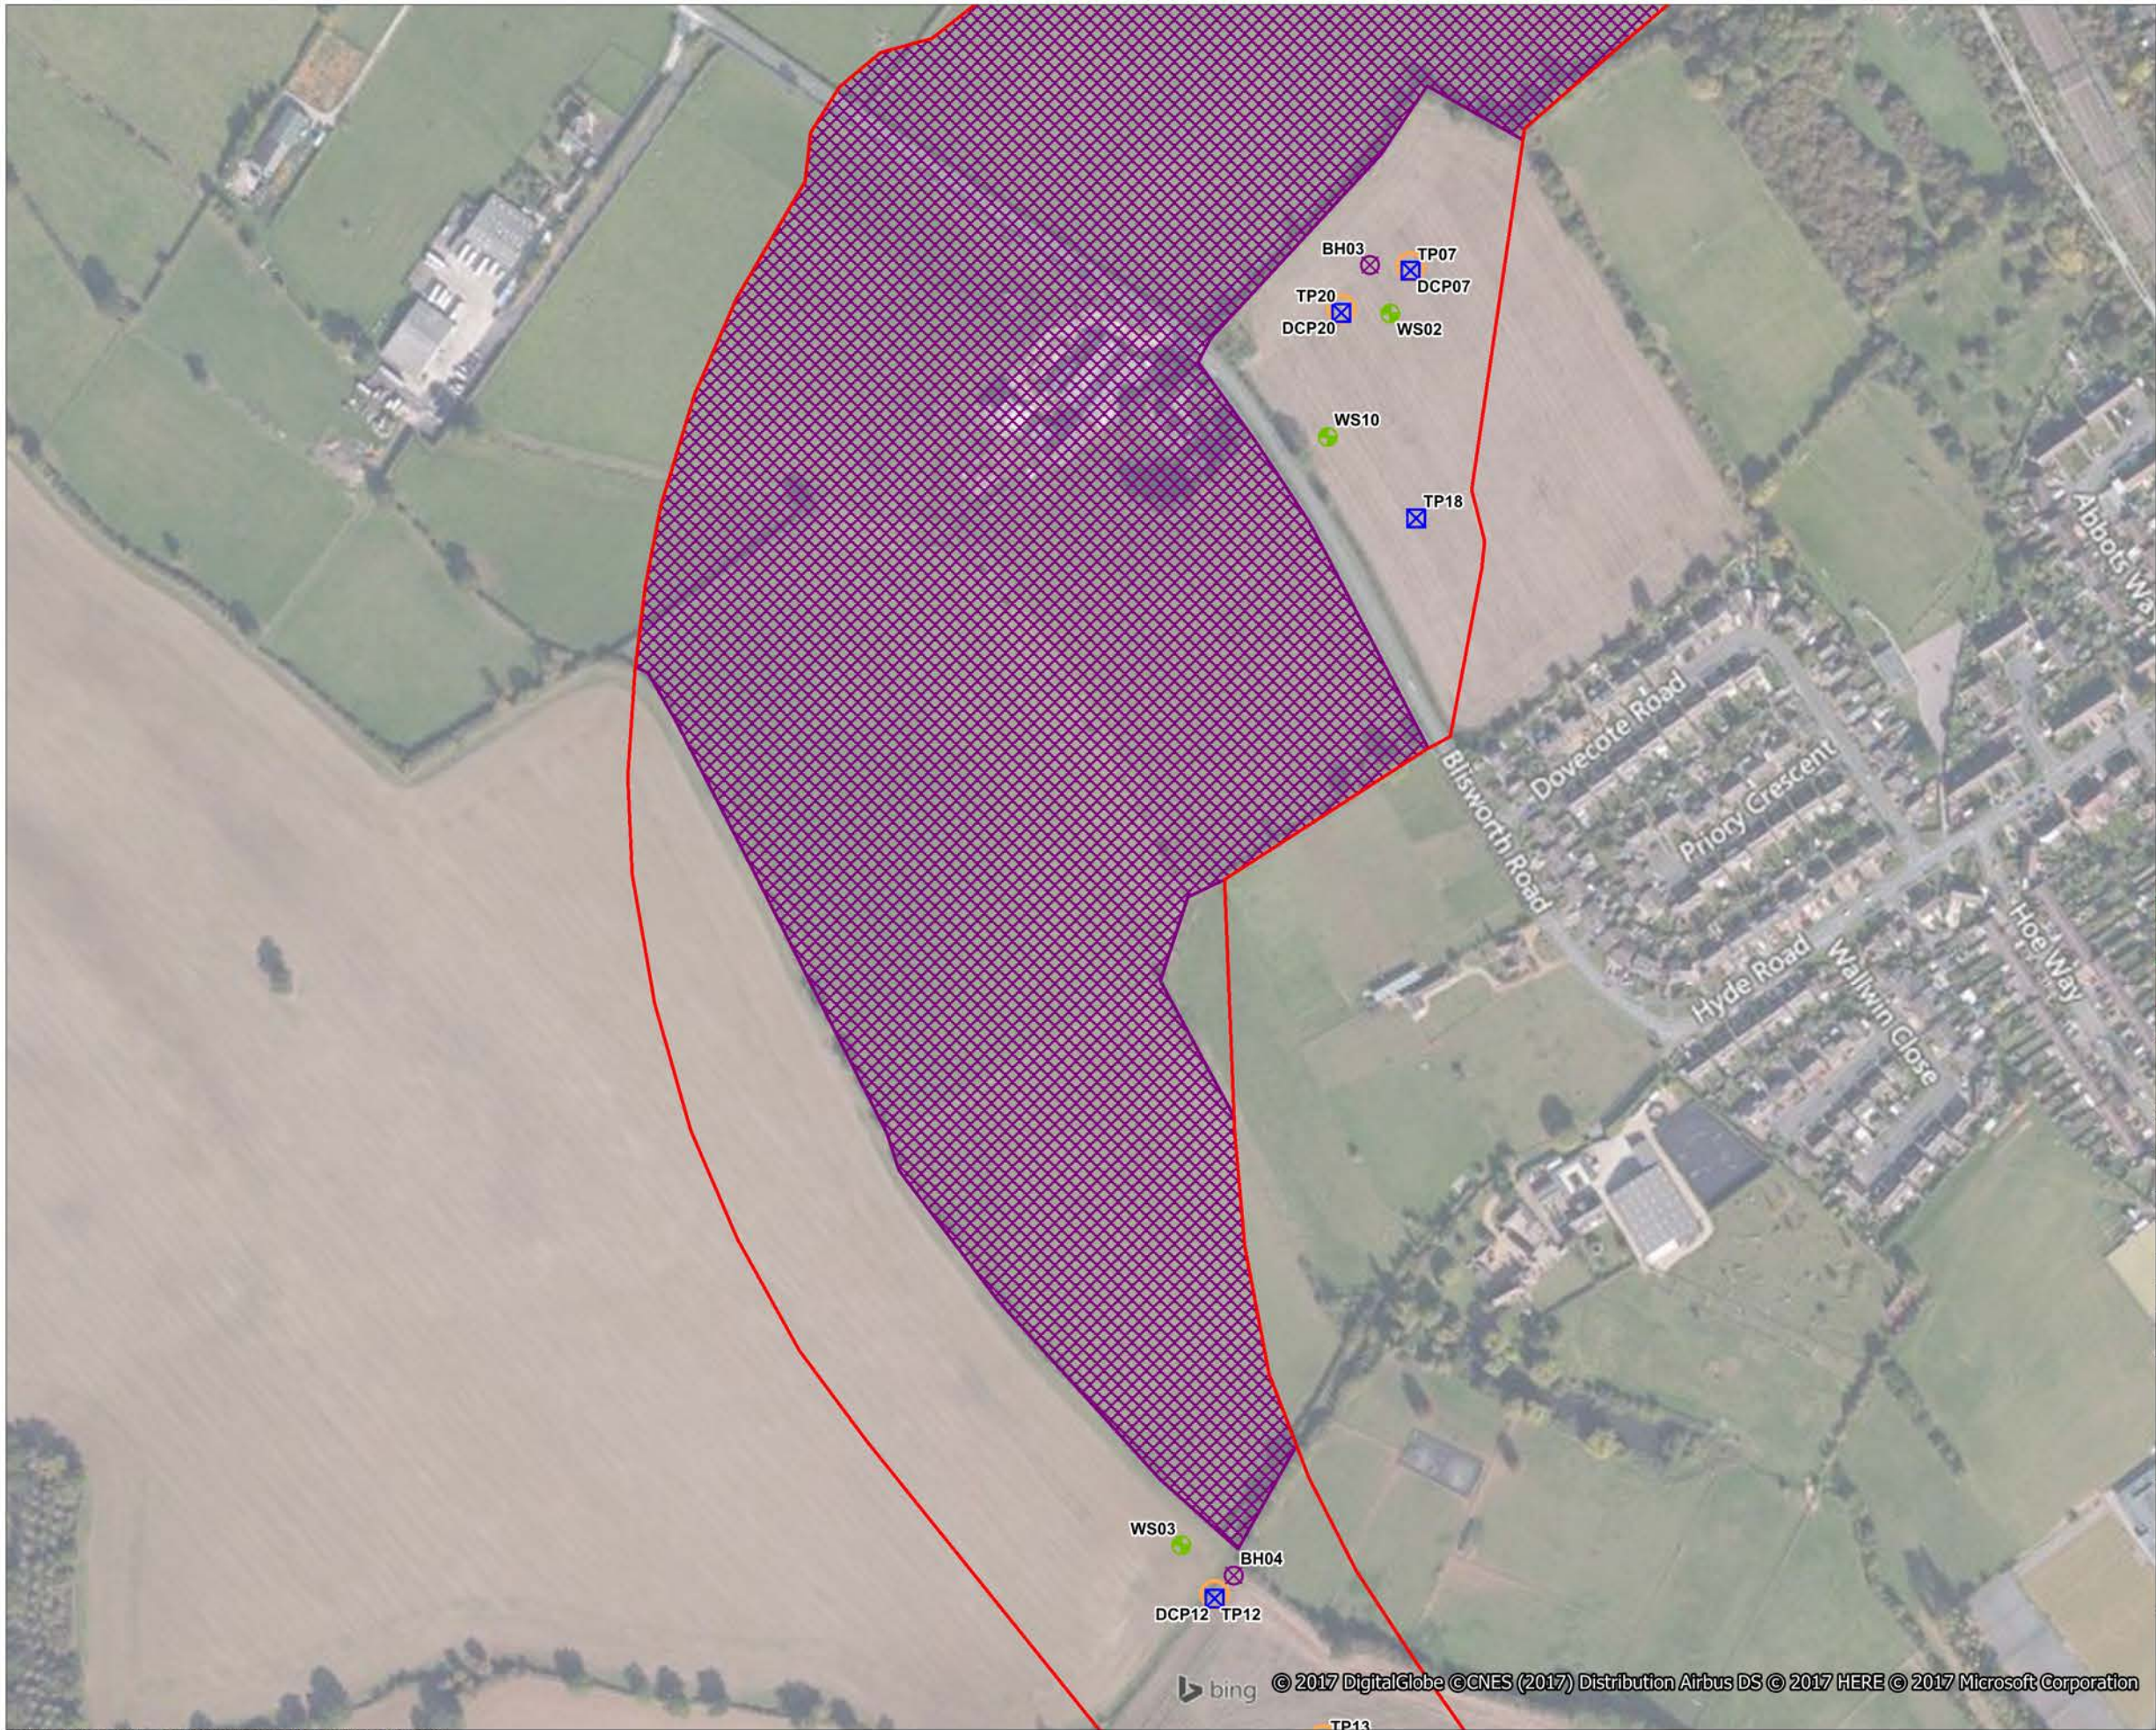
- Site boundary (Feb 2017)
- Borehole (BH)
- Dynamic Cone Penetrometer (DCP)
- Trial Pit (TP) with Soakaway (S)
- Window Sample (WS)
- No access

Trial pits 6, 8, 9, 10, 11, 19, 21, 24 and 25 were not excavated as access permissions were not in place at the time of works

Access to numerous parcels (plots 100, 105 and 120) of land were not granted. Therefore several trial pits TP06, 08, 09, 10, 11, 19, 21, 24 and 25 were not undertaken as planned within the central portion of the route alignment. This is shown on Figure 2.

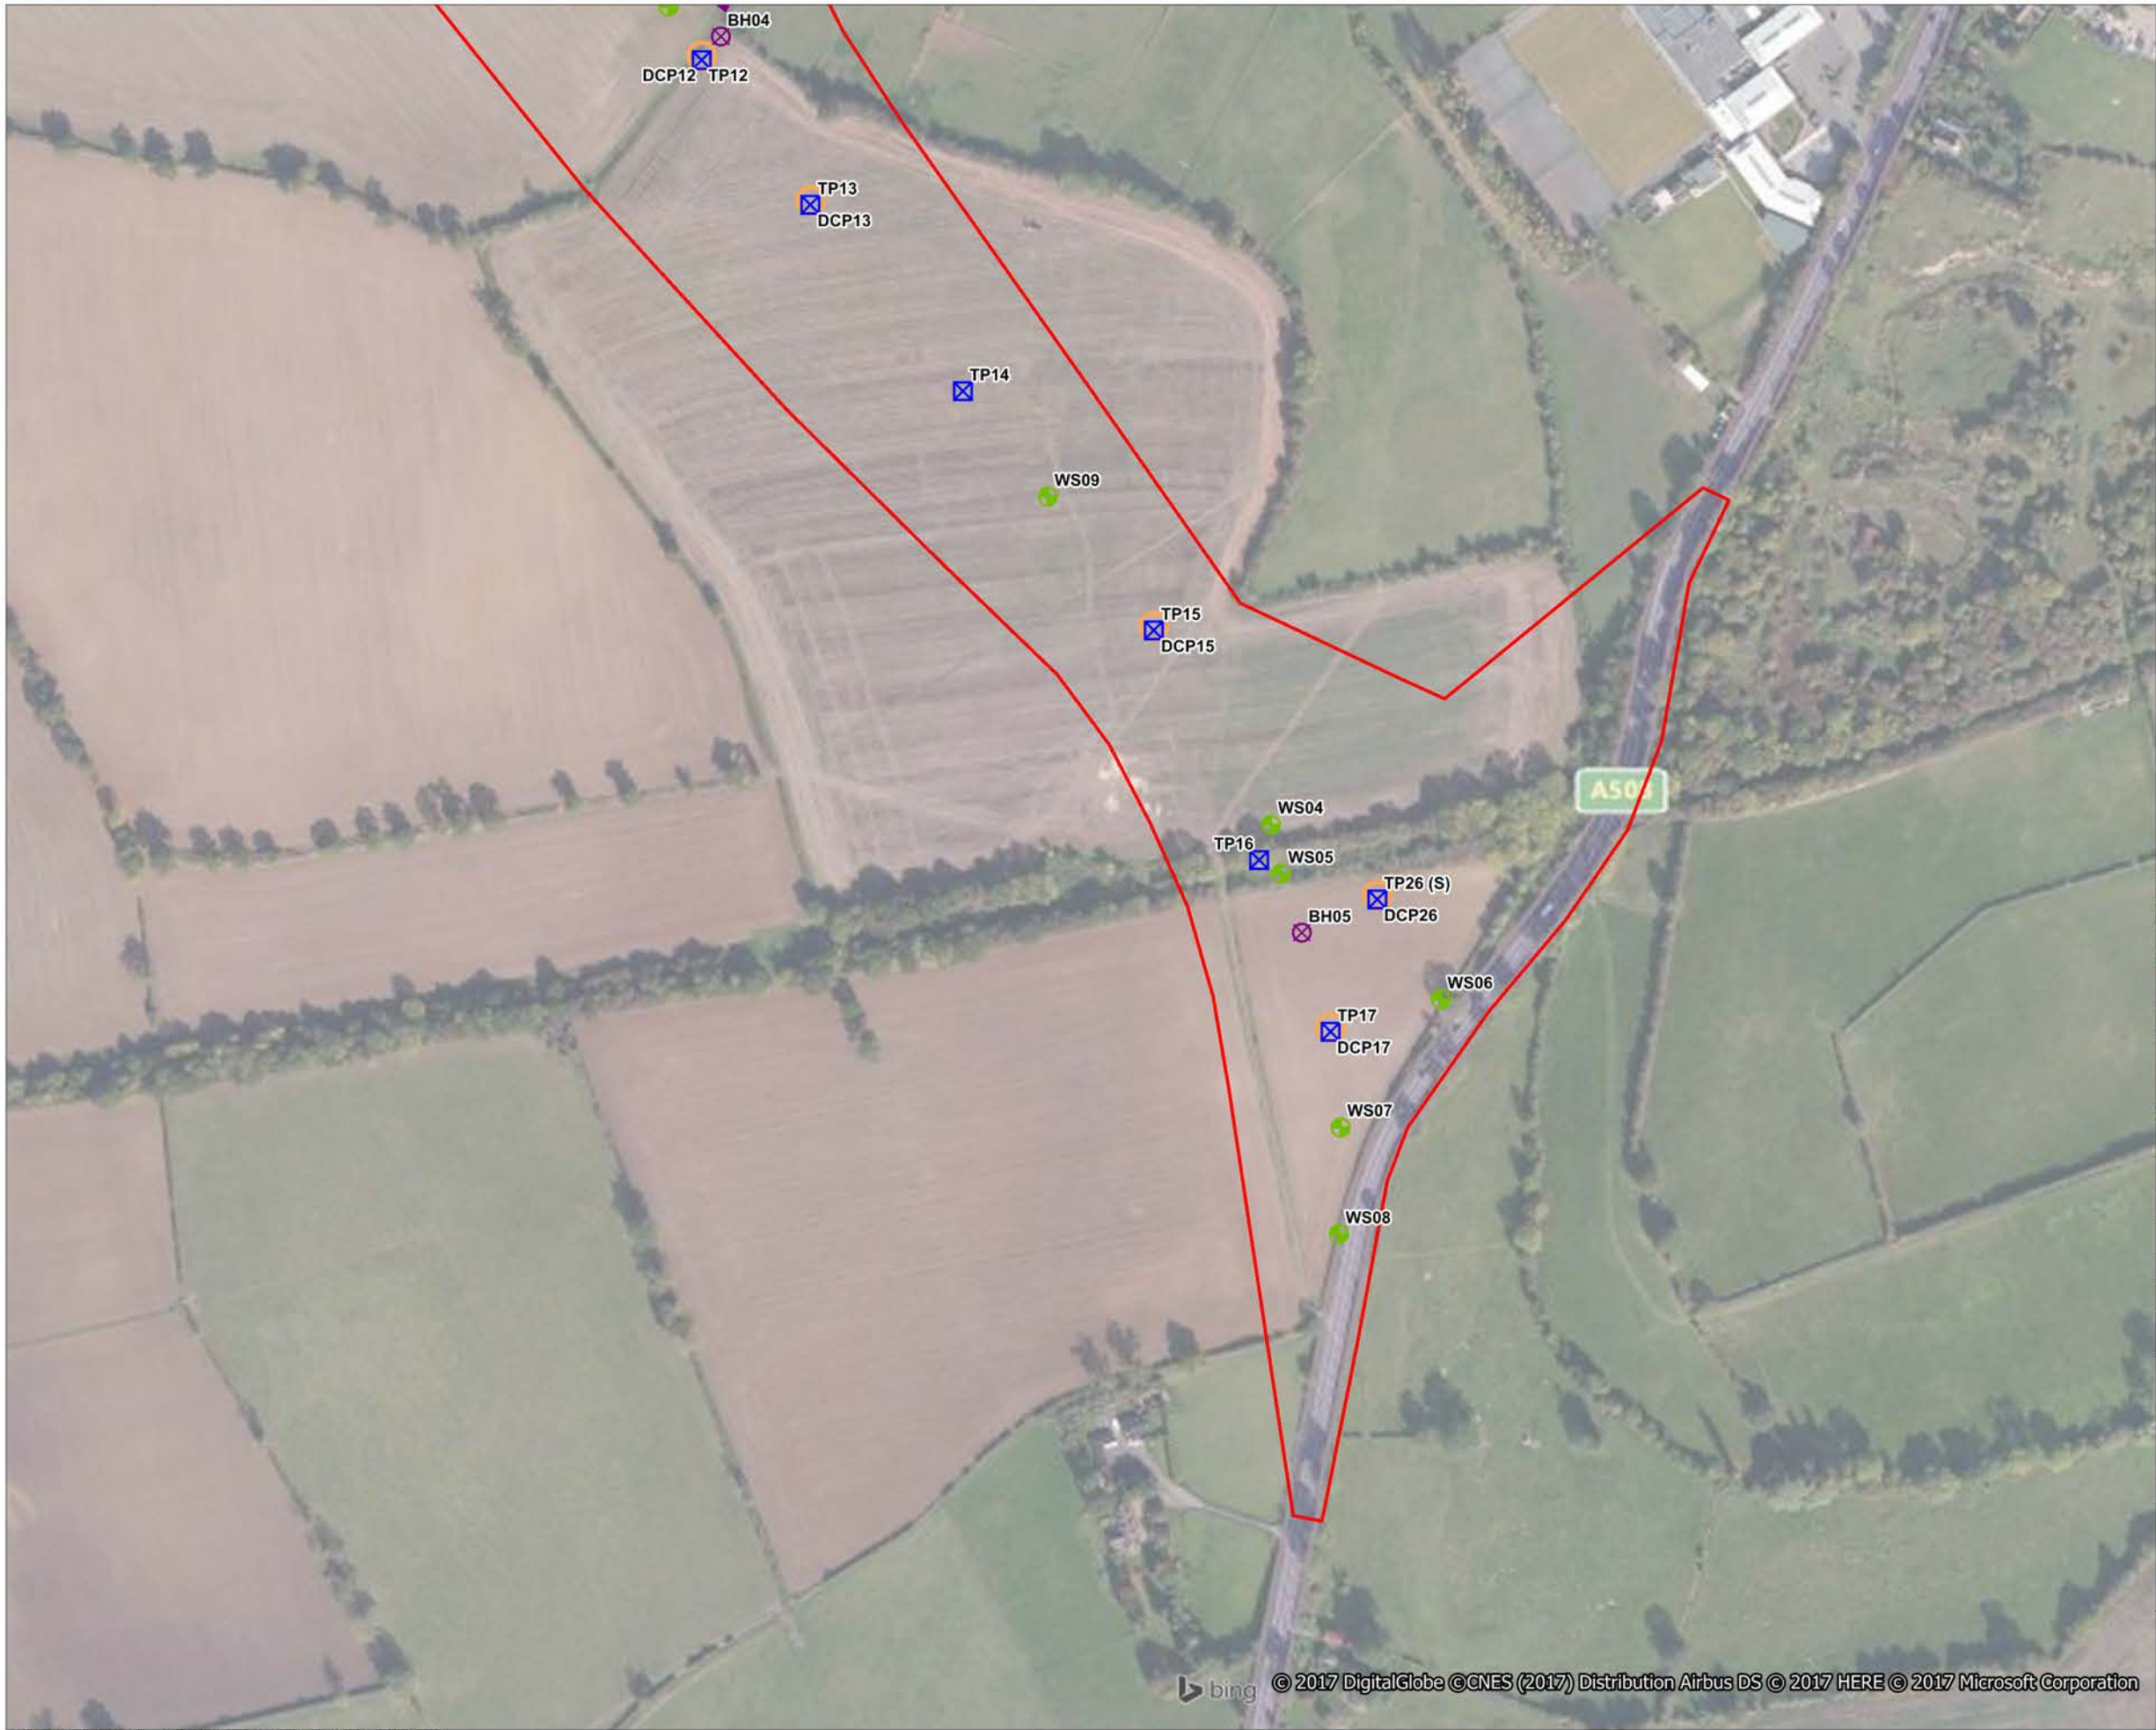
Figure 2
As Built Exploratory Hole Location Plan
Map 2 of 3

- Site boundary (Feb 2017)
- Borehole (BH)
- Dynamic Cone Penetrometer (DCP)
- Trial Pit (TP) with Soakaway (S)
- Window Sample (WS)
- No access

Trial pits 6, 8, 9, 10, 11, 19, 21, 24 and 25 were not excavated as access permissions were not in place at the time of works

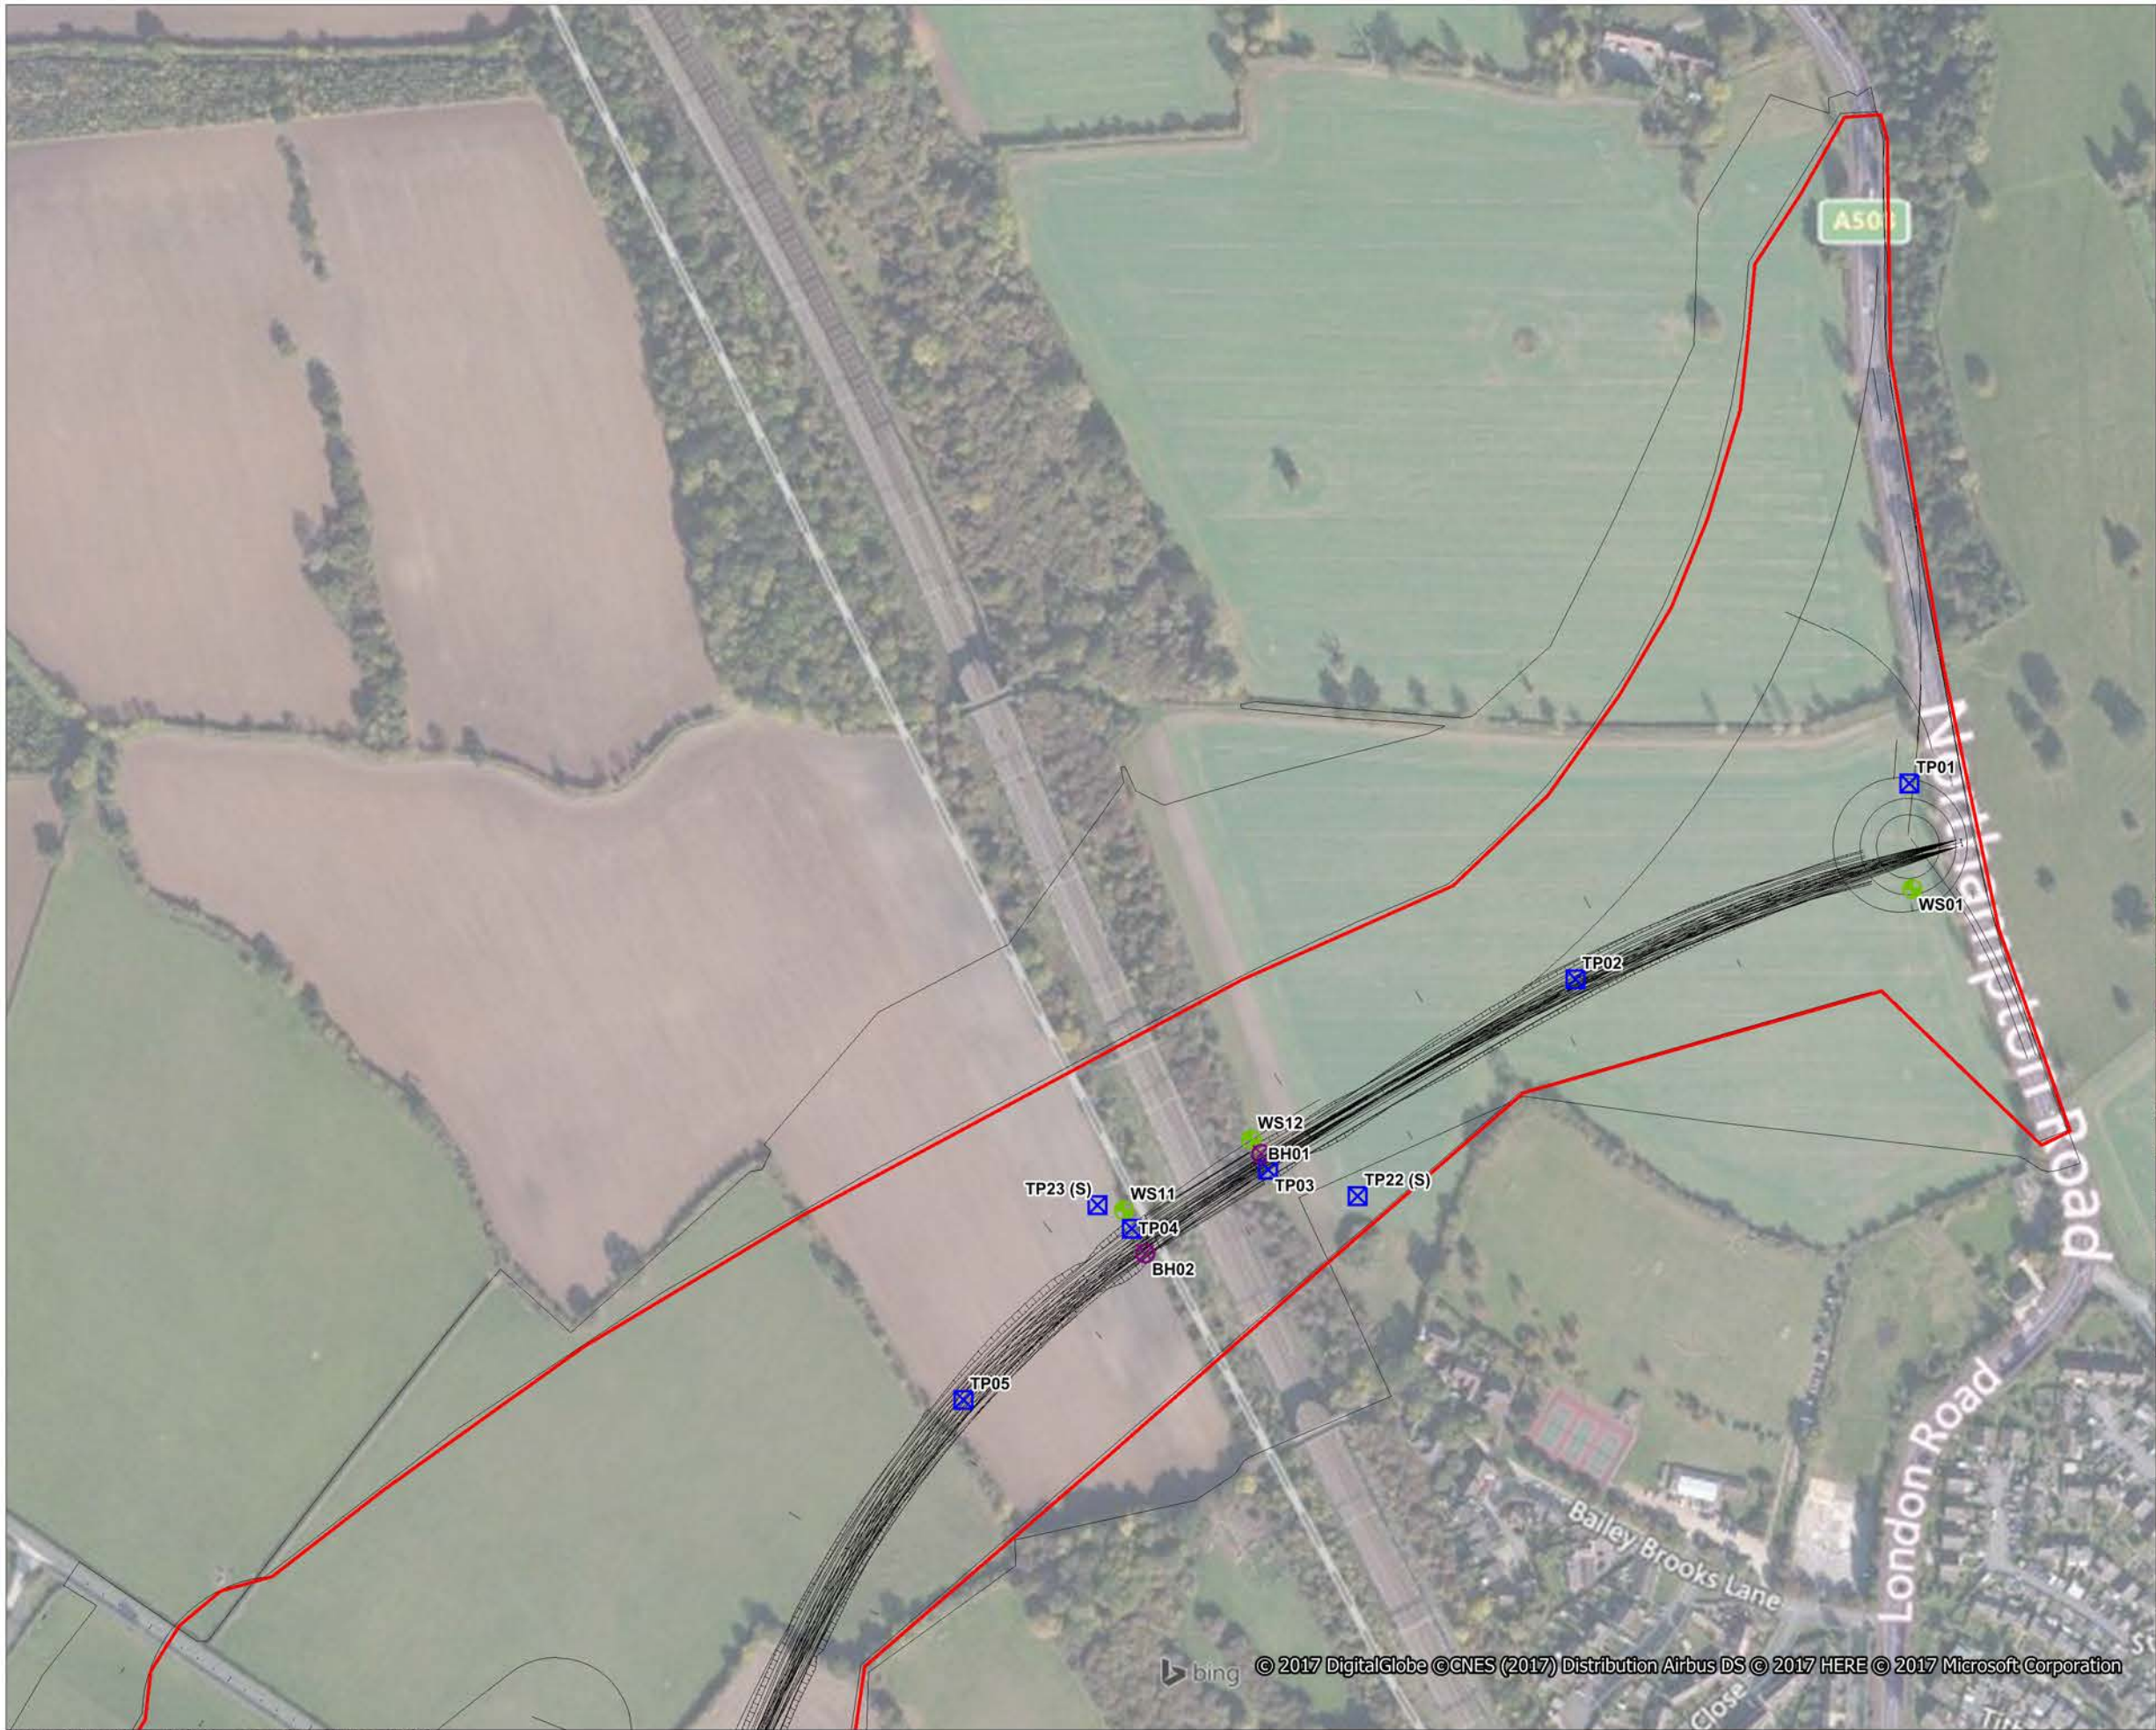
Figure 2
As Built Exploratory Hole Location Plan
Map 3 of 3

- Site boundary (Feb 2017)
- Borehole (BH)
- Trial Pit (TP) with Soakaway (S)
- Window Sample (WS)

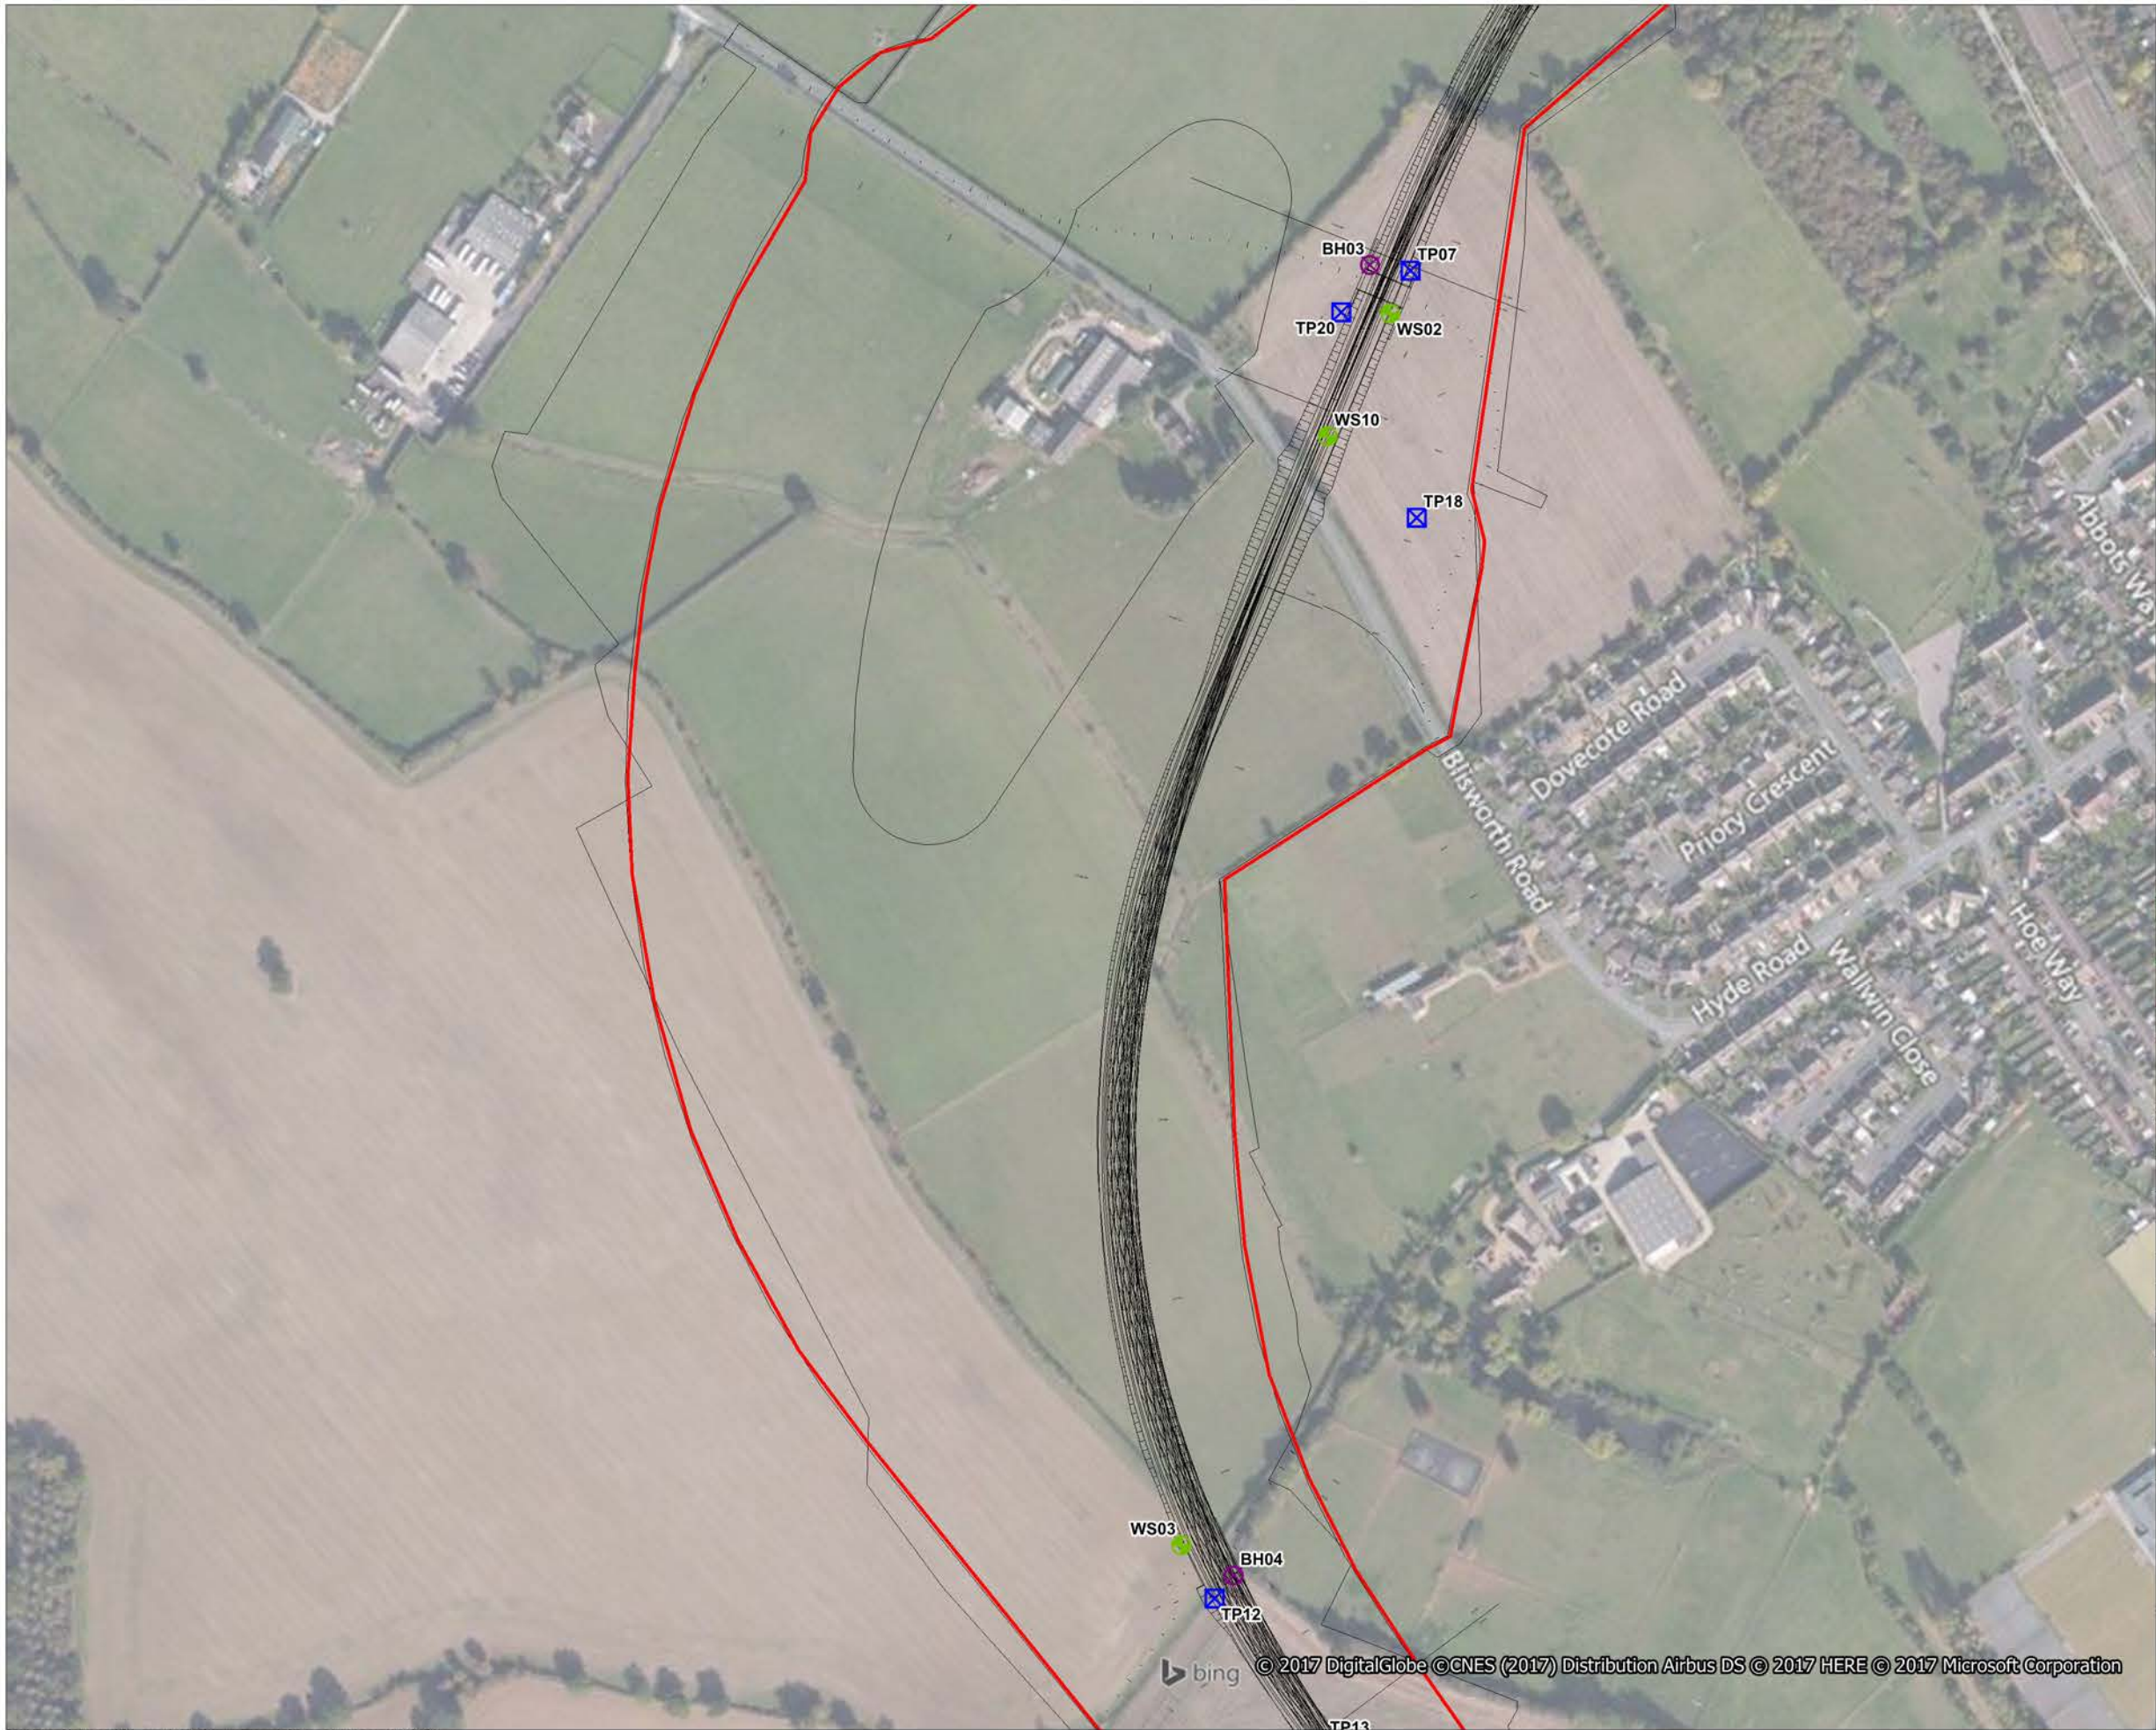
Figure 3
As Dug Exploratory Hole Location Plan
Map 2 of 3

Site boundary (Feb 2017)

Borehole (BH)

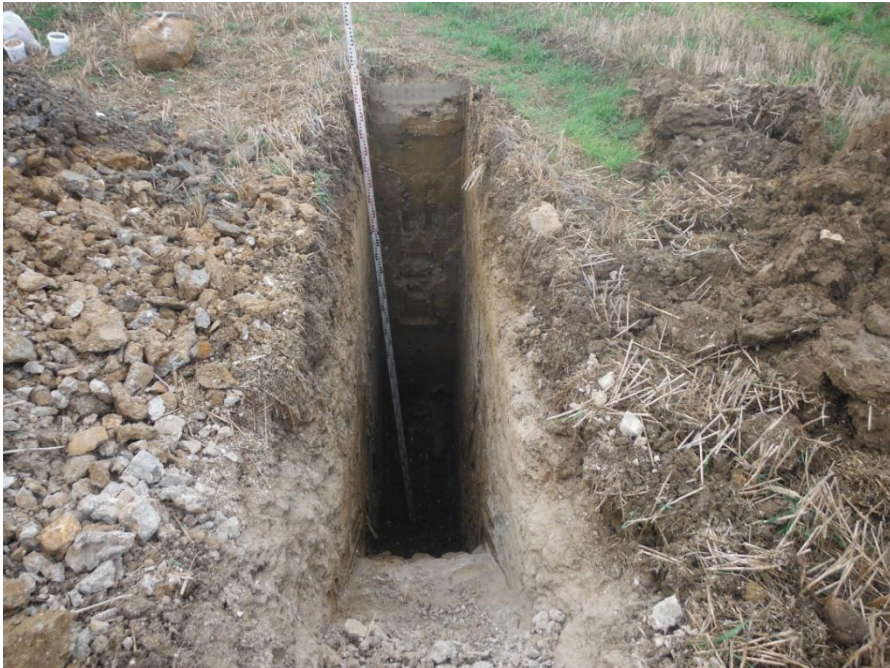
Photo no. 1	Date: 11/09/2017

Exploratory hole number: Trial pit 1		
Description: Trial Pit 1 excavated to a maximum depth of 3.80m.

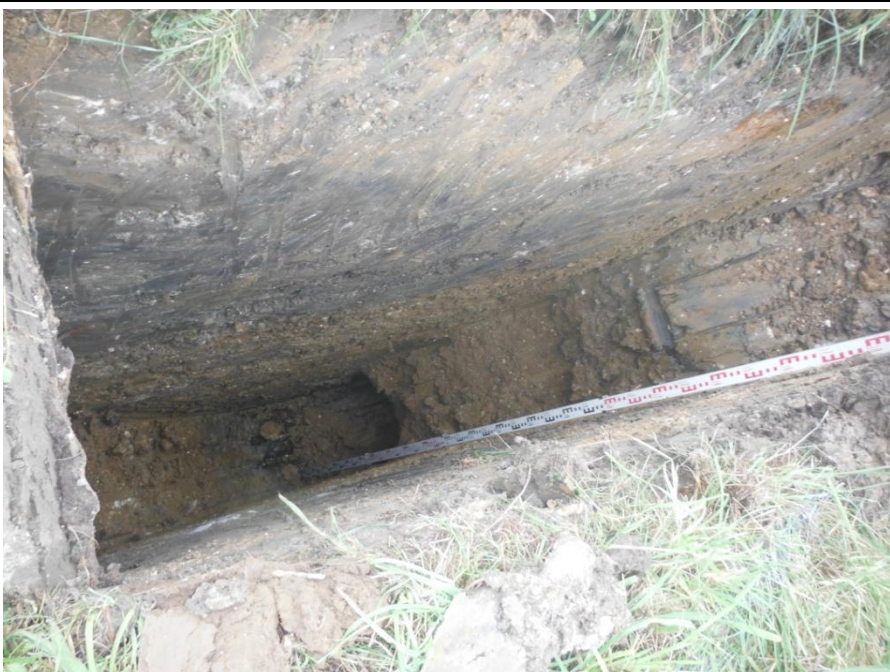
Photo no. 5	Date: 11/09/2017

Exploratory hole number: Trial pit 3		
Description: Trial pit 3 excavated to a maximum depth of 4.00m.

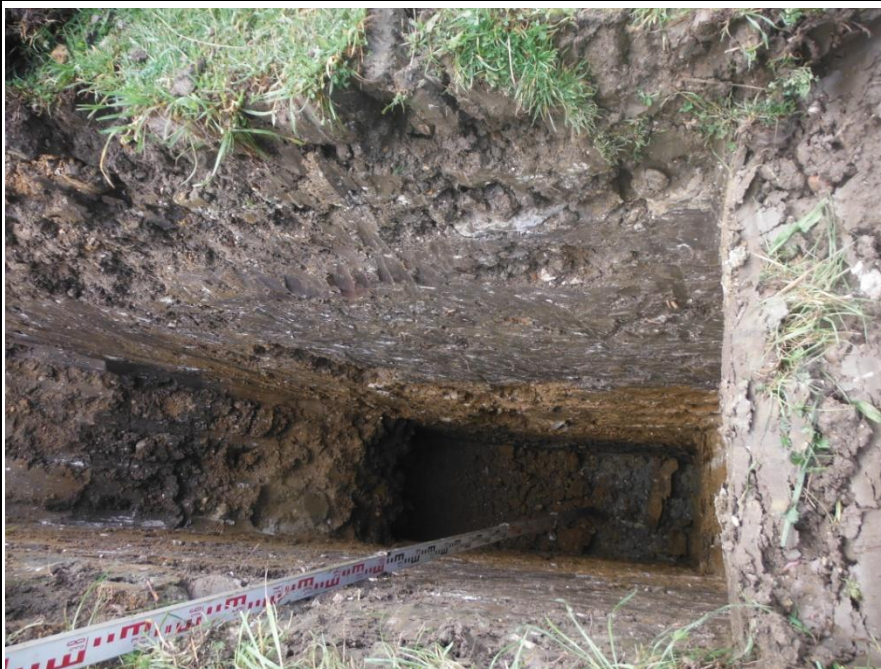
Photo No. 7	Date: 11/09/2017

Exploratory hole number: Trial pit 4		
Description: Trial pit 4 excavated to a maximum depth of 3.80m.

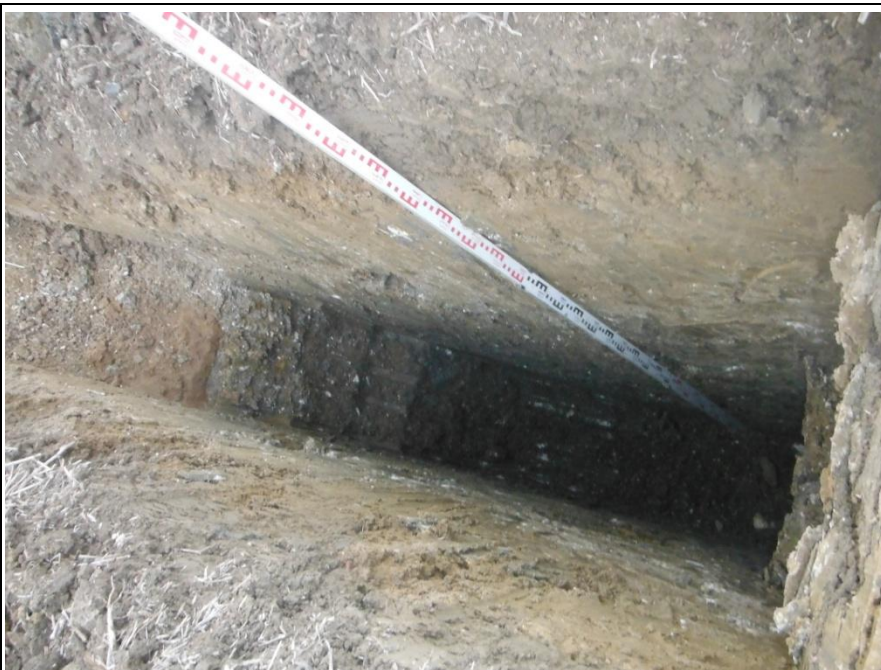
Photo No. 11	Date: 08/09/2017

Exploratory hole number: Trial pit 7		
Description: Trial pit 7 excavated to a maximum depth of 3.80m.

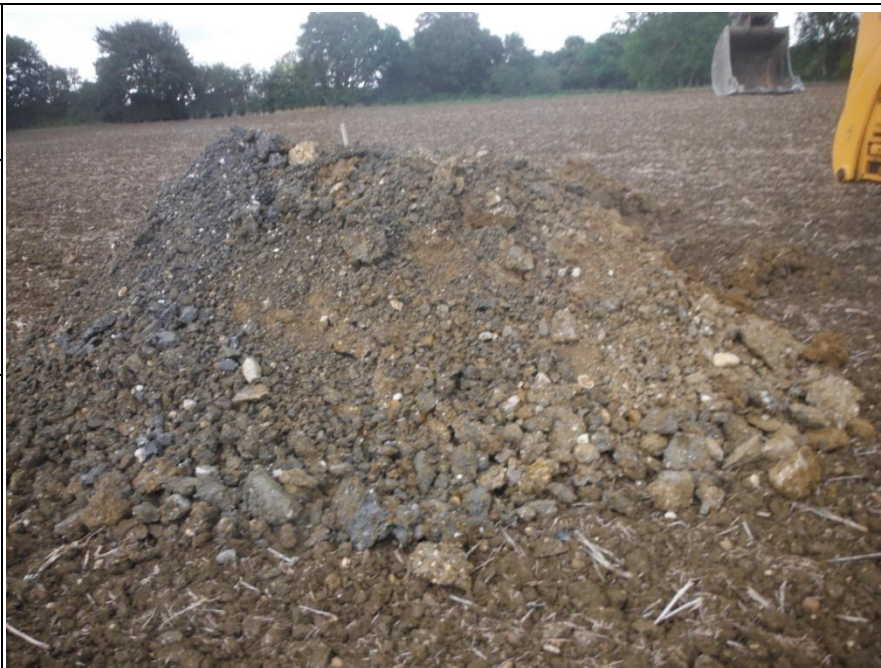
Photo No. 12	Date: 08/09/2017

Exploratory hole number: Trial pit 7		
Description: Trial pit 7 stockpiled material

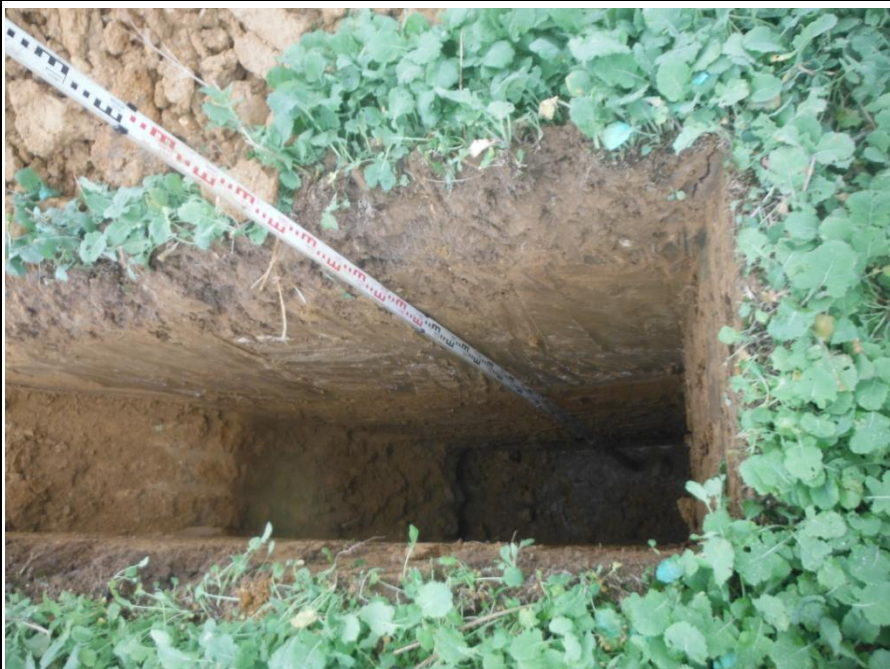
Photo No. 15	Date: 08/09/2017

Exploratory hole number: Trial pit 13		
Description: Trial pit 7 excavated to a maximum depth of 3.60m.
