Roxhill Developments Limited

M1 Junction 15 West - Roade Bypass

Interpretative Ground Investigation Report

313583-02 (00)

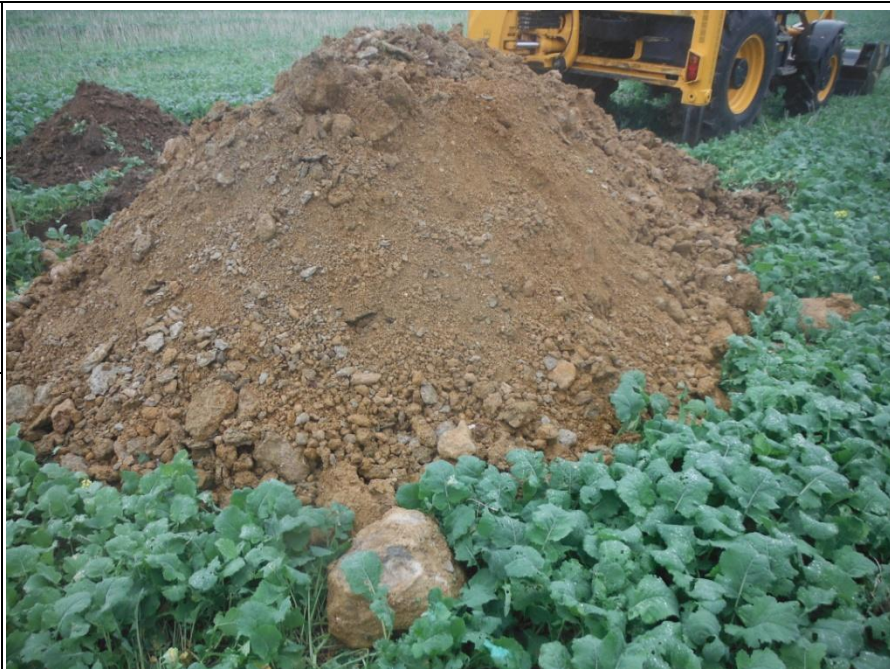
Photo No. 16	Date: 08/09/2017

Exploratory hole number: Trial pit 13		
Description: Trial pit 13 stockpiled material

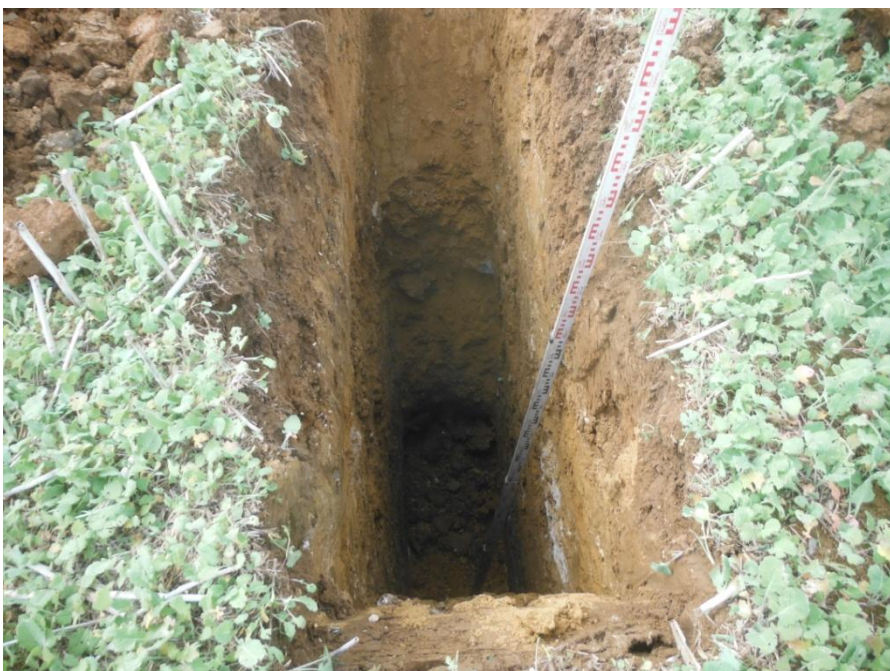
Photo no. 17	Date: 07/09/2017

Exploratory hole number: Trial pit 14		
Description: Trial pit 14 excavated to a maximum depth of 3.60m.

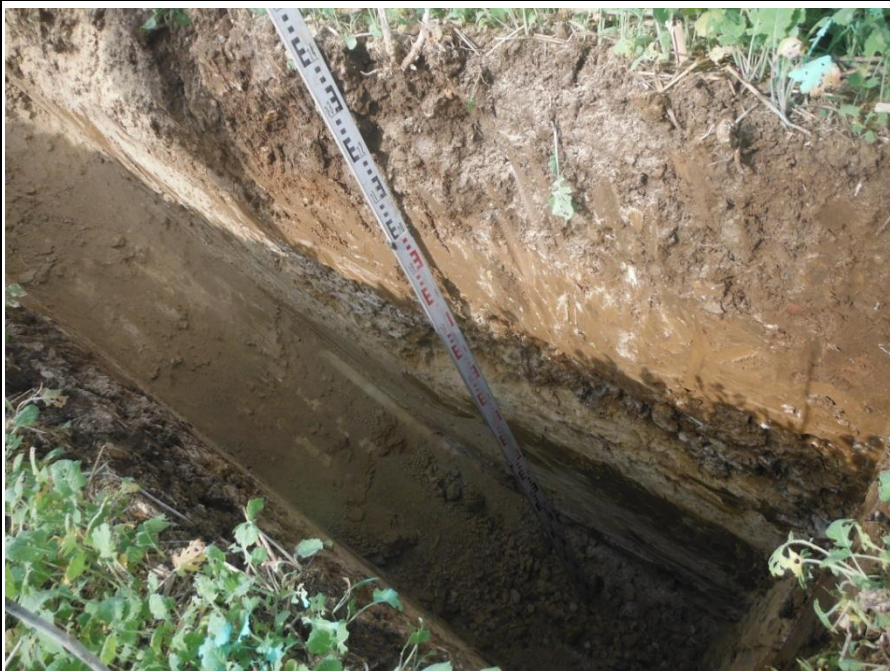
Photo No. 19	Date: 07/09/2017

Exploratory hole number: Trial pit 15		
Description: Trial pit 15 excavated to a maximum depth of 2.50m.

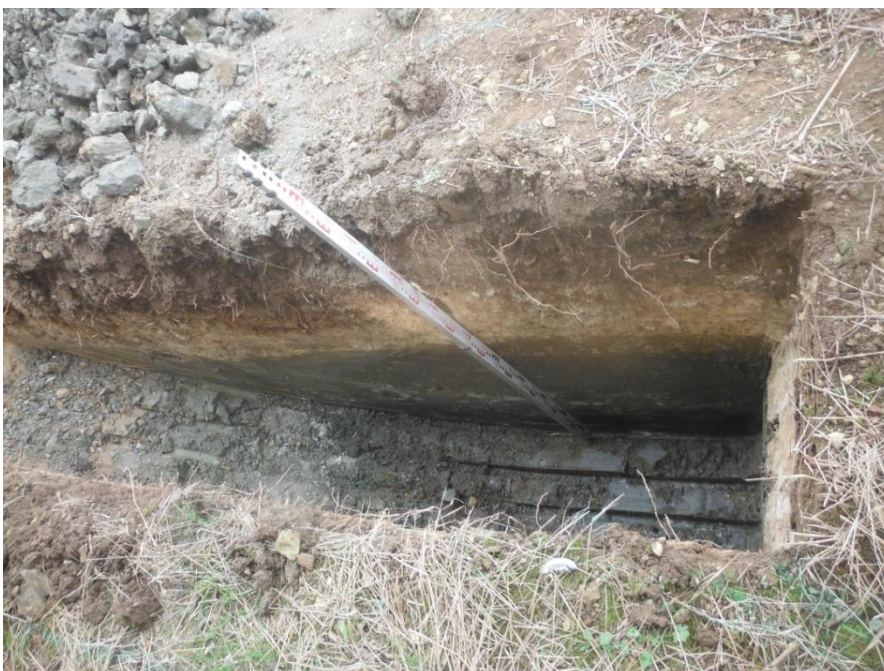
Photo no. 21	Date: 07/09/2017

Exploratory hole number: Trial pit 16		
Description: Trial pit 15 excavated to a maximum depth of 1.80m.

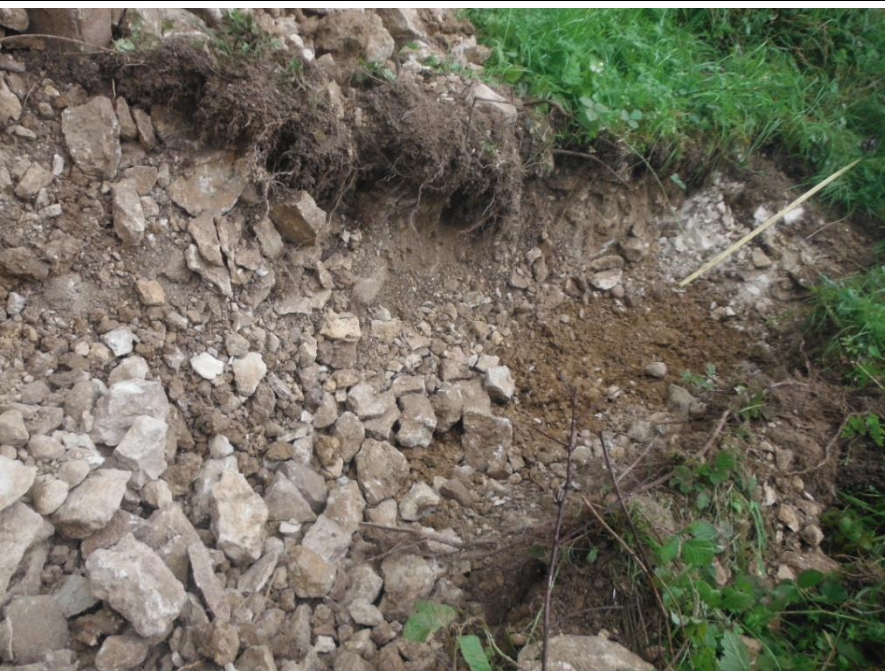
Photo No. 23	Date: 07/09/2017

Exploratory hole number: Trial pit 16A		
Description: Trial pit 16 excavated to a maximum depth of 0.50m.

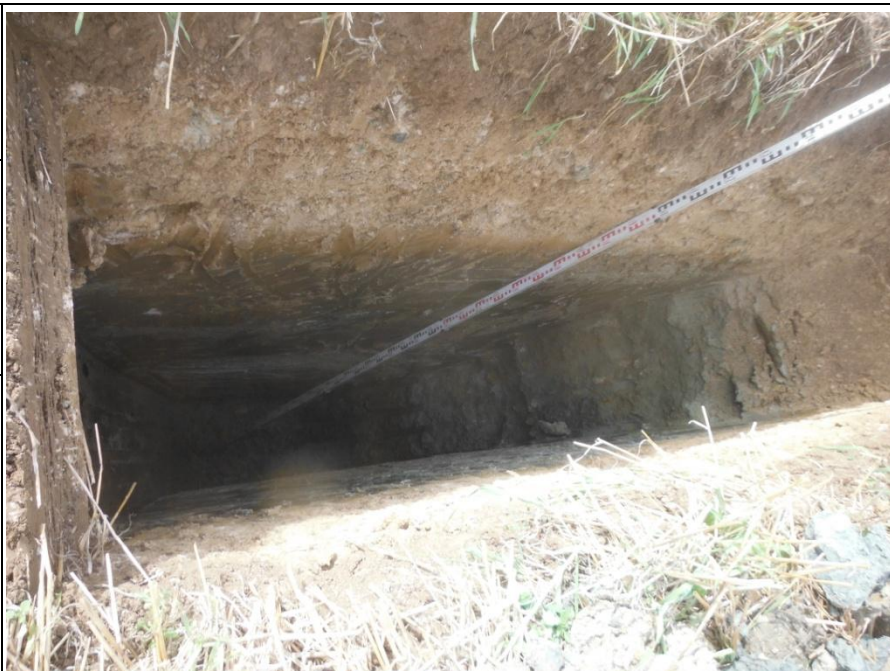
Photo No. 24	Date: 07/09/2017

Exploratory hole number: Trial pit 17		
Description: Trial pit 17 excavated to a maximum depth of 4.50m.

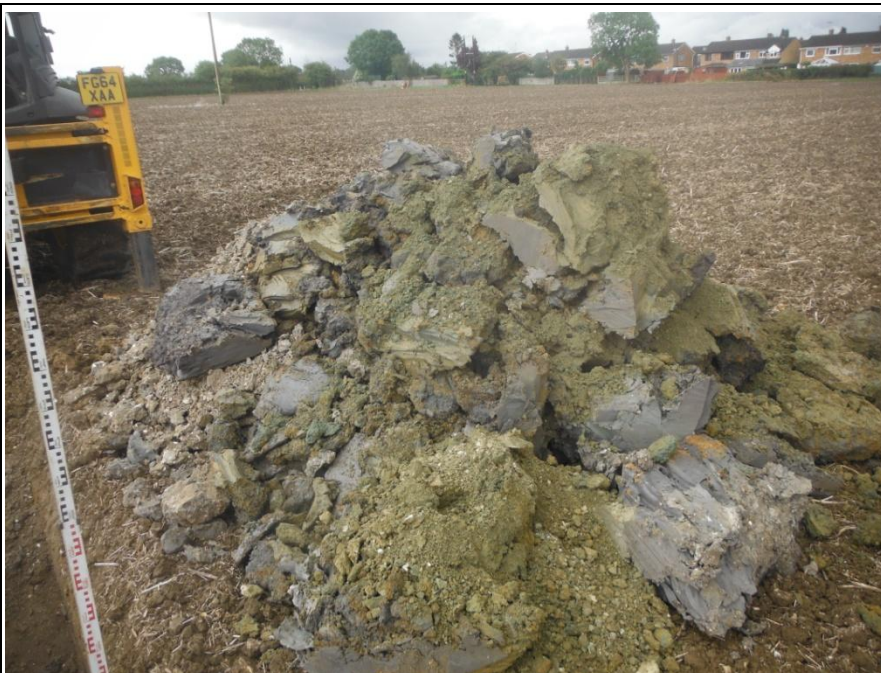
Photo No. 27	Date: 08/09/2017

Exploratory hole number: Trial pit 18		
Description: Trial pit 18 stockpiled material.

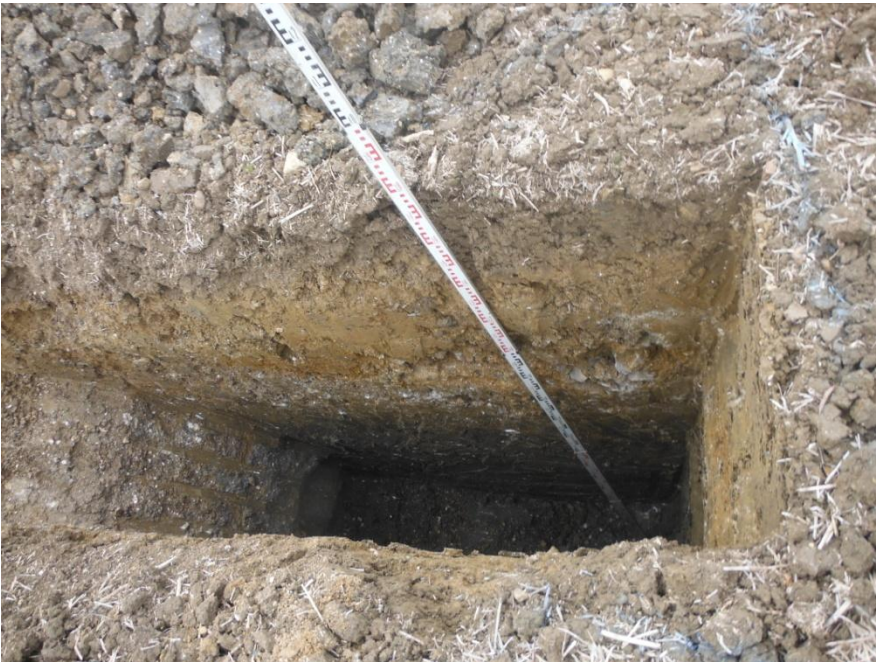
Photo No. 28	Date: 08/09/2017

Exploratory hole number: Trial pit 20		
Description: Trial pit 20 excavated to a maximum depth of 3.80m.

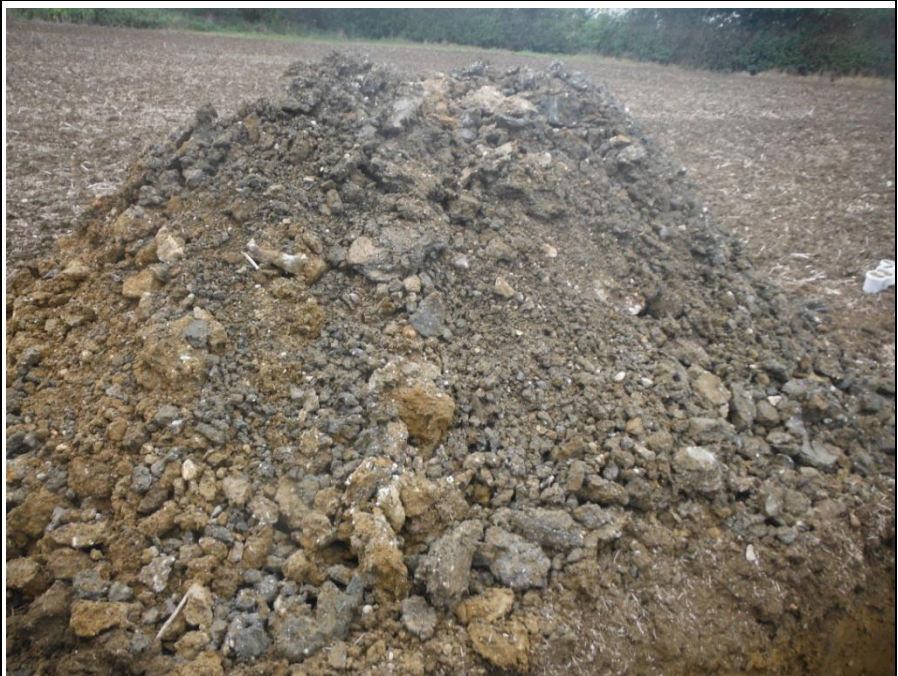
Photo No. 30	Date: 13/09/2017
Exploratory hole number: Trial pit 23	
Description: Trial pit 23 excavated to a maximum depth of 3.00m and soakaway test undertaken.

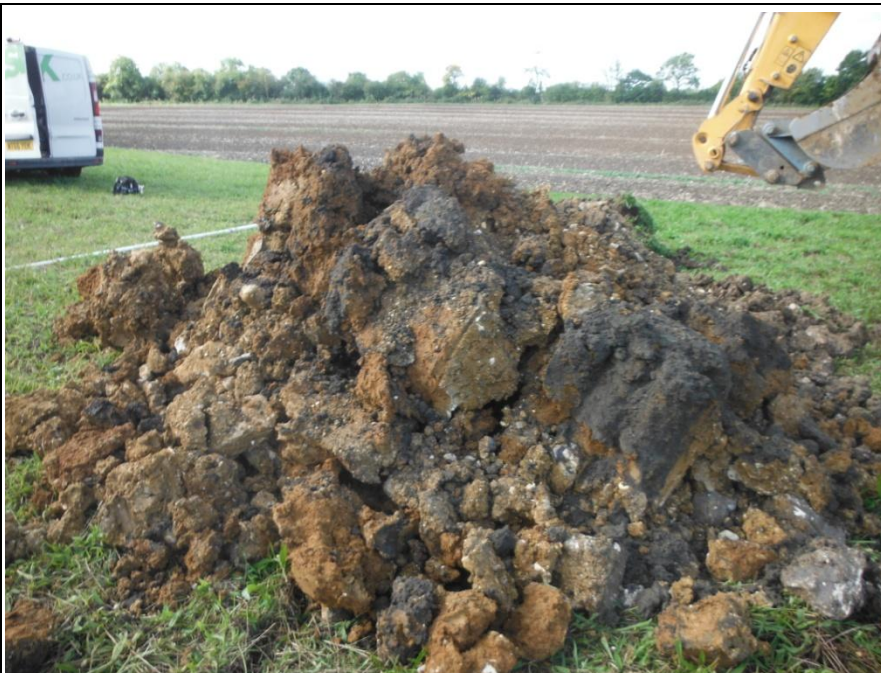
Photo No. 31	Date: 13/09/2017

Exploratory hole number: Trial pit 23		
Description: Trial pit 23 stockpiled material.

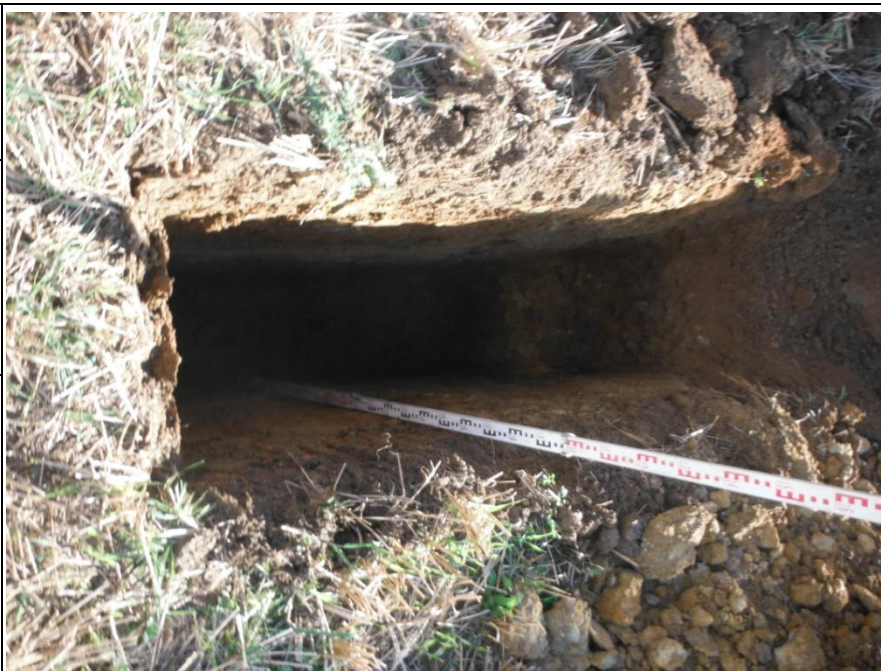
Photo No. 32	Date: 13/09/2017

Exploratory hole number: Trial pit 26		
Description: Trial pit 26 excavated to a maximum depth of 3.00m

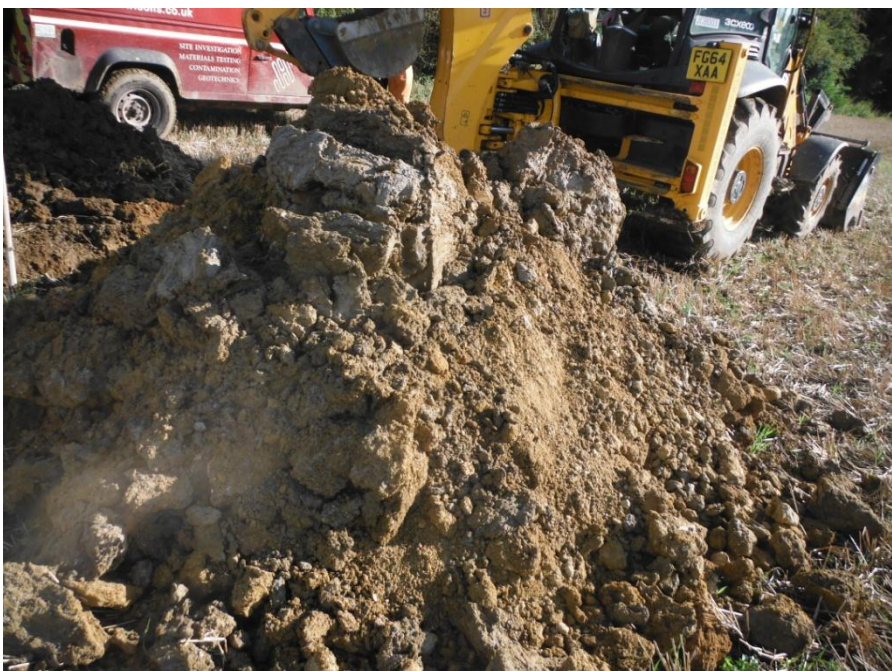
Photo no. 33	Date: 13/09/2017

Exploratory hole number: Trial pit 26		
Description: Trial pit 26 stockpiled material

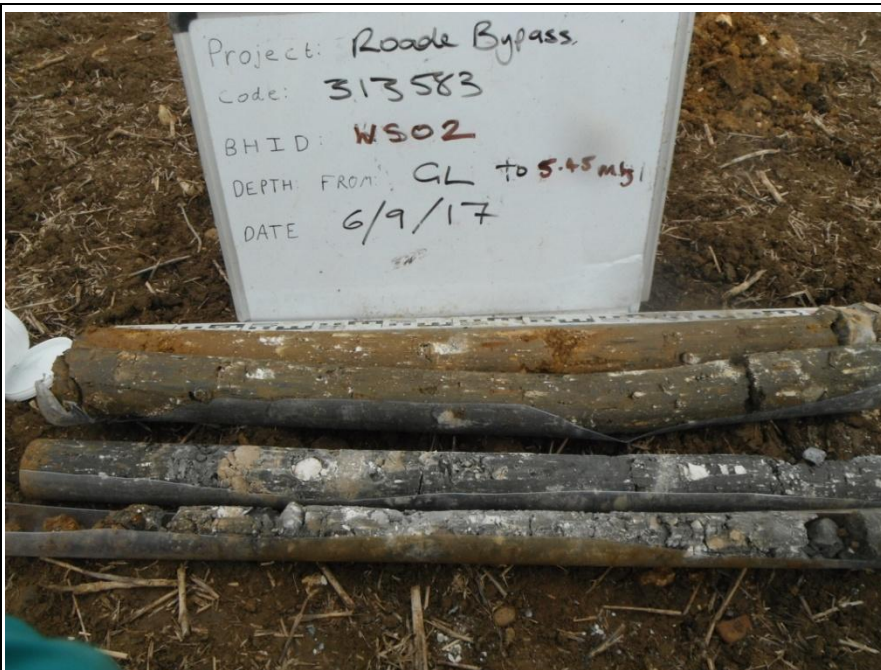
Photo No. 35	Date: 06/09/2017

Exploratory hole number: Window Sample 02		
Description: Window sample 02 drilled to 5.45m.

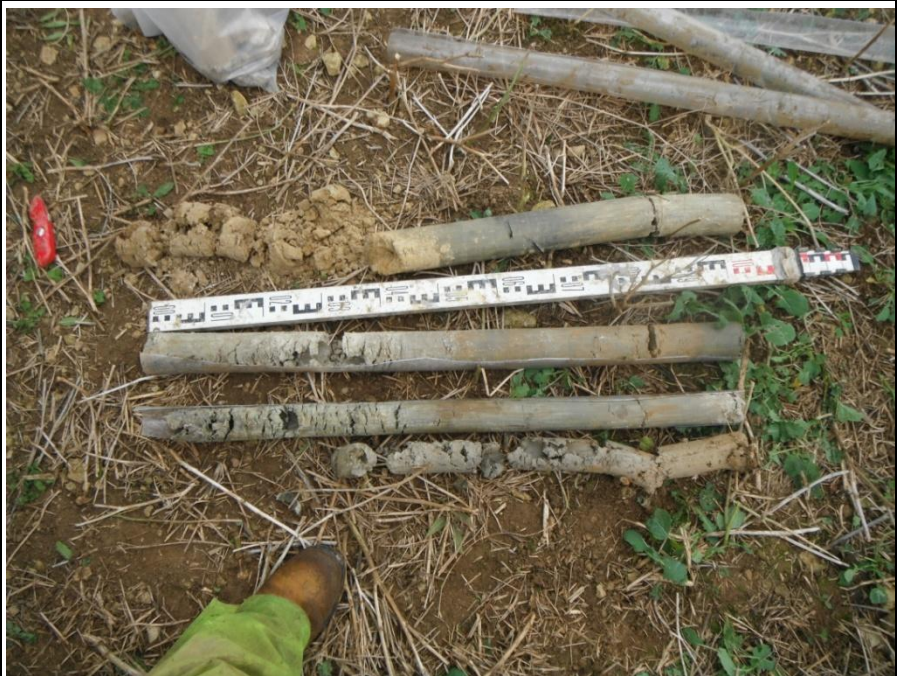
Photo No. 38	Date: 05/09/2017
Exploratory hole number: Window Sample 05	
Description: Window sample 05 drilled to 4.45m.

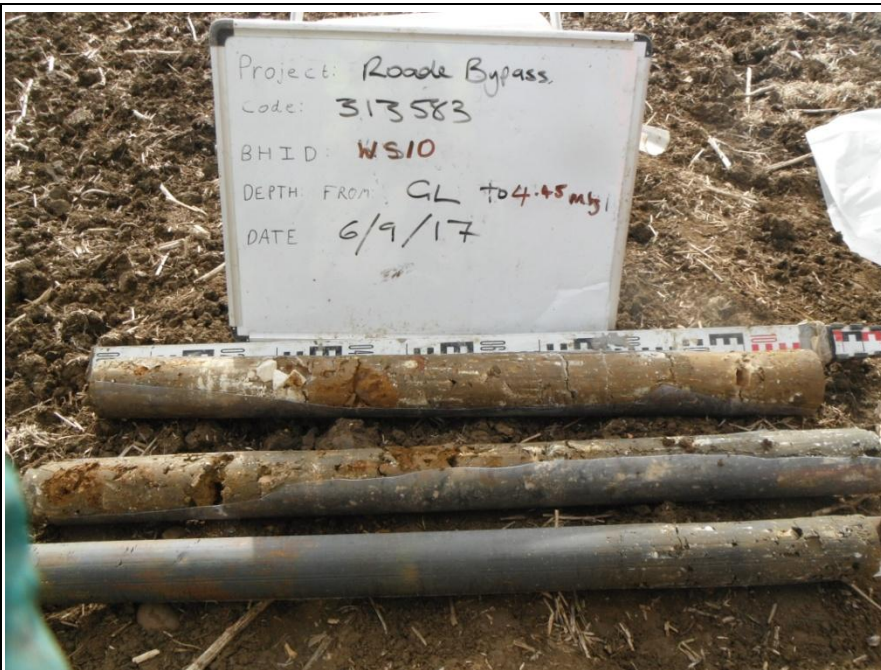
Photo No. 43	Date: 06/09/2017

Exploratory hole number: Window Sample 10		
Description: Window sample 10 drilled to 4.45m

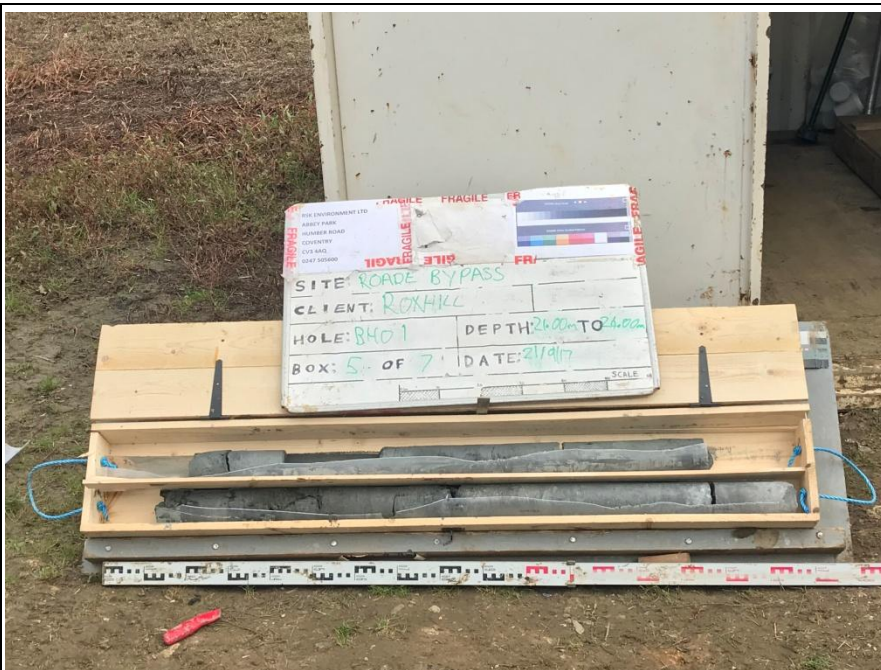
Photo No. 51	Date: 21/09/2017

Exploratory hole number: Borehole 01		
Description: Borehole 01, box 5 of 7, 21.00m to 24.00m.

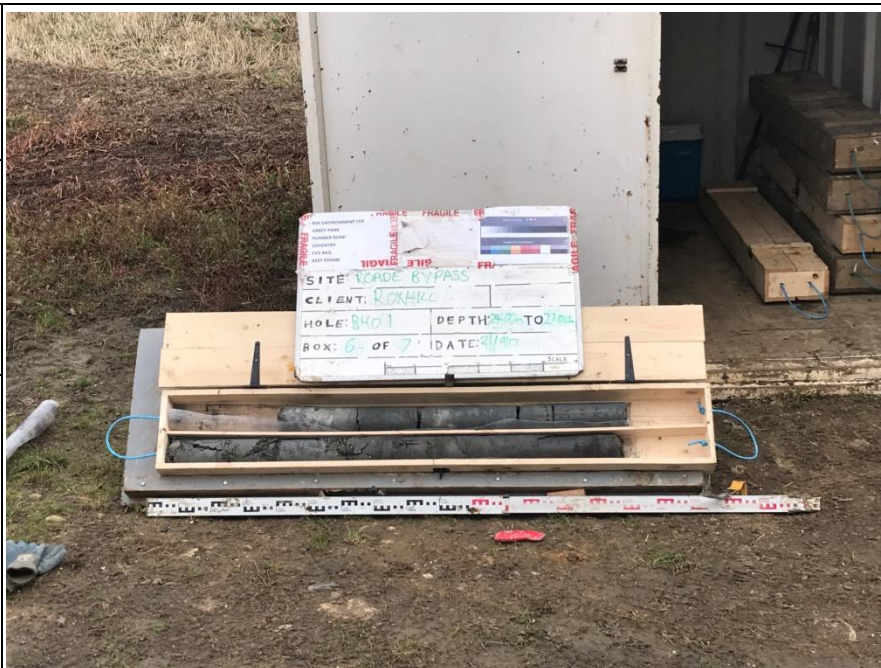
Photo No. 52	Date: 21/09/2017

Exploratory hole number: Borehole 01		
Description: Borehole 01, box 6 of 7, 24.00m to 27.00m

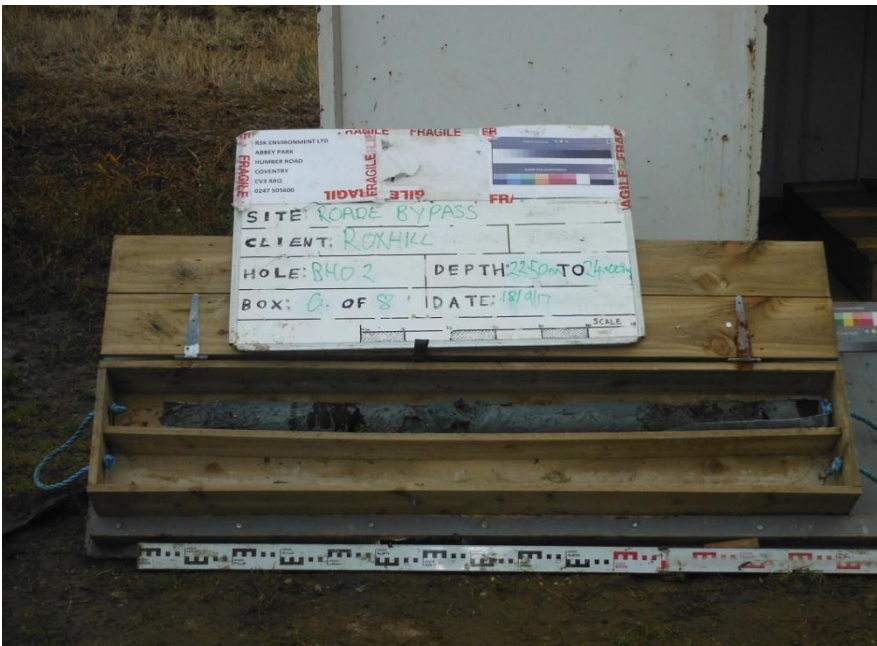
Photo No. 60	Date: 18/09/2017

Exploratory hole number: Borehole 02		
Description: Borehole 02, Box 6 of 8, 22.50m to 24.00m.

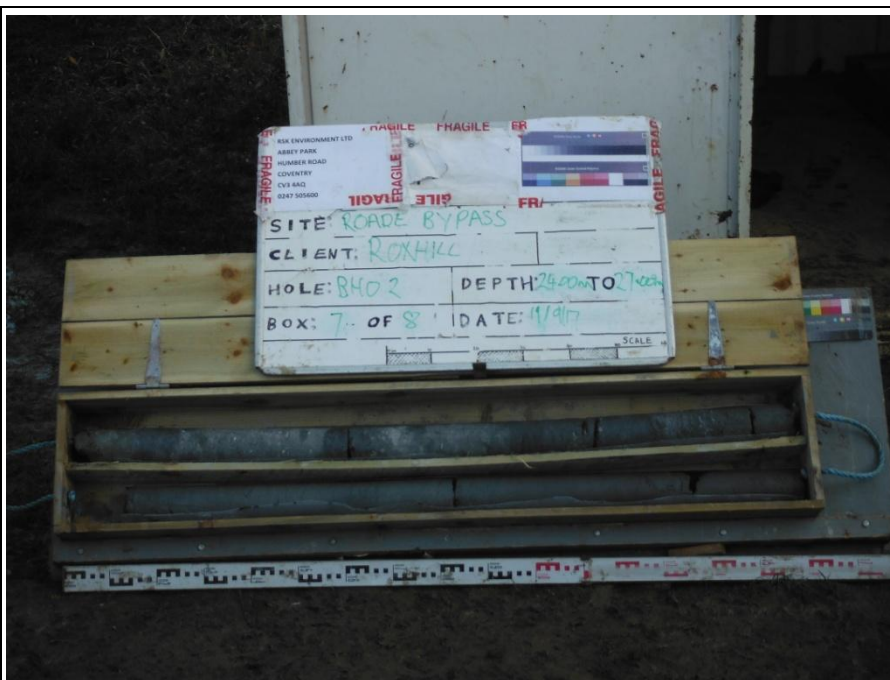
Photo no. 61	Date: 19/09/2017
Exploratory hole number: Borehole 02	
Description: Borehole 02, Box 7 of 8, 24.00m to 27.00m.

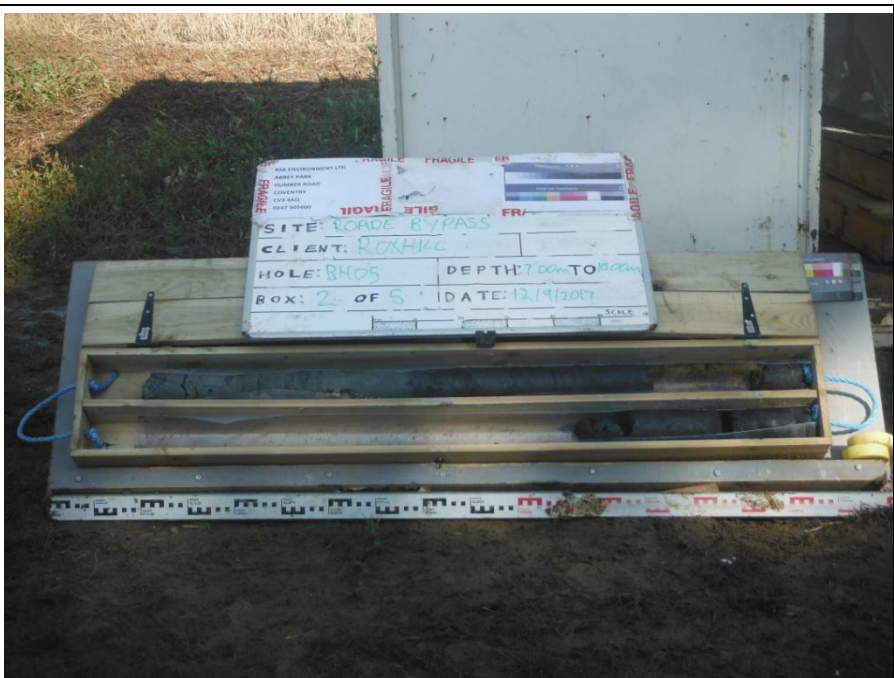
Photo No. 81	Date: 12/09/2017
Exploratory hole number: Borehole 05	
Description: Borehole 05, Box 3 of 5, 11.50m to 14.00m

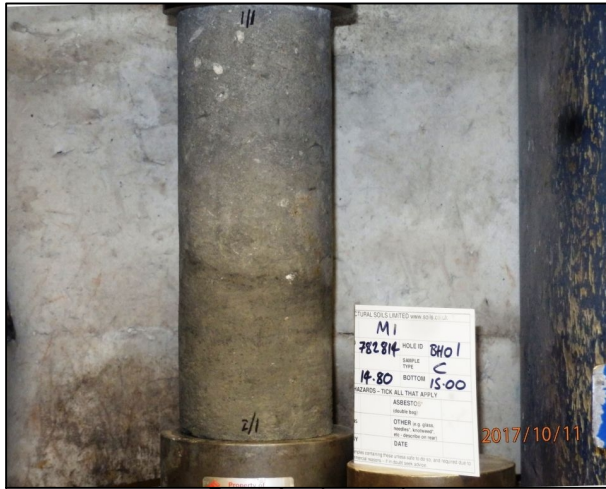
Front view (pre-test)

Sample tolerance checks: Straightness: **FAIL**. Flatness: **PASS**. Perpendicularity: **PASS**.

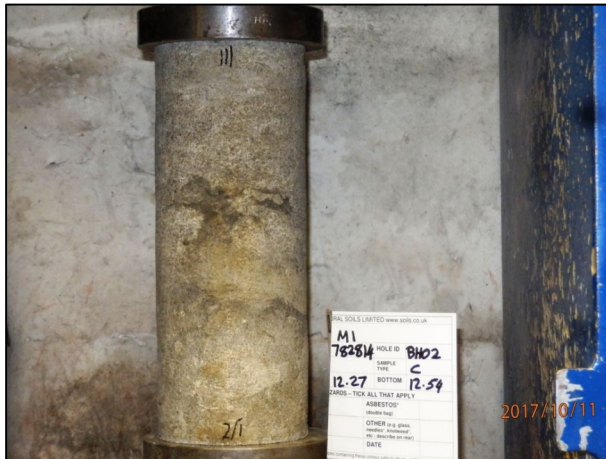
Front view (pre-test)

Sample tolerance checks: Straightness: **FAIL**. Flatness: **PASS**. Perpendicularity: **PASS**.
