DCO Submission

Chapter 9: Water Environment
Appendix 9.5: Water Framework Directive Assessment

Document 6.9E

Water Framework Directive (WFD) Assessment

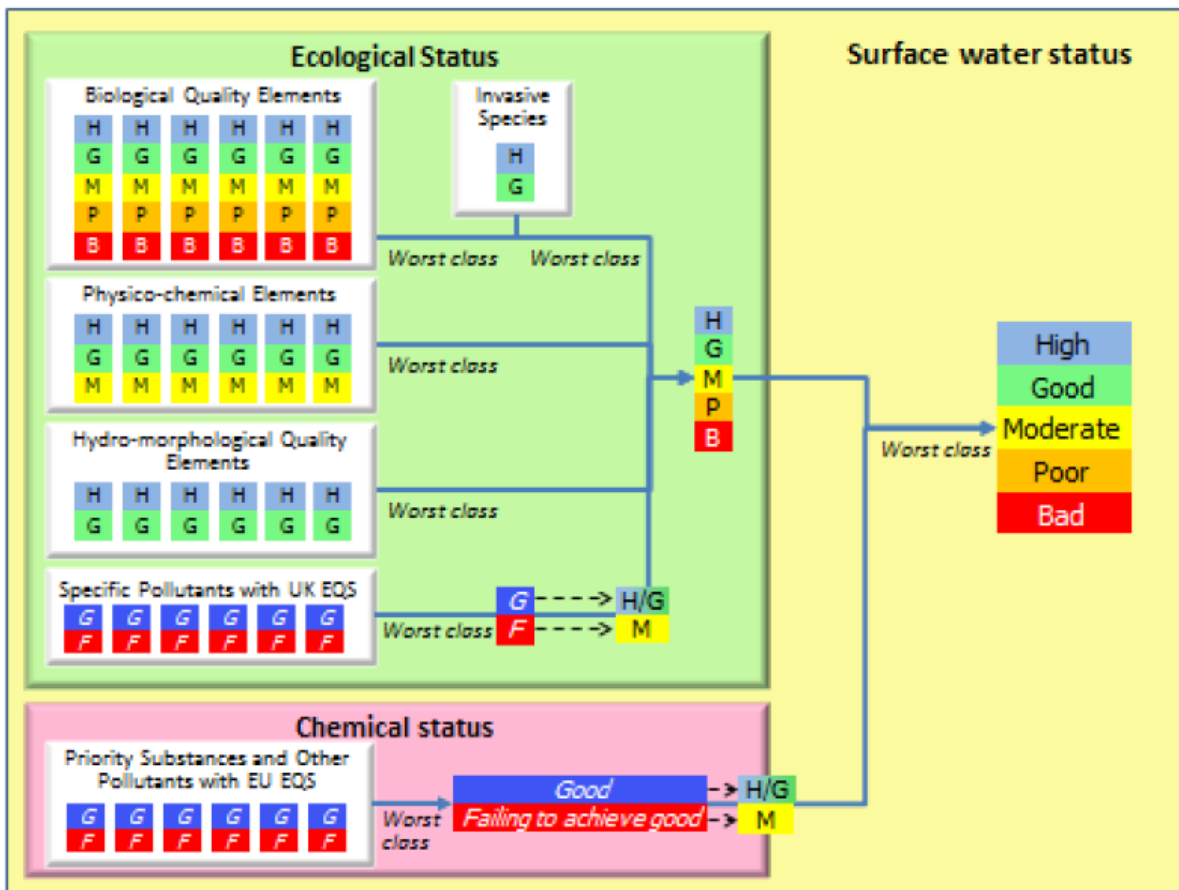
Under the WFD, surface water body status is classified on the basis of ecological and chemical status or potential. Ecological status is assigned to surface water bodies that are natural and considered by the Environment Agency not to have been significantly modified for anthropogenic purposes. Ecological potential is assigned to artificial and man-made water bodies (such as canals), or natural water bodies that have undergone significant modification; these are termed Heavily Modified Water Bodies (HMWBs). The term ‘ecological potential’ is used as it may be impossible to achieve good ecological status because of modification for a specific use, such as navigation or flood protection. The ecological potential represents the degree to which the quality of the water body approaches the maximum it could achieve. The worst-case classification is assigned as the overall surface water body status, in a ‘one-out all-out’ system. This system is summarised below in Figure 2.

Figure 2 WFD classification elements – Bringing all of the strands of evidence together (Environment Agency, 2015)

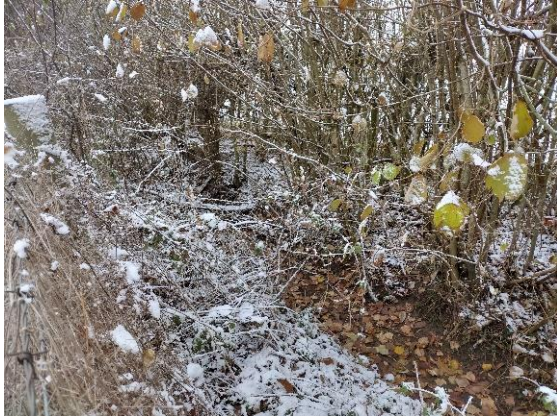
The upper extent of Gagle Brook (west stem) was dry at the time of survey. The channel here was straight, forming the border to arable agricultural fields, measuring approximately 1m side and 0.4m deep. The upper reaches of the channel were fenced on both banks and lined by a hedgerow on the right bank, however had limited vegetated riparian buffer on the left (Figure 2.1). Channel substrate here consisted of loam.

Figure 2.1 Dry upper reaches (looking downstream at SP 52588 26391)

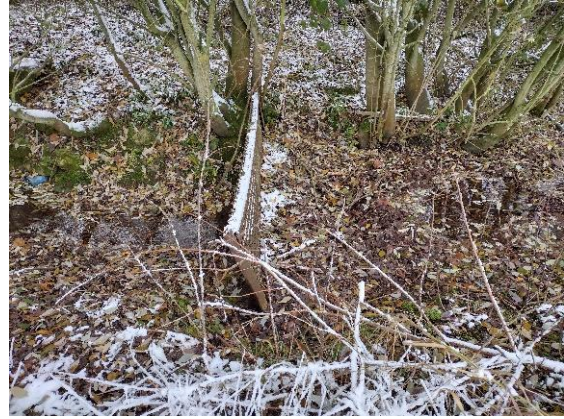
Figure 2.2 Grate crossing channel causing trapping of organic debris and backing up of water (looking from left bank to right at SP 52927 26132)

Longitudinal connectivity was impacted by a culvert under a farm access track and a grate crossing the channel which had resulted in an accumulation of organic material (largely leaf litter) and backing up of water upstream (Figure 2.2). An inlet structure with a timber headwall was also observed downstream of the grate (Figure 2.3), with all water in the channel diverted into the structure. The purpose of this inlet was not clear on site.

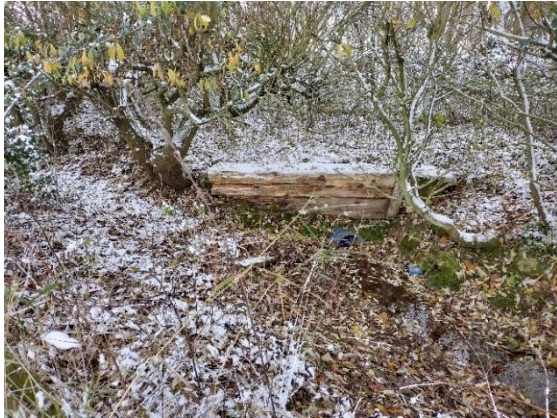
Figure 2.3 Inlet pipe (looking downstream at SP 52927 26132)

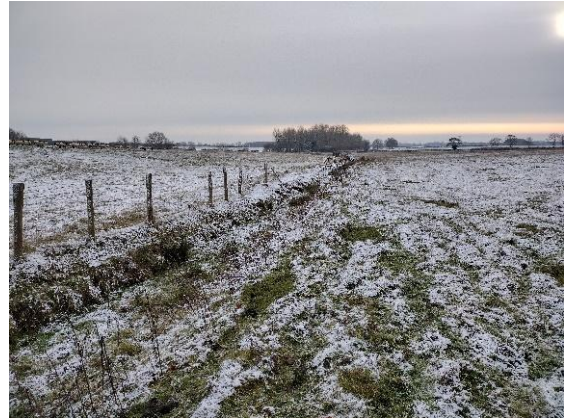
Figure 2.4 Straight channel, minimal riparian buffer (looking downstream at SP 52971 25962)

The watercourse re-emerges at SP 52963 26069 where the channel has a straight planform (Figure 2.4) which is predominantly overgrown with rush (*Juncus effusus*). The channel was fenced on the left bank, however both banks had no significant riparian vegetated buffer. A section of erosion was observed on the right bank at SP 52970 26029 and poaching was present along the majority of the left bank. Downstream of the road crossing, the channel continues in a highly modified, straightened planform with no riparian complexity and minimal habitat diversity (Figure 2.5).

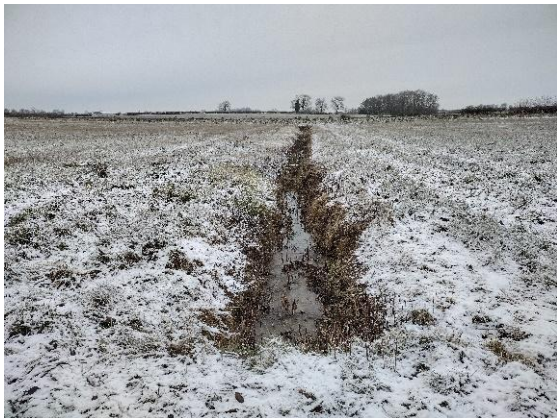
Figure 2.5 Straight channel, minimal riparian buffer (looking upstream at SP 53072 25707)

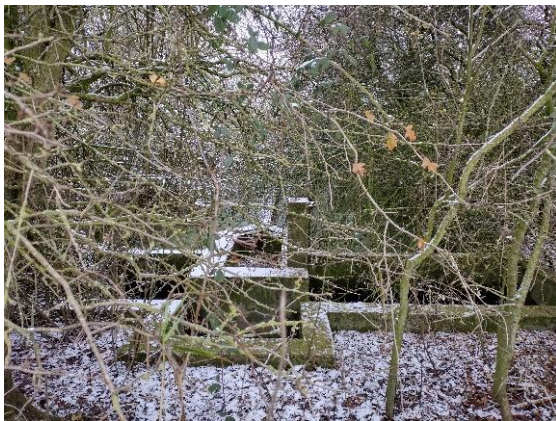
Figure 2.6 Channel source – impounding dam and sluice structure (looking upstream at SP 53289 26850)

The source of the east stem tributary of Gagle Brook was at a concrete structure which appeared to be controlled by two sluice outlets (Figure 2.6). Analysis of historical mapping suggests that the structure could potentially be associated with discharge from Upper Heyford Airbase as it does not appear to be on mapping prior to construction of the site. From here, the channel appears to be culverted under a farm access track and discharges into an open, straight channel via a large concrete culvert headwall. The channel runs alongside a farm track in an incised channel measuring approximately 1m wide and 0.5m deep with gravel and loam substrate. A hedgerow runs along the left bank of the channel at this location.

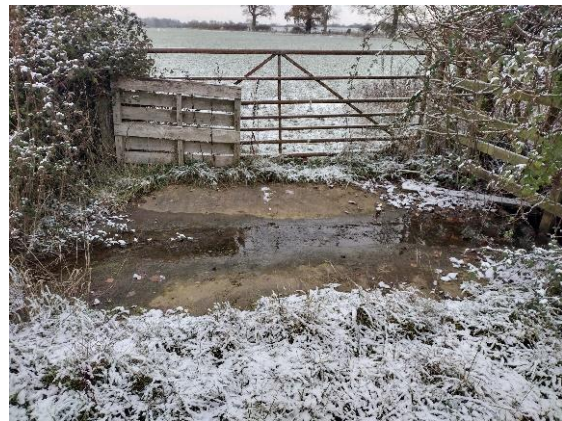
Figure 2.7 Concrete ford (looking from right to left bank at SP 53607 26455)

At SP 53607 26455 the channel flows over a concrete ford (Figure 2.7) before forming the boundary to a grazing field. Here the channel is bordered by a row of mature trees on the Left Bank and a fence on the left. The channel has a uniform trapezoidal cross section and straight planform with gravel and silt substrate. The channel continues past Ashgrove Farm and through an online pond where it enters a woodland area at SP 53462 26069 (Figure 2.8). Here the channel measured approximately 1.25m wide with bank approximately 0.25m high and has clean gravel substrate and run and riffle flow with wood dams creating some additional variability in flow types (Figure 2.9). Downstream of the road crossing, the channel has straight planform and limited riparian vegetation. The channel flows through a further culvert under a farm access track (Figure 2.10) before meeting the east stem at SP 53074 25706. The culvert here measured approximately 0.2m wide and constricted flow, limiting longitudinal connectivity.

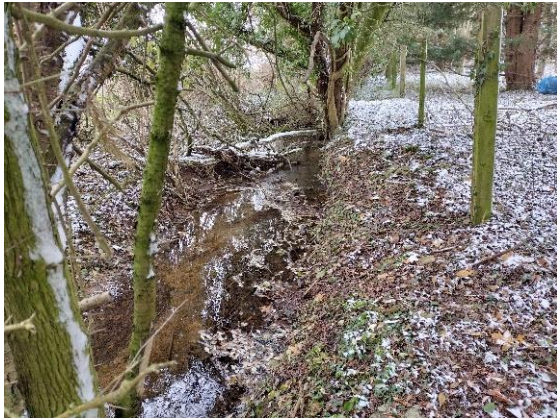
Figure 2.8 Gravel substrate, channel flowing through woodland (SP 53373 25982)

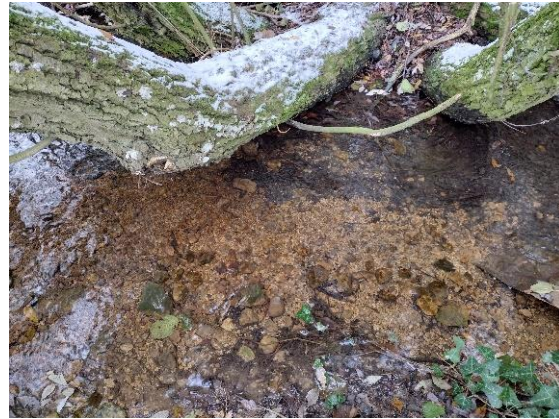
Figure 2.9 Gravel substrate (looking from left to right bank at SP 53373 25982)

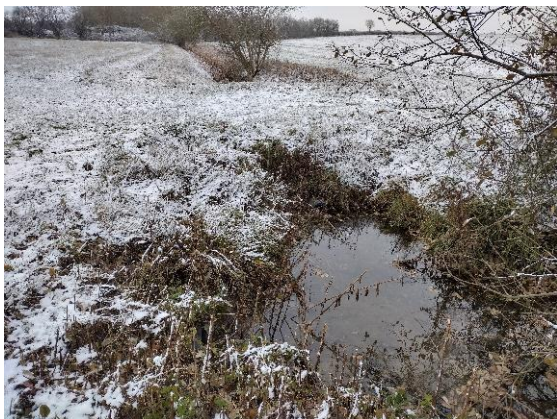
Figure 2.10 Straight drainage channel, limited riparian vegetation (looking upstream at SP 53081 25709)

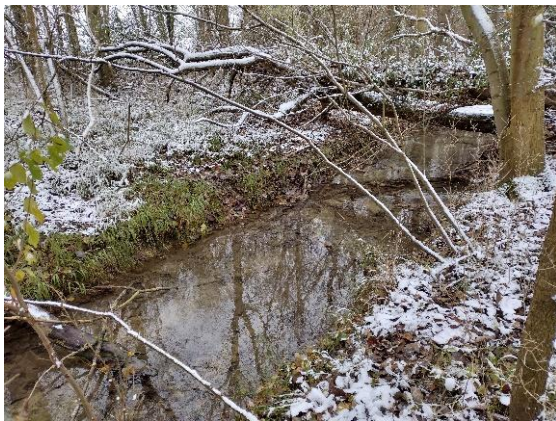
Figure 2.11 Channel flowing through woodland (looking downstream at SP 53038 25637)

The Tributary of Gagle Brook flows through woodland between SP 53074 25706 and SP 52994 25426. Here the channel has fine gravel and silt substrate with several large wood dams (Figure 2.11). The channel has a trapezoidal cross section measuring approximately 1.5m wide with 0.3m high banks. The predominant flow type at this location was glide. Some lengths of undercutting were noted along the left bank. A concrete outfall headwall is present on the left bank at SP 52998 25447, set back approximately 0.75m from the channel bank. No water was discharging from the outfall at the time of survey.

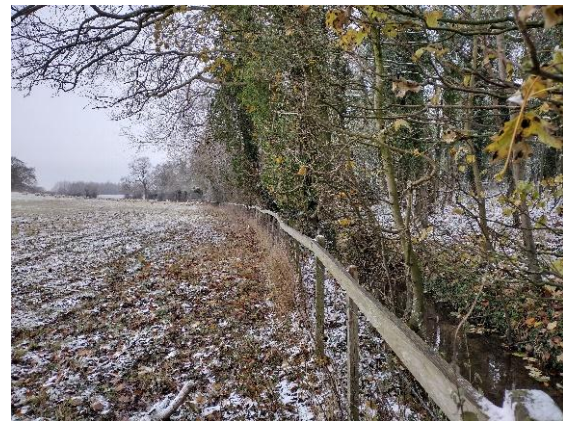
Downstream of the woodland, the channel flows alongside a grazing field. The channel is wider at this location, measuring approximately 2m wide with substrate consisting of sand and fine gravels over clay and glide and run flow types. The channel is fenced on the right bank (Figure 2.12) and a designated livestock drinking area located at SP 53157 25135 (Figure 2.13). The right bank borders an arable field which is unfenced and has no riparian buffer. The channel was crossed by two culverts for farm access vehicles.

Figure 2.12 Straight channel flowing adjacent to grazing field (looking upstream at SP 53181 24875)

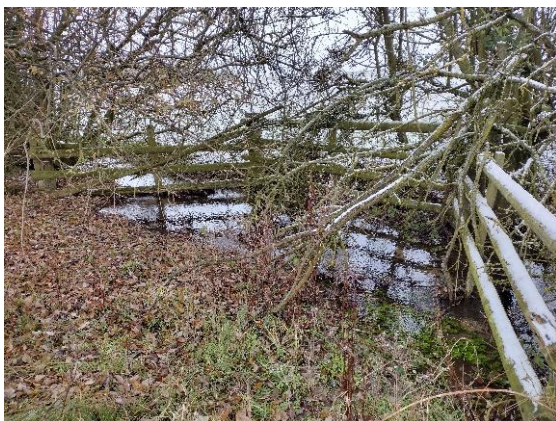
Figure 2.13 Designated drinking area (looking from right to left bank at SP 53157 25135)

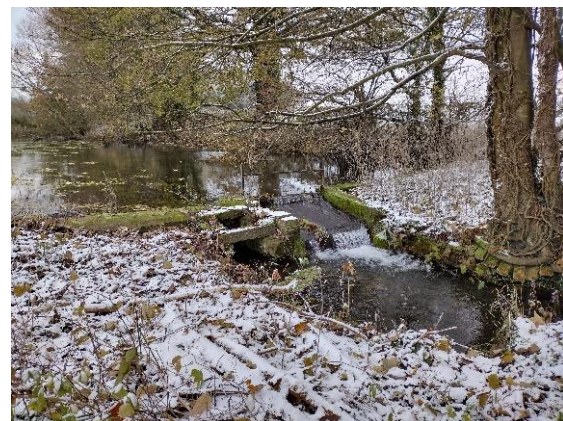
Figure 2.14 Online pond and downstream weir (looking upstream at SP 53131 24639)

The channel enters a large online pond adjacent to Manor Farm which is impounded by a weir outlet measuring approximately 0.75m high and 1m wide (Figure 2.14). Downstream of the pond, another designated livestock drinking point was observed. From here the channel flows through a modified straightened channel measuring approximately 1.5-2m wide with trapezoidal banks approximately 0.6m high (Figure 2.15). The channel was fenced with no tree lining or riparian buffer. The water within the channel at this section begins to stagnate with distance downstream and was dry upstream of Ardley Road (Figure 2.16). This suggests that subsurface flow occurs within this section. There was no indication that the flow was diverted to the pond at Dewars Farm (which also appeared to be at a higher gradient than the channel).

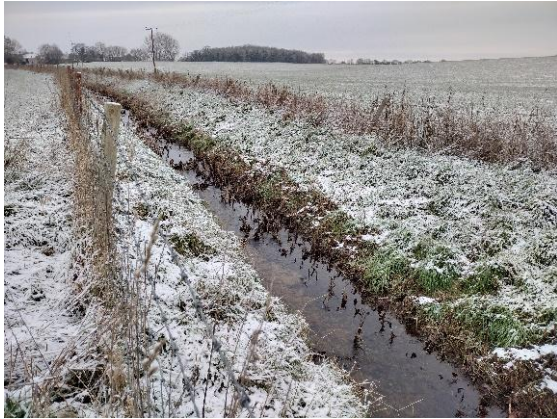
Figure 2.15 Straight, modified channel (looking upstream at SP 53318 24332)

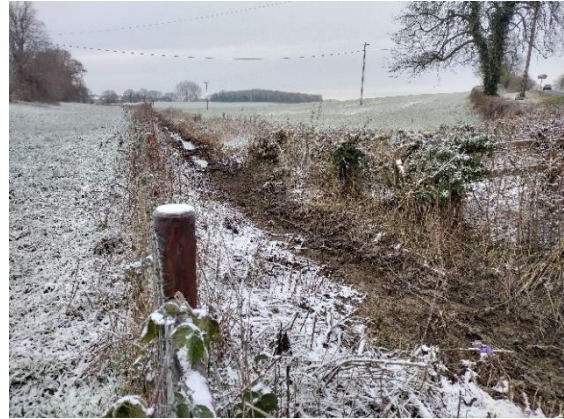
Figure 2.16 Stagnant water and dry channel upstream of Ardley Road (looking upstream at SP 53413 24177)

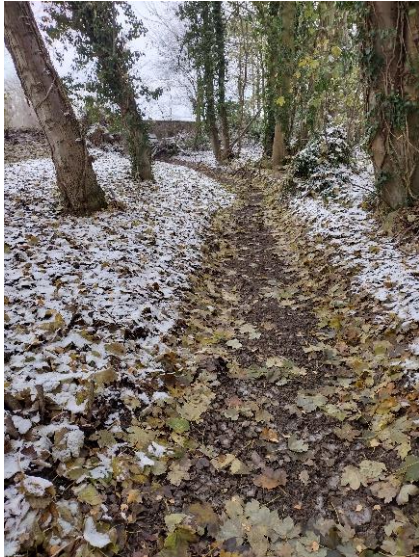
Figure 2.17 Straight, dry channel (looking upstream at SP 53417 24160)

Downstream of Ardley Road, the channel was dry at the time of survey (Figure 2.17) with loam substrate. A small outfall was observed from the pond at Dewars Farm to the channel at SP 53457 24094. Immediately upstream of its confluence with Gagle Brook, the channel has gravel substrate.

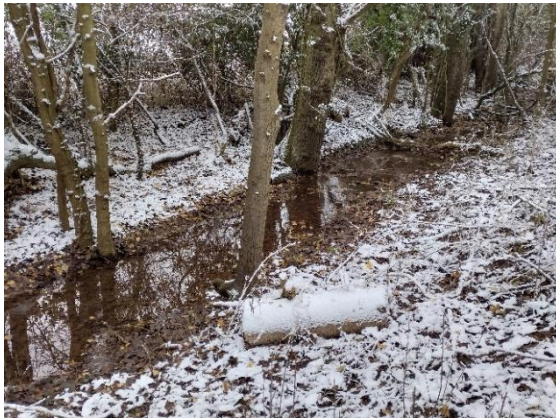
Downstream of the railway, the channel continued in a straight planform with run flow and gravel substrate through a woodland corridor (Figure 2.18). Several large wood dams were noted through this section. Structures observed through this length included a footbridge, fence crossing the channel outfall and culvert under a farm access track. The Gagle Brook

Figure 2.18 Straight channel through woodland (looking downstream at SP 54754 25991)

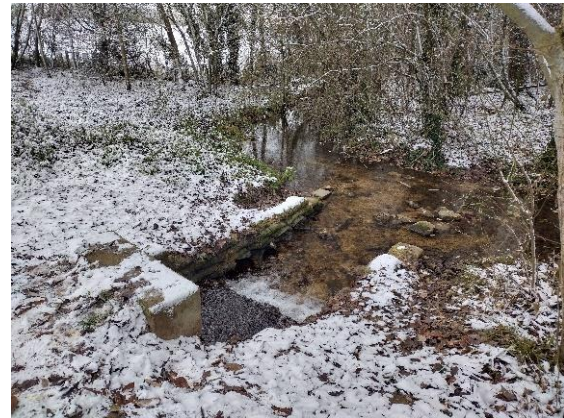
Figure 2.19 Outfall from Trow Pool (looking downstream at SP 54647 24893)

A large offline pond, referred to as Trow Pool is present at SP 54662 24931 (outside of the study area). Water is discharged from the pond to Gagle Brook at SP 54647 24893 (Figure 2.19). Downstream of the pond, the channel is much wider, measuring approximately 2.5m wide, flowing through a woodland corridor. The channel is crossed by a large farm access bridge at SP 54519 24542 measuring approximately 5m wide. From here to the B4030 road crossing, the channel has sand and gravel substrate overlying clay and glide (Figure 2.20), riffle and pool flow.

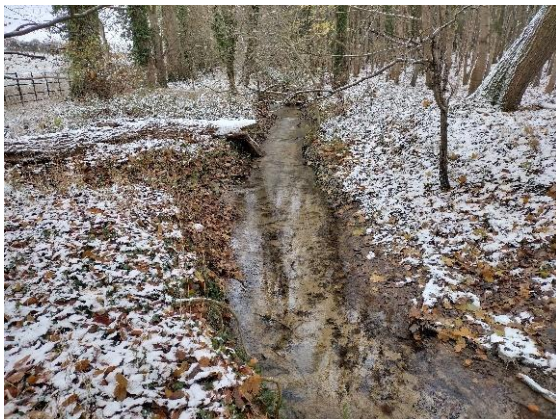
Figure 2.20 Channel flowing through woodland (looking downstream at SP 53857 23994)

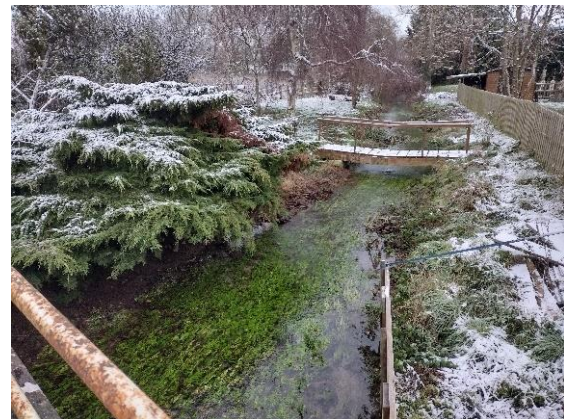
Figure 2.21 Submerged fine leaved macrophytes (looking downstream at SP 53837 23505)

Downstream of the B4030 road crossing, the channel has a straight planform and shallow glide flow (water approximately 0.25m deep) with submerged fine leaved macrophytes (Figure 2.21).

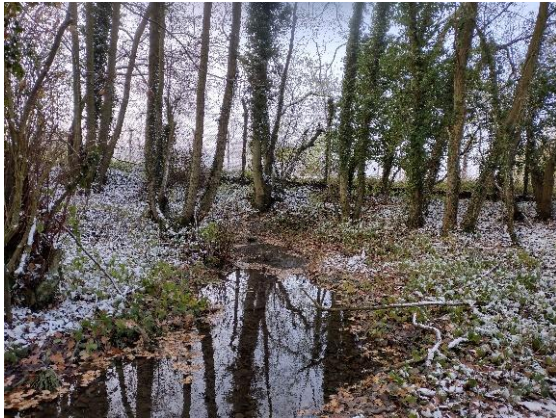
Figure 2.22 Culvert outlet from Upper Heyford airbase (looking upstream at SP 52457 27393)

The Tributary of Padbury Brook emerges from Upper Heyford airbase in a small concrete culvert measuring approximately 0.2m wide (Figure 2.22). From here the channel flows through a wooded area with a sinuous planform, fine gravel, sand and silt substrate and glide and run flow (Figure 2.23). The channel here varies between 1.2-2m in width with shallow banks measuring approximately 0.3m high. Several large wood dams were noted here.

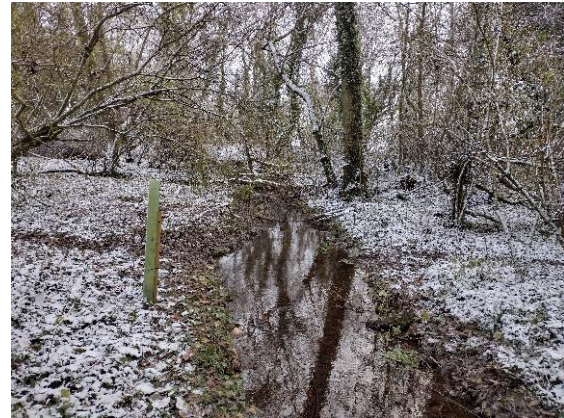
Figure 2.23 Channel through woodland (looking downstream at SP 52582 27426)

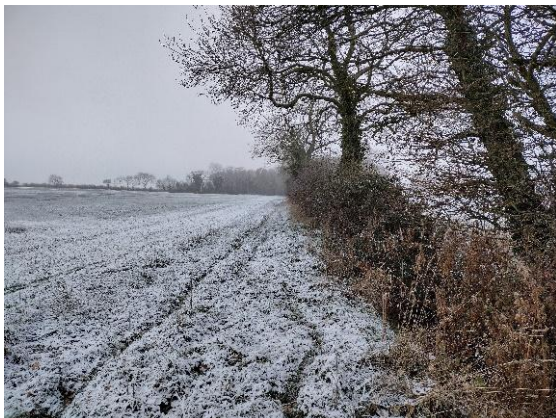
Downstream of Raghouse Lane road crossing, the channel has a straight planform with a modified and incised cross-section forming the boundary to an arable agricultural field (Figure 2.24). Channel substrate is dominated by fine gravel over clay. The channel flows under the railway line in a concrete culvert measuring approximately 0.75m wide with a brick headwall (Figure 2.25).

Figure 2.24 Channel forming boundary to arable field (looking upstream at SP 53016 27531)

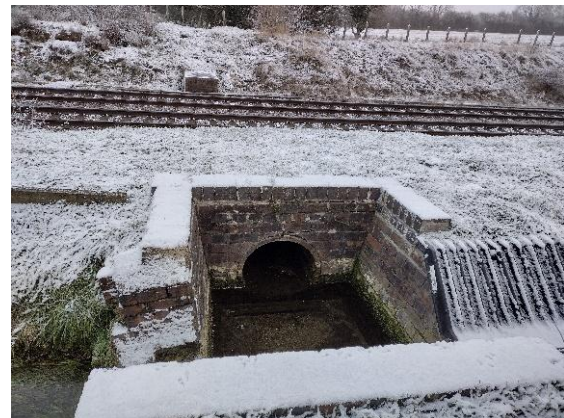
Figure 2.25 Culvert under railway (looking downstream at SP 53131 27573)

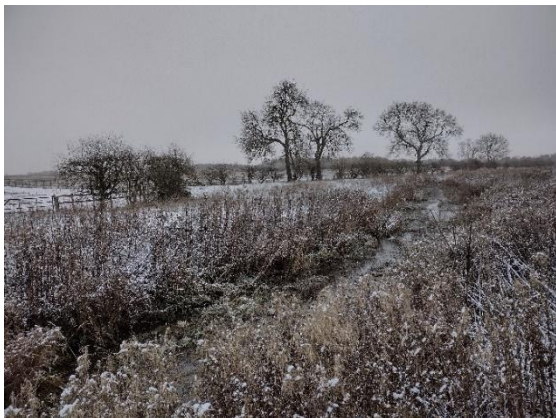
Padbury Brook between Fritwell Road and Ardley Sewage Works has a straight planform with substantial riparian buffer consisting of grasses and scrub (Figure 2.26), measuring approximately 7-10m wide. The channel itself measures 3.3-4m wide and banks are 0.5-1m high. Channel substrate consists of sand and gravels and flow is predominantly glide and run. Reed dieback dominated the channel at this location and a vehicle ford crosses the channel at SP 54287 28006 (with no associated bed reinforcement).

Figure 2.26 Straight channel with substantial riparian buffer (looking downstream at SP 54305 28022)

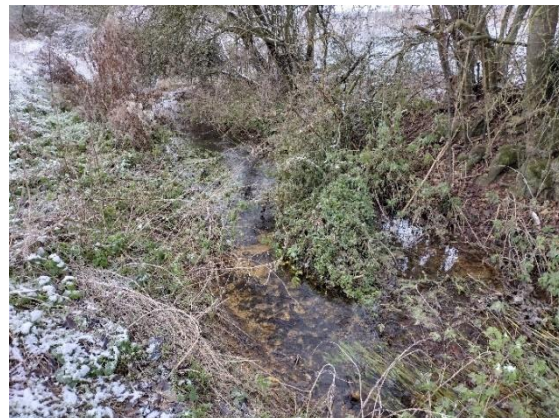
Figure 2.27 Gravel substrate (looking upstream at SP 54586 28225)

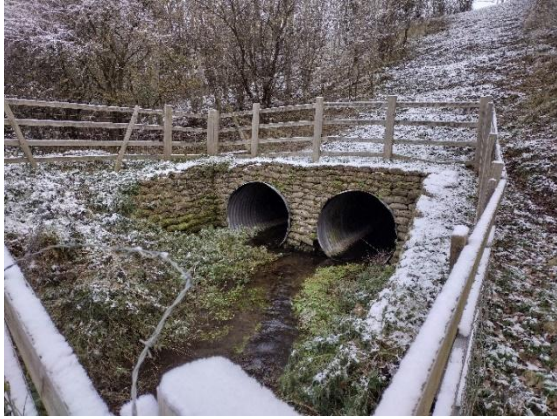
Figure 2.28 Twin culvert under M40 motorway (looking downstream at SP 54607 28232)

Downstream of the sweage works and upstream of the M40 motorway the channel forms the boundary to a large arable field. The channel is narrower at this location measuring approximately 2m wide and has an embankment measuring approximately 0.75m high on the right bank. Channel substrate alternated between silt at areas of glide or pooled water and gravels at lengths of faster run flow (Figure 2.27). The channel has submerged broadleaf macrophytes along much of its length, and floating duckweed where there is less tree cover. The brook passes under the M40 in a twin culvert, each measuring approximately 1m wide (Figure 2.28).

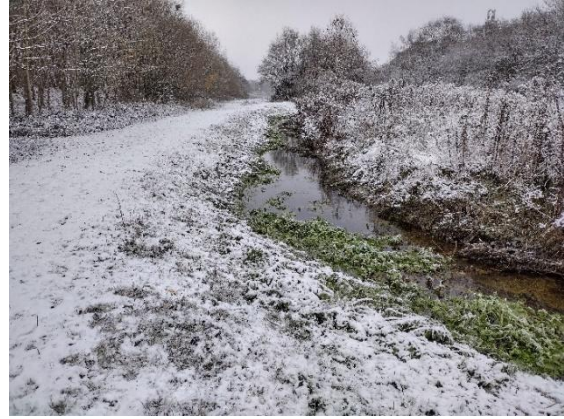
Figure 2.29 Straight, modified channel adjacent to Cherwell Valley Motorway Services (looking downstream at SP 54864 28314)

Downstream of the A43, the channel emerges from another set of twin culverts measuring approximately 1.25m wide. From here, the channel has a modified trapezoidal cross section measuring approximately 1.5-2m wide and with bank height of 0.8m (Figure 2.29). The channel has gravel substrate and gravelly loam banks with glide flow within the upper section and run and riffle within the downstream section. Several macrophytes were noted here including submerged broadleaf and floating duckweed. The channel is crossed by three footbridges and two pipes.
