**East Midlands Gateway  
Phase 2 (EMG2)**

# EMG1 Factual Ground Investigation Report

# **East Midlands Gateway Strategic Rail Freight Interchange**

Factual Ground Investigation Report

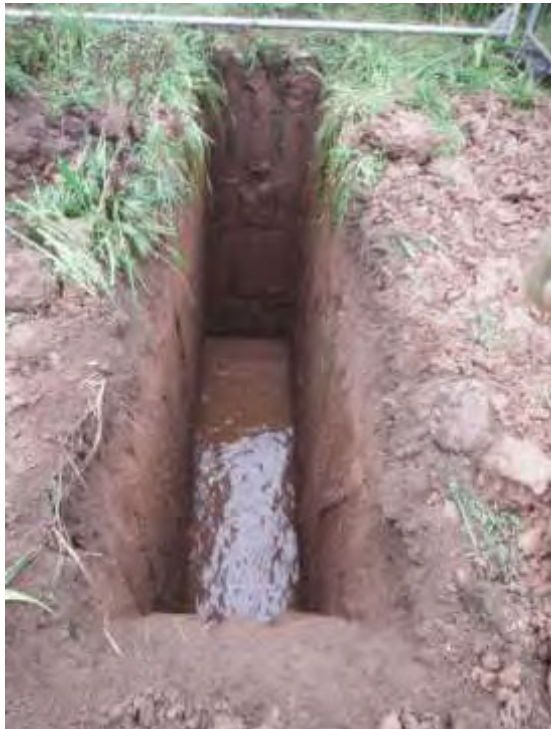
<b>Photo No.</b>  <b>1</b>	<b>Date:</b>  3.10.13

<b>Direction Taken:</b>  N/A	<b>Photo Taken:</b>	
<b>Description:</b>  TPS301 – soakaway test completed within trial pit

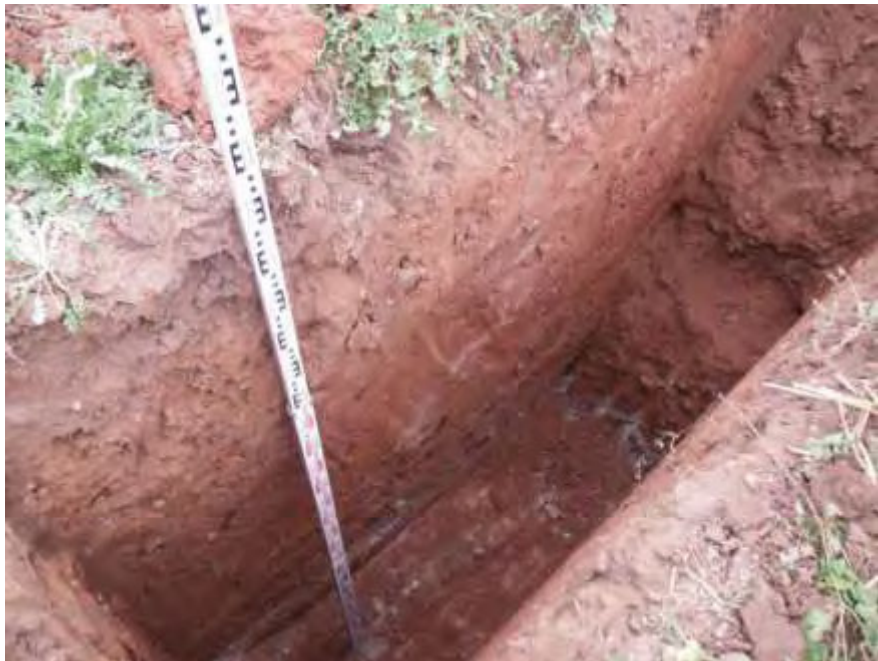
<b>Photo No.</b>  <b>4</b>	<b>Date:</b>  1.10.13

<b>Direction Taken:</b>  N/A	<b>Photo Taken:</b>	
<b>Description:</b>  TPS304 – soakaway test completed within trial pit

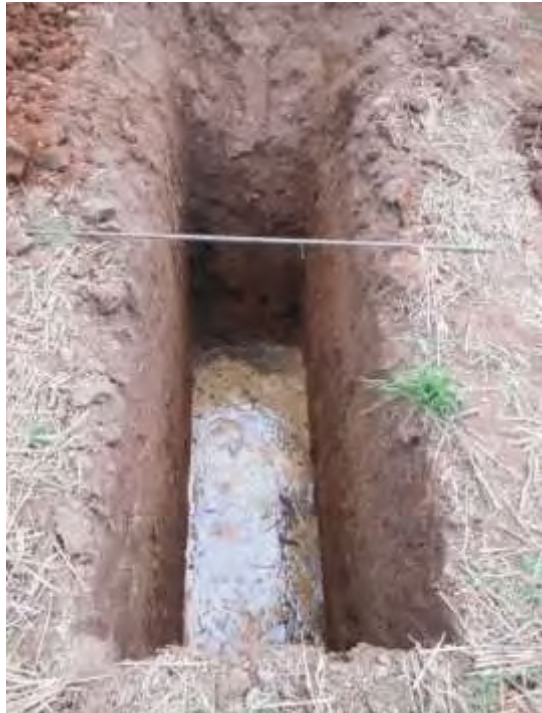
<b>Photo No.</b>  <b>5</b>	<b>Date:</b>  1.10.13

<b>Direction Taken:</b>  N/A	<b>Photo Taken:</b>	
<b>Description:</b>  TPS305 – soakaway test completed within trial pit

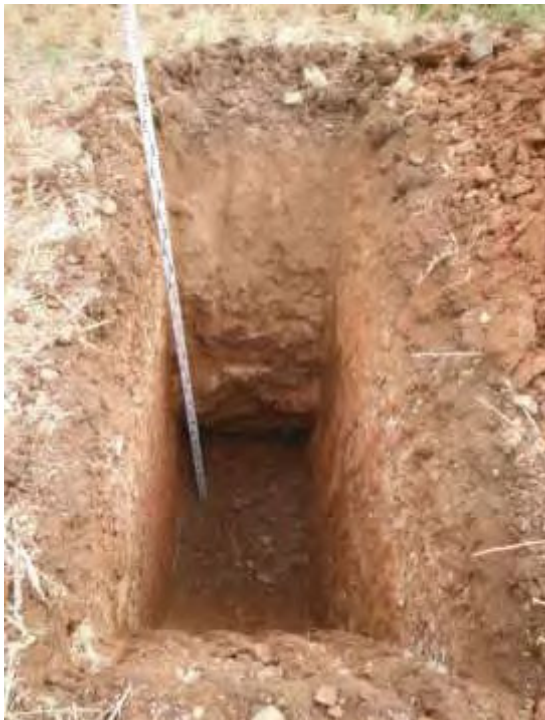
<b>Photo No.</b>  8	<b>Date:</b>  25.09.13

<b>Direction Taken:</b>  N/A	<b>Photo Taken:</b>	
<b>Description:</b>  TP309

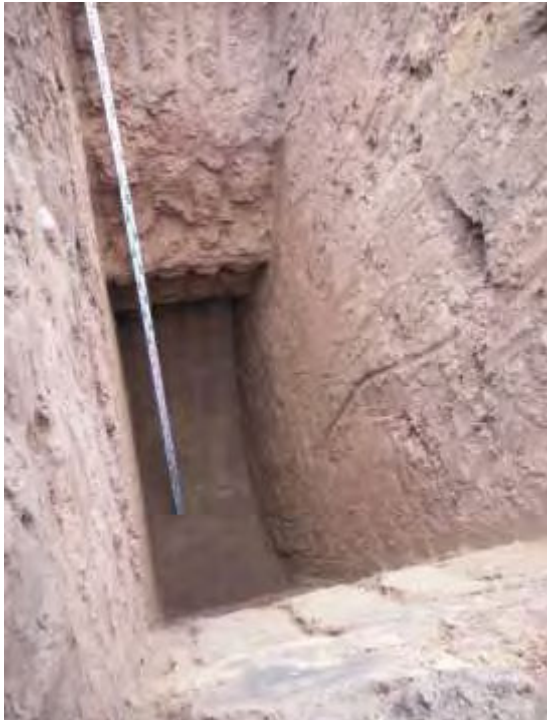
<b>Photo No.</b>  <b>9</b>	<b>Date:</b>  25.09.13

<b>Direction Taken:</b>  N/A	<b>Photo Taken:</b>	
<b>Description:</b>  TP310

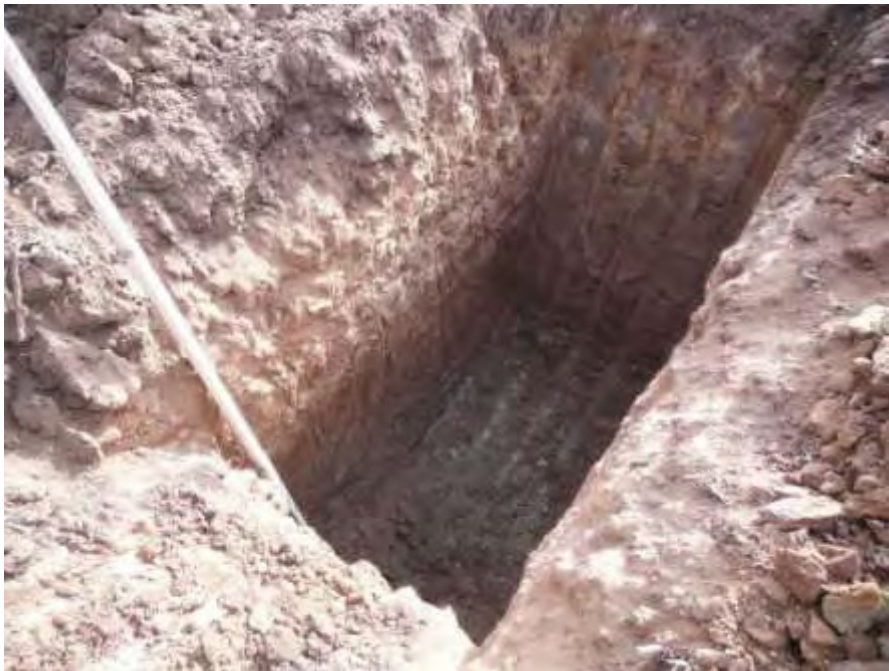
<b>Photo No.</b>  <b>11</b>	<b>Date:</b>  27.09.13

<b>Direction Taken:</b>  N/A	<b>Photo Taken:</b>	
<b>Description:</b>  TP312

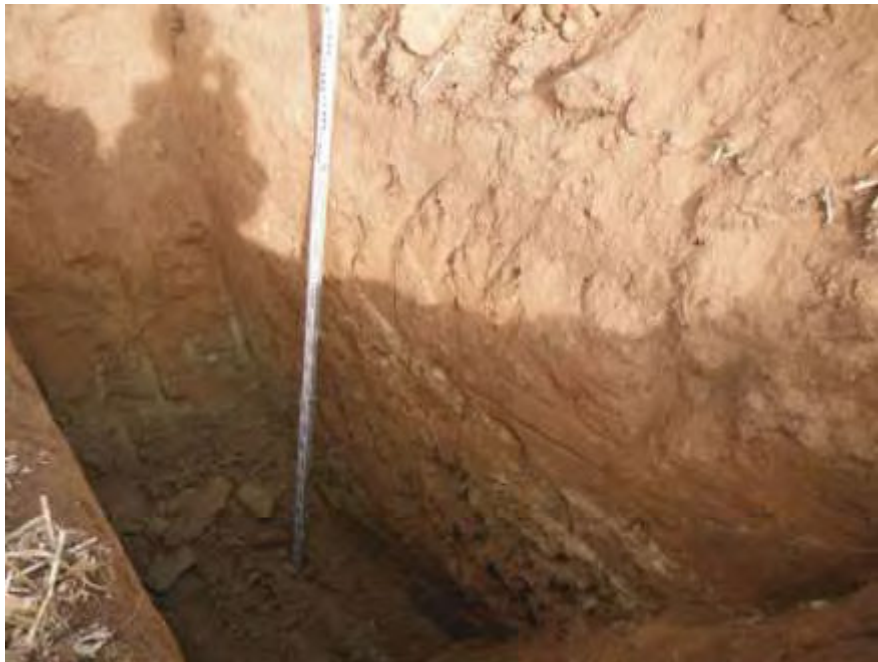
<b>Photo No.</b>  <b>12</b>	<b>Date:</b>  24.09.13
<b>Direction Taken:</b>  N/A	<b>Photo</b>
<b>Description:</b>  TP313

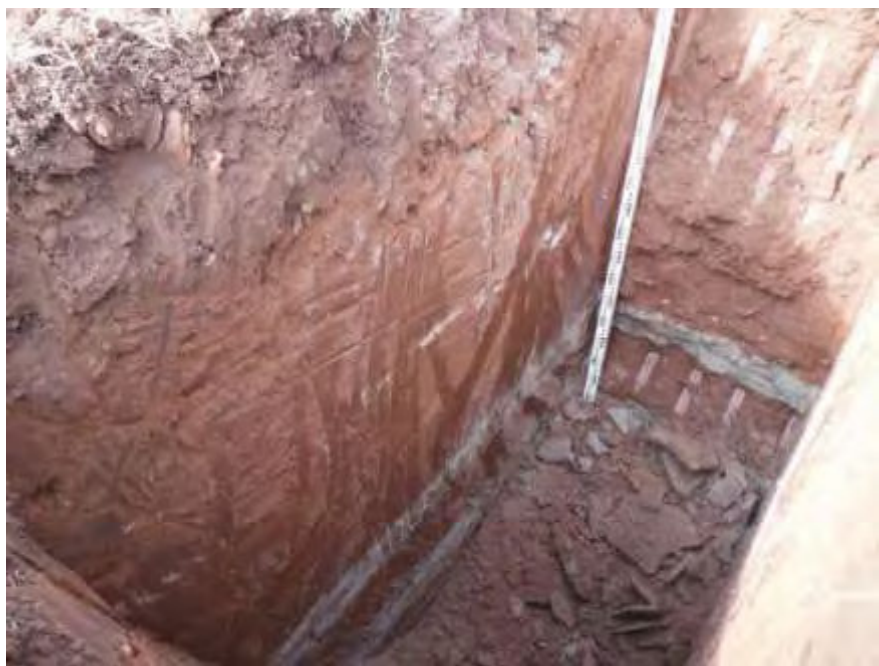
<b>Photo No.</b>  <b>15</b>	<b>Date:</b>  26.09.13

<b>Direction Taken:</b>  N/A	<b>Photo Taken:</b>	
<b>Description:</b>  TP316

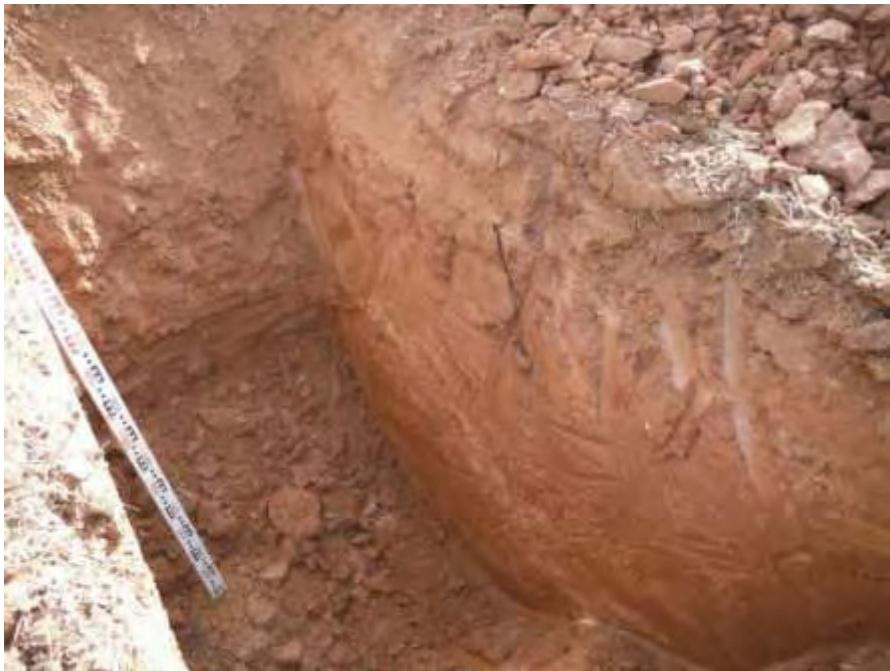
<b>Photo No.</b>  <b>17</b>	<b>Date:</b>  25.09.13

<b>Direction Taken:</b>  N/A	<b>Photo Taken:</b>	
<b>Description:</b>  TP319

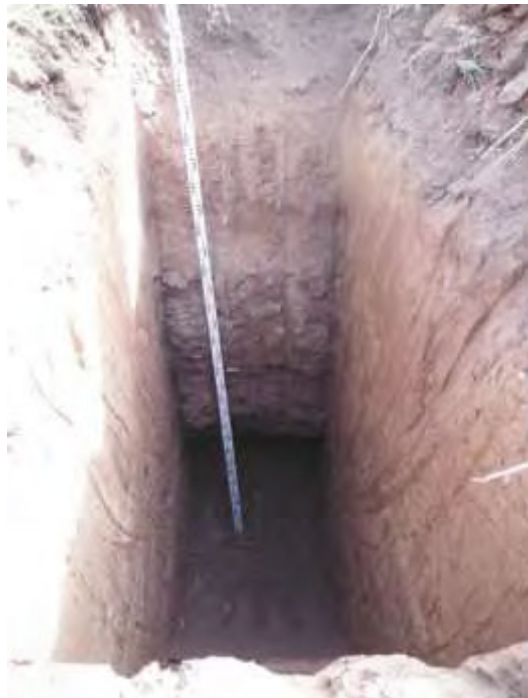
<b>Photo No.</b>  <b>18</b>	<b>Date:</b>  26.09.13

<b>Direction Taken:</b>  N/A	<b>Photo Taken:</b>	
<b>Description:</b>  TP320

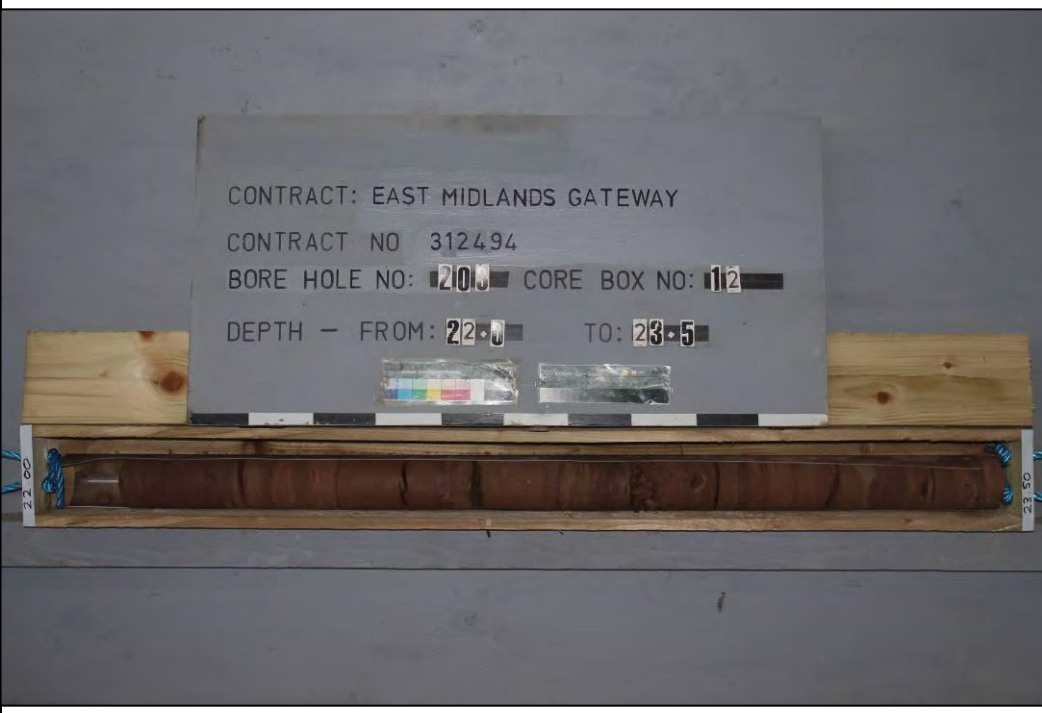
<b>Borehole number:</b> CP(R)203	
<b>Date drilled:</b> 02/10/13	
<b>Depth range:</b> 22.00 – 23.50m

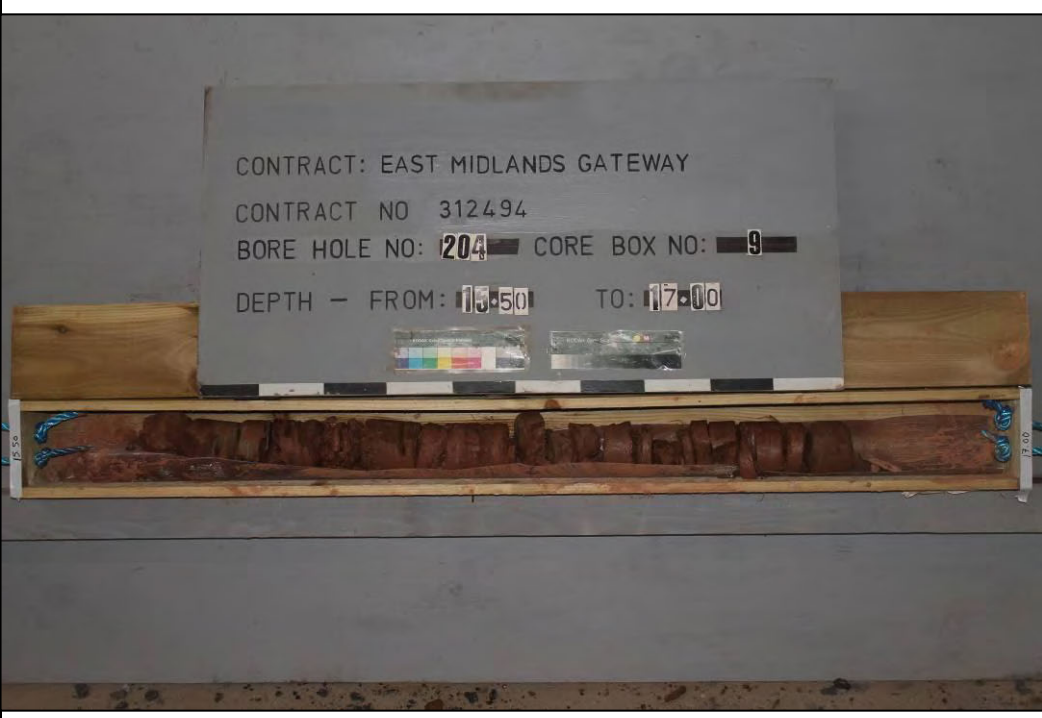
<b>Borehole number:</b> CP(R)204	
<b>Date drilled:</b> 03/10/13	
<b>Depth range:</b> 15.50 – 17.00m

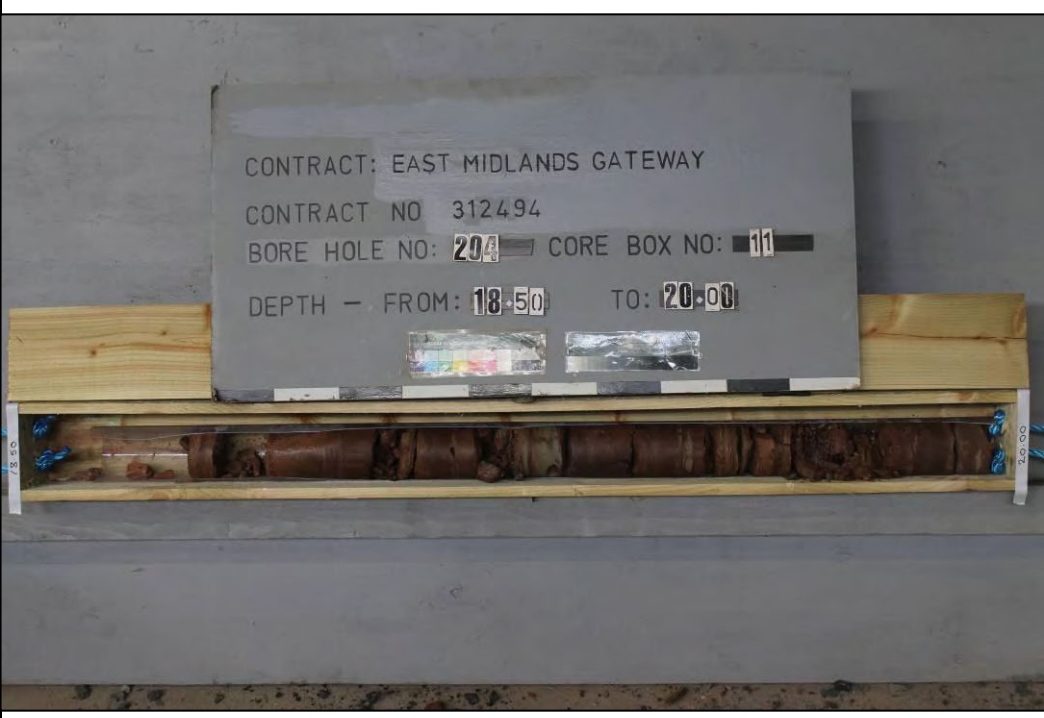
<b>Borehole number:</b> CP(R)204	
<b>Date drilled:</b> 03/10/13	
<b>Depth range:</b> 18.50 – 20.00m

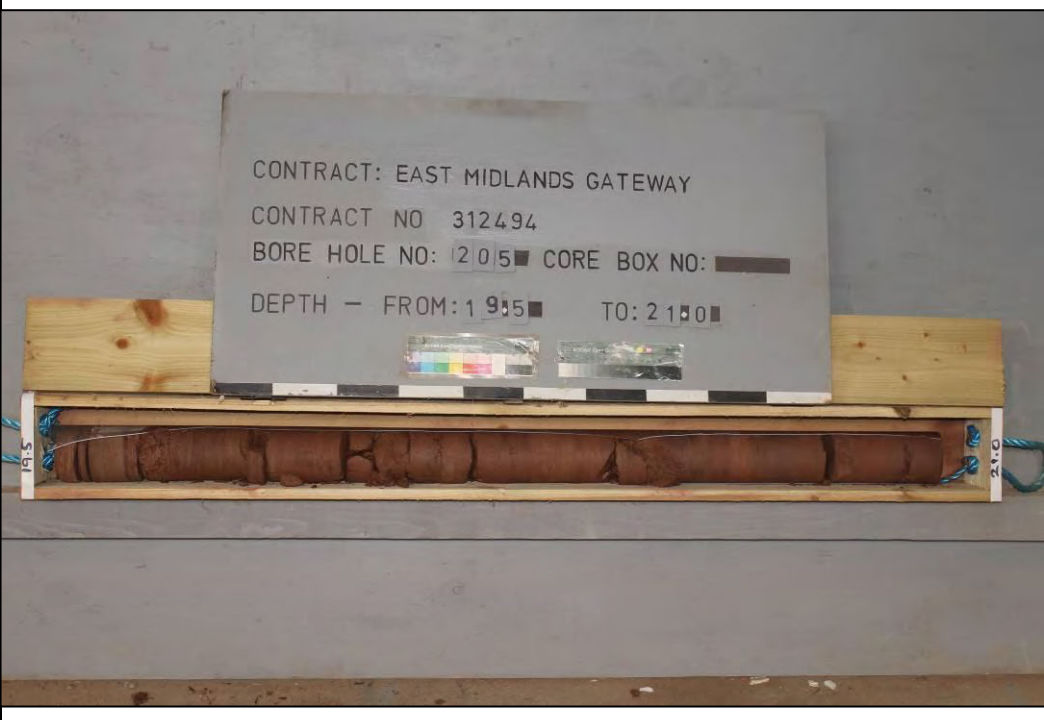
<b>Borehole number:</b>  CP(R)205	
<b>Date drilled:</b>  03/10/13	
<b>Depth range:</b>  19.50 – 21.00m

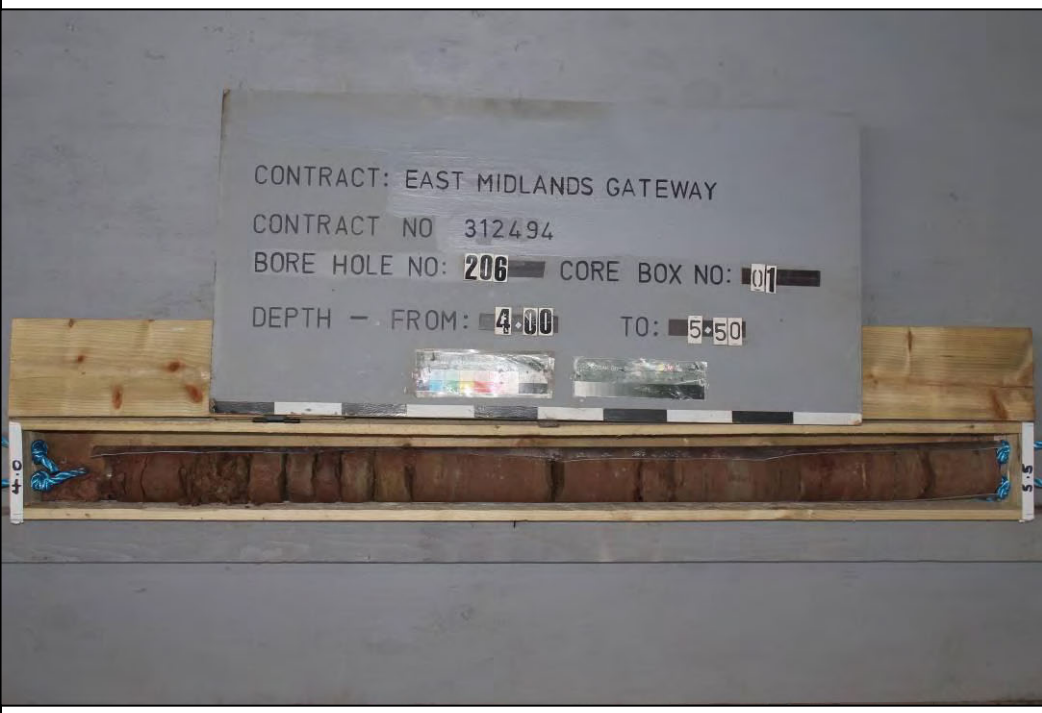
<b>Borehole number:</b> CP(R)206	
<b>Date drilled:</b> 04/10/13	
<b>Depth range:</b> 4.00 – 5.50m

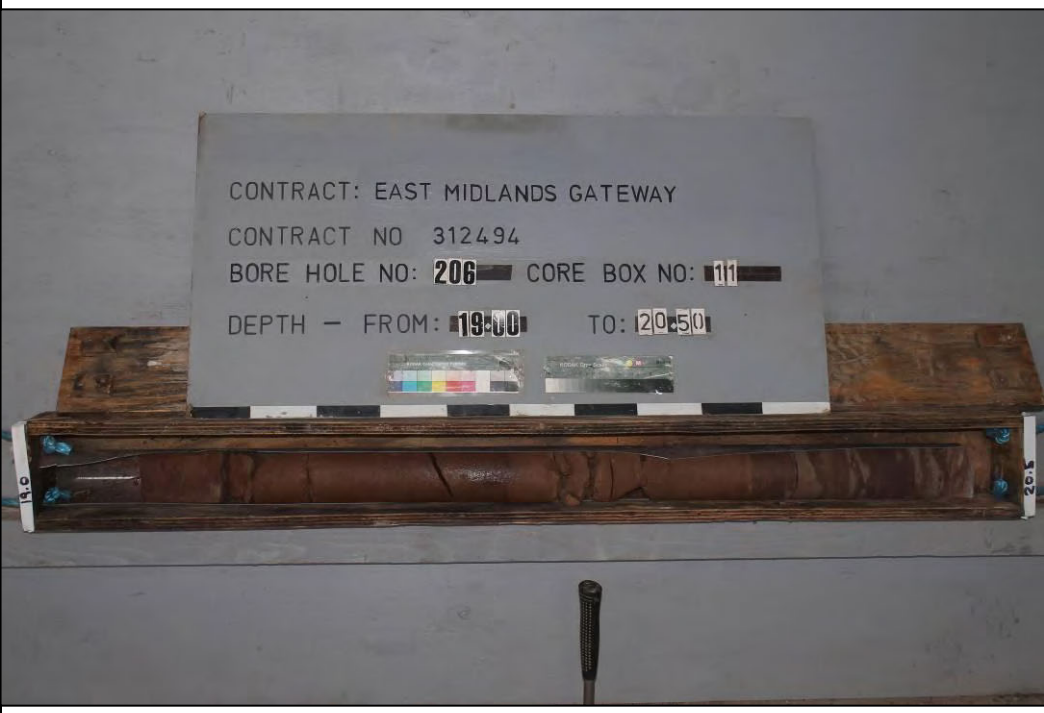
<b>Borehole number:</b>  CP(R)206	
<b>Date drilled:</b>  04/10/13	
<b>Depth range:</b>  19.00 – 20.50m

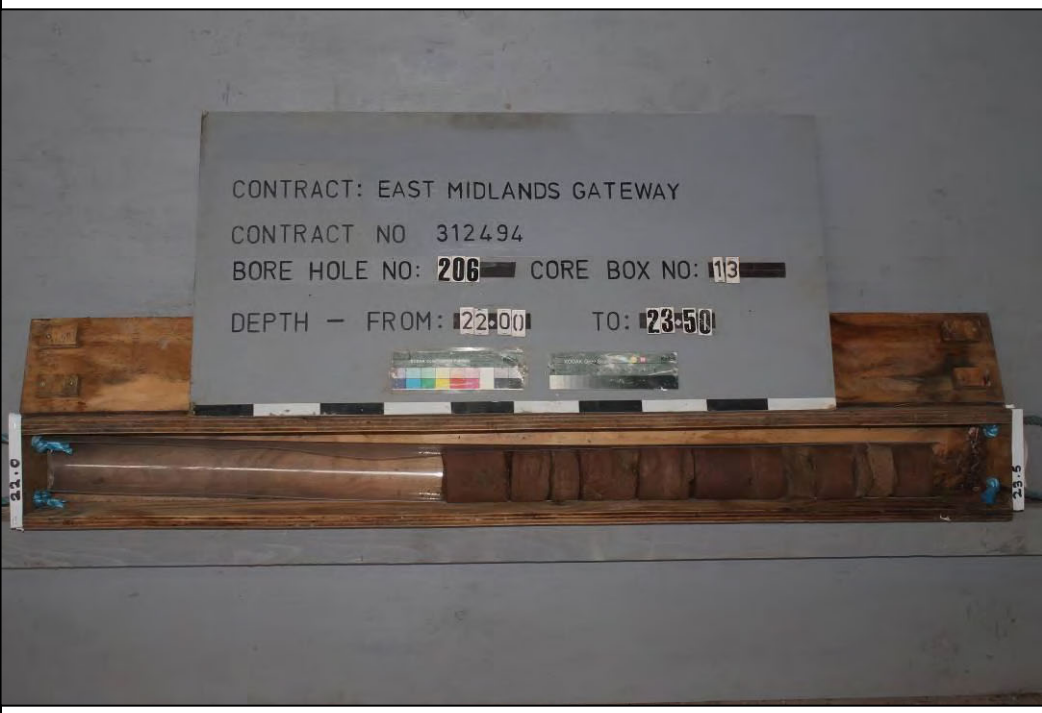
<b>Borehole number:</b> CP(R)206	
<b>Date drilled:</b> 04/10/13	
<b>Depth range:</b> 22.00 – 23.50m

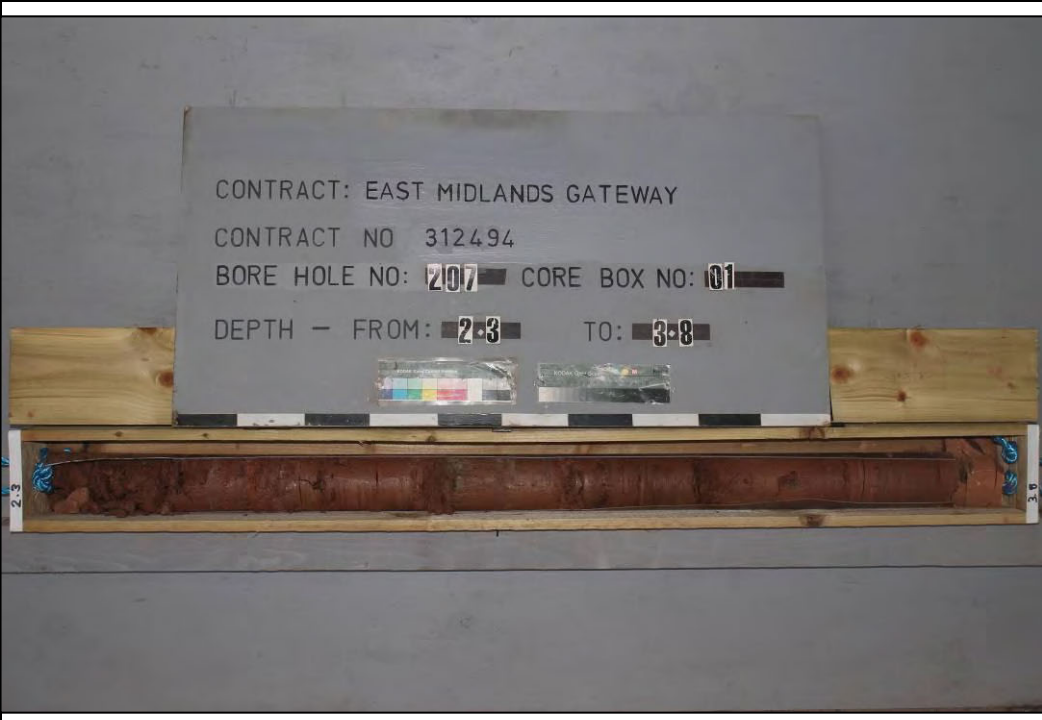
<p>CONTRACT: EAST MIDLANDS GATEWAY  CONTRACT NO 312494  BORE HOLE NO: 207 CORE BOX NO: 01  DEPTH - FROM: 2.3 TO: 3.8</p>
<b>Borehole number:</b> CP(R)207	
<b>Date drilled:</b> 01/10/13	
<b>Depth range:</b> 2.30 – 3.80m

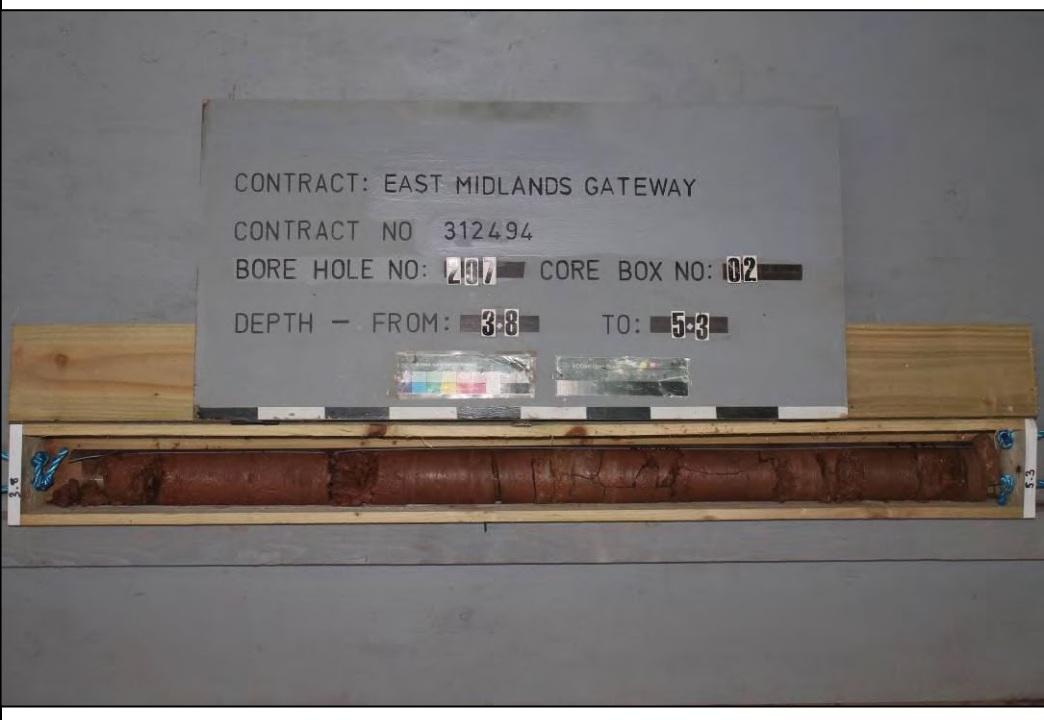
<b>Borehole number:</b> CP(R)207	
<b>Date drilled:</b> 01/10/13	
<b>Depth range:</b> 3.80 – 5.30m

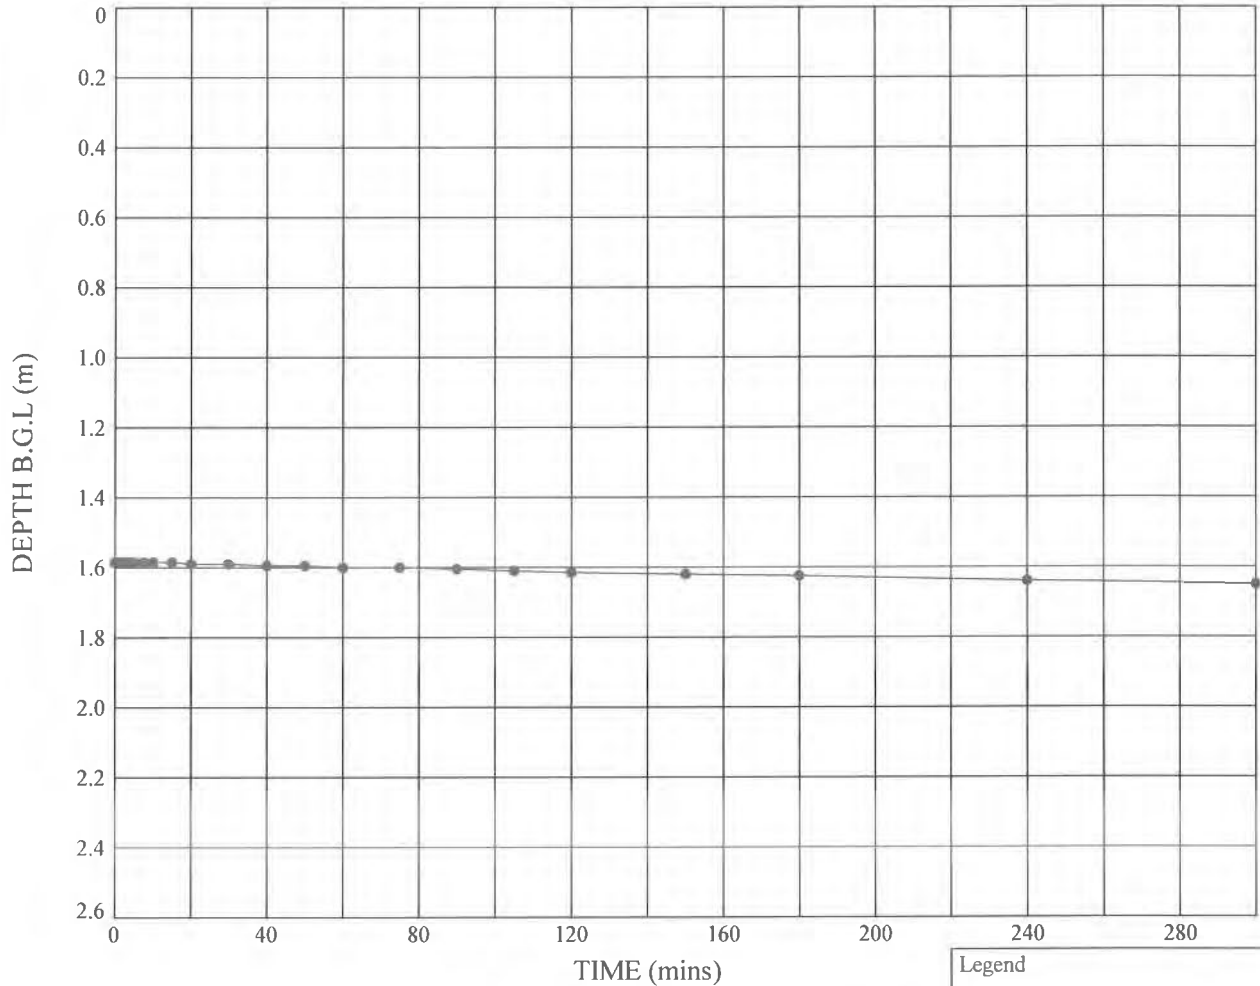
## PLOT OF DEPTH OF WATER BELOW GROUND LEVEL AGAINST TIME

Pit start depth: = **2.65** m  
 Pit final depth: = **2.55** m  
 Effective depth,  $D_e$  = **0.97** m  
 Effective storage volume,  $V_{p75-25}$  = **0.7768** m<sup>3</sup>  
 Surface area,  $a_{p50}$  = **4.5050** m<sup>2</sup>  
 Time,  $t_{p75-25}$  = **NA** secs  
 Infiltration rate,  $f$  = **NA** m/s

In-situ soakaway testing was undertaken in selected trial pit locations as denoted upon the exploratory hole plan presented as Figure 4. Preliminary soakaway tests were undertaken in unsupported shallow trial pits and were attempted in general accordance with the recommendation of BRE 365. Tests undertaken within TPs 301, 302, 303, 304, 305, 351 & 352 did not soakaway sufficiently to allow calculation of infiltration rates. The strata in which these tests were undertaken were predominantly cohesive and not considered to be conducive to soakaway and the testing undertaken has confirmed this. The in-situ soakaway test results are presented in Appendix F and the results are summarised below within Table3.

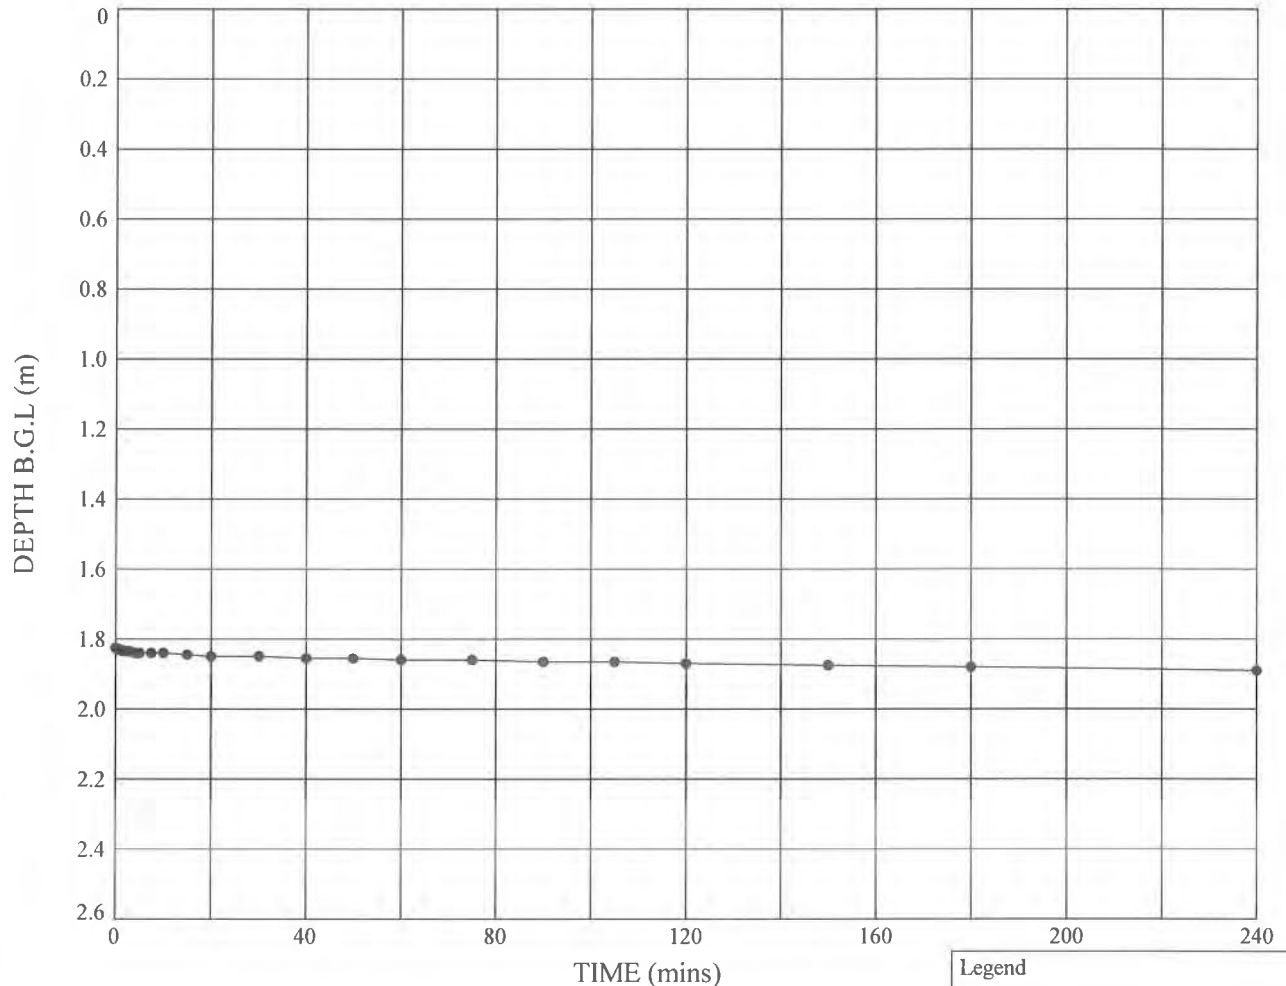
## PLOT OF DEPTH OF WATER BELOW GROUND LEVEL AGAINST TIME

Pit start depth: = **2.58** m  
 Pit final depth: = **2.55** m  
 Effective depth,  $D_e$  = **0.73** m  
 Effective storage volume,  $V_{p75-25}$  = **0.6090** m<sup>3</sup>  
 Surface area,  $a_{p50}$  = **3.9275** m<sup>2</sup>  
 Time,  $t_{p75-25}$  = **NA** secs  
 Infiltration rate,  $f$  = **NA** m/s

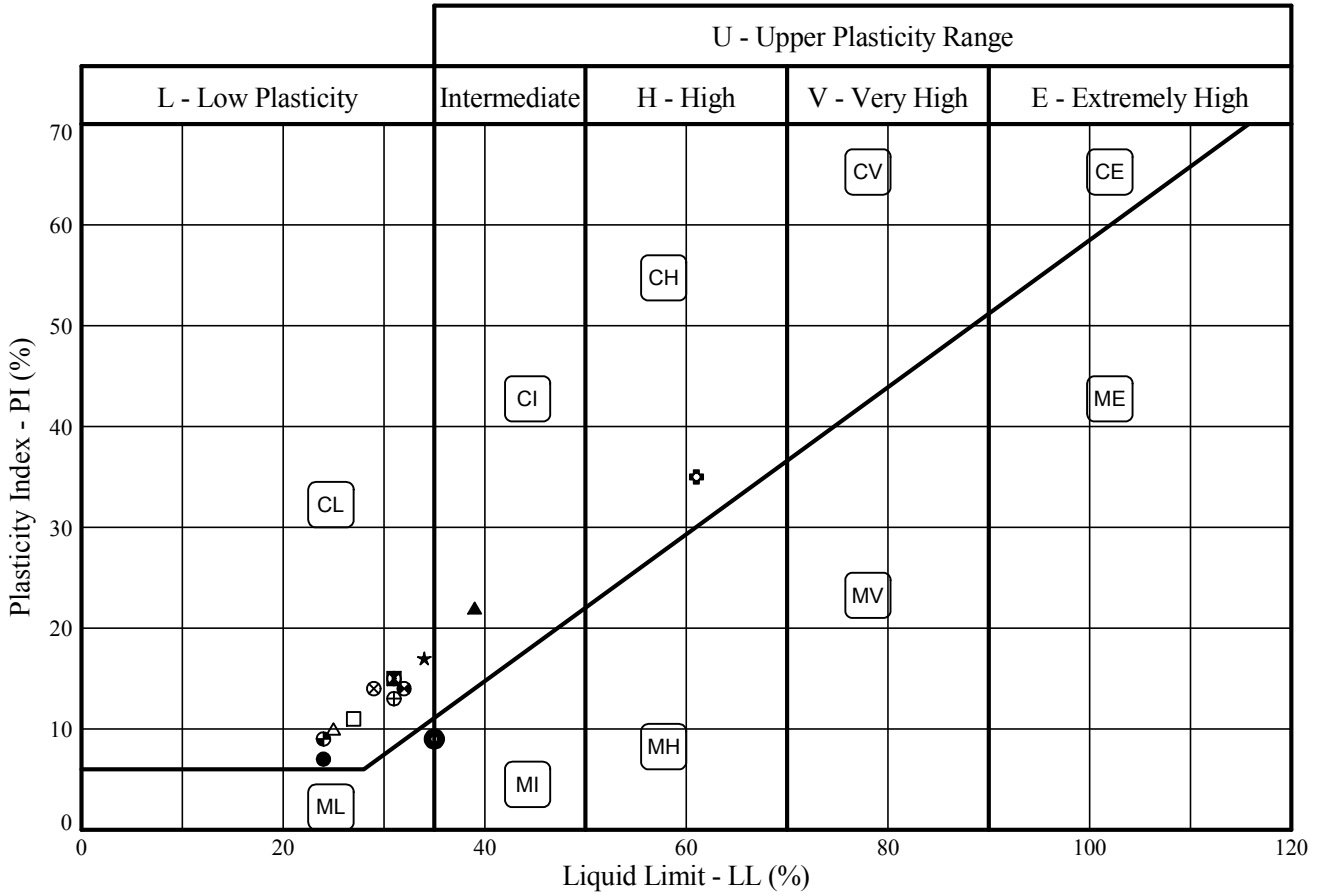
Sample Identification				BS Test Method #	Preparation Method +	MC %	LL %	PL %	PI %	<425um %	
Exploratory Position ID	Sample	Depth (m)									
●	CP203	5U	1.27	3.2/4.4/5.3/5.4	4.2.3	13	24	17	7	100	
⊠	CP204	7U	2.20	3.2/4.4/5.3/5.4	4.2.3	15	31	16	15	100	
▲	CP210	3U	1.57	3.2/4.4/5.3/5.4	4.2.3	17	39	17	22	92	
★	CP210	9U	3.06	3.2/4.4/5.3/5.4	4.2.3	19	34	17	17	74	
⊙	CP210	14U	5.00	3.2/4.4/5.3/5.4	4.2.3	12	31	16	15	69	
⊕	CP221	9U	3.35	3.2/4.4/5.3/5.4	4.2.3	40	61	26	35	100	
⊗	CP222	9U	3.42	3.2/4.4/5.3/5.4	4.2.3	32	35	26	9	98	
△	TP301	B	0.70	3.2/4.4/5.3/5.4	4.2.3	23	25	15	10	93	
⊗	TP302	B	1.60	3.2/4.4/5.3/5.4	4.2.4	14	29	15	14	23	
⊕	TP321	B	2.70	3.2/4.4/5.3/5.4	4.2.4	12	31	18	13	17	
□	TP322	1LB	2.20	3.2/4.4/5.3/5.4	4.2.4	14	27	16	11	73	
⊗	TP324	1LB	2.00	3.2/4.4/5.3/5.4	4.2.3	16	32	18	14	78	
⊕	TP326	1LB	1.50	3.2/4.4/5.3/5.4	4.2.3	15	24	15	9	100

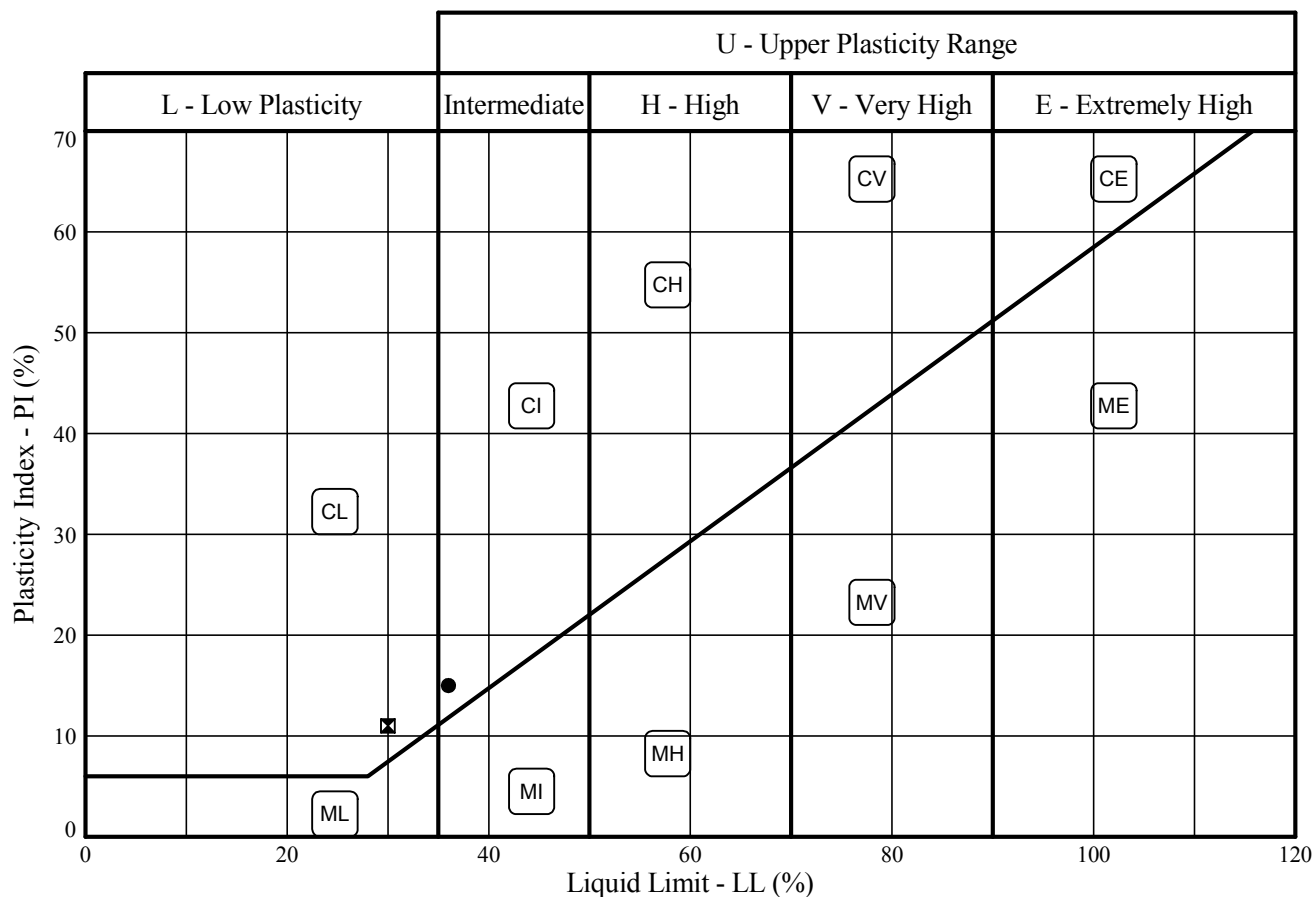
Sample Identification				BS Test Method #	Preparation Method +	MC %	LL %	PL %	PI %	<425um %
Exploratory Position ID	Sample	Depth (m)								
●	TP327	1LB	1.20	3.2/4.4/5.3/5.4	4.2.4	23	36	21	15	77
☒	TP328	1LB	2.10	3.2/4.4/5.3/5.4	4.2.3	14	30	19	11	62

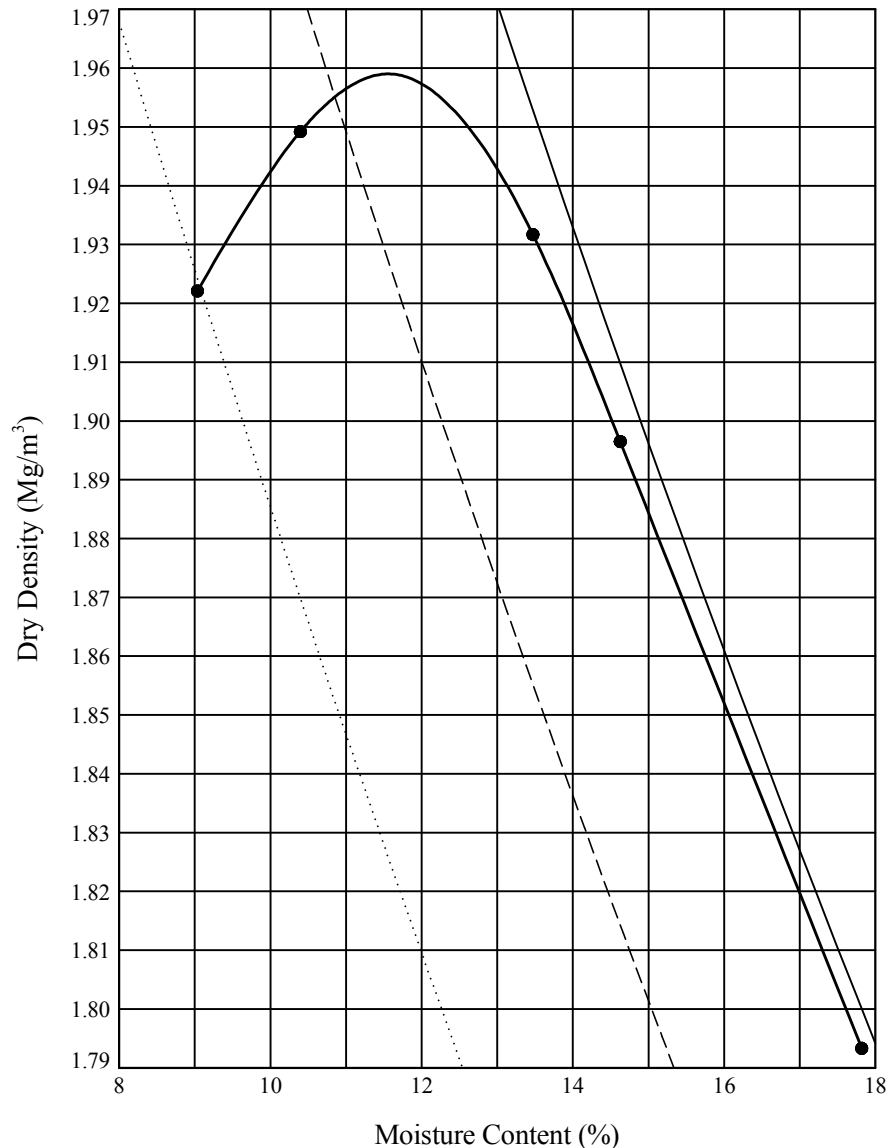
Trial Pit : **TP327**      Sample Ref: **1**      Sample Type: **LB**      Depth (m): **1.20**

Initial Sample Conditions		Test Details		Test Results	
Initial Moisture Content (%)	: 18	Compaction Type	: Heavy	Maximum Dry Density (Mg/m³)	: 1.96
% Retained on 37.5mm BS Sieve	: 0	Mass of Rammer (kg):	4.5	Optimum Moisture Content (%)	: 12
% Retained on 20.0mm BS Sieve	: 3	Type of Mould	: Proctor	Method Used:	Clause 3.5
Particle Density - assumed (Mg/m³)	: 2.65	Remarks:			
Size of Soil Pieces	: <20mm				
Sample Description			Key to Air Voids Lines		
Reddish brown slightly gravelly slightly sandy CLAY			——— 0%	— — — — 5%	..... 10%

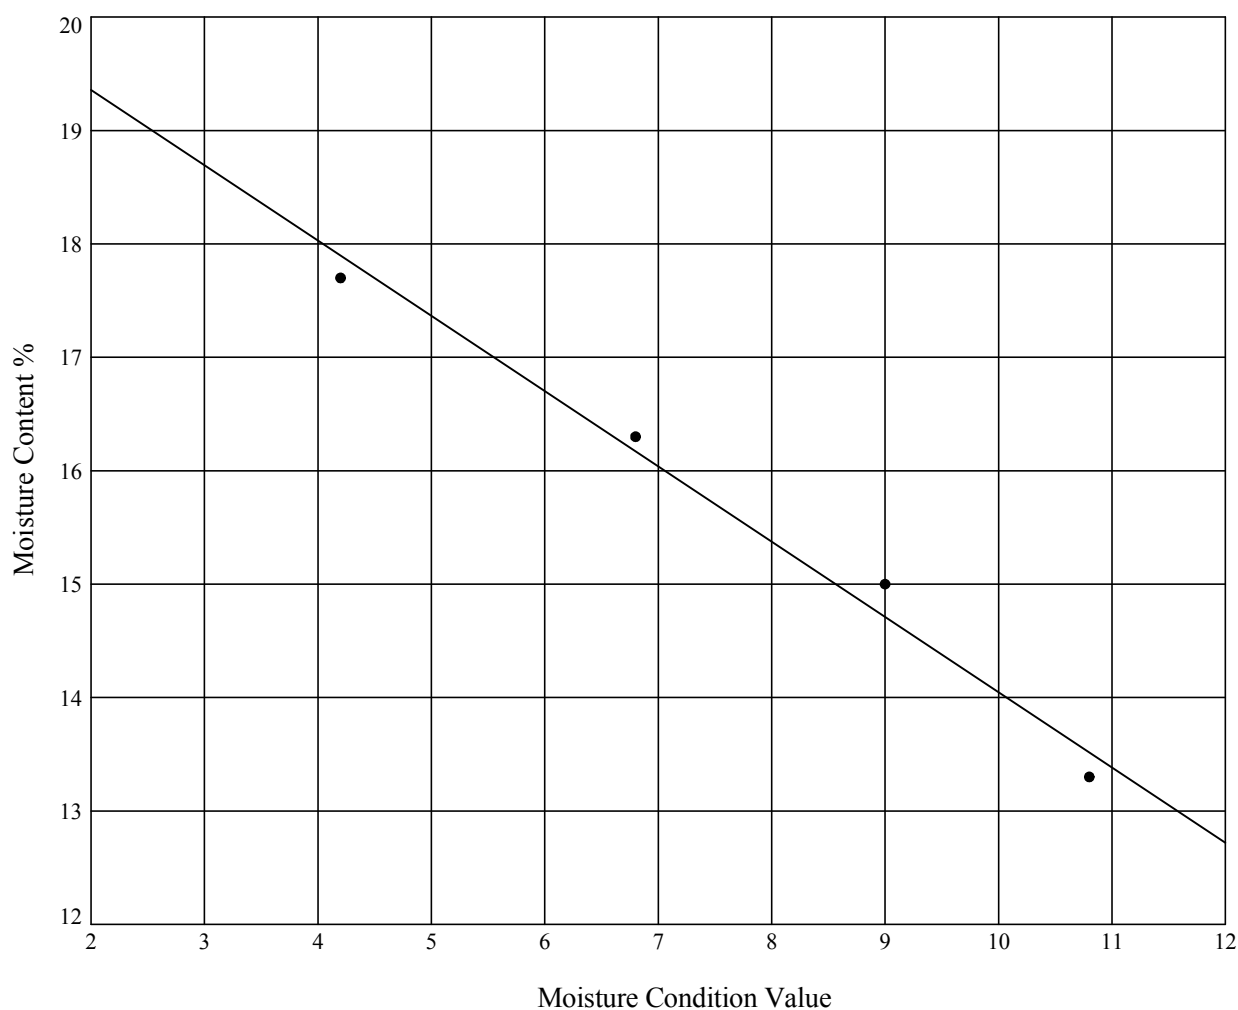
Test Number	1	2	3	4	5
Moisture Content	15.0	16.3	17.7	13.3	-
MCV	9.0	6.8	4.2	10.8	-

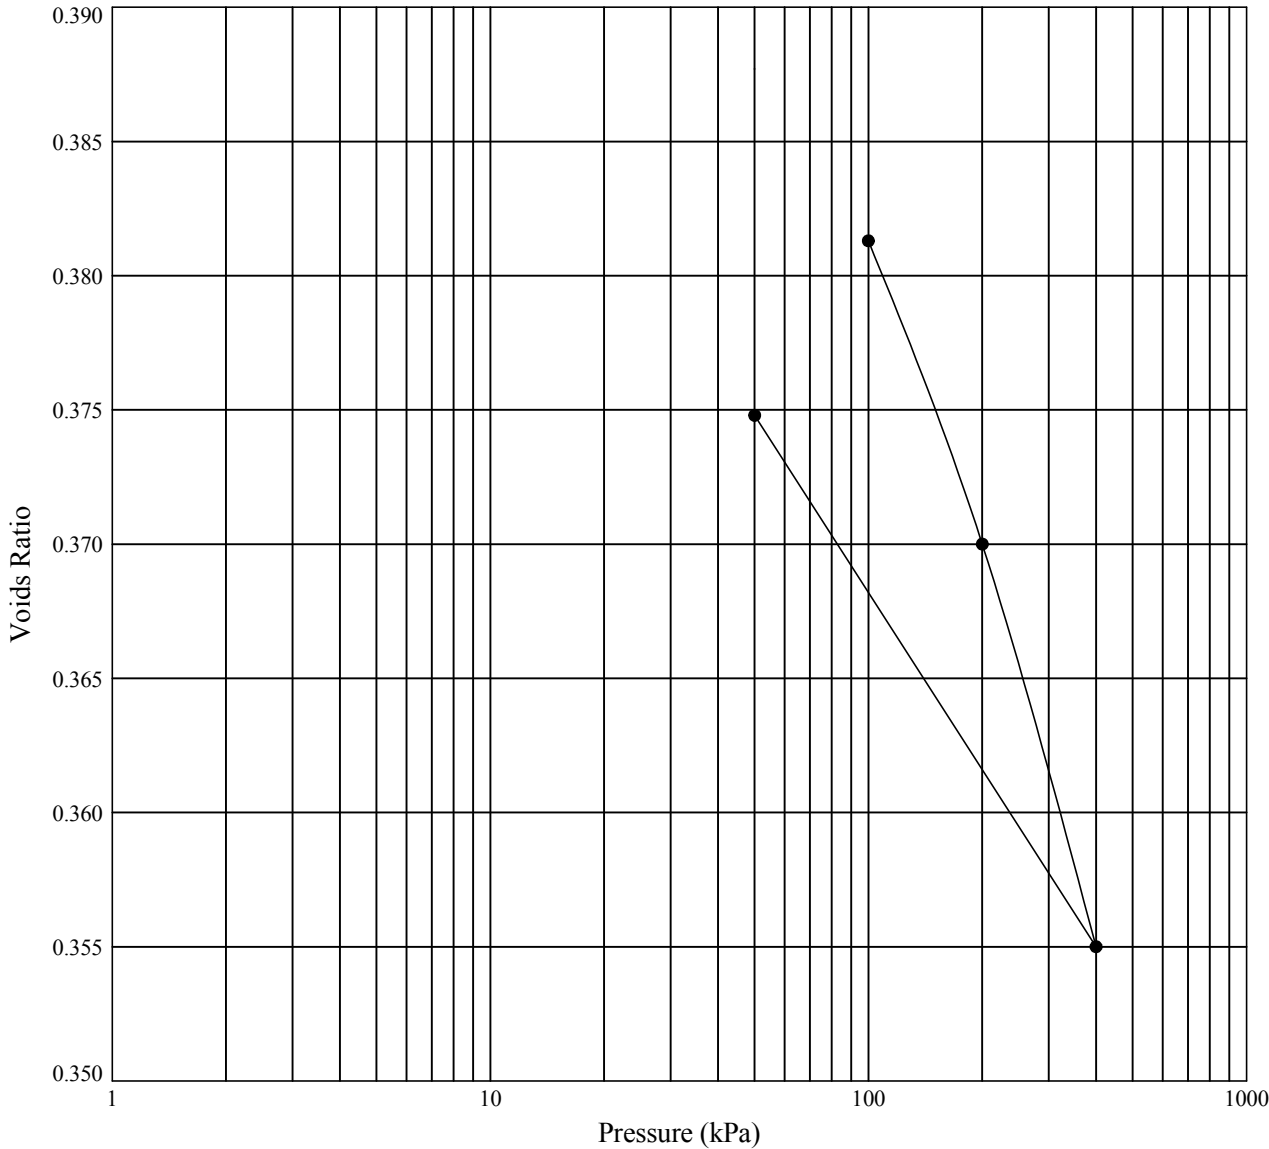
Position ID : CP216      Sample Ref: 3      Sample Type: U      Depth (m): 1.41

Initial Specimen Condition		Final Specimen Condition		Test Results		
Moisture Content (%)	: 14	Moisture Content (%)	: 16	Pressure Range (kPa)	Mv (m²/MN)	Cv (m²/yr)
Bulk Density (Mg/m³)	: 2.16	Bulk Density (Mg/m³)	: 2.24	0 - 50	Sample	Swelling
Dry Density (Mg/m³)	: 1.89	Dry Density (Mg/m³)	: 1.93	50 - 100	0.093	32
Void Ratio	: 0.3985	Void Ratio	: 0.3748	100 - 200	0.081	27
Specimen Details				200 - 400	0.055	43
Description <b>Reddish brown CLAY</b>	Height (mm)		: 20.14	400 - 50	NA	NA
	Diameter (mm)		: 75.05			
	Particle Density (Mg/m³) (assumed)		: 2.65			
	Swelling Pressure (kPa)		: NA

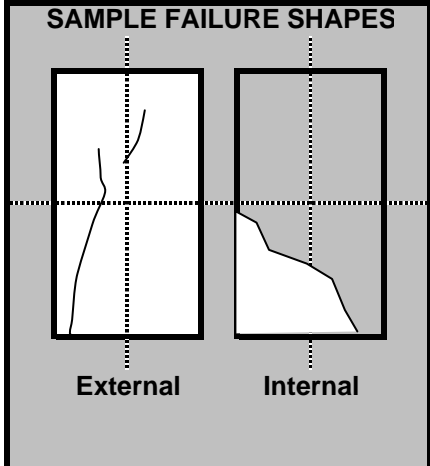
BOREHOLE		CP(R)203	<div>SAMPLE FAILURE SHAPES</div> <div>

</div> <div>ExternalInternal</div>
CORE RUN		-	
DEPTH		12.10	
SAMPLE DIAMETER	mm	85.75	
SAMPLE HEIGHT	mm	192.80	
WATER CONTENT	%	6.7	
TEST CONDITION		As received	
RATE OF LOADING	kN/s	0.2	
TEST DURATION	min.sec	4.05	
DATE OF TESTING		20-Nov-13	
LOAD FRAME USED		50kN	
LOAD DIRECTION WITH RESPECT TO LITHOLOGY		Perpendicular	
FAILURE LOAD	kN	39.0	
UNCONFINED COMPRESSIVE STRENGTH	MPa	6.8

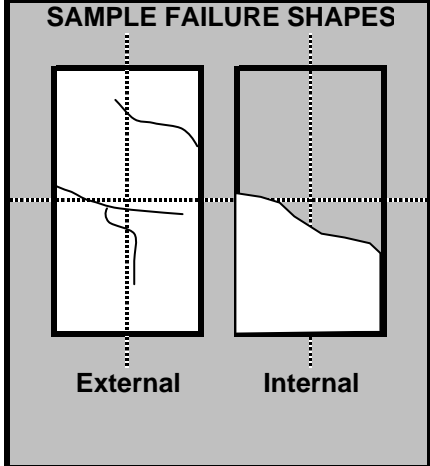
</div> <div>ExternalInternal</div>
CORE RUN		-	
DEPTH		18.60	
SAMPLE DIAMETER	mm	86.30	
SAMPLE HEIGHT	mm	194.80	
WATER CONTENT	%	4.4	
TEST CONDITION		As received	
RATE OF LOADING	kN/s	0.2	
TEST DURATION	min.sec	5.00	
DATE OF TESTING		20-Nov-13	
LOAD FRAME USED		2000kN	
LOAD DIRECTION WITH RESPECT TO LITHOLOGY		Perpendicular	
FAILURE LOAD	kN	72.6	
UNCONFINED COMPRESSIVE STRENGTH	MPa	12.4

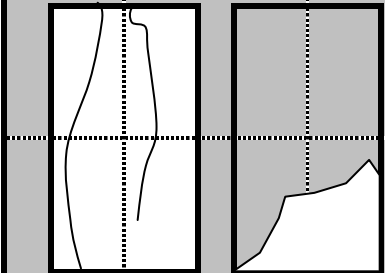
</div> <div>ExternalInternal</div>
CORE RUN		-	
DEPTH		7.57	
SAMPLE DIAMETER	mm	86.73	
SAMPLE HEIGHT	mm	149.31	
WATER CONTENT	%	10.1	
TEST CONDITION		As received	
RATE OF LOADING	kN/s	0.1	
TEST DURATION	min.sec	14.14	
DATE OF TESTING		20-Nov-13	
LOAD FRAME USED		2000kN	
LOAD DIRECTION WITH RESPECT TO LITHOLOGY		Perpendicular	
FAILURE LOAD	kN	124.3	
UNCONFINED COMPRESSIVE STRENGTH	MPa	21.0
