# Hampshire Water Transfer and Water Recycling Project

## Environmental Statement - Appendix 11.2 Geotechnical and geo- environmental reports- 12 of 18 documents - Geo-Environmental Interpretative Report – Proposed Water Recycling Plant

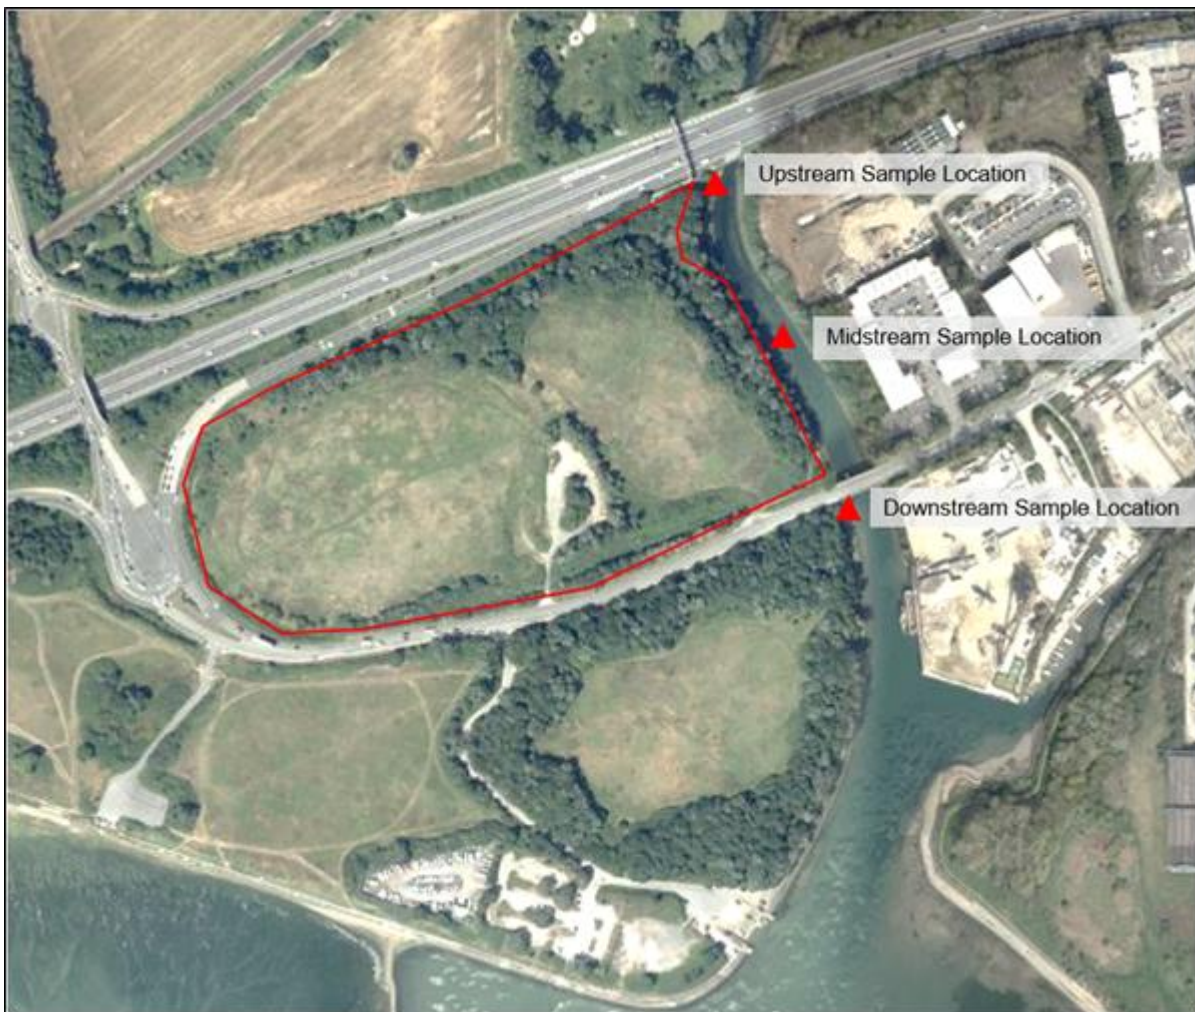
The sampling locations were not provided within the Delta Simons reports, however a marked up aerial image was subsequently provided by Delta Simons to show the locations, and is presented as Figure 7.1 below.

**Figure 7.1 – Delta Simons Surface Water Sample Locations**

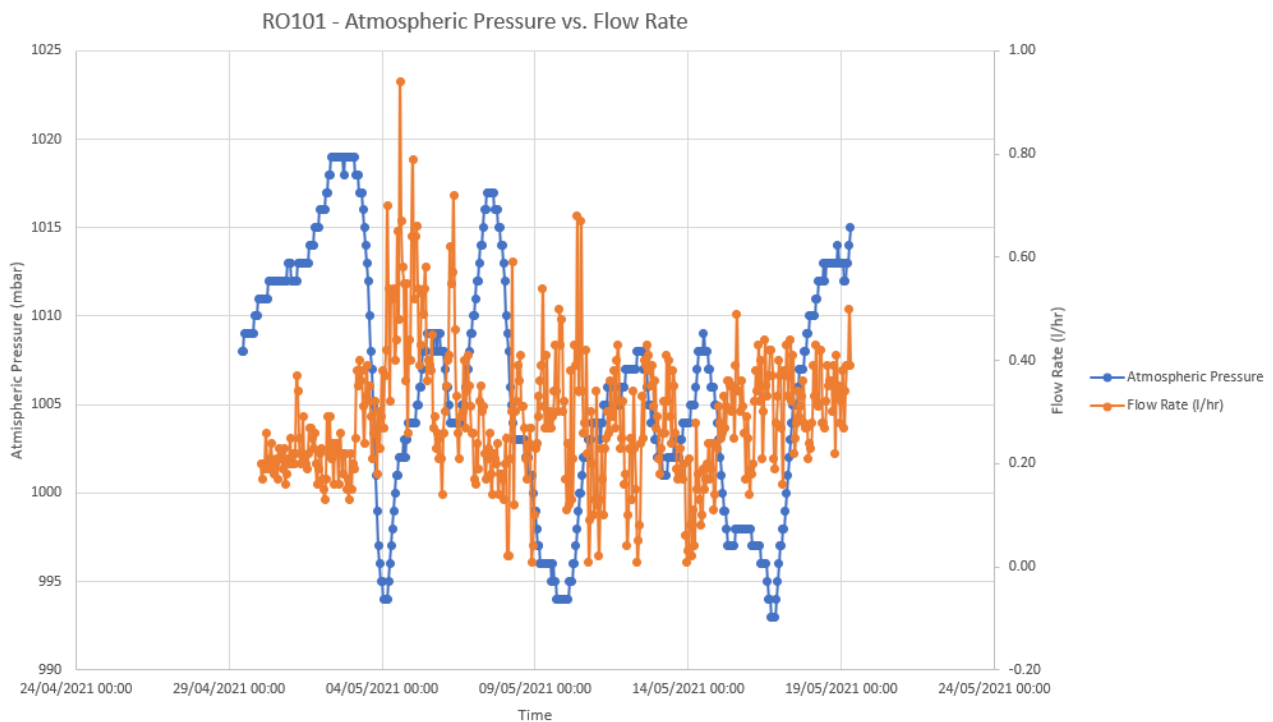
Within boreholes RO101 (S) to RO104 (S) and RO105 (S) it appears that there is a slight correlation between falling atmospheric pressure and increased gas flow rate. The example graph from RO101 (S) (Figure 5) shows that spikes in gas flow rate (orange) tend to correlate with rapid drops in atmospheric pressure (blue).

**Figure 8.2 – Graph Comparing Atmospheric Pressure with Gas Flow Rate in Borehole RO101 (S)**

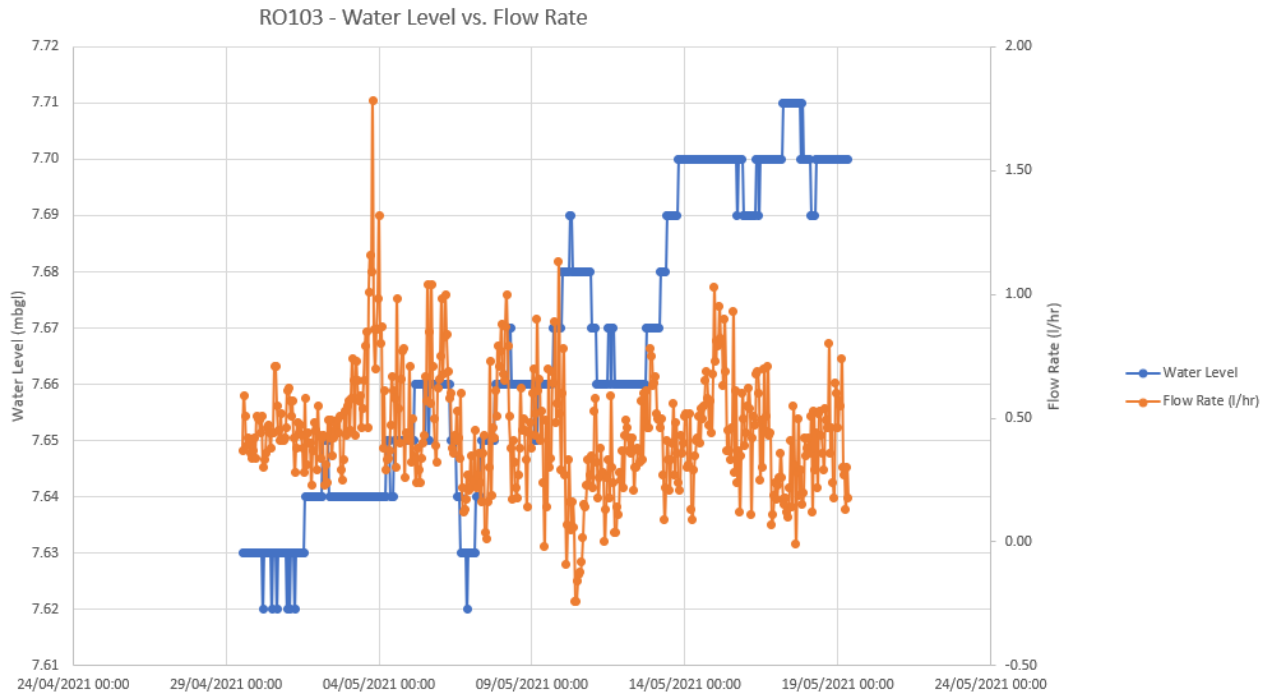
It does not appear that groundwater (or landfill leachate) level is an influencing factor on ground gas flow rate. This is true in situations where the groundwater is tidally influenced (RO105 (S) and RO106 (S)) and where it does not appear to be tidally influenced (RO101 (S) to RO104 (S)). As shown on the example graphs below (Figures 6 and 7), there does not appear to be an obvious correlation between gas flow rate (orange) and water level (blue).

Figure 8.3 - Graph Comparing Gas Flow Rate and Water Level in RO103 (Non-Tidal)
