Hampshire Water Transfer and Water Recycling Project

Environmental Statement – Appendix 12.1 Agricultural land quality

APPLICATION DOCUMENT REFERENCE: 6.2

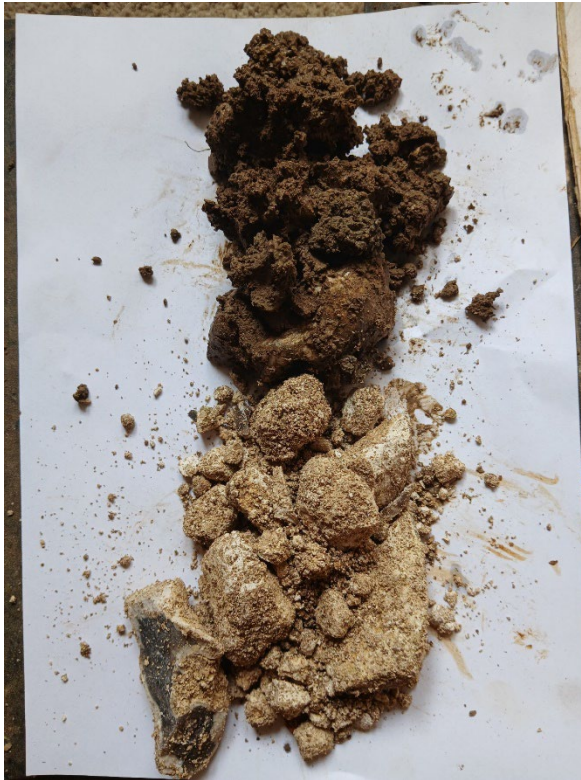
Graphic A-1 3E3113HP Typical Upton 1 soil. Medium clay loam over heavy clay loam and chalk, WC I and Grade 2

- 3.2.4 In the east where the bedrock is chalk, and aligning with the Upton 1 soil association, the topsoil comprises dark greyish brown (10YR4/2) medium clay loam which is slightly stony and calcareous. This overlies light grey (10YR7/1) heavy clay loam which is very stony with chalk stones. The subsoil is friable with a crumb structure and is extremely calcareous. The subsoil sample was from a depth of 50cm, indicating at least moderate depth to chalk bedrock. The profile is well-drained, WC I, and is limited by droughtiness to Grade 2. This soil type is illustrated by profile 3E3113HP in Annex A.4.

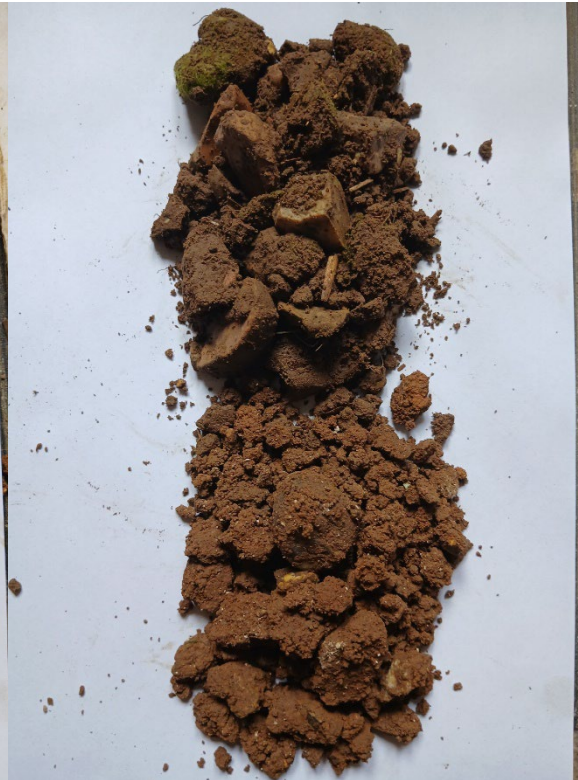
Graphic A-2 3F2521HP Typical Carstens soil. Medium clay loam over heavy clay loam, WC II and Grade 2

- 3.2.5 Near the Wallington River, largely aligning with the mapped Carstens association, the profile includes brown (7.5YR4/2) medium clay loam topsoil which is non-calcareous and moderately flinty. The topsoil is friable with fine angular blocky structure. The subsoil is similar but heavy clay loam in texture and includes mottling which is indicative of soil wetness. The structure remains permeable and the profile is in WC II. There is a soil wetness limitation to Grade 2. This soil type is illustrated by profile 3F2521HP in Annex A.4.

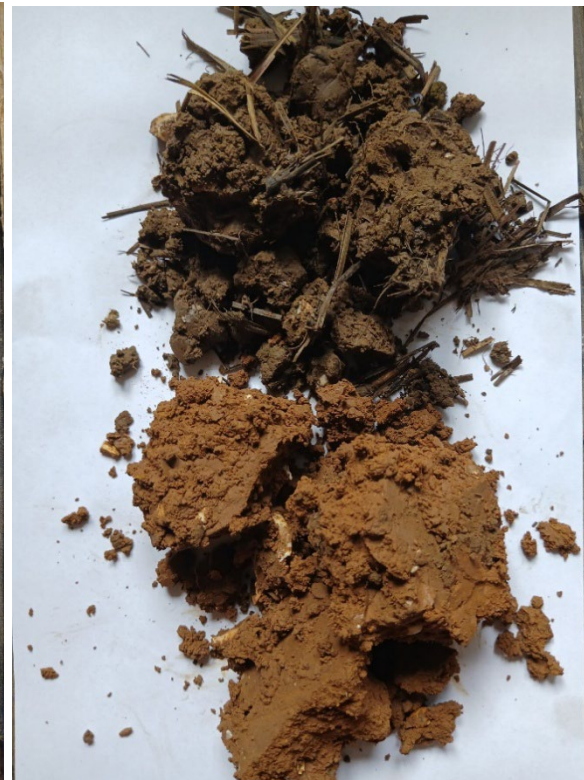
Graphic A-3 3F3602HP Medium clay loam over slowly permeable clay. WC IV and Subgrade 3b

- 3.2.6 On the east-facing valley side at Crockerhill, there is a dark greyish brown (10YR5/2) medium clay loam topsoil, which is firm and has a fine to medium angular blocky structure. This passes to brown (7.5YR5/3) clay subsoil which is firm to very firm with a medium angular blocky structure and is slowly permeable. The profile is in WC IV and limited by wetness to Subgrade 3b. This soil type is illustrated by profile 3F3602HP in Annex A.4.

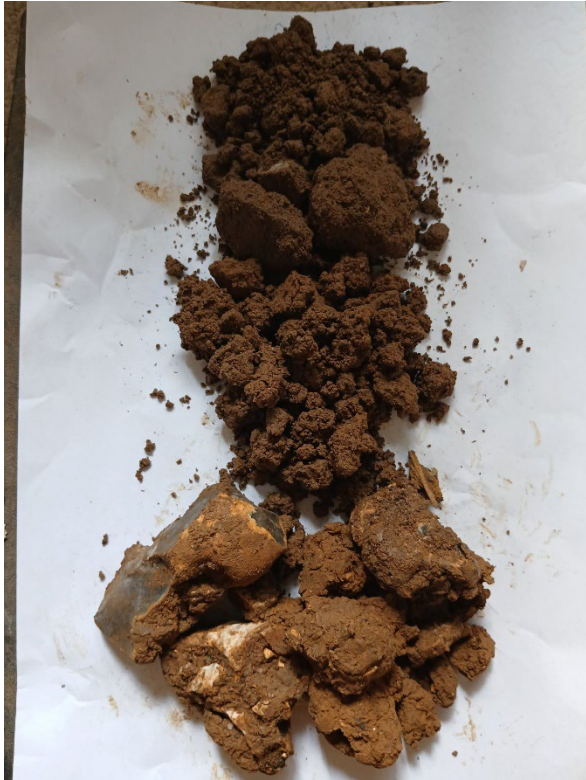
Graphic A-4 3W8535SA Sandy silt loam over sandy clay loam and sandy clay. WC II and Grade 2

- 3.2.7 To the south of Wickham and broadly coinciding with geology of the Bracklesham Group, the topsoil is sandy silt loam which is dark brown (10YR3/3). The topsoil is friable with a fine subangular blocky structure. There is an upper subsoil of brown (10YR4/3) sandy clay loam which is mottled and very slightly stony, with a fine subangular blocky structure and weak consistency. A lower subsoil is distinguishable and comprises dark yellowish brown (10YR4/4) sandy clay, with a firm, medium angular blocky structure. The profile is moderately well-drained, WC II, but limited most by droughtiness, to Grade 2. This soil type is illustrated by profile 3W8535SA in Annex A.4.

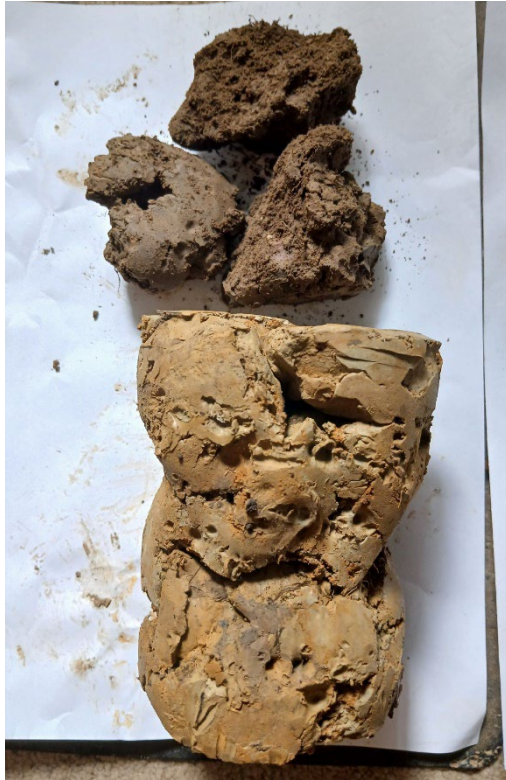
Graphic A-5 3H4511HP Typical Wickham soil, medium clay loam over clay, WC IV and Subgrade 3b

- 3.2.8 North of Wickham, the soil profile aligns with the mapped Wickham association and includes dark greyish brown (10YR4/2) medium clay loam topsoil which is non-calcareous and very slightly stony. It has a coarse subangular blocky structure. The subsoil is grey (10YR5/1) clay which is extremely firm and has a massive structure. There is common mottling. The subsoil is gleyed and slowly permeable and the profile in WC IV. There is a wetness limitation to Subgrade 3b. This soil type is illustrated by profile 3H4511HP in Annex A.4.

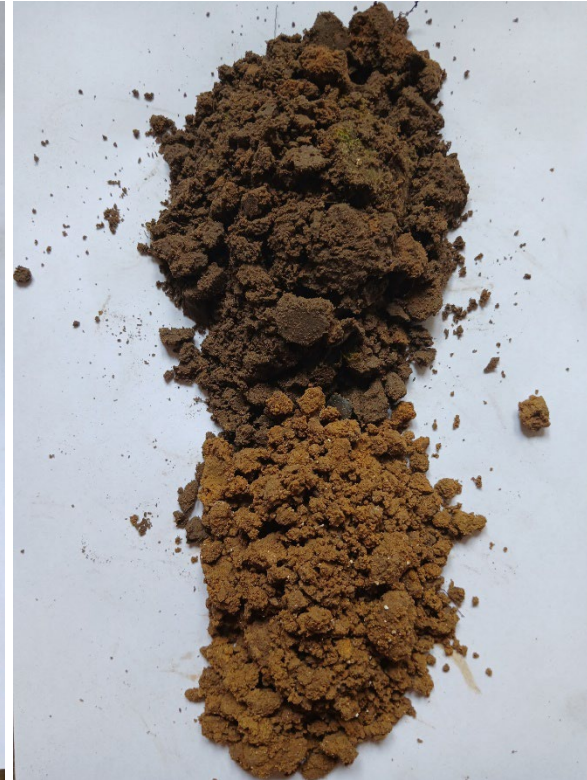
Graphic A-6 3J5003HP Medium sandy loam over clayey sand. WC II and Grade 2

- 3.2.9 Between Shirrell Heath and Waltham Chase, the topsoil is very dark greyish brown (10YR3/2) medium sandy loam which is very slightly stony and has a loose crumb structure. The upper subsoil is greyish brown to brown (10YR5/2 to 10YR5/3) clayey sand, which is friable and permeable, but gleyed. The profile is assessed as WC II, with a likely droughtiness limitation to Grade 2, but may be limited by the effect of groundwater. This soil type is illustrated by profile 3J5003HP in Annex A.4.

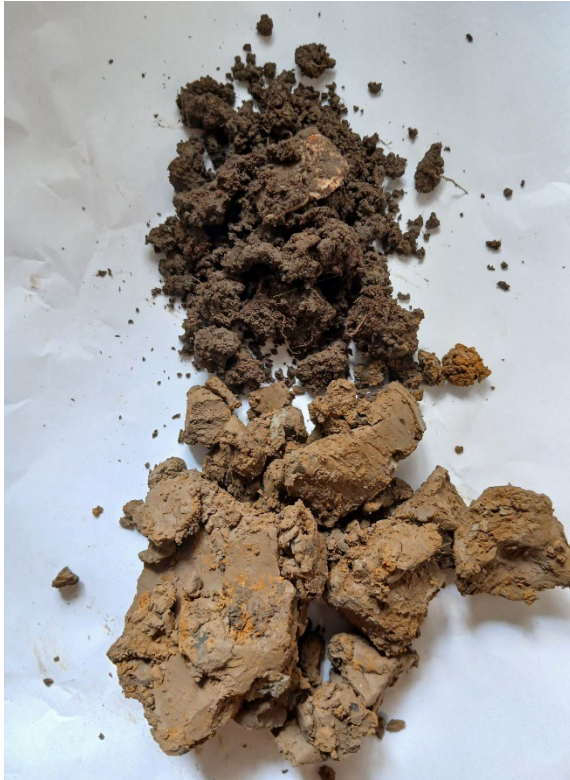
Graphic A-7 3L6027HP Typical Windsor soil. Clay/silty clay over clay. WC IV and Grade 4

- 3.2.10 To the north of Crowdhill, the soil correlates well with the mapped Windsor association and comprises very dark grey (10YR3/1) clay to silty clay topsoil overlying mottled dark greyish brown (10YR4/2) clay subsoil, which is very firm, coarse angular blocky and slowly permeable. The profile is in WC IV and is limited by wetness to Grade 4. This soil type is illustrated by profile 3L6027HP in Annex A.4.
