Engineering Report: Assessment of Surface Water Runoff from Proposed Green Hill Solar Farm (Green Hill G)

Subject: Preliminary Opinion of Surface Water Runoff and Contribution to Localised Flooding from the Proposed Green Hill Solar Farm (Green Hill G)

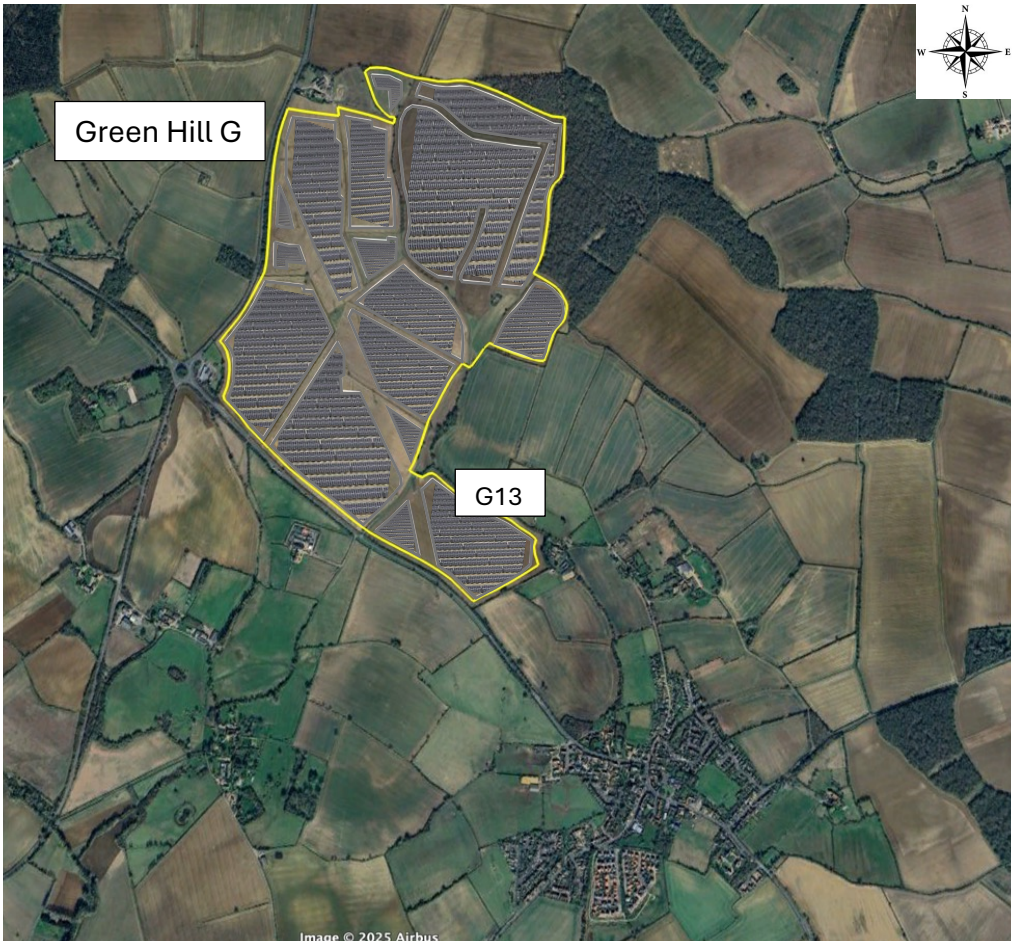
The proposed site for the Green Hill Solar Farm that forms the basis of this report is Green Hill G in relation to the Village of Lavendon is as follows:

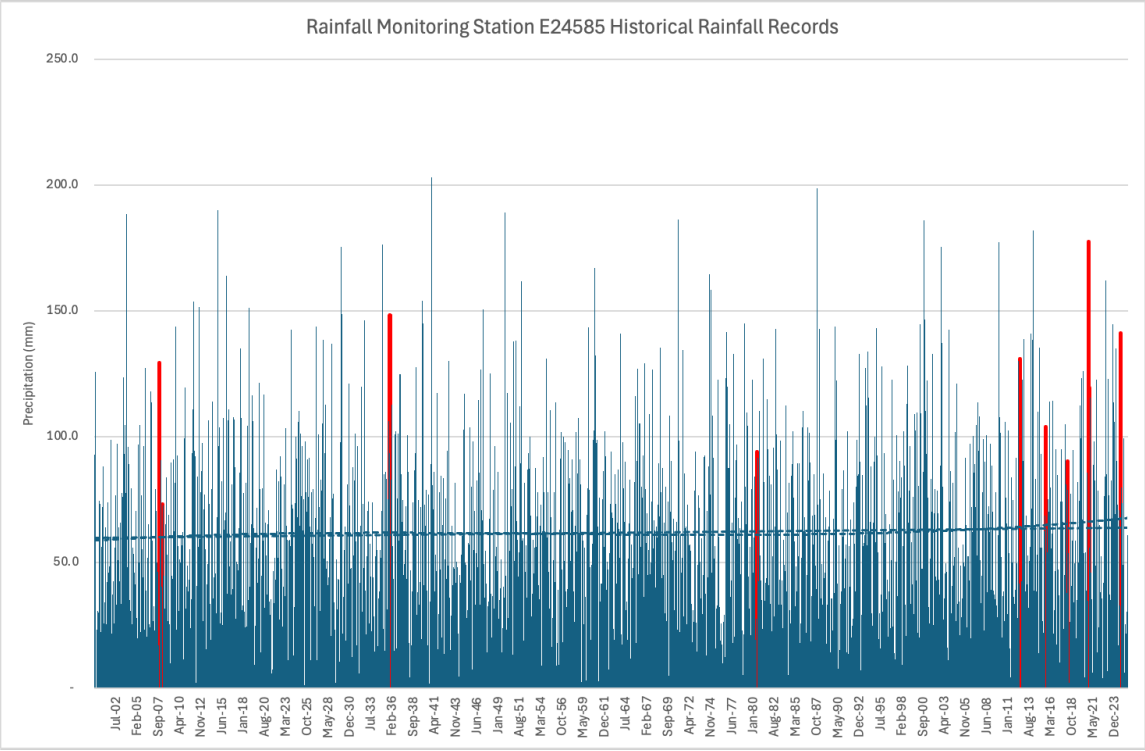
Direct weather station data for Lavendon is unavailable. To provide historical context, rainfall records from Rainfall Monitoring Station E24585 were sourced, covering the period from January 1900 to the present, and are presented in the following graph (together with a 3rd order polynomial) to visually illustrate long-term meteorological trends.

Each data point highlighted in red (a total of 11) represents a major flood event in Lavendon, recorded as follows:

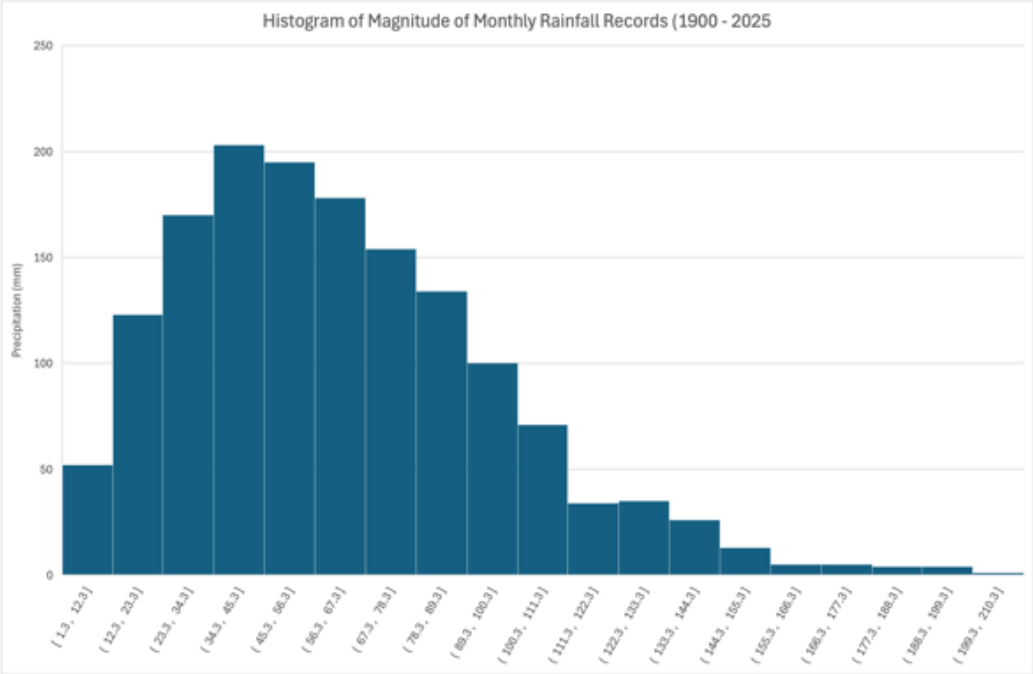
Of these 11 flood events, a total of five have occurred in the last 10 years. A histogram of the monthly precipitation intensity over the period 1900 to 2025 is shown below.
