**East Midlands Gateway  
Phase 2 (EMG2)**

**Document DCO 6.10C/MCO 6.10C**

# Arboricultural Assessment

## Appendix 10.C ARBORICULTURAL ASSESSMENT

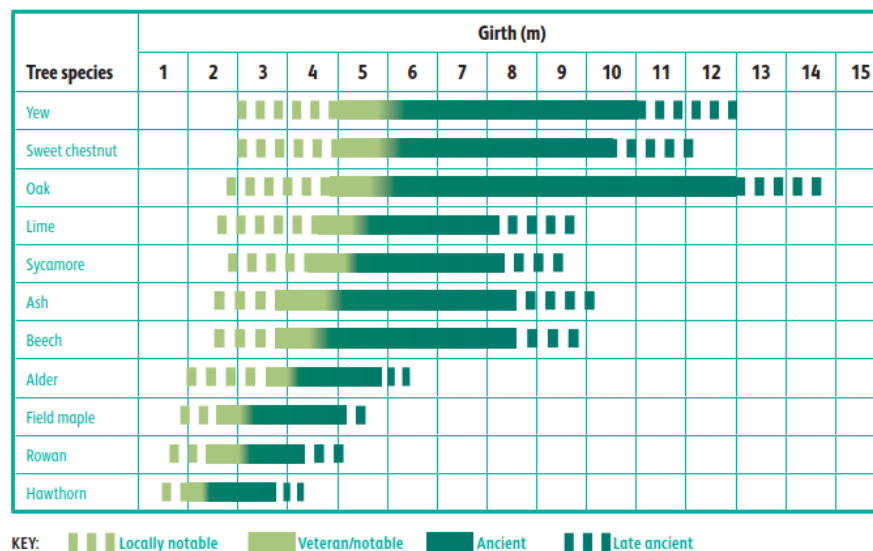
**Figure 1: The chart of girth in relation to age and development classification of trees, as shown in Lonsdale (2013)<sup>4</sup>.**

- 4.25 T4 recorded a stem girth considered large for the species, in accordance with the chart shown in Figure 1 of this report. Whilst principal decay fungi were not identified during the survey, associated brown rot and white rot was identified, indicating stem hollowing and decay. Both primary and secondary features, along with series of habitat features associated with veteran trees were identified on T4.
