## **Wylfa Newydd Project**

**6.3.25 ES Volume C - Road traffic-related effects (project-wide) App C2-4 - DCO TA Appendix K - Road Safety Audits**

**Logistics Centre External Layout**

**Stage 1 Road Safety Audit**

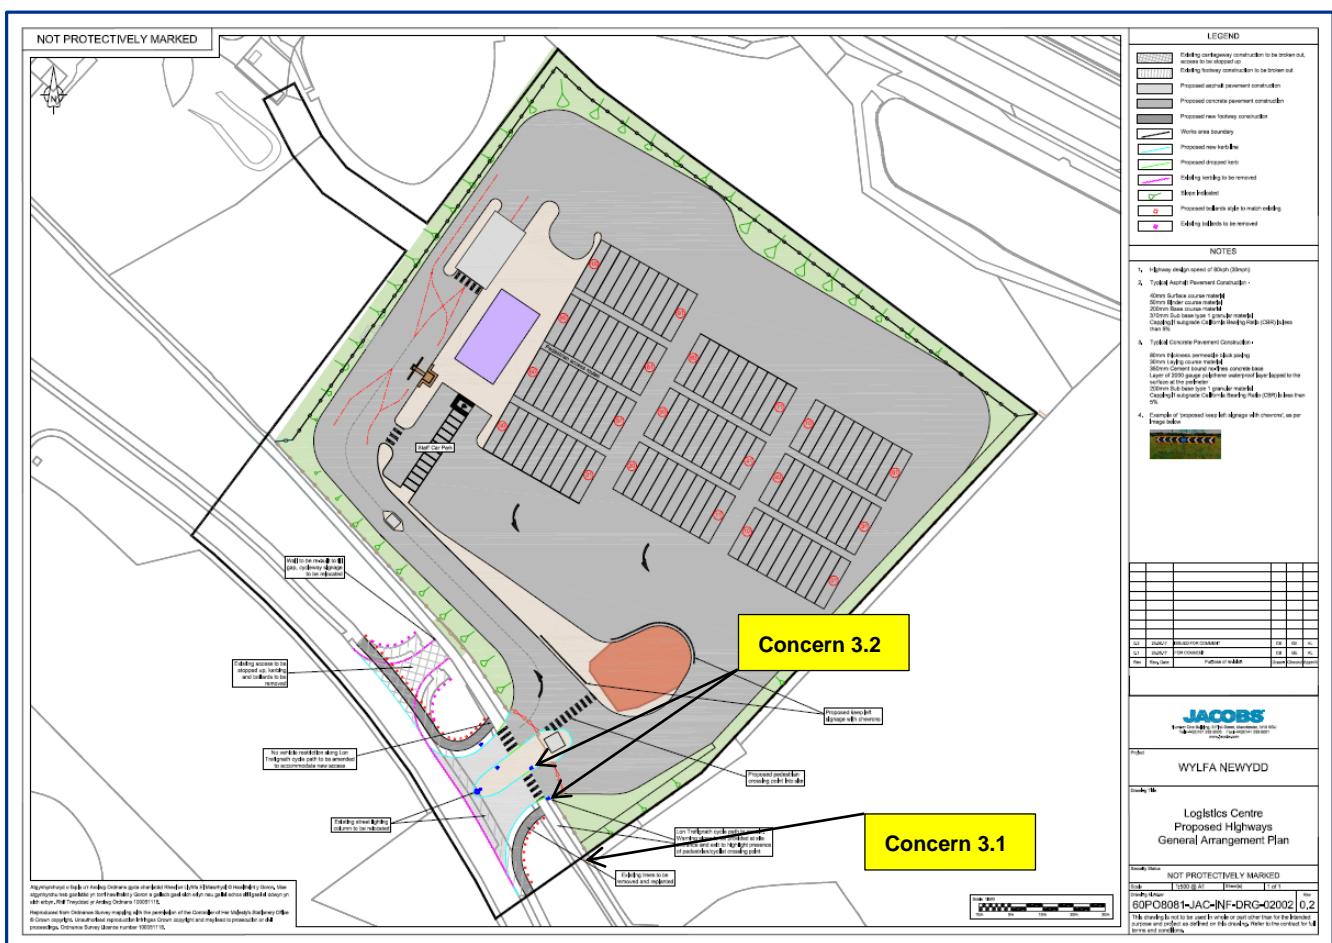
**Figure A.1 – Appendix A. Site location plan indicating the location of the problems.**

Concern that warning signs for drivers leaving the facility are poorly located. This could lead to drivers failing to see the signs or seeing them too late colliding with a cyclist.

If the scheme is implemented it is recommended that the location of the start of the access track and gate is located to avoid the need for a vehicle to drive along the cycleway

If the scheme is implemented it is recommended that the advanced warning signs for the cycleway are located further from the cycleway and in a position that they can be clearly seen.

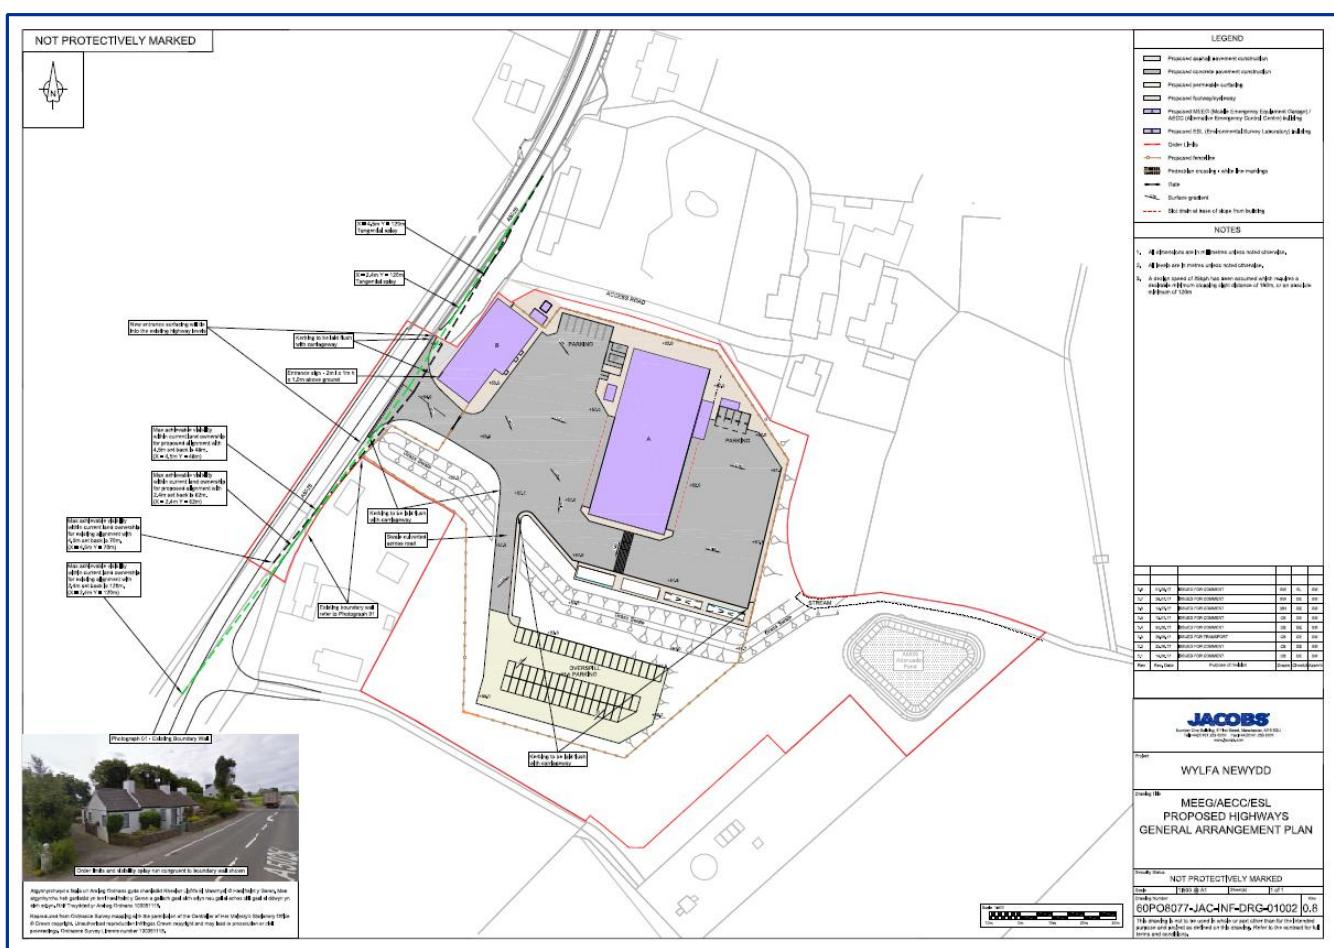
**Figure 2.1: Extents of the proposed Off-site Power Station Facilities**

The visibility to the south is limited on the exiting arrangement. The proposed realignment of the A5025 and potential changes to the speed limits will further impact on the visibility. Figure 2.1 indicates the impact on the visibility. HNP/IACC to review.

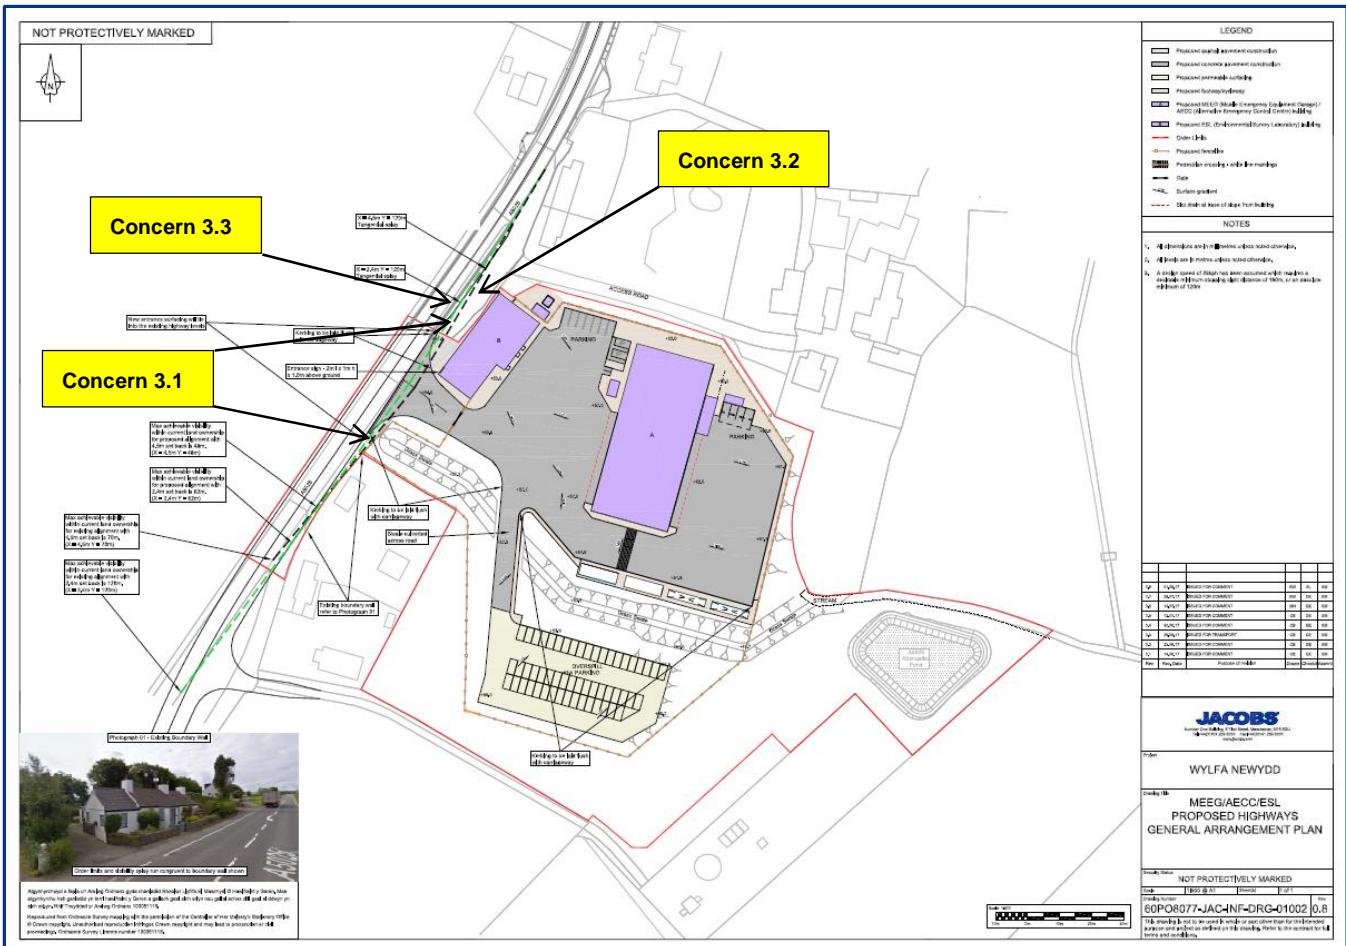
Figure 3.3 – Appendix A. Site location plan indicating the location of the problems.

There is a retaining wall adjacent to the service road which is close to the proposed Off-site Power Station Facilities. This retaining wall results in a level difference of 0.83m between the service road and the main carriageway. There is section of rusty/damaged tubular fencing on top of this retaining wall which allows neither visibility nor an appropriate vehicular restraint system. Drivers turning out of the proposed access may fail to see a southbound vehicle and a collision could occur. This feature also falls within the 4.5 x 12m visibility splay: **See figure 3.3 below.**

If the scheme is implemented, it is recommended that the requirement for this retaining wall/tubular fence should be removed by lifting the service road level to that of the existing carriageway in this location.

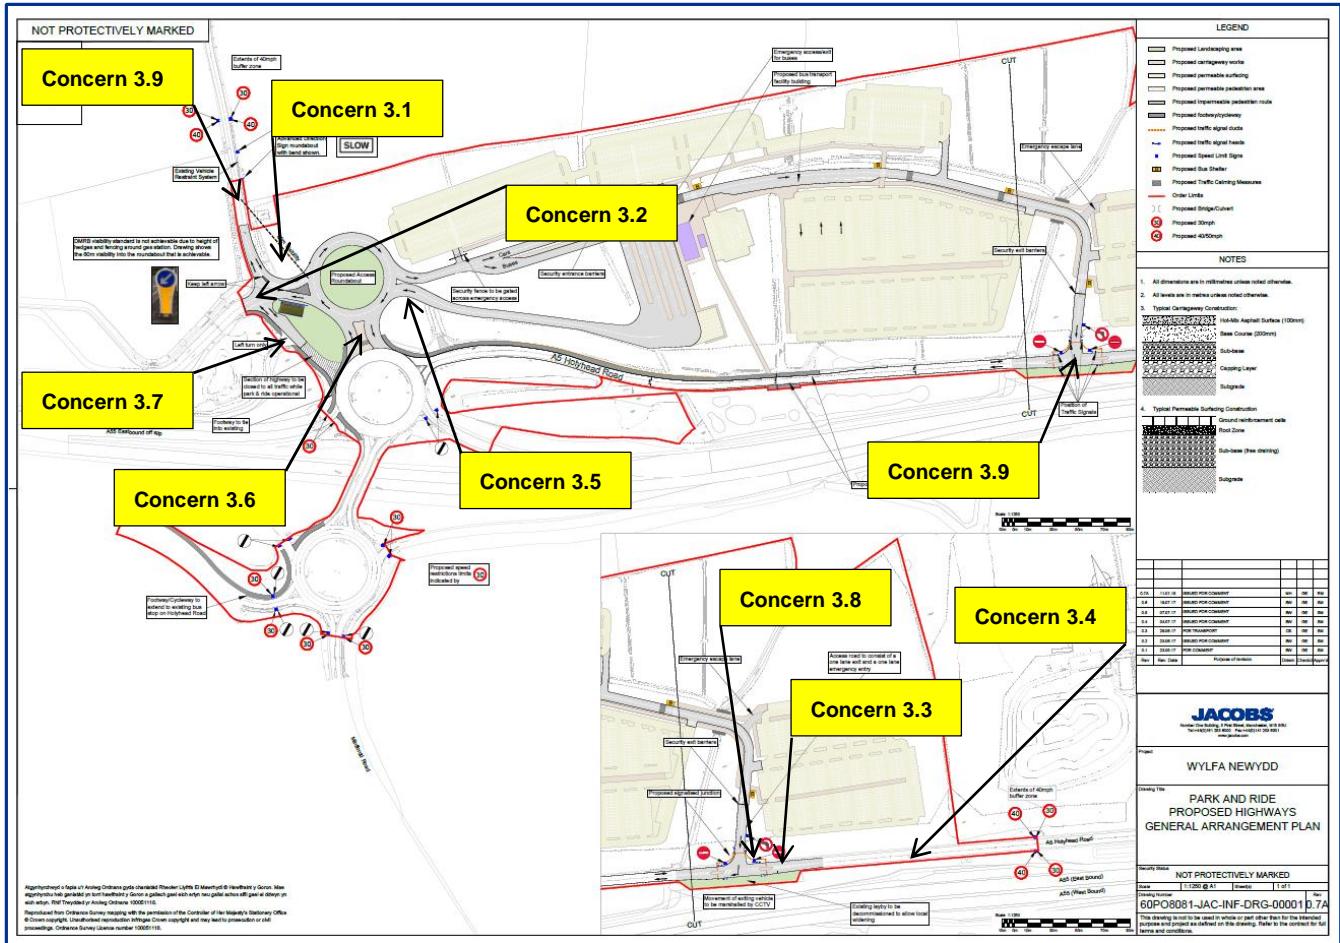
Figure A.1 – Appendix A. Site location plan indicating the location of the problems.

There is insufficient forward visibility (Stopping Site Distance (SSD)) available on the London Road (southbound approach) towards the proposed roundabout. Inadequate forward visibility could result in 'rear-end shunt' type collisions as drivers may not appreciate the location of the roundabout Give Way point.

There is insufficient forward visibility available on the London Road (southbound approach) towards the proposed roundabout. Approach curvature should follow the '*horizontal radii recommended in TD 9/93 Link Design*' (as recommended in paragraph 7.60 TD 16/07 Geometric Design of Roundabouts). As the centreline radius is approximately 30m at this location, drivers may not anticipate the severity of the turn, especially as the visibility is below standard. The drawing provided refers to sketch 01 and 02 which references the removal of the existing boundary hedge but it would still appear that an SSD of 90m to the roundabout Give Way will be obstructed by the existing gas compound and security fencing.

If the scheme is implemented, it is recommended that an SSD of 90m is provided (for a 30mph limit) over a distance of 135m in advance of the Give Way point in accordance with TD 9/93 Link Design paragraph 1.26b. Any existing obstructions such as hedges or the electricity substation should be removed. The severity of the radius should also be lessened. Vehicle Activated Signs (VAS) and reflective road studs have been proposed, however, these would normally only be installed at an existing collision site.
