# SIGNIFICANT INCIDENT REPORT

Incident: 018965 - 15092020

Address: Orsted BESS, Carnegie Road, Liverpool, L137HY

Date of incident: 15<sup>th</sup> September 2020

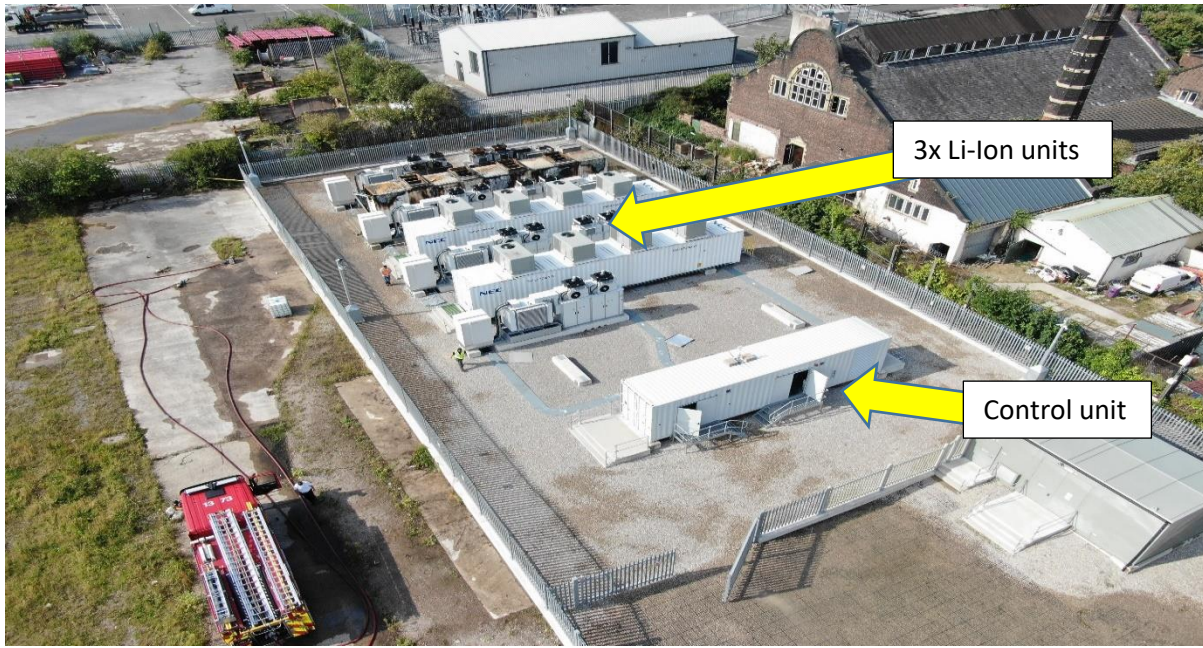
### **AIR unit aerial view of Orsted BESS:**

Image above: Taken from [REDACTED] AIR Unit. Full extent of damage visible. Roof mounted cooling units ejected to side of unit. Pressure damage visible along length of unit. Note scorching of top edge of second unit to mid-right of image. Firefighting tactics mitigated further spread and damaged beyond original unit and blast.

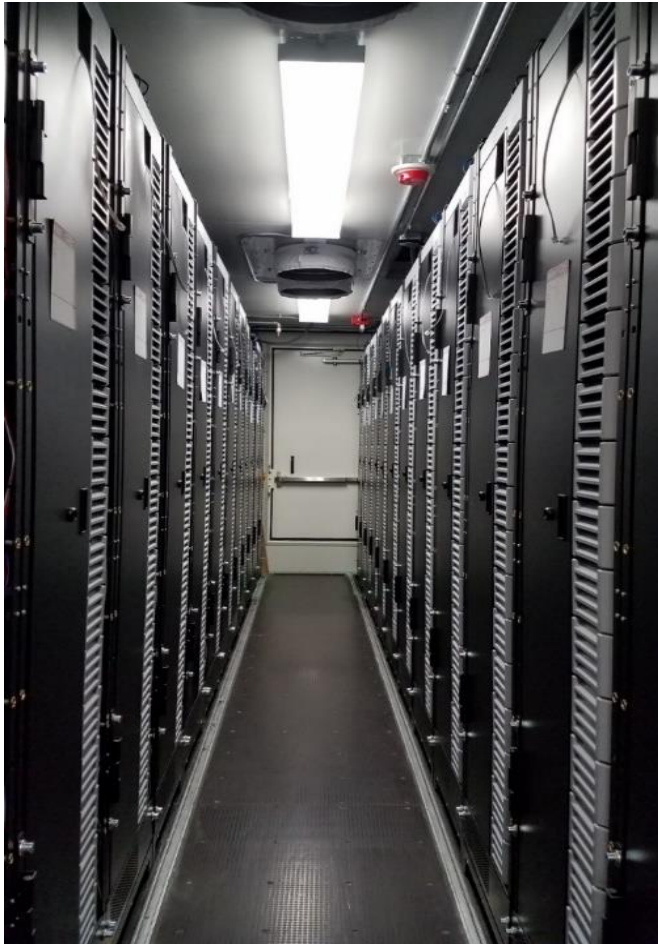
## Inside a BESS Unit<sup>2</sup>:

Note configuration of lithium ion banks, narrow access corridor and cooling vents fitted to ceiling.
