# BOTLEY WEST SOLAR FARM

## Veteran & Ancient Tree Survey

Veteran Tree Survey –  
Botley West  
V3

May 2025

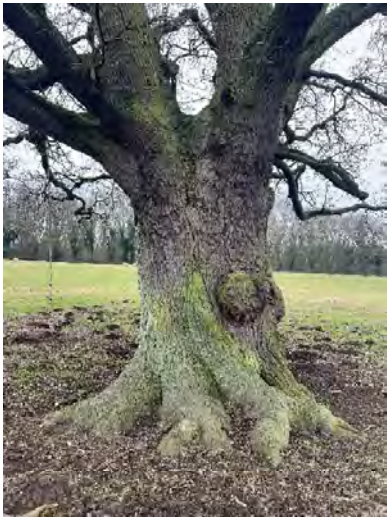
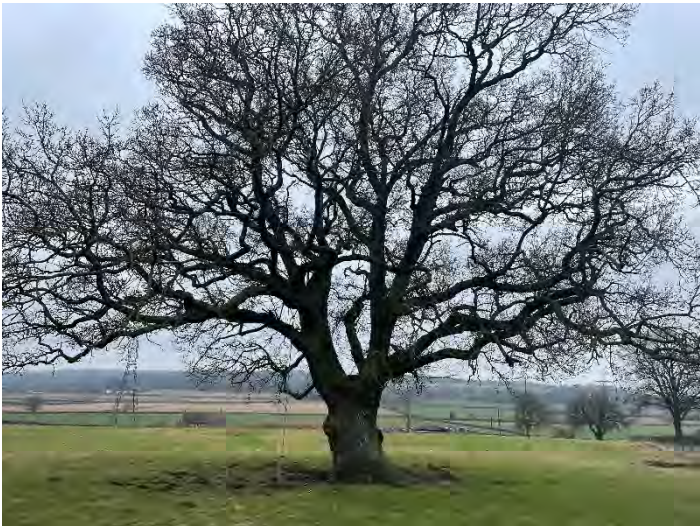
| Secondary Tree Qualities | | | | | | | | | | | |
|---|---|---|---|---|---|---|---|---|---|---|---|
| 0.2m | X | Dry nest in hollow, dry hollow at pollard union at 2.5m | Root flare at buttress | None | None | Bulged | None visible | Ganoderma root fflare | None | None | - |

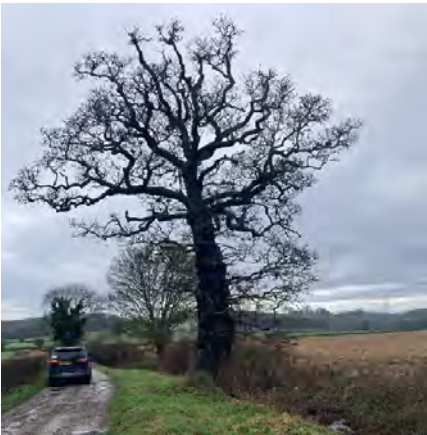
| Secondary Tree Qualities | | | | | | | | | | | |
|---|---|---|---|---|---|---|---|---|---|---|---|
| X | X | X | X | X | X | X | X | Yes | Yes | X | - |

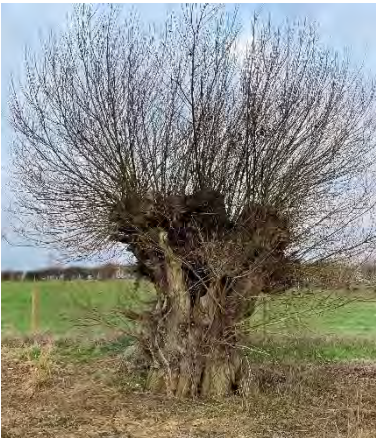
| Secondary Tree Qualities | | | | | | | | | | | |
|---|---|---|---|---|---|---|---|---|---|---|---|
| X | X | Yes | Yes | X | X | Yes | Yes | X | Yes | X | - |

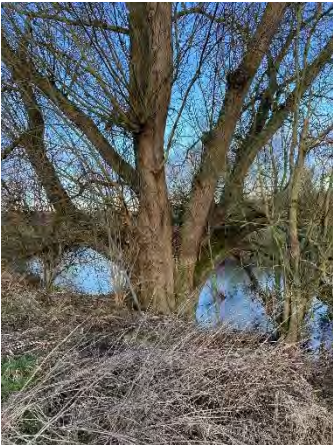
| Secondary Tree Qualities | | | | | | | | | | | |
|---|---|---|---|---|---|---|---|---|---|---|---|
| X | Yes | X | X | Yes | Yes | Yes | X | Yes | X | X | - |

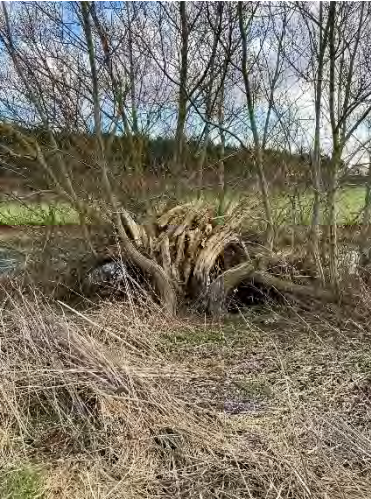
| Secondary Tree Qualities | | | | | | | | | | | |
|---|---|---|---|---|---|---|---|---|---|---|---|
| Yes | X | Yes | X | X | X | Yes | Yes | X | X | X | - |

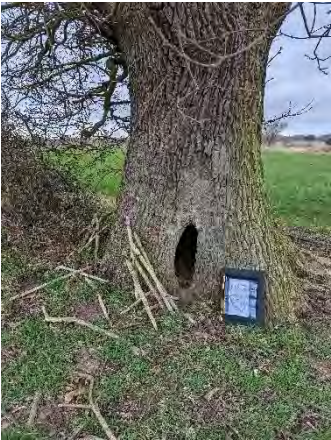
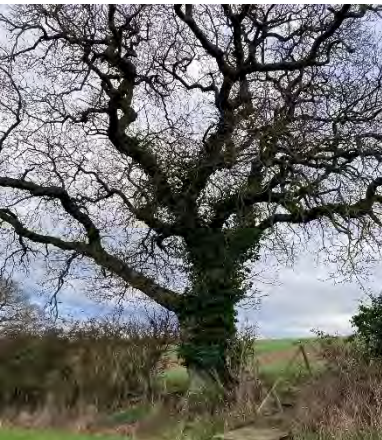
| Secondary Tree Qualities | | | | | | | | | | | | |
|---|---|---|---|---|---|---|---|---|---|---|---|--|
| Minor | Yes | Possible | None | None | None | Localised in crown | X | X | 2+ | X | Ivy/Moss | |

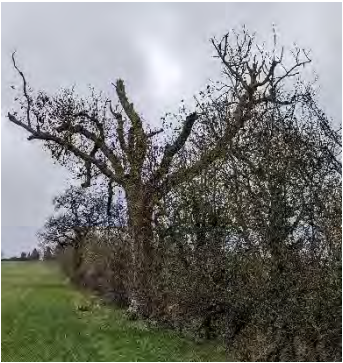
| Secondary Tree Qualities | | | | | | | | | | | |
|---|---|---|---|---|---|---|---|---|---|---|---|
| <5% in crown | Yes | Possible birds and bats | None | None | None | Stem | X | X | 3 | X | Moss |

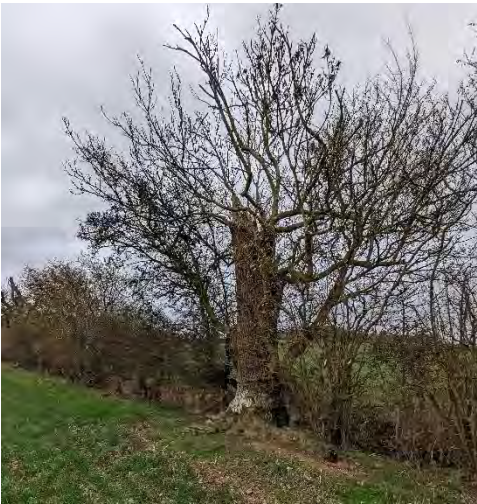
| Secondary Tree Qualities | | | | | | | | | | | |
|---|---|---|---|---|---|---|---|---|---|---|---|
| <10% in crown | Yes | Possible birds and bats | None | None | None | Crown and Stem | Inonoyus hispidus scars in crown and stem | X | X | X | Ivy |

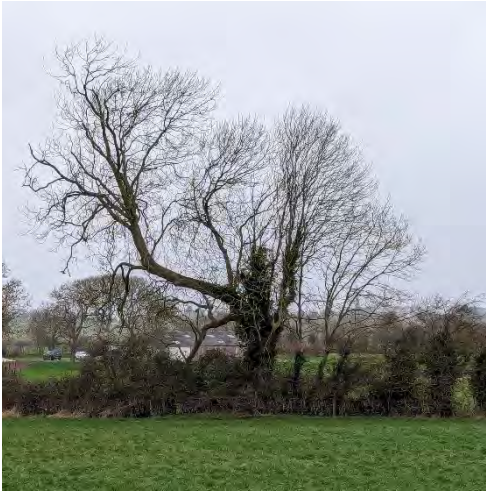
| Secondary Tree Qualities | | | | | | | | | | | |
|---|---|---|---|---|---|---|---|---|---|---|---|
| <5% of crown | Yes | Possible birds and bats | None | None | None | None | X | X | 3 | X | Ivy |

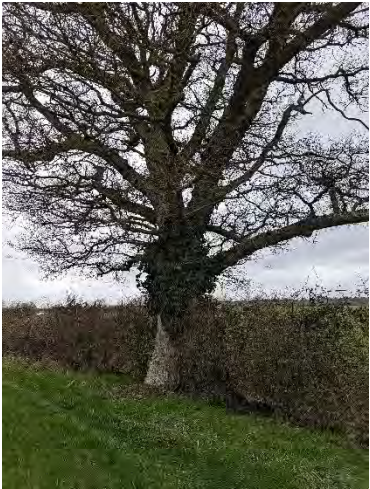
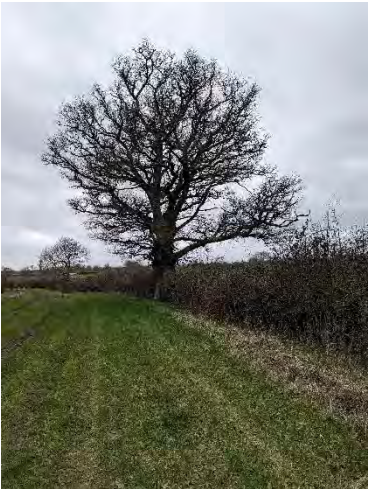
| Secondary Tree Qualities | | | | | | | | | | | | |
|---|---|---|---|---|---|---|---|---|---|---|---|--|
| Minor | Yes | Possible birds and bats | None | None | None | Crown | X | X | 2 | X | None | |

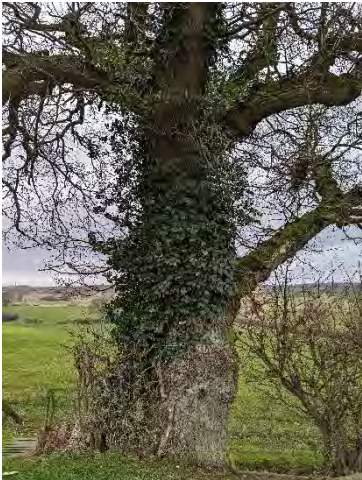
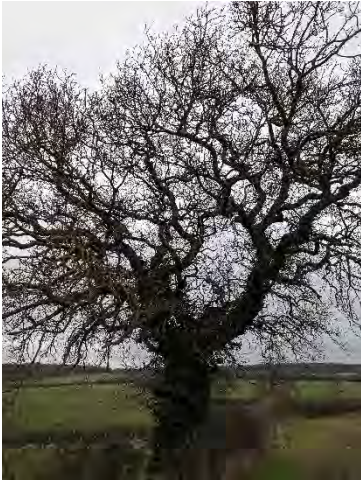
| Secondary Tree Qualities | | | | | | | | | | | | |
|---|---|---|---|---|---|---|---|---|---|---|---|--|
| <5% in crown | Yes | Possible | None | None | None | None | X | X | 2 | X | None | |

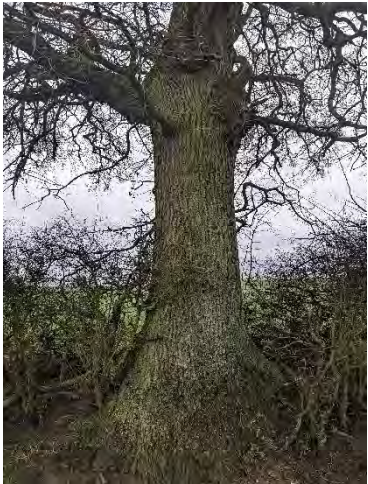
| Secondary Tree Qualities | | | | | | | | | | | | |
|---|---|---|---|---|---|---|---|---|---|---|---|--|
| <5% in crown | Yes | Possible | None | None | None | None | X | X | 2 | X | None | |

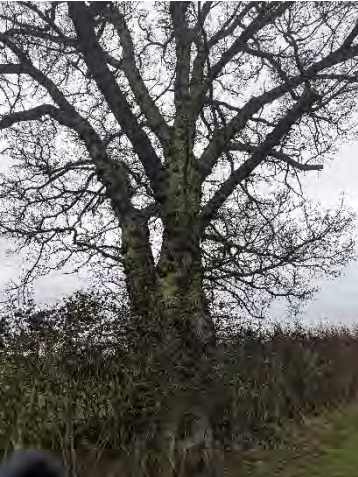
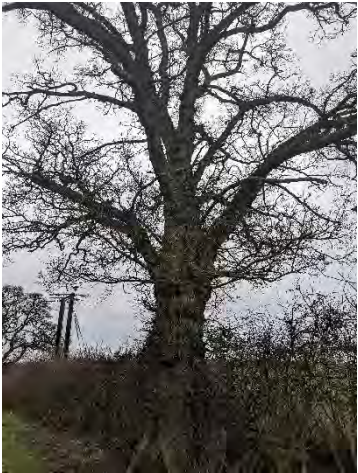
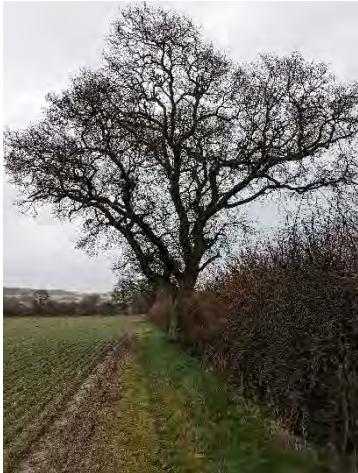
| Secondary Tree Qualities | | | | | | | | | | | | |
|---|---|---|---|---|---|---|---|---|---|---|---|--|
| Minor | Yes | X | None | None | None | None | Fistulina hepatica at base | X | 2+ | X | None | |

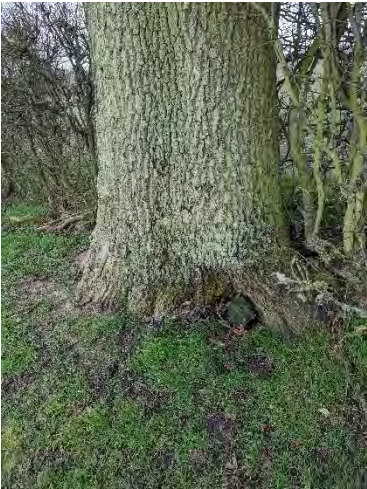
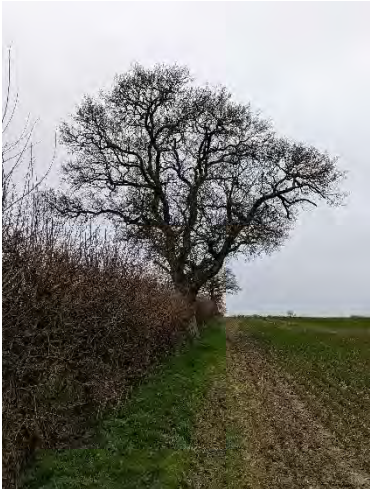
| Secondary Tree Qualities | | | | | | | | | | | |
|---|---|---|---|---|---|---|---|---|---|---|---|
| 5-10% of crown | Yes | X | None | None | None | Crown | X | X | 1 | X | Ivy |

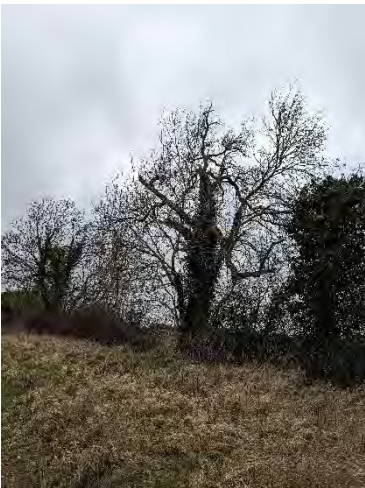
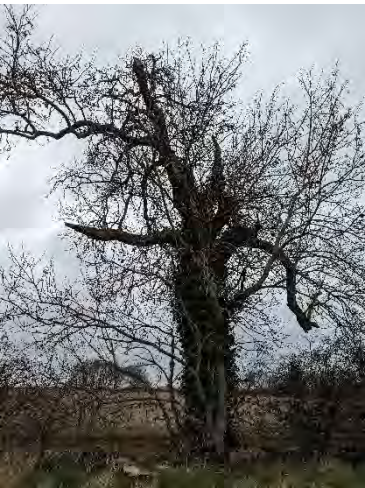
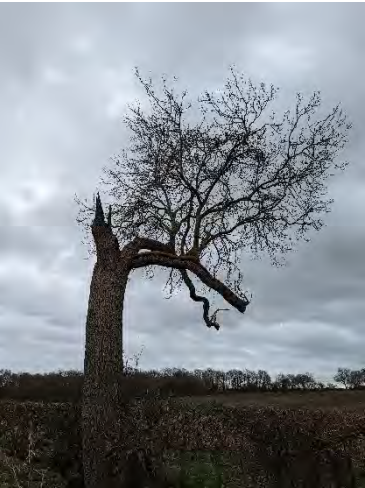
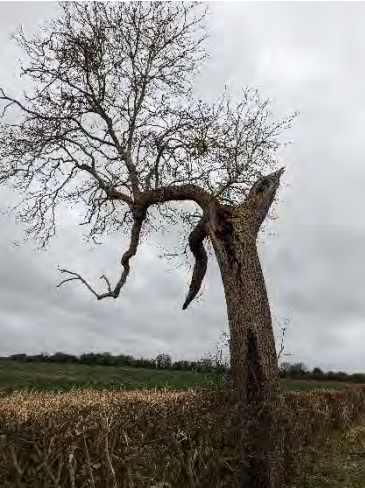
| Secondary Tree Qualities | | | | | | | | | | | |
|---|---|---|---|---|---|---|---|---|---|---|---|
| Sections of remaining crown | Yes | Possible | None | Main stem | Stem | Stem and Crown | X | X | X | X | X |

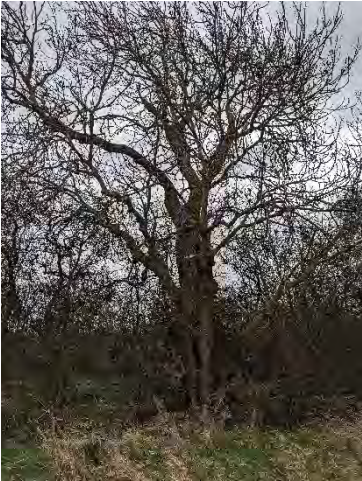
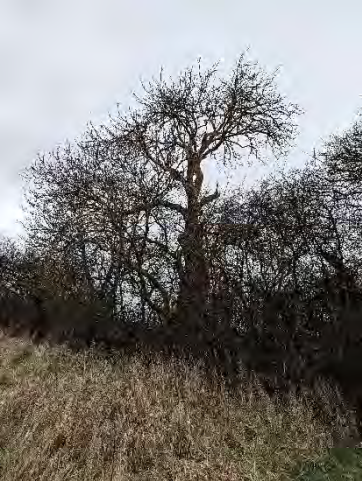
| Secondary Tree Qualities | | | | | | | | | | | | |
|---|---|---|---|---|---|---|---|---|---|---|---|--|
| None | Yes | Yes | None | None | None | Stem and crown | X | X | 2 | X | Moss | |

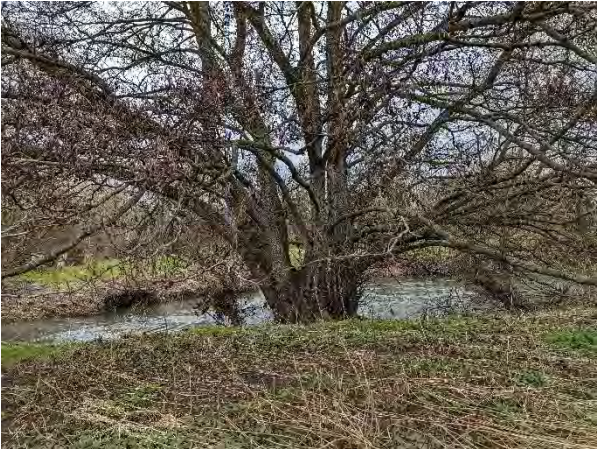
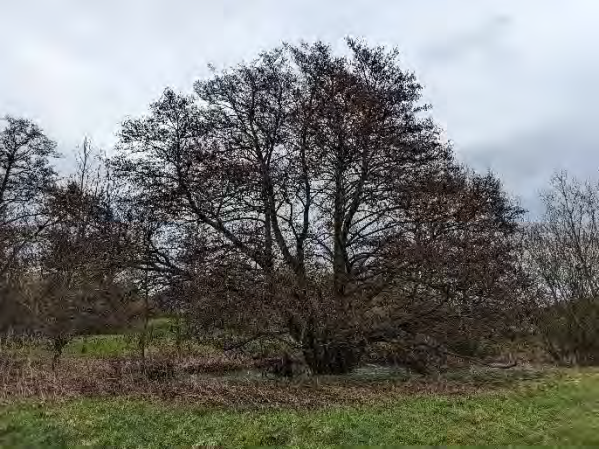
| Secondary Tree Qualities | | | | | | | | | | | |
|---|---|---|---|---|---|---|---|---|---|---|---|
| X | X | Possible birds | None | None | None | None | X | X | >2 | No | - |

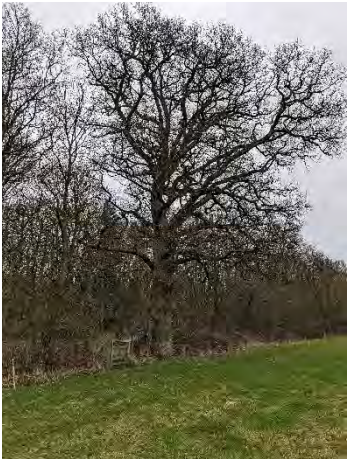
| Crown spread (m) | | | | | | | | | | | | | | | | | |
|---|---|---|---|---|---|---|---|---|---|---|---|---|---|---|---|---|---|
| T41 | Quercus robur - Pedunculate Oak | 17.0 | 8.0 | 6.0 | 7.0 | 6.0 | 1230 | 1.00 | 3.00 | - | V | Fair | Woodland edge/Maiden | Previous branch failures, Stubs, tears and splits in crown, Moderate deadwood in crown, Main leader failure. | 40+ | A3 | Woodland |

| Secondary Tree Qualities | | | | | | | | | | | |
|---|---|---|---|---|---|---|---|---|---|---|---|
| 5-10% of crown | Yes | Possible birds and bats | None | Exudation on main stem | None | Crown | X | X | >2 | No | Moss |

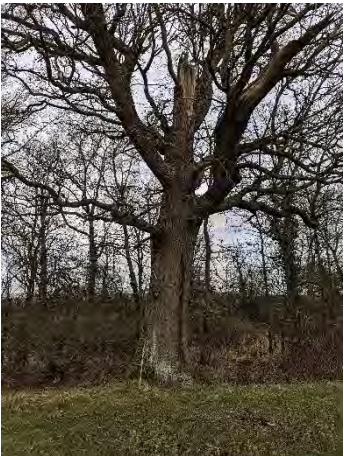
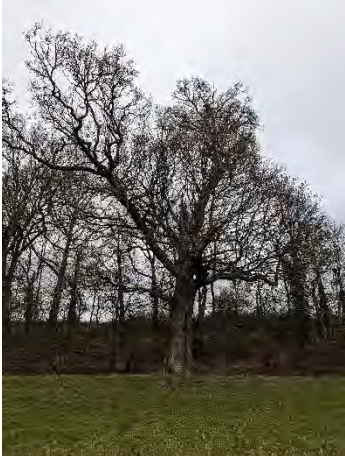
| Species | Crown spread (m) | | | | | | Stem dia. (mm) Including irregularities information | Stem no. at 1.5m | Height of crown clearance (m) | Dir/ height | Age class | Condition | Type | General observations Management recommendations | Estimated remaining contribution (years) | Tree Quality Category (BS5837) | Tree Typology |
|---|---|---|---|---|---|---|---|---|---|---|---|---|---|---|---|---|---|
| T42 | <i>Fraxinus excelsior</i> - Ash | 20.0 | 4.0 | 9.0 | 8.0 | 5.0 | 1270 | 1.00 | 3.50 | - | V | Poor | Woodland edge/Maiden | Multiple failures, Stubs, tears and splits, woodpeckers in cavities. | 20+ | C3 | Woodland |

| Secondary Tree Qualities | | | | | | | | | | | |
|---|---|---|---|---|---|---|---|---|---|---|---|
| 30% of crown | Yes | Possible birds and bats | None | None | Possible | Stem and Crown | Innonotus hispidus in crown | X | >2 | No | Ivy |

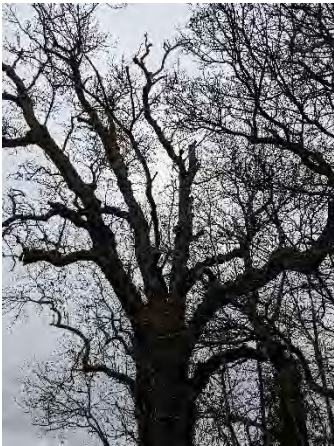
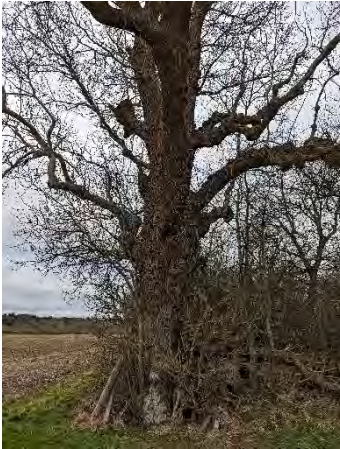
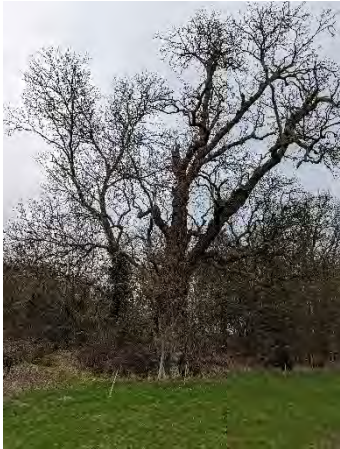
| T43 | Species | Height (m) | Crown spread (m) | | | | Stem dia. (mm) Including irregularities information | Stem no. at 1.5m | Height of crown clearance (m) | Dir/ height | Age class | Condition | Type | General observations Management recommendations | Estimated remaining contribution (years) | Tree Quality Category (BS5837) | Tree Typology |
|---|---|---|---|---|---|---|---|---|---|---|---|---|---|---|---|---|---|
| | <i>Salix alba</i> - White Willow | 10.0 | 15.0 | 20.0 | 4.0 | 4.0 | 2000 | 2.00 | 0.00 | - | V | Fair | River edge pollard | Collapsed crown, Layering with Pheonix growth, Multiple failures | 20+ | B3 | Riverside |

| Secondary Tree Qualities | | | | | | | | | | | |
|---|---|---|---|---|---|---|---|---|---|---|---|
| Collapsing | 15% of crown | Possible birds and bats | X | X | X | X | Main stem | X | X | X | Moss |

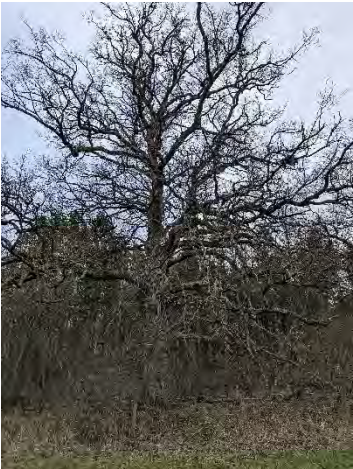
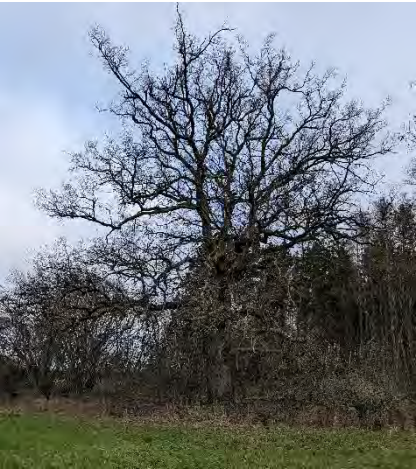
| Crown spread (m) | | | | | | | | | | | | | | | | | | Tree Typology |
|---|---|---|---|---|---|---|---|---|---|---|---|---|---|---|---|---|---|---|
| T45 | <i>Fraxinus excelsior</i> - Ash | 18.0 | 4.0 | 3.0 | 6.0 | 6.0 | 1260 | 1.00 | 4.00 | - | V | Poor | Field Boundary | Major crown failures, Hollow main stem, Limb stem fractures, Epicormics to stem and crown | 10+ | C3 | Field Boundary | |

| Secondary Tree Qualities | | | | | | | | | | | | |
|---|---|---|---|---|---|---|---|---|---|---|---|--|
| Most of the remaining crown | Yes | Possible bats | X | X | X | Main stem | Likely Innonotus and Polyporous sp. | Daldinia concentric | 2+ | X | - | |

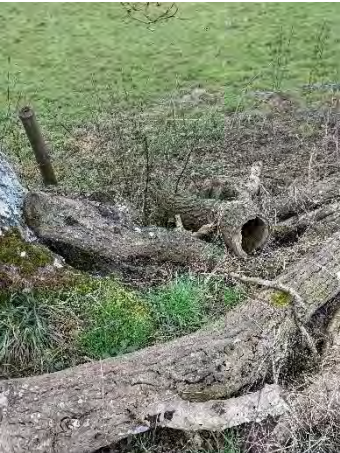
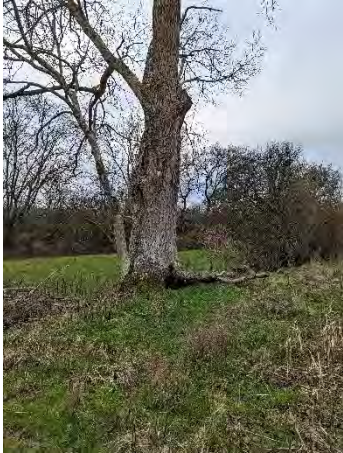
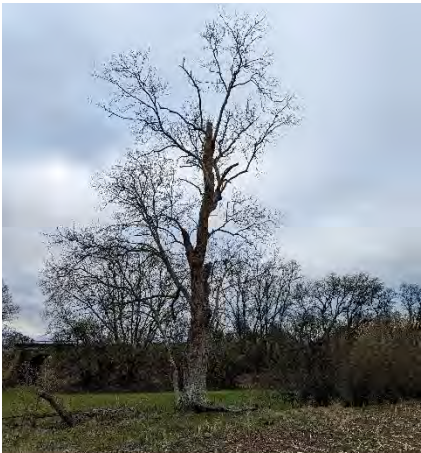
| Species | Height (m) | Crown spread (m) | | | | Stem dia. (mm) Including irregularities information | Stem no. at 1.5m | Height of crown clearance (m) | Dir/ height | Age class | Condition | Type | General observations Management recommendations | Estimated remaining contribution (years) | Tree Quality Category (BS5837) | Tree Typology |
|---|---|---|---|---|---|---|---|---|---|---|---|---|---|---|---|---|
| T46 | <i>Quercus robur</i> - Pedunculate Oak | 20.0 | 8.0 | 8.0 | 8.0 | 1430 | 1.00 | 1.00 | S/5 | V | Fair | Woodland edge/Maiden | Epicormics on stem and crown, Moderate deadwood, Previous limb failures, | 40+ | A3 | Woodland |

| Secondary Tree Qualities | | | | | | | | | | | |
|---|---|---|---|---|---|---|---|---|---|---|---|
| <10% of canopy | Yes | Possible birds and bats | X | X | X | X | X | X | >2 | X | Moss |

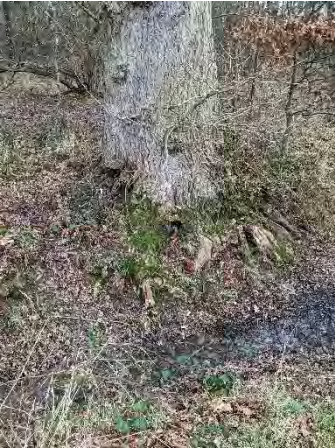
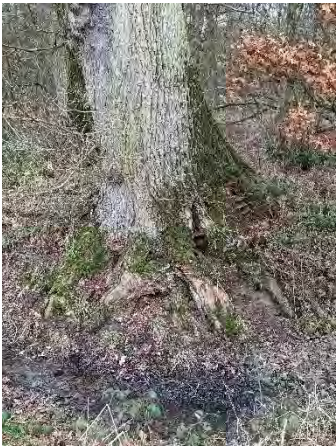
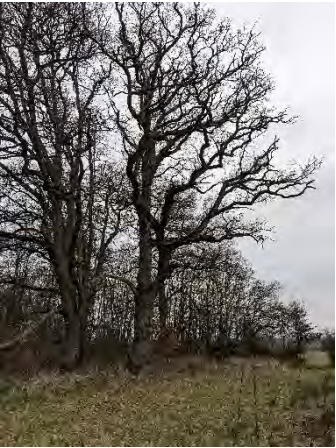
| Species | Height (m) | Crown spread (m) | | | | Stem dia. (mm) Including irregularities information | Stem no. at 1.5m | Height of crown clearance (m) | Dir/ height | Age class | Condition | Type | General observations Management recommendations | Estimated remaining contribution (years) | Tree Quality Category (BS5837) | Tree Typology | |
|---|---|---|---|---|---|---|---|---|---|---|---|---|---|---|---|---|---|
| T48 | <i>Quercus robur</i> - Pedunculate Oak | 20.0 | 8.0 | 5.0 | 5.0 | 5.0 | 1590 | 1.00 | 2.00 | W/5 | V | Fair | Field boundary | Hollow main stem, Major crown failures, Rips, splits and tears, Unbalanced crown | 40+ | A3 | Field boundary |

| Secondary Tree Qualities | | | | | | | | | | | |
|---|---|---|---|---|---|---|---|---|---|---|---|
| <15% crown | Yes | Possible birds and bats | X | X | X | X | X | X | X | X | Ivy/moss |

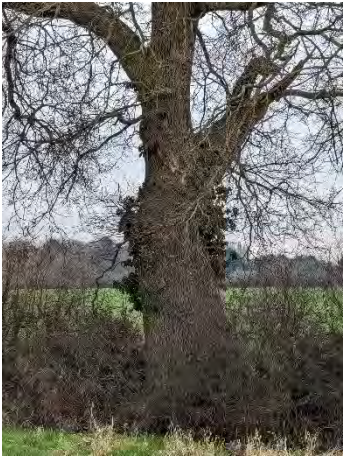
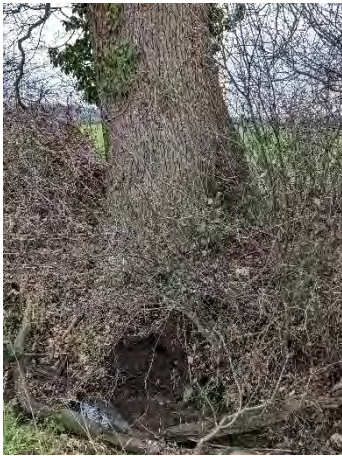
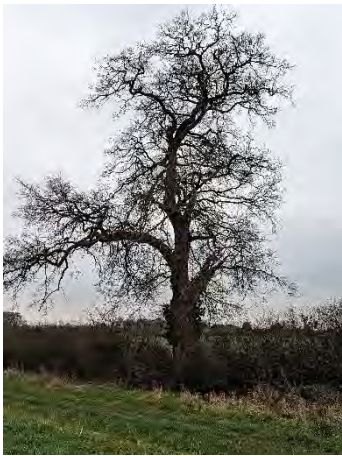
| Species | Height (m) | Crown spread (m) | | | | Stem dia. (mm) Including irregularities information | Stem no. at 1.5m | Height of crown clearance (m) | Dir/ height | Age class | Condition | Type | General observations Management recommendations | Estimated remaining contribution (years) | Tree Quality Category (BS5837) | Tree Typology |
|---|---|---|---|---|---|---|---|---|---|---|---|---|---|---|---|---|
| T49 | <i>Quercus robur</i> - Pedunculate Oak | 13.0 | 6.0 | 6.0 | 6.0 | 1200 | 1.00 | 2.50 | E/5 | V | Fair | Field boundary | Storm damage, Epicormics stem and crown, Splits, cracks, Large scar main stem, | 40+ | A3 | Field boundary |

| Secondary Tree Qualities | | | | | | | | | | | |
|---|---|---|---|---|---|---|---|---|---|---|---|
| <15% crown | Yes | Possible birds and bats | X | X | X | Callus wound | X | X | X | X | Ivy/moss |

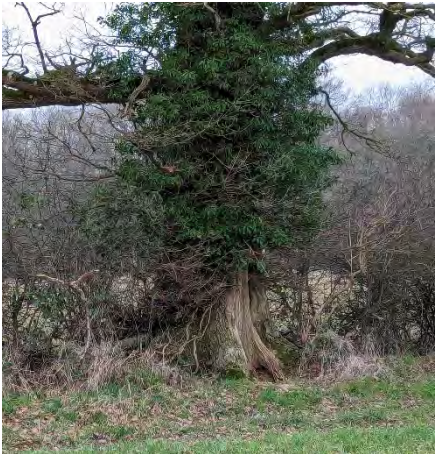
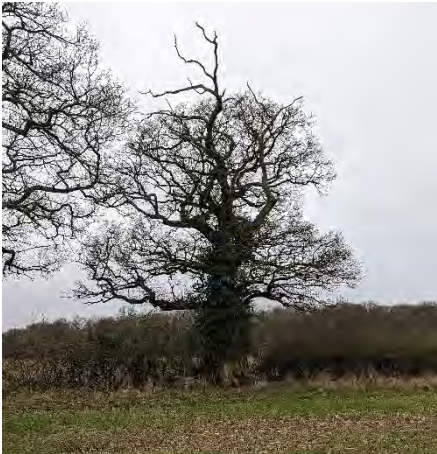
| Crown spread (m) | | | | | | | | | | | | | | | | | | Tree Typology |
|---|---|---|---|---|---|---|---|---|---|---|---|---|---|---|---|---|---|---|
| T50 | <i>Quercus robur</i> - Pedunculate Oak | 14.0 | 6.0 | 6.0 | 6.0 | 6.0 | 1910 | 1.00 | 1.00 | NE/4 | V | Fair | Field boundary | Epicormics Stem and crown, Previous branch failures, Scars, tears and rips. | 40+ | A3 | Field boundary | |

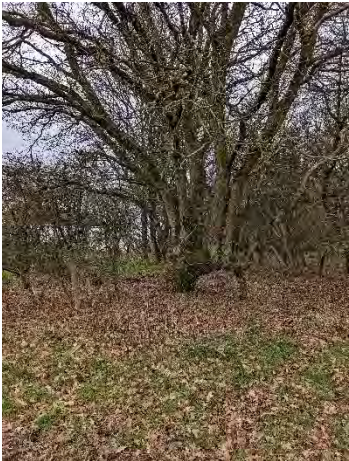
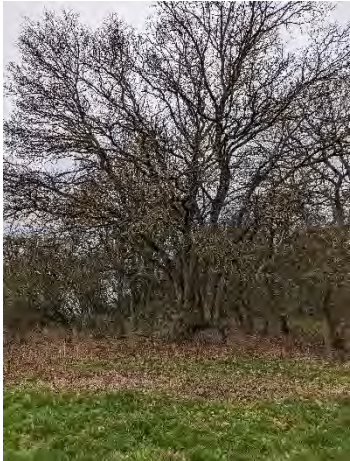
| | | Crown spread (m) | | | | | Stem dia.<br>(mm)<br>Including<br>irregularities<br>information | Stem<br>no.<br>at<br>1.5m | Height of<br>crown<br>clearance<br>(m) | Dir/<br>height | Age<br>class | Condition | Type | General<br>observations<br>Management<br>recommendations | Estimated<br>remaining<br>contributio<br>n (years) | Tree Quality<br>Category<br>(BS5837) | Tree<br>Typology |
|---|---|---|---|---|---|---|---|---|---|---|---|---|---|---|---|---|---|
| T53 | Salix alba -<br>White Willow | 7.0 | 3.0 | 3.0 | 3.0 | 3.0 | 1200 | Multi-<br>stem | 2.00 | - | OM/V | Poor | Field<br>Boundary | Collapsing stems,<br>open main stem,<br>various failures, decay<br>and rot in main stem. | 20+ | B3 | Field<br>Boundary |

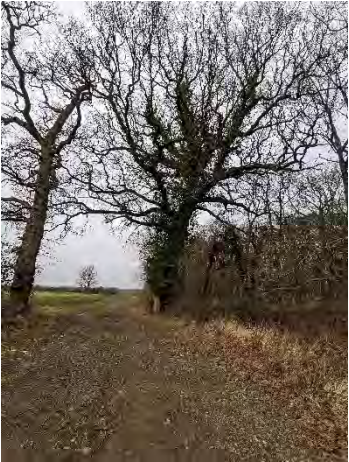
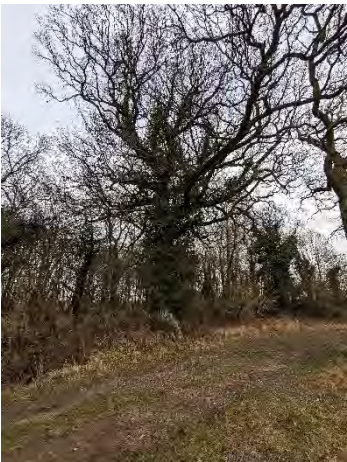
| Crown spread (m) | | | | | | | | | | | | | | | | | |
|---|---|---|---|---|---|---|---|---|---|---|---|---|---|---|---|---|---|
| T55 | Quercus robur - Pedunculate Oak | 23.0 | 10.0 | 10.0 | 7.0 | 5.0 | 2260 | 1.00 | 3.00 | S/6 | V | Fair | Field Boundary | Large branch and limb failures, Epicormics to stem and crown, Basal cavities with brown rot, Ivy on main stem. | 20+ | A3 | Field Boundary |

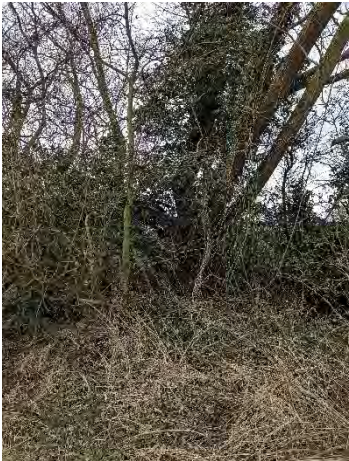
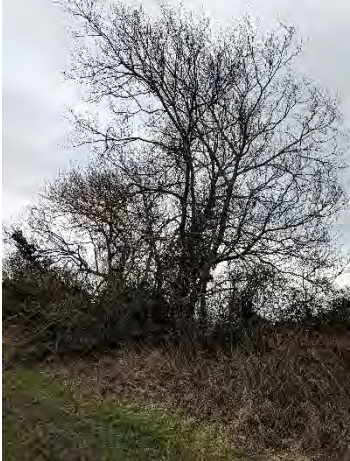
| Crown spread (m) | | | | | | | | | | | | | | | | | Tree Typology |
|---|---|---|---|---|---|---|---|---|---|---|---|---|---|---|---|---|---|
| T60 | <i>Fagus sylvatica</i> - Beech | 30.0 | 8.0 | 8.0 | 6.0 | 9.0 | 1110 | 1.00 | 10.00 | N/6 | OM/V | Poor | Woodland edge/Maiden | Major storm damage with associated limb failures, Pine hung up in crown, Ivy on stem, Moderate deadwood in the crown, Ganoderma sp. Bracket at base | 10+ | C3 | Woodland |

| Primary Tree Qualities | | | | | | | | | | | | | | | | |
|---|---|---|---|---|---|---|---|---|---|---|---|--|---|--|---|--|
| None visible | | None visible | | X | | | Maiden | | | Minor decline | | | <10% mostly storm damage | | | |

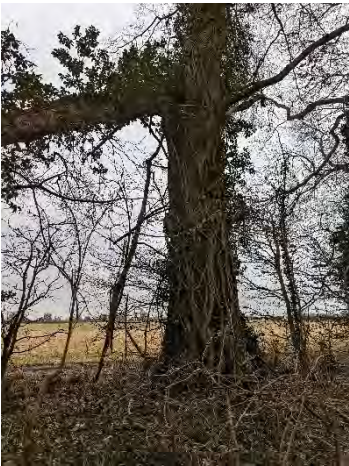
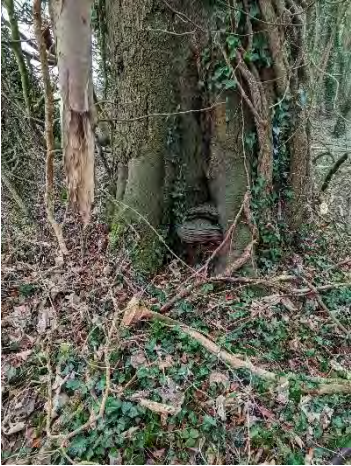
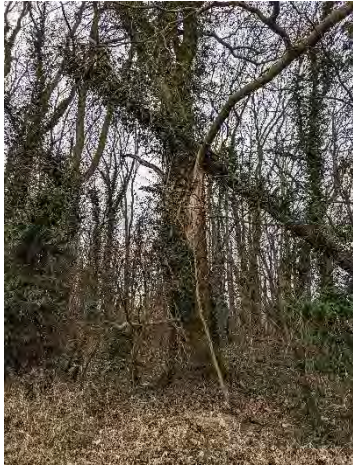
| Species | Height (m) | Crown spread (m) | | | | Stem dia. (mm) Including irregularities information | Stem no. at 1.5m | Height of crown clearance (m) | Dir/ height | Age class | Condition | Type | General observations Management recommendations | Estimated remaining contribution (years) | Tree Quality Category (BS5837) | Tree Typology | |
|---|---|---|---|---|---|---|---|---|---|---|---|---|---|---|---|---|---|
| T61 | <i>Fagus sylvatica</i> - Beech | 27.0 | 12.0 | 4.0 | 8.0 | 9.0 | 1080 | 1.00 | 12.00 | S/10 | V | Fair | Woodland edge/Maiden | Large limb and branch wood failures, Tears, rips in crown, Possible Kretzschmaria deusta at base | 20+ | B3 | Woodland |

| Primary Tree Qualities | | | | | |
|---|---|---|---|---|---|
| None visible | None visible | X | Maiden | Mature no clear decline | <10% mostly storm damage |

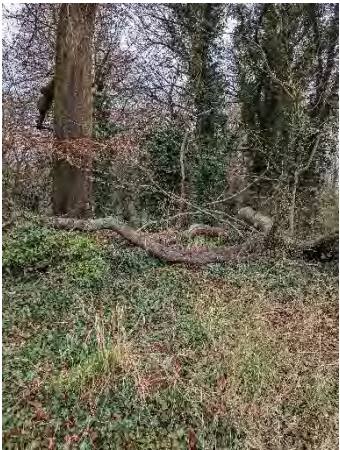
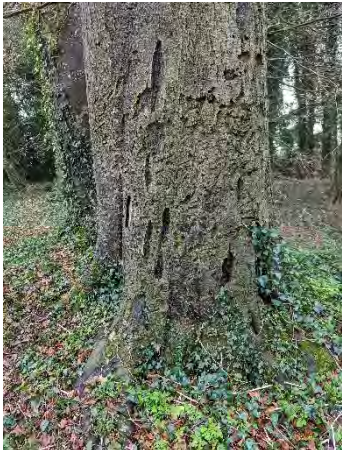
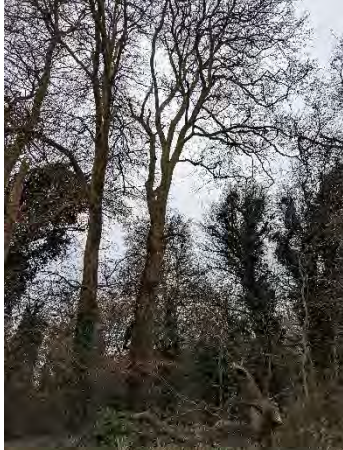
| Crown spread (m) | | | | | | | | | | | | | | | | | | Tree Typology |
|---|---|---|---|---|---|---|---|---|---|---|---|---|---|---|---|---|---|---|
| T62 | <i>Fraxinus excelsior</i> - Ash | 13.0 | 5.0 | 5.0 | 5.0 | 5.0 | 1270 | 1.00 | 2.00 | S/5 | V | Poor | Field Boundary | Major crown failure, Restricted inspection due to volume of ivy on stem and crown, Ash Dieback present, Scars and rips to crown. Hollow main stem. | 10+ | C3 | Field Boundary | |

| Primary Tree Qualities | | | | | | | | | | | | | | | | |
|---|---|---|---|---|---|---|---|---|---|---|---|--|---|--|---|--|
| Likely in main stem | | In upper crown | | Main Stem hollow | | | Maiden | | | < 20 years to failure | | | Partial Live Residual Canopy | | | |

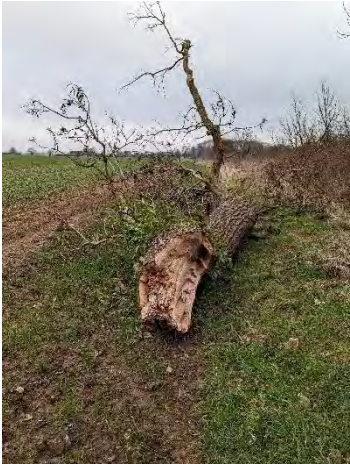
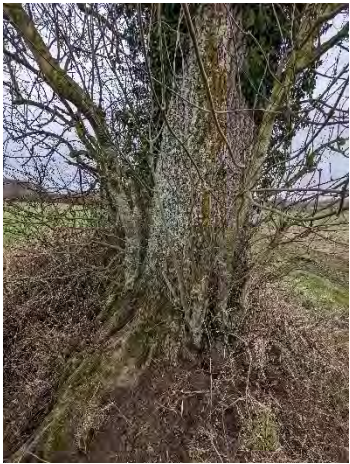
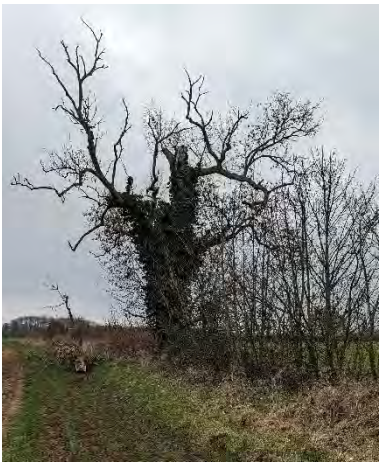
| Crown spread (m) | | | | | | | | | | | | | | | | | | Tree Typology |
|---|---|---|---|---|---|---|---|---|---|---|---|---|---|---|---|---|---|---|
| T63 | <i>Fraxinus excelsior</i> - Ash | 10.0 | 5.0 | 6.0 | 4.0 | 4.0 | 1210 | 1.00 | 2.50 | N/5 | V | Poor | Field Boundary | Major crown failure, Restricted inspection due to volume of ivy on stem and crown, Ash Dieback present, Scars and rips to crown, Cavity at base appears to be being used by an animal. | 20+ | C3 | Field Boundary | |

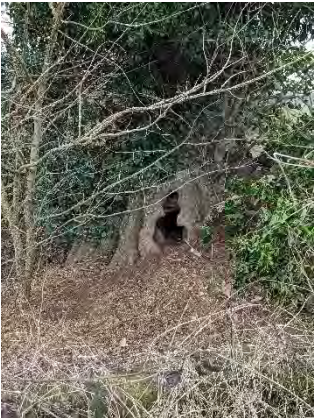
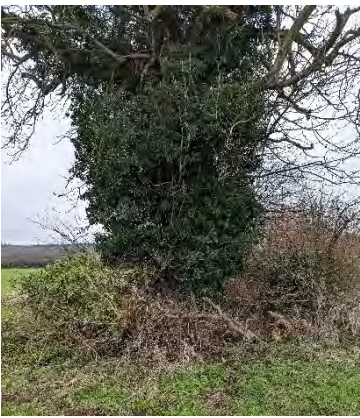
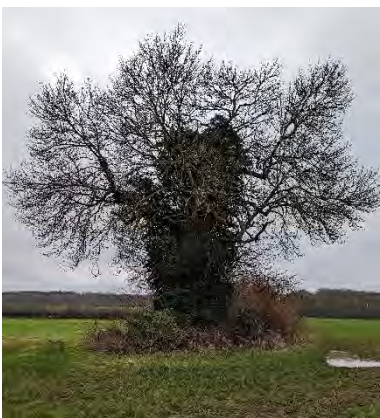
| | | Crown spread (m) | | | | | Stem dia. (mm) Including irregularities information | Stem no. at 1.5m | Height of crown clearance (m) | Dir/ height | Age class | Condition | Type | General observations Management recommendations | Estimated remaining contribution (years) | Tree Quality Category (BS5837) | Tree Typology |
|---|---|---|---|---|---|---|---|---|---|---|---|---|---|---|---|---|---|
| T64 | <i>Fraxinus excelsior</i> - Ash | 8.0 | 2.0 | 3.0 | 3.0 | 2.0 | 950 | 1.00 | 0.30 | - | V | Poor | Field Boundary | Major crown failure, Restricted inspection due to volume of ivy on stem and crown, Ash Dieback - Moderate extent | <20 | C3 | Field Boundary |

| Primary Tree Qualities | | | | | | |
|---|---|---|---|--|---|---|
| None visible | None visible | Main Stem hollow | Natural Pollard | | < 20 years to failure | >75% Live residual Canopy |

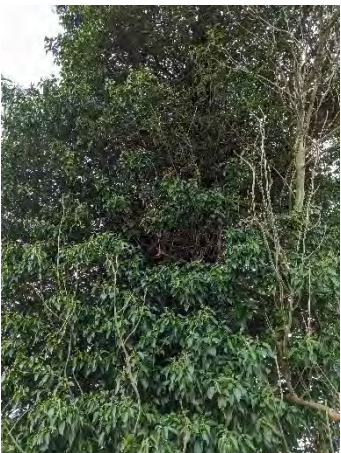
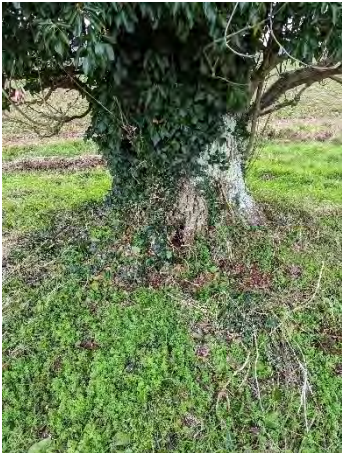
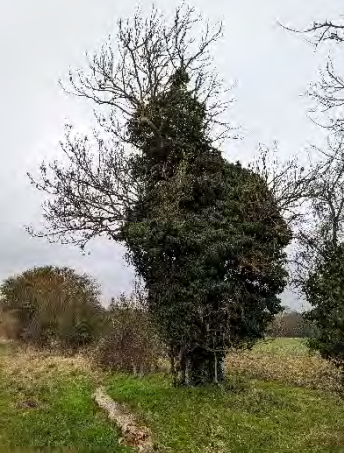
| Species | Height (m) | Crown spread (m) | | | | Stem dia. (mm) Including irregularities information | Stem no. at 1.5m | Height of crown clearance (m) | Dir/ height | Age class | Condition | Type | General observations Management recommendations | Estimated remaining contribution (years) | Tree Quality Category (BS5837) | Tree Typology | |
|---|---|---|---|---|---|---|---|---|---|---|---|---|---|---|---|---|---|
| T65 | <i>Quercus robur</i> - Pedunculate Oak | 18.0 | 10.0 | 6.0 | 5.0 | 10.0 | 1080 | 1.00 | 4.00 | NW/7 | V | Fair | Woodland edge/Maiden | Previous branch failures, Stubs, tears and splits in crown, Woodpecker activity in upper crown. | 40+ | A3 | Woodland |

| Primary Tree Qualities | | | | | | | | | |
|---|--|---|--|---|---|--|---|--|---|
| None visible | | None visible | | X | Maiden | | Mature no clear decline | | <10% mostly storm damage |

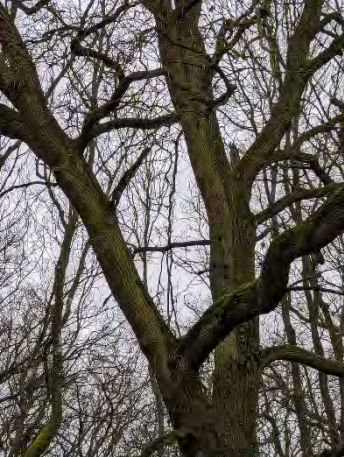
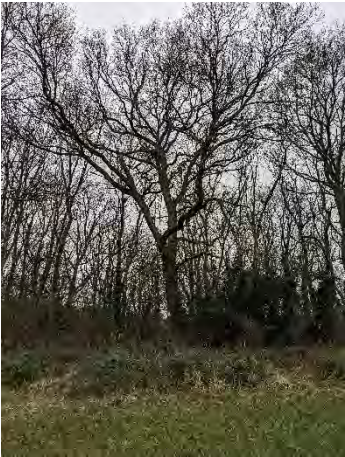
| Secondary Tree Qualities | | | | | | | | | | | | |
|---|---|---|---|---|---|---|---|---|---|---|---|--|
| X | X | Multiple crevasses at base of tree | X | X | X | X | Remnant of Inonotus hispidus Bracket noted | X | X | X | X | |

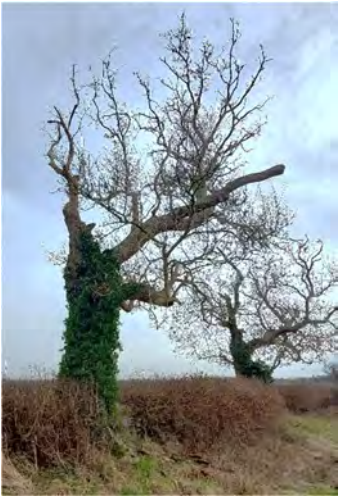
| Primary Tree Qualities | | | | | |
|---|---|---|---|---|---|
| Ye,s extensive | Yes, extensive, at forked union. | 50% | None, possible fomer pollard ot huge bifurcation at 1.9m | Yes, retrenching, large decay in main fork. | Yes, to north west bough dead / decaying. |

| Secondary Tree Qualities | | | | | | | | | | | |
|---|---|---|---|---|---|---|---|---|---|---|---|
| Yes, multiple | | Mainly crevice type | | | | Huge decay saddle at main union | | | | | None, but set on deep, dry ditch (to west) |

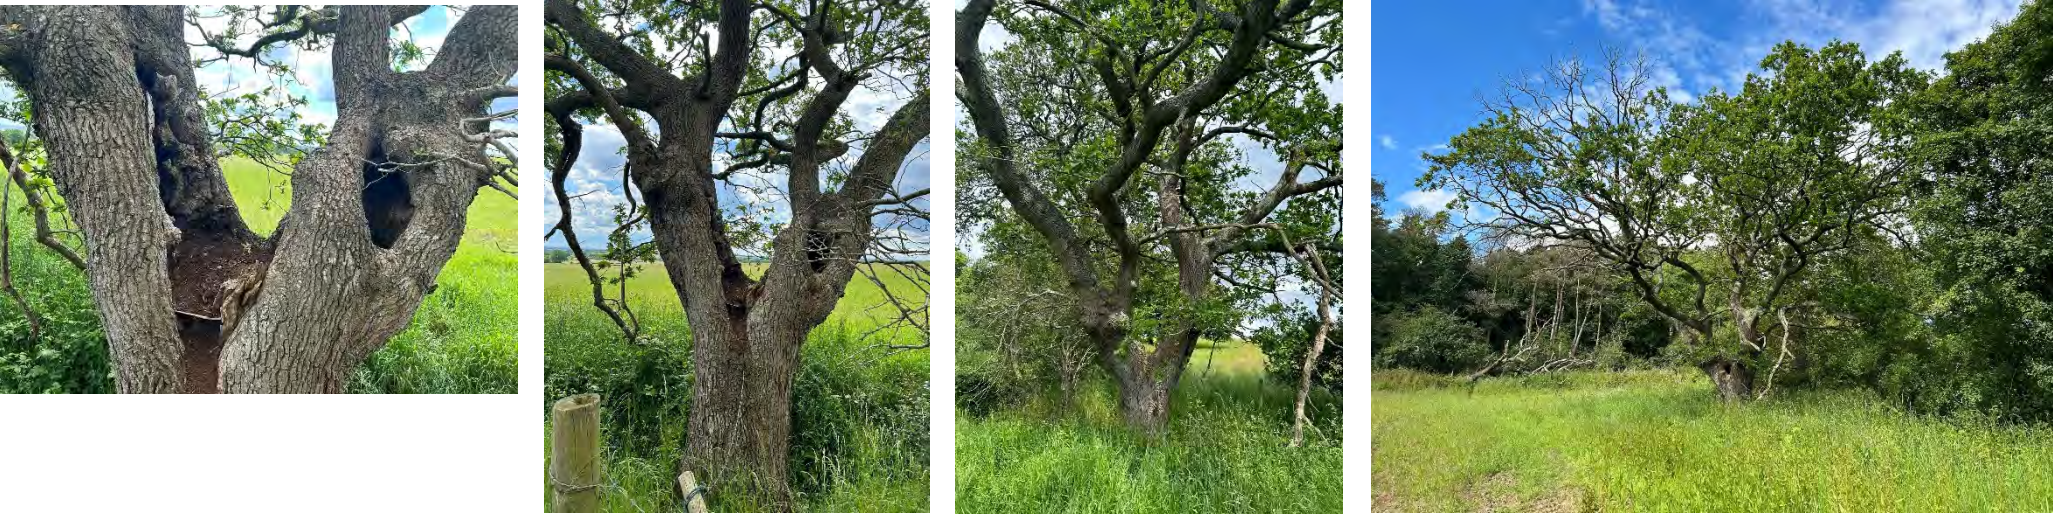
| Primary Tree Qualities | | | | | |
|---|---|---|---|---|---|
| Yes, internal, single hollow at root flare to south leading to deep hollo heartwood. | Single hollow to south | Est. 40% | Pollard at 3-4m. Local children swing, play and bridges beneath canopy. | Major attached deadwood. Decayed stubs | Yes, 25% to north west and north east. |

| Secondary Tree Qualities | | | | | | | | | | | |
|---|---|---|---|---|---|---|---|---|---|---|---|
| Yes, +300mm | | Lifted bark | | | | Yes, on decayed bough | | | | | |

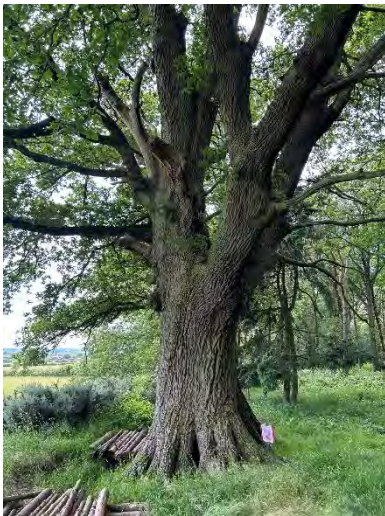
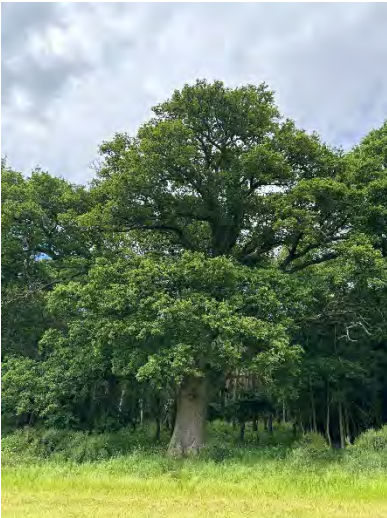
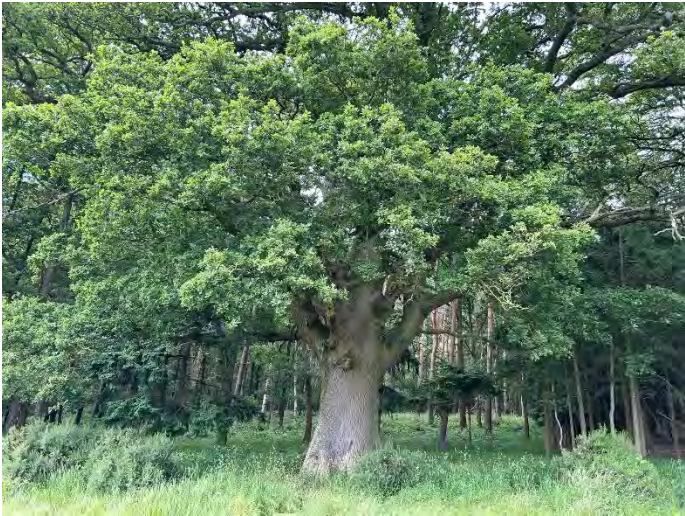
| Primary Tree Qualities | | | | | | | | | | | | | | | |
|---|---|---|---|---|---|---|---|---|---|---|---|---|---|---|--|
| Yes, 80% | | Yes, 80% in open coppice head | | 70% | | | High coppice, or low pollard at 1.4m | | | Outer cambium decay, circa 30cm open decayed hollow approx. 80-90cm | | | No, no current ash die back indications. | | |
| | | Open decayed heart | | | | Yes, open decayed coppice head | | | | | | | | | |

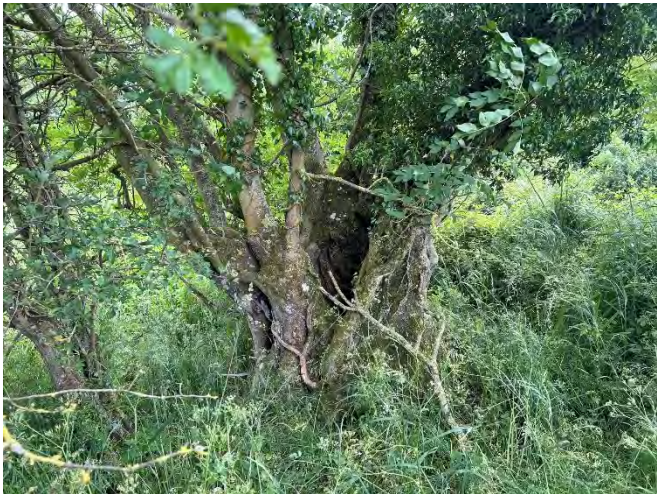
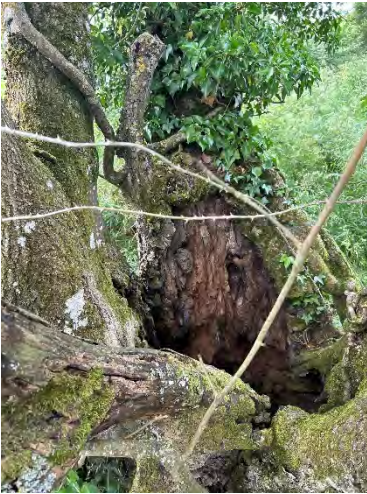
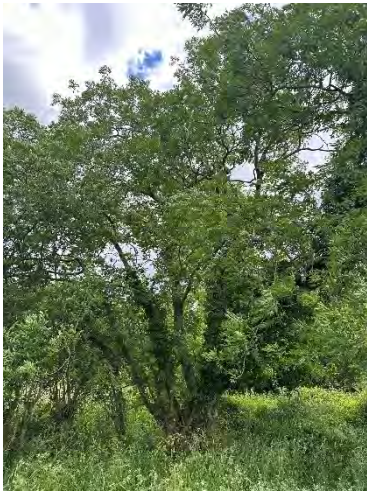
| Secondary Tree Qualities | | | | | | | | | | | |
|---|---|---|---|---|---|---|---|---|---|---|---|
| Yes, large snags | Yes, large snags | | | | | | | | | | |

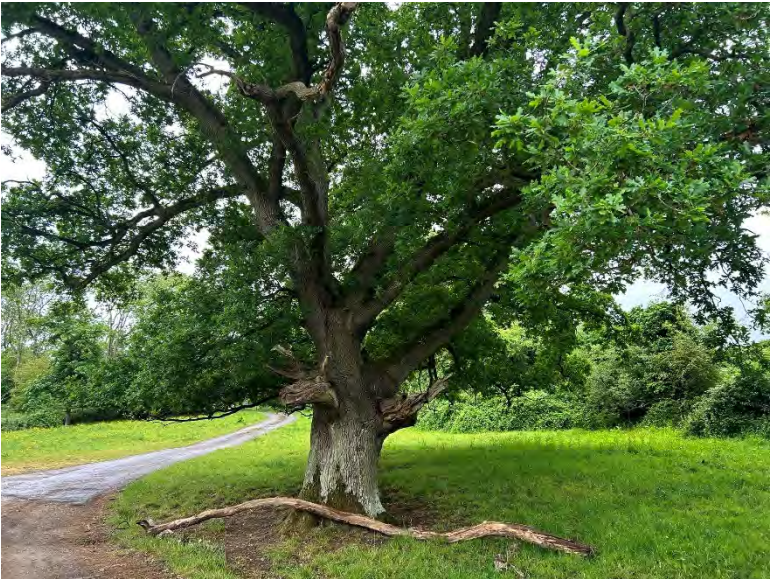
| Secondary Tree Qualities | | | | | | | | | | | |
|---|---|---|---|---|---|---|---|---|---|---|---|
| Yes, large snags | Yes, large snags | | | | | Huge storm tear-out | | | | | |

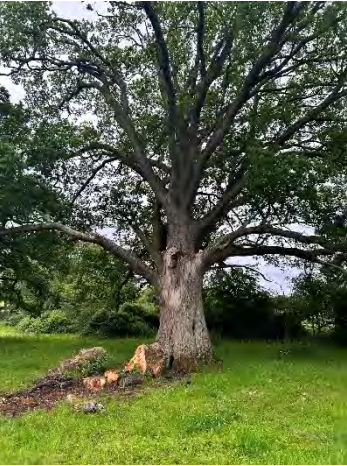
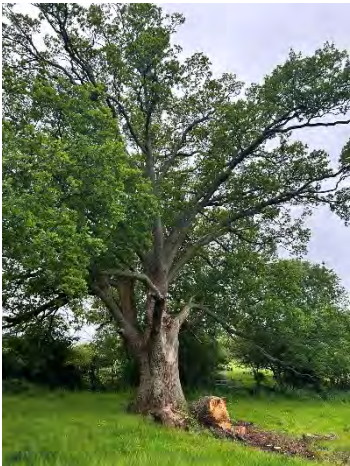
| Secondary Tree Qualities | | | | | | | | | | | |
|---|---|---|---|---|---|---|---|---|---|---|---|
| Yes, large snags | Yes, large snags | | | | | | | | | | |

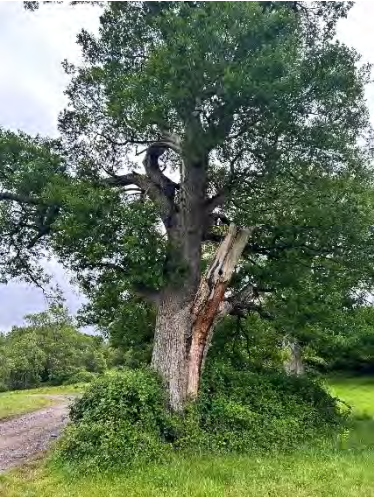
| Primary Tree Qualities | | | | | | | | | | | | | | | | |
|---|---|---|---|---|---|---|---|---|---|---|---|---|---|--|---|--|
| 5% of crown | X | Possible birds | X | X | X | X | X | X | X | X | X | Ivy | | | | |

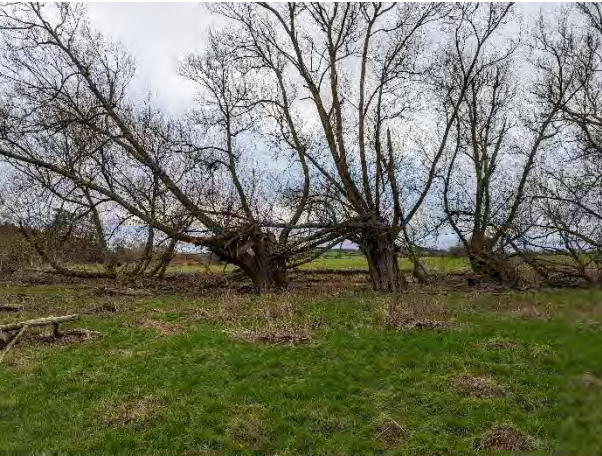
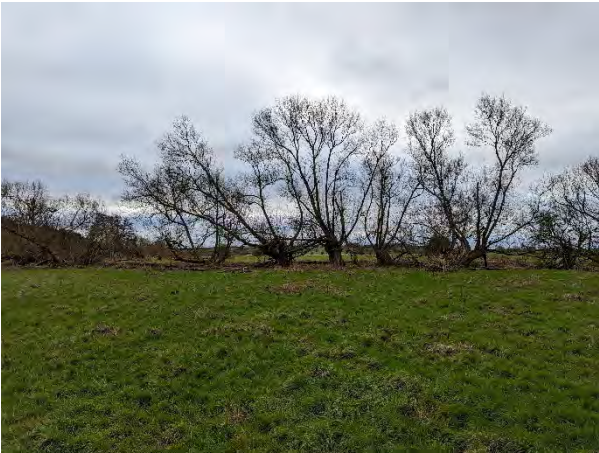
What3words location: [:///drones.fail.consoled](#)

| G3 | Species | Height (m) | Crown spread (m) | | | | Stem dia. (mm) Including irregularities information | Stem no. at 1.5m | Height of crown clearance (m) | Dir/ height | Age class | Condition | Type | General observations Management recommendations | Estimated remaining contribution (years) | Tree Quality Category (BS5837) | Tree Typology |
|---|---|---|---|---|---|---|---|---|---|---|---|---|---|---|---|---|---|
| | <i>Salix alba</i> - White Willow | 15.0 | 8.0 | 8.0 | 8.0 | 8.0 | 1000 | Multi-stem | 0.00 | - | V | Poor | River edge | Collapsing trees (6) Main stem split and decayed, Regenerating from failed limbs. | 20+ | B3 | Riverside |

| Secondary Tree Qualities | | | | | | | | | | | |
|---|---|---|---|---|---|---|---|---|---|---|---|
| 20% in crown | Yes | Possible birds and bats | X | X | X | Main stem | X | X | 1 | X | Moss |
