CASSINGTON TORNADO 2021

Report by the Tornado and Storm Research Organisation (TORRO)

On 31st October 2021, a tornado went through the village of Cassington. This report covers the findings from a site investigation conducted by Sarah Horton (TORRO) over two days following the event

Author:
Sarah Horton (TORRO)

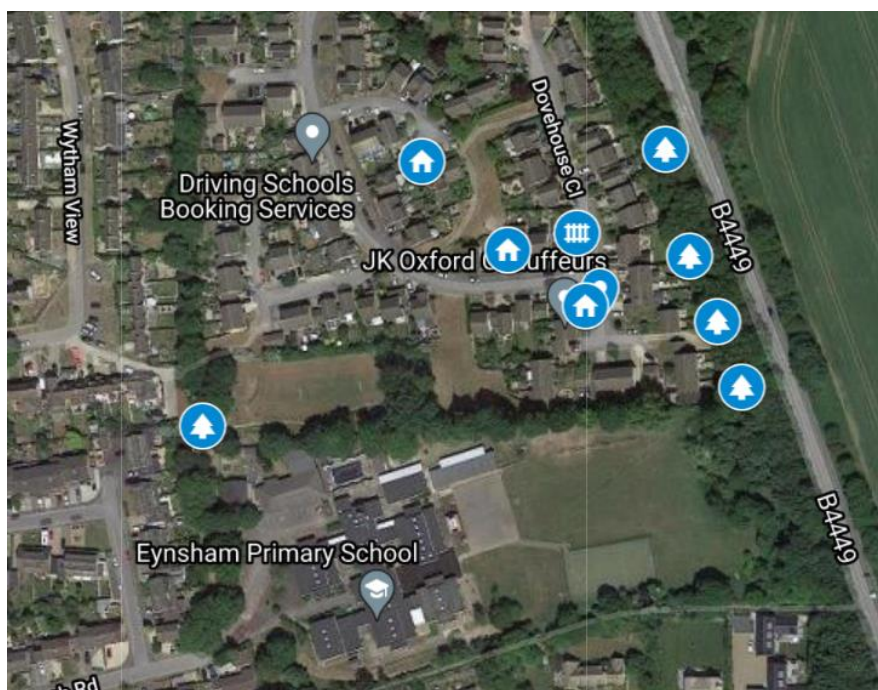
The most south-western point of damage found was close to Eynsham Primary school and consisted of large branches from a tree. These had been tidied into a pile and so direction of fall could not be ascertained.

There was some tile damage to houses close to the B4449. One garden wall had partially collapsed. Several large trees had lost branches or snapped high up.

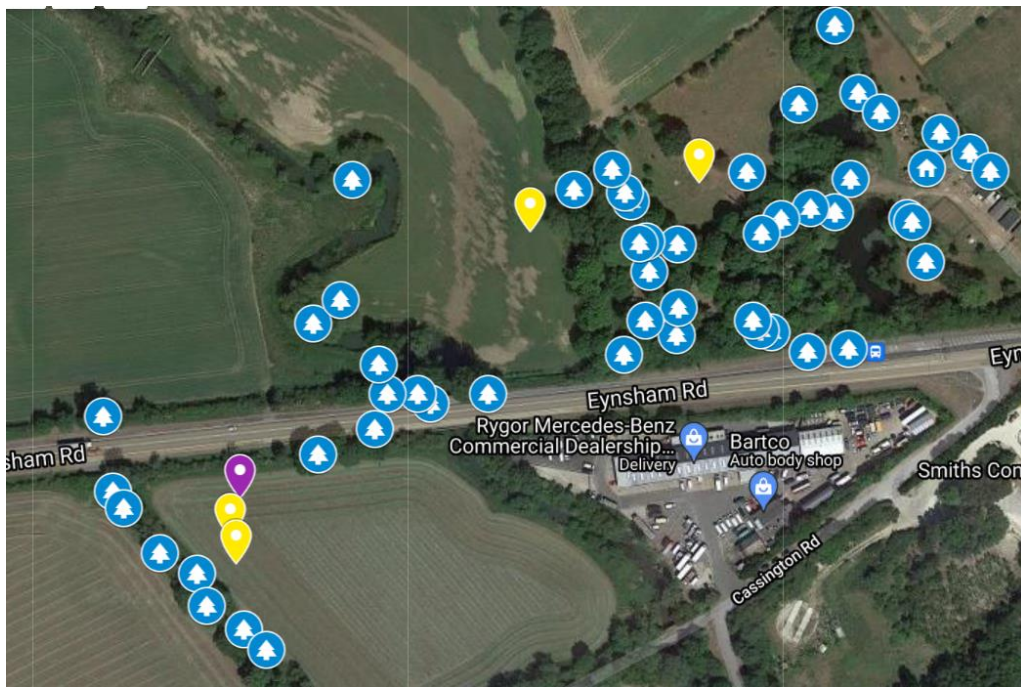
Land bordering the A40 near the Cassington Turn.

Note that much of the tree damage shown here is indicative. Such was the density of felled trees, it was impossible to walk through much of it. Damage to the bottom left of the image was less severe than damage through the woodland shown. The yellow markers are a few examples of debris that travelled. The Purple marker indicates a particularly notable example.

To the south of Eynsham road in the field, many trees were damaged. The line gives a good indicator of the width of the tornado at this point. c. 160m

The line of trees bordering the south of the A40 had suffered substantial damage.

Two extremely large poplar trees had been completely uprooted alongside the River Evenlode. There was much evidence of twisting on broken branches. Debris had been scattered to the north.

Further trees had come down on the border of woodland next to the A40, west of the river. On the east of the river there was a clear path of damaged and felled trees through the woodland.

Power lines that crossed the open fields had come down in three places. The poles had been recently replaced. Power was not restored to parts of the village until 2nd November, because access through the fallen trees was impossible without mechanical diggers. This evidence suggests a T3 tornado of width of around 150m

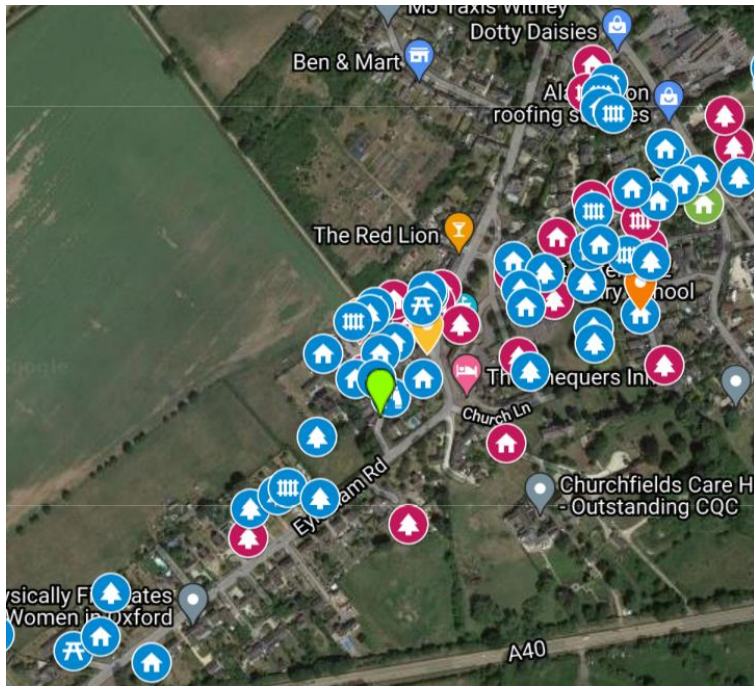
Cassington Village centre.

As with the previous map, some damage will not have been marked. Village residents were extremely helpful in helping to identify damage, both online and in person during the site visit. On the south-eastern side of Eynsham road, very little damage was found despite speaking to residents.

In the centre of the village many houses had lost some tiles or suffered fence or wall damage with some brick walls being blown over entirely. There were reports of a collapsed chimney, but this was not seen on the site investigation. One house in Bell Lane lost part of its roof. A garage door had been ripped off. Cladding came off the school and travelled approximately 200m.

Many large trees had suffered severe damage throughout the village. Trees lay in different directions. One resident said "Our apple tree fell towards the north west. Our big ash tree fell towards the north east."

Damage in central Cassington village was generally commensurate with a tornado of strength T2, although there were some elements suggesting T3 in places. Width remained around 160m

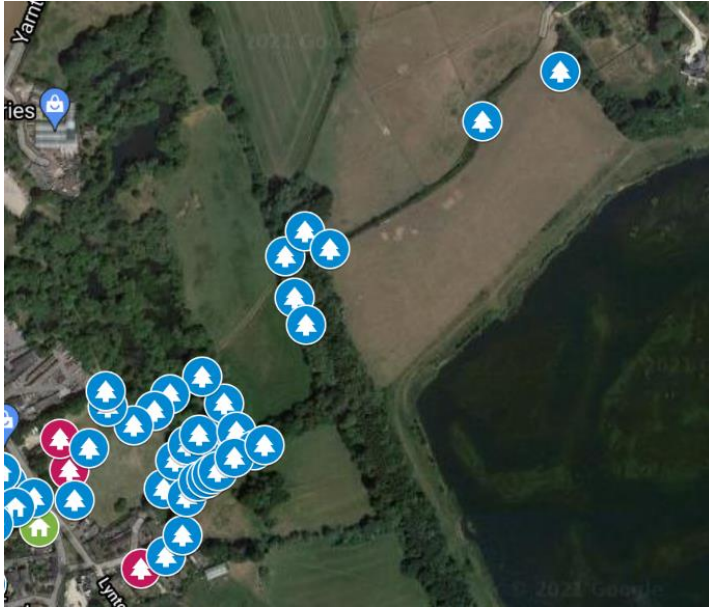
North-west of Lynton Lane.

As before, the descriptions of tree damage are only indicative. In this case not all trees could be accessed due to being on private land.

The damage in this area was similar to the damage at the A40 end of Cassington. Numerous large trees, including sycamores and oaks, were either felled, or badly damaged. In the field to the north east of the village there was damage along the periphery, in the centre and throughout the wooded area.

Property owners on Lynton Lane showed the damage that their wooded area had received. The trees had been planted by the gentleman in 1973/1974 and consisted of a mix of tree types. They estimated that they had lost around twenty of their trees.

A footpath led to another tree boundary. Most of the damaged trees could not be accessed as they were on private land, but the front edge contained a number of snapped trees. On the back edge of this there were some trees that had clearly fallen to the north east.

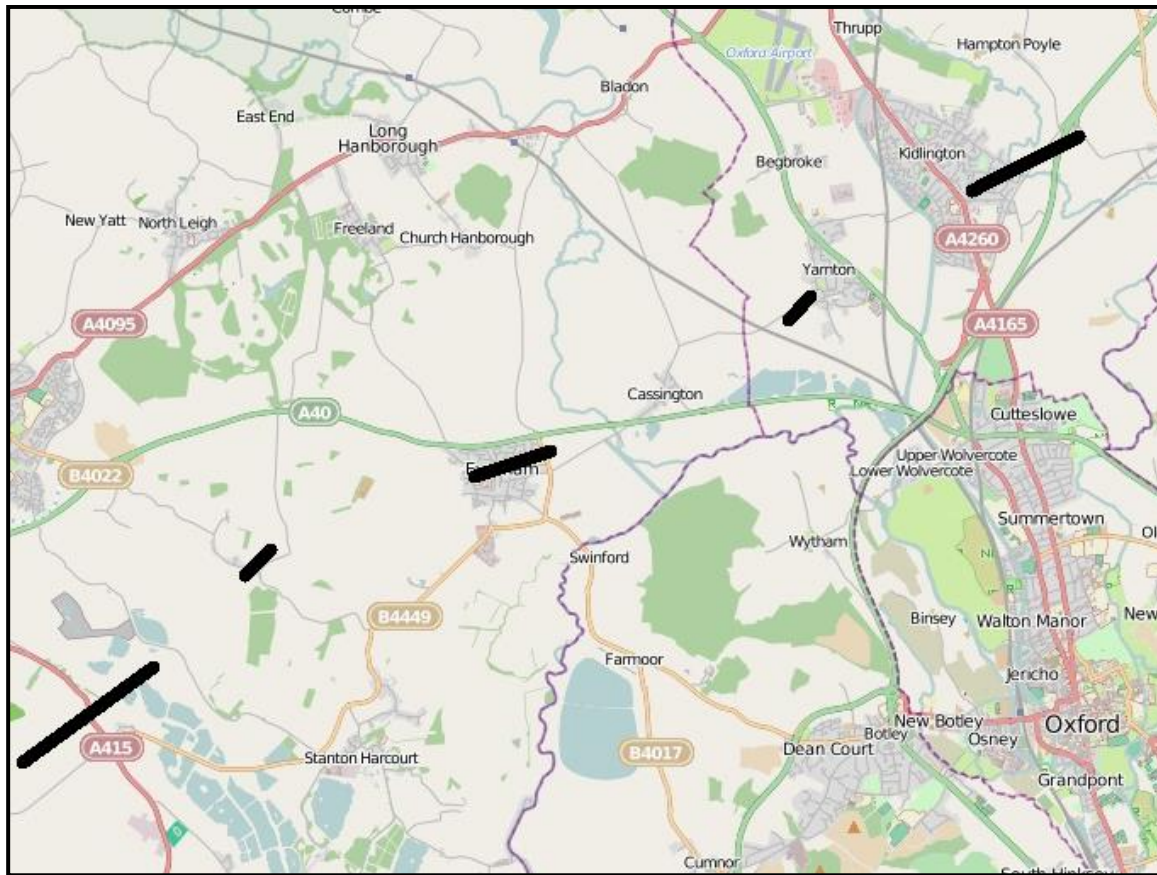
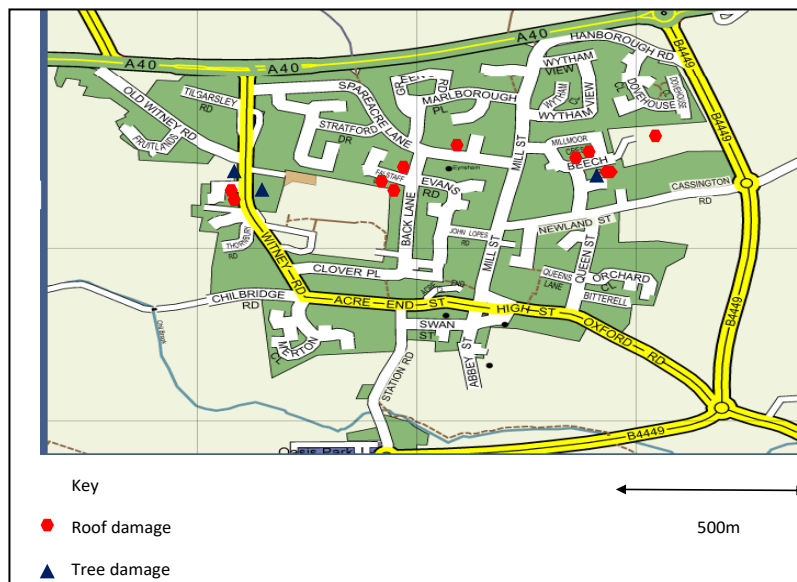
Some may remember the tornado that hit the same area in on 7th May 2012. For interest a map and summary are included for ease of comparison. During that site investigation Cassington was not explored. A discontinuous 17km path was found.

Note how close this path overlapped the start of the Cassington tornado.
