BURLEIGH WOOD TORNADO 2021

Report by the Tornado and Storm Research Organisation (TORRO) SI20211031_Burleigh Wood

On 31st October 2021, a tornado went through the Burleigh Wood. This report covers the findings from a site investigation conducted by Sarah Horton (TORRO) over two days following the event

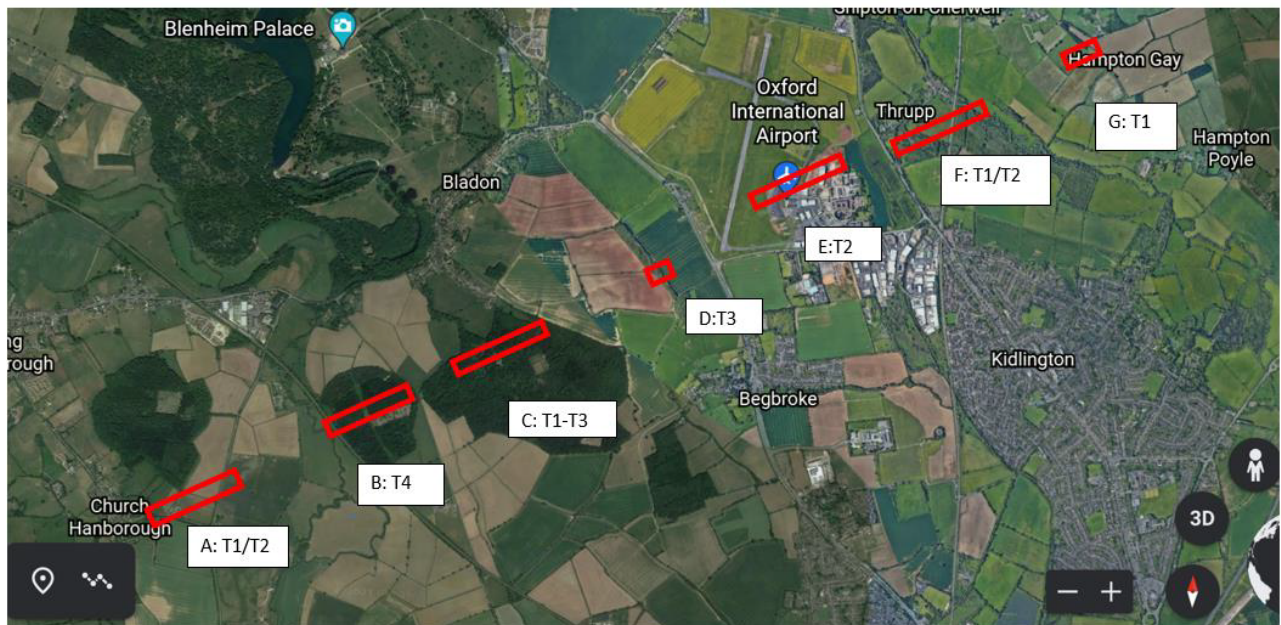
A: Church Hanborough/ Edge of Pinsley Wood. Mostly T1. Estimated T2 through binoculars of Pinsley Wood. B: Burleigh Wood T4, some evidence of weakening as it exited. C: Bladon Heath. Mostly weak, T1, sporadic but restrengthened to poss T3 on exit. D: Provisional T3 Report from Blenheim head forester. Half a dozen mature ash trees pulled out of the ground. E: Mostly T1, but some T2 evident in woodland. F: Some evidence of T1.
