BOTLEY WEST SOLAR FARM

Veteran & Ancient Tree Survey

Veteran Tree Survey –
Botley West
V5

June 2026

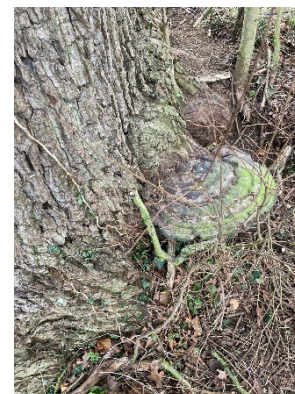
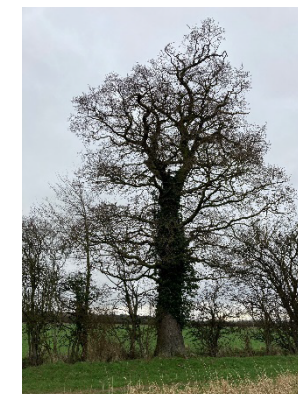
What3words location: ///removes.conjoining.covenants ZG

Species	Height (m)	Crown spread (m)				Stem dia. (mm) Including irregularities information	Stem no. at 1.5m	Height of crown clearance (m)	Dir/height	Age class	Condition	Type	General observations Management recommendations	Estimated remaining contribution (years)	Tree Quality Category (BS5837)	Tree Typology	
		N	E	S	W												
T16	<i>Fraxinus excelsior</i> - Ash	10.0	5.0	7.0	5.0	2.0	970	1	4	N/3	M/V	Poor	-	Near veteran girth, displaying significant decay/hollowing indicative of veteran characteristic and habitat value. Western side of stem exposed hollow to 40%. Healthy buds from old pollard point.	20+	B3	Field Boundary

Primary Tree Qualities						
Extensive Decay			Previous aged management	Senescence / Aged decline	Retrenchment / Canopy Reduction	
Brown rot	Exposed heartwood	Hollowing (by %)				
X	Yes	40%	Pollard	Yes	X
