Rosefield Solar Farm

Environmental Statement

Volume 4
Appendix 11.1: Preliminary Risk
Assessment (Part 1)

EN010158/APP/6.4
September 2025
Rosefield Energyfarm Limited

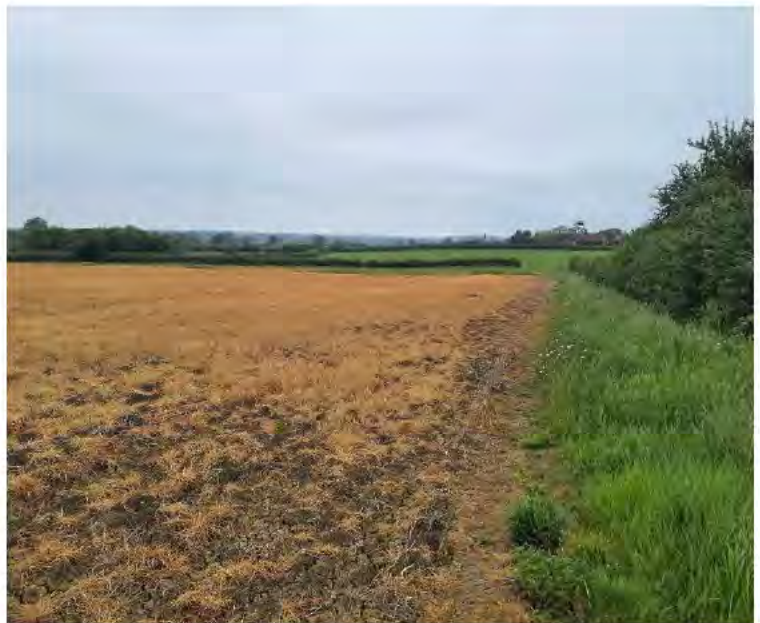
<p>Photo No. 3 Date 21/05/2024 10:07:00</p> <p>Description B4 looking S from gateway in B6. Note ditch under track</p> <p>Co-ordinates 51.918174416:-0.989024979</p>	 
<p>Photo No. 4 Date 21/05/2024 10:09:00</p> <p>Description B13 from Pond Farm access track</p> <p>Co-ordinates 51.918110759:-0.988050724</p>

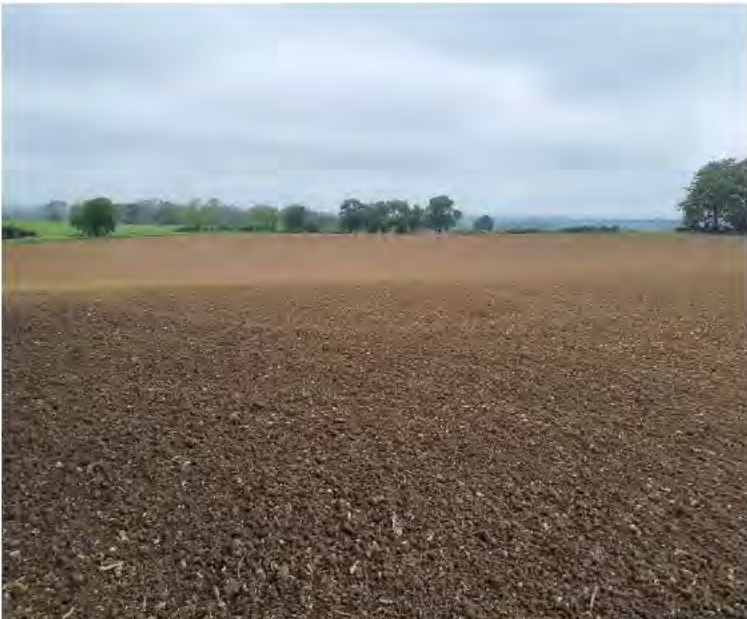
<p>Photo No. 31 Date 21/05/2024 12:28:00</p> <p>Description B11</p> <p>Co-ordinates 51.912149077:-0.982435227</p>	 
<p>Photo No. 32 Date 21/05/2024 12:35:00</p> <p>Description B11 with B12, B14 and B15 beyond. Possible spring in central midground - ground boggy</p> <p>Co-ordinates 51.912719015:-0.97991147</p>

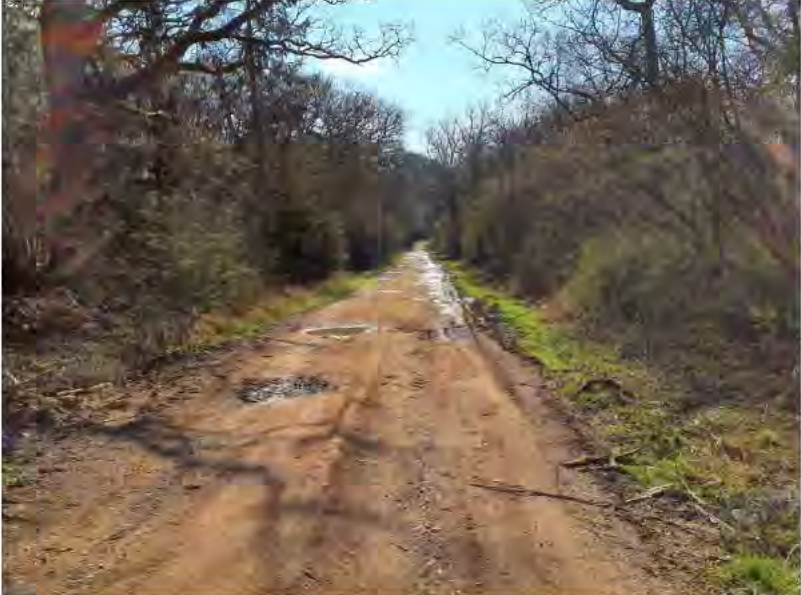
<p>Photo No. 74 Date 26/03/2025</p> <p>Description Brook running beneath the road the access track will use</p> <p>Co-ordinates 51° 54' 10.565" N 0° 57' 51.859" W</p>

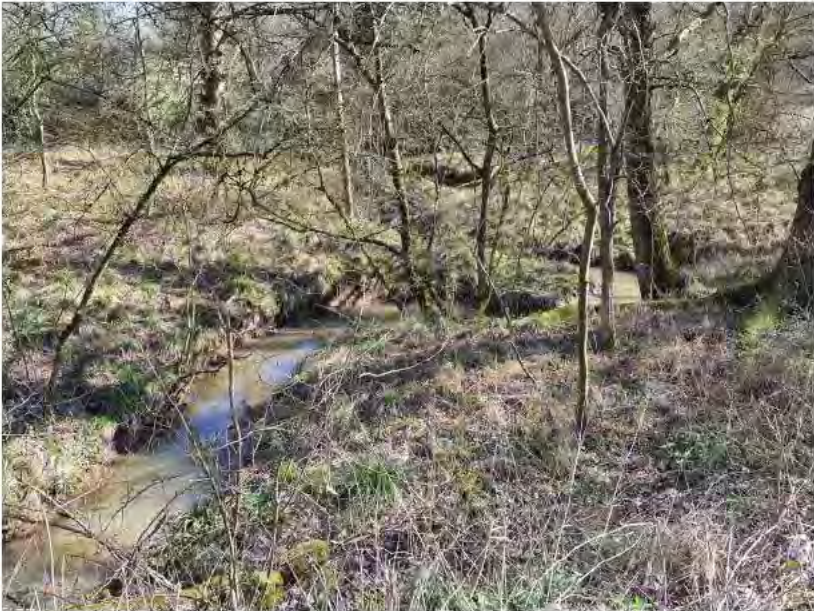
<p>Photo No. 75 Date 26/03/2025</p> <p>Description Brook close to access track</p> <p>Co-ordinates 51° 54' 10.607" N 0° 57' 51.72" W</p>
