# **WHITESTONE SOLAR FARM**

## **Volume 6: Environmental Statement**

### **6.20 Appendix 6.4.1: River Condition Assessment**

Application Document ref. EN0110020/APP/6.20

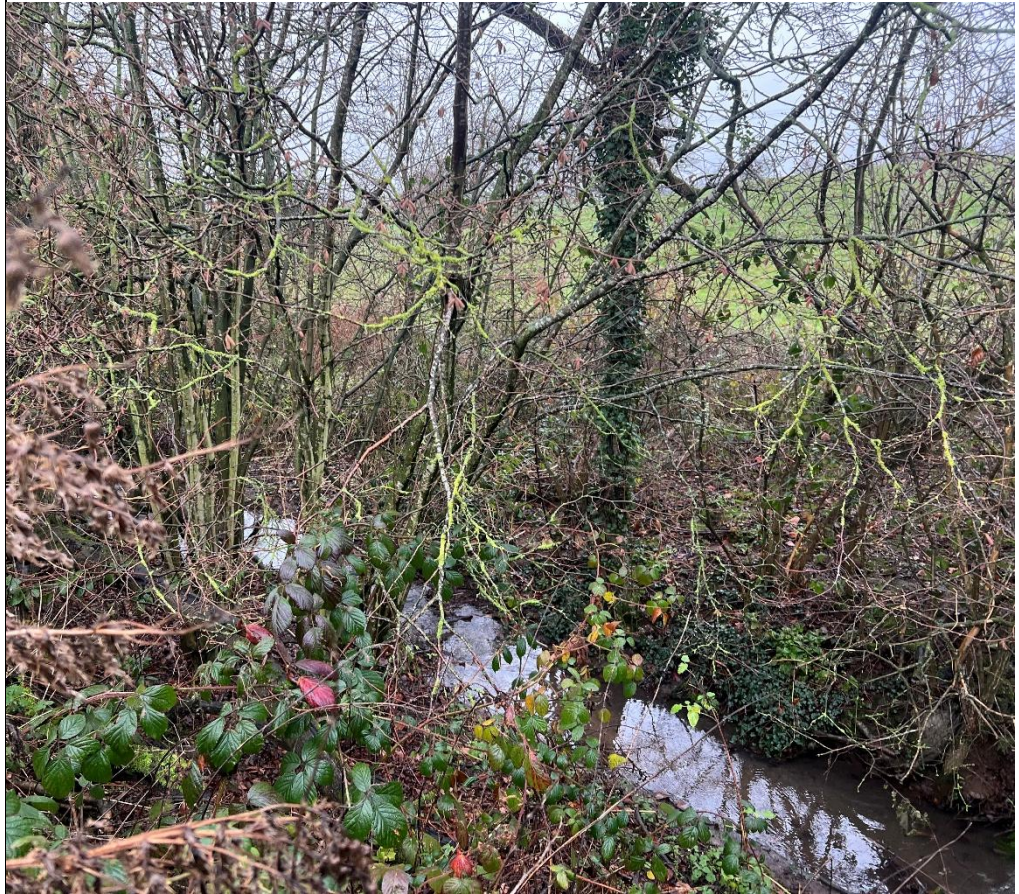
Pinch Mill Brook  
(Wc17)

| Pinch Mill brook was allocated RCA River Type K. It is a straight/sinuuous watercourse which is unconfined and no invasive species were noted during the survey. The survey for this reach was undertaken during December 2025. Scrub was dense along much of the bank top, limiting access and visibility of the channel and opposite bank face and bank top. Access was only available from the left hand bank top. Surrounding habitat was pasture. | | | |
| River Condition Assessment FINAL CLASS: | Moderate | IS THE RCA FINAL CLASS MODIFIED ?<br>If yes, why and what supporting evidence is provided? | No |

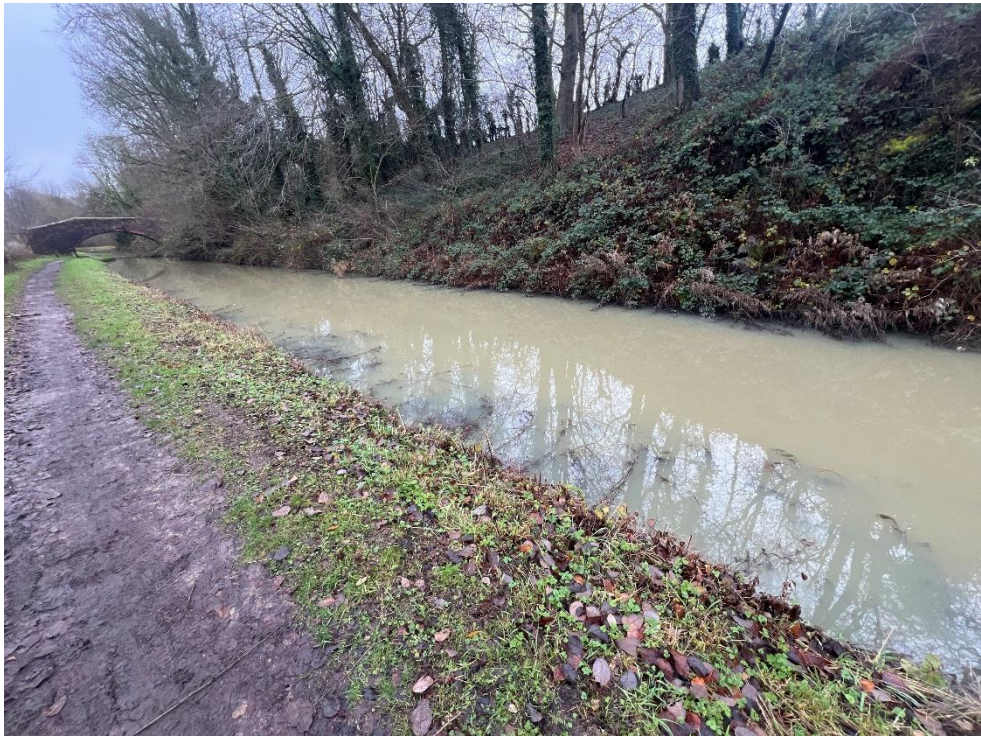
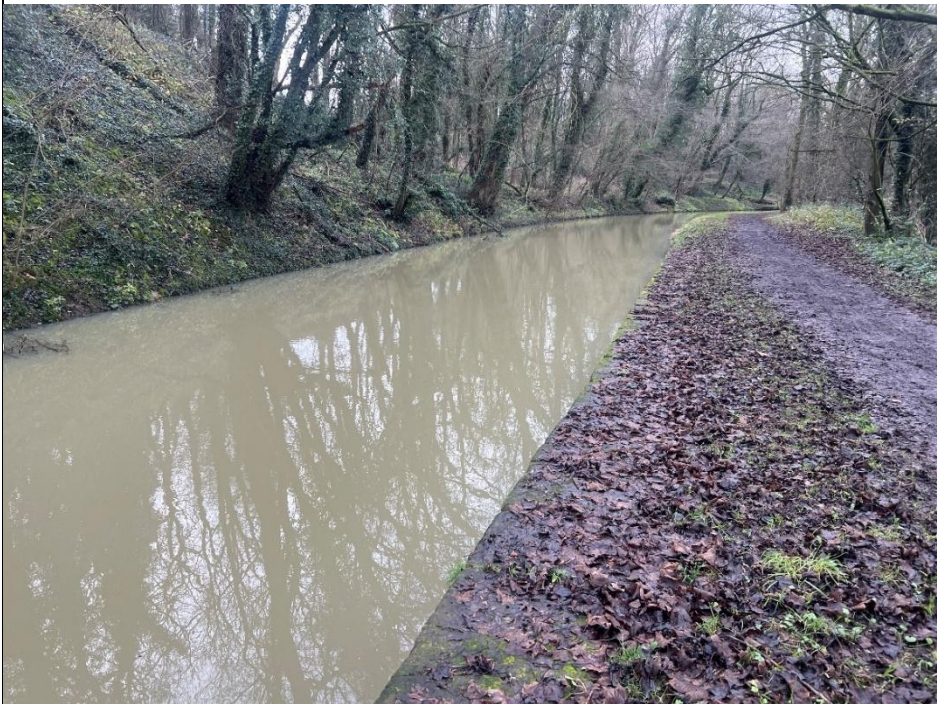
| Chesterfield Canal was allocated a Navigable/Canal RCA River Type. The survey for this reach was undertaken during December 2025 and no invasive species were noted during the survey. A public footpath follows the stretch of the Canal, and surrounding habitats within this reach of the Canal is dominated by woodland and agricultural land. | | | |
| River Condition Assessment FINAL CLASS: | Moderate | IS THE RCA FINAL CLASS MODIFIED ?<br>If yes, why and what supporting evidence is provided? | No |
