Response for Deadline 4 concerning the use of the Hoverport part 1

Planning Inspectorate ref: EN020026

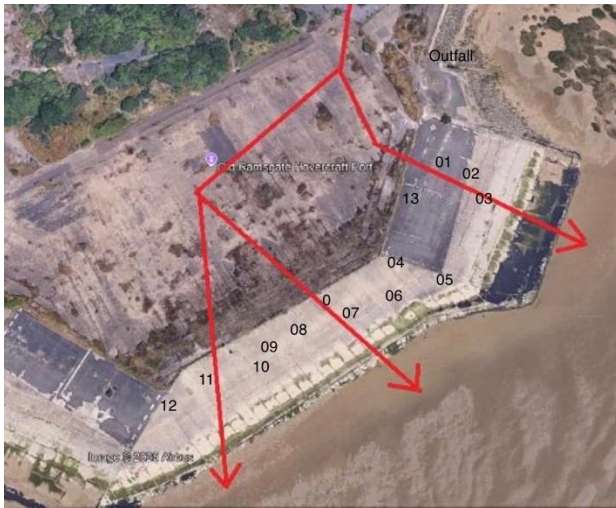
The diagram to the left shows the access routes proposed by the Applicant with the position of the outfall and where the 13 photographs shown below were taken.
