# **M25 junction 28 improvement scheme TR010029**

## **6.3 Environmental Statement Appendix 7.7: Arboricultural impact assessment**

#### 6.3 ENVIRONMENTAL STATEMENT APPENDIX 7.7: ARBORICULTURAL IMPACT ASSESSMENT

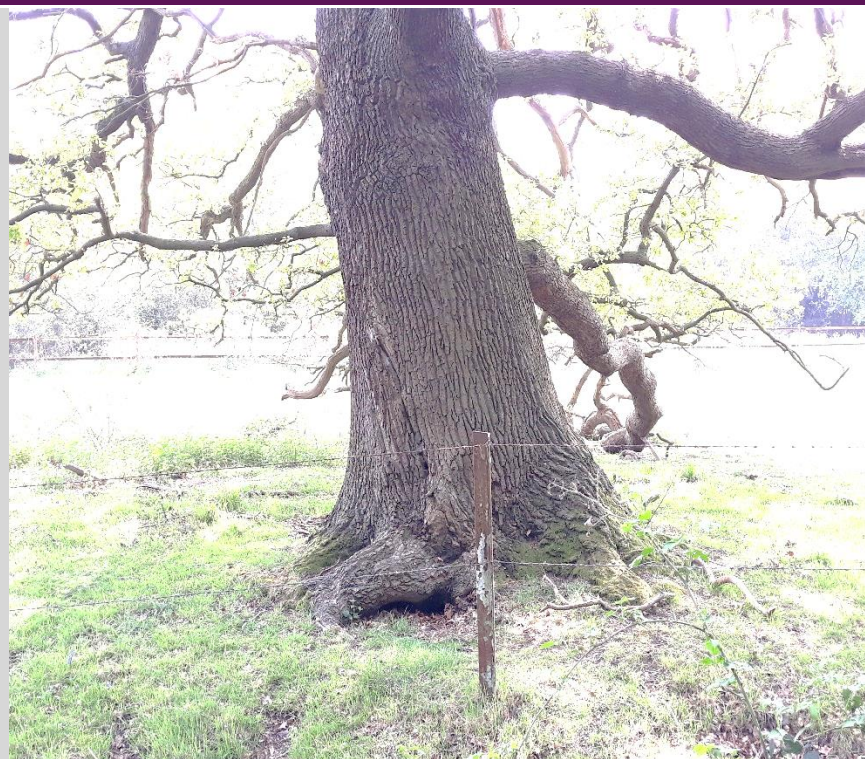
Tree ref	Species	Location	Summary of value	Tree photographs
			within the 'veteran/notable' criterion of girth in relation to age as shown in Figure 1.3 of 'Ancient and other veteran trees: further guidance on management' (Lonsdale, 2013).

T059	Common Oak	Easing: 55629447 Northing: 19266471  Grove Farm, growing within hedgerow linking The Grove Wood and Alder Wood.  TPP:	<b><u>Size:</u></b> Large stem girth in comparison to other trees in locality.  <b><u>Condition:</u></b> Decay features present including hollowing main stem, revealing developing heartwood decay. Occasional dead branches in crown with desiccated white rot.

Tree ref	Species	Location	Summary of value	Tree photographs
		HE551519-ATK-ELS-XX-DR-LL-000203 (Appendix C)	<p>Crown lost vitality to east, dieback and dead wood present in upper and middle crown extents. Potential natural retrenchment given age, or ground compaction in root zone to east. Sections of loose bark.</p> <p><b><u>Biodiversity value:</u></b></p> <p>Decayed heartwood rot and white rot providing habitat for saproxylic invertebrates.</p> <p><b><u>Cultural and heritage value:</u></b></p> <p>Tree appears to be present on 1866 OS mapping.</p> <p>Limited visibility from surrounding views given existing tree stock and site topography.</p> <p><b><u>Age:</u></b></p> <p>It's diameter of 1100mm means it has a girth of 3.45m and means it is included within the 'locally notable' criterion of girth in relation to age as shown in Figure 1.3 of 'Ancient and other veteran trees: further guidance on management' (Lonsdale, 2013).</p>
