# **A46 Coventry Junctions (Walsgrave) Scheme number: TR010066**

### **Appendix 8.10 Otter and Water Vole Report**

November 2024

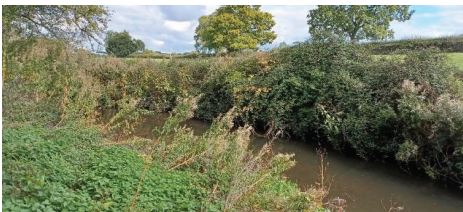
Section 7	0	0	1	1	1	1	0	0	4 – sub-optimal
Description: A section on a bend in the river, where water level was 1m deep and the bed was silt. The river was slow flowing with some watercress <i>Nasturtium officinale</i> growing on the margins. The eastern bank was vegetated by bramble with a grazed field behind it. Vegetation on the western bank included nettles with bankside trees, and a public footpath. Evidence of hand pulling of Himalayan balsam was recorded. <b>Section length: 30m.</b>

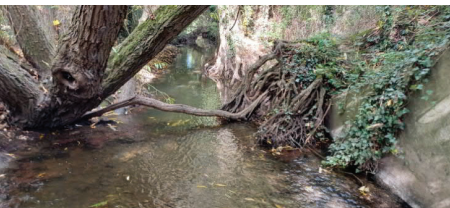
Section 4	0	0	1	0	1	1	0	0	3 – sub-optimal
Description: The brook was 10cm deep with a fast rippled flow and a cobbles and silt bed. The eastern bank was a concrete wall and the western bank was earthen and shallower in profile at 45 degrees with ivy cover. This section is close to public footpaths and dogs are likely to use the water regularly. <b>Section length: 10m.</b>

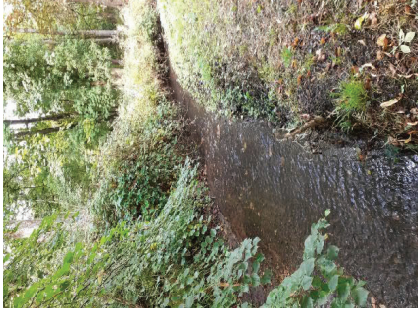
<b>Section 2</b>	0	0	1	1	1	0	0	0	<b>3 – sub-optimal</b>
Description: The watercourse was 5-30cm deep water with a silty bed containing cobbles and pebbles and a slow flow and bare banks. The eastern bank was shallow and the western bank vertical. Both banks were composed of earth with a higher amount of organic material. <b>Section length: 105m.</b>

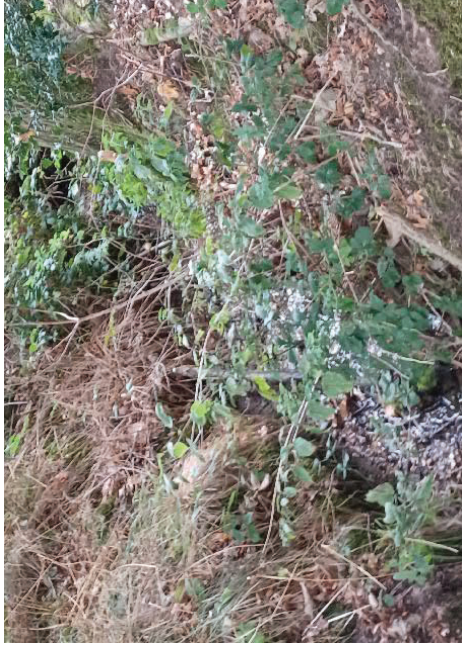
Unnamed Watercourse 3									
<b>Section 1</b>	0	0	1	1	0	0	1	0	<b>3 – sub-optimal</b>
Description: The watercourse was approximately 5cm deep with a fast rippled flow. The banks were comprised of earth and were steep, with bramble in parts. <b>Section length: 55m.</b>
