DESIGN APPROACH DOCUMENT

CENTRAL HUB

Document number 5.5B

MARCH 2026

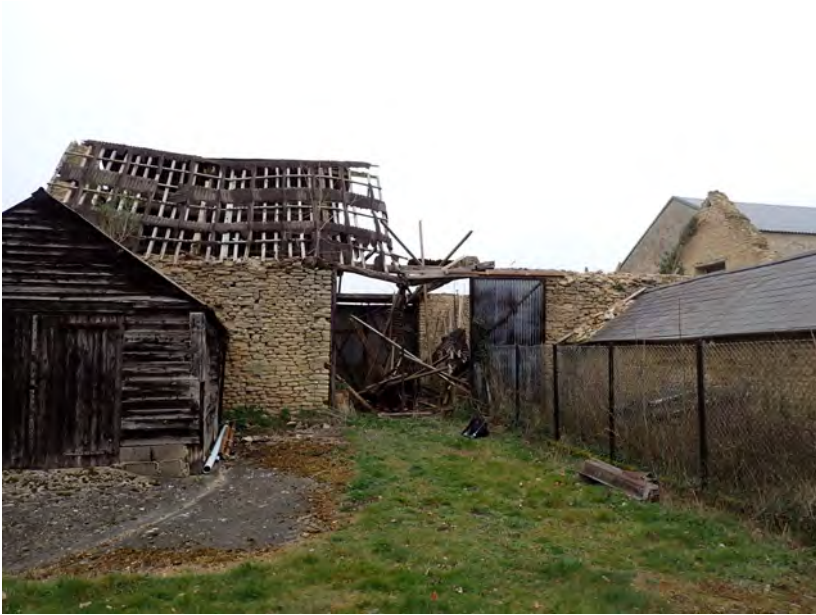
Fig 1:

South elevation; showing a general overview to the barn. Note complete structural collapse to the east 3no. bays with partial collapse to the central bay. 2no. west bays remaining without an external roof envelope

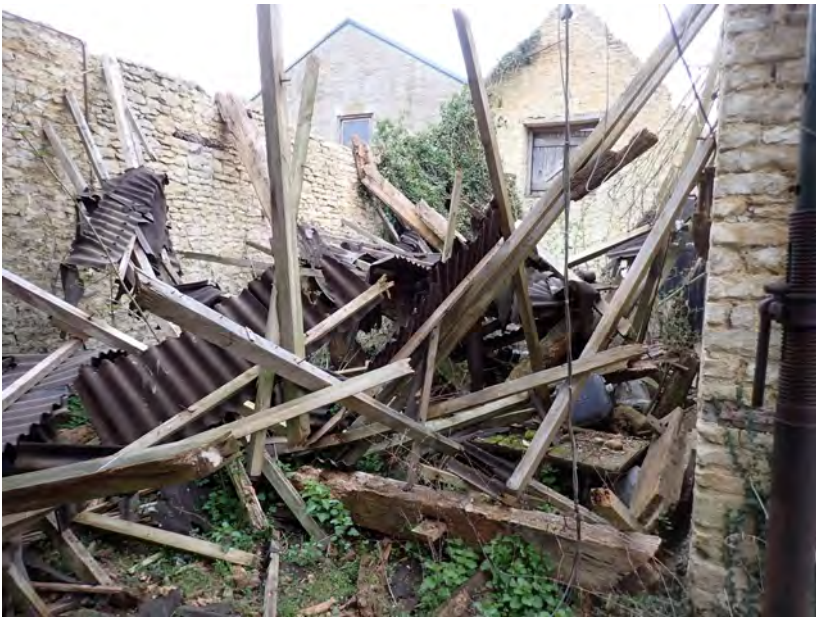
Fig 2:

Bay 3; showing a general view looking east. Note complete structural collapse of the 3-4no. west bays with collapsed debris remaining and exposed to the elements

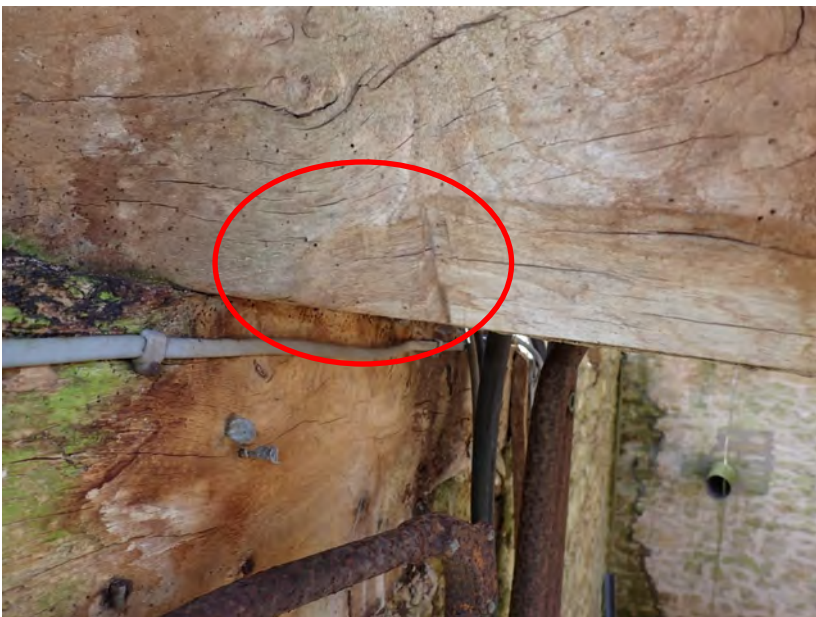
Fig 8:

Truss 2; showing historic constructional detail of the chamfer stop to the principal truss tie beam being of lambs tongue variant (*cyma reversa*)

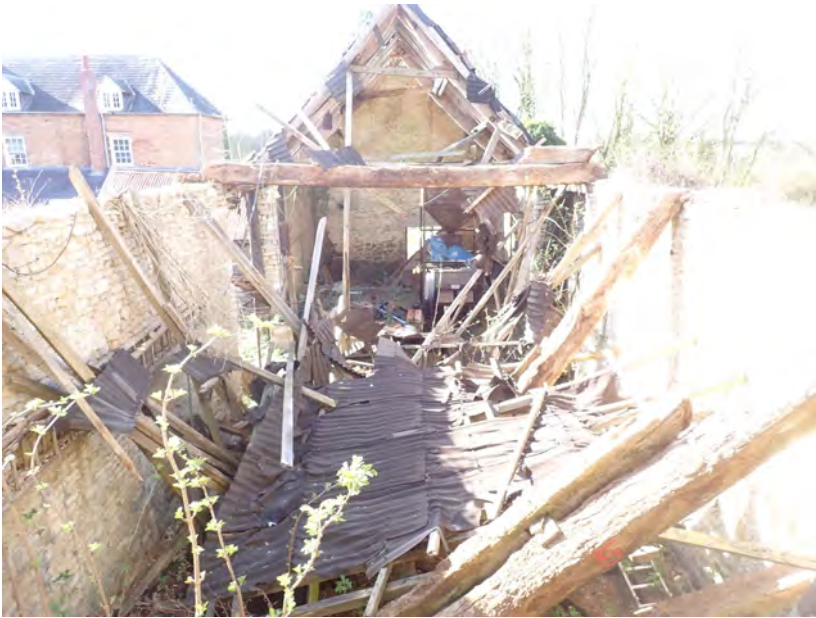
Fig 9:

Bay 6; showing a general view looking west

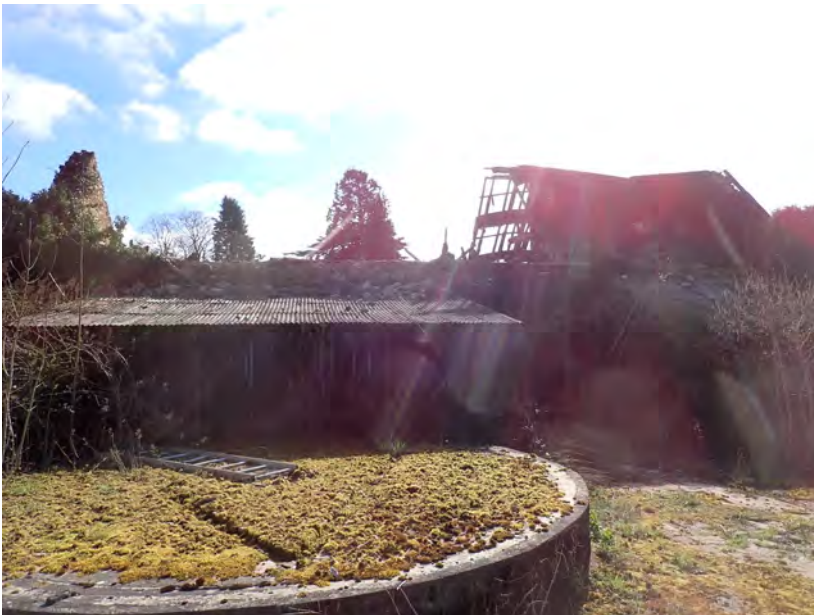
Fig 12:

North elevation; showing a general view towards the north facade

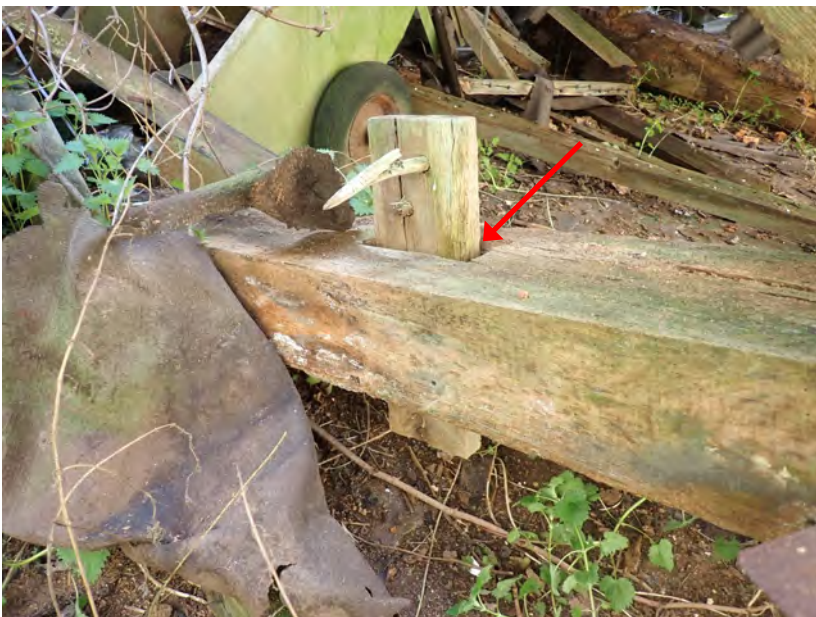
Fig 14:

Bay 6; showing representative constructional detail of a purlin joint formed via an inserted slip tenon pegged independently into the principal rafter as well as to the purlins. Also not purlins 'let-in' to the principal rafters for additional strength at the bearing end

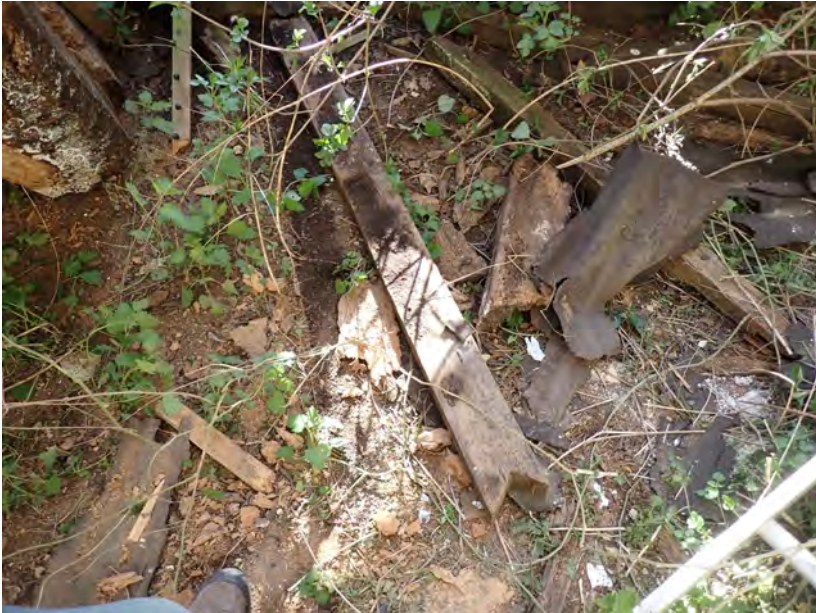
Fig 25:

Bay 6; showing what appeared to be a later addition remedial strut at ground level. No timbers identified as suitable for salvage

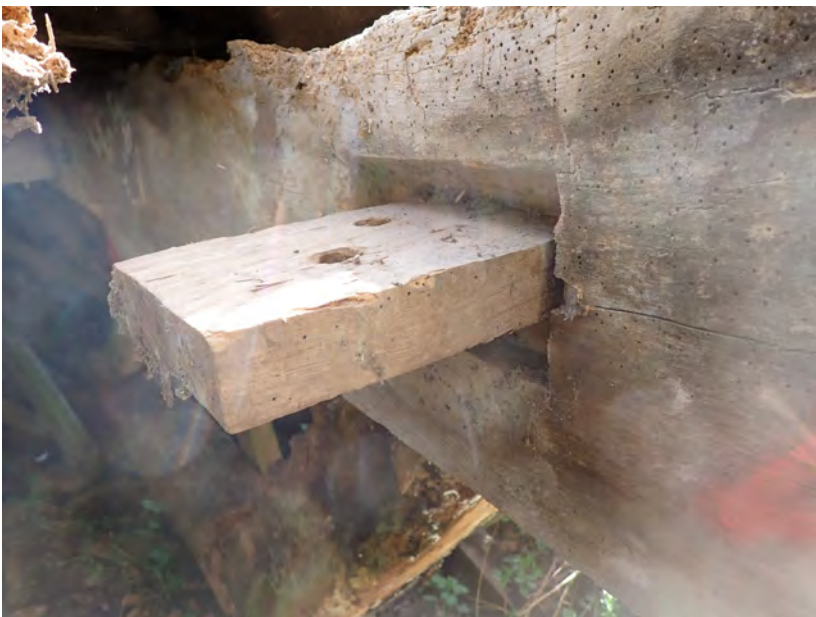
Fig 26:

Bay 4; showing constructional detail of a principal truss joint to a purlin via a slip tenon with ~1" rebated housings to receive the purlin ends

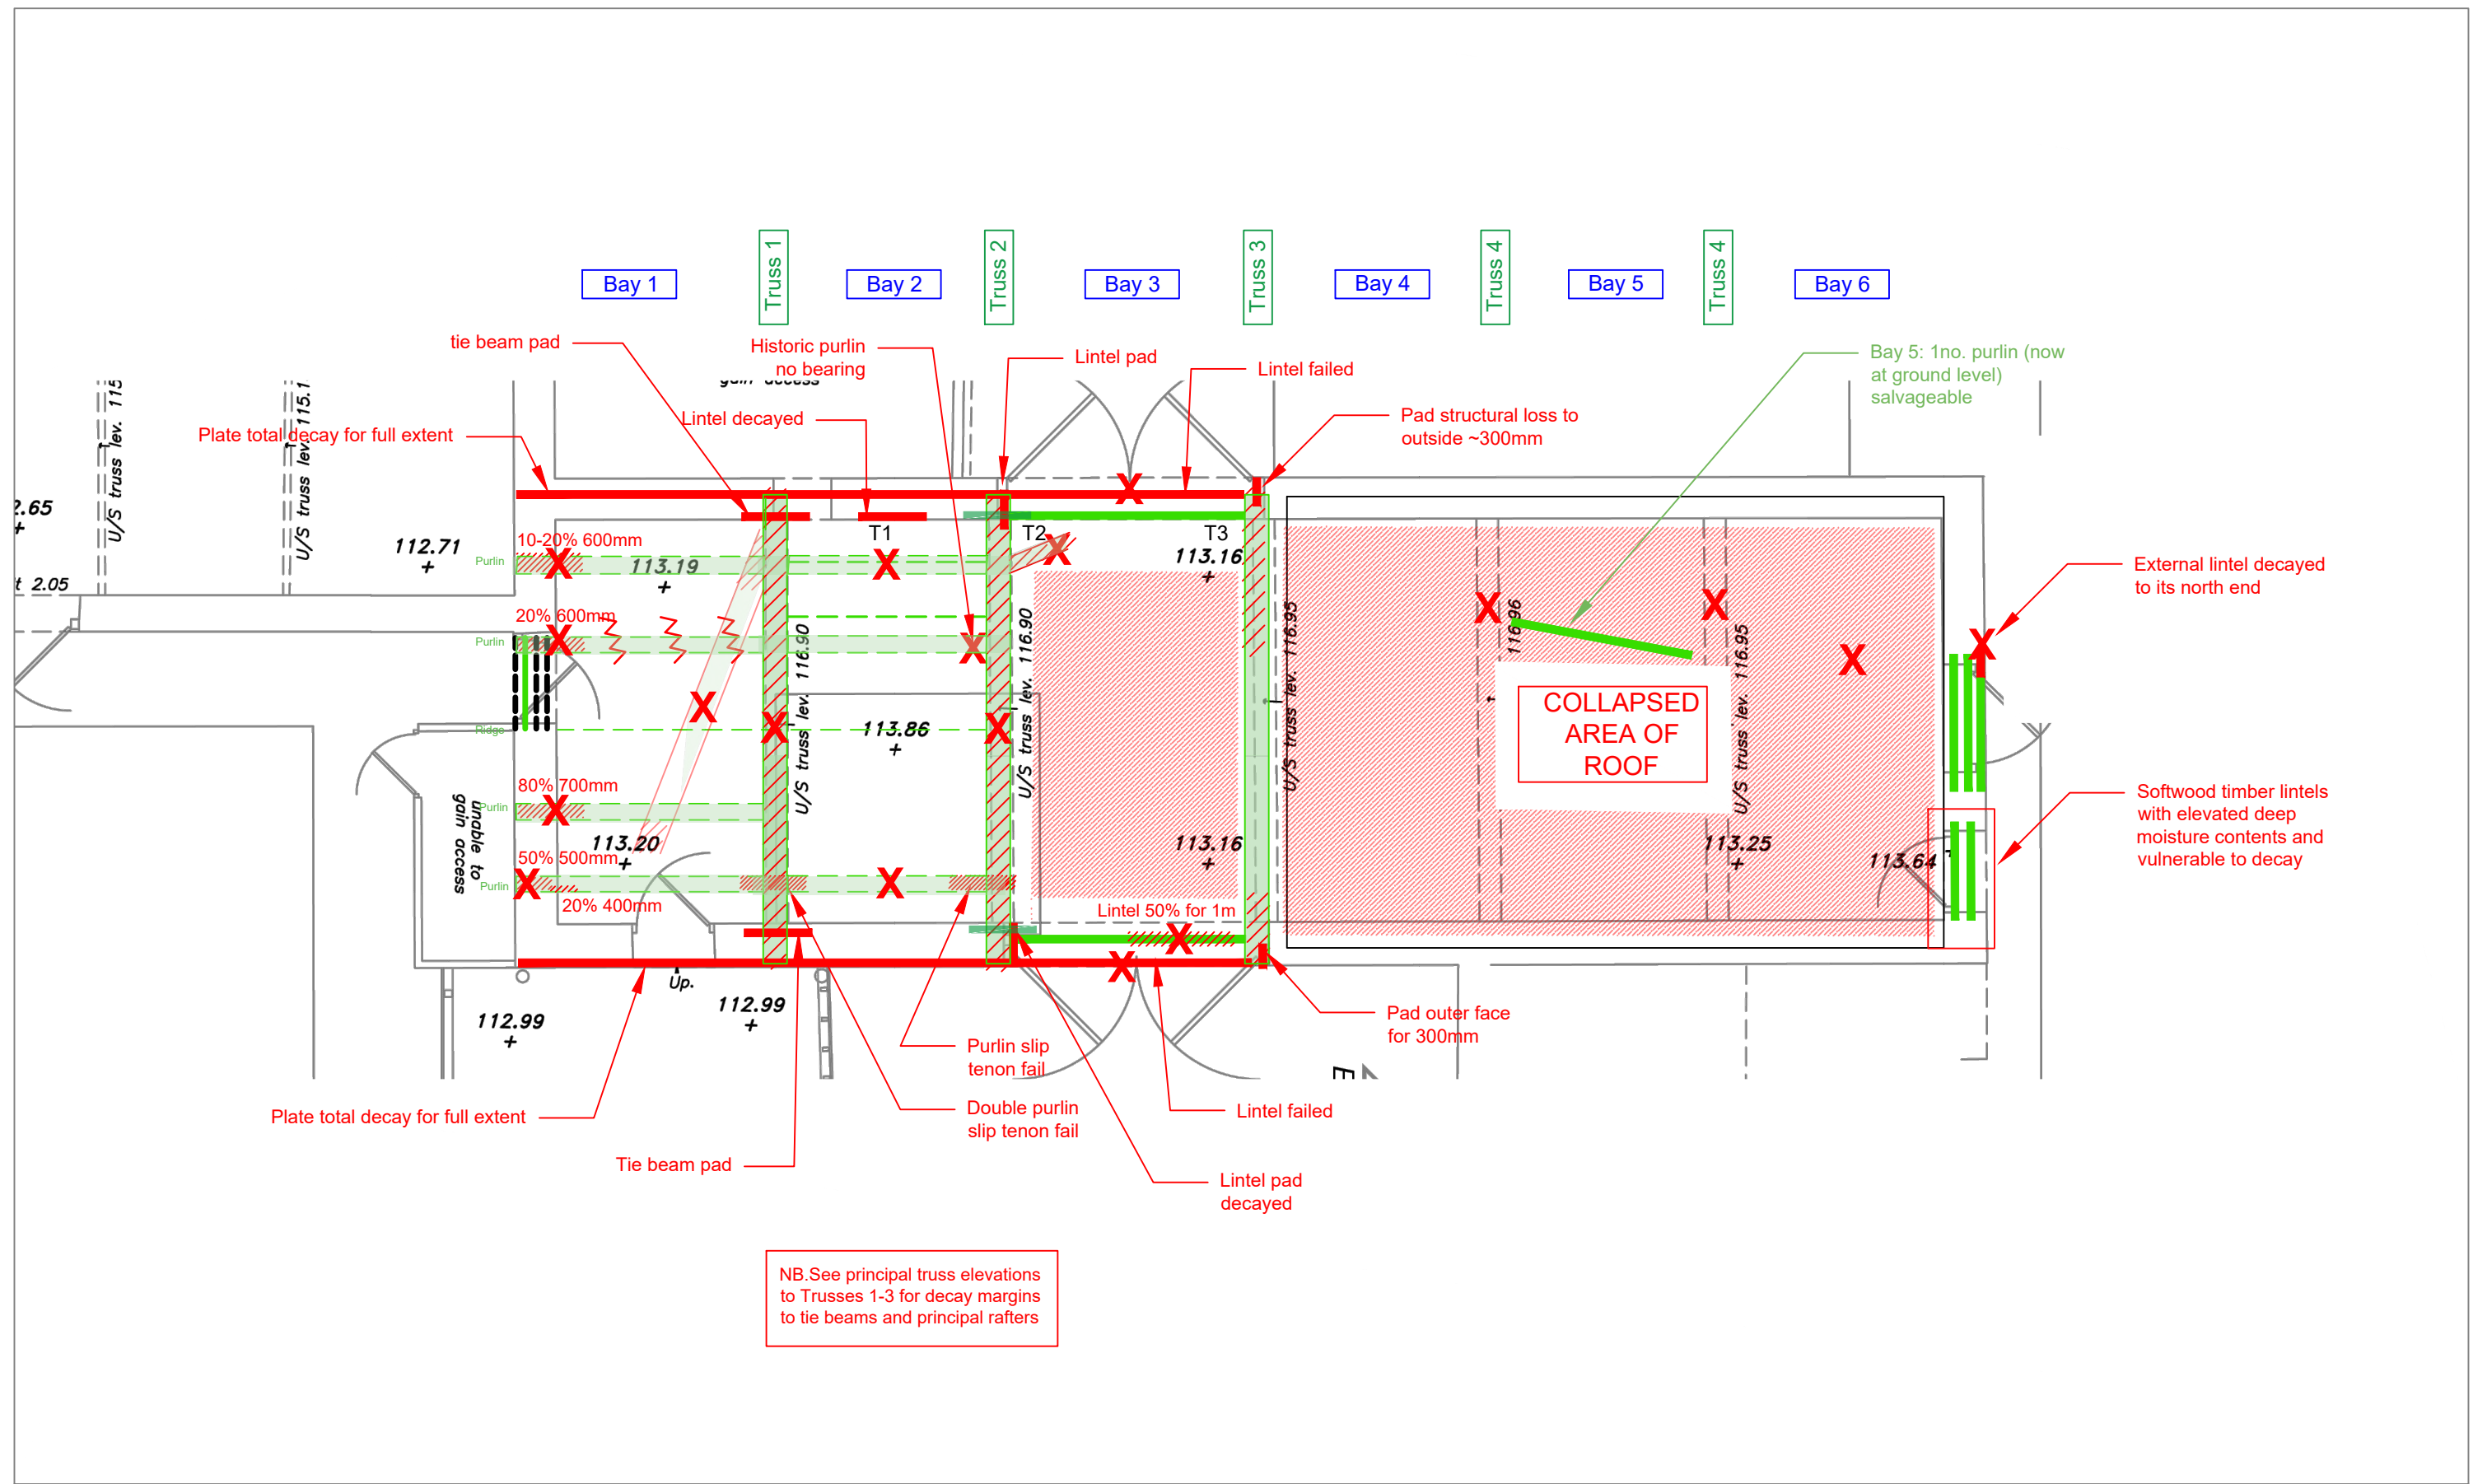
Ashgrove Farm - Primary Roof Timbers
 Timber Condition Investigation
 March 2025

The remaining standing and partially standing roof structures comprised solely towards the west 3no. bays of the barn roof structure. Generally, roof timbers diminished in condition and quantity from west to east. Remaining timbers comprised of principal trusses 1, 2, truss 3 tie beam, 3-4no. purlin pairs and approximately ~23no. common rafter pairs. Approximately ~95 per cent of all investigated items featured structural decay issues, with all (100 per cent) principal elements (purlins, principal trusses and collars) identified as having some degree of structurally significant decay in one or more locations. The existing standing and partially standing roof structures had no provision for an external roof envelope of roof drainage at the time of investigation. Therefore, it is reasonable to assume that the existing condition will progressively deteriorate before action can be made to safeguard the property. Further collapse should therefore be anticipated and suitable safety precautions adopted

Total collapse of roof structures forming the principal trusses and bay infill elements to the 3no. east bays had unfortunately occurred prior to H+Rs investigation. Generally, collapsed timbers worsened in condition from west to east, with remaining grounded timbers to bay 6 having reached advanced stages of disintegration. The remaining collapsed roof wreckage to bays 4-5 (and partial collapse to bay 3) were examined for remaining salvageable materials and to identify the previous structural composition of the lost roofscape. 100% of the principal truss elements were subject to extreme levels of decay. 1no. (of 16no.) purlin was identified as potentially suitable for salvage/re-use subject to suitable repair. No common truss or rafter plate timbers were deemed suitable for salvage/retention. Access to the ground areas beneath bays 3-6 was significantly hampered by roof wreckage, much of which remained highly vulnerable to further collapse/settlement during the later stages of structural decay of the larger half standing components

Structural Engineer to comment. In H+Rs opinion, and dependent upon available budget, and approval of the Conservation Authority/Design Team, the existing standing roofscape requires such considerable repairs that it renders it unsuitable/unsafe for retention in situ/as a standing structure. Provision should therefore be made for careful labelling, photo documentation and raising of the roofscape prior to removal and repair in a workshop environment by suitably qualified conservation carpenters. Subject to approval of the Structural Engineer, it should be anticipated that only ~25 per cent of the existing roof structures may be suitable for retention. No common rafter were deemed suitable for retention. All salvageable timbers should be projected as requiring some level of remedial attention via cutting back decayed sections to sound timber and scarfing in new pieces to a detail specified by the Structural Engineer and approved by H+R. See Plans and Photos for all identified structurally decayed and compromised timbers

Structural Engineer to comment. In H+Rs opinion, all but 1no. collapsed purlin and potentially ~3-4no. raking struts to the collapsed bays were deemed unsalvageable due to their excessive decay margins. The identified 3-4no. salvageable timbers should be anticipated as requiring remedial attention via cutting back decayed sections to sound timber and scarfing in new pieces to a detail specified by the Structural Engineer and approved by H+R. See Plans and Photos for identified potentially salvageable materials
