**6.7.23 ES Volume G - A5025 Off-line Highway
Improvements App G9-2 - A5025 Terrestrial
Ecology Factual Report 2014-2016**

A5025 On-line and Off-line Highway Improvements Terrestrial Ecology Factual Report 2014-2015

60PO8008/TER/REP002 | 1

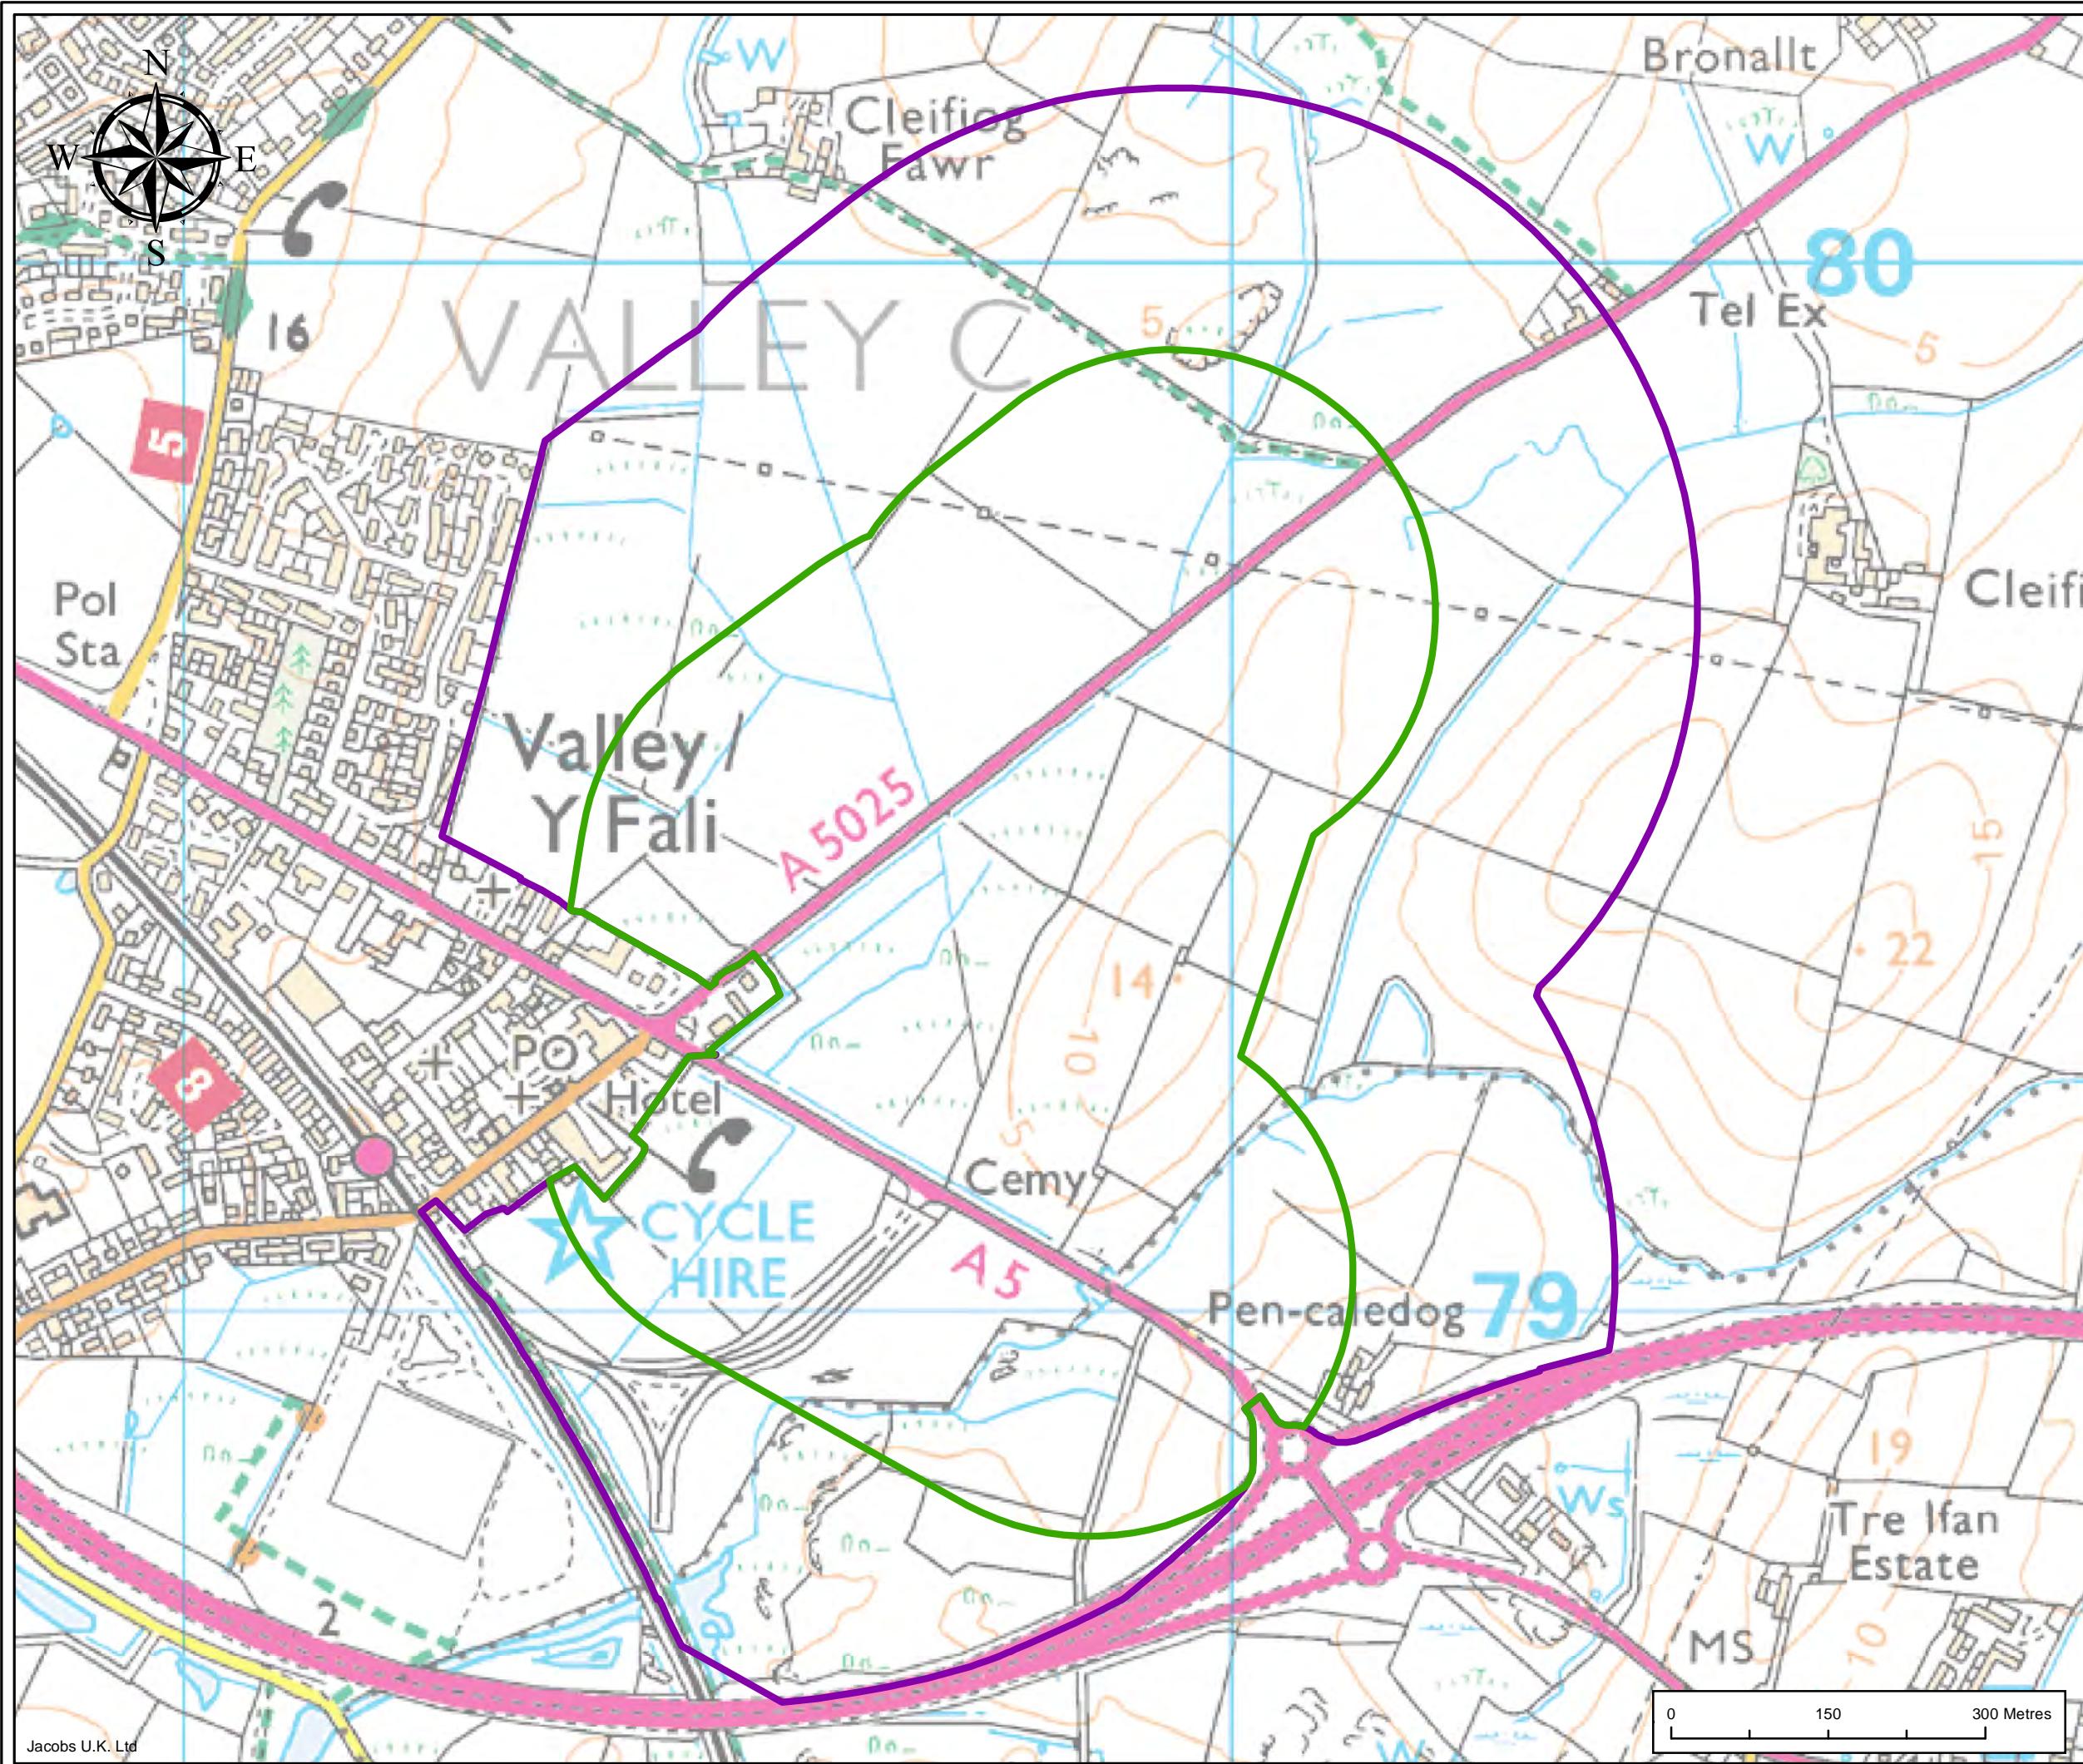
Figure 1.1 Status FINAL Project no. 60PO8008

- 250 m survey area
- 500 m survey area

At the time of survey, the preferred route of the proposed A5025 On-line and Off-line Highways Improvements had yet to be confirmed and the ecological survey areas therefore incorporated all route options and surrounding areas (termed buffer zones). Appendix A, Figures 1.1–1.4 detail the off-line terrestrial ecology survey areas.

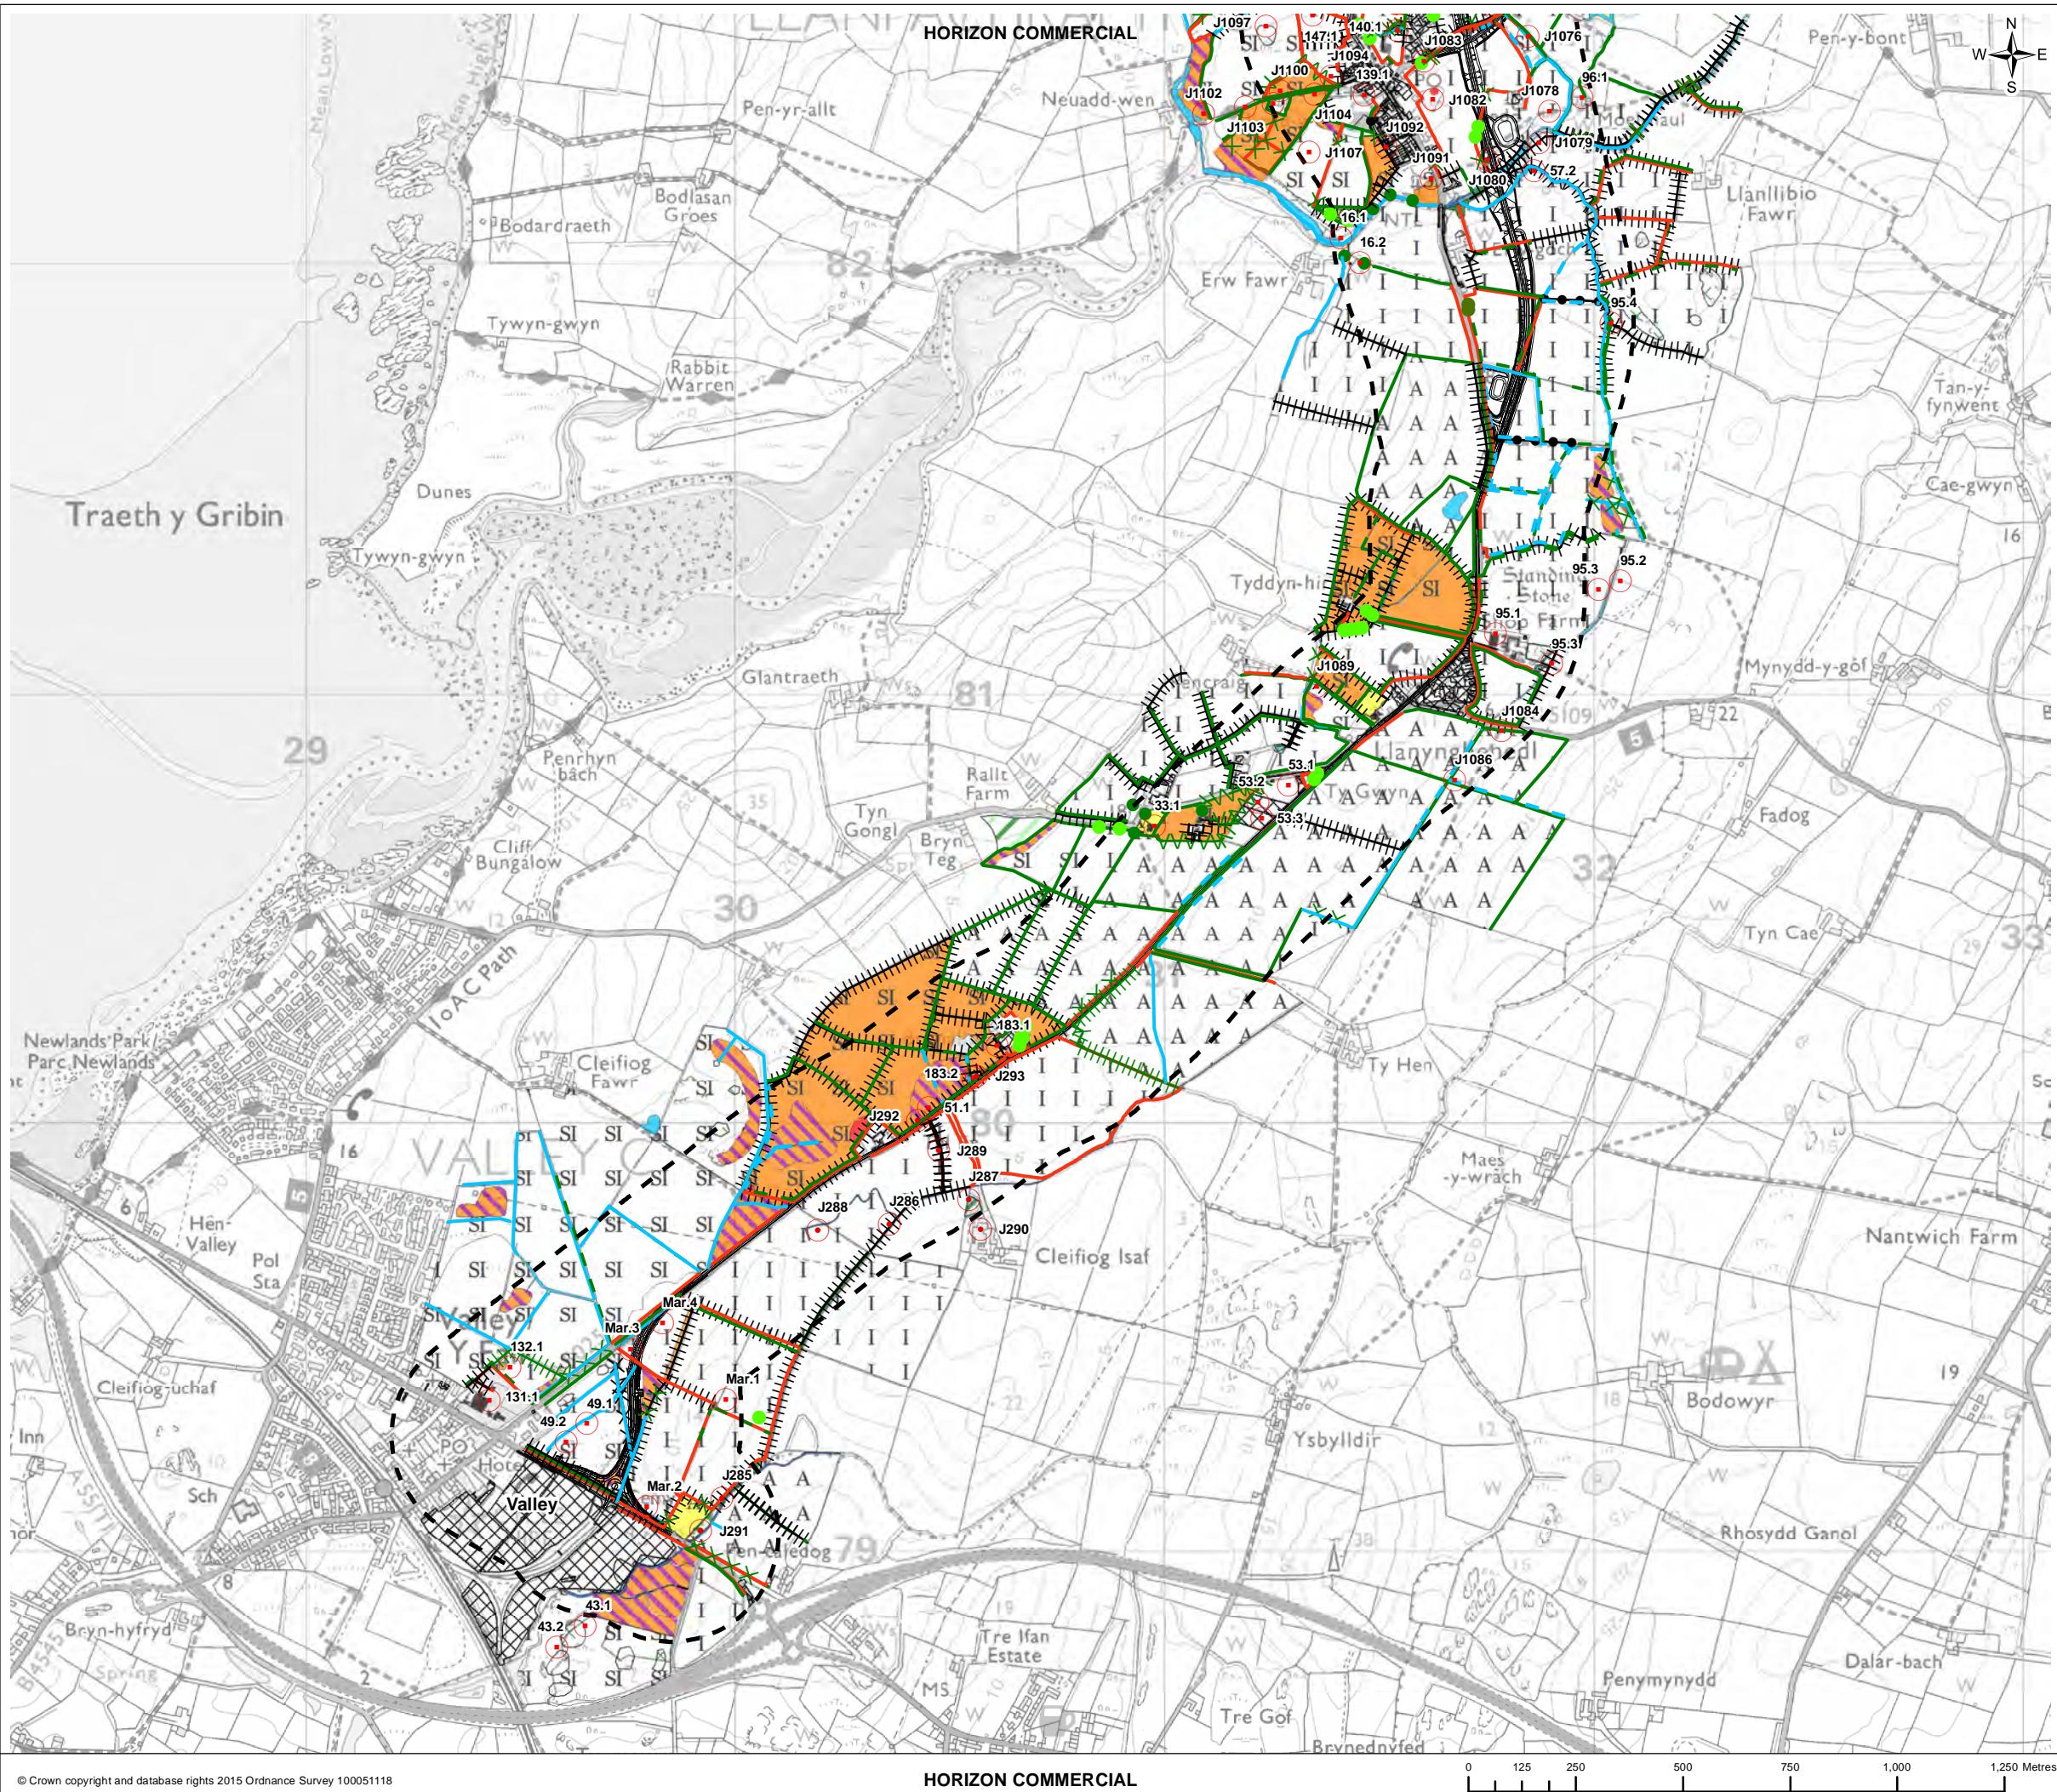
FIGURE 2

Proposed Scheme	Plantation woodland
Target notes	Swamp
Phase 1 habitat survey	Inundation vegetation
Scattered scrub - linear	Standing water
Scattered broadleaved trees - linear	Running water
Scattered coniferous trees - linear	Coastal grassland
Scattered mixed trees - linear	Coastal heathland
Upland species-rich ledges	Hard standing
Running water	Inland cliff
Intact hedge - species rich	Scree
Intact hedge - species poor	Other exposure - acid/neutral
Defunct hedge - species rich	Other exposure - basic
Defunct hedge - species poor	Quarry
Hedge with trees - species rich	Spoil
Hedge with trees - species poor	Arable
Fence	Amenity grassland
Wall	Ephemeral
Dry ditch	Introduced shrub
X Boundary removed	Dry ditch
● Earth bank	Building
Broadleaved semi-natural woodland	Bare ground

Extended Phase 1 Habitat surveys were undertaken between 11-15 May and 21-25 September 2015 by experienced Jacobs' Ecologists. The aim of these was to identify broad habitats present within the site, (the extent of which is shown in Appendix A, Figure 2.1 to 2.4 and identify evidence of protected species and habitats that may support these species.

The Phase 1 habitat map is shown in Appendix A, Figure 2.1 – 2.4. The study area comprised arable fields, improved grassland, poor semi-improved grassland, marshy grassland, semi-improved neutral grasslands, tall ruderal vegetation, buildings and hardstanding. Scattered trees, hedgerows, scrub and old stone wall embankments were recorded along the field boundaries and ditches.

An area of marshy grassland displaying species associated with estuarine habitat was recorded at Target Note J1102 (see Appendix A, Figure 2.1). Species included frequent creeping bent and sea club-rush (*Bolboschoenus maritimus*), with occasional soft-rush and sea plantain (*Plantago maritima*), and locally abundant stands of spear-leaved orache (*Atriplex prostrata*) and hemlock water-dropwort (*Oenanthe crocata*).

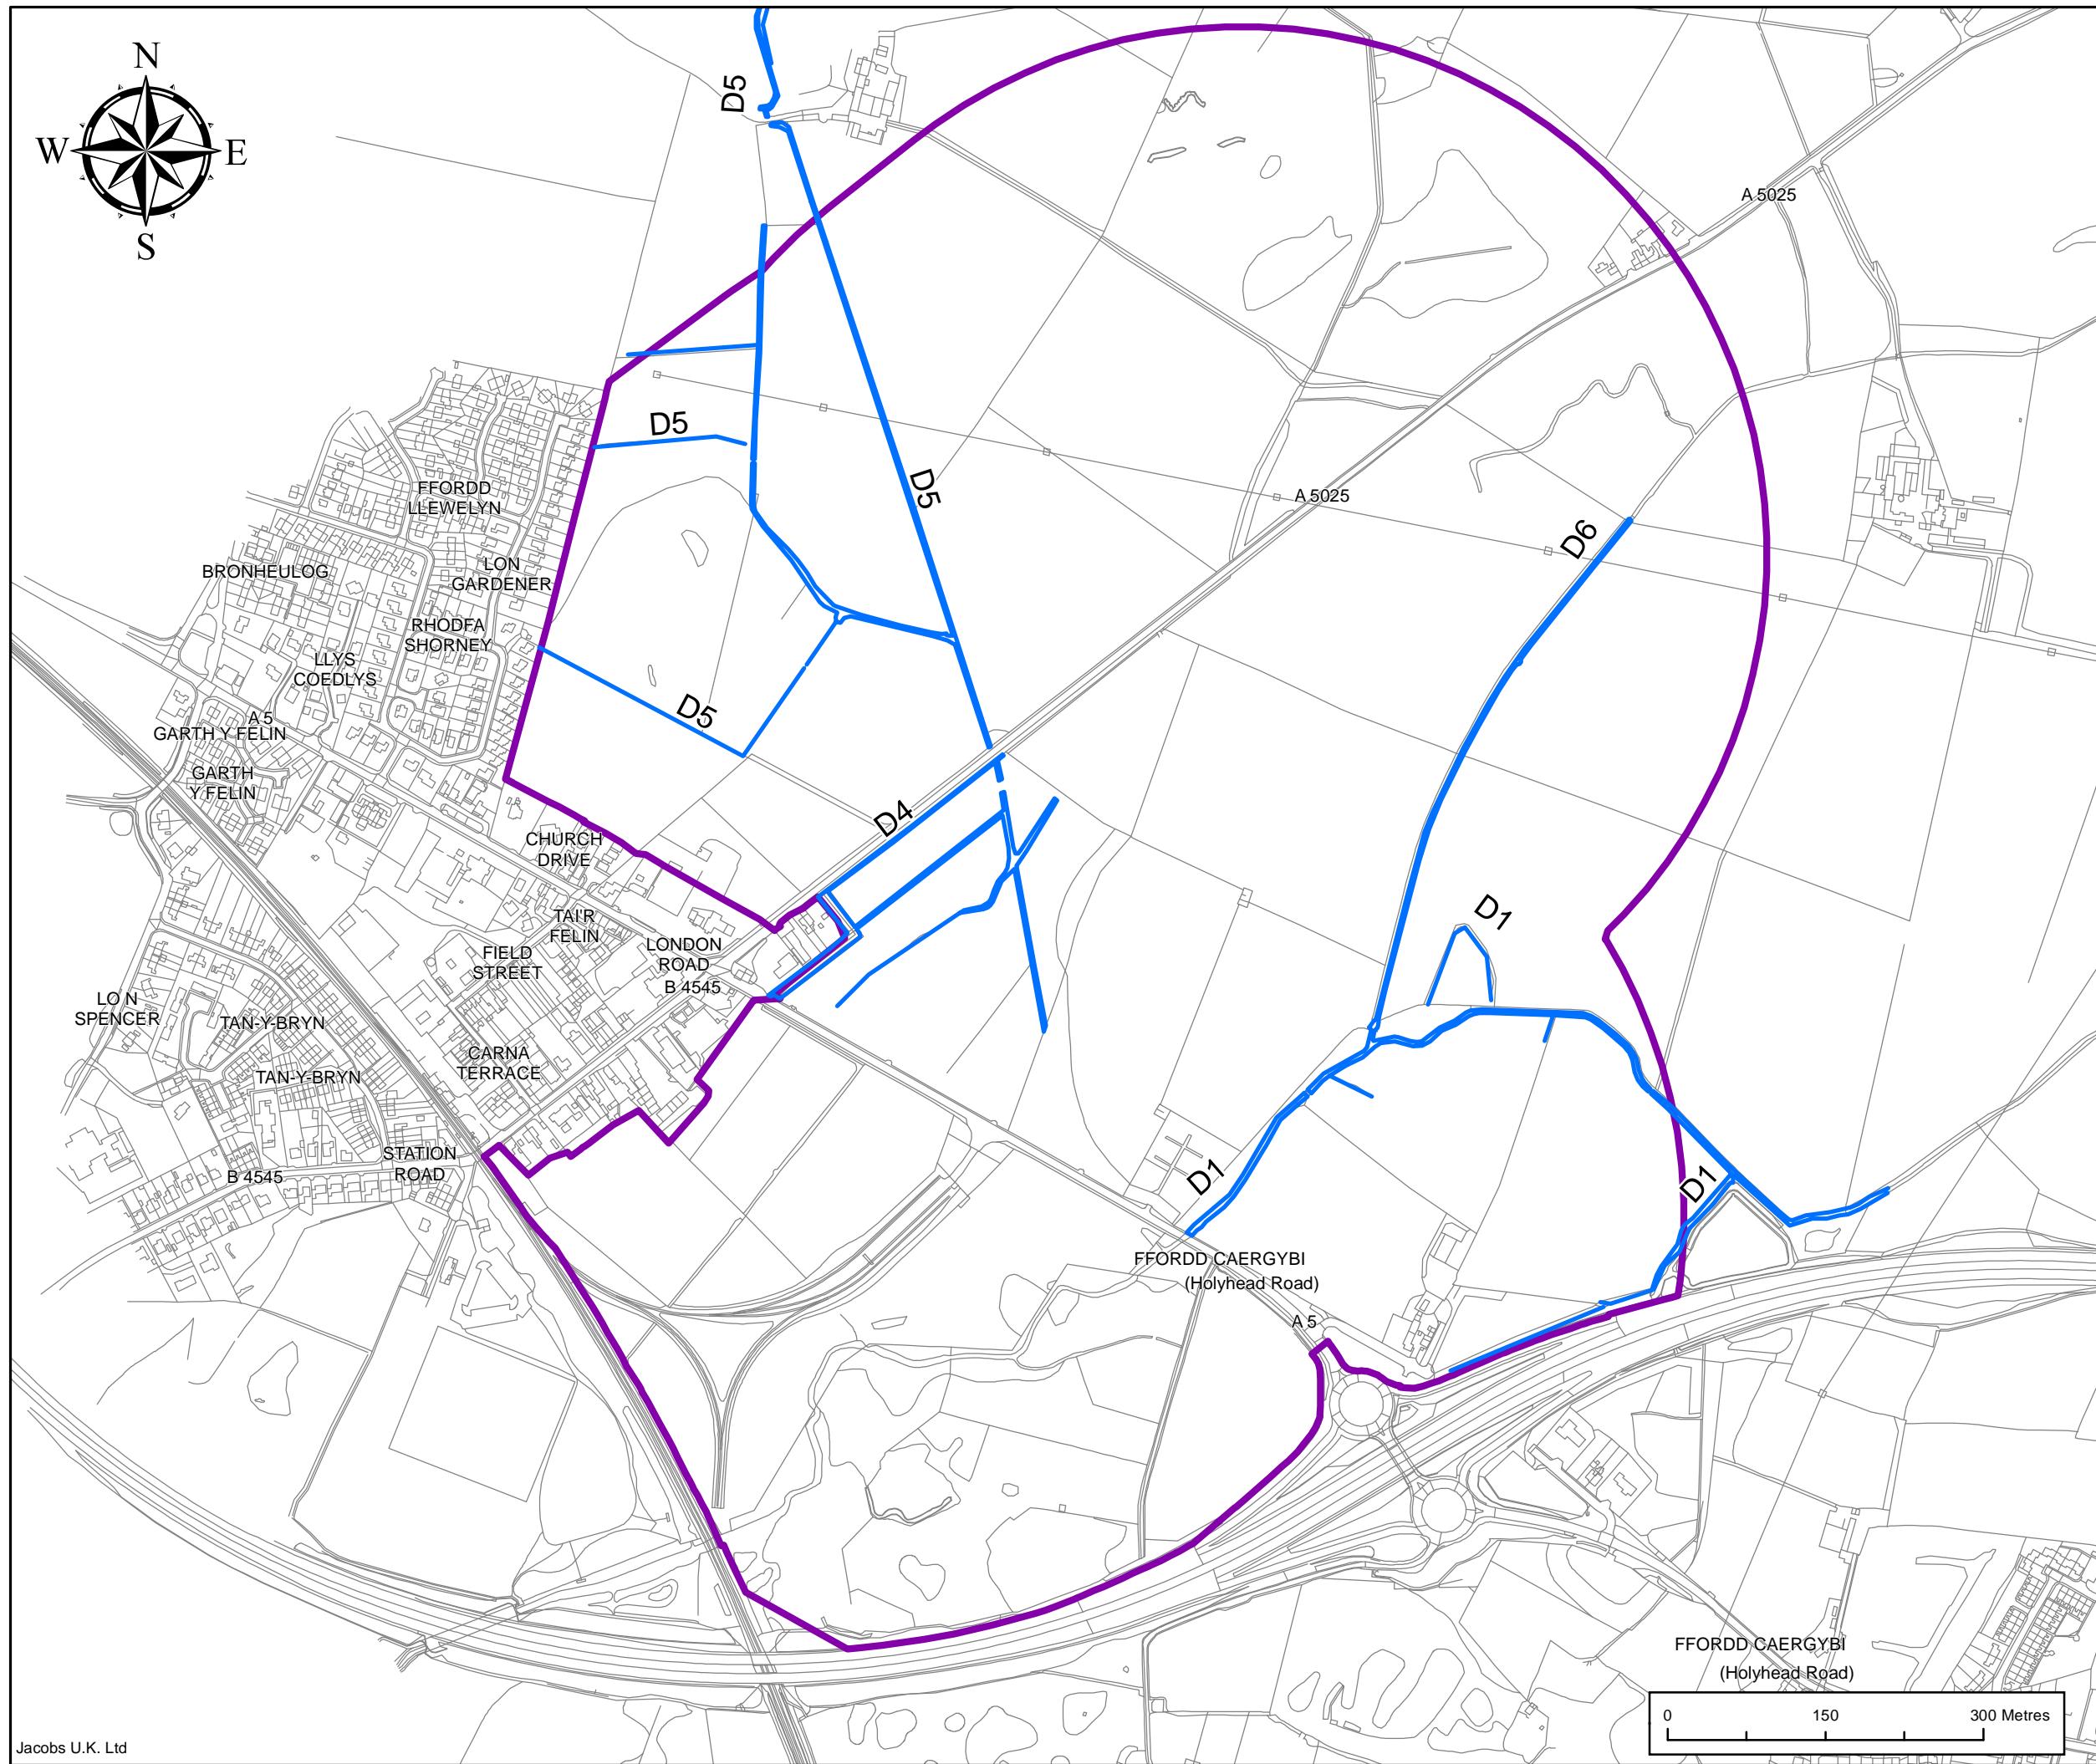
- Water course surveyed
- Water course surveyed - GCN Present
- Pond surveyed
- Pond surveyed - GCN Present
- 500 m survey area

All waterbodies within the proposed A5025 Off-line Highway Improvements study areas (see Table 2.2) and scoped in by Mott MacDonald were surveyed for the presence/absence of GCN. A total of 19 water bodies were surveyed and the survey locations are shown in Appendix A, Figures 3.1 – 3.4.

Nineteen water bodies within the study area were surveyed for amphibians as shown in Appendix A, Figures 3.1–3.4.

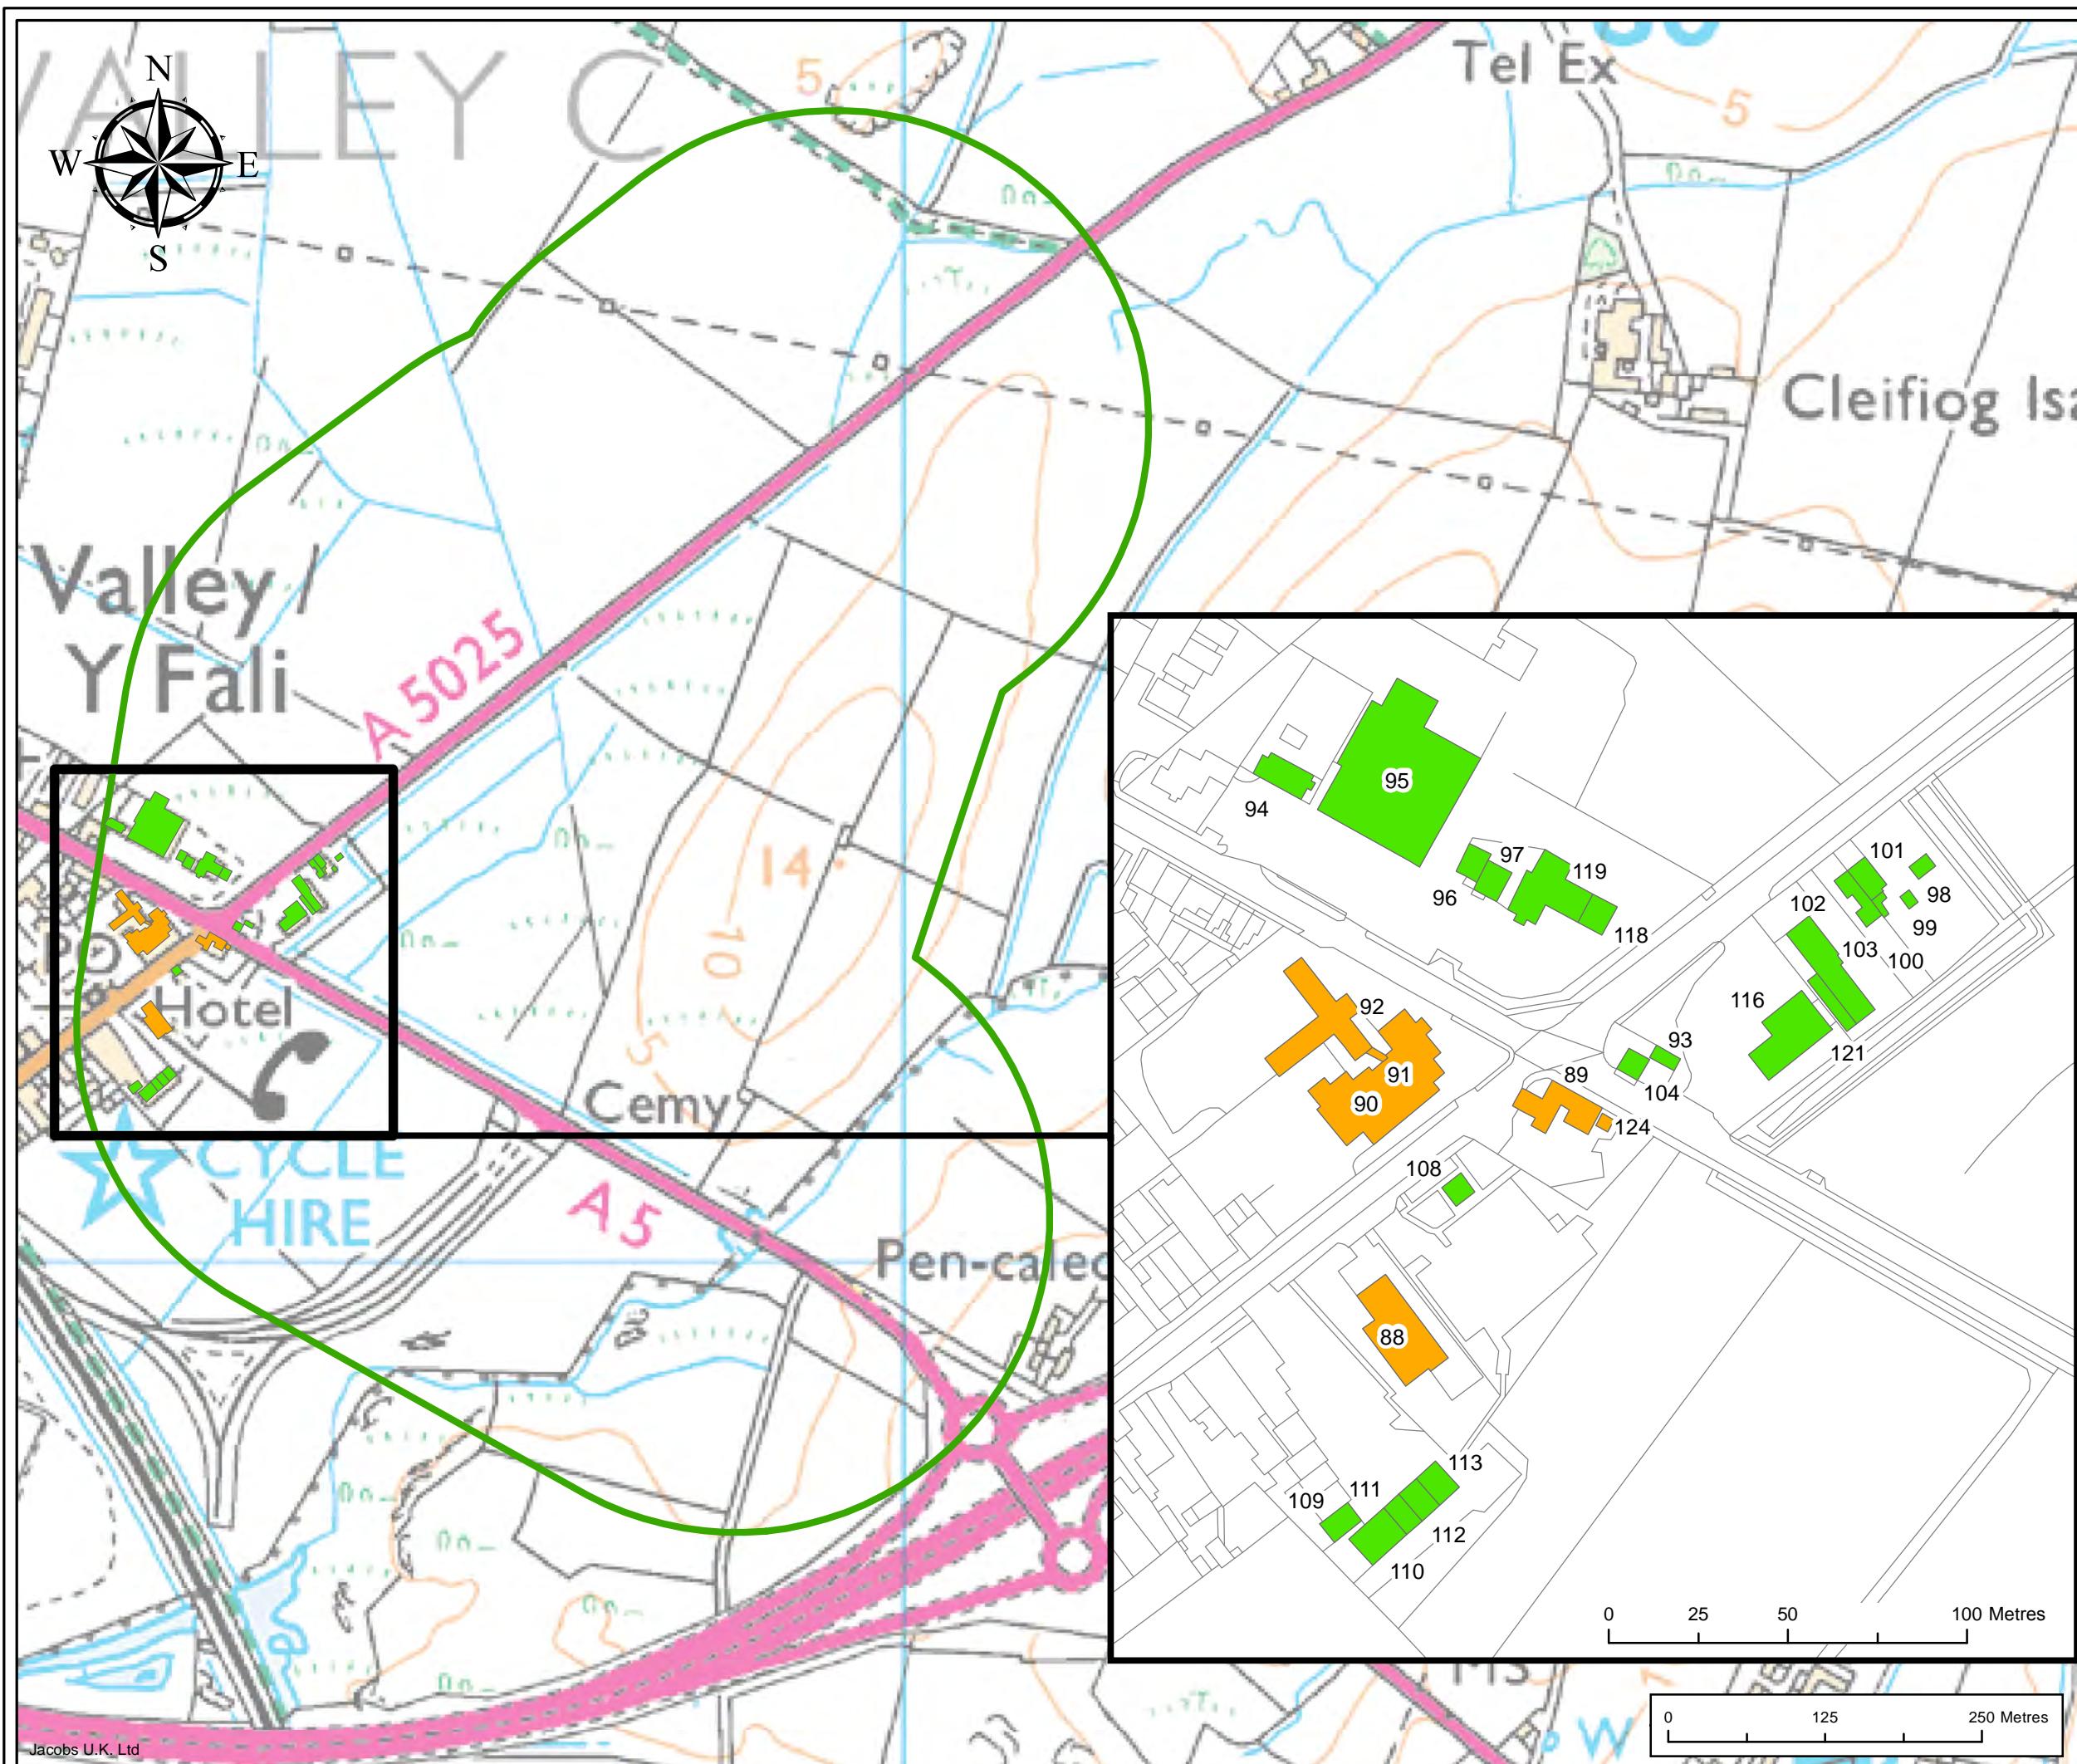
Figure 5.1 Status FINAL Project no. 60PU8008

Surveyed Bat Buildings

The results from these surveys were then used to inform the need for further surveys which comprised either an evening emergence survey or dawn re-entry survey. Appendix A, Figures 5.1–5.4.2 show the locations of the buildings surveyed. The emergence surveys were undertaken in July and August 2014.

A number of buildings externally assessed as having potential to support roosting bats were not surveyed further due to access restriction by land or property owners. Therefore their status as bat roosts could not be confirmed. These are shown in Appendix A, Figures 5.1 - 5.4.

Thirty-seven buildings with the potential to contain bat roosts were identified within the 50m buffer area around the proposed route. Of these, 10 were of high potential, 13 were of medium potential and 14 were found to have low potential to support roosting bats. The locations of these buildings are shown in Figures 5.1-5.4. The complete field data sheets for all buildings within the study area are provided in Appendix E.

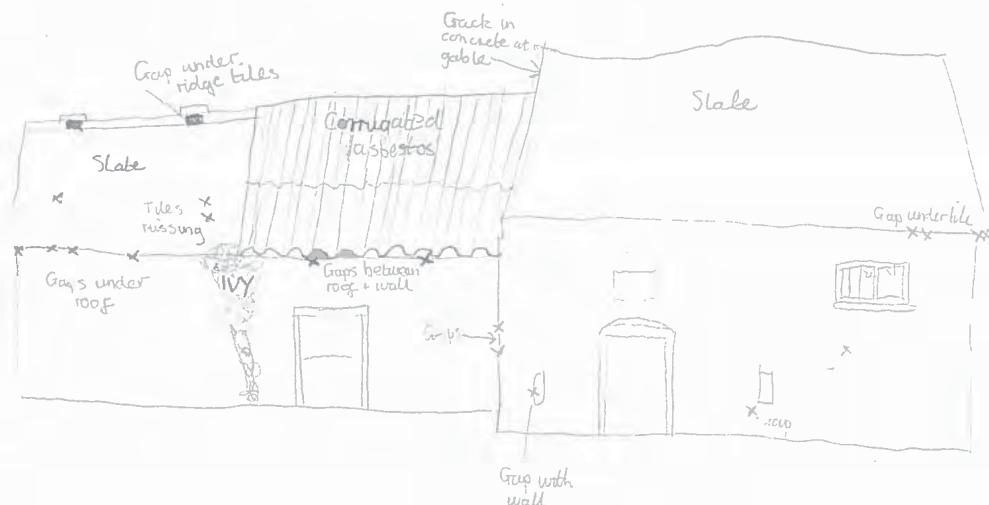
South East Aspect

Building ID Code	638					
Building Features						
Building Type	House	Barn	Photo file id			
	<input type="checkbox"/>	<input checked="" type="checkbox"/>		Age	Old	
	Outhouse	Garage		Church/Chapel	Aspect	
Building Type						
Wall type	Stone	Wood	Roof Type	Flat	Pitched	
	<input checked="" type="checkbox"/>	<input type="checkbox"/>		<input type="checkbox"/>	<input type="checkbox"/>	
	Metal	Brick		Slate	Tile	
	<input type="checkbox"/>	<input type="checkbox"/>		Tin sheet	Thatch	
Wall bat features? (Y/N)						
Y		Numerous holes and gaps				
Describe cracks/gaps/hanging tiles		Gaps between stone and where some stones are missing. Large enough for birds to nest in.				
Roof Bat features? (Y/N)						
		Was an internal inspection possible? (Y/N)		Y	Partial	
Describe e.g. gaps under eaves, broken tiles, gaps under lead flashing, roof part missing						
Area inspected e.g. roof space, loft room						
Other Bat features (Y/N)

Internal features noted e.g. insulation present, roof lining type, rafter type, presence of crevices						
Describe e.g. gaps around windows, broken bows						
Evidence of use by bats						
Live bats noted (Y/N)	Number	Location	Species			
Corpses of skeletons noted (Y/N)	Number	Location	Species			
Droppings noted (Y/N)	Y	Number	Location	Notes e.g. freshness, shape/size		
Feeding Remains (Y/N)	Quantity	Location				
Characteristic staining/grease marks (Y/N)	Quantity	Location				
Known/potential access points (Y/N)	Quantity	Location				
Historical Evidence of roost? (Y/N)	Nature of evidence (e.g. landowner report)	Location	Species			
Assessment of Roost Potential						
Roost Potential	High	Medium	Low

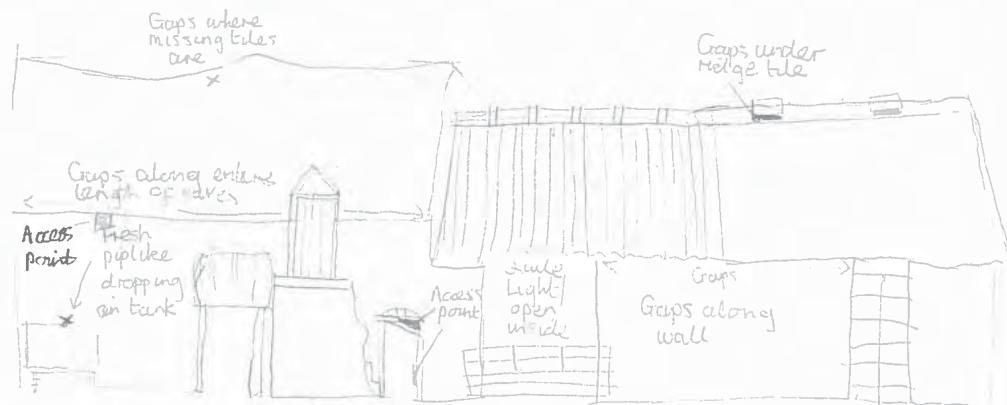
North W Aspect

638 Cont - PTO

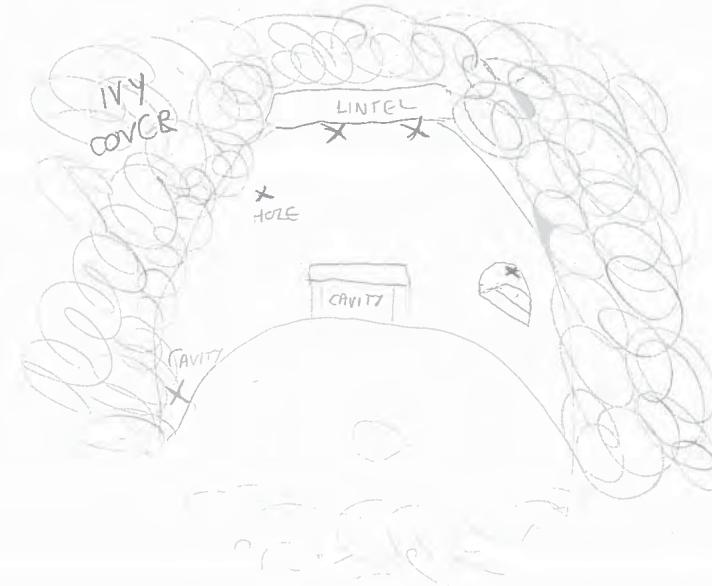
South-west Aspect

Other Bat features (Y/N)	Y	Cavity where shelf is may be suitable	Was an Internal Inspection possible? (Y/N)	Y	Inside	
Area inspected e.g. Roof space, loft room						
Internal features noted e.g. insulation present, roof lining type, rafter type, presence of crevices						
Quite light (SW Aspect)						
Evidence of use by bats						
Live bats noted (Y/N)	Number	Location	Species			
Corpses of skeletons noted (Y/N)	Number	Location	Species			
Droppings noted (Y/N)	Number	Location	Notes e.g. freshness, shape/size			
Feeding Remains (Y/N)	Quantity	Location				
Characteristic staining/grease marks (Y/N)	Quantity	Location				
Known/potential access points (Y/N)	Quantity	Location				
Historical Evidence of roost? (Y/N)	Nature of evidence (e.g. landowner report)	Location	Species			
Assessment of Roost Potential						
Roost Potential	High	Medium	Low	FOR HIBERNATION

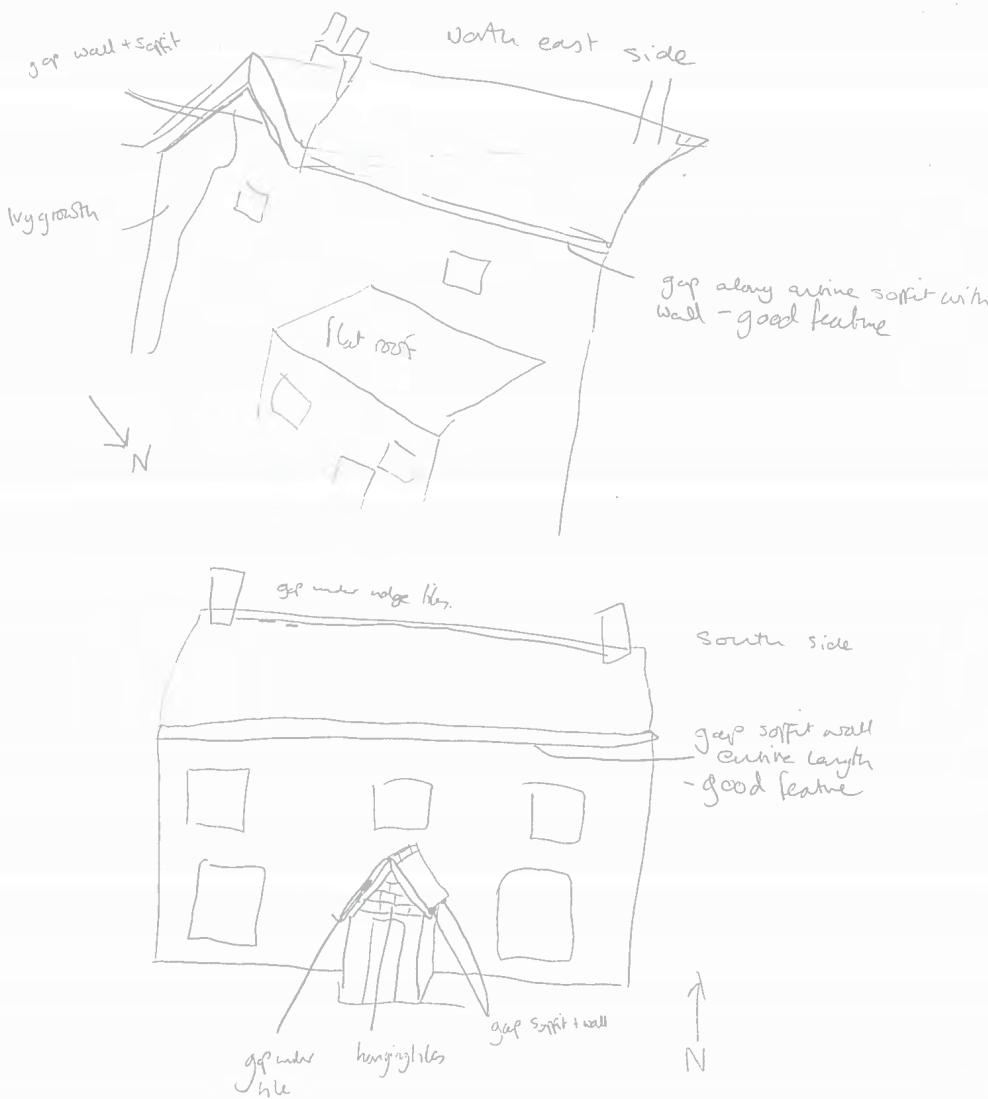
Cracks/gaps/hanging tiles	scribe		<input type="checkbox"/>	e.g. cracks/gaps/hanging tiles		
Roof Bat features? (Y/N)	Y		<input type="checkbox"/>	Was an Internal Inspection possible? (Y/N)		N
Describe e.g. gaps under eaves, broken tiles, gaps under lead flashing, roof part missing	Gap b/w soffit + wall, under eaves + flashing		<input type="checkbox"/>	Area inspected e.g. Roof space, loft room		
Other Bat features (Y/N)		<input type="checkbox"/>	Internal features noted e.g. insulation present, roof lining type, rafter type, presence of crevices			
Describe e.g. gaps around windows, broken windows	<input type="checkbox"/>	<input type="checkbox"/>				
Evidence of use by bats						
Live bats noted (Y/N)		Number	Location	Species		
Corpses of skeletons noted (Y/N)		Number	Location	Species		
Droppings noted (Y/N)		Number	Location	Notes e.g. freshness, shape/size		
Feeding Remains (Y/N)		Quantity	Location

Characteristic staining/grease marks (Y/N)		Quantity	Location			
Known/potential access points (Y/N)		Quantity	Location			
Historical Evidence of roost? (Y/N)	Y	Nature of evidence (e.g. landowner report)	Owner says 1800s and 1900s	+	Species	
Assessment of Roost Potential						
Roost Potential	High <input checked="" type="checkbox"/>	Medium <input type="checkbox"/>	Low <input type="checkbox"/>			
	<input checked="" type="checkbox"/>	<input type="checkbox"/>	<input type="checkbox"/>

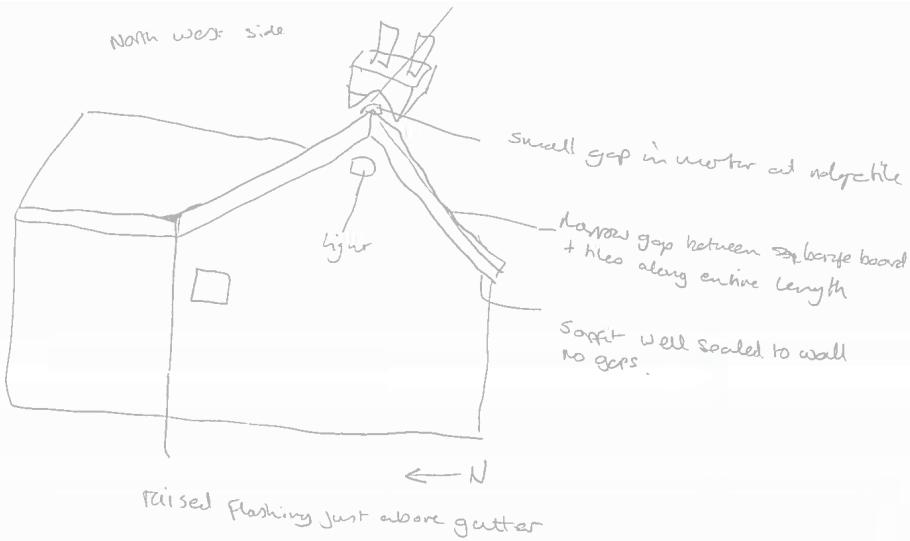
North west side

748 continued

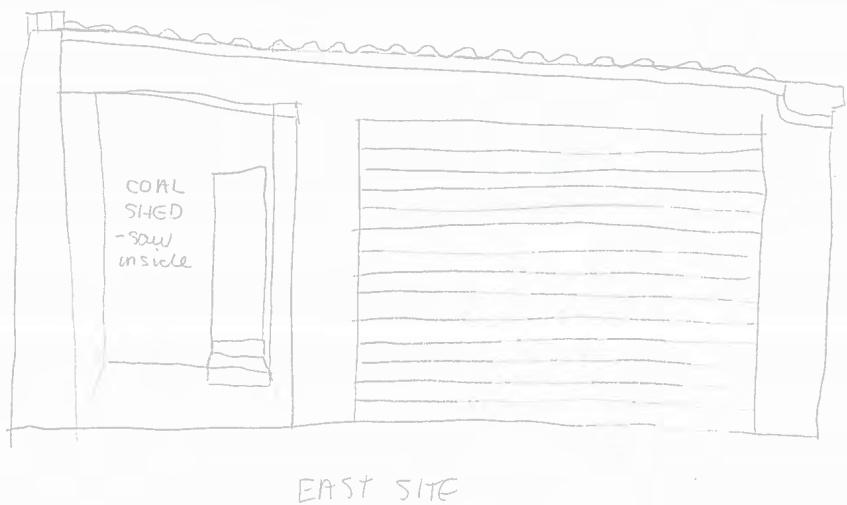
Building ID Code	749				
Building Features					
Building Type	House	Barn	Photo file id Age Aspect Part garage, part slimy chick		
	<input type="checkbox"/>	<input type="checkbox"/>			
	<input checked="" type="checkbox"/>	<input checked="" type="checkbox"/>			
	<input type="checkbox"/>	<input type="checkbox"/>			
Wall type					
Stone	Wood	Roof Type	Flat		
	<input checked="" type="checkbox"/>		<input type="checkbox"/>	<input type="checkbox"/>	
	<input type="checkbox"/>		<input type="checkbox"/>	Slate	
	<input type="checkbox"/>		<input type="checkbox"/>	Tile	
Metal	Brick	Roof Material	Tin sheet		
	<input type="checkbox"/>		<input type="checkbox"/>	Thatch	
	<input type="checkbox"/>		<input type="checkbox"/>	<input type="checkbox"/>	
	<input type="checkbox"/>		<input type="checkbox"/>	<input type="checkbox"/>	
Wall bat features?					
(Y/N)	<input checked="" type="checkbox"/>	Describe e.g. cracks/gaps/hanging tiles.	Corrugated metal

<input type="checkbox"/>				
Roof bat features?					
(Y/N)	<input checked="" type="checkbox"/>	Where metal roof meets timber beams internally	Was an internal inspection possible? (Y/N)		
Describe e.g. gaps under eaves, broken tiles, gaps under lead flashing, roof part missing					
Area inspected e.g. Roof space, loft room					
Other Bat features (Y/N)					
Internal features noted e.g. insulation present, roof lining type, rafter type, presence of crevices					
Describe e.g. gaps around jaws, broken windows					
Evidence of use by bats					
Live bats noted (Y/N)		Number	Location	Species	
Corpses of skeletons noted (Y/N)		Number	Location	Species	
Droppings noted (Y/N)		Number	Location	Notes e.g. freshness, shape/size	
Feeding Remains (Y/N)		Quantity	Location		
Characteristic staining/grease marks (Y/N)		Quantity	Location		
Known/potential access points (Y/N)		Quantity	Location		
Historical Evidence of roost? (Y/N)		Nature of evidence (e.g. landowner report)	Location	Species

Assessment of Roost Potential					
Roost Potential	High	Medium	Low		
	<input type="checkbox"/>	<input checked="" type="checkbox"/>	<input type="checkbox"/>

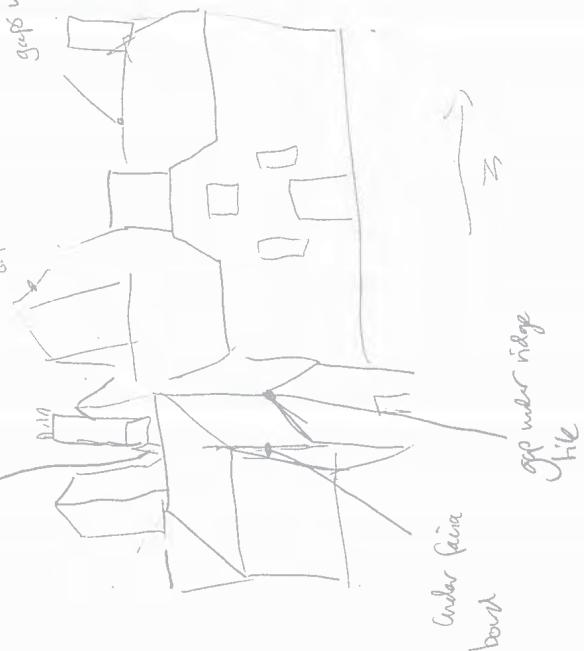
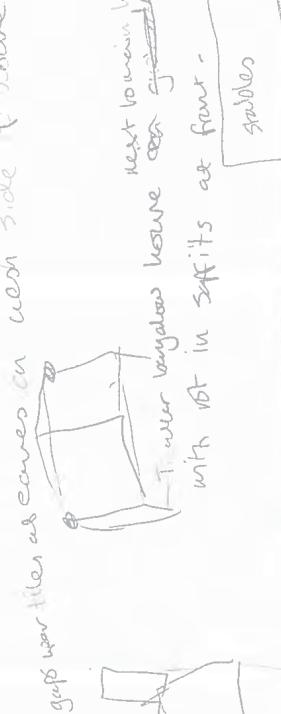
Facia board on west side of main gable end facing stable on house

Gaps under tiles

In grounds long old wall all the way round grounds Stables to N of house with large garden. Very large thick walls all the way round grounds Stables - old well built red metal roof

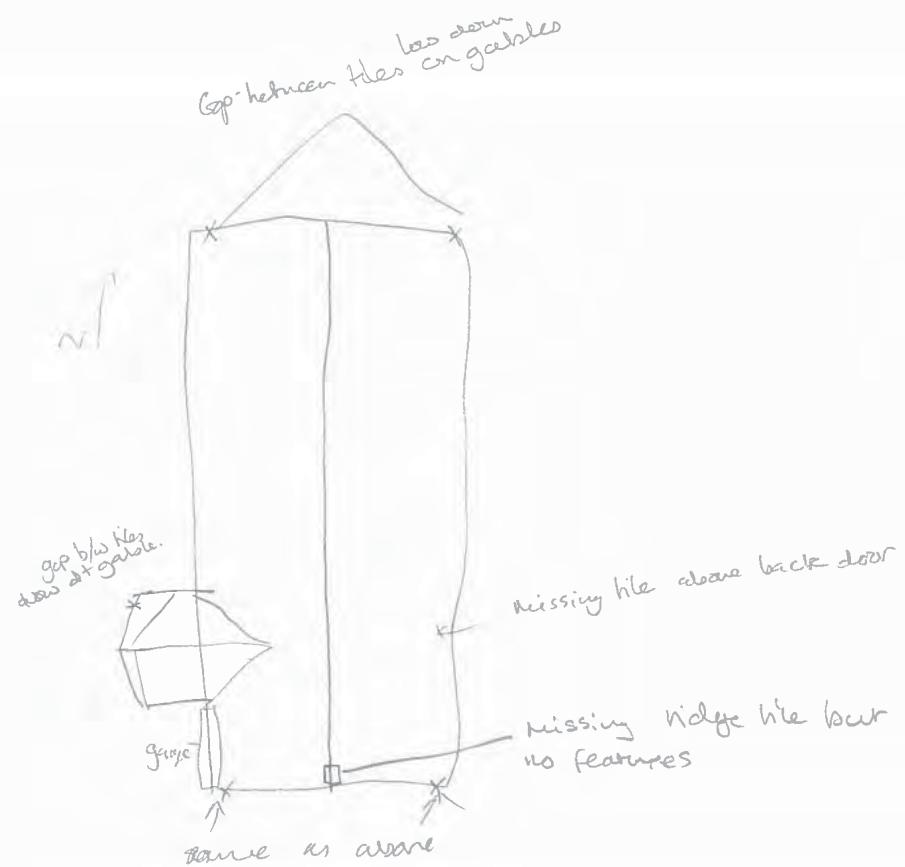
Detached bungalow

Area inspected e.g. Roof space, loft room				
Other Bat features (Y/N)			Internal features noted e.g. insulation present, roof lining type, rafter type, presence of crevices				
Describe e.g. gaps around eaves, broken windows							
Evidence of use by bats							
Live bats noted (Y/N)	Number	Location	Species				
Corpses of skeletons noted (Y/N)	Number	Location	Species				
Droppings noted (Y/N)	Number	Location	Notes e.g. freshness, shape/size				
Feeding Remains (Y/N)	Quantity	Location					
Characteristic staining/grease marks (Y/N)	Quantity	Location					
Known/potential access points (Y/N)	Quantity	Location					
Historical Evidence of roost? (Y/N)	Nature of evidence (e.g. landowner report)	Location	Species				
Assessment of Roost Potential							
Roost Potential	High	Medium	Low				
	<input type="checkbox"/>	<input checked="" type="checkbox"/>	<input type="checkbox"/>
