# Norfolk Vanguard Offshore Wind Farm

## HDD Feasibility Report for East Anglia Tranche 1

# **HDD FEASIBILITY REPORT**

## **Cable Landfalls for East Anglia North Tranche 1 (EAN) U.K.**

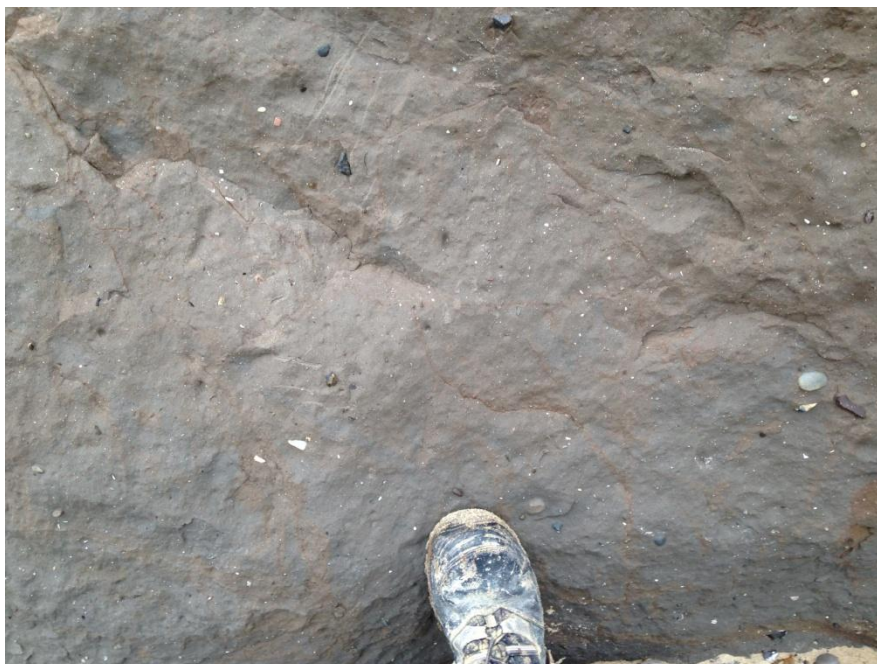
**Figure 5. Happisburgh Till member exposed in cliffs at Happisburgh.**

The various till members within the formations in the study areas are expected to form a stable borehole when drilled with HDD. No large boulders or beds of cobbles were seen in any of the tills during the site visit, however locally they might occur. If boulders or cobbles within a till were encountered during a HDD they would cause inconvenience (additional time required to clean the borehole) and a relatively small cost increase for the contractor. They would be unlikely to require re-drilling or re-routing of the HDD.

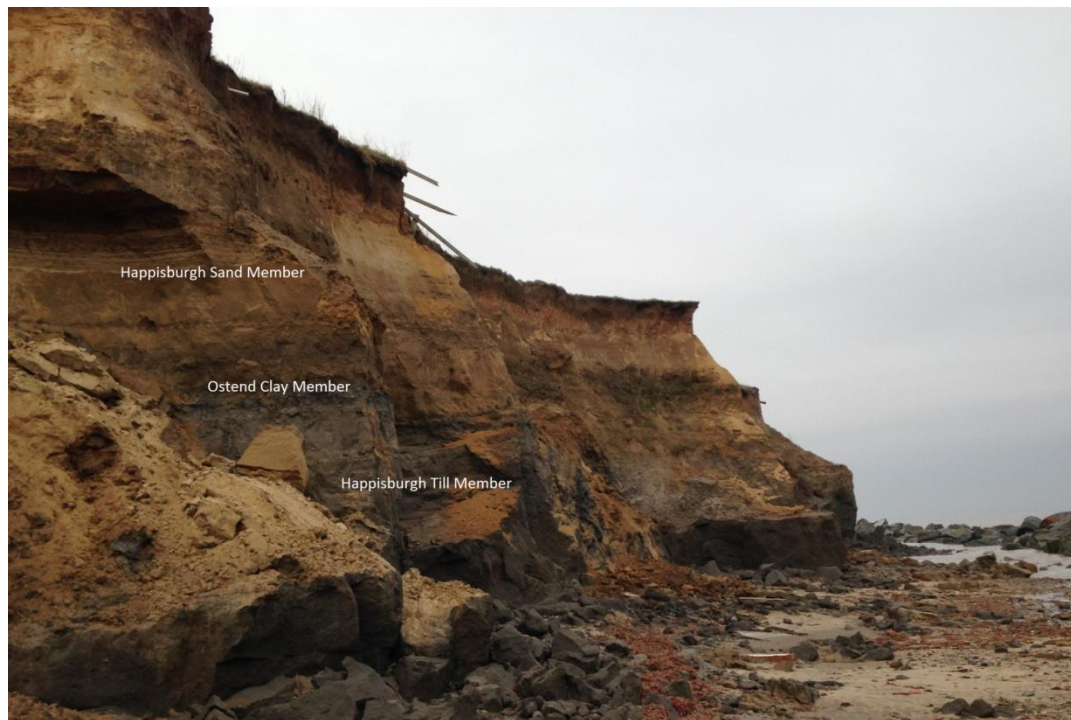
Figure 6. Cliff exposure at Happisburgh with stratigraphy shown.

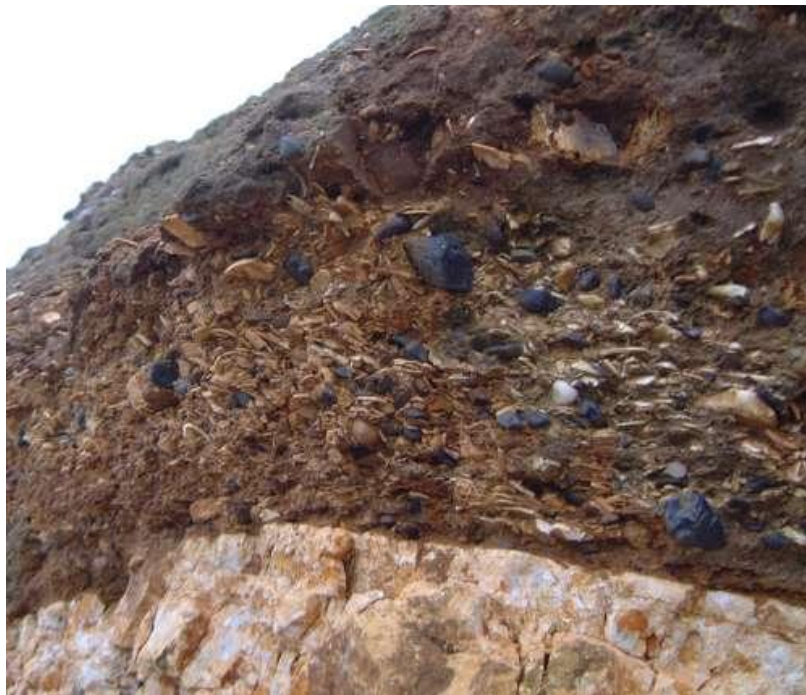
Figure 8. Cliff exposure from Weybourne, Norfolk showing Crag deposit overlying chalk. Note the well graded nature of the crag. Photograph from <http://www.weybourne.ukfossils.co.uk/Weybourne-Fossils-Geology/geology-guide.htm>.

The Crag is comprised of interbedded sands, gravels, silts and clays and is usually dense and well graded (i.e. they contain a range of grain sizes). Figure 7 and Figure 8 illustrate some typical coarser grained layers within the Crag. These characteristics, along with near horizontal stratification indicates they should usually stand up well when drilled with HDD and with the support of drilling fluid they will form a very stable borehole. A proviso to this is the potential existence of running sands within the Crag, mentioned by Ander *et Al* (2006) in their regional analysis of the Crag.

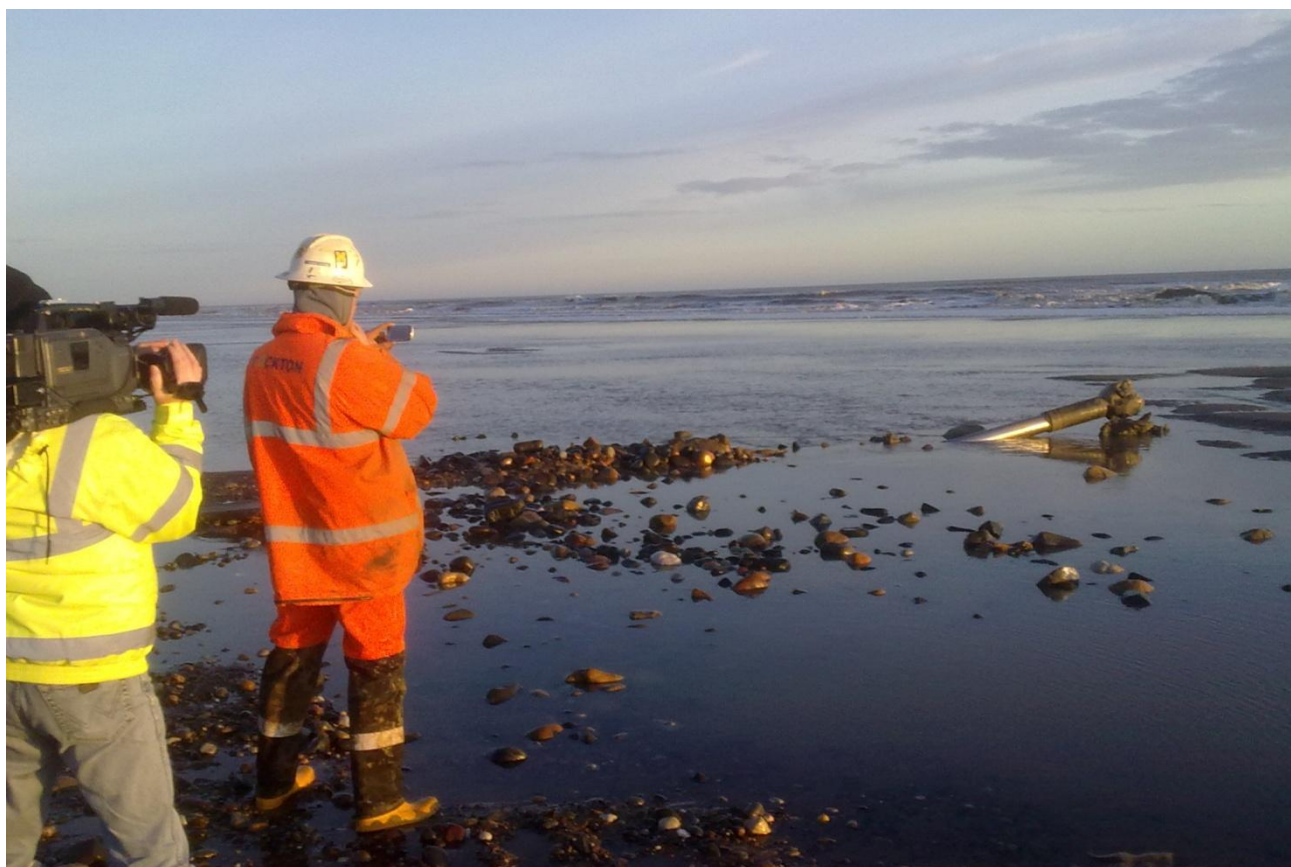
Figure 10. HDD exit on the Humber Gateway project illustrating the short HDD option of exit near MLW.

An example of the Short HDD Option is the cable landfalls at Easington drilled in 2012 for the Humber Gateway project by Stockton Drilling. The pair of HDD's exited 60m from the shoreline at approximately -0.75m ODN and 50m apart horizontally. The HDD's were 320m in length and Figure 10 shows the exit position at low tide in an area of sand, gravel and cobble.

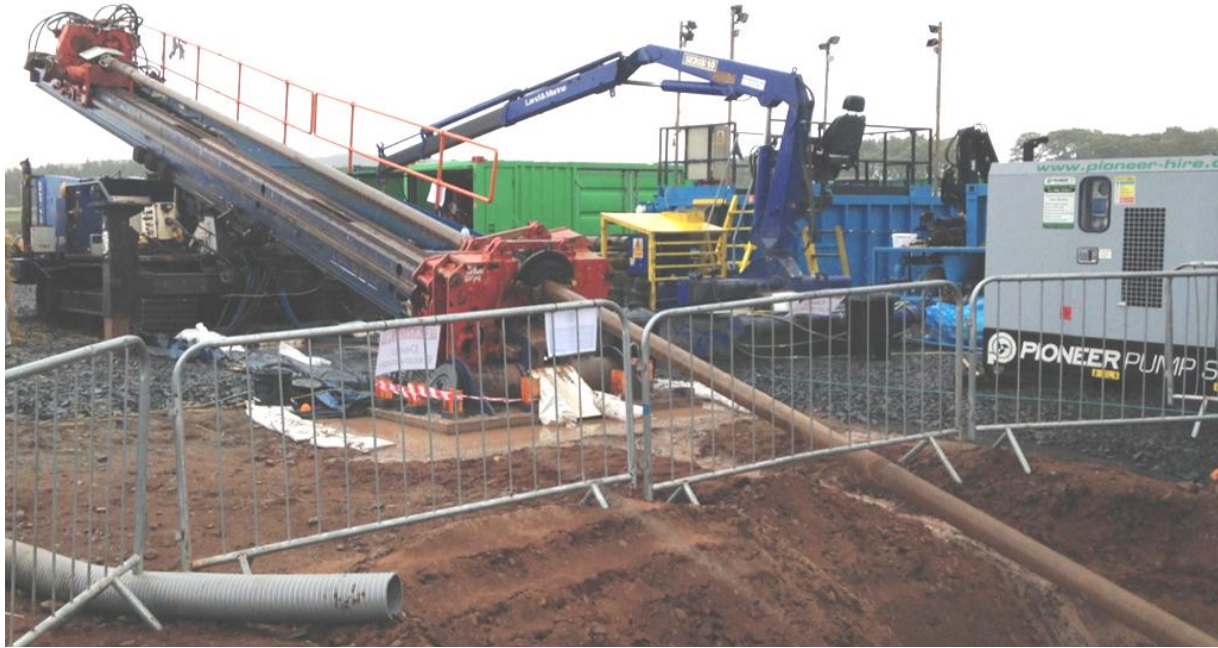
**Figure 13.** Example HDD rig of similar size to that required for the HDD's.

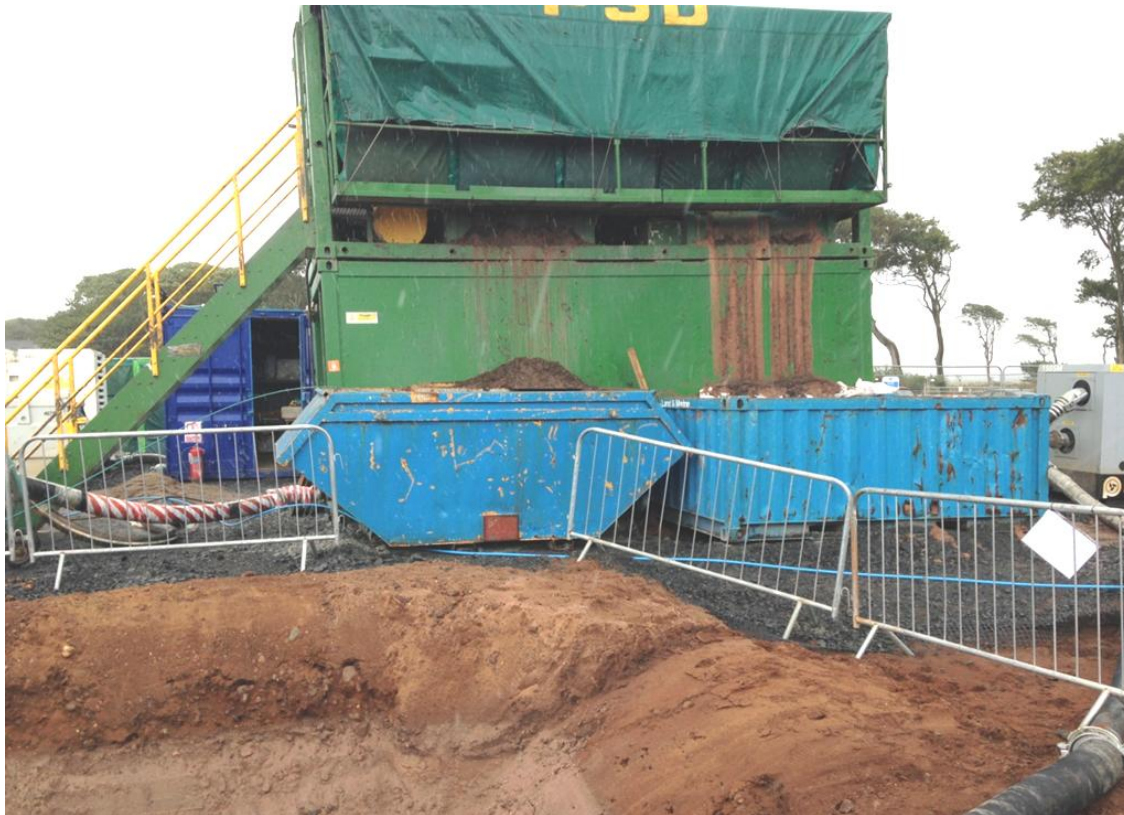
**Figure 15. A drilling fluid recycling unit with hydrocyclones and shaker screens on the upper level and active mud tank underneath. The blue bins capture cuttings as they are removed by the shaker screens. On the right is a grey transfer pump for transferring cuttings from the entry pit (foreground) to the hydrocyclones and shaker screens.**

The bentonite drilling fluid is circulated down through the drill rods and back up the outside the rods in the annulus of the borehole. Exiting into the entry pit, the fluid is then pumped to the mud recycling unit (Figure 15) where hydro-cyclones and shaker screens remove cuttings. The cuttings accumulate beneath the shakers and are usually disposed of at landfill sites. The cleaned drilling fluid transfers to the active tank ready for circulation through the hole.

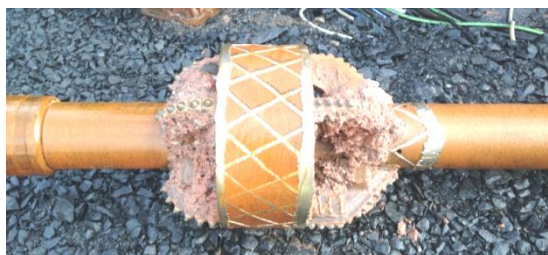
Figure 16. Typical flycutter hole opener

There are a variety of types of reamers and hole openers designed for different ground conditions. For the clayey conditions a flycutter (Figure 16) is likely to be used. For sandy ground, particularly loose sands, barrel reamers are often used (Figure 17) although for forward reaming a flycutter might be judged more suitable in denser sands.

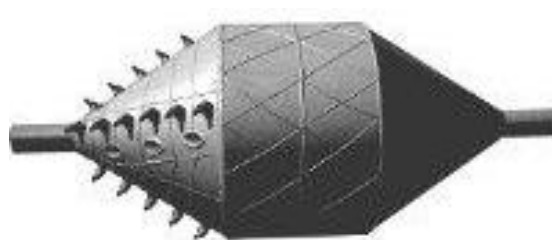
Figure 17. Typical Barrel Reamer

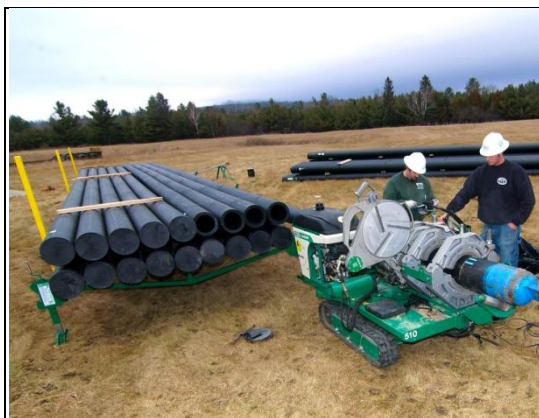
Figure 18. Typical setup of PE butt fusion welder

It is likely that the ducts will be floated into position at the exit point, flooded with water, and then pulled into the reamed borehole for installation (commonly termed “pullback”). The ducting can either be fabricated as a single piece (by Pipelife in Norway) and towed to a mooring position nearby awaiting installation, or it can be fabricated at a nearby convenient location by butt fusion welding 12m or 18m lengths to form the duct. This can then be towed to the exit position as required. A typical setup for butt fusion welding of PE pipe is shown in Figure 18.

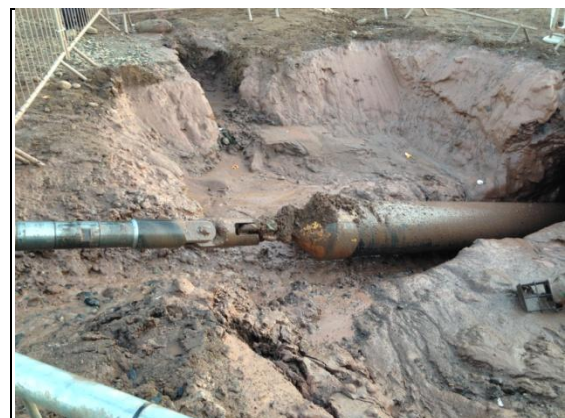
Figure 19. Drilling rod, swivel, pulling head and duct being pulled into the entry pit

The duct will be prepared for installation by attaching a pulling head (Figure 19) and the duct is then ballasted by filling the duct with water to reduce its buoyancy.

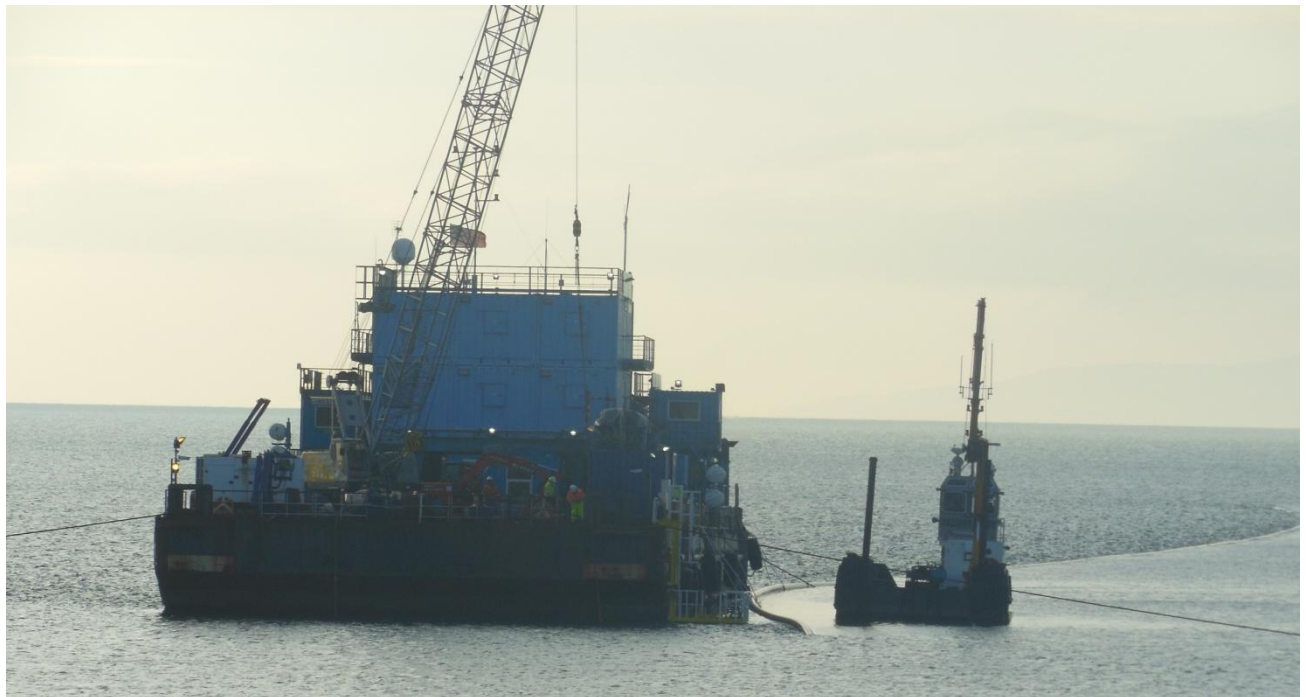
**Figure 20. Large barge with four point anchoring and workboat. On the right hand side of the barge the duct can be seen being pulled into the HDD. The water depth is approximately 4m.**

On previous landfalls a range of methods have been used from large scale grounded barges to smaller scale legged or jack-up barges that eliminate the need for divers. At the small scale end are workboats with divers used to retrieve and connect equipment. In shallow water (<5m) with fair visibility divers are unlikely to be required. The drilling bit will probably extend close to or above the water as it exits and can be brought onto a barge or workboat with a crane or other lifting equipment to allow disconnection and connection of reamers and pulling heads.

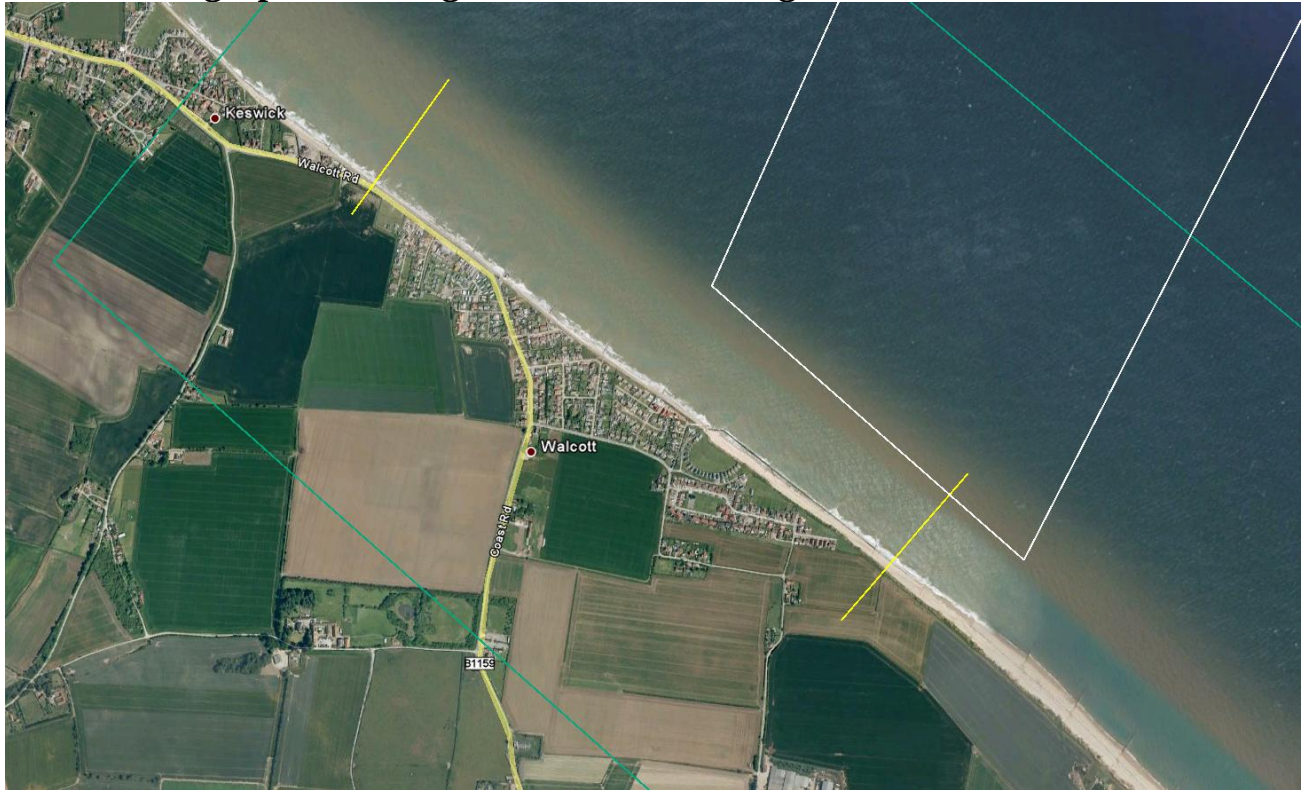
Indicative HDD Alignments for Site 1(left) and Site 2 (right) in yellow.

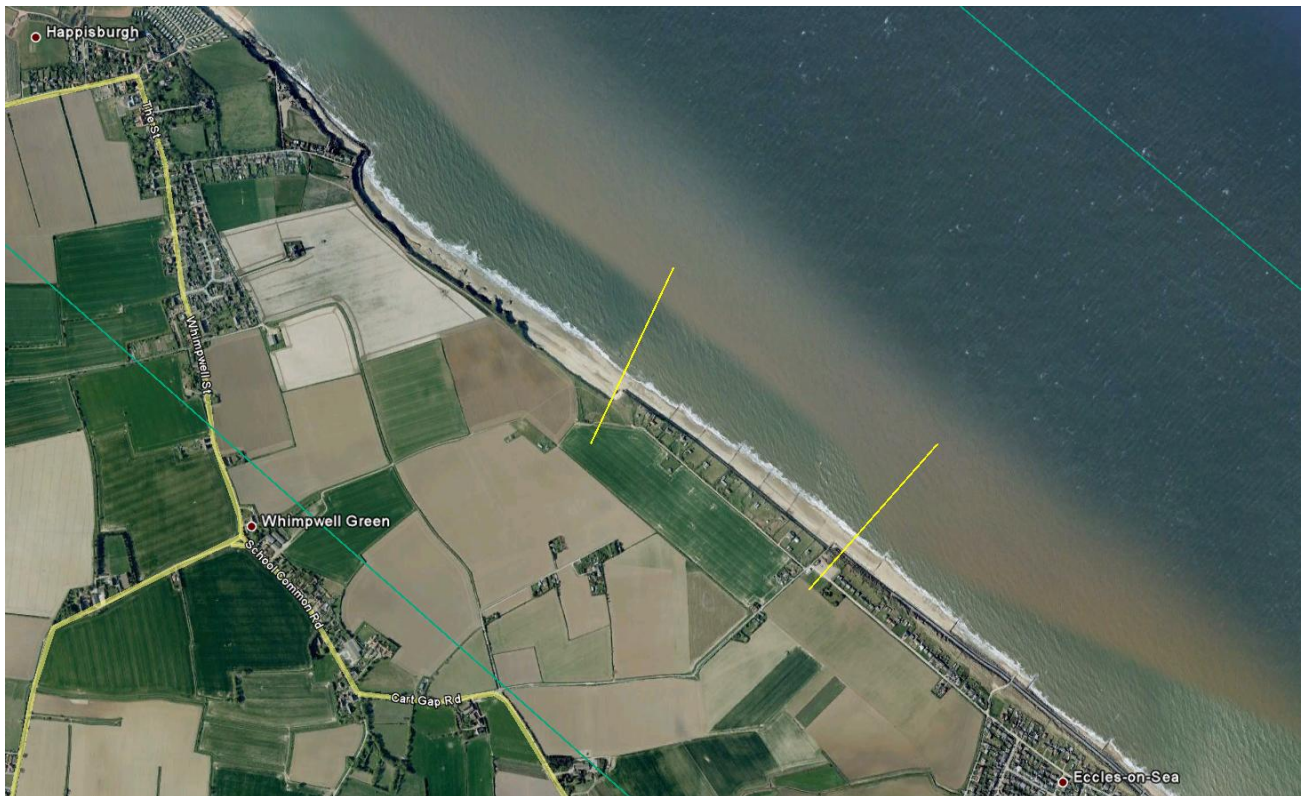
Indicative HDD Alignments for Site 3a (left) and Site 3b (right) in yellow.

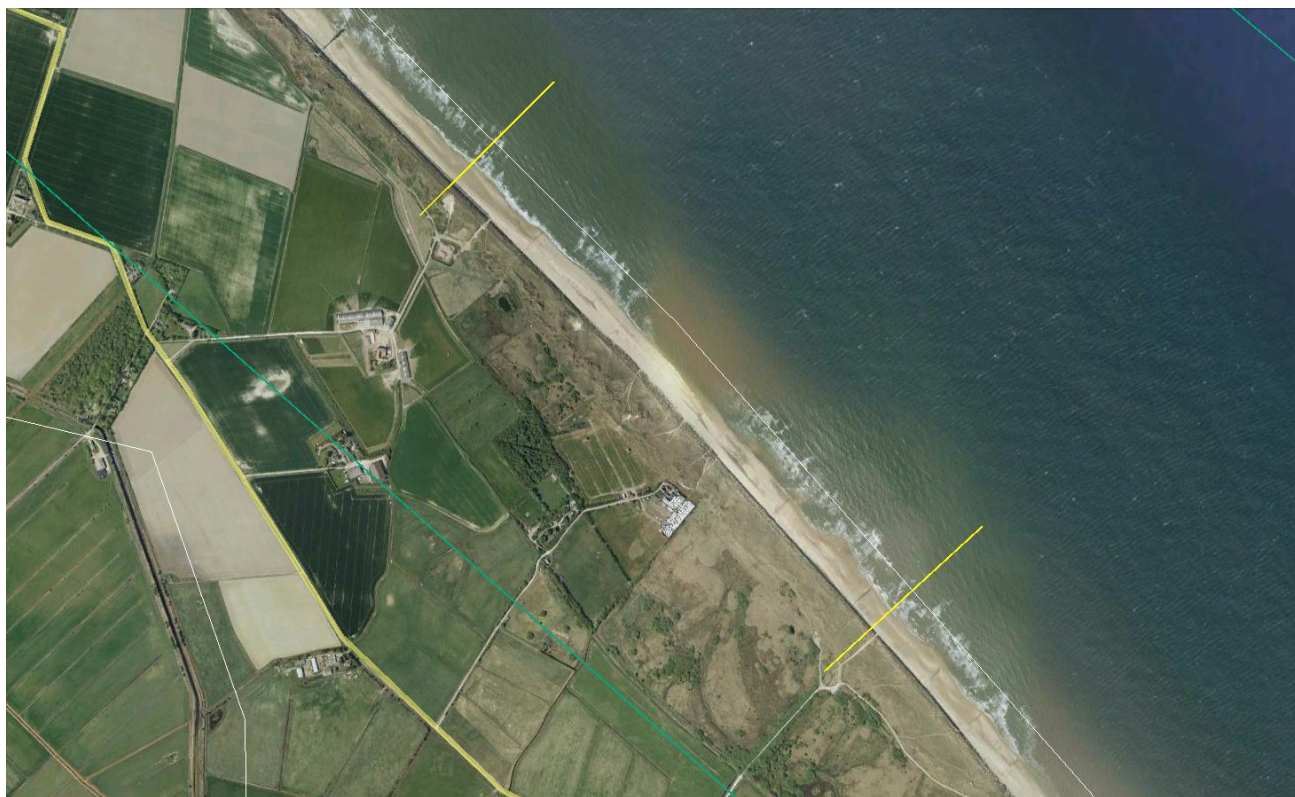
Indicative HDD Alignments near Horsey for Site 6 (left) and Site 7 (right) in yellow.

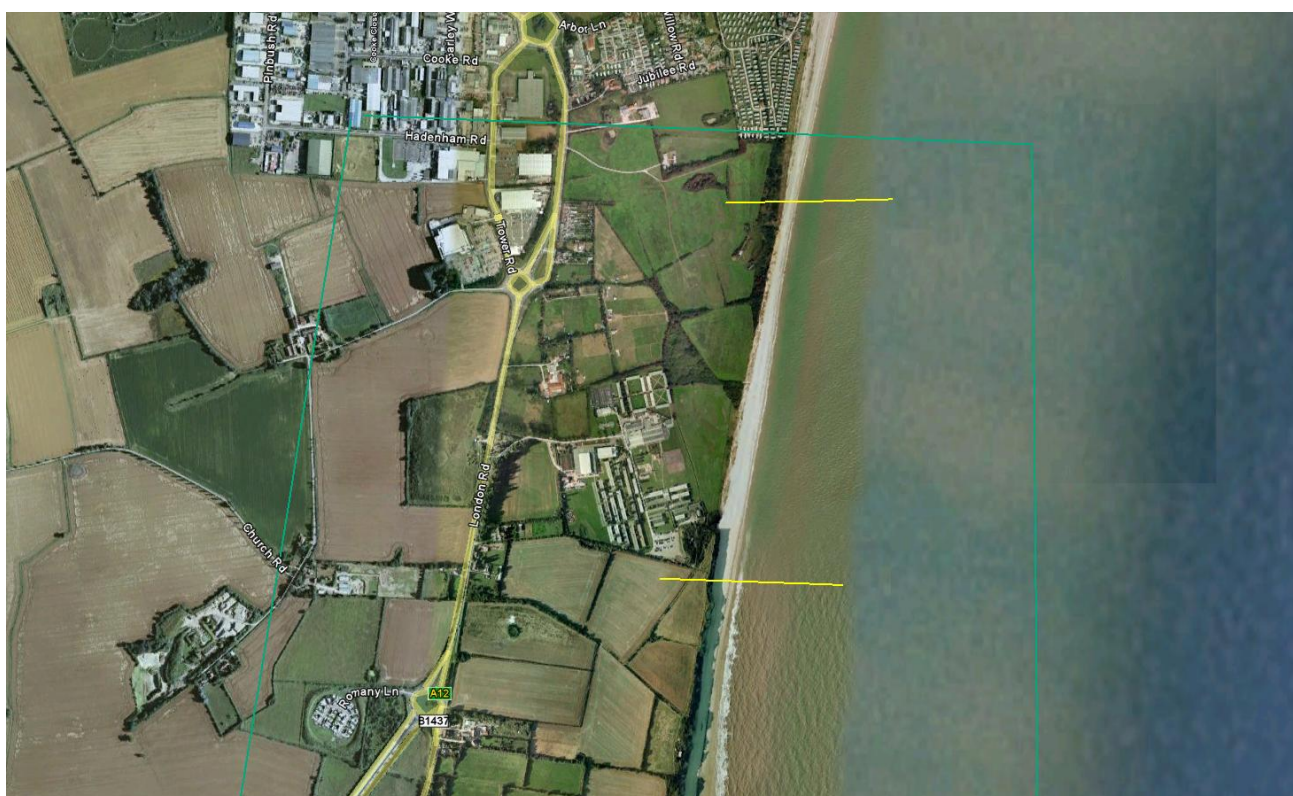
Indicative HDD Alignments for Site 11 (top) and Site 12 (bottom) in yellow.

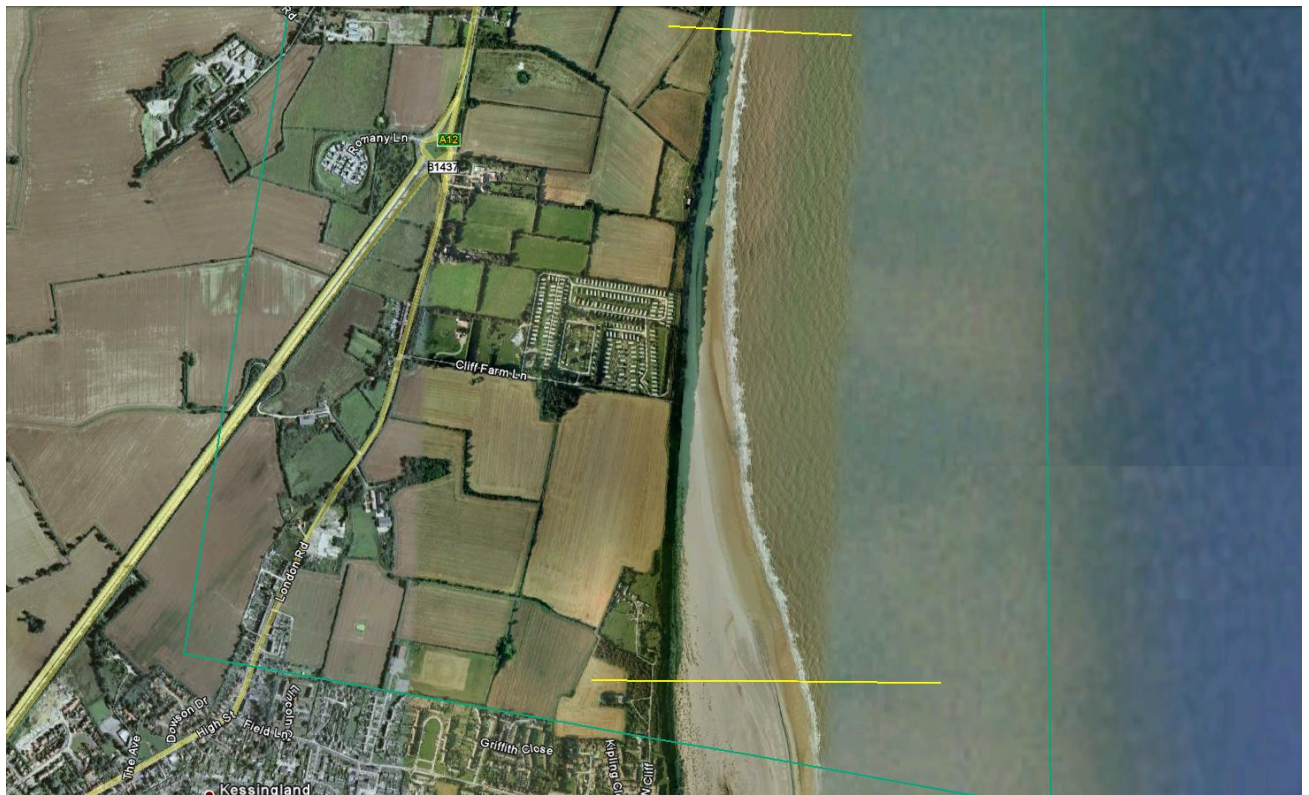
Indicative HDD Alignments for Site 10 (top) and Site 11 (bottom) in yellow.

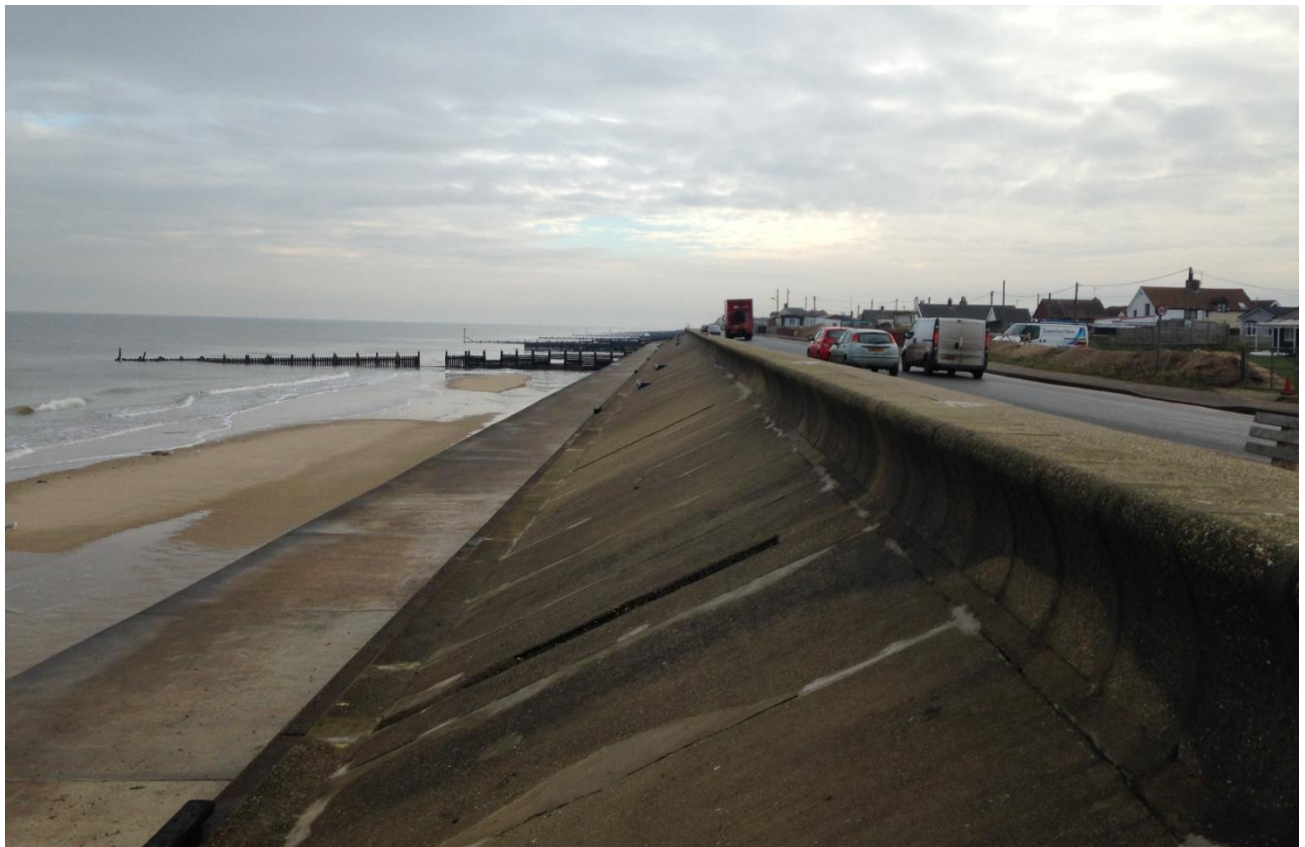
Figure 29. Site 1. View to Southeast from above the potential HDD alignment showing coastal defences and B1159.

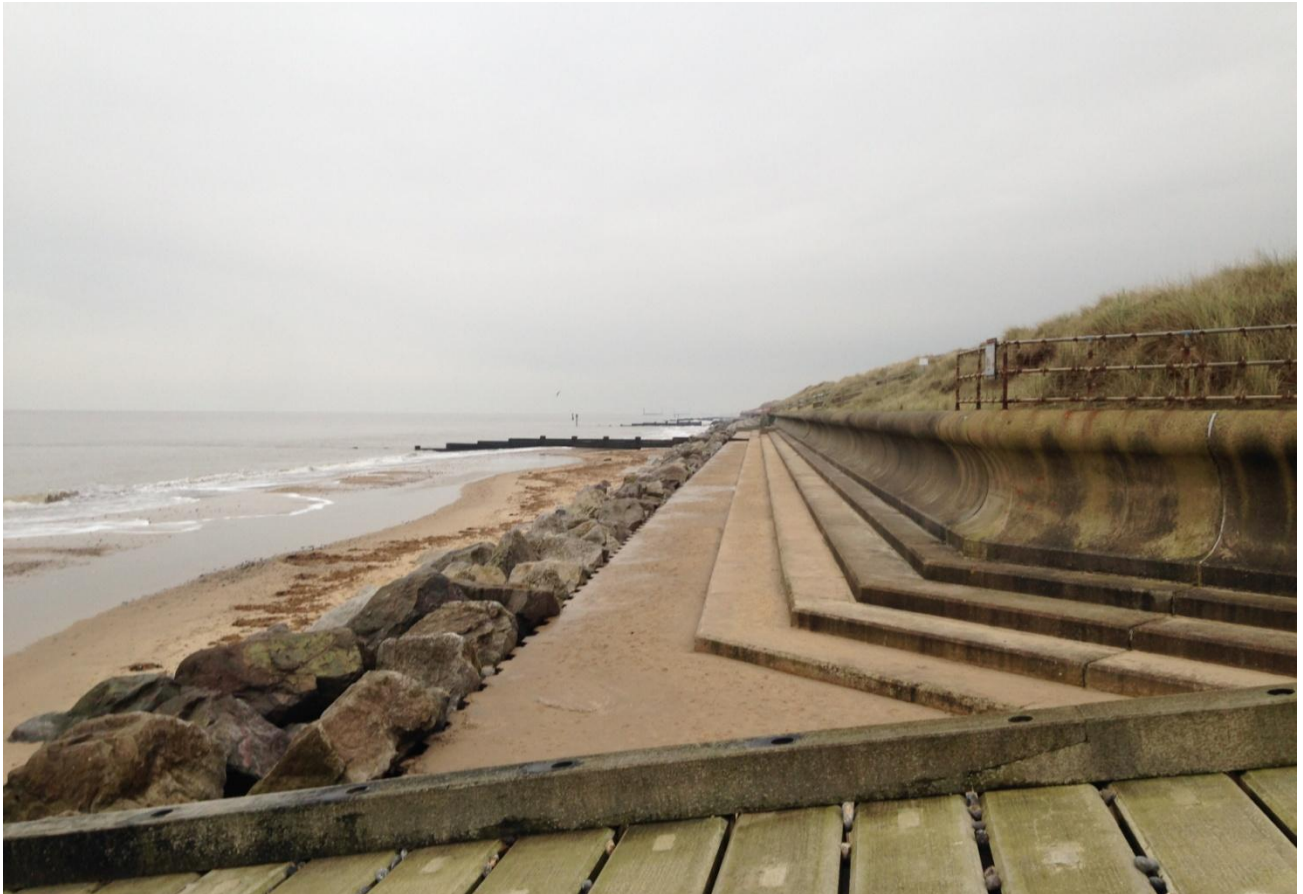
Figure 36. Site 3b. View south from beach access ramp. HDD alignment will be between the ramp and the wooden groyne in mid distance.

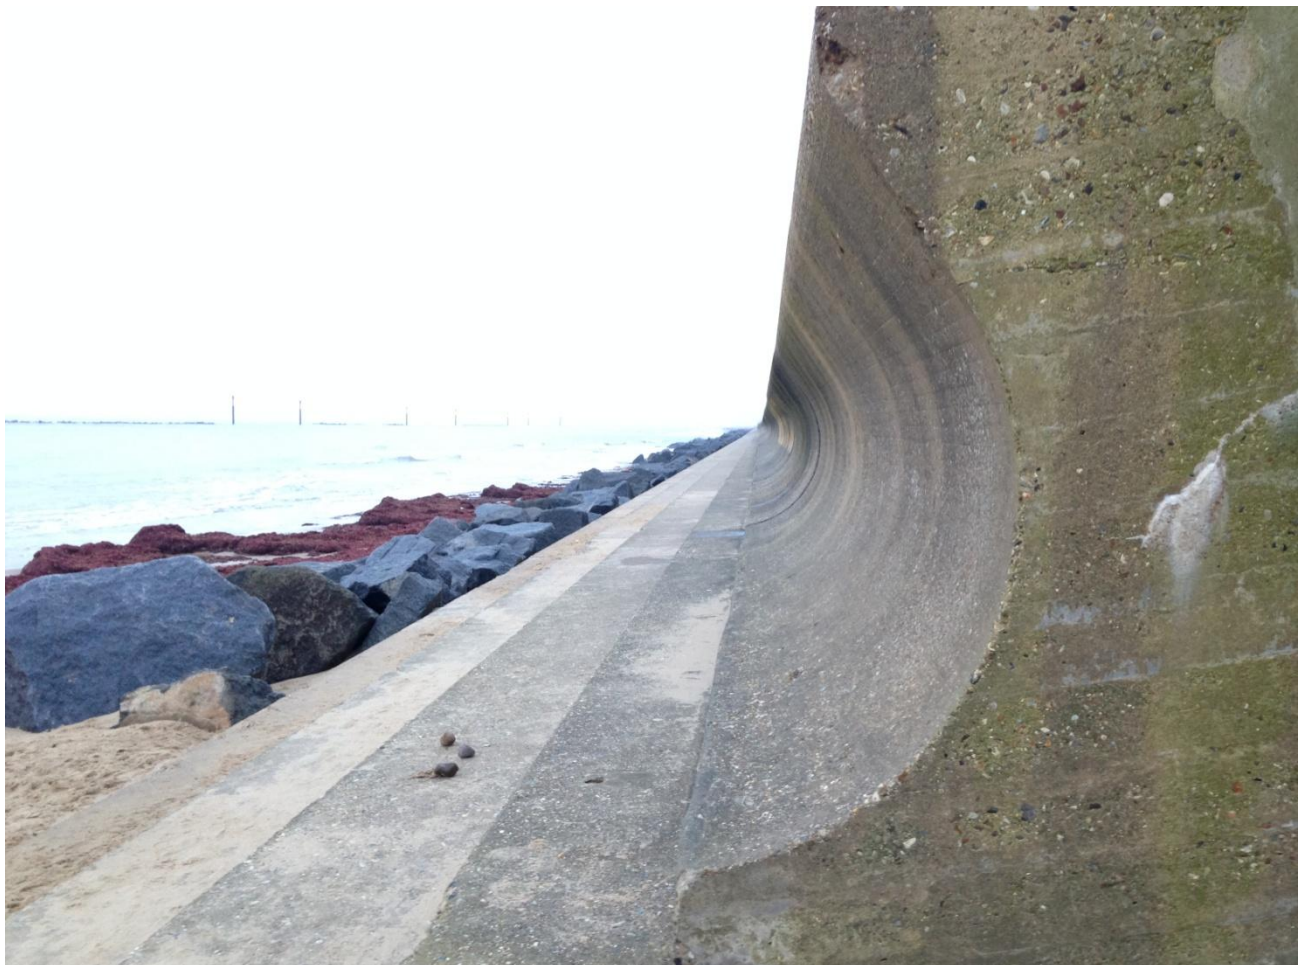
**Figure 41. Site 5. Beach defences looking south east from Sea Palling beach access. Offshore rock walls are 250m from the shore. The concrete shoreline defences continue beyond the HDD alignment, 300m from the viewpoint. Alignment 5 passes to the left of the offshore rock wall on the left of the photograph.**

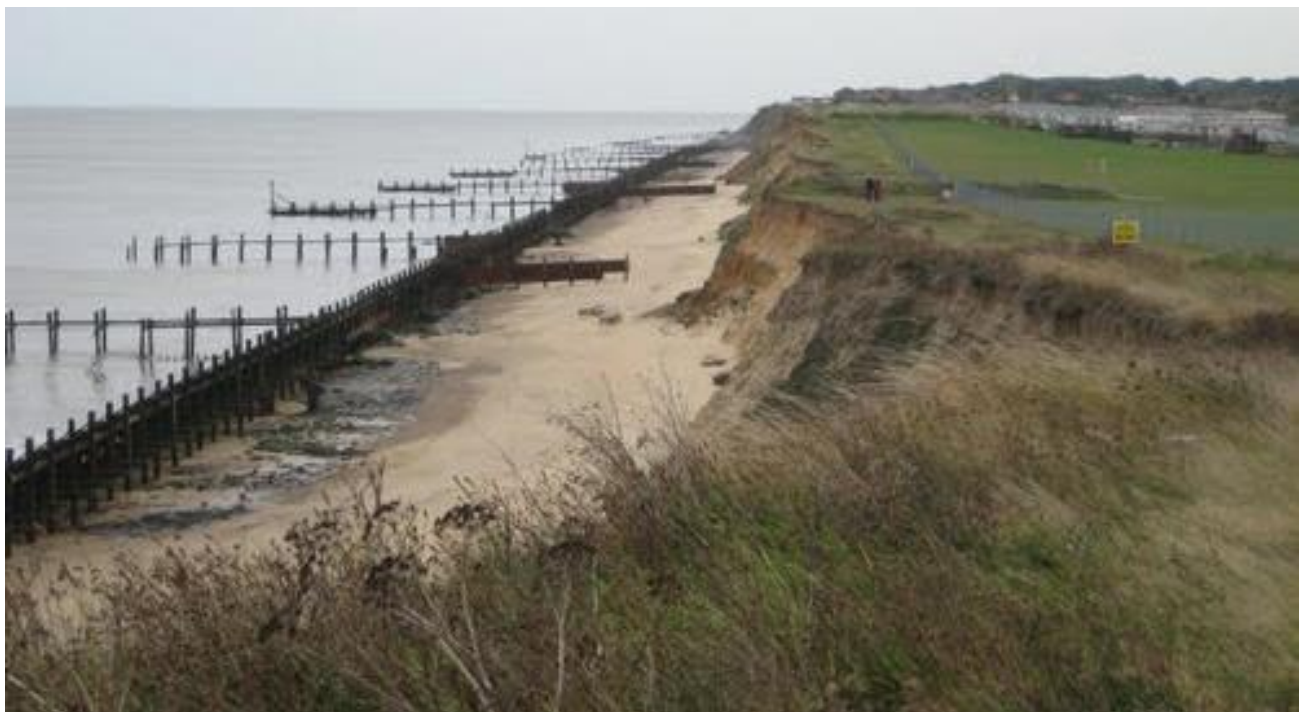
**Figure 51. Site 9. Google Earth Panoramio photograph viewed southwards towards Broadlands Sands Holiday Park. Site 9 HDD route crosses the cliffs 50m beyond the people in mid distance. Erosion has since reached the boundary fence, taking the coastal footpath and preventing access. Vehicle access to a short HDD exit position would be very difficult due to sea defences.**

**Site 9:** Difficult unless the Environment Agency allow temporary removal of a section of timber ramparts. A ramp is visible on aerial photographs at Broadland Sands Holiday Park, 150m south of the alignment. To access the low tide area any machinery or equipment would need to traverse the timber rampart currently at mid tide level (see Figure 50 and Figure 51 in Appendix G).

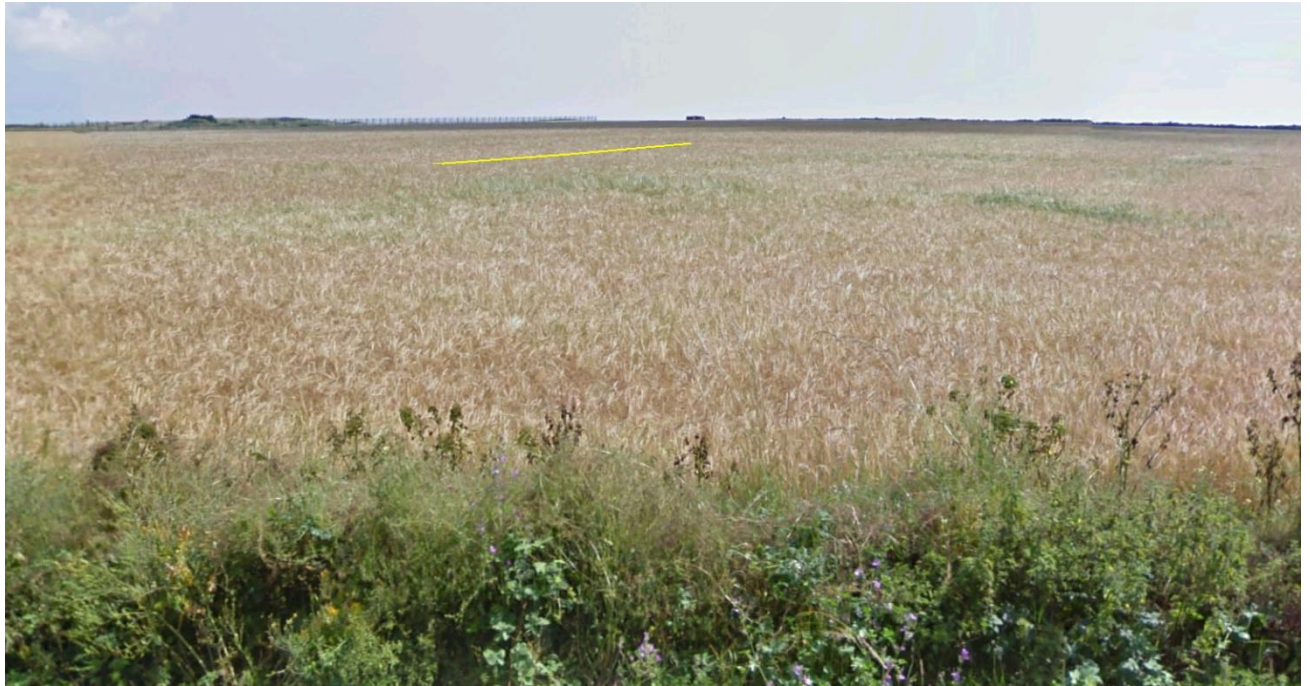
**Figure 52. Site 9. Google Street View from Coast Road looking eastward towards the coastal cliffs. Approximate line of HDD is indicated in yellow. Building in far distance, centre is a WWII defensive post at the cliff edge.**

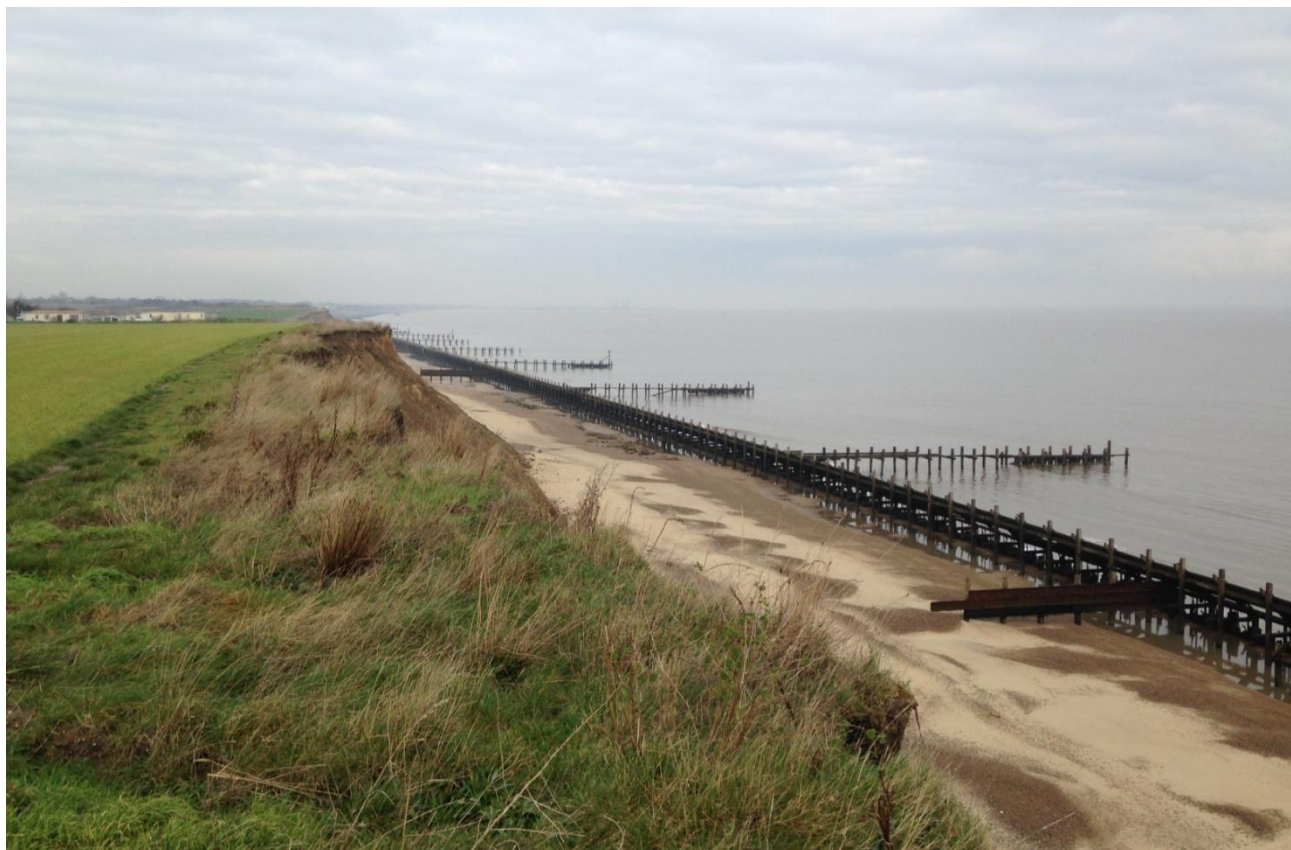
**Figure 54. Site 10. View northwards from Site 10 illustrating the coastal topography and sea defence structures.**

**Site 10:** Difficult unless the Environment Agency allow temporary removal of a section of timber ramparts. Broadland Sands Holiday Park ramp 700m north. To access low tide area any machinery or equipment would need to traverse the timber rampart currently at mid tide level. (See Figure 54 in Appendix G).

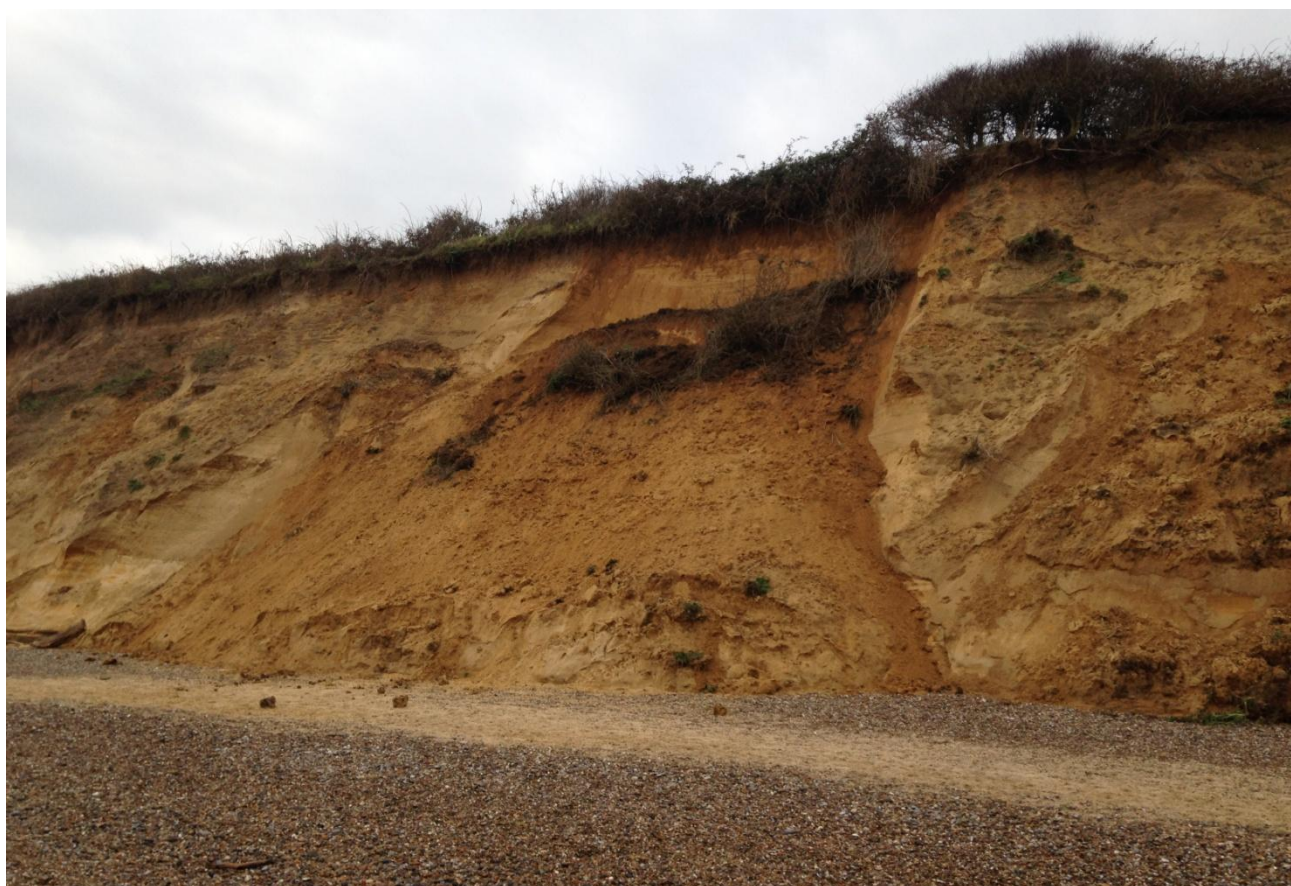
**Figure 55. Site 11. Coastal cliffs at Site 11 showing erosion of fine sands.**

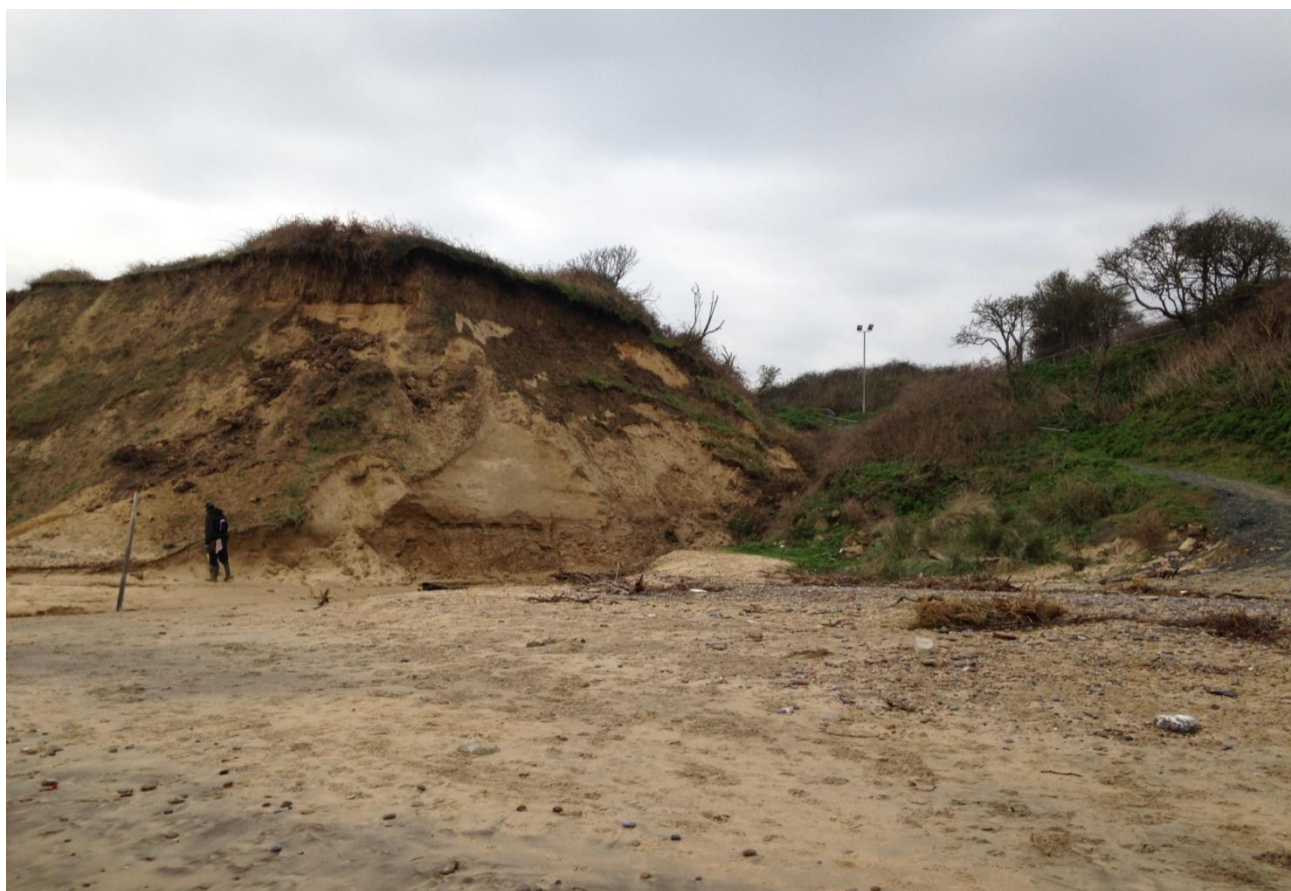
**Figure 59. Site 12. Footpath to Pakefield Coastwatch Tower showing eroding cliffs of fine sand.**
