# Norfolk Vanguard Offshore Wind Farm

## HDD Feasibility Report for East Anglia Tranche 1

# **HDD FEASIBILITY REPORT**

## **Cable Landfalls for East Anglia North Tranche 1 (EAN) U.K.**

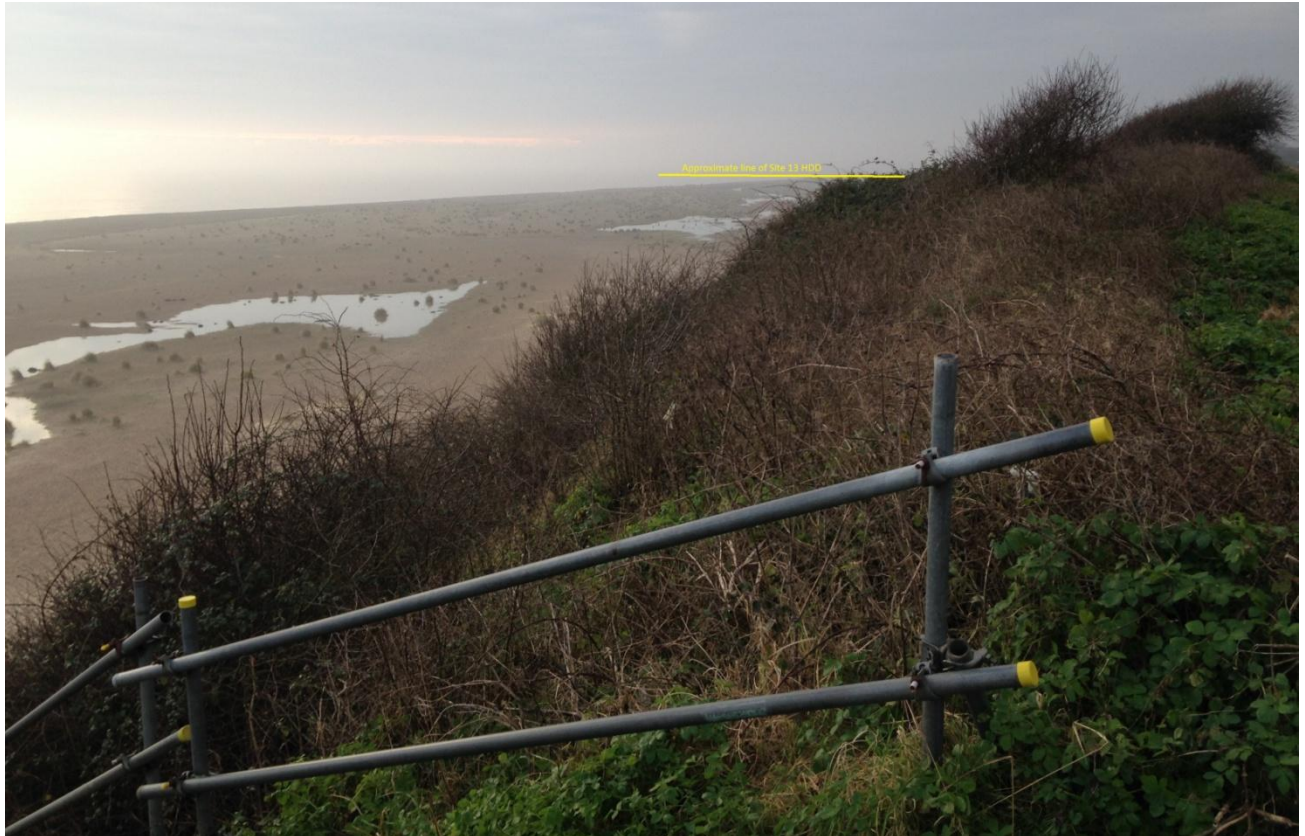
**Figure 62. Site 13. View south from Cliff Farm Lane footpath, 600m north of Site 13. Approximate HDD route indicated in yellow across the Ness. The photograph gives an indication of cliff heights and the width of the Ness.**
