# APPENDIX I

# Civil Aviation Authority – Safety review of offshore public transport helicopter operations in support of the exploitation of oil and gas

**CAP 1145**

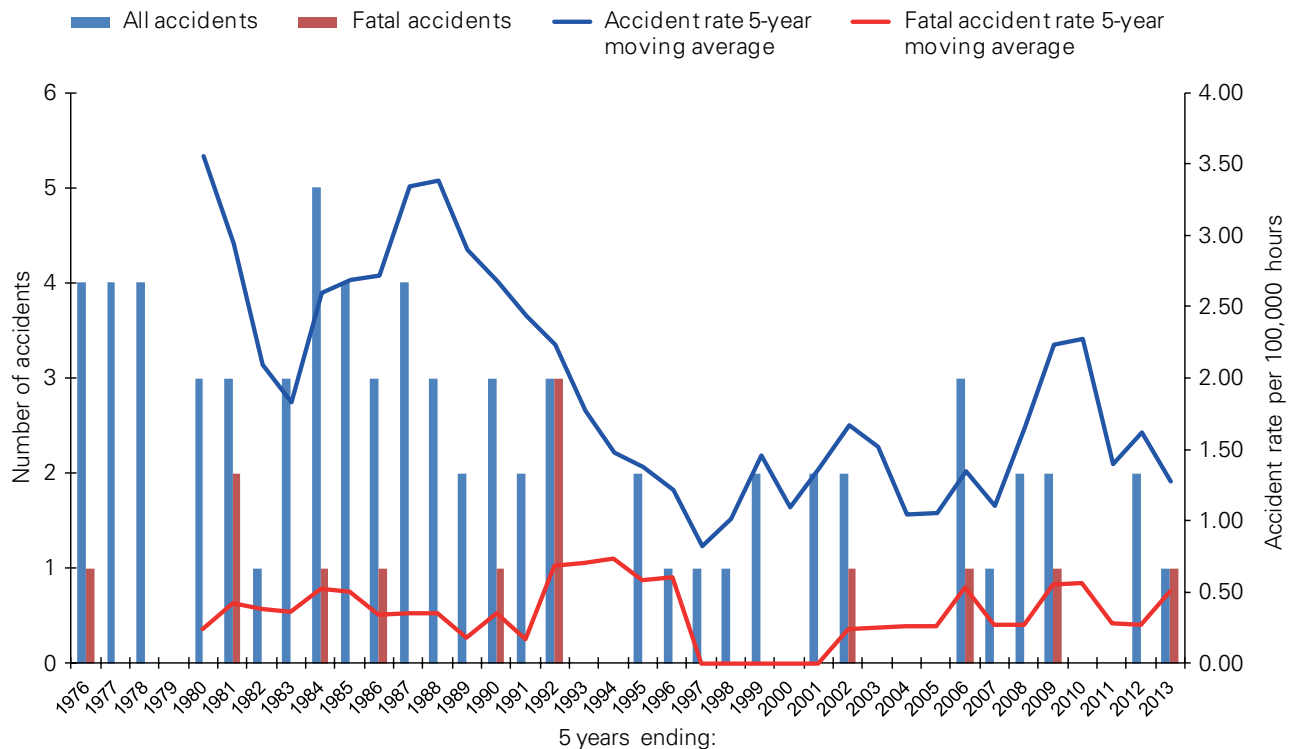
- 5.4 The overall results presented in Figure 1 below. Five year moving averages are used to smooth the accident rate per flight hour data and help to identify any underlying trends. Plots based on accident rates per flight sector were also produced but, in the interests of brevity, are not presented as they did not identify any different patterns in the data.

**Figure 1:** Chronology of reportable accidents (rate per 100,000 flight hours)

- 5.5 The variation in the 'all accident' rate throughout the period is largely driven by variations in the technical cause accident rate. The operational and external cause accident rates are relatively constant, and the reduction in the 'all accident' rate from the early 1990s is driven by the corresponding reduction in the technical cause rate. The reduction in the technical cause rate accidents in the early 1990s is coincident and consistent with the introduction of Health & Usage Monitoring Systems (HUMS).

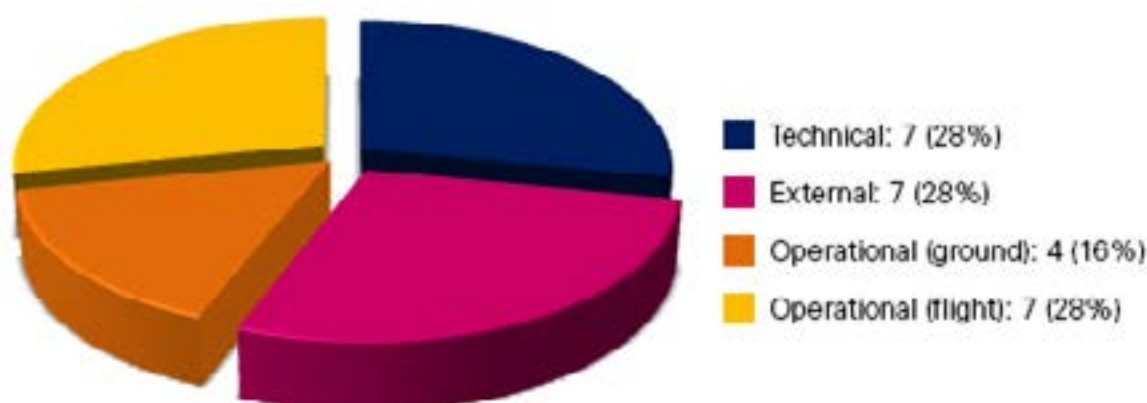
- 5.7 There were a total of 25 reportable UK offshore helicopter accidents during the period 1992 to 2013. The overall accident rate is just over one per year. This equates to 1.35 accidents per 100,000 flight hours or 0.66 per 100,000 flight sectors. The breakdown of the accidents during the period 1992 to 2013 by top level grouping is presented in Figure 2 below.

**Figure 2:** Offshore helicopter accidents for the period 1992 to 2013 by grouping

- 5.8 Overall, operational causes of accidents (flight and ground combined) dominate, accounting for 11 out of the 25 (44%) accidents. Technical and external cause accidents each account for seven out of the 25 (28%) accidents.

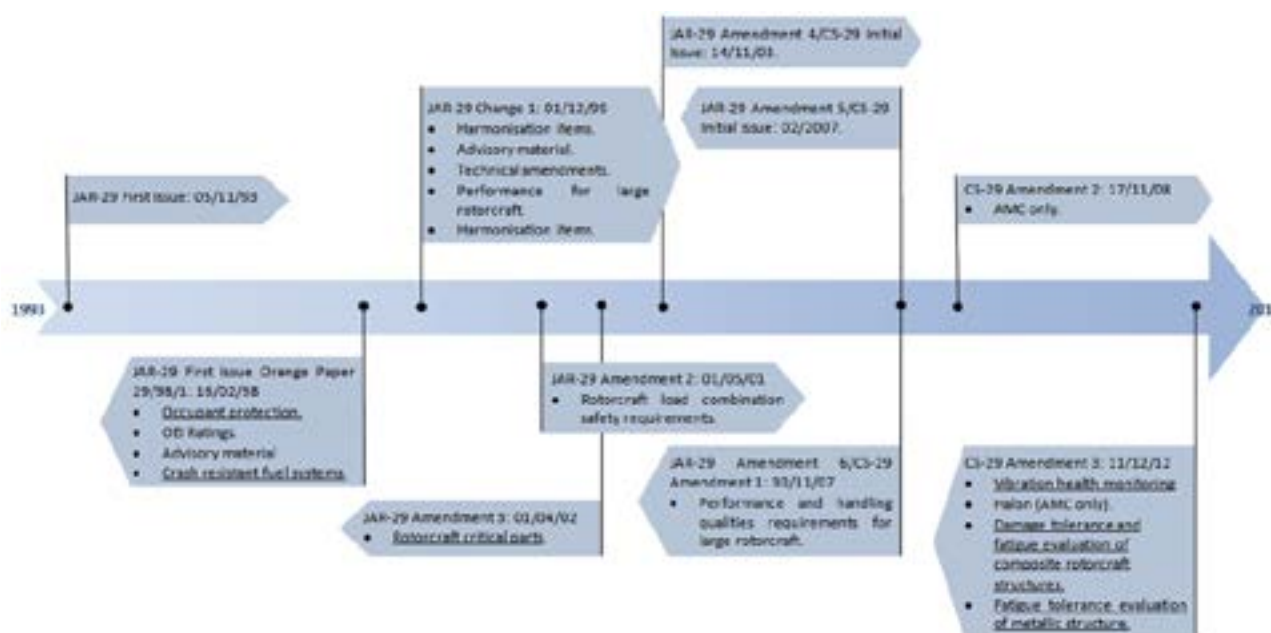
- 20.1 This chapter provides a baseline for the Certification Specifications (CS) achieved by the aircraft types that operate in the North Sea. A brief history of these standards is provided and a brief description of what has changed as they have developed through the 1990s to the present day. A summary 'timeline' is given below, with the information reduced to just the titles of the Notice of Proposed Amendments (NPAs) and with those changes of particular relevance to offshore operation highlighted by underlining.
- 20.2 It is important to note that not all helicopters operating in the North Sea are certificated to the latest standard of requirements. Many are 'derivatives' whose original certification basis may have been set many years prior to their entry into service, it being associated with an original version of the helicopter type.

**Figure 3:** History of airworthiness certification standards

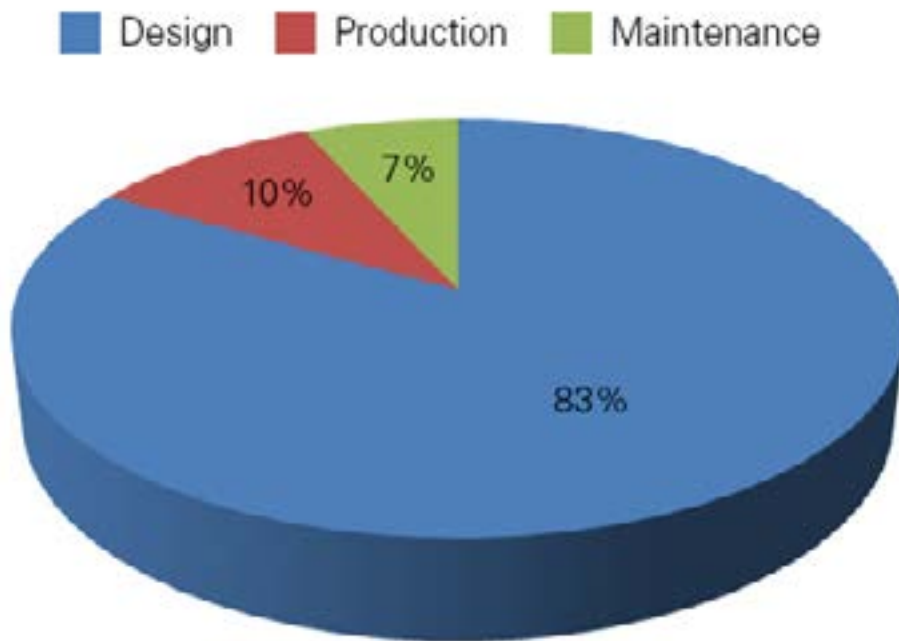
- 21.2 Figure 4 below gives a schematic picture of how the technical causes of these accidents can be partitioned into their general subject areas. It should be noted that this data differs from that discussed in Section C and Annex C because the range of accident reports considered in this element of the review included reports worldwide, as opposed to only those associated directly with the UKCS operation. From the data in Annex C, there is a clear step change in the accident rate that coincided with the introduction of Health and Usage Monitoring Systems (HUMS) in offshore operations.

**Figure 4:** Causal factors

21.4 This group has not been ranked according to their severity, and they range from minor incidents to catastrophic accidents. From this high level review, although it is clear that causes arising from design aspects account for the major share of the target group of accidents, it is not possible at this time, therefore, in lieu of a more detailed analysis, to draw specific conclusions as to the real contribution made by design causes to offshore safety. Of the events attributed to design causes, the top five areas that have contributed are:

- Main Gear Box and transmission system - 20%
- Electrical - 20%
- Engines - 15%
- Horizontal Stabiliser - 11%
- Main Rotor Blade - 11%

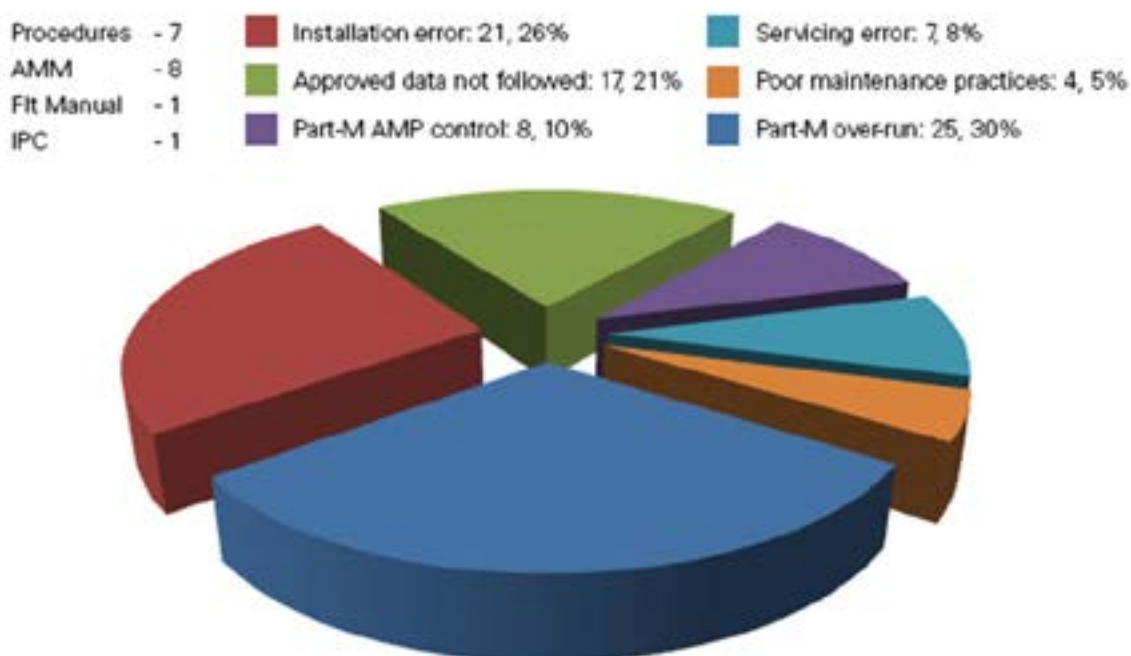
- 26.4 The CAA has been carrying out a wider review of MOR data between 2005 and 2011. This has been assessed by Confidential Human Factors Incident Reporting Programme (CHIRP) personnel, to identify and extract maintenance error occurrences from the data. The chart below indicates that Part-M overrun has the largest number of reported errors (30%). These are typically life-controlled items which have overrun their scheduled replacement date. However, this is a relatively small number of errors in comparison to the large number of life-controlled items managed on helicopters. The next issue identified is installation error (26%), of which over half were related to errors that would have been subjected to either a second inspection by an independent person, or a duplicate or independent inspection.

**Figure 5:** MOR Human Factors Errors reported in the North Sea organisations

- 26.5 It is clear from Figure 5 that the safety and quality system within the approved maintenance and continuing airworthiness approvals has an important part to play in reducing human error. Some of the contributing factors that affect human error include: distraction, lack of knowledge, lack of communication, complacency, lack of team work, fatigue, lack of resources, pressure, lack of assertiveness, stress, and lack of awareness. Human Factors training alone is not considered sufficient to minimise maintenance error. Most of the above can be attributed to the safety culture and associated behaviours of the organisation.

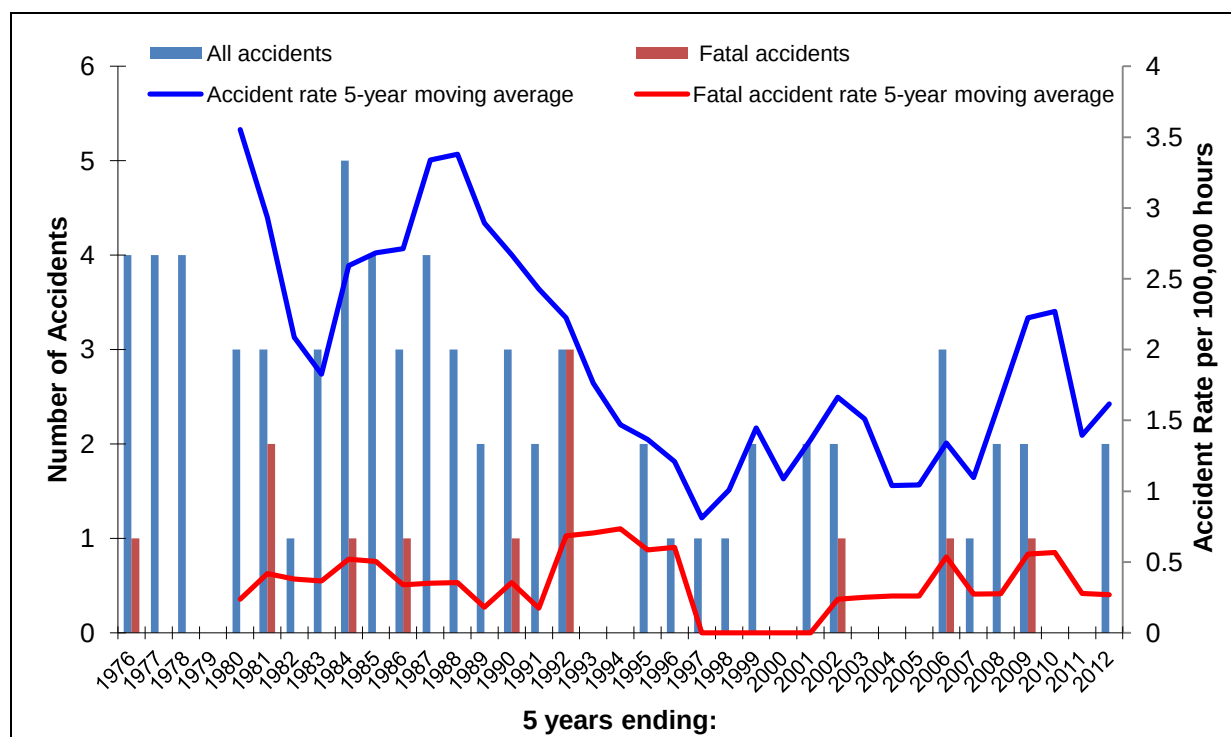
- 2.2 The accidents are presented as rates per flight hour in order to remove the effect of exposure; a rise in the number of accidents could reflect an increase in flying activity rather than a reduction in safety performance. The accident rate in the 1970s was very high, but gradually decreased thereafter reaching a minimum in 1997. Since then, however, there has been a slight upward trend. The fatal accident rate appears to have been relatively constant over the entire period.
- 2.3 Plots based on rates per sector did not identify any different patterns in the data and so are not presented; the variation in sector length does not appear to be significant in this data set.
- 2.4 The numbers of all accidents (blue columns) and fatal accidents (red columns) for each year of the review period are also presented for information/completeness.

**Figure C1 Chronology of reportable accidents (rate per 100,000 flight hours)**

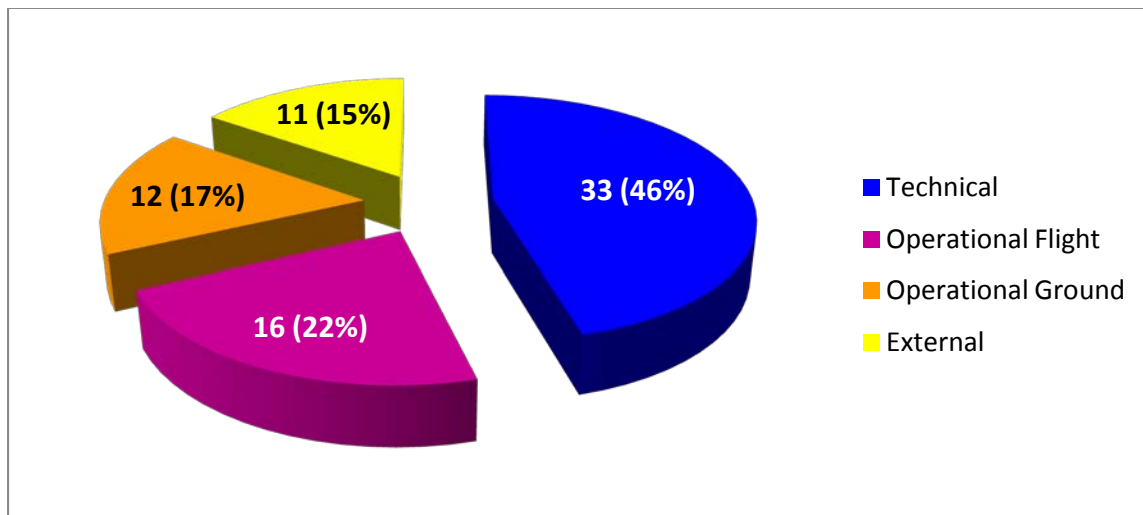
3.4 The results of the classification are presented in Figure C2 and Figure C3. The very high proportion of SCF-NP (system/component failure non-powerplant) is very apparent, but this should be viewed in the context of the very broad scope of this code. Nevertheless, technical accidents do represent the largest single grouping (even larger than operational flight and ground combined) and account for 46% of the accidents during this period.

**Figure C2 Offshore helicopter accidents for the period 1976 to 2012 by CICTT operational groupings**

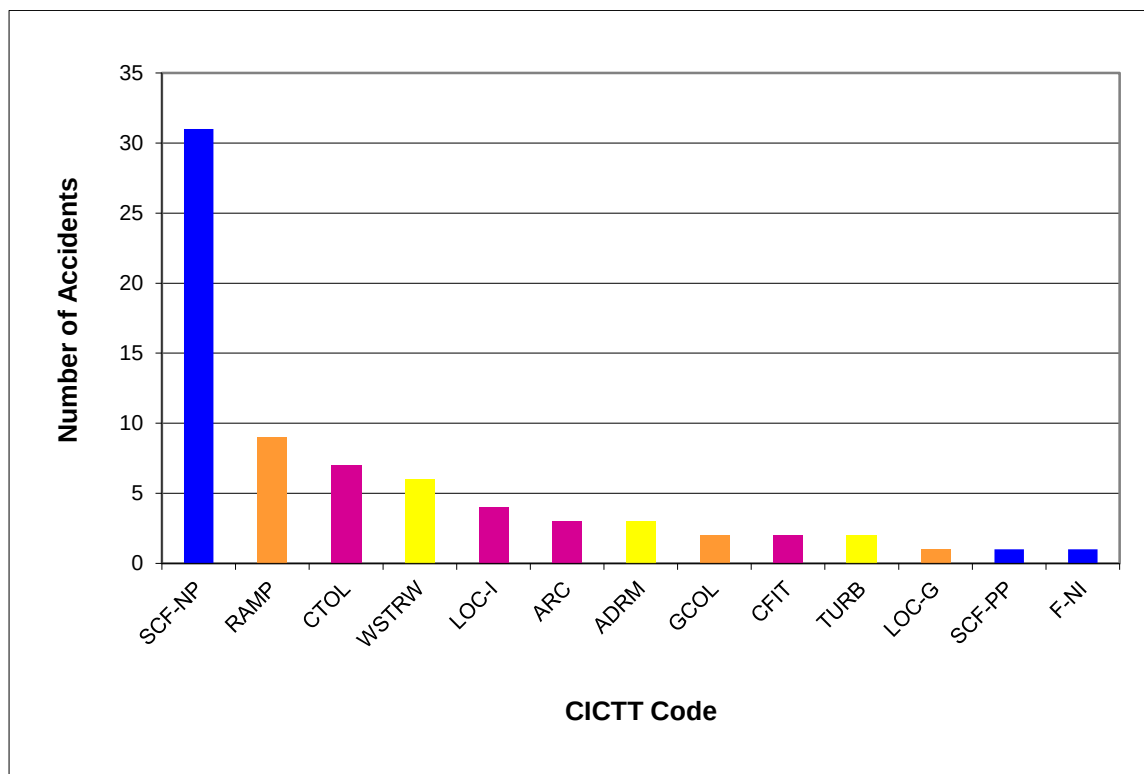
**Figure C3 CICTT classification of offshore helicopter accidents for the period 1976 to 2012**  
(NB: Colour coding per Figure C2)

7.2.2 It is immediately apparent that SCF-NP (system/component failure non-powerplant) accidents dominate, as is the case for all accidents over the same period (see Figure C3). The same considerations apply, however, and applying the CICTT operational groupings of Section 3 shows an even split between technical and operational accidents, and no external cause fatal accidents.

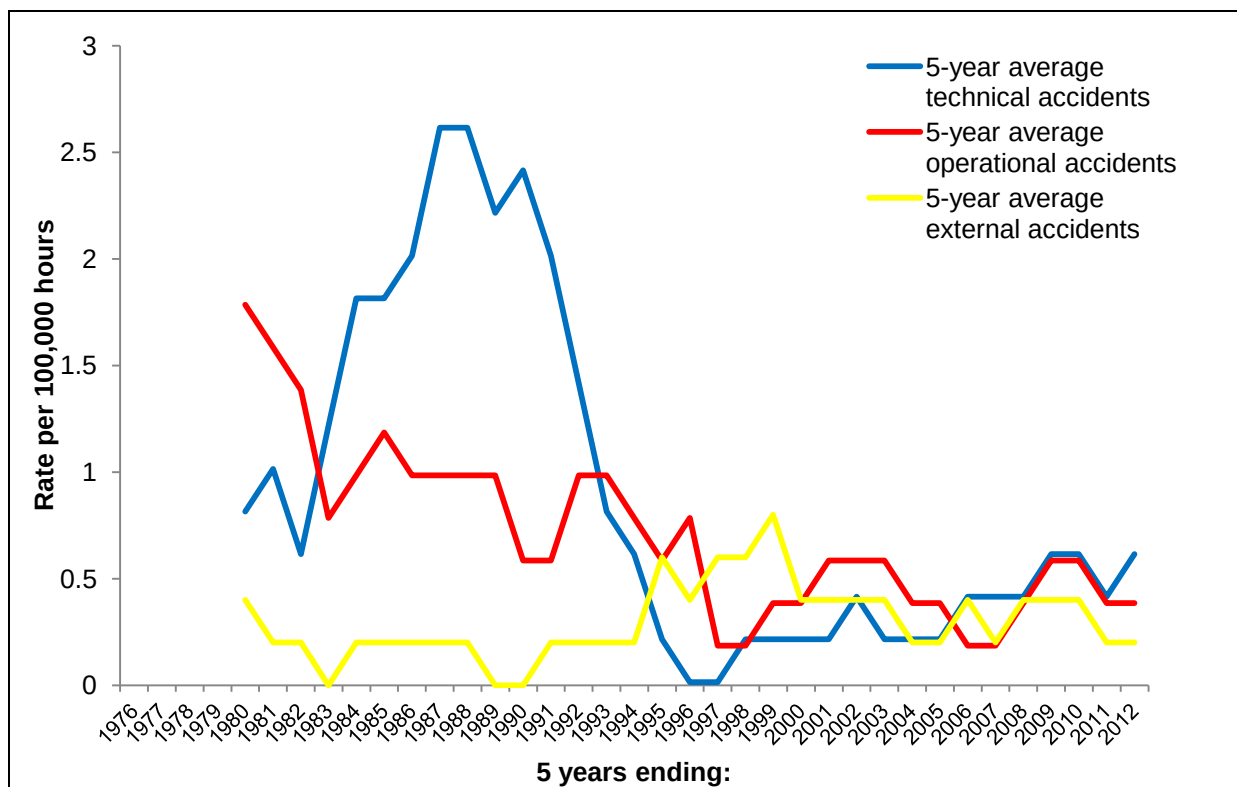
- 4.1 The chronology of the groupings is plotted in Figure C4 in the form of five-year moving averages. Note that the two operational groups (flight and ground) have been combined for simplicity.

- 4.3 Also of note is the step up in external accidents from 1995 onwards which coincides with the lightning strike to G-TIGK in 1995. This strike was especially severe and a catastrophic outcome was only narrowly avoided. As will be presented later, the majority (86%) of external cause accidents are related to lightning strikes which have occurred at a relatively steady rate over the entire period. It is thought, therefore, that the increased awareness of the potential consequences of lightning strikes following the G-TIGK strike in 1995 may have led to higher grades being awarded to the associated MORs, and that this could explain the step.

**Figure C4 Chronology of offshore helicopter accidents for the period 1976 to 2012 by CICTT operational groups (5-year moving averages)**

- 5.6 The characteristics of the underlying data change significantly from the early 1990s with operational, technical and external cause accident rates converging and stabilising (see Figure C4 in Annex C). Consequently, the period from 1992 to the end of 2012 is considered to be most representative of current operations and therefore formed the main focus of the review.

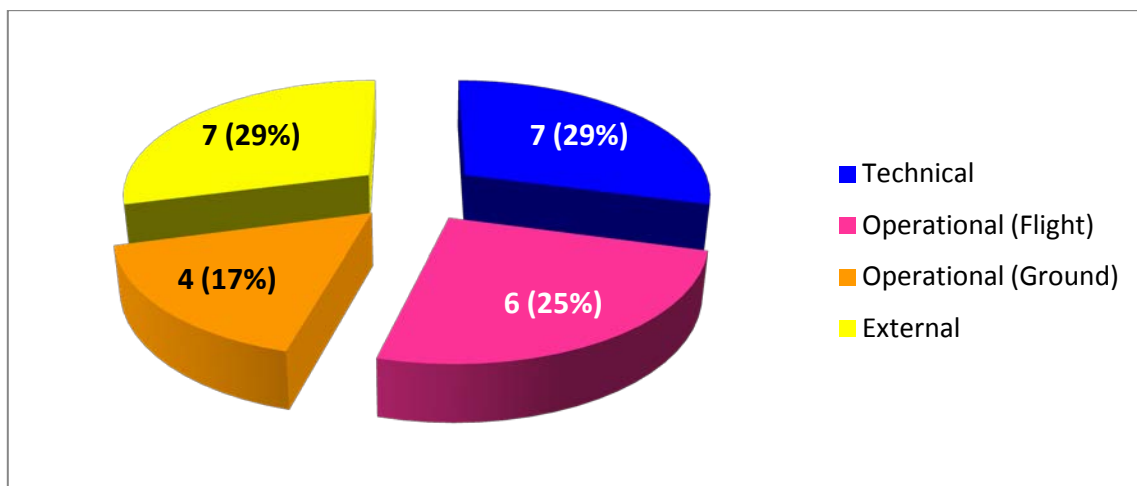
5.3 The results of the classification for this period are presented in Figure C5 and Figure C6 below.

**Figure C5 Offshore helicopter accidents for the period 1992 to 2012 by CICTT operational groupings**

- 5.4 Comparing these results with those for the period 1976 to 2012 (see Figure C2 and Figure C3), SCF-NP (system/component failure non-powerplant) is again the most common code. Also of note is the large number of WSTRW (windshear or thunderstorm) accidents and the corresponding increase in the proportion of these from 8.3% of the total number of accidents (1976 to 2012) to 25% (1992 to 2012). This is mainly because all of the lightning strike accidents occurred during the latter period, i.e. post the G-TIGK accident in 1995.
- 5.5 Taking the operational groupings as a whole, however, operational (flight and ground combined) dominate accounting for 10 out of 24 (42%) of the accidents. Technical and external cause accidents each account for seven out of 24 (29%) of the accidents.

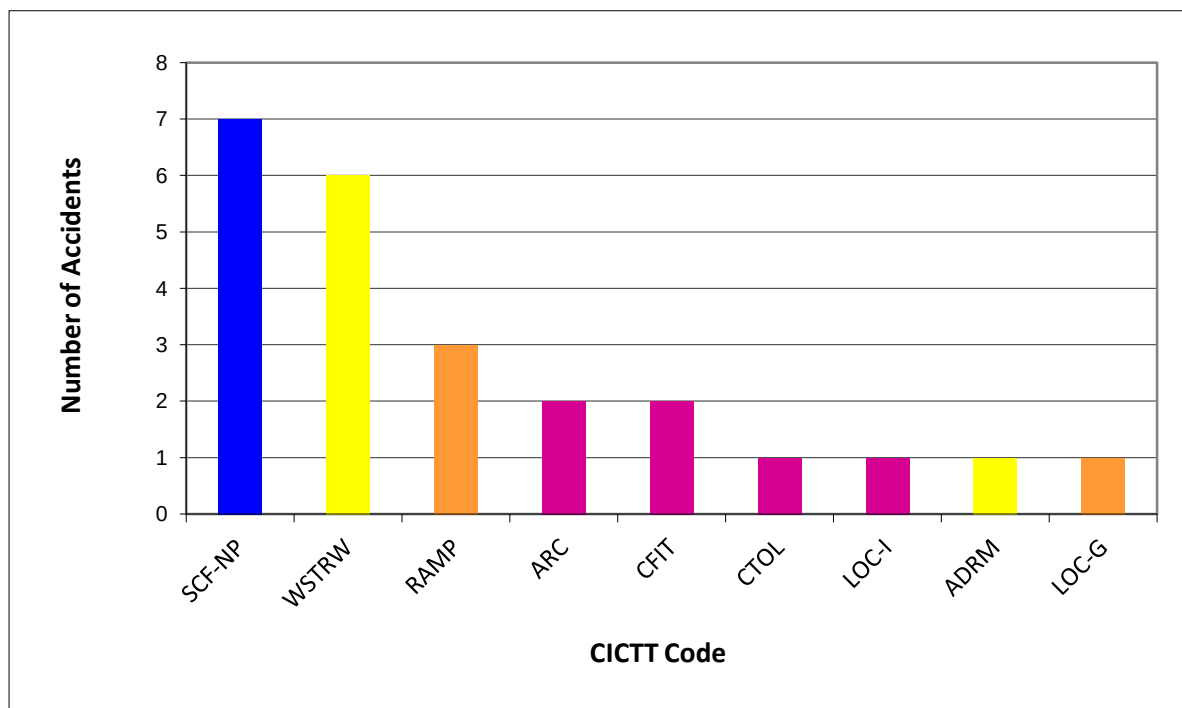
**Figure C6 CICTT classification of offshore helicopter accidents for the period 1992 to 2012 (NB: Colour coding per Figure C5)**

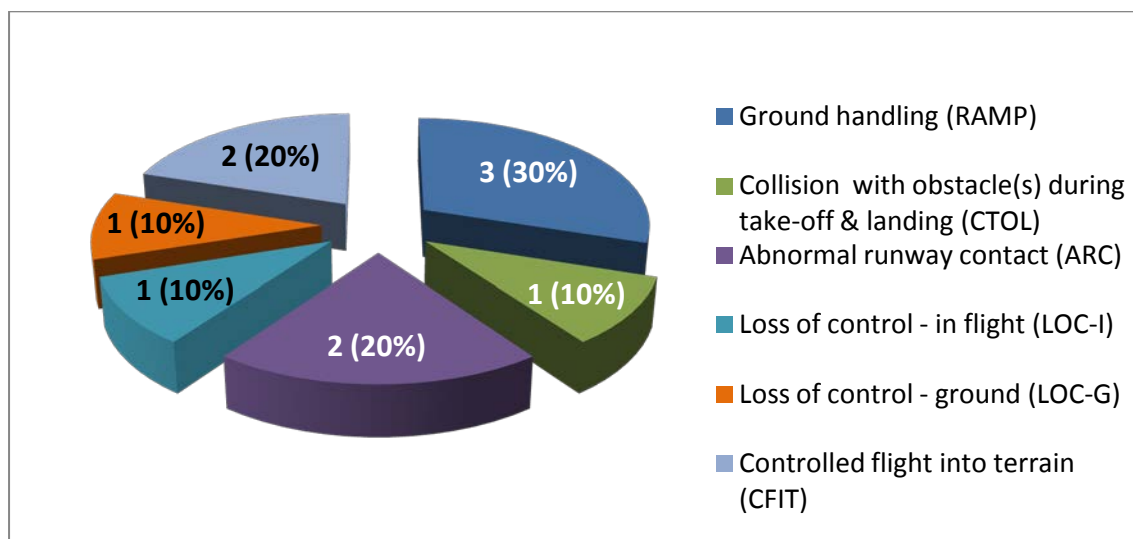
- 6.2.1 Operational causes accounted for 10 out of 24 (42%) of the accidents during the period 1992 to 2012. The classification of these accidents by CICTT occurrence code is shown in Figure C7 below.

**Figure C7 CICTT classification of operational cause offshore helicopter accidents for the period 1992 to 2012**

- 6.2.2 The largest single category is ground handling (RAMP), of which most (two out of the three) relate to operations to moving decks where the issue is the lack of appropriate operating criteria (G-BOND, 18/04/1992 and G-BKZE, 10/11/2001). The research into operations to moving helidecks is addressing this issue. The third (G-BLEZ, 22/09/1992) involved a fatal rotor strike to a ground crew member on a non-moving helideck for which no definitive explanation could be found.
- 6.2.3 The remaining seven operational accidents cover a range of accident scenarios but all involve a flight crew performance related factor. The classification of these

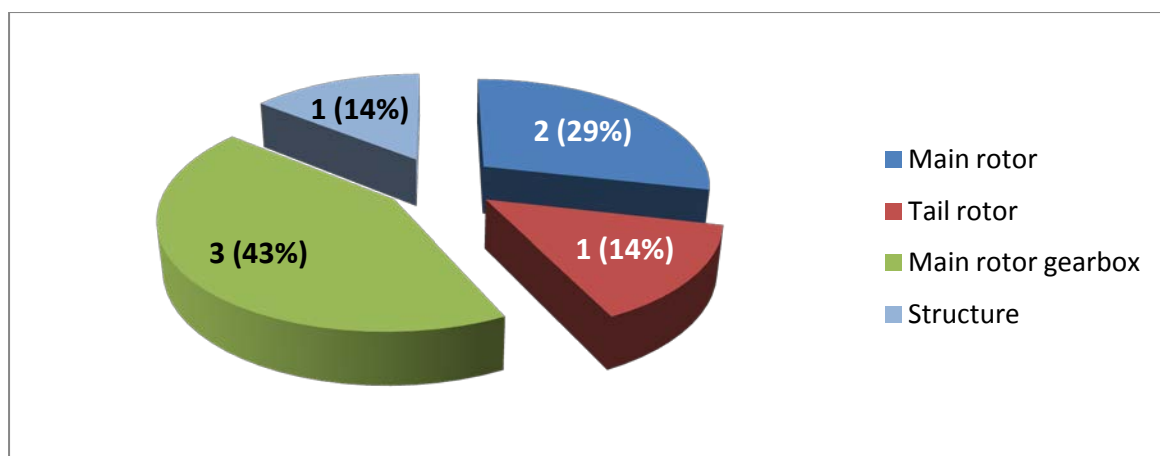
- 6.3.1 Technical causes accounted for seven out of 24 (29%) of the accidents during the period 1992 to 2012. The CICTT classification scheme is not especially discriminating where technical accidents are concerned and, in fact, all seven accidents are associated with the same code of SCF-NP (system/component failure non-powerplant). In order to gain further insight, these seven accidents were classified according to which system/component failed to cause the accident. The results are presented in Figure C8 below.

**Figure C8 Classification of technical cause offshore helicopter accidents by failed system/component for the period 1992 to 2012.**

- 6.3.2 Rotors and transmission account for all but one of the technical cause accidents, which is perhaps unsurprising in view of the criticality of these systems.

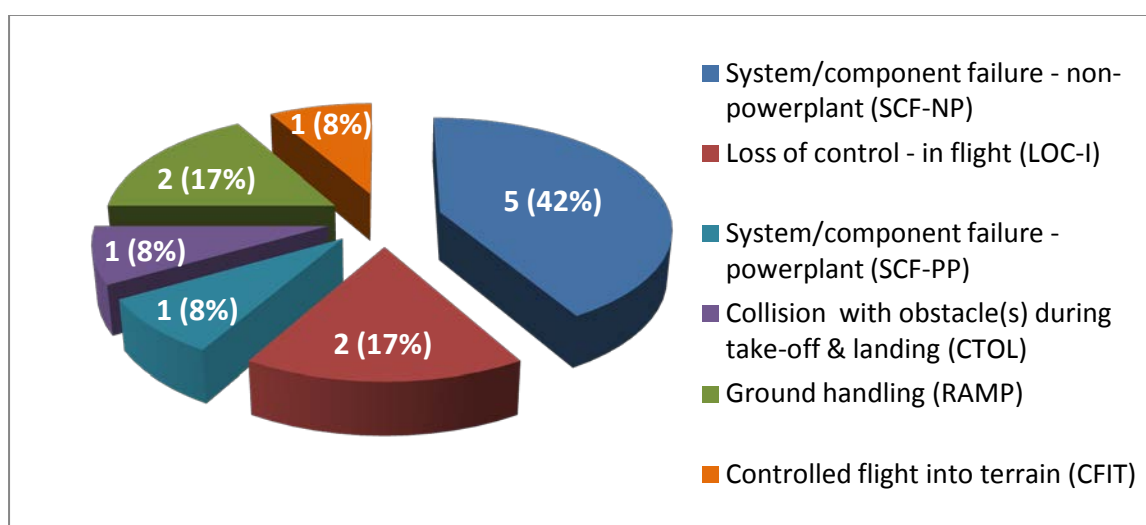
- 7.2.1 The classification of the fatal accidents by CICTT occurrence code is presented in Figure C9 below.

**Figure C9** CICTT classification of fatal offshore helicopter accidents for the period 1976 to 2012

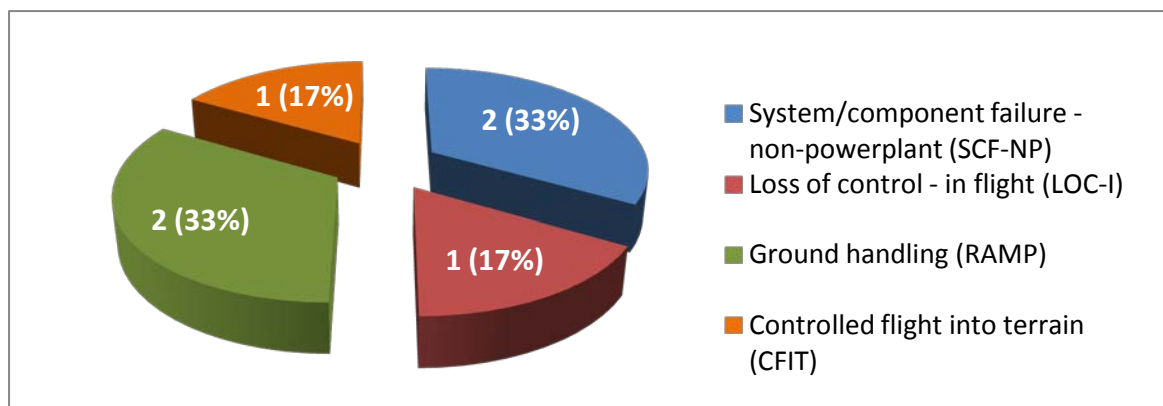
**Figure C10 CICTT classification of fatal offshore helicopter accidents for the period 1992 to 2012**

7.2.3 For completeness the classification of the fatal accidents by CICTT occurrence code for the more recent period of 1992 to 2012 is presented in Figure C10 below.

7.2.4 This suggests the same shift in emphasis from technical cause accidents to operational cause accidents seen in the data for all accidents, although it should be noted that three of the operational cause fatal accidents occurred on the boundary of the period in 1992. As ever, care is needed when working with small sample sizes.

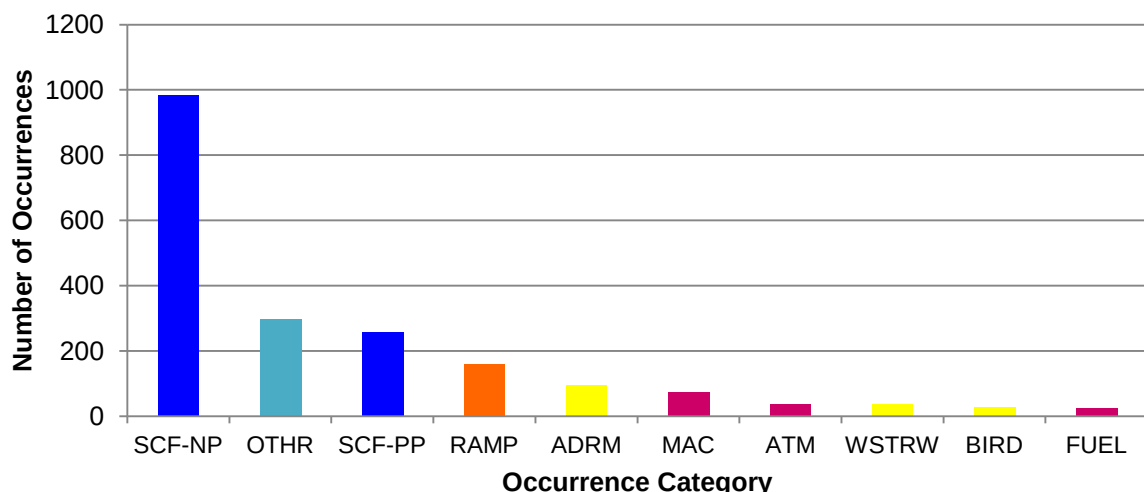
**Figure C11 Norwegian occurrence categories for the period 2008 – 2012 (NB: Colour coding per Figure C13 and C14)**

8.4.1 In recognition of the likely under reporting in Norway during the period 2003 to 2007, Figure C11 and Figure C12 present breakdowns of the occurrences by CICTT code for Norwegian and UK operations, respectively, for the period 2008 to 2012.

- 8.4.3 For both sectors, 'System/Component Failure – Non-Powerplant' (SCF-NP) was the most commonly assigned occurrence category. The second most commonly assigned occurrence category for Norway was 'Other' (OTHR). This category included, but was not limited to, level busts, infringements, incorrect/misread charts/information, callsign confusion, and ash encounters. For the UK the second most commonly assigned occurrence category was 'System/Component Failure – Powerplant' (SCF-PP).

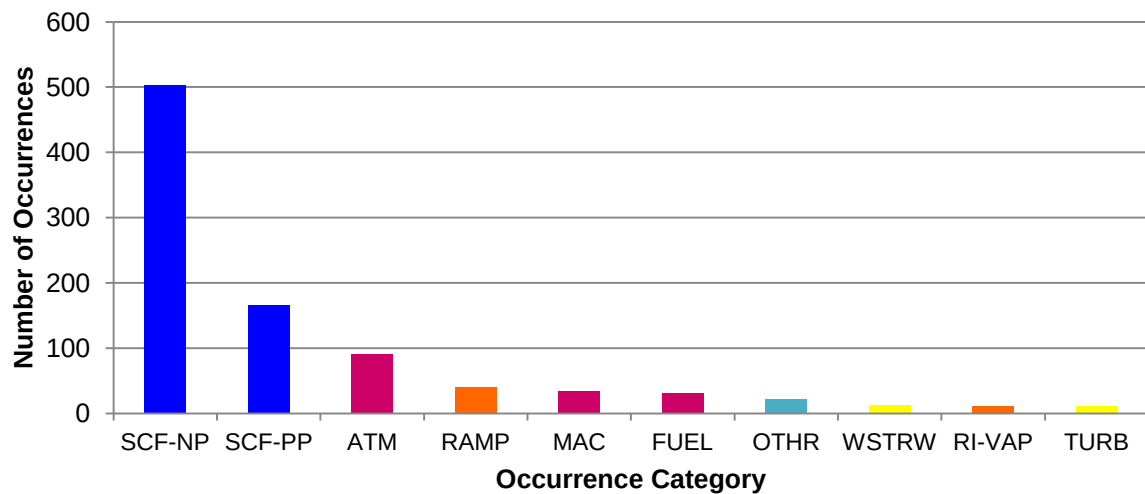
**Figure C12 UK occurrence categories for the period 2008 – 2012 (NB: Colour coding per Figure C13 and C14)**

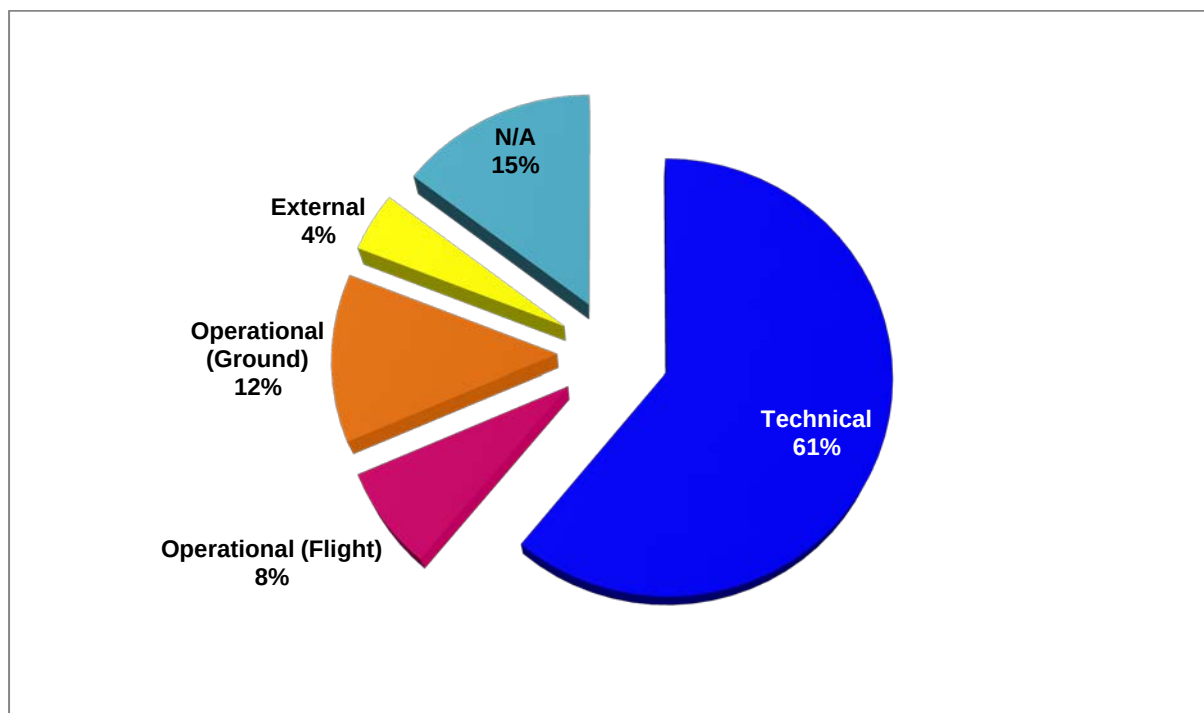
**Figure C13 Occurrence Category Groups for Norwegian Events for the period 2008 – 2012**

- 8.4.4 Using the same grouping as in Section 3, the occurrence categories have been grouped into 'Technical', 'Operational – Flight', 'Operational – Ground', 'External', and 'Not Applicable'. Figures C13 and C14 show the results for Norwegian and UK data respectively. Note that, in this case, the data is presented as a percentage of the total number of CICTT codes rather than total number of occurrences; this is considered to represent the most robust comparison that can be made with the data available.

8.4.5 For the Norwegian data presented in Figure C13, of the 1984 occurrences, 1905 occurrences had one CICTT code, and 79 had two codes. Therefore, the pie chart shows the groupings as a percentage of 2063 ( $1905 + (79 \times 2)$ ).

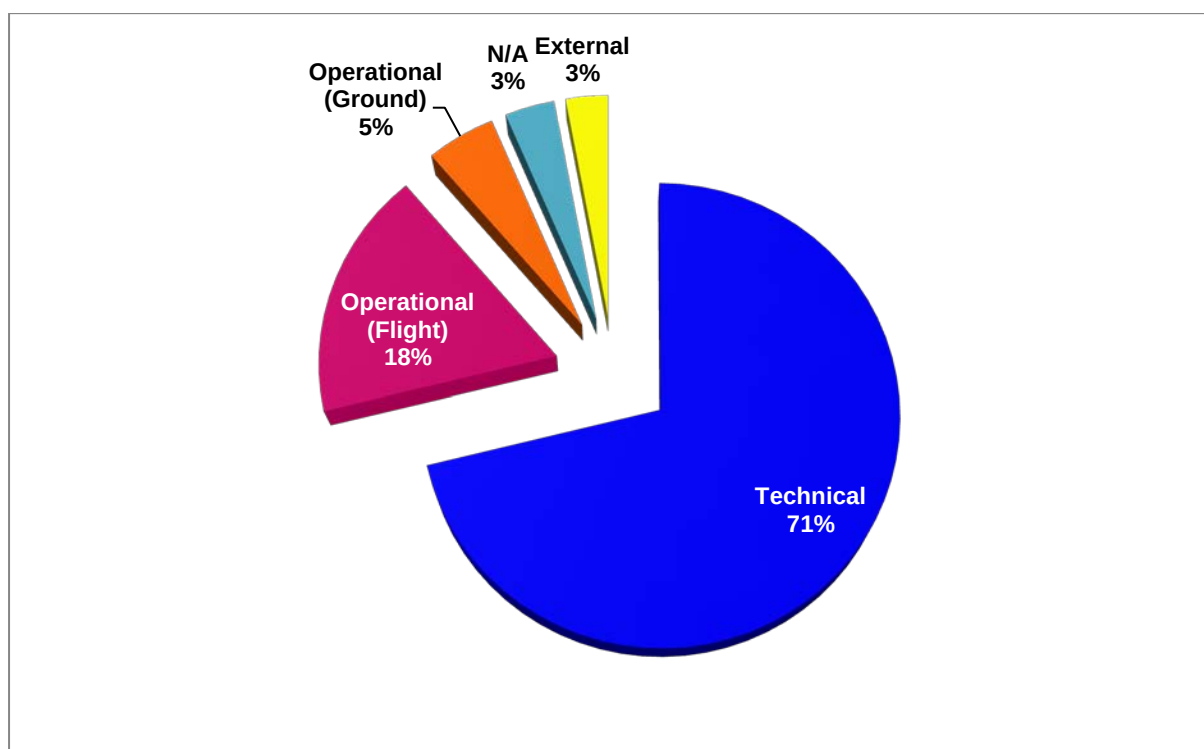
**Figure C14 Occurrence Category Groups for UK Events for the period 2008 – 2012**

- 8.4.6 For the UK data presented in Figure C14, of the 1294 occurrences, 419 had no code, 803 had one code, and 72 had two codes. Therefore, the pie chart shows the groupings as a percentage of 947 (803 + (72 x 2)).
- 8.4.7 As can readily be seen, the breakdowns for the UK and Norway are quite similar with technical accidents dominating both data sets. One noticeable difference, however, is the inversion between Operations – Flight and Operations – Ground; the CAA is unaware of any explanation for this feature in the data.

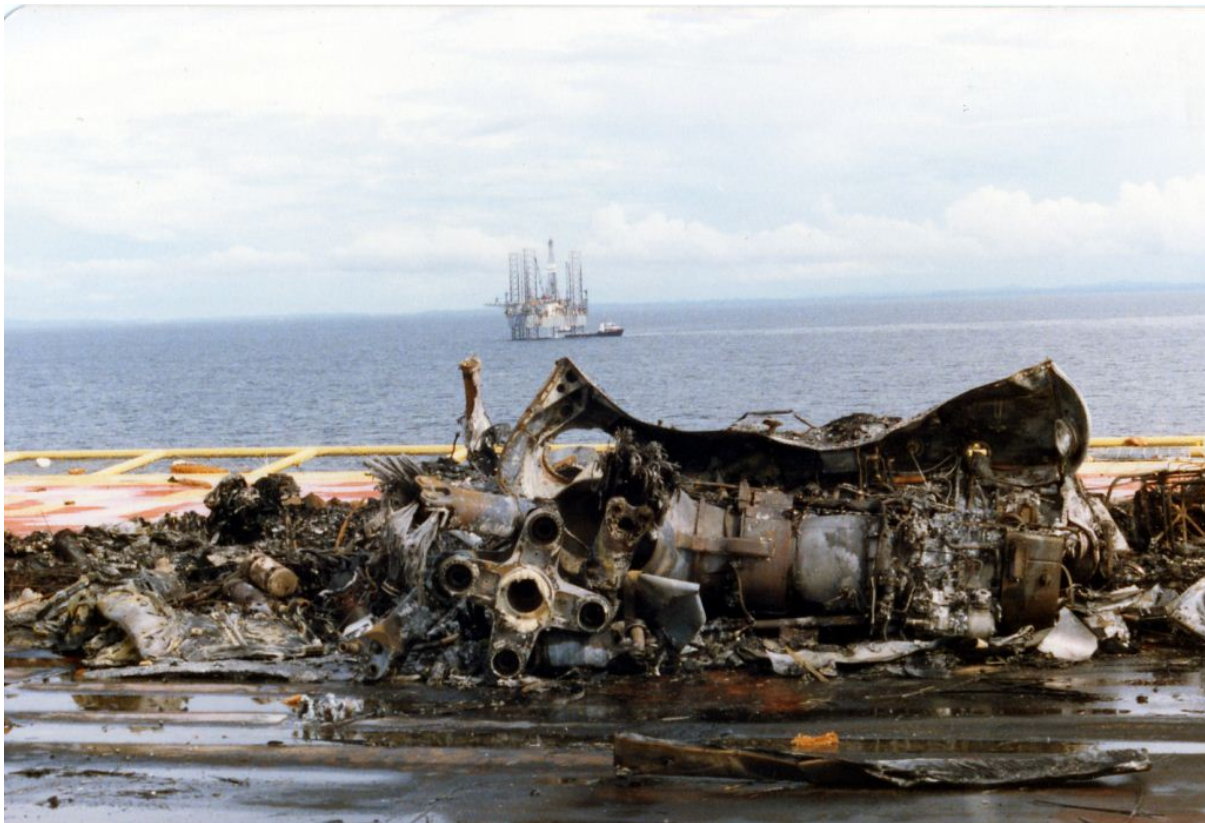
**Figure E1 Remains of Puma 330J on Temena E Platform**

- 1.1.3.9 It is evident for this issue that, supported by the goal-setting requirements of the HSE PFEERs, with their endorsement of the prescriptive requirements of CAP 437, and if helidecks are to be certificated, there is good support from the HSE's suite of goal setting regulations to enable the application of CAP 437 minimum standards for the certification of offshore helidecks.
- 1.1.3.10 A post-crash fire is a major hazard for offshore helideck operations and as a reasonably foreseeable event needs to be appropriately mitigated. Major fires with the consequential loss of the helicopter have occurred on offshore helidecks outside the UKCS. Figure E1 below shows a crash and burn incident on the Temena E platform in the South China Sea which occurred in 1985. The helicopter pictured is the remains of a Puma 330J.

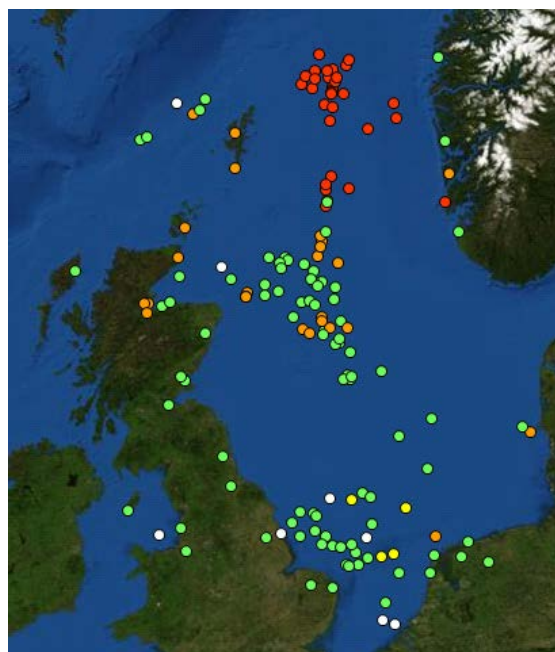
**Figure E2** Screen shot from Helimet showing installations providing real time information

- access to live weather information from over 105 installations mainly in the North Sea and shown in graphical and tabular forms;
- map based information highlighting where weather may be below (or above) certain limits;
- a facility for the weather observer to complete and issue the weather report form; and
- an archive of weather report forms.

2.5.5 The Helimet system has been designed for two main users, firstly those who wish to see the output from cloud and visibility sensors from a neighbouring installation to assist in the assessment of the weather conditions and secondly to enable an efficient method of submitting the weather report to the helicopter operators. Additionally it provides situational awareness of weather conditions across the North Sea for helicopter operations staff.

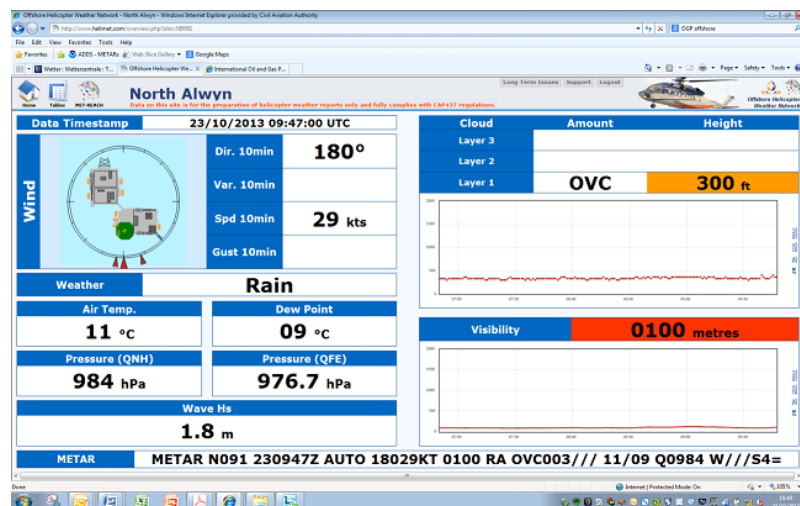
**Figure E3 Screen shot from Helimet showing live weather information for the N Alwyn**

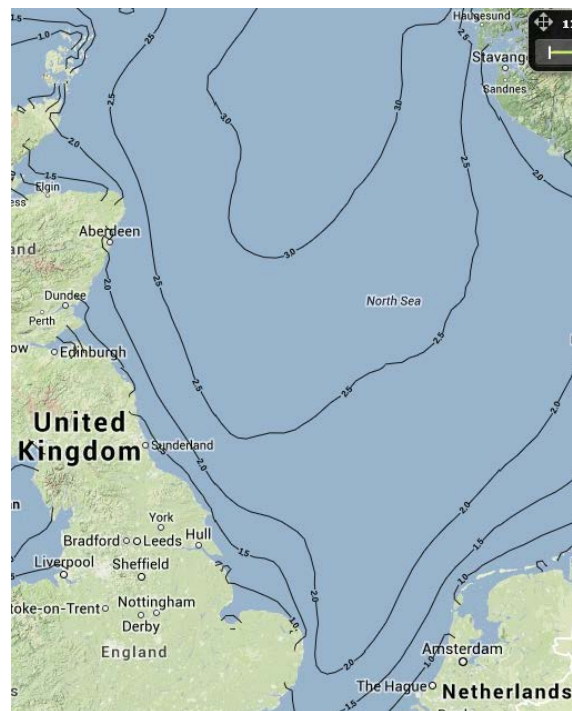
**Figure E4 Forecast Significant Wave Height – Screen Shot from OHWeb**

2.10.3 In addition forecast significant wave height information is provided on OHWeb.

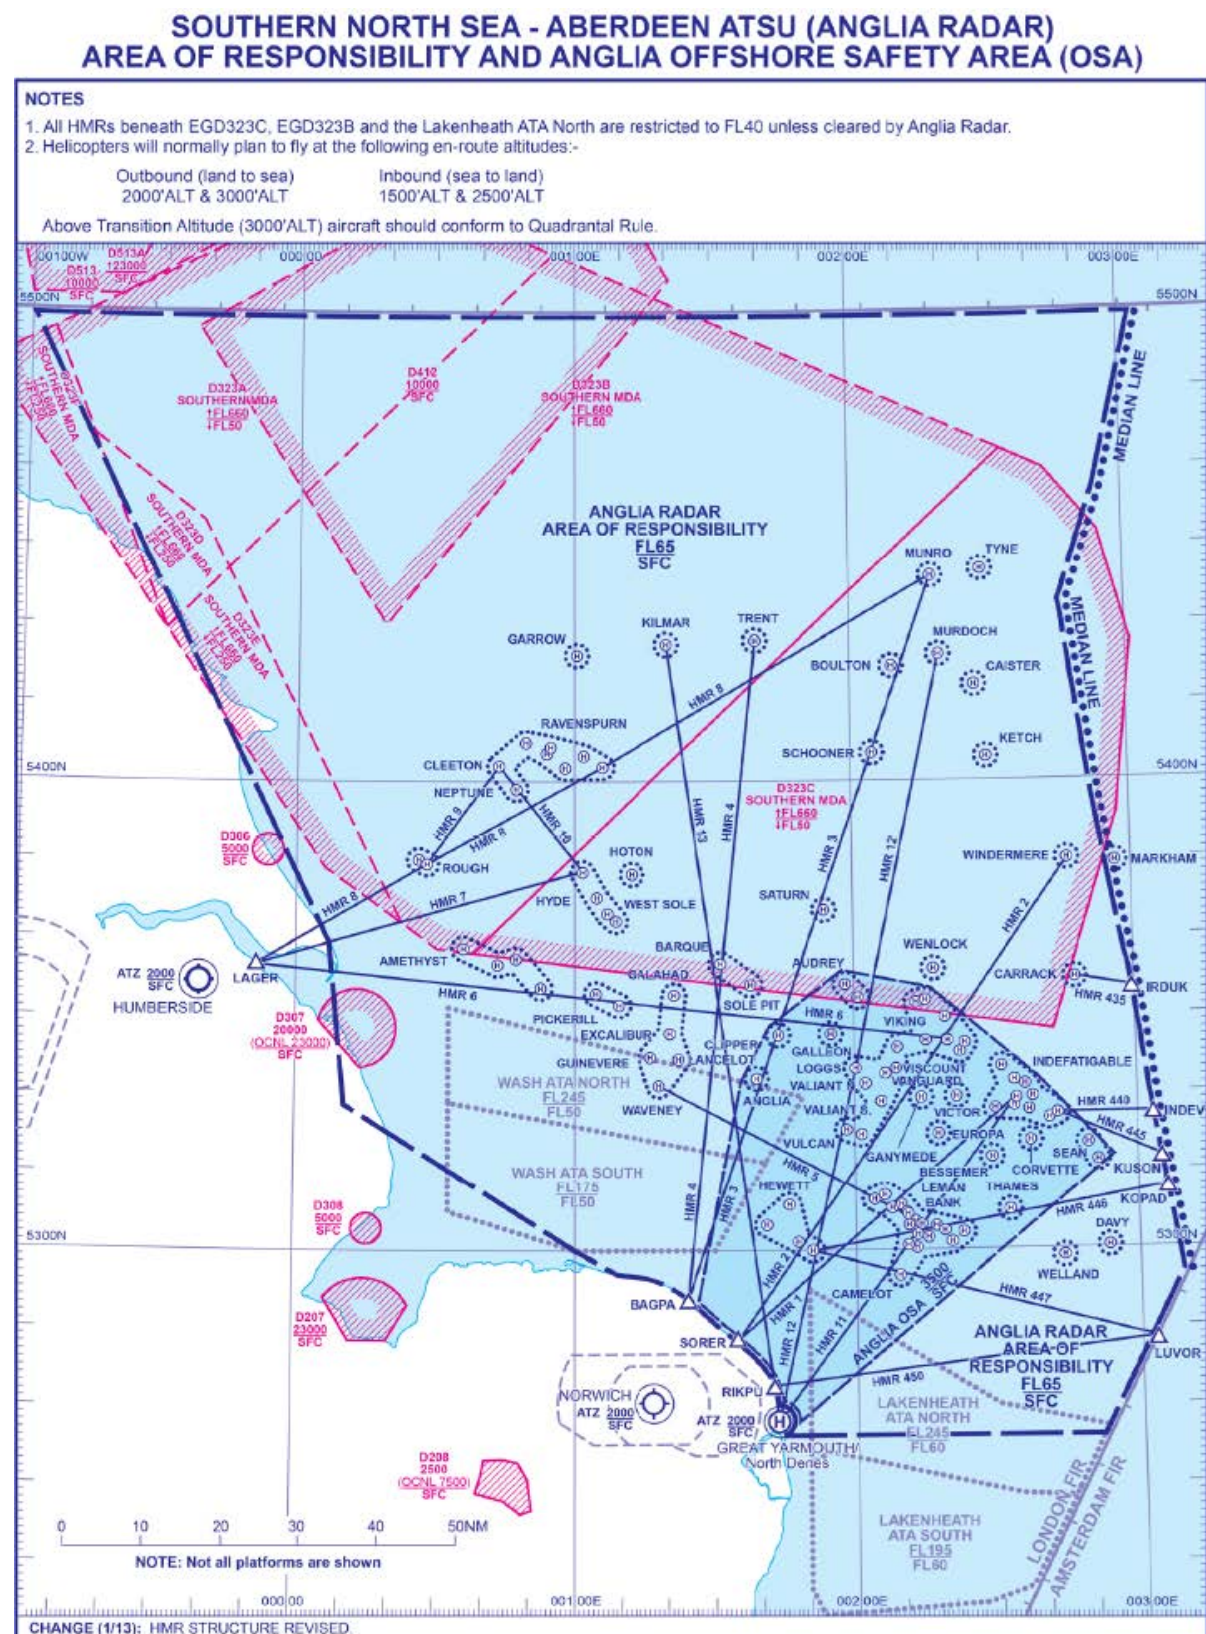
Figure E5 ATM Map of Southern North Sea

- Helicopter Traffic Zones (HTZ) are established in the Southern North Sea as notification of helicopters engaged in platform approaches, departures and extensive uncoordinated inter-platform transit flying. Inter-platform flying by civil helicopters within HTZs contained within the OSA will be conducted on the company or field discrete frequency. HTZs consist of the airspace from sea level to 2,000 ft ALT contained within tangential lines, not exceeding 5 NM in length, joining the neighbouring circumferences of circles 1.5 NM radius around each individual platform helideck.
