# APPENDIX I

# Civil Aviation Authority – Safety review of offshore public transport helicopter operations in support of the exploitation of oil and gas

**CAP 1145**

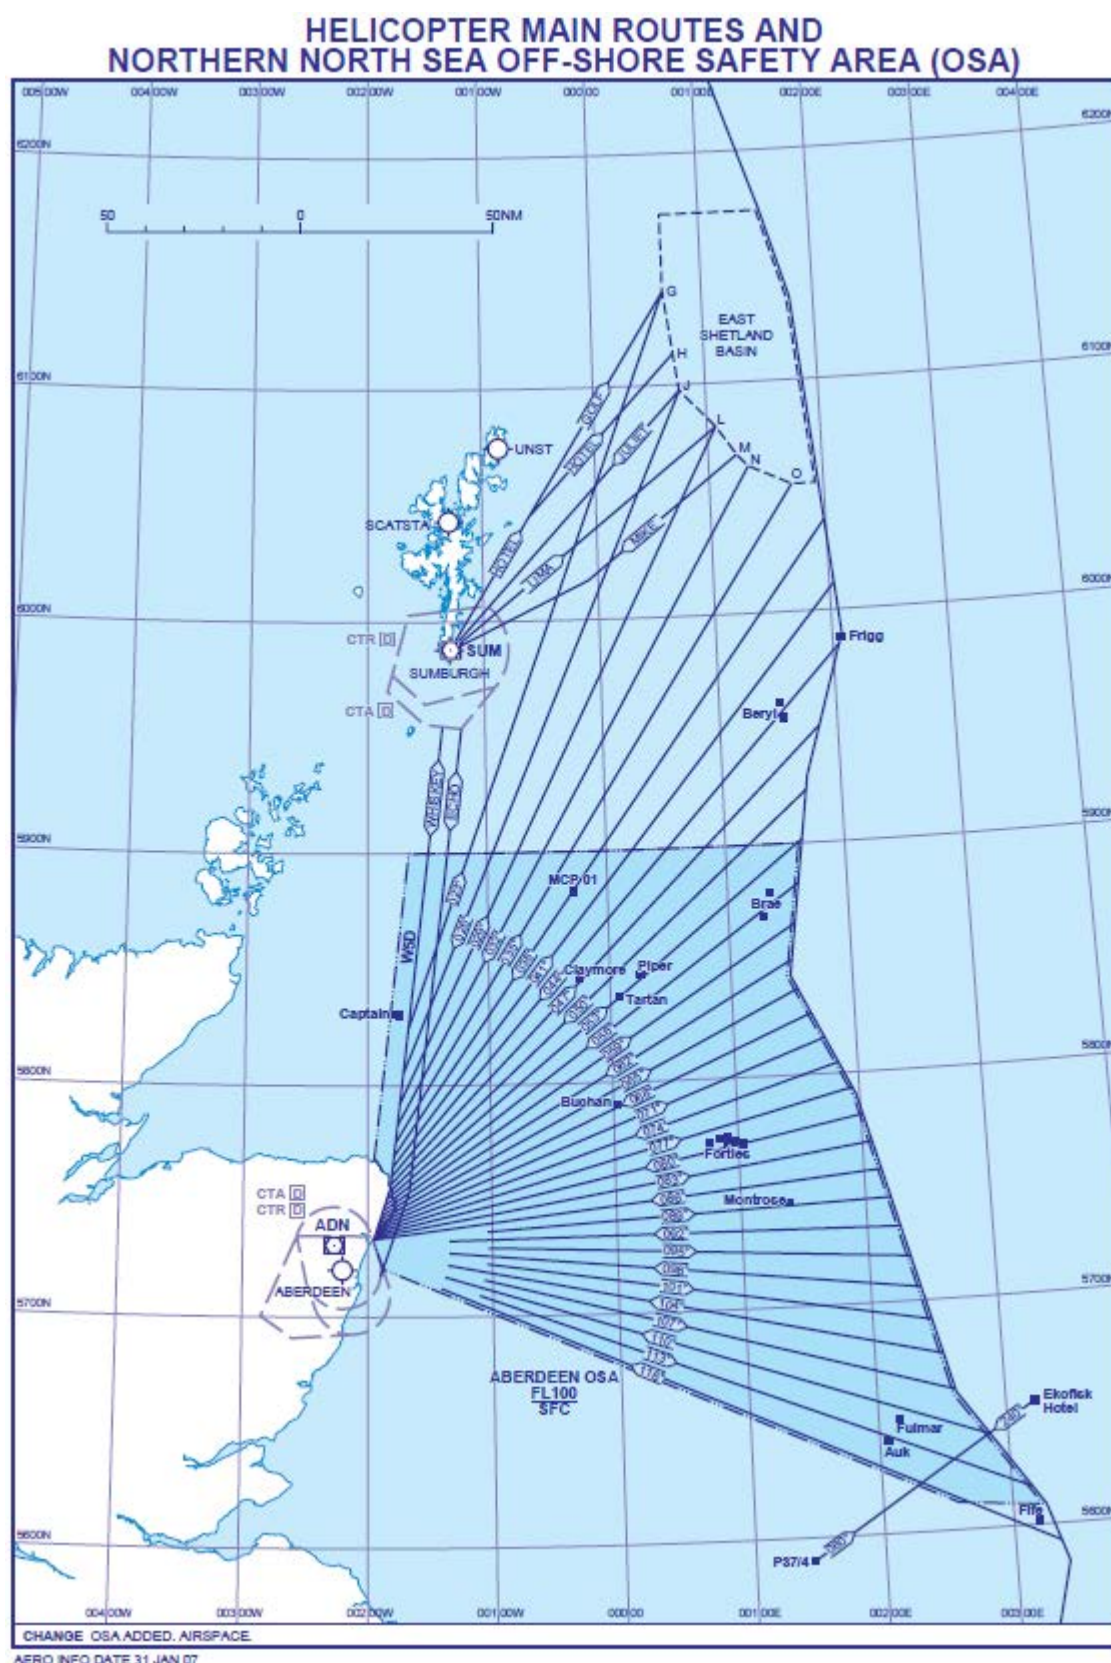
Figure E6 Helicopter Main Routes

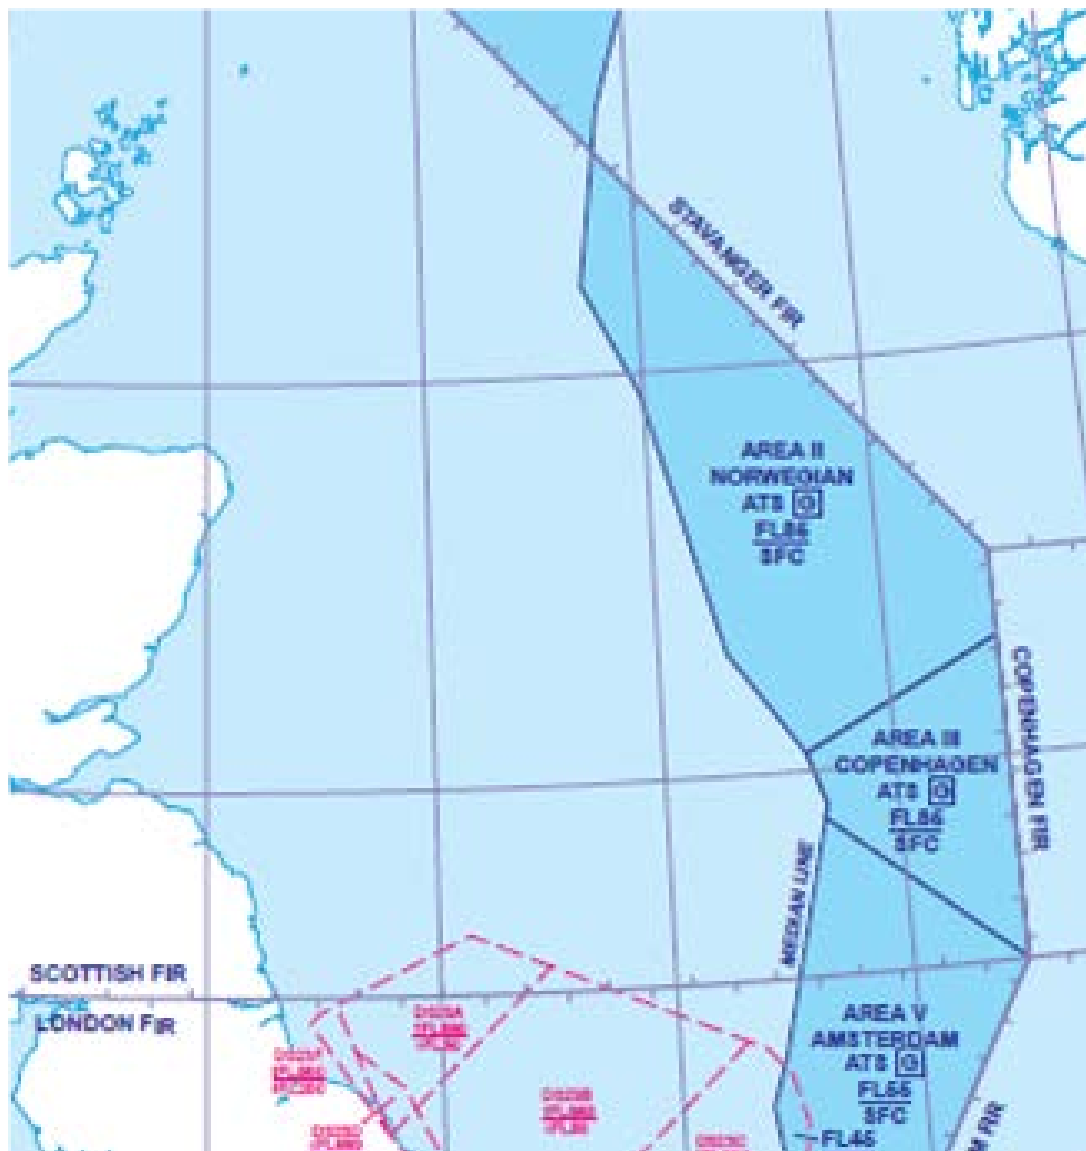
Figure E7 North Sea ATM Meridian

- Statfjord CTA (based on radar) which was established in 1995, after the Gullfaks offshore (MSSR) radar was installed in 1994. Class E airspace established as this was the highest class it was realistically possible to achieve in international waters. Upgraded to class D in 2011 when Heidrun CTA was established. Statfjord CTA planned to be based on ADS-B from 2015/16.
- Heidrun CTA (based on radar) established in 2012, after installation of Heidrun offshore radar. Class D airspace established.
- Ekofisk CTA (based on ADS-B) will be established November 2014. Class D.
- Balder CTA (based on ADS-B) will be established November 2014. Class D.

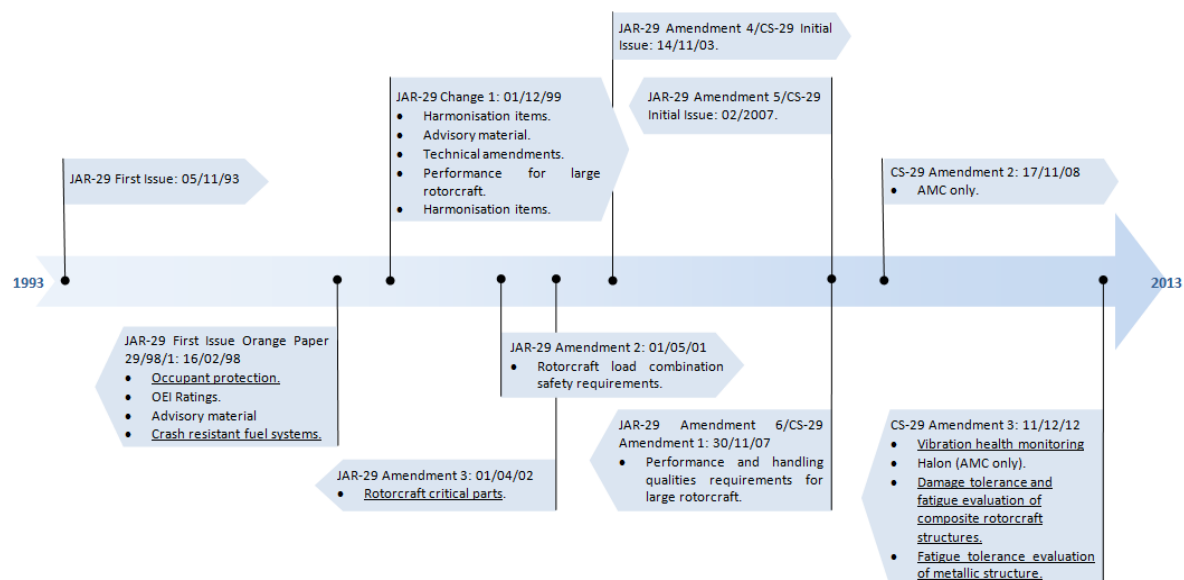
**Figure F1 Summary Timeline of Helicopter Certification Regulatory Developments**

- 2.2.6 As demonstrated in Figure F1, significant rulemaking and changes have taken place but the benefits of these new certification requirements will take a while to show tangible benefits as they are mainly applicable to new designs (not derivatives, unless the applicant for a derivative elects to comply with a later requirement or the change itself is deemed significant). These requirement developments are not applied retrospectively to already certificated aircraft.

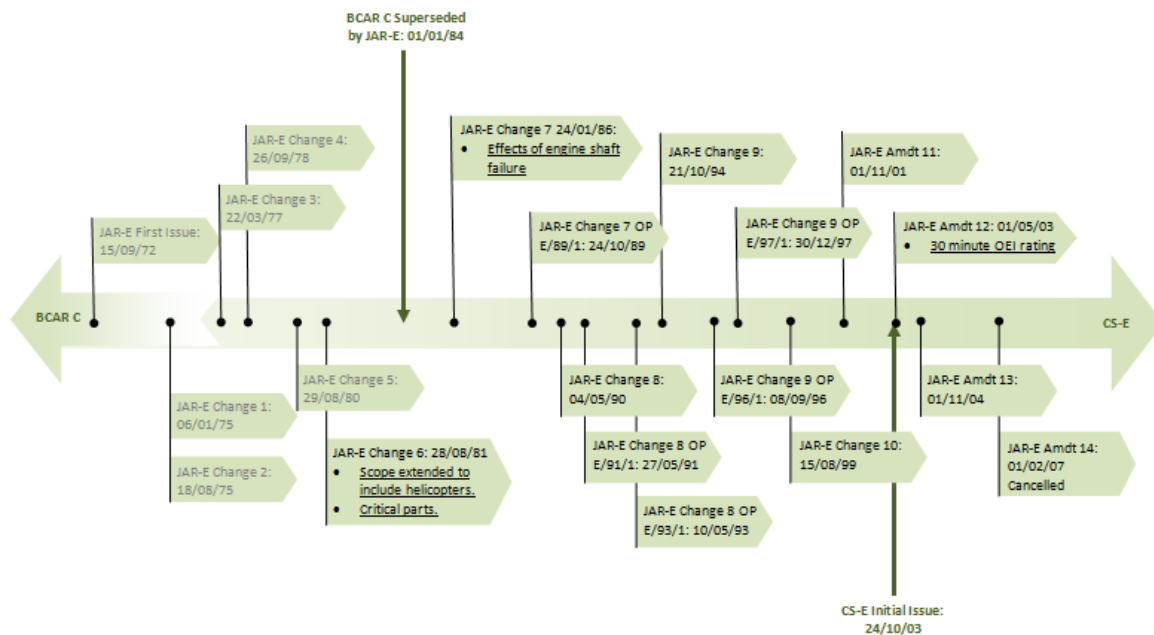
**Figure F2 Summary Timeline of Engine Certification Regulatory Developments**

- 2.5.1 For completeness, engine types fitted to the current offshore fleet are listed below with their reference dates and nominal applied certification code.
- 2.5.2 Helicopter engines were not specifically addressed by JAR-E before amendment 6 in August 1981. Thus, in the period between JAR-E's initial issue in September 1972 and amendment 6, use was made of existing national codes such as the UK's BCAR Section C. A regulatory change of particular relevance to the offshore helicopter fleet (the 30-minute OEI rating/NPA E-19) was introduced at JAR-E Amendment 12, just before the code transitioned into CS-E (which was equivalent to JAR-E Amendment 13).
- 2.5.3 Due to the low number of purely engine-related occurrences offshore in the period when compared to those for the aircraft as a whole, details of developments to the European Engine code CS-E (formerly JAR-E) are not included.

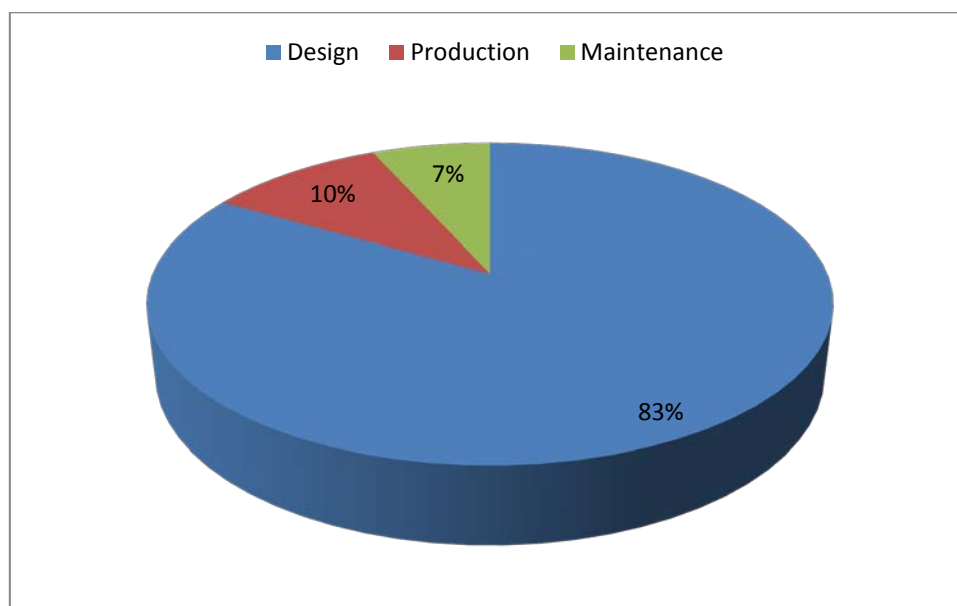
Figure F3 Causal factors

- Production - Components / parts / fabrications not conforming to the design drawing or other deviations in the process.

3.3.4 This group has not been ranked according to their severity, and they range from minor incidents to catastrophic accidents..From this high level review, although it is clear that causes arising from design aspects account for the major share of the target group of accidents, it is not possible at this time, therefore, in lieu of a more detailed analysis, to draw specific conclusions as to the real contribution made by design causes to offshore safety. Of the events attributed to design causes, the top five areas that have contributed are:

- Main Gear Box and transmission system - 20%
- Electrical - 20%
- Engines - 15%
- Horizontal Stabiliser - 11%
- Main Rotor Blade - 11%

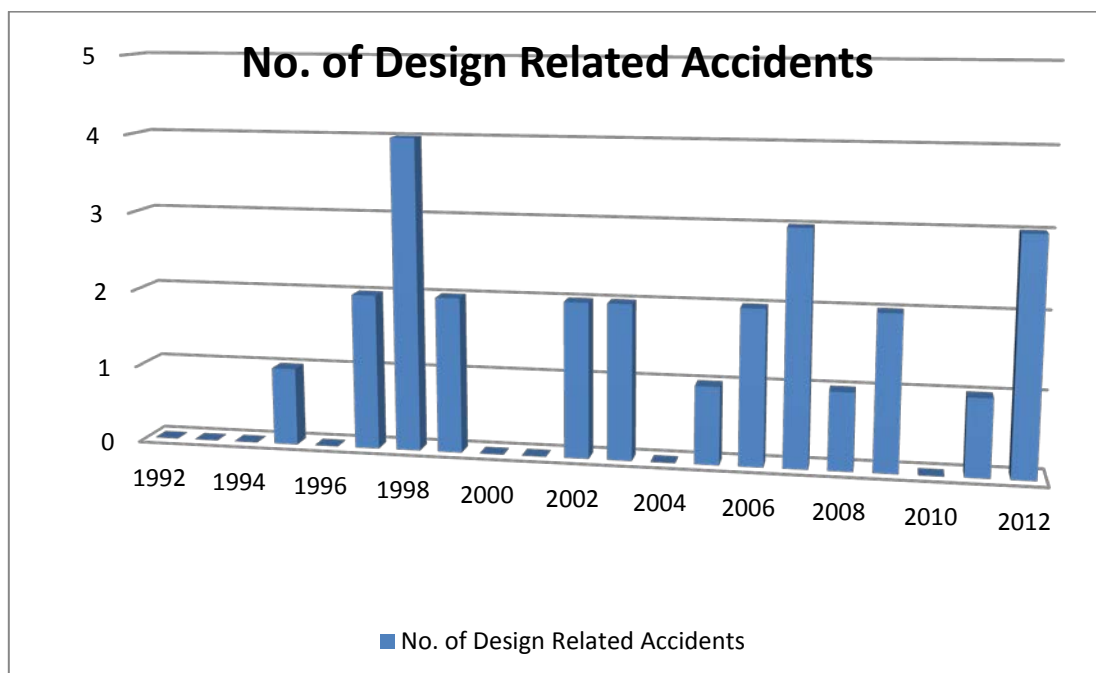
**Figure F4 Number of Design-Related Helicopter Accidents Per Year**

3.3.5 Figure F4 is a simple chart of number of design related accidents which does not take into account parameters such as operating hours / cycles etc, hence does not indicate normalised rates. This simple view therefore does not indicate any specific trending.

3.3.6 Caution needs to be applied when drawing conclusions from this raw data. For detailed and meaningful conclusions to be drawn from this data, e.g. breaking the data into causal versus contributory factors and then ranking that data, greater analysis would be required. This is covered in Recommendation 3 above.

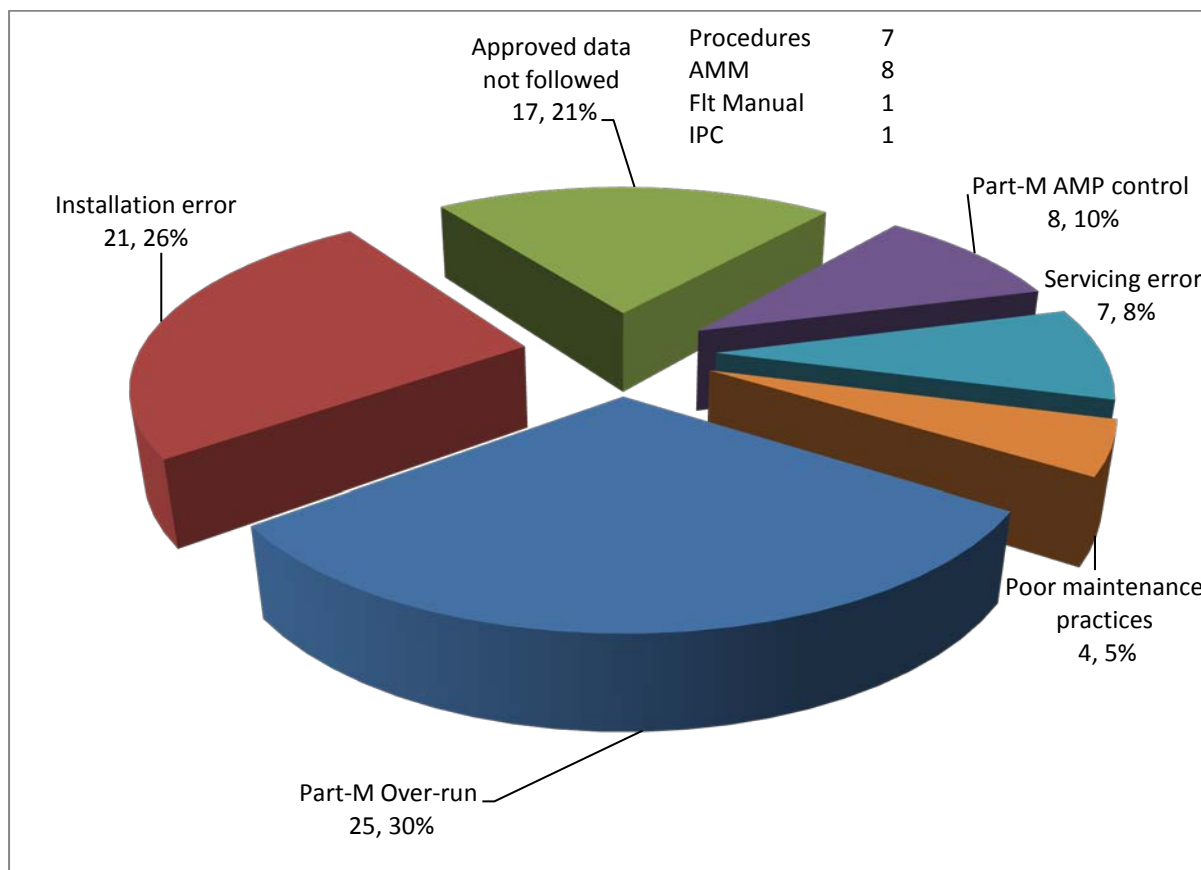
**Figure F5 MOR Human Factors Errors reported in the North Sea organisations**

The CAA will carry out a further review of Human Factors Maintenance Error data referred to in this report and publish the results.
