# EAST PARK ENERGY

## Outline Construction Traffic Management Plan

**Document Reference: EN010141/DR/7.4**

**September 2025**

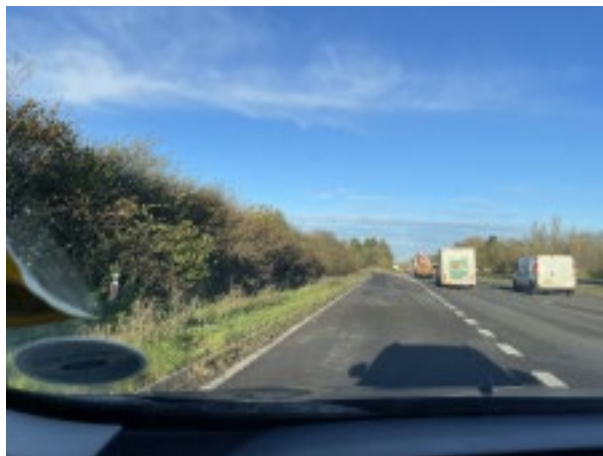
**Photograph 1 - (OS Grid Ref: TL 17115 61019)**

Vehicle moves away from camera and to leave A1 Northbound at junction for Kimbolton B645.

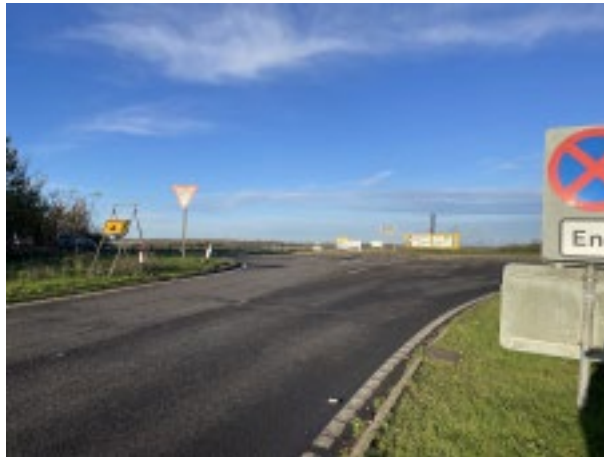
**Photograph 2 - (OS Grid Ref: TL 17187 61297)**

Vehicle moves away from camera. Make left hand turn onto B645.

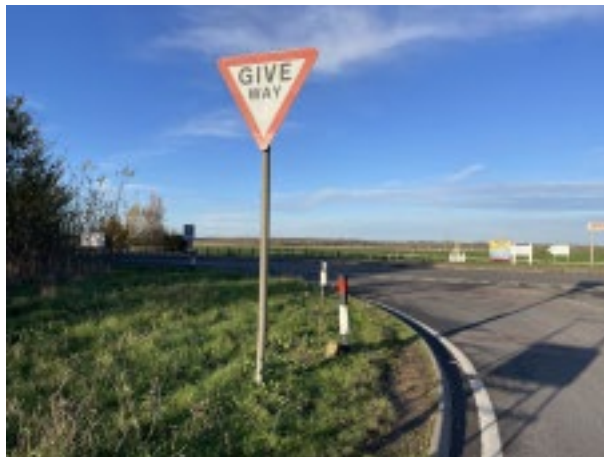
**Photograph 3 - (OS Grid Ref: TL 17187 61297)**

'Give Way' signpost and bollards may be temporarily removed in order to make use of the over sail on left hand turn. This will be assessed at the time by the appointed haulier and driven by the size of frame trailer being used for the movement.

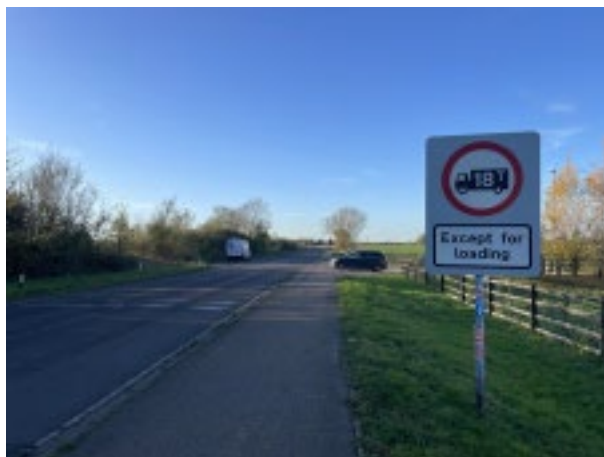
**Photograph 4 - (OS Grid Ref: TL 17187 61297)**

Vehicle moves away from camera. Travel through environmental 18Te weight limit restrictions is permitted under the agreed Special Order.

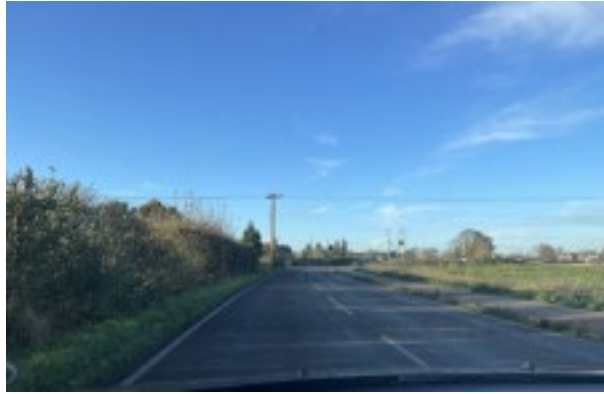
**Photograph 5 - (OS Grid Ref: TL 16652 61612)**

Vehicle moves away from camera and travels underneath overhead electrical power lines.

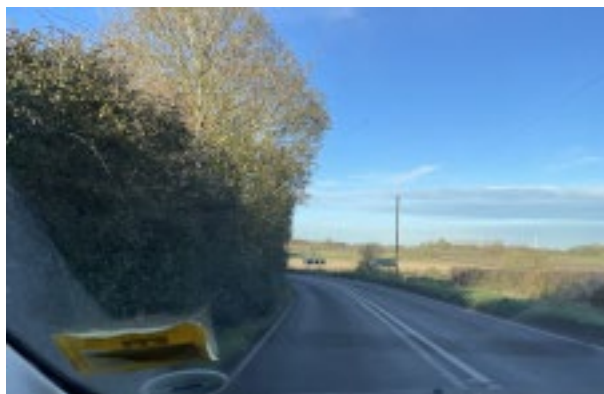
**Photograph 6 - (OS Grid Ref: TL 15673 63002)**

Vehicle moves away from camera. Roadway meanders around tree lined bends. Due to long sweeping nature of highway, this is deemed to be negotiable with full use of width of carriageway. A Police escort would be required to temporarily close the roadway. In some instances, Police forces have stipulated that temporary traffic regulation orders (TTRO) are in place.

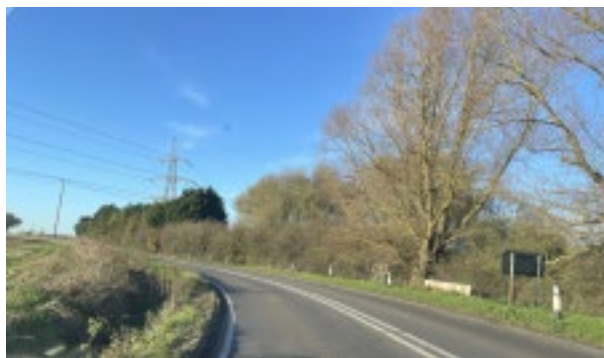
**Photograph 7 - (OS Grid Ref: TL 15356 63390)**

Vehicle moves away from camera. Long sweeping left hand bend on approach to potential access area. Over sail area available.

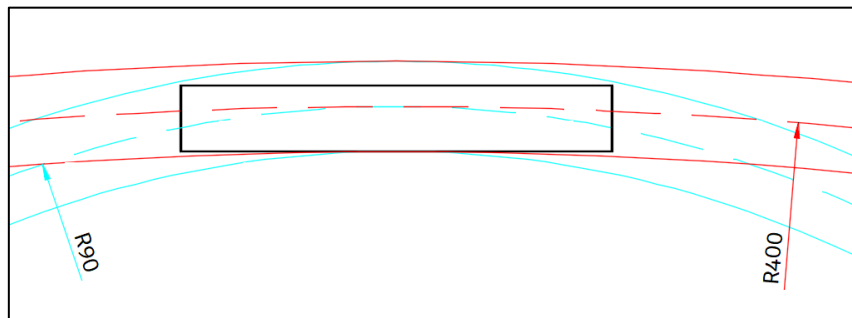
**Figure 2. Horizontal Alignment Check**

All the underbridges on the proposed load route within Area 6 & 8 and under National Highways ownership support either the A47 or A1 main westbound / southbound bound carriageways respectively, which are in general two-lane dual carriageways. Standard lanes widths are 3.65 m as published in CD 127, equating to an available running width of 7.3m for two-lane carriageways. The proposed vehicle width of 5.35m over a rigid length of 34.95m is just able to be accommodated by a 90m radius as shown in Figure 2 below. In comparison, CD 127 allows a radius of greater than 400 m for conventional road sections. Tightened radii of 90 – 400 metres is governed by CD 109, and radii less than 90 metres if governed by CD 123, both of which provide requirements for widening in accommodation of the tighter radii. For the majority of the route, it is considered suitable to accommodate the rigid dimensions of the proposed vehicle, on the understanding that the vehicle

will straddle both traffic lanes. The route comprises a number of roundabout crossings which could affect vehicle movement across underbridges, however no structures are identified within close proximity to the roundabout radii based on the vehicle dimensions above.

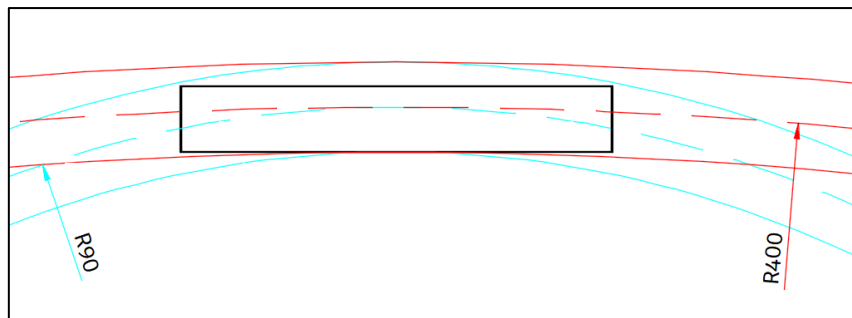
**Figure 3. Horizontal Alignment Check**

available running width of 7.3m for two-lane carriageways. The proposed vehicle width of 5.35m over a rigid length of 34.95m is just able to be accommodated by a 90m radius as shown in Figure 2 below. In comparison, CD 127 allows a radius of greater than 400 m for conventional road sections. Tightened radii of 90 – 400 metres is governed by CD 109, and radii less than 90 metres if governed by CD 123, both of which provide requirements for widening in accommodation of the tighter radii. For the majority of the route, it is considered suitable to accommodate the rigid dimensions of the proposed vehicle, on the understanding that the vehicle will straddle both traffic lanes. The route comprises a number of roundabout crossings which could affect vehicle movement beneath overbridges, however no structures are identified within close proximity to the roundabout radii based on the vehicle dimensions above.
