# EAST PARK ENERGY

EN010141

## Outline Construction Traffic Management Plan

**Document Reference: EN010141/DR/7.4**

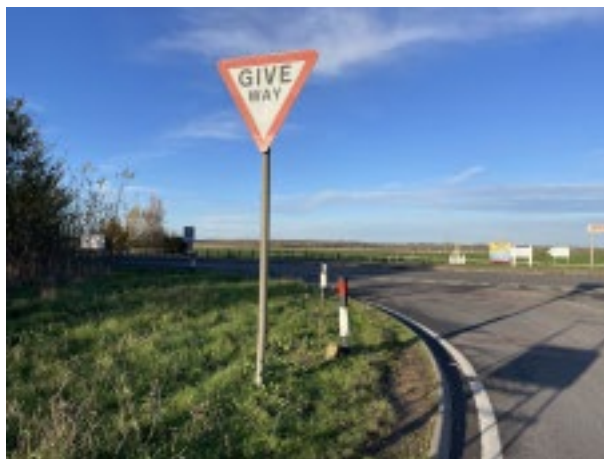
**Photograph 3 - (OS Grid Ref: TL 17187 61297)**

'Give Way' signpost and bollards may be temporarily removed in order to make use of the over sail on left hand turn. This will be assessed at the time by the appointed haulier and driven by the size of frame trailer being used for the movement.

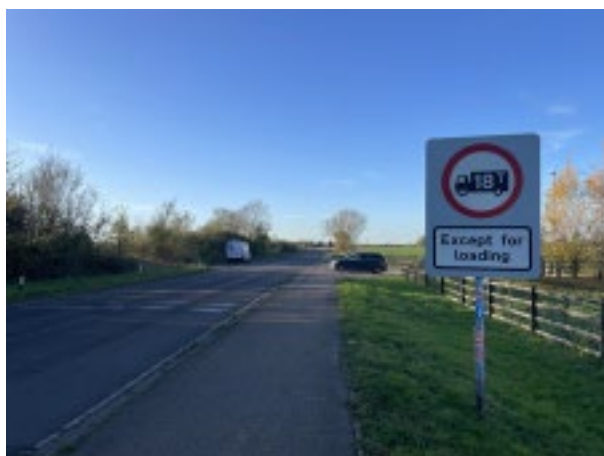
**Photograph 4 - (OS Grid Ref: TL 17187 61297)**

Vehicle moves away from camera. Travel through environmental 18Te weight limit restrictions is permitted under the agreed Special Order.

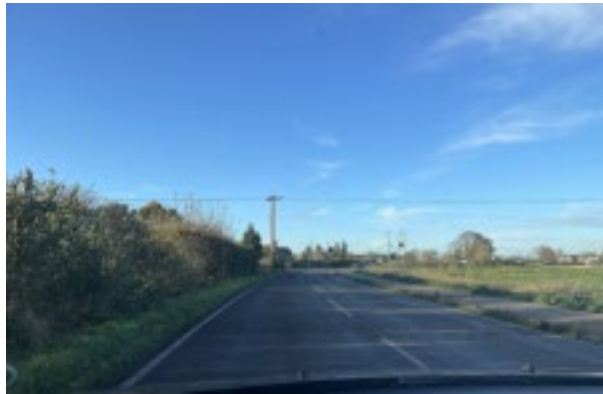
**Photograph 5 - (OS Grid Ref: TL 16652 61612)**

Vehicle moves away from camera and travels underneath overhead electrical power lines.

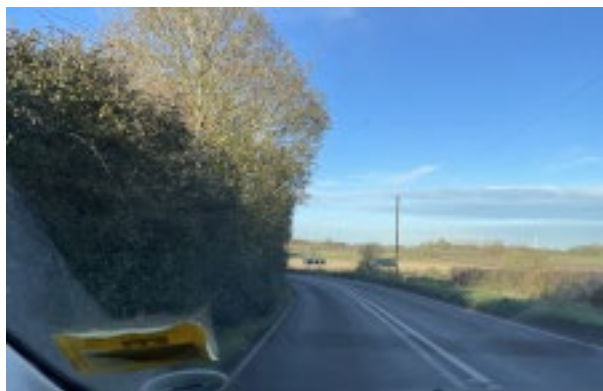
**Photograph 6 - (OS Grid Ref: TL 15673 63002)**

Vehicle moves away from camera. Roadway meanders around tree lined bends. Due to long sweeping nature of highway, this is deemed to be negotiable with full use of width of carriageway. A Police escort would be required to temporarily close the roadway. In some instances, Police forces have stipulated that temporary traffic regulation orders (TTRO) are in place.

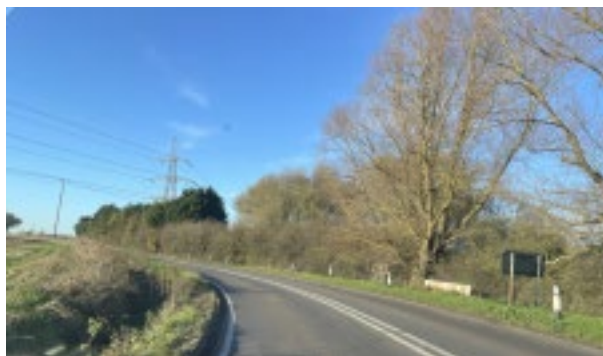
**Photograph 7 - (OS Grid Ref: TL 15356 63390)**

Vehicle moves away from camera. Long sweeping left hand bend on approach to potential access area. Over sail area available.

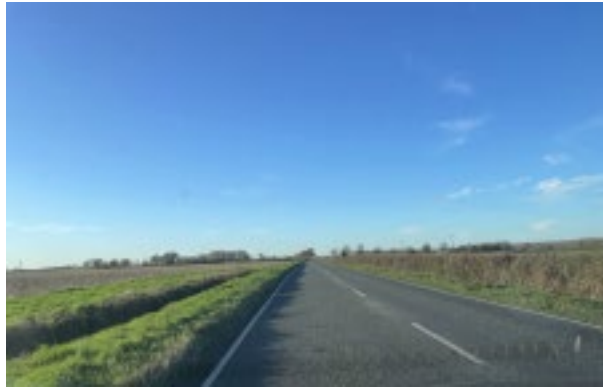
**Photograph 8 - (OS Grid Ref: TL 14674 63845)**

- 8.1. Access is yet to be constructed to the proposed solar farm site. The below photograph is an approximate location of where the access will be located.

Left of photograph is approximate location of entrance to access road development. No issues anticipated although temporary structure or installation of culvert will be required to traverse the drainage channel near to roadside. The proposed site access design will need to be considerate of the AIL delivery vehicle.

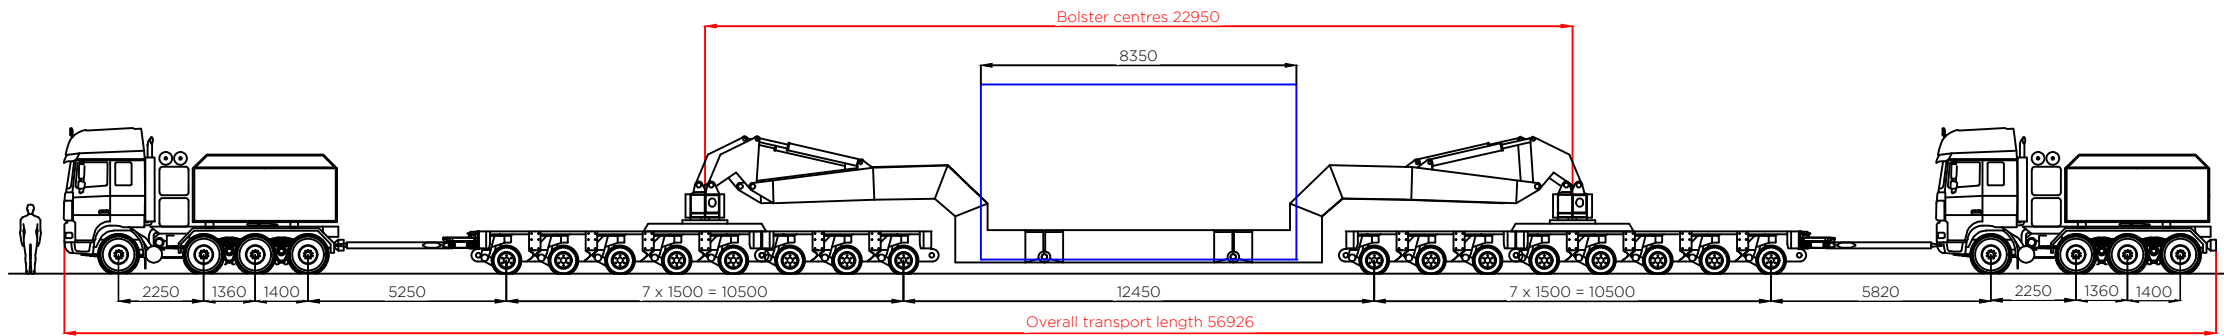
Elevation view - 16 axle girder frame trailer - concept model only  
Indicative 160 te transformer  
Scale 1:200

Final Carrying Arrangements, including Final Overall Transport  
Sizes to be Confirmed via Appointed Haulier.  
Transformer Dimensions are:  
8.35m (L), 3.885m (W), 4.625m (H)

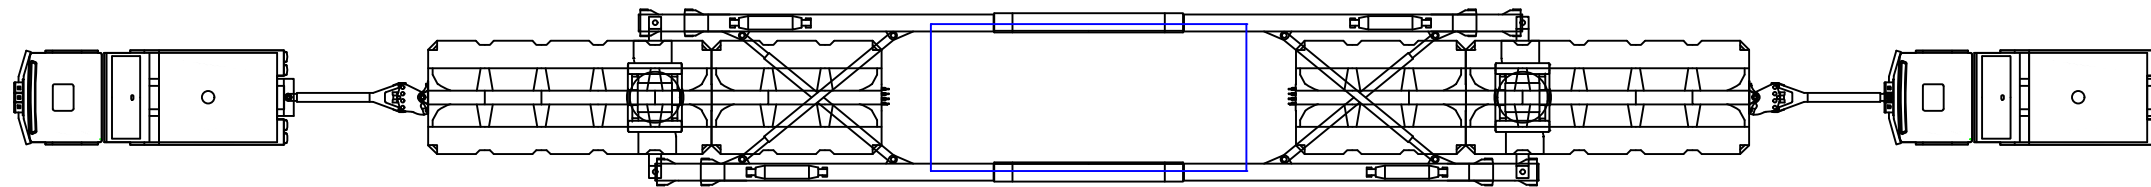
Plan view - 16 axle girder frame trailer - concept model only  
Indicative 160 te transformer  
Scale 1:200

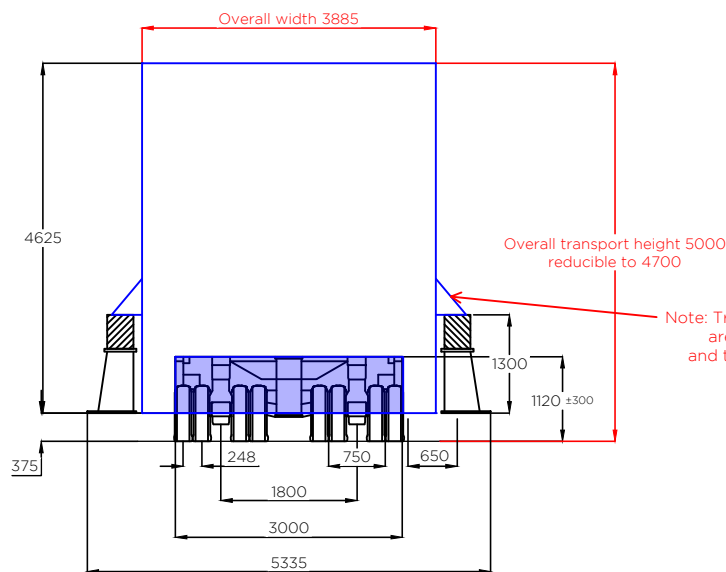
Profile view  
Indicative 160 te transformer  
Scale 1:100

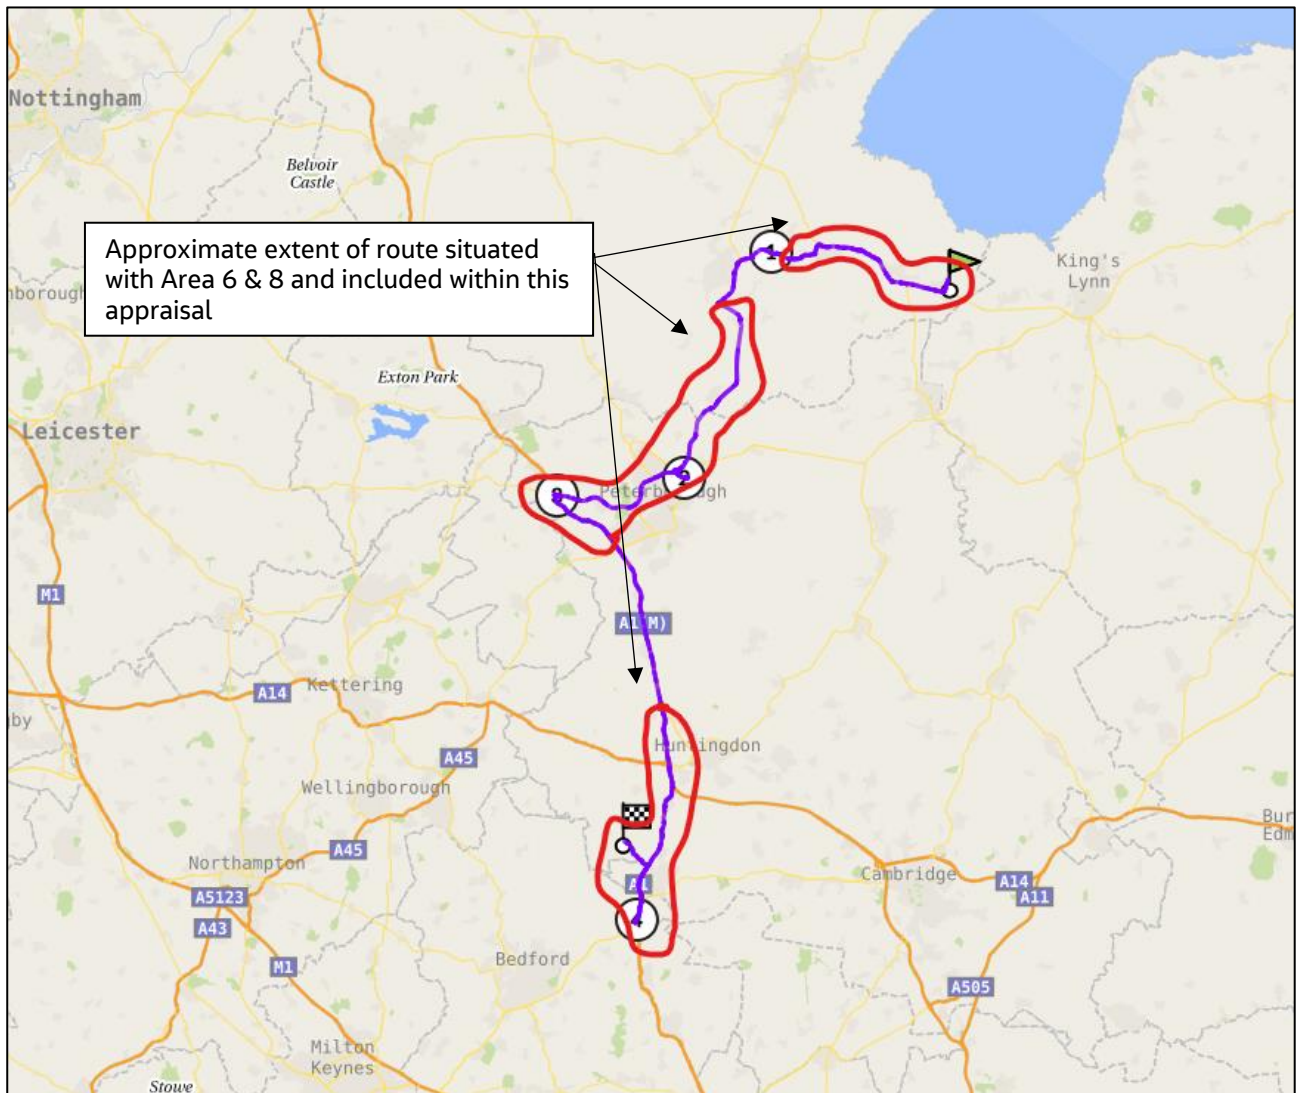
Figure 1. Route Map

This report covers the proposed special load movement Route: WYNL/192/S1 as illustrated in Figure 1. Only National Highways structures, specifically those within Areas 6 & 8 only, are to be covered under this scheme. Any remaining structures, such as local authorities, are assumed to be appraised by the relevant overseeing organisation.

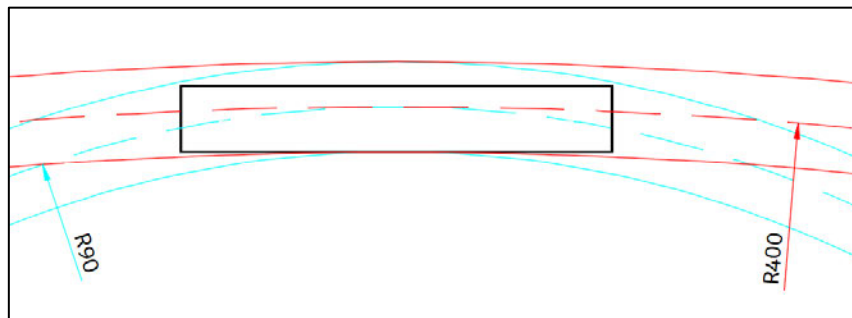
**Figure 2. Horizontal Alignment Check**

All the underbridges on the proposed load route within Area 6 & 8 and under National Highways ownership support either the A47 or A1 main westbound / southbound bound carriageways respectively, which are in general two-lane dual carriageways. Standard lanes widths are 3.65 m as published in CD 127, equating to an available running width of 7.3m for two-lane carriageways. The proposed vehicle width of 5.35m over a rigid length of 34.95m is just able to be accommodated by a 90m radius as shown in Figure 2 below. In comparison, CD 127 allows a radius of greater than 400 m for conventional road sections. Tightened radii of 90 – 400 metres is governed by CD 109, and radii less than 90 metres if governed by CD 123, both of which provide requirements for widening in accommodation of the tighter radii. For the majority of the route, it is considered suitable to accommodate the rigid dimensions of the proposed vehicle, on the understanding that the vehicle

will straddle both traffic lanes. The route comprises a number of roundabout crossings which could affect vehicle movement across underbridges, however no structures are identified within close proximity to the roundabout radii based on the vehicle dimensions above.

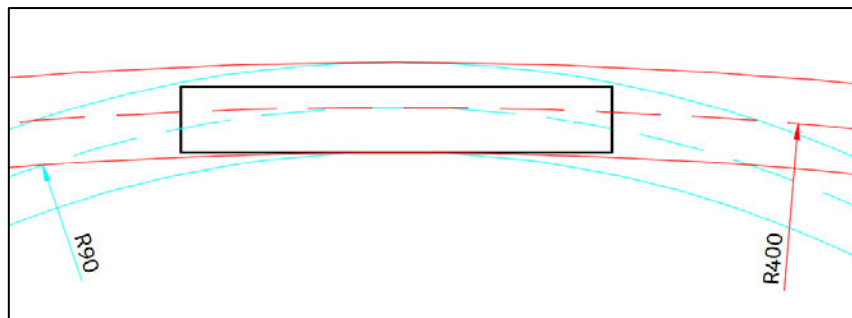
**Figure 3. Horizontal Alignment Check**

available running width of 7.3m for two-lane carriageways. The proposed vehicle width of 5.35m over a rigid length of 34.95m is just able to be accommodated by a 90m radius as shown in Figure 2 below. In comparison, CD 127 allows a radius of greater than 400 m for conventional road sections. Tightened radii of 90 – 400 metres is governed by CD 109, and radii less than 90 metres if governed by CD 123, both of which provide requirements for widening in accommodation of the tighter radii. For the majority of the route, it is considered suitable to accommodate the rigid dimensions of the proposed vehicle, on the understanding that the vehicle will straddle both traffic lanes. The route comprises a number of roundabout crossings which could affect vehicle movement beneath overbridges, however no structures are identified within close proximity to the roundabout radii based on the vehicle dimensions above.

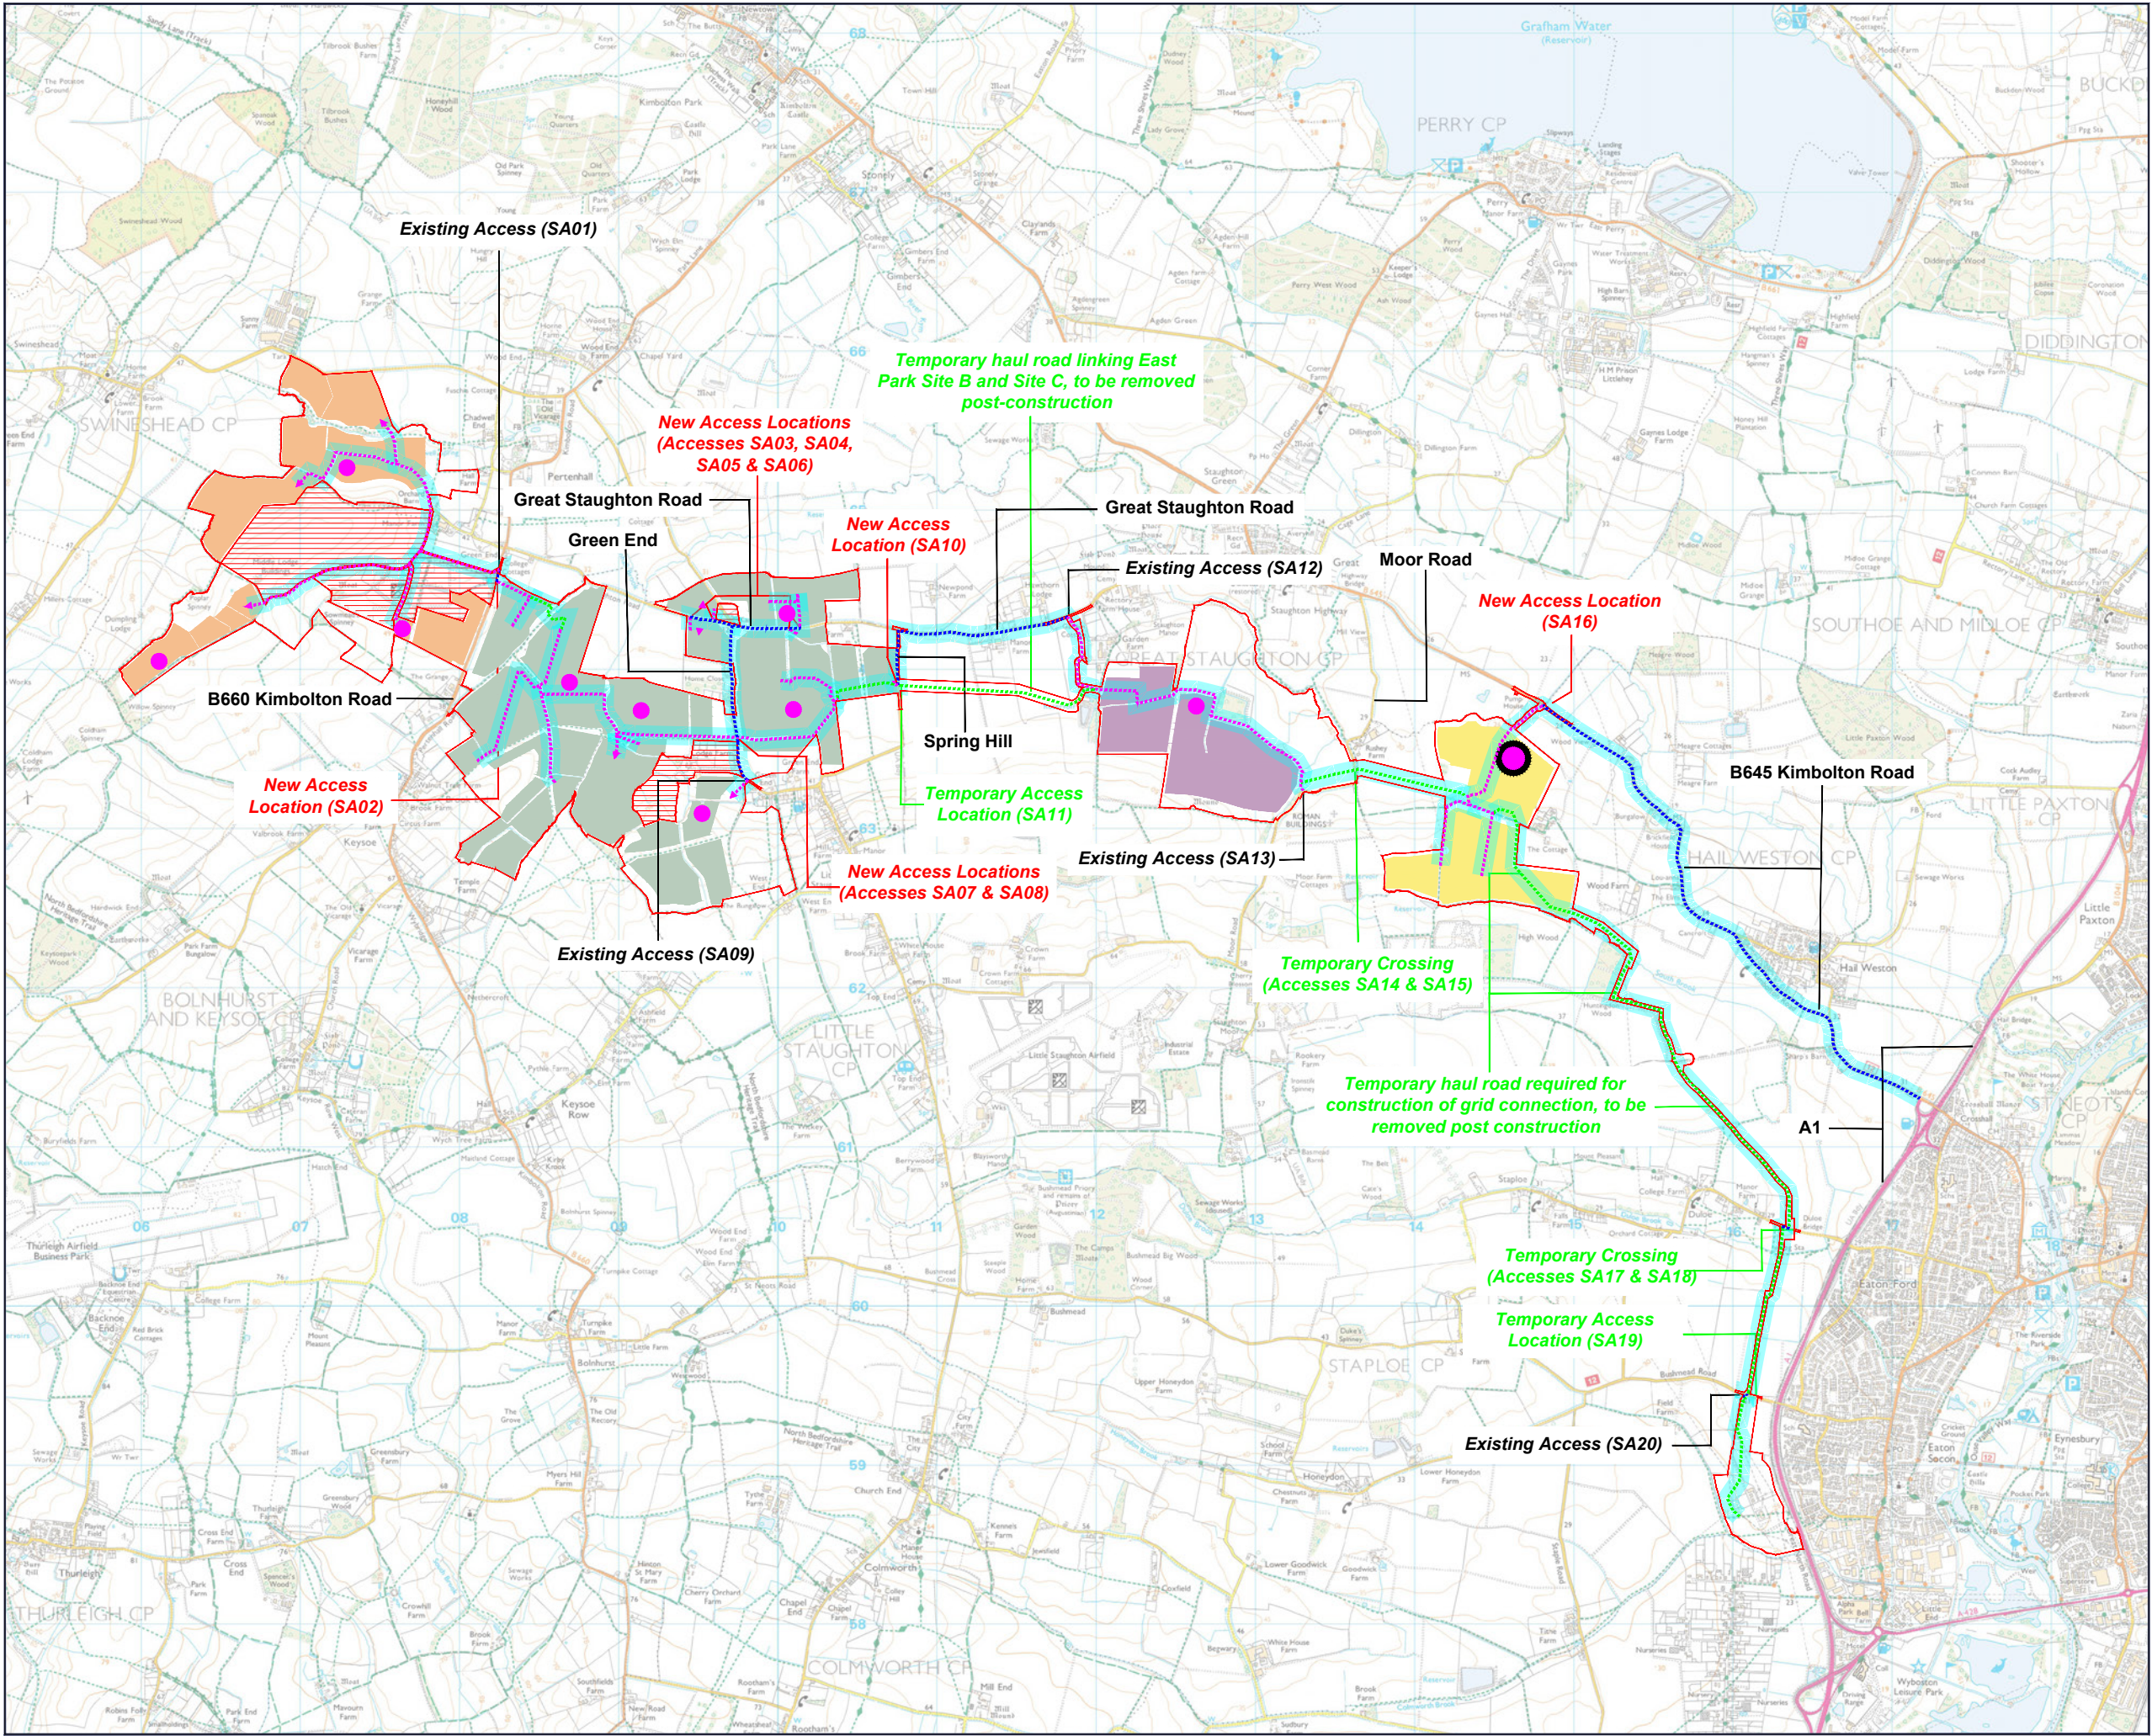
## APPENDIX C: PROPOSED CONSTRUCTION ACCESS STRATEGY

- Order Limits
- Land Excluded from Order Limits
- East Park Site D
- East Park Site C
- East Park Site B
- East Park Site A
- HGV Delivery Route
- Construction access utilising section of existing public highway
- Indicative construction access utilising existing access tracks or proposed new access tracks internal to the site, and which would be retained post-construction
- Indicative temporary access tracks (haul roads) required to install cabling and the grid connection that will be implemented at the start of the construction phase to keep construction traffic off local roads as far as possible. To be removed post construction
- Main construction compound
- Satellite construction compound

**Note:** The full extent of construction access tracks internal to the site are illustrated in ES Vol 3 Figure 2-5 Indicative Construction Access and Compounds Plan (APP-125)
