# EAST PARK ENERGY

EN010141

## Outline Construction Traffic Management Plan

**Document Reference: EN010141/DR/7.4**

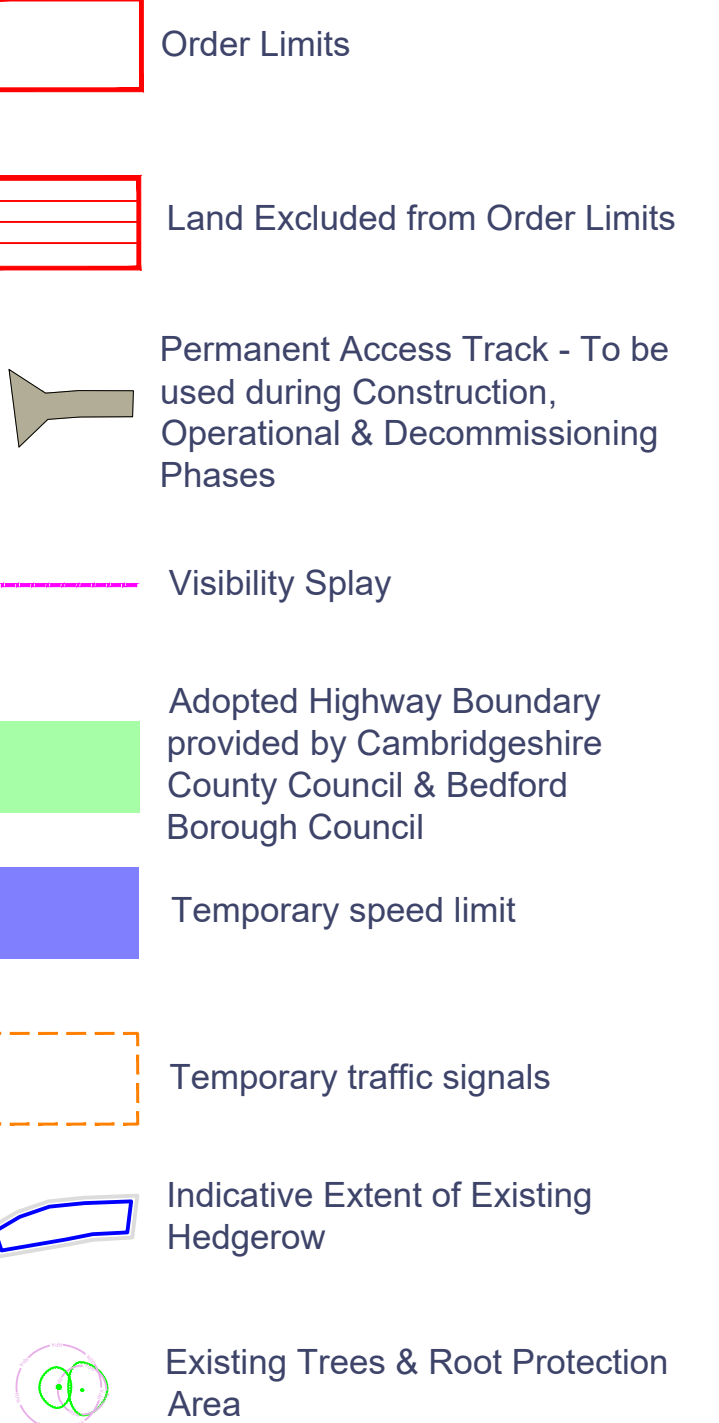
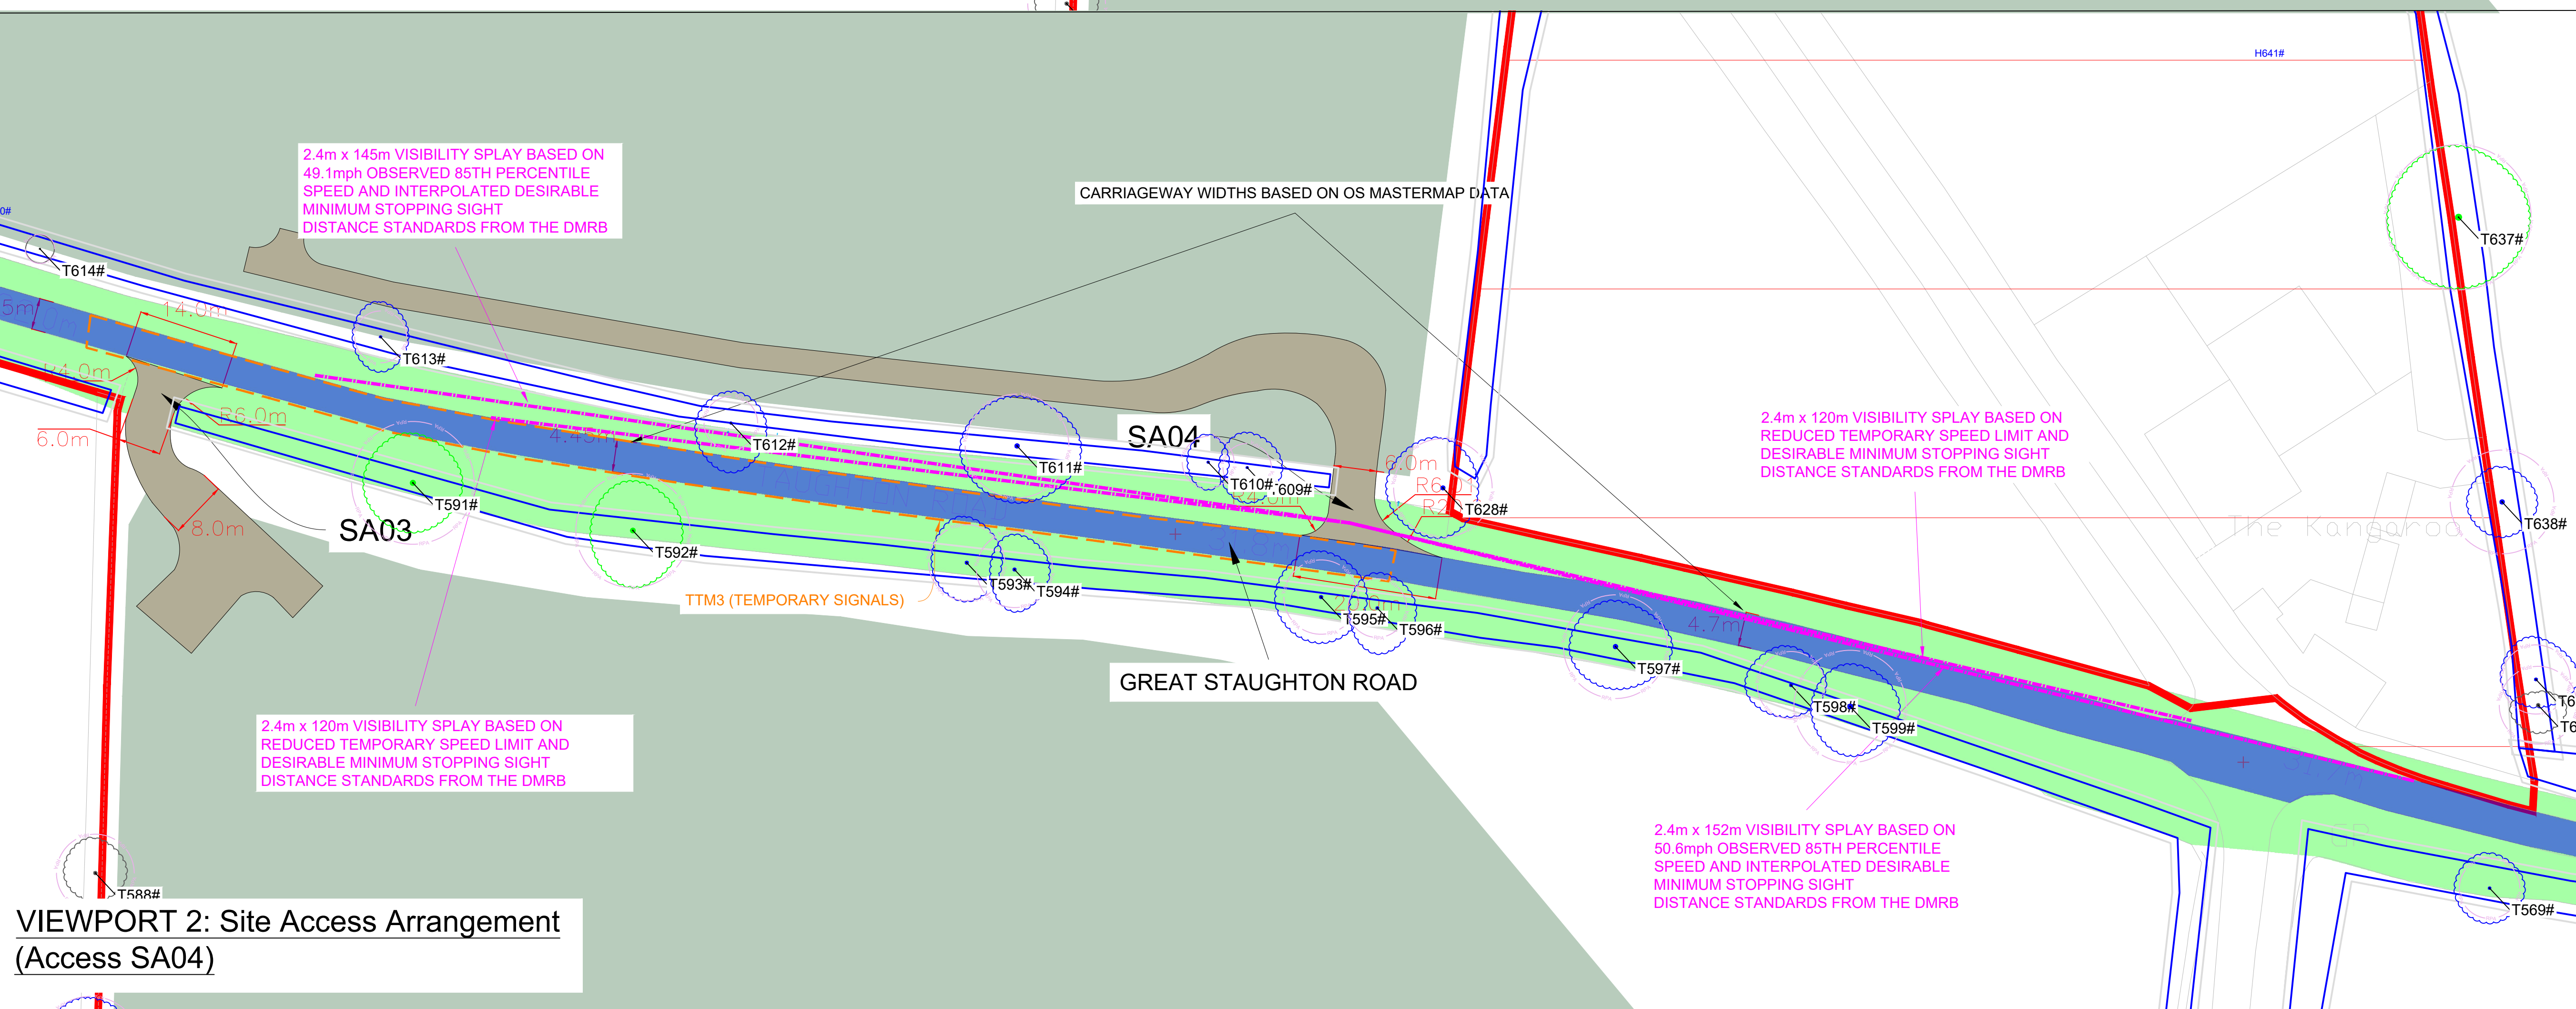
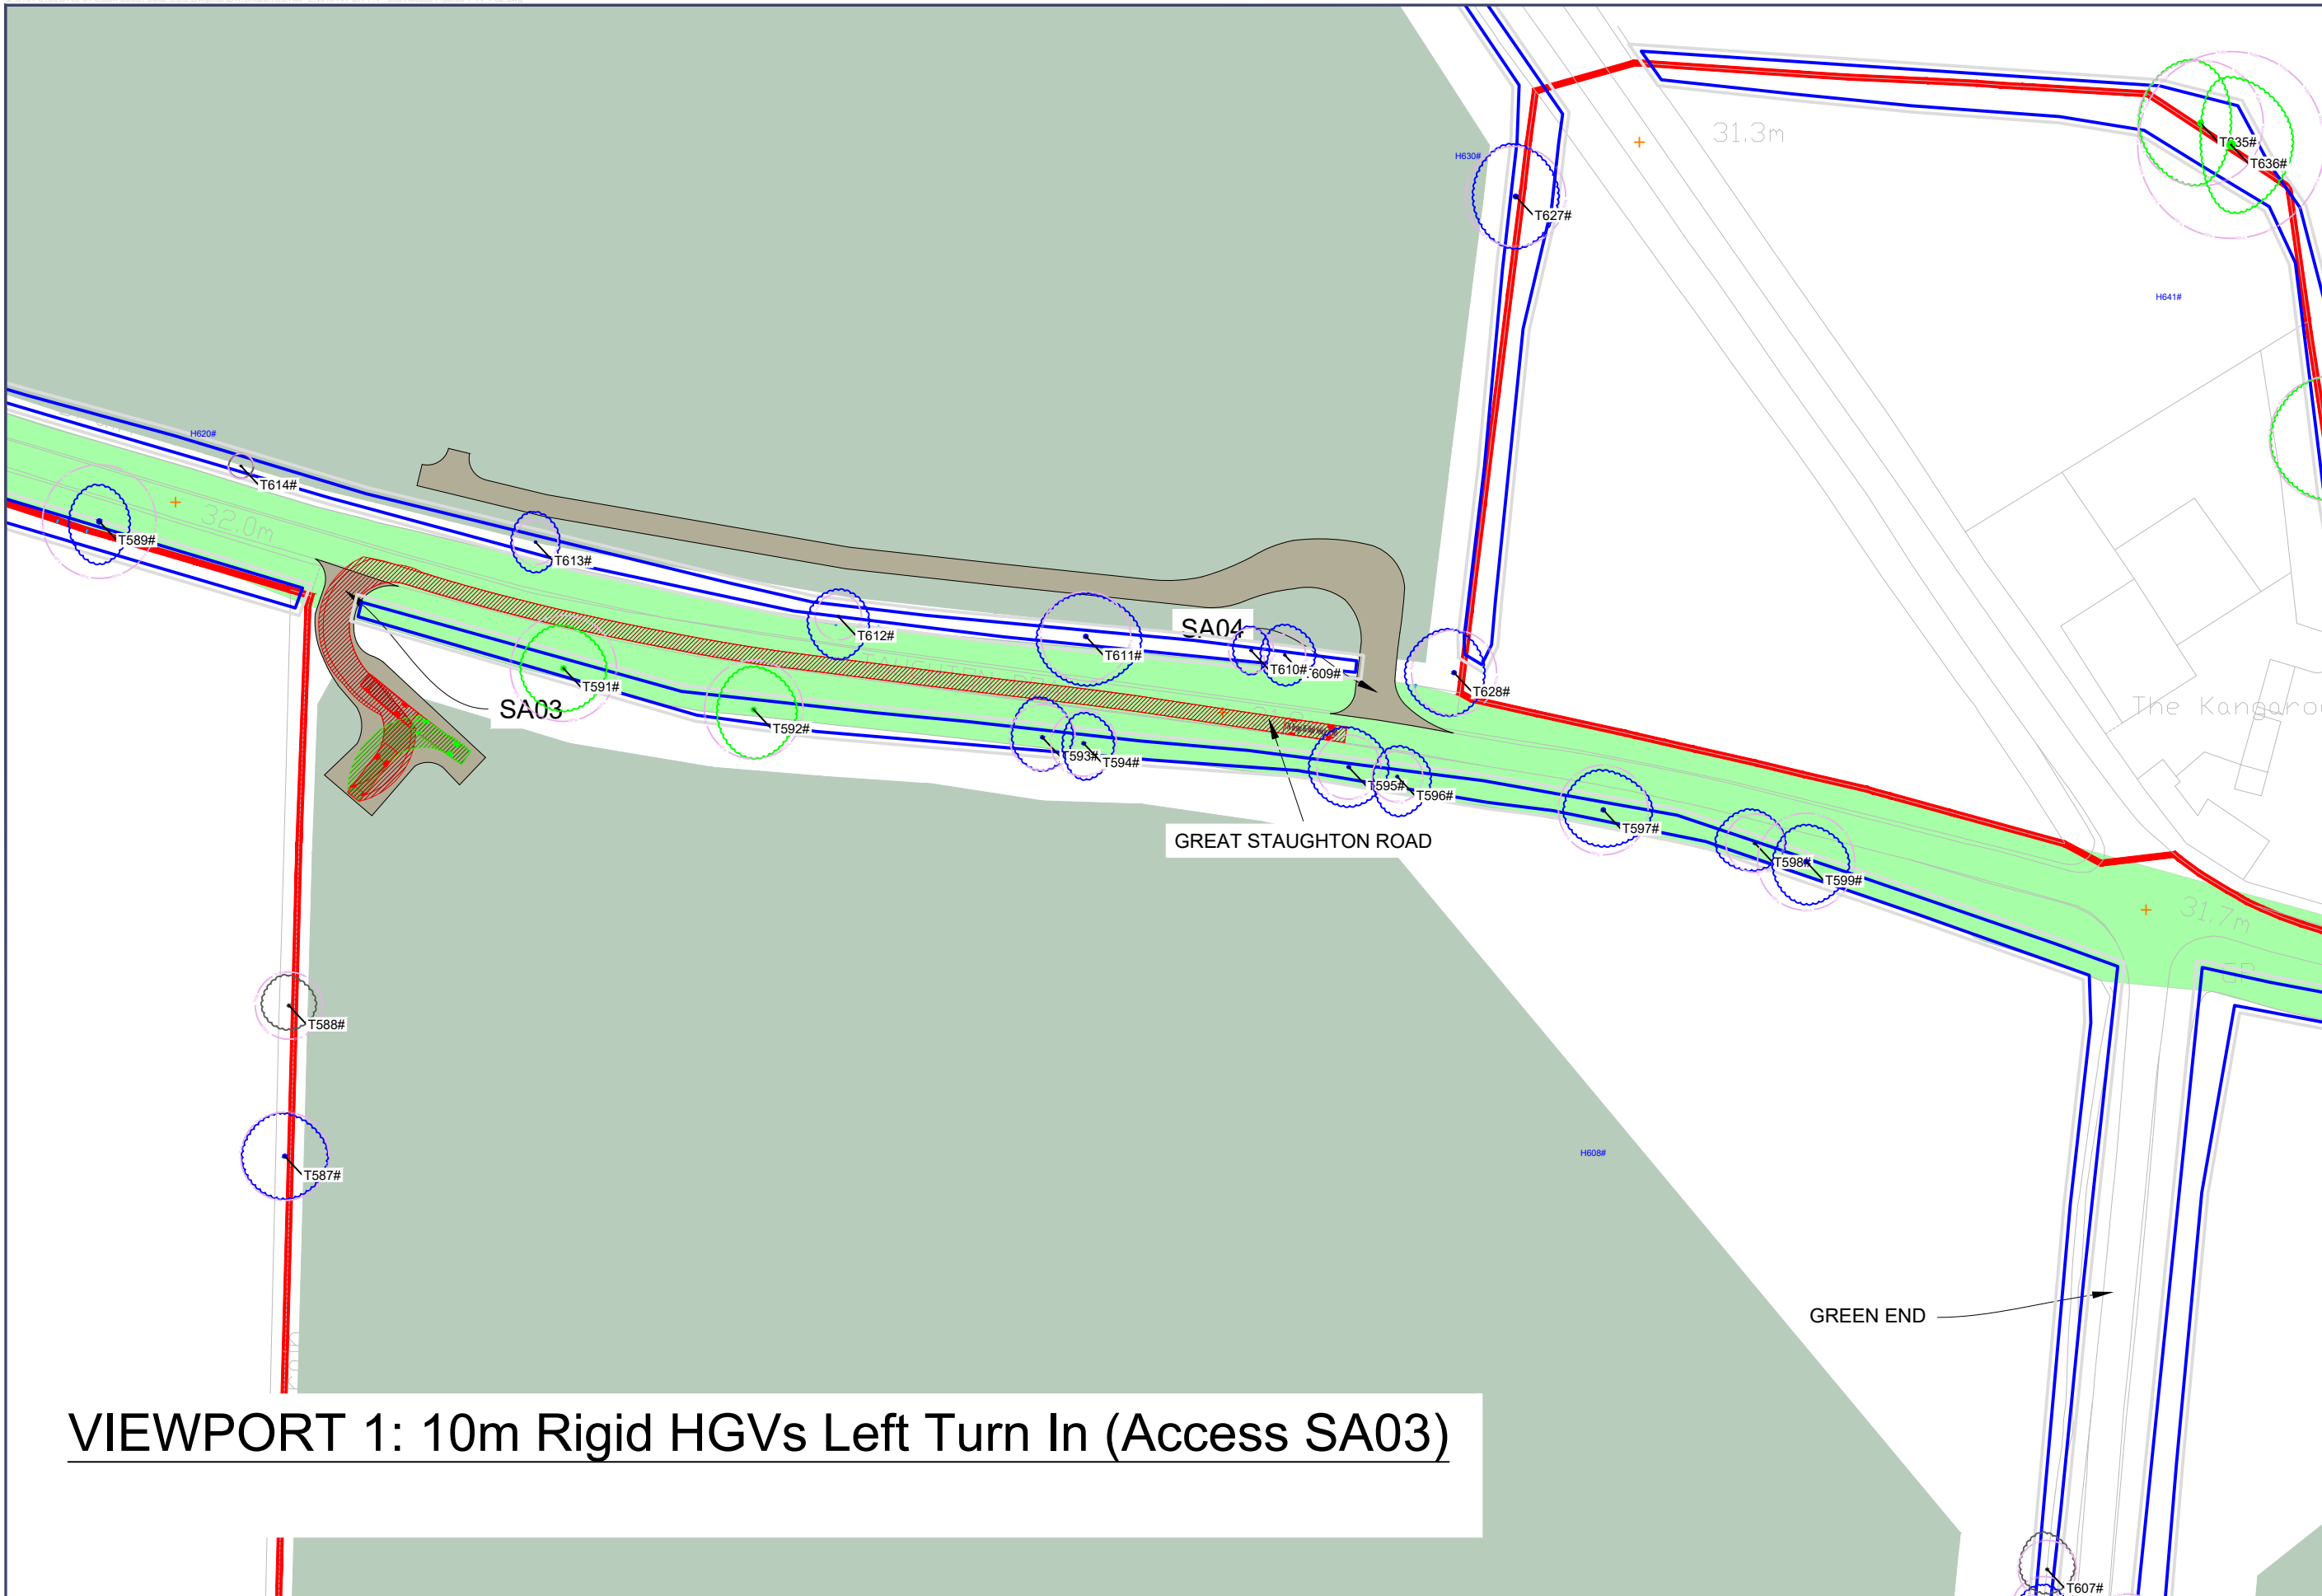
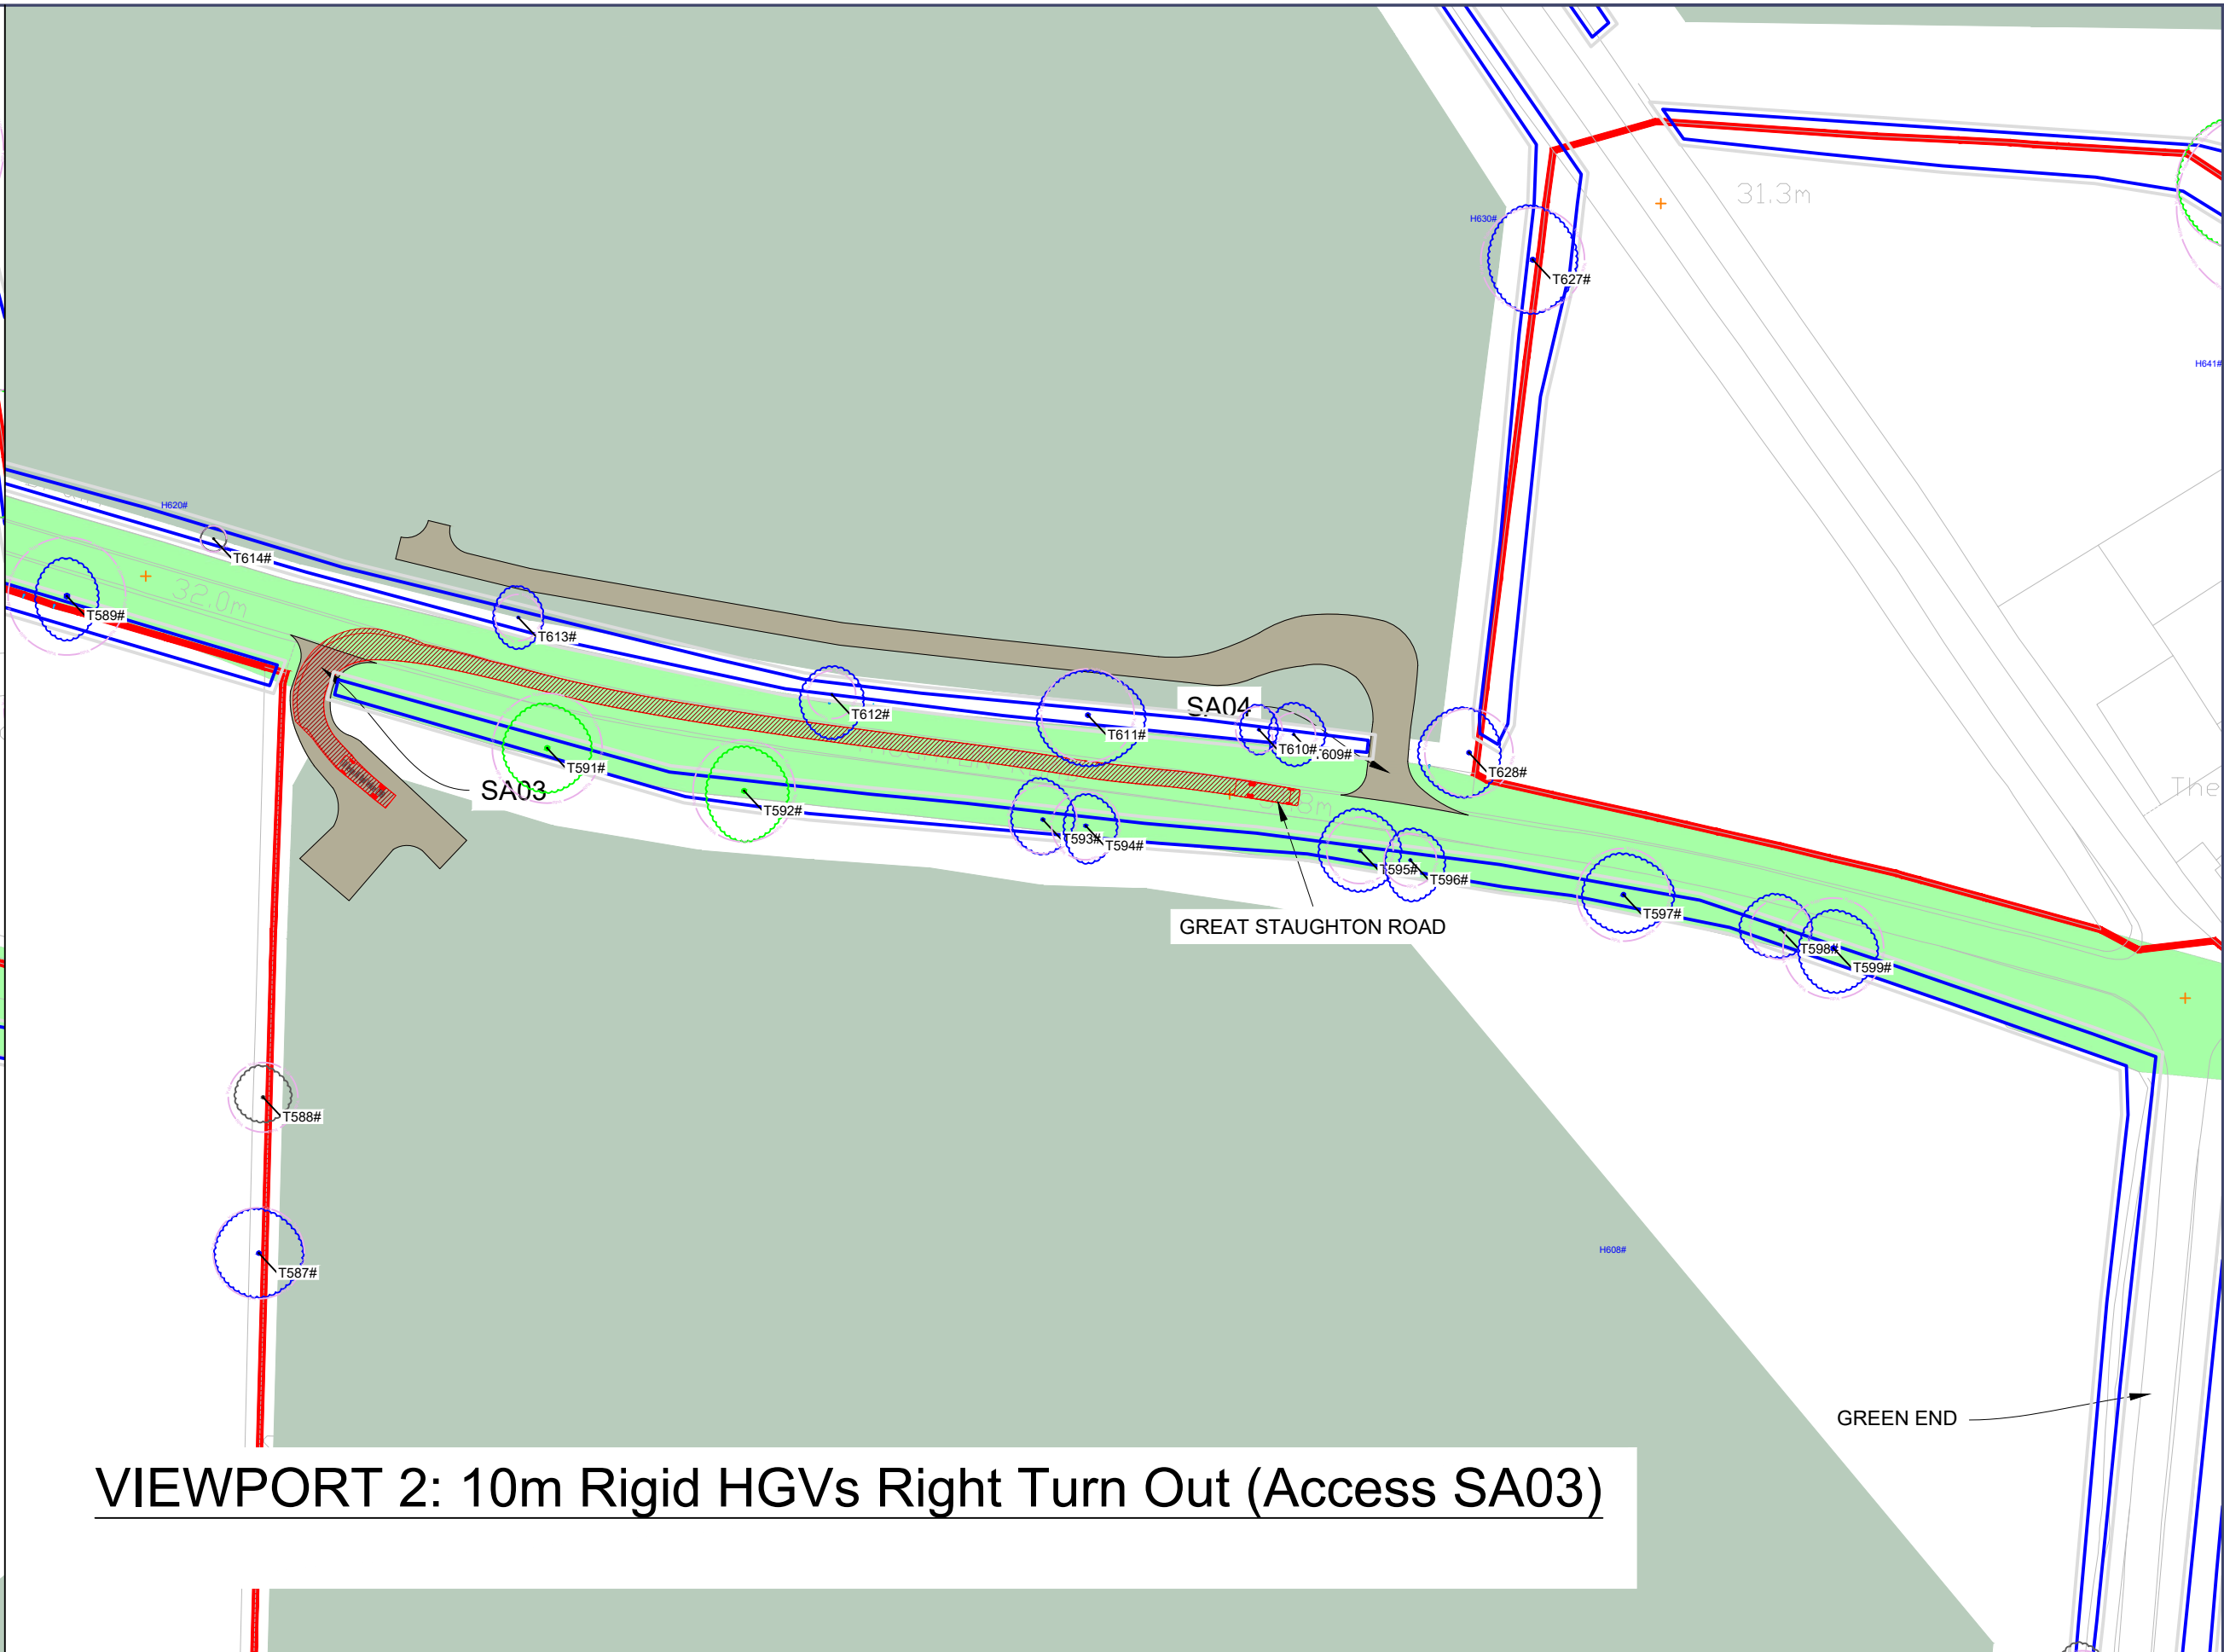
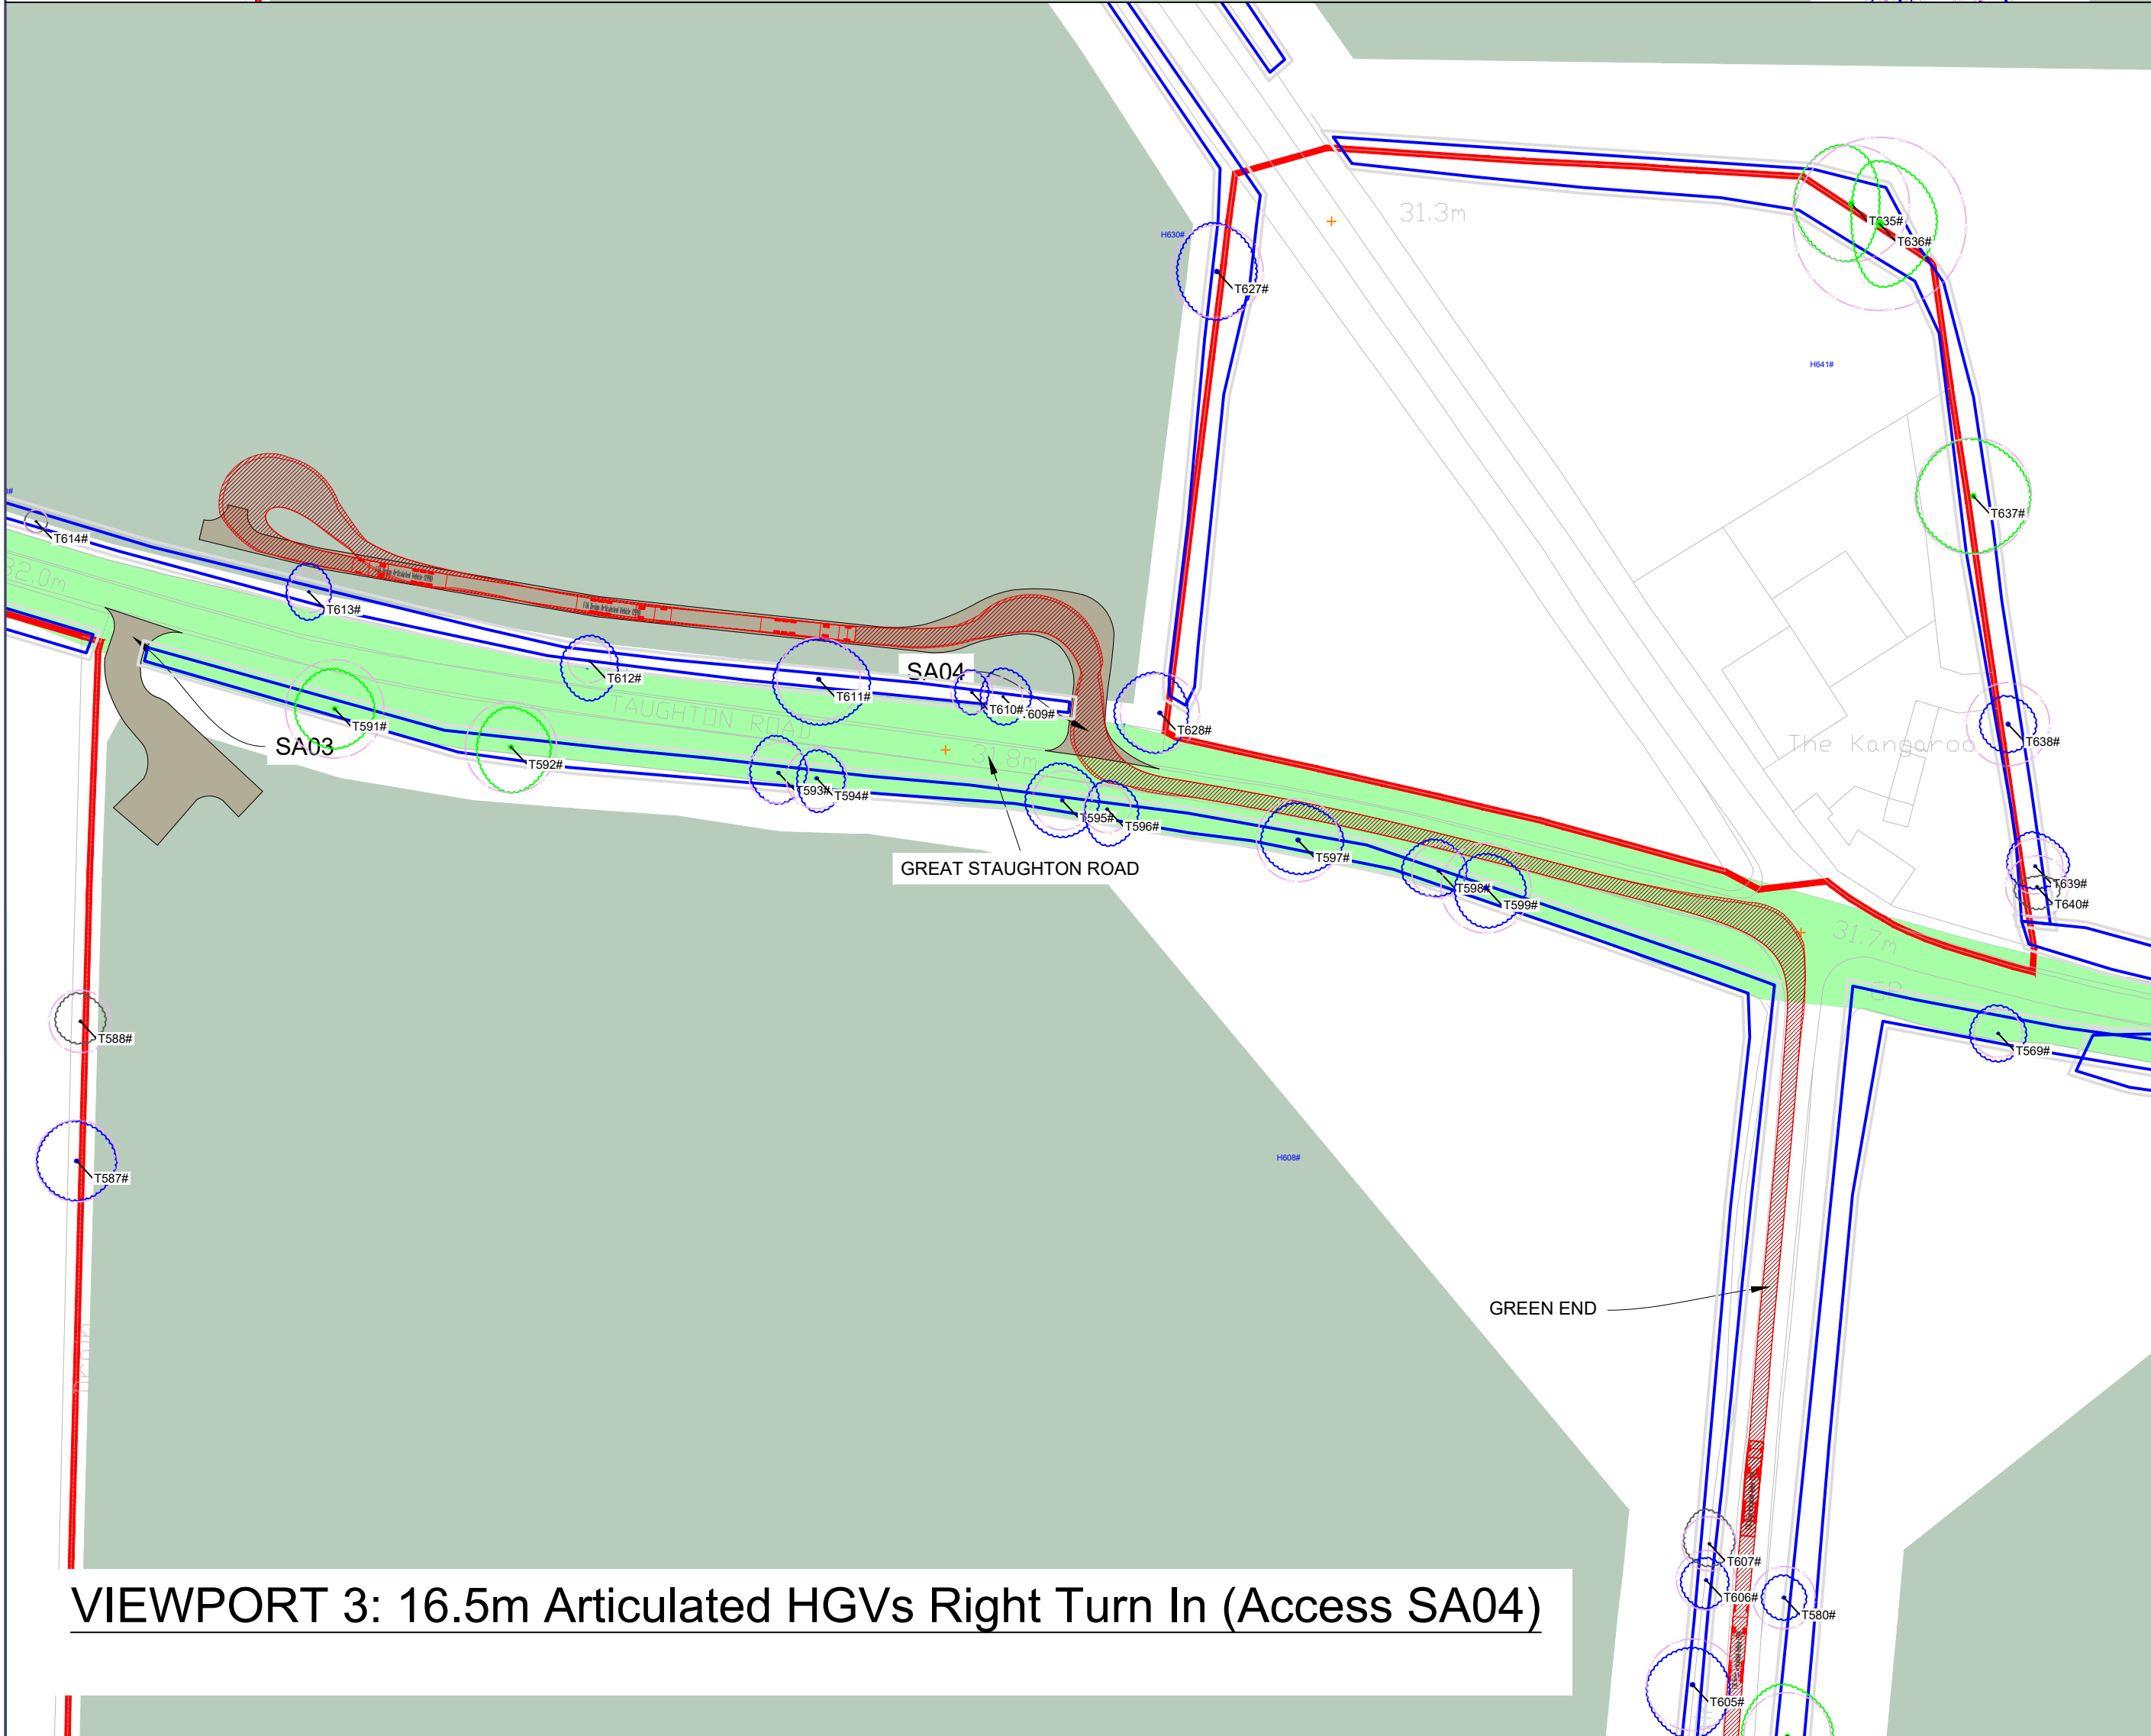
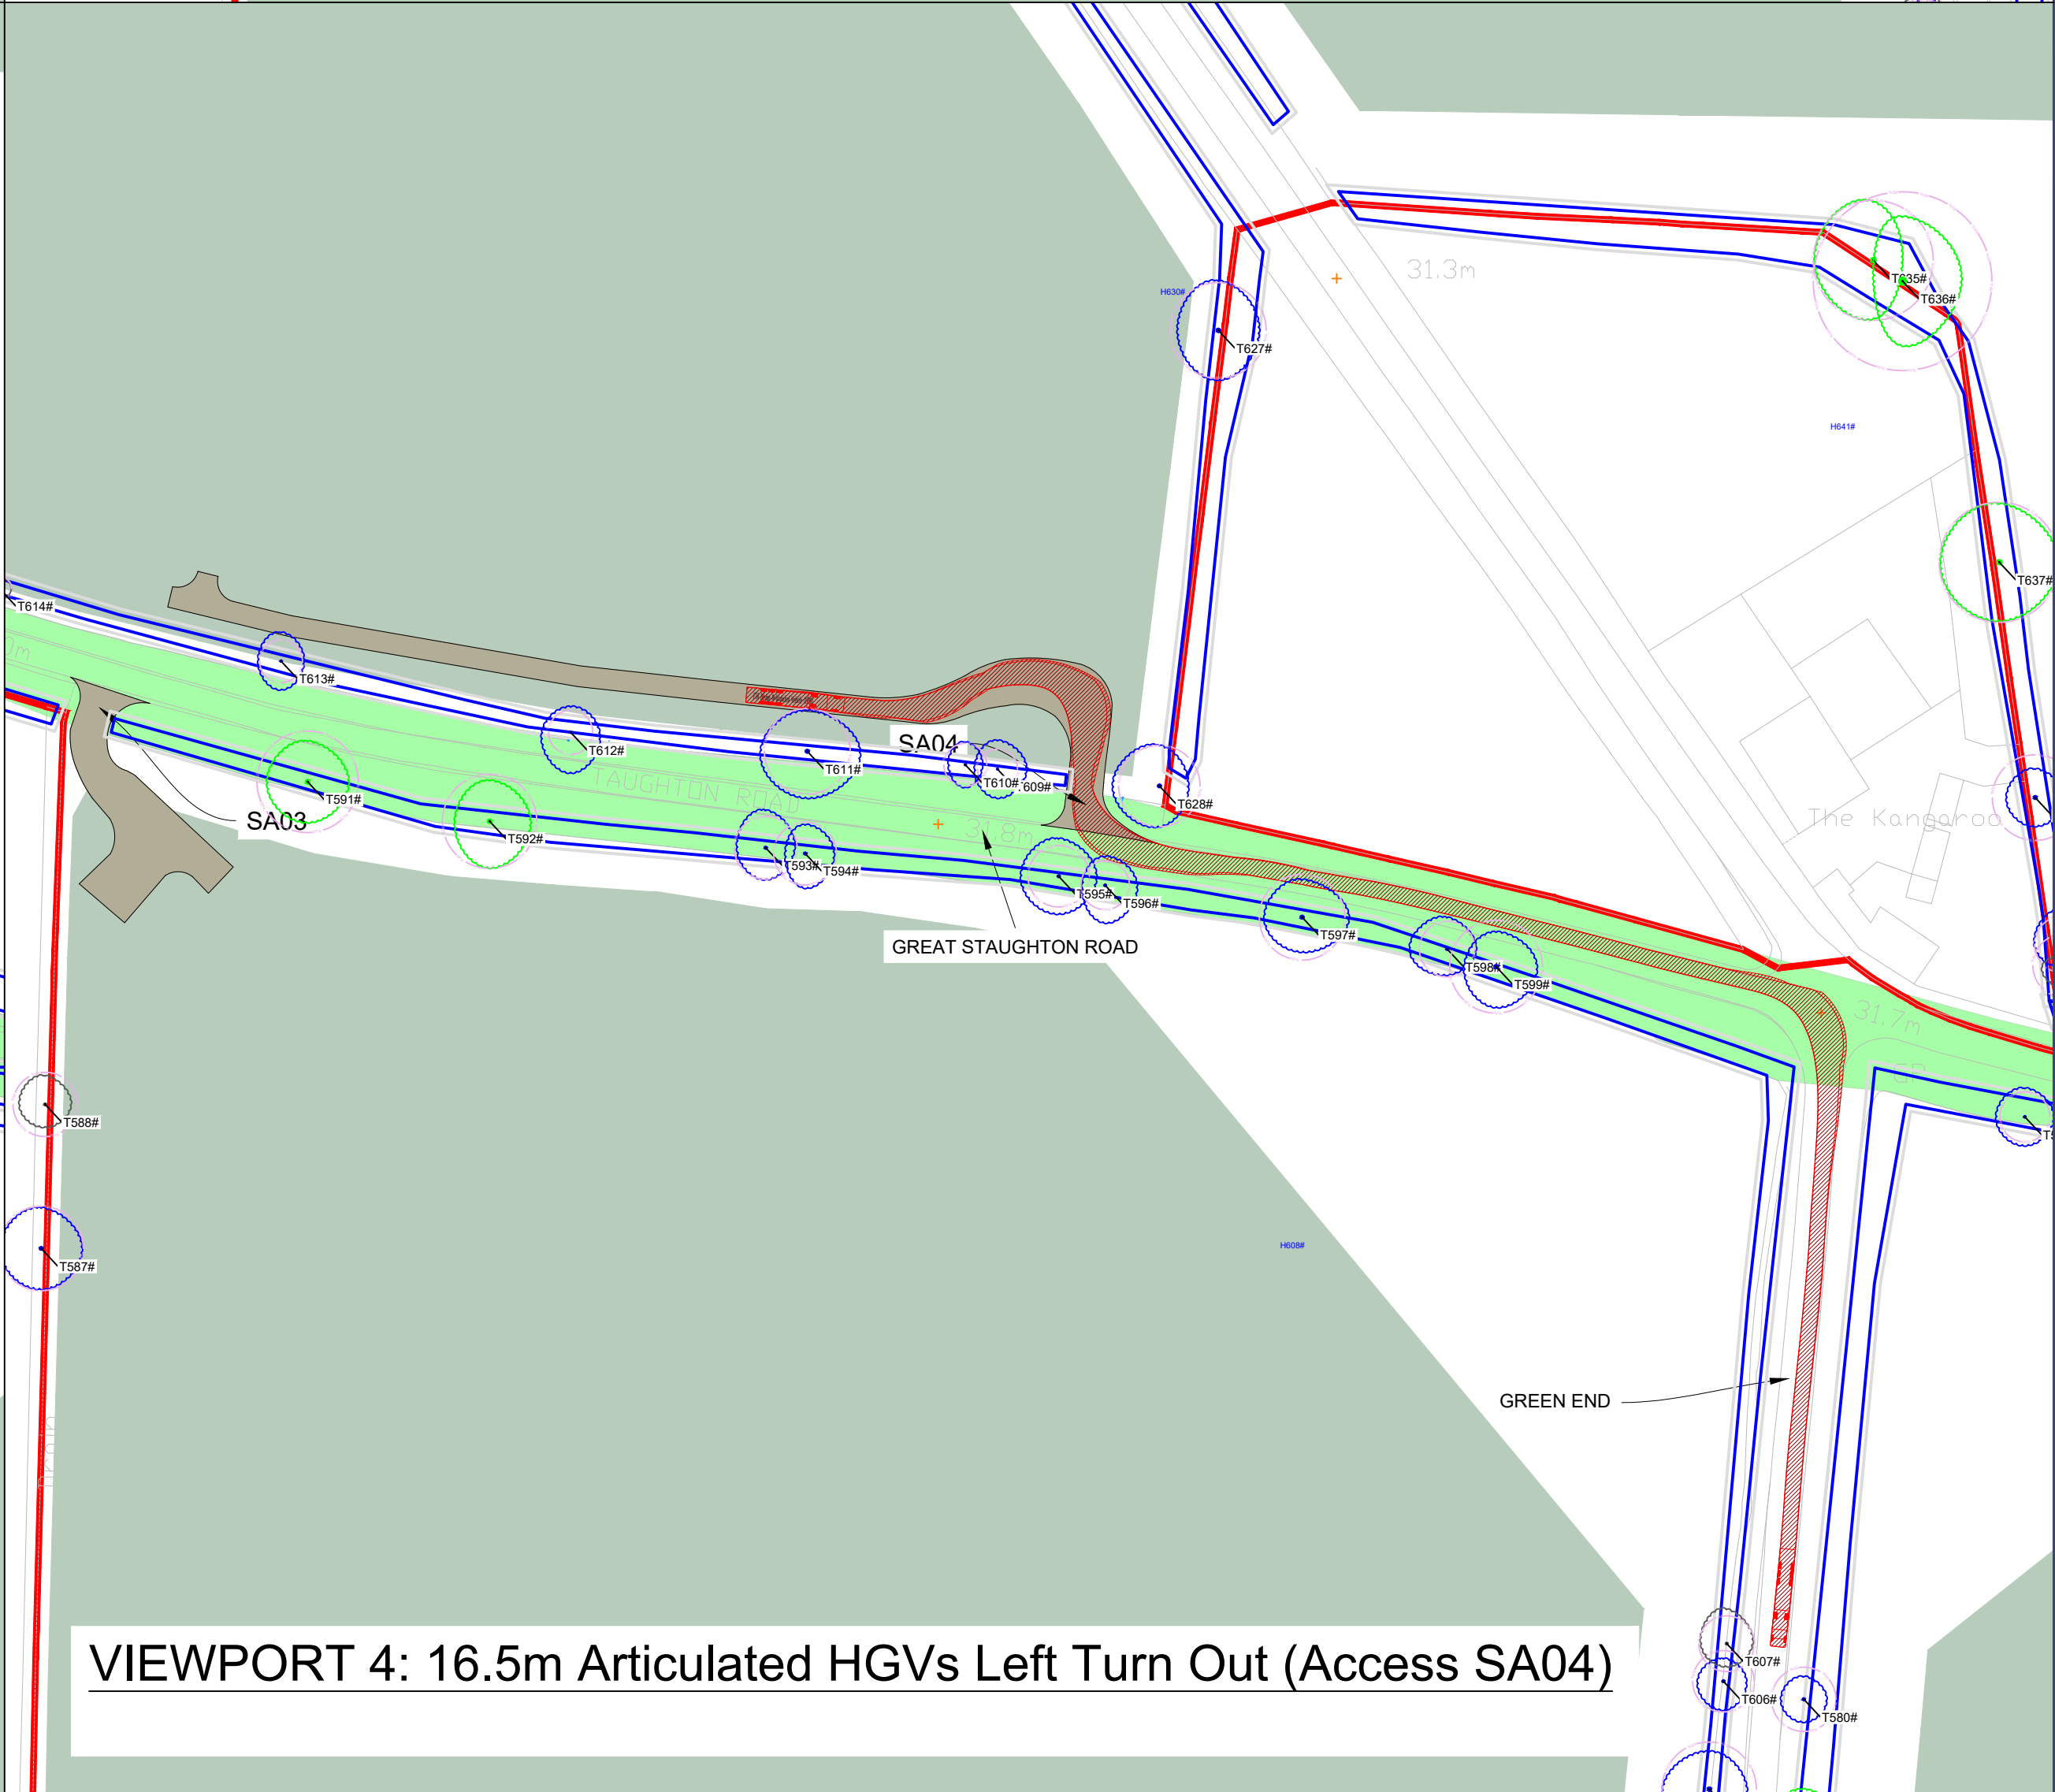
### VIEWPORT 1: Site Access Arrangement (Access SA03)

### VIEWPORT 2: Site Access Arrangement (Access SA04)

VIEWPORT 1: 10m Rigid HGVs Left Turn In (Access SA03)

VIEWPORT 2: 10m Rigid HGVs Right Turn Out (Access SA03)

VIEWPORT 3: 16.5m Articulated HGVs Right Turn In (Access SA04)

VIEWPORT 4: 16.5m Articulated HGVs Left Turn Out (Access SA04)

- 5.1.15 As mentioned earlier, indicative site access designs for each of the accesses described above, including visibility splays and swept path analysis of the largest vehicles that are anticipated to use each access, are shown on Figure 1 to 14 at **Appendix D** of this **outline Construction Traffic Management Plan [EN010141/DR/7.4]**.

- 5.4.2 Visibility splays at each of the proposed new Site accesses, including those accesses which will comprise the upgrade of an existing field access, have been determined based on the guidance and standards set out in the DMRB. For completeness, visibility splays based on the observed traffic speeds / posted speed limits, as well as the temporary reduced speed limits, are shown on Figures 1 to 14 in **Appendix D**.

- 5.4.4 The achievable visibility splays at each of the proposed site access junctions is illustrated in Figures 1 to 14 in **Appendix D** of this oCTMP.
