# EAST PARK ENERGY

EN010141

## Outline Construction Traffic Management Plan

**Document Reference: EN010141/DR/7.4**

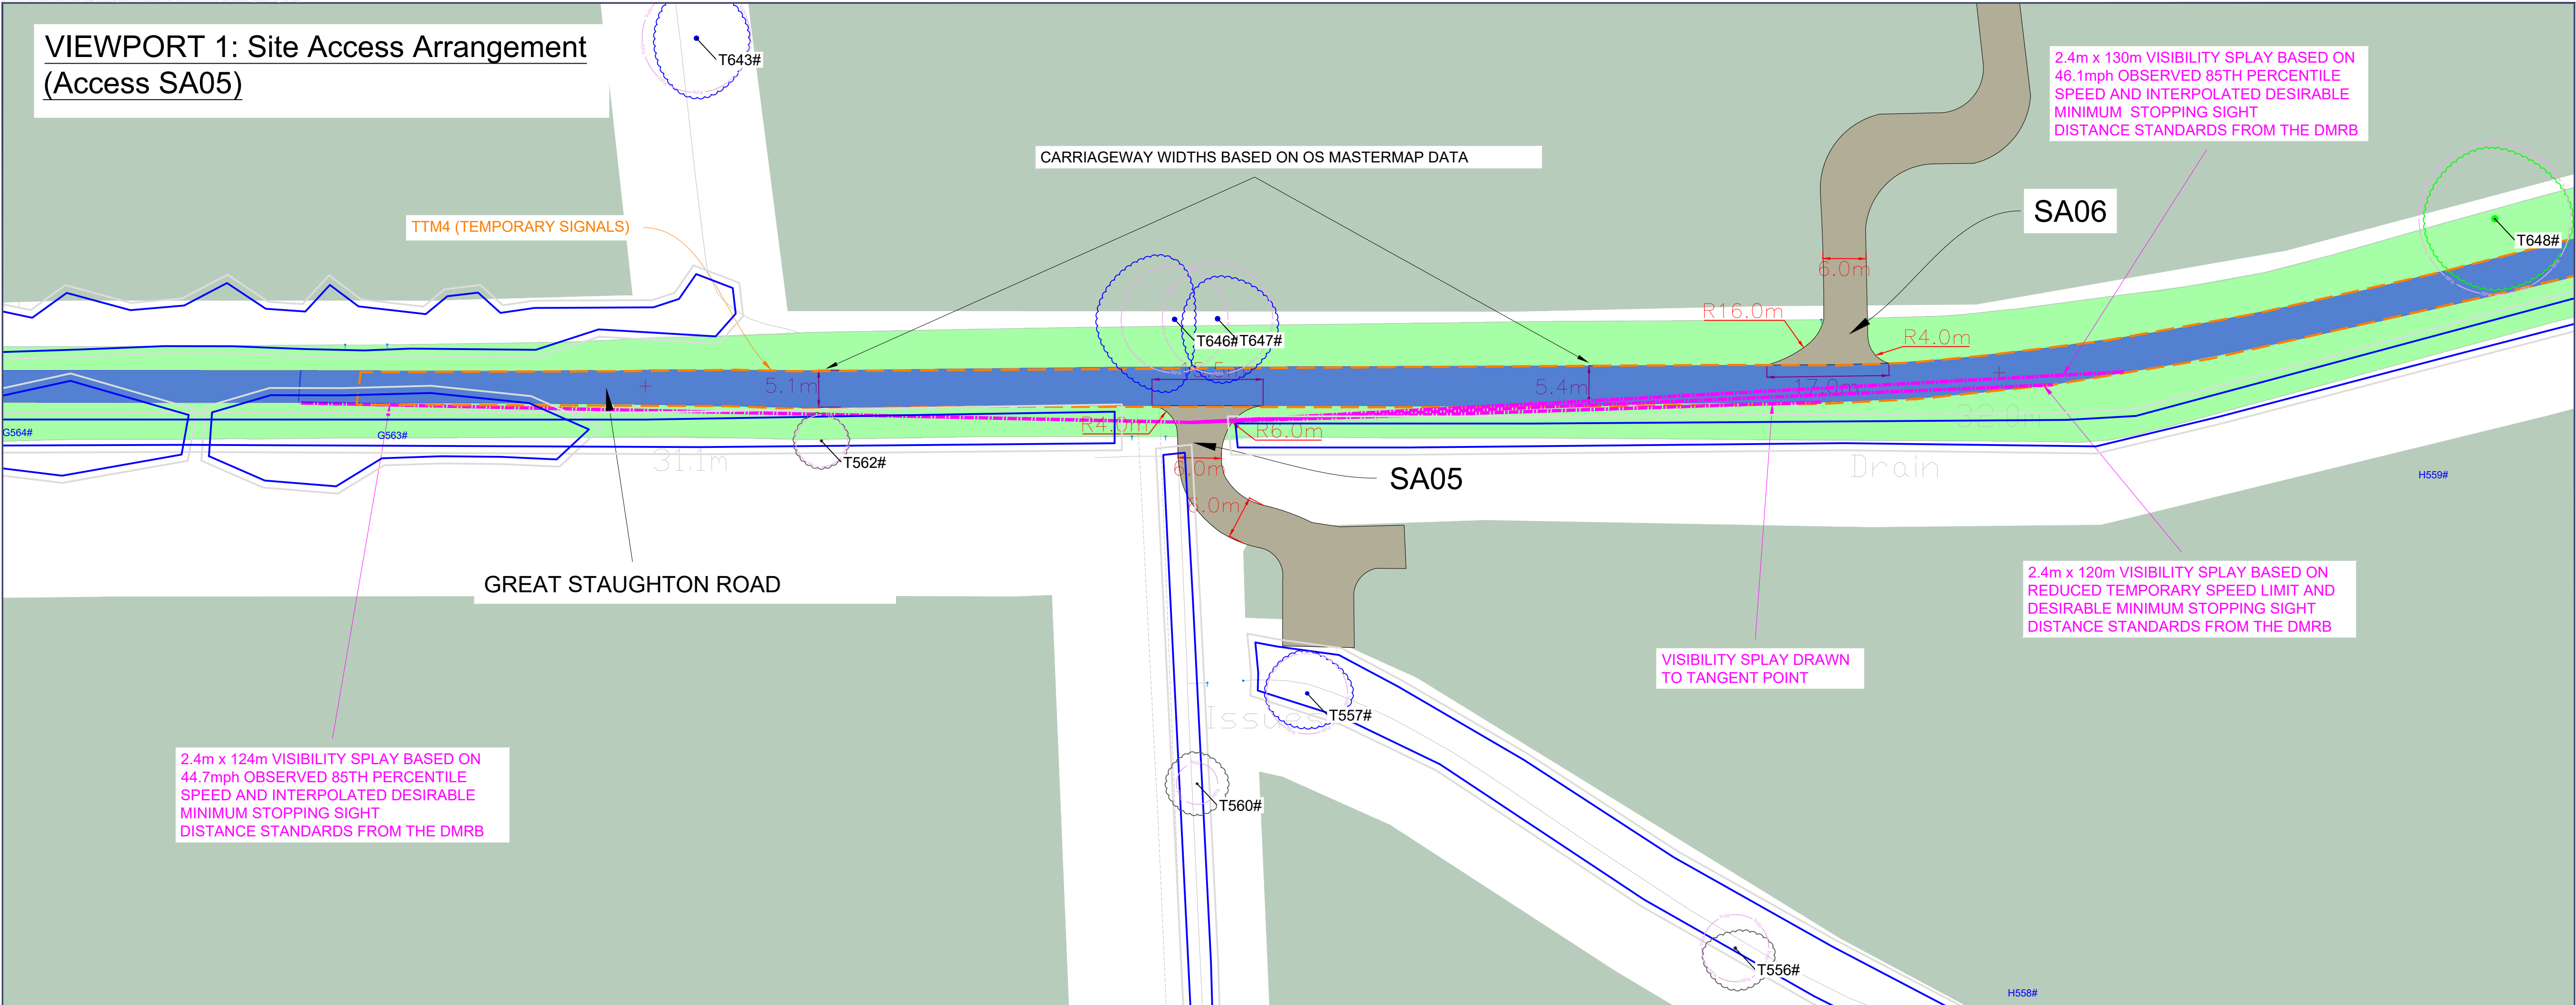
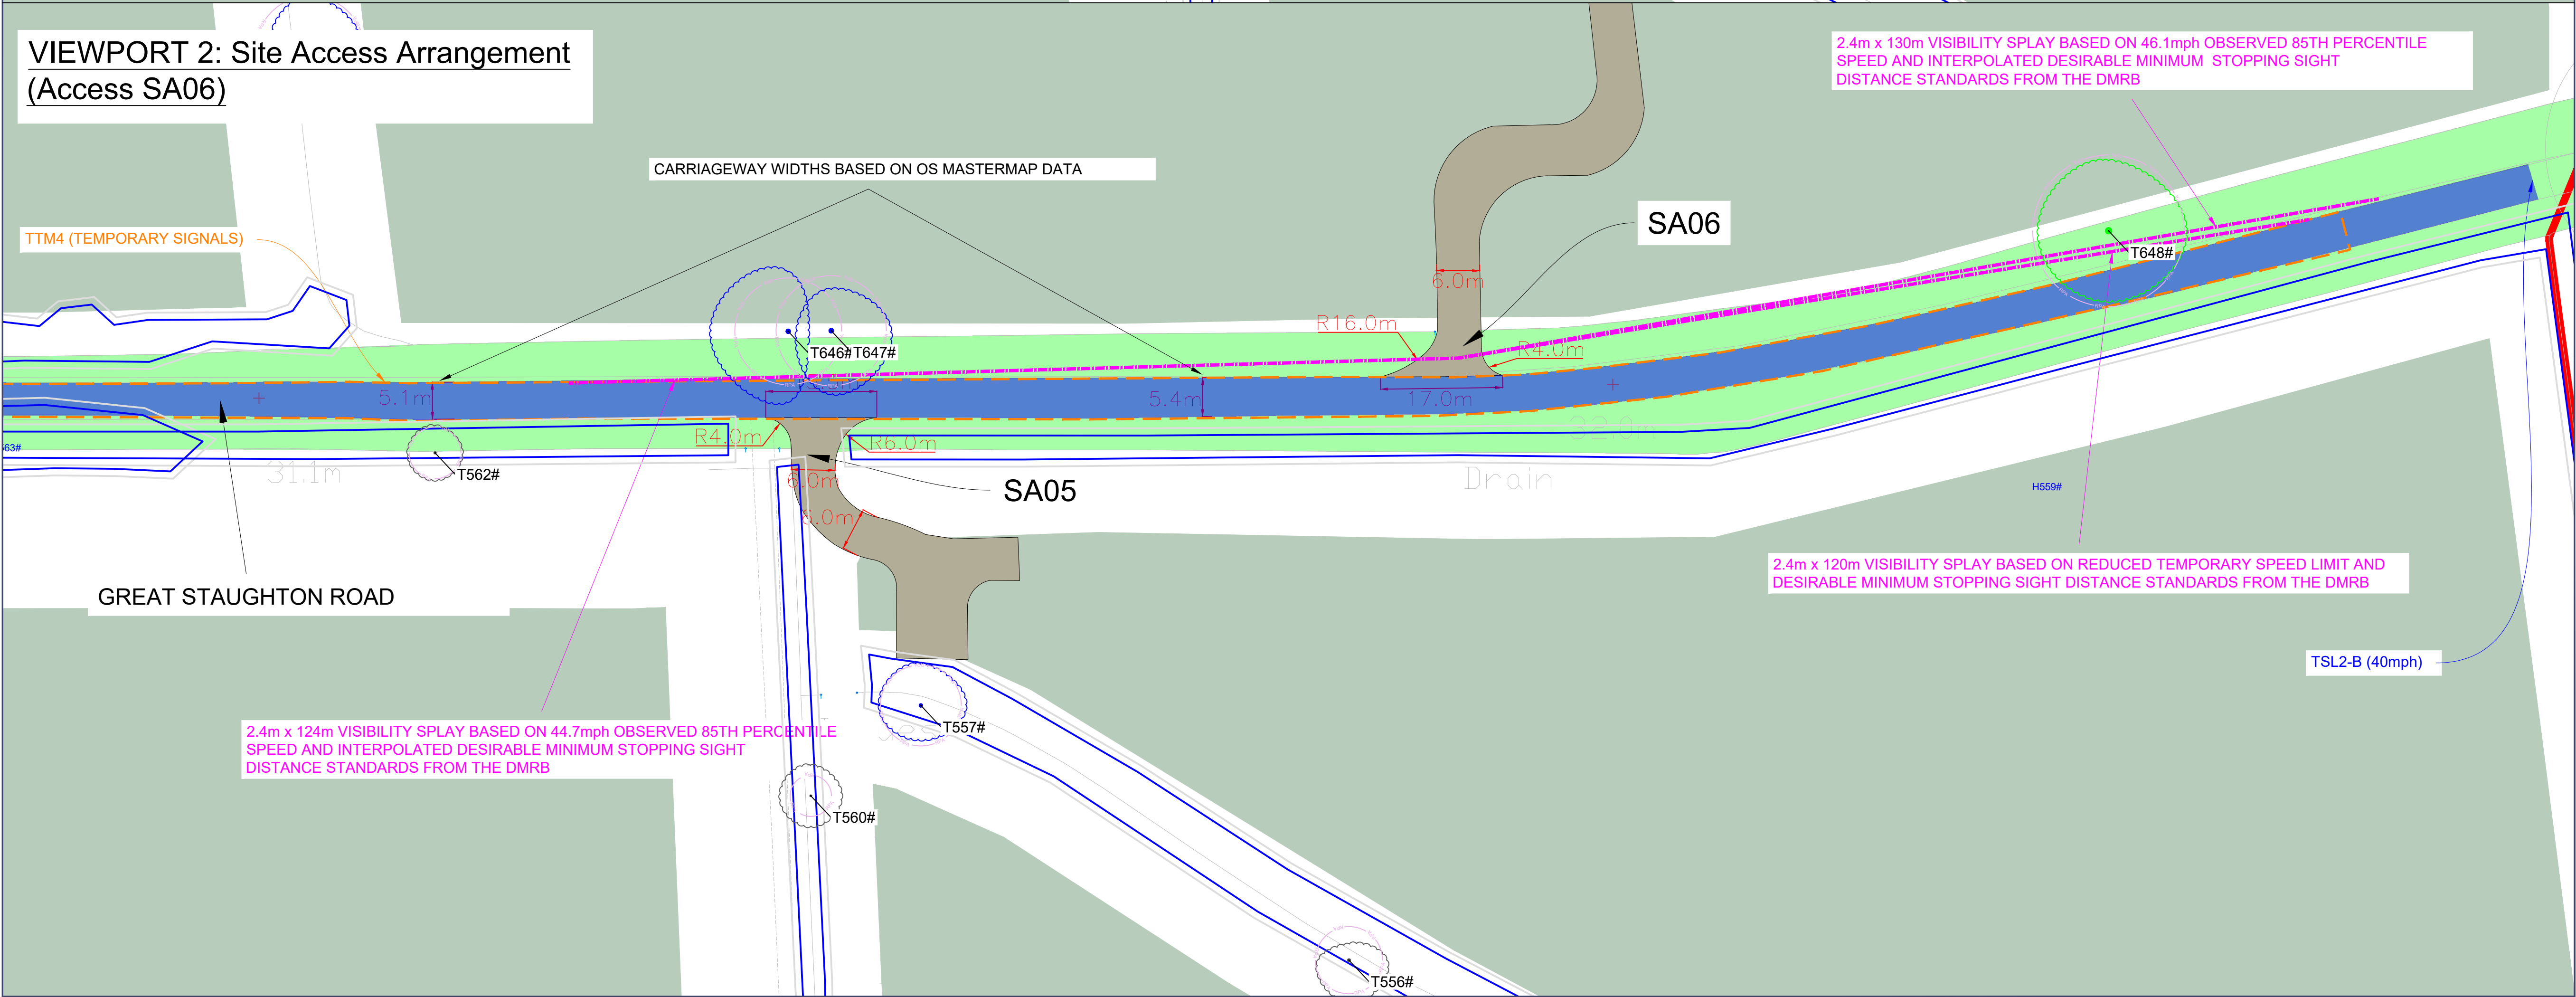
**Indicative Site Access Drawings**  
**Sheet 2b of 14**

- Order Limits
- Permanent Access Track - To be used during Construction, Operational & Decommissioning Phases
- Visibility Splay
- Adopted Highway Boundary provided by Cambridgeshire County Council & Bedford Borough Council
- Temporary speed limit
- Temporary traffic signals
- Indicative Extent of Existing Hedgerow
- Existing Trees & Root Protection Area

- 5.1.15 As mentioned earlier, indicative site access designs for each of the accesses described above, including visibility splays and swept path analysis of the largest vehicles that are anticipated to use each access, are shown on Figure 1 to 14 at **Appendix D** of this **outline Construction Traffic Management Plan [EN010141/DR/7.4]**.

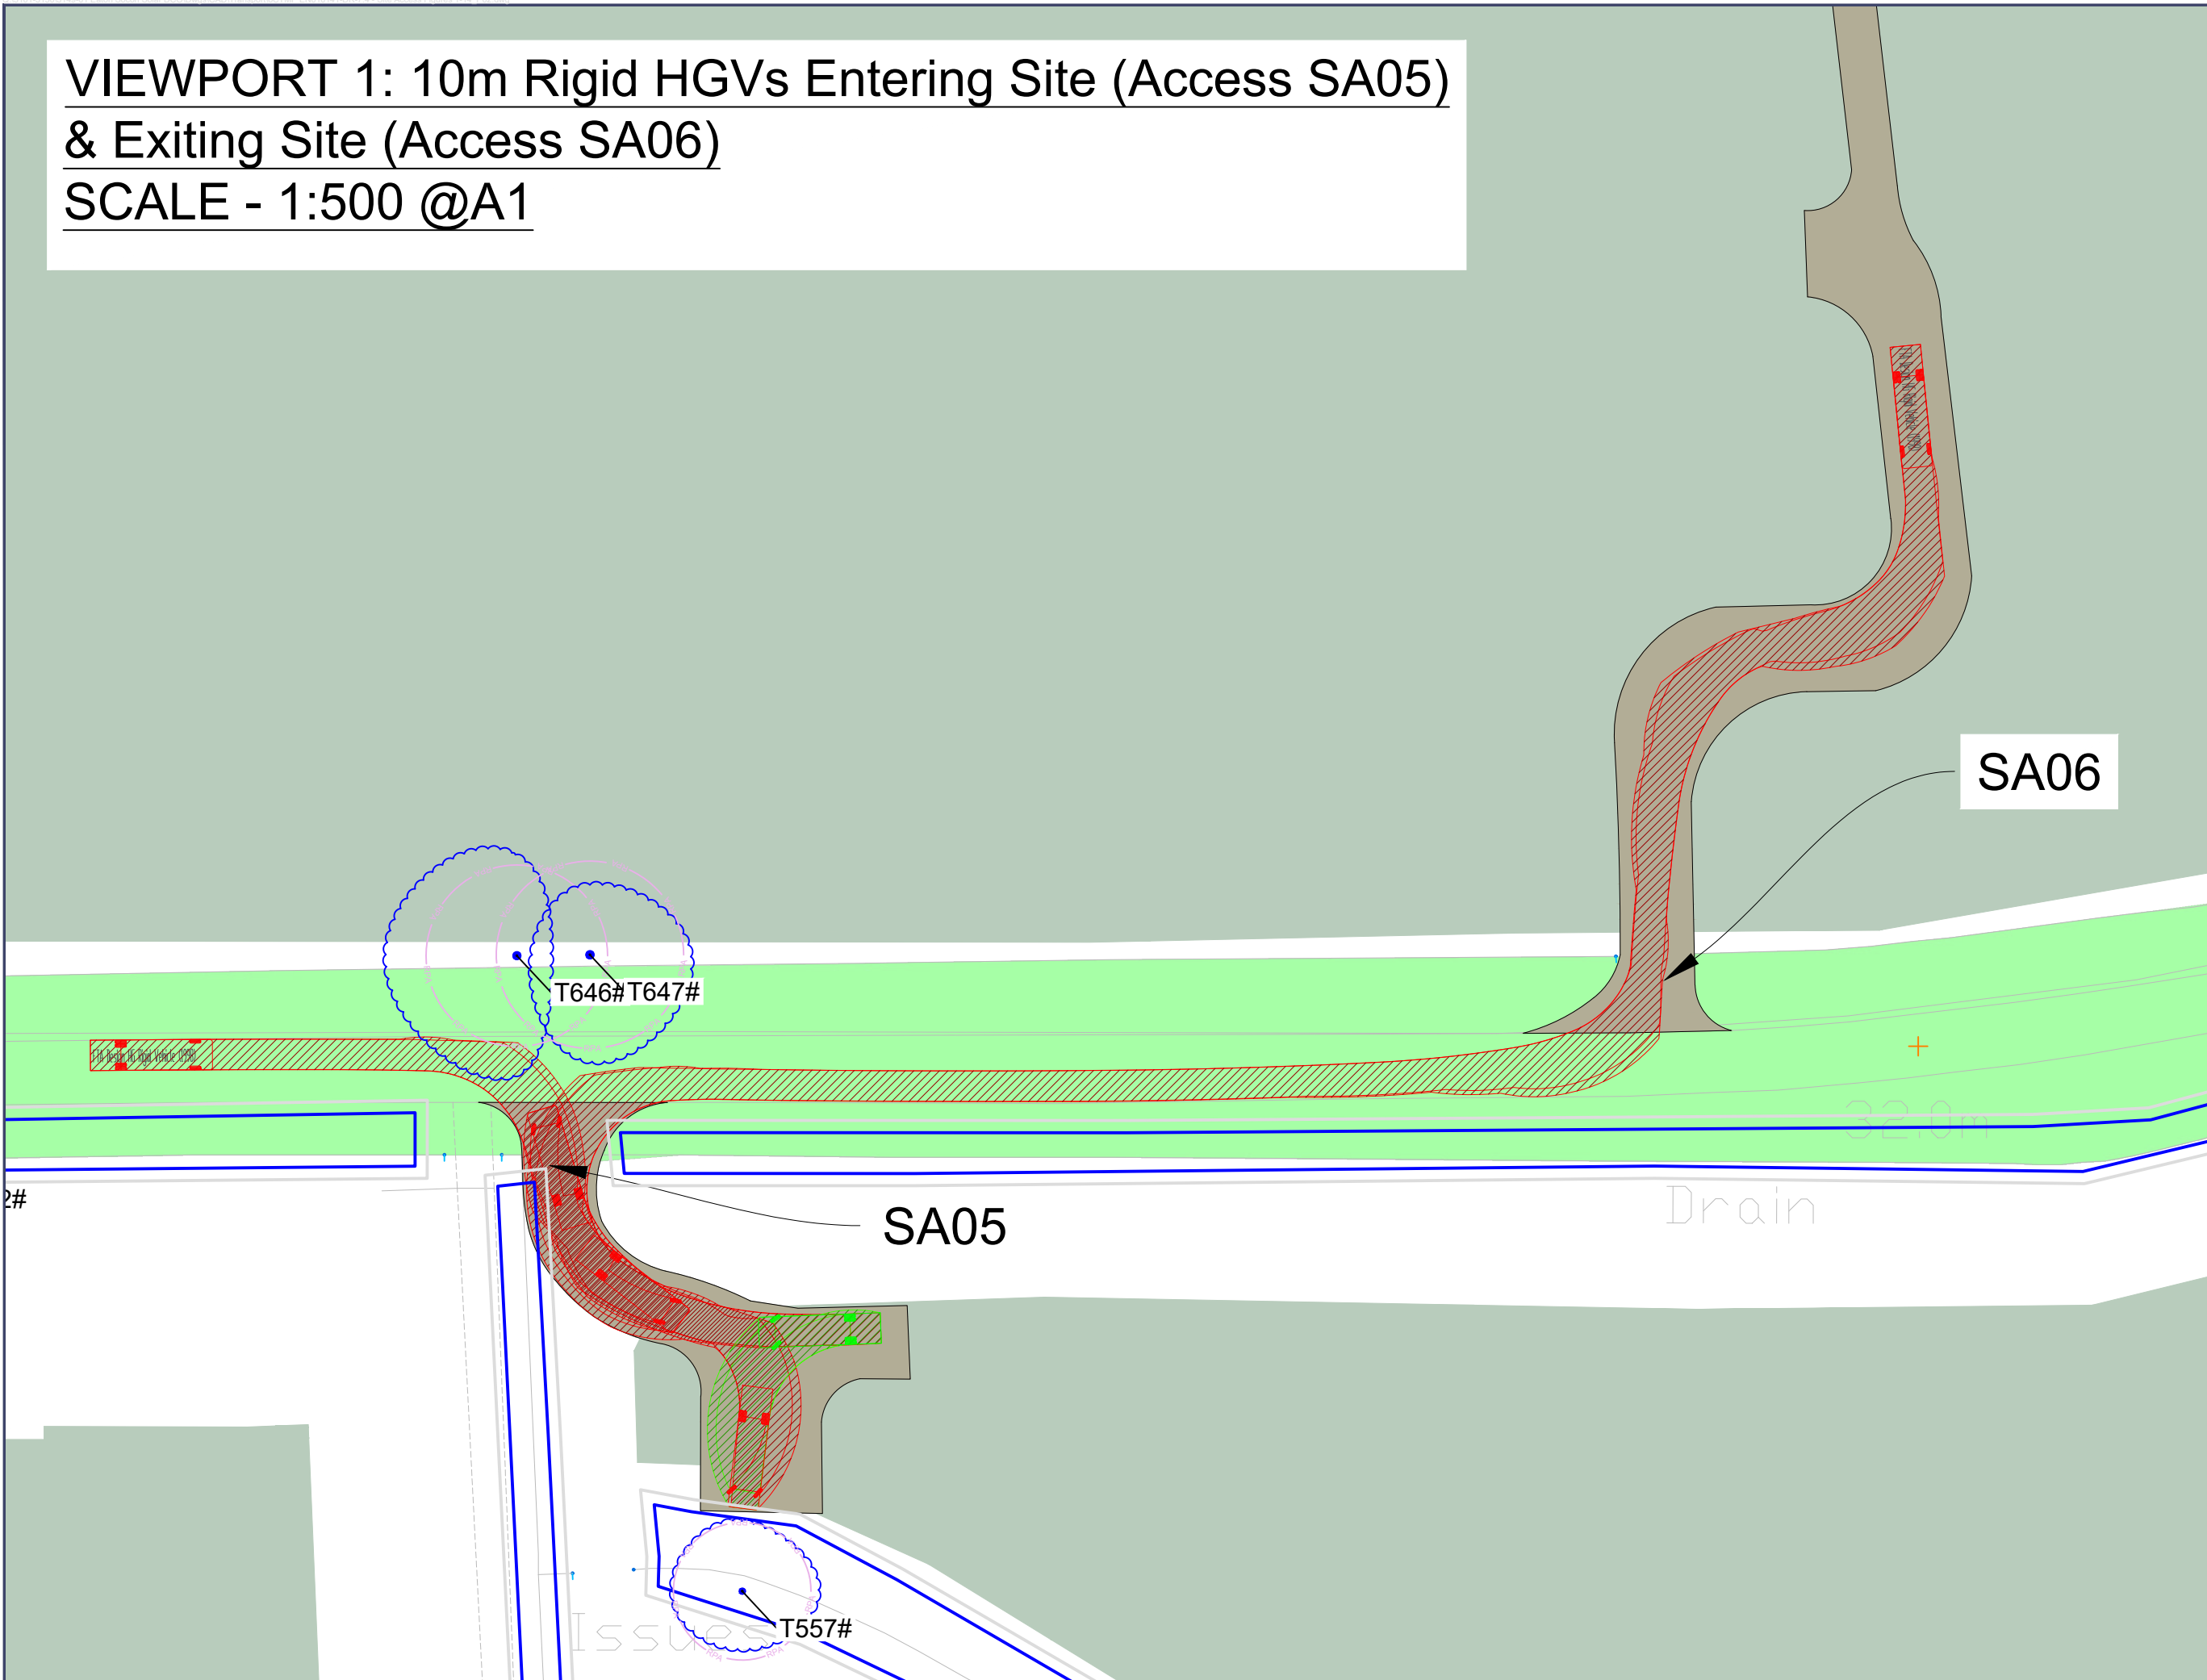
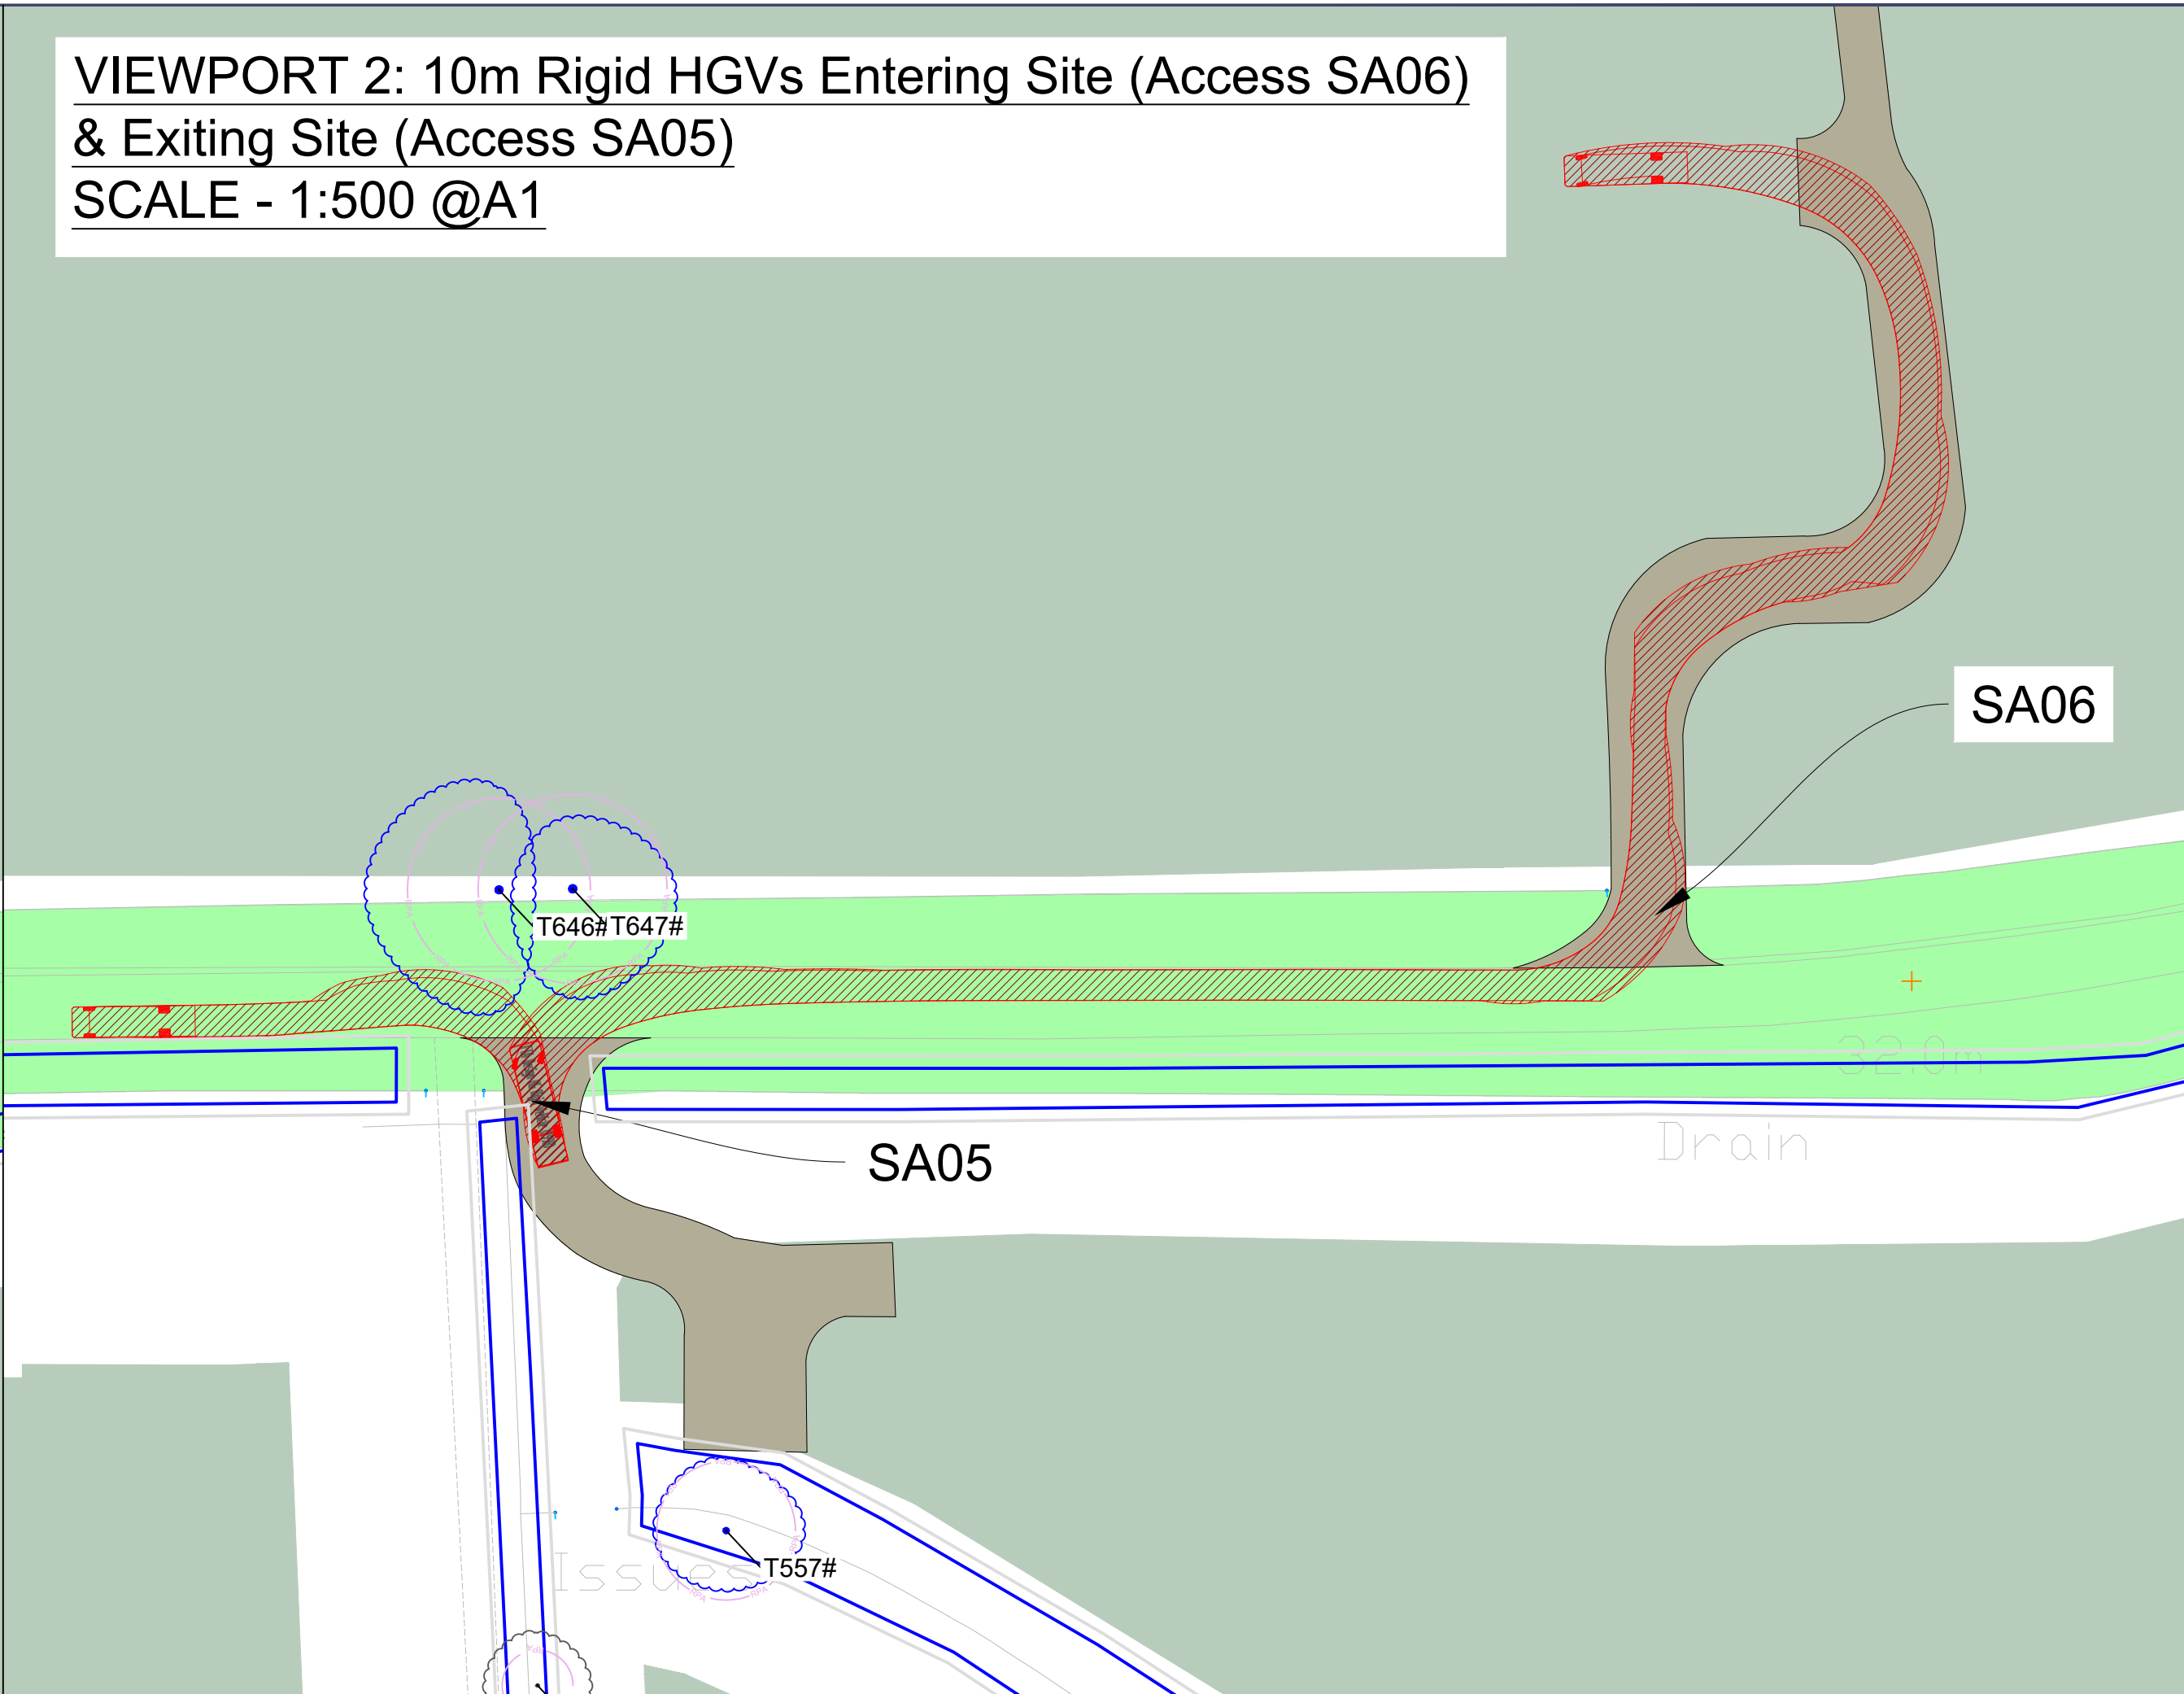
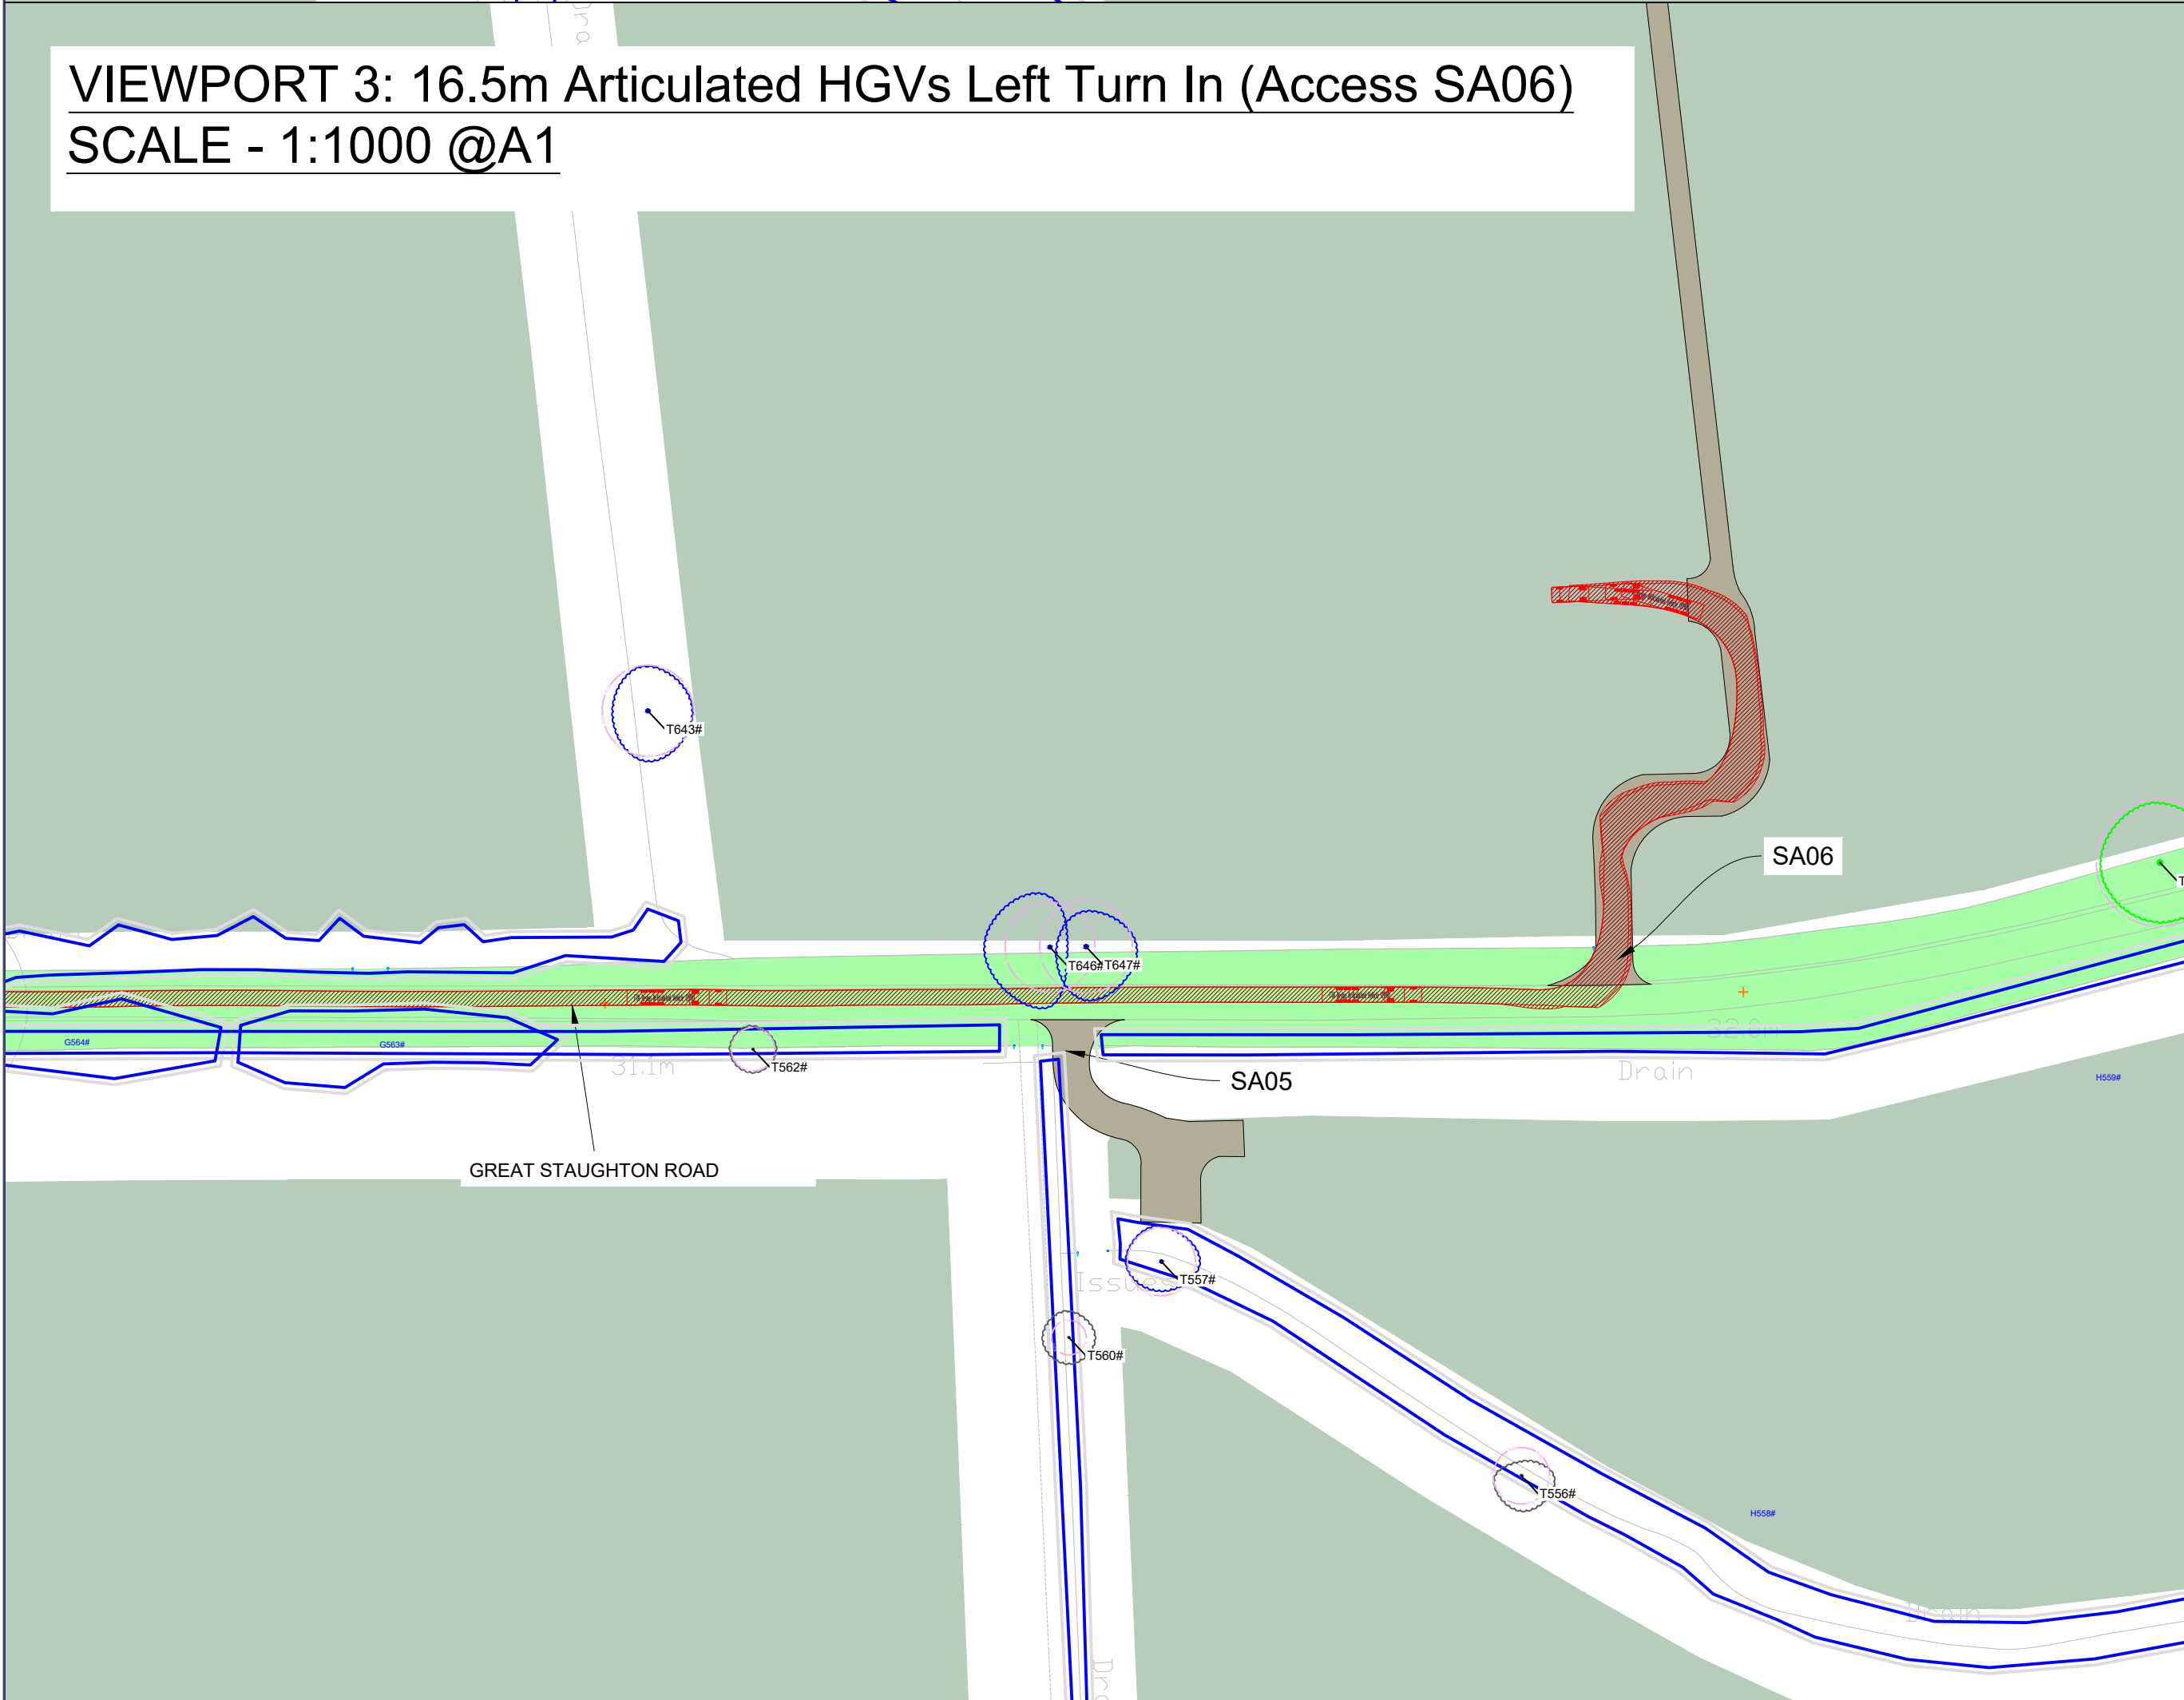
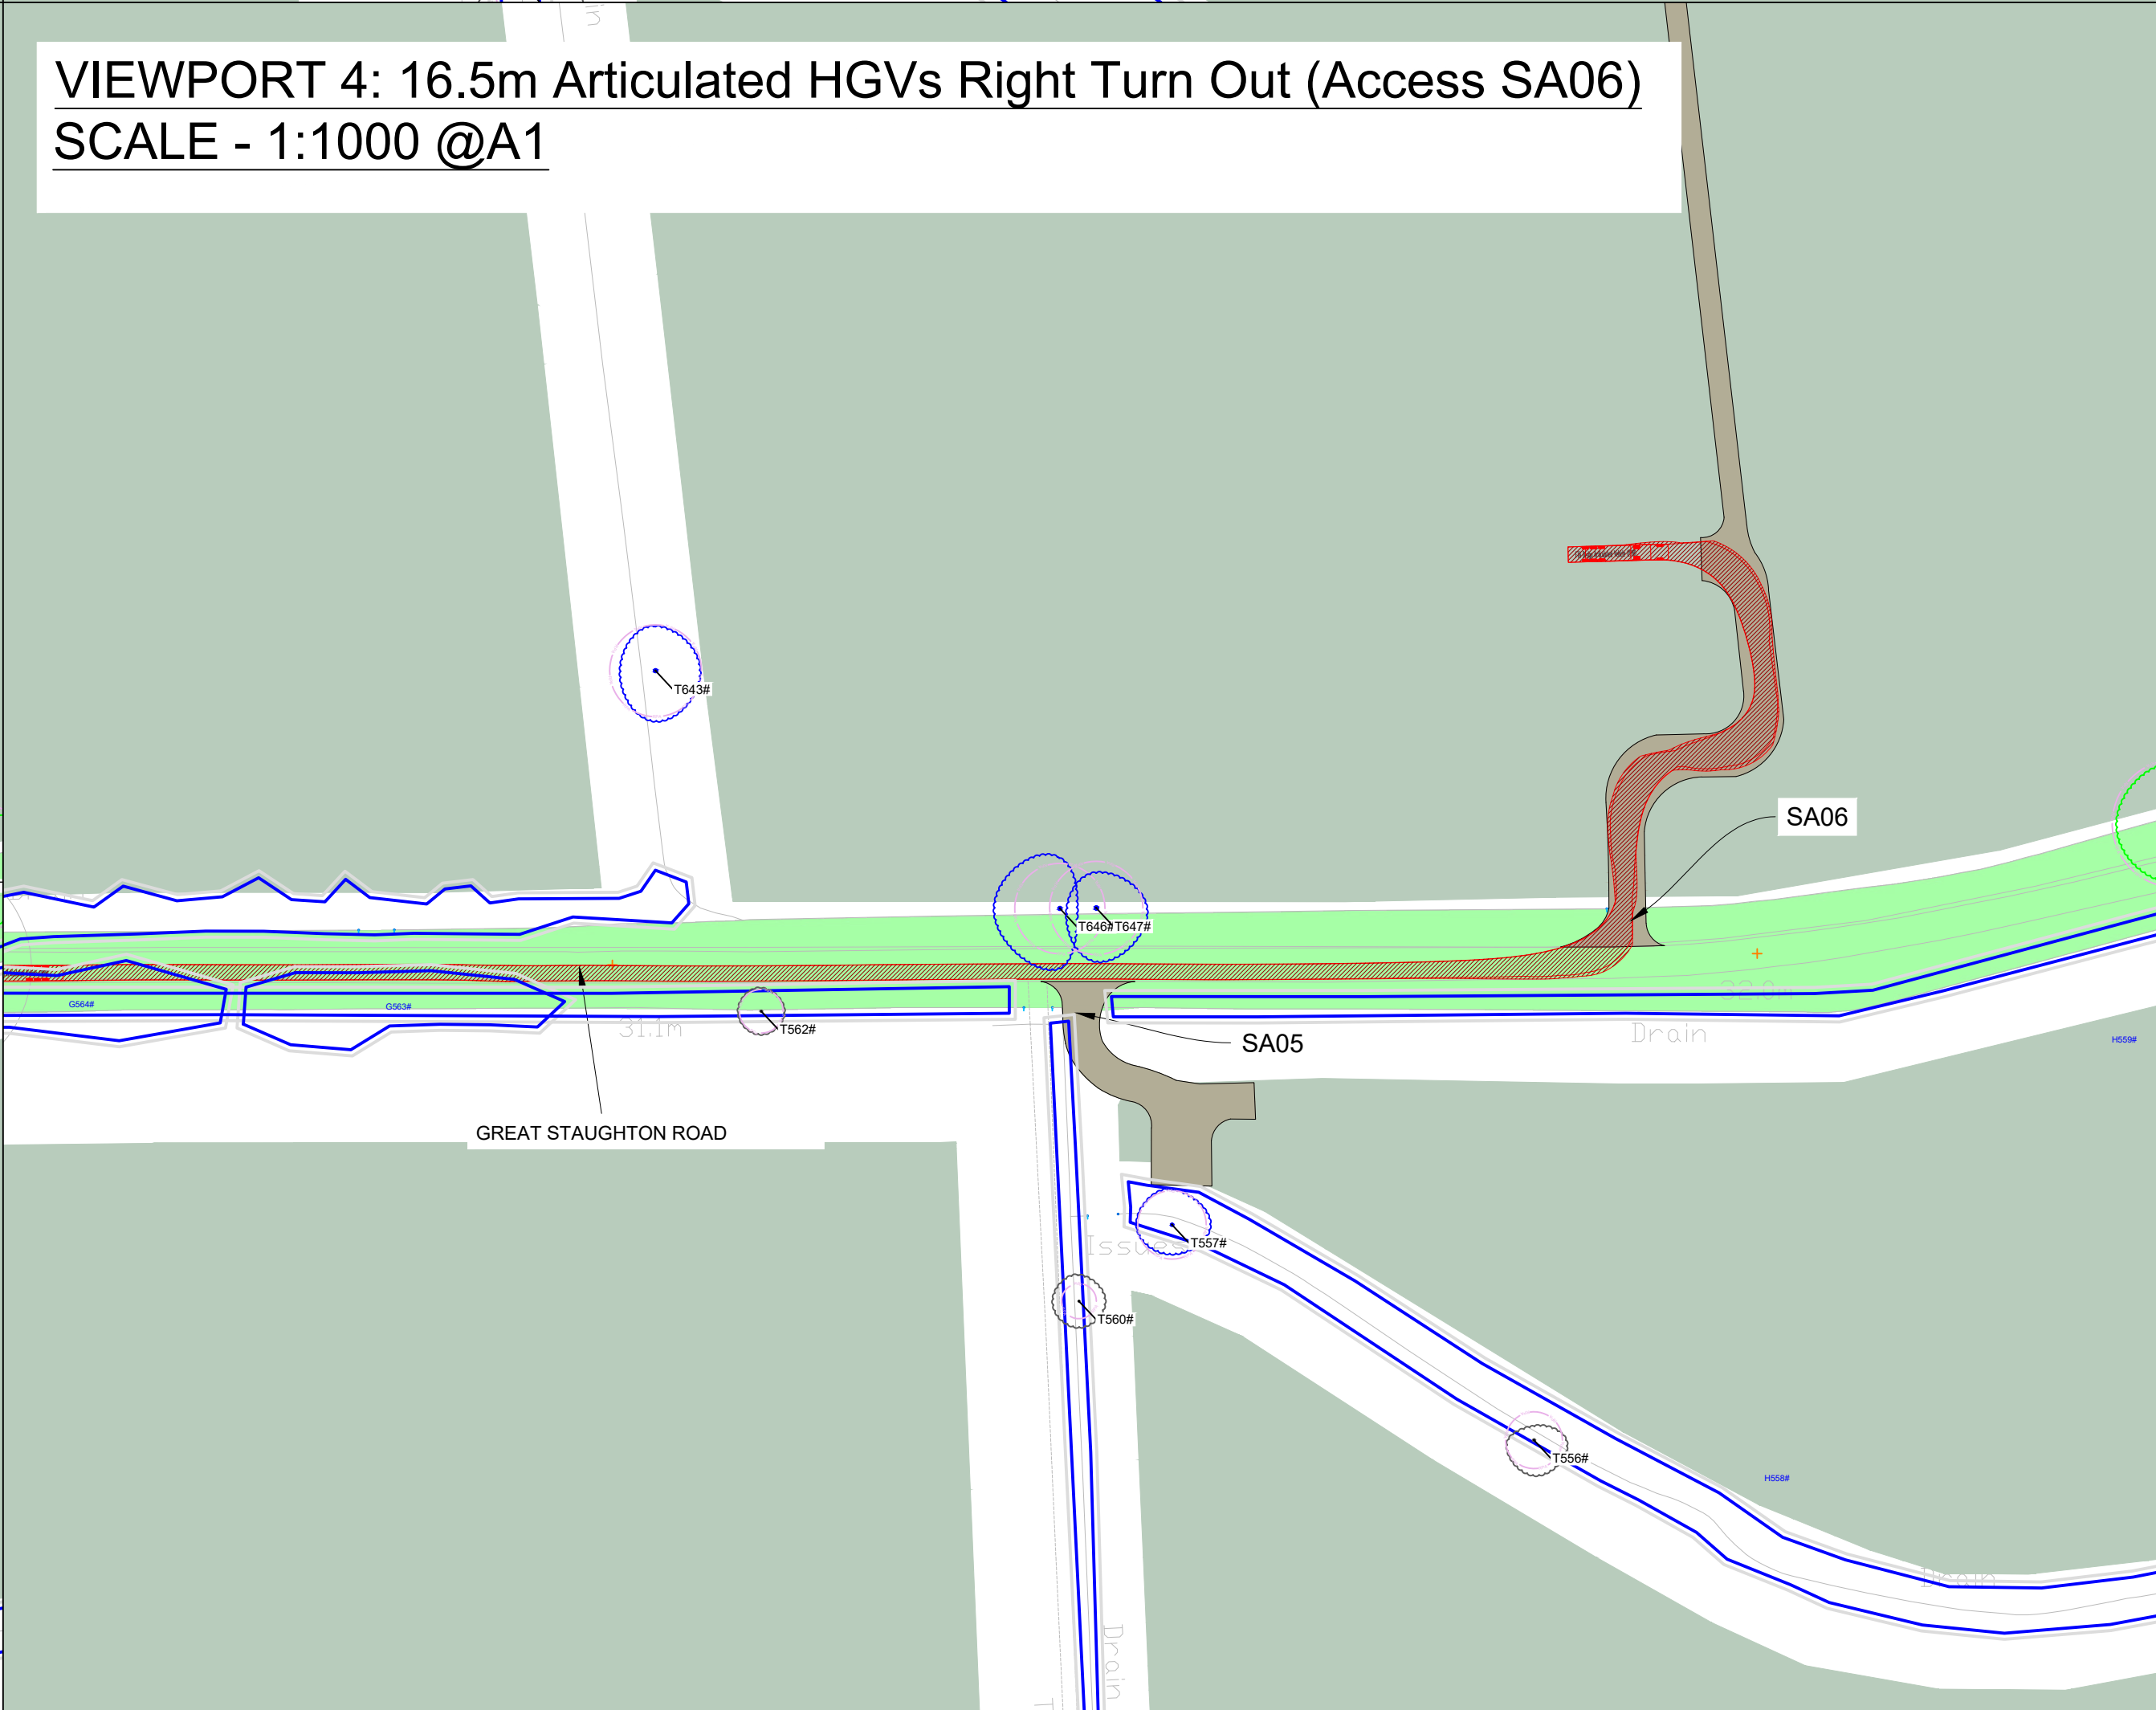
Dwg no  
**Figure 3a**  
Rev  
**P02**

VIEWPORT 1: 10m Rigid HGVs Entering Site (Access SA05)  
& Exiting Site (Access SA06)  
SCALE - 1:500 @A1

VIEWPORT 2: 10m Rigid HGVs Entering Site (Access SA06)  
& Exiting Site (Access SA05)  
SCALE - 1:500 @A1

VIEWPORT 3: 16.5m Articulated HGVs Left Turn In (Access SA06)  
SCALE - 1:1000 @A1

VIEWPORT 4: 16.5m Articulated HGVs Right Turn Out (Access SA06)  
SCALE - 1:1000 @A1

- 5.4.4 The achievable visibility splays at each of the proposed site access junctions is illustrated in Figures 1 to 14 in **Appendix D** of this oCTMP.
