# EAST PARK ENERGY

EN010141

## Outline Construction Traffic Management Plan

**Document Reference: EN010141/DR/7.4**

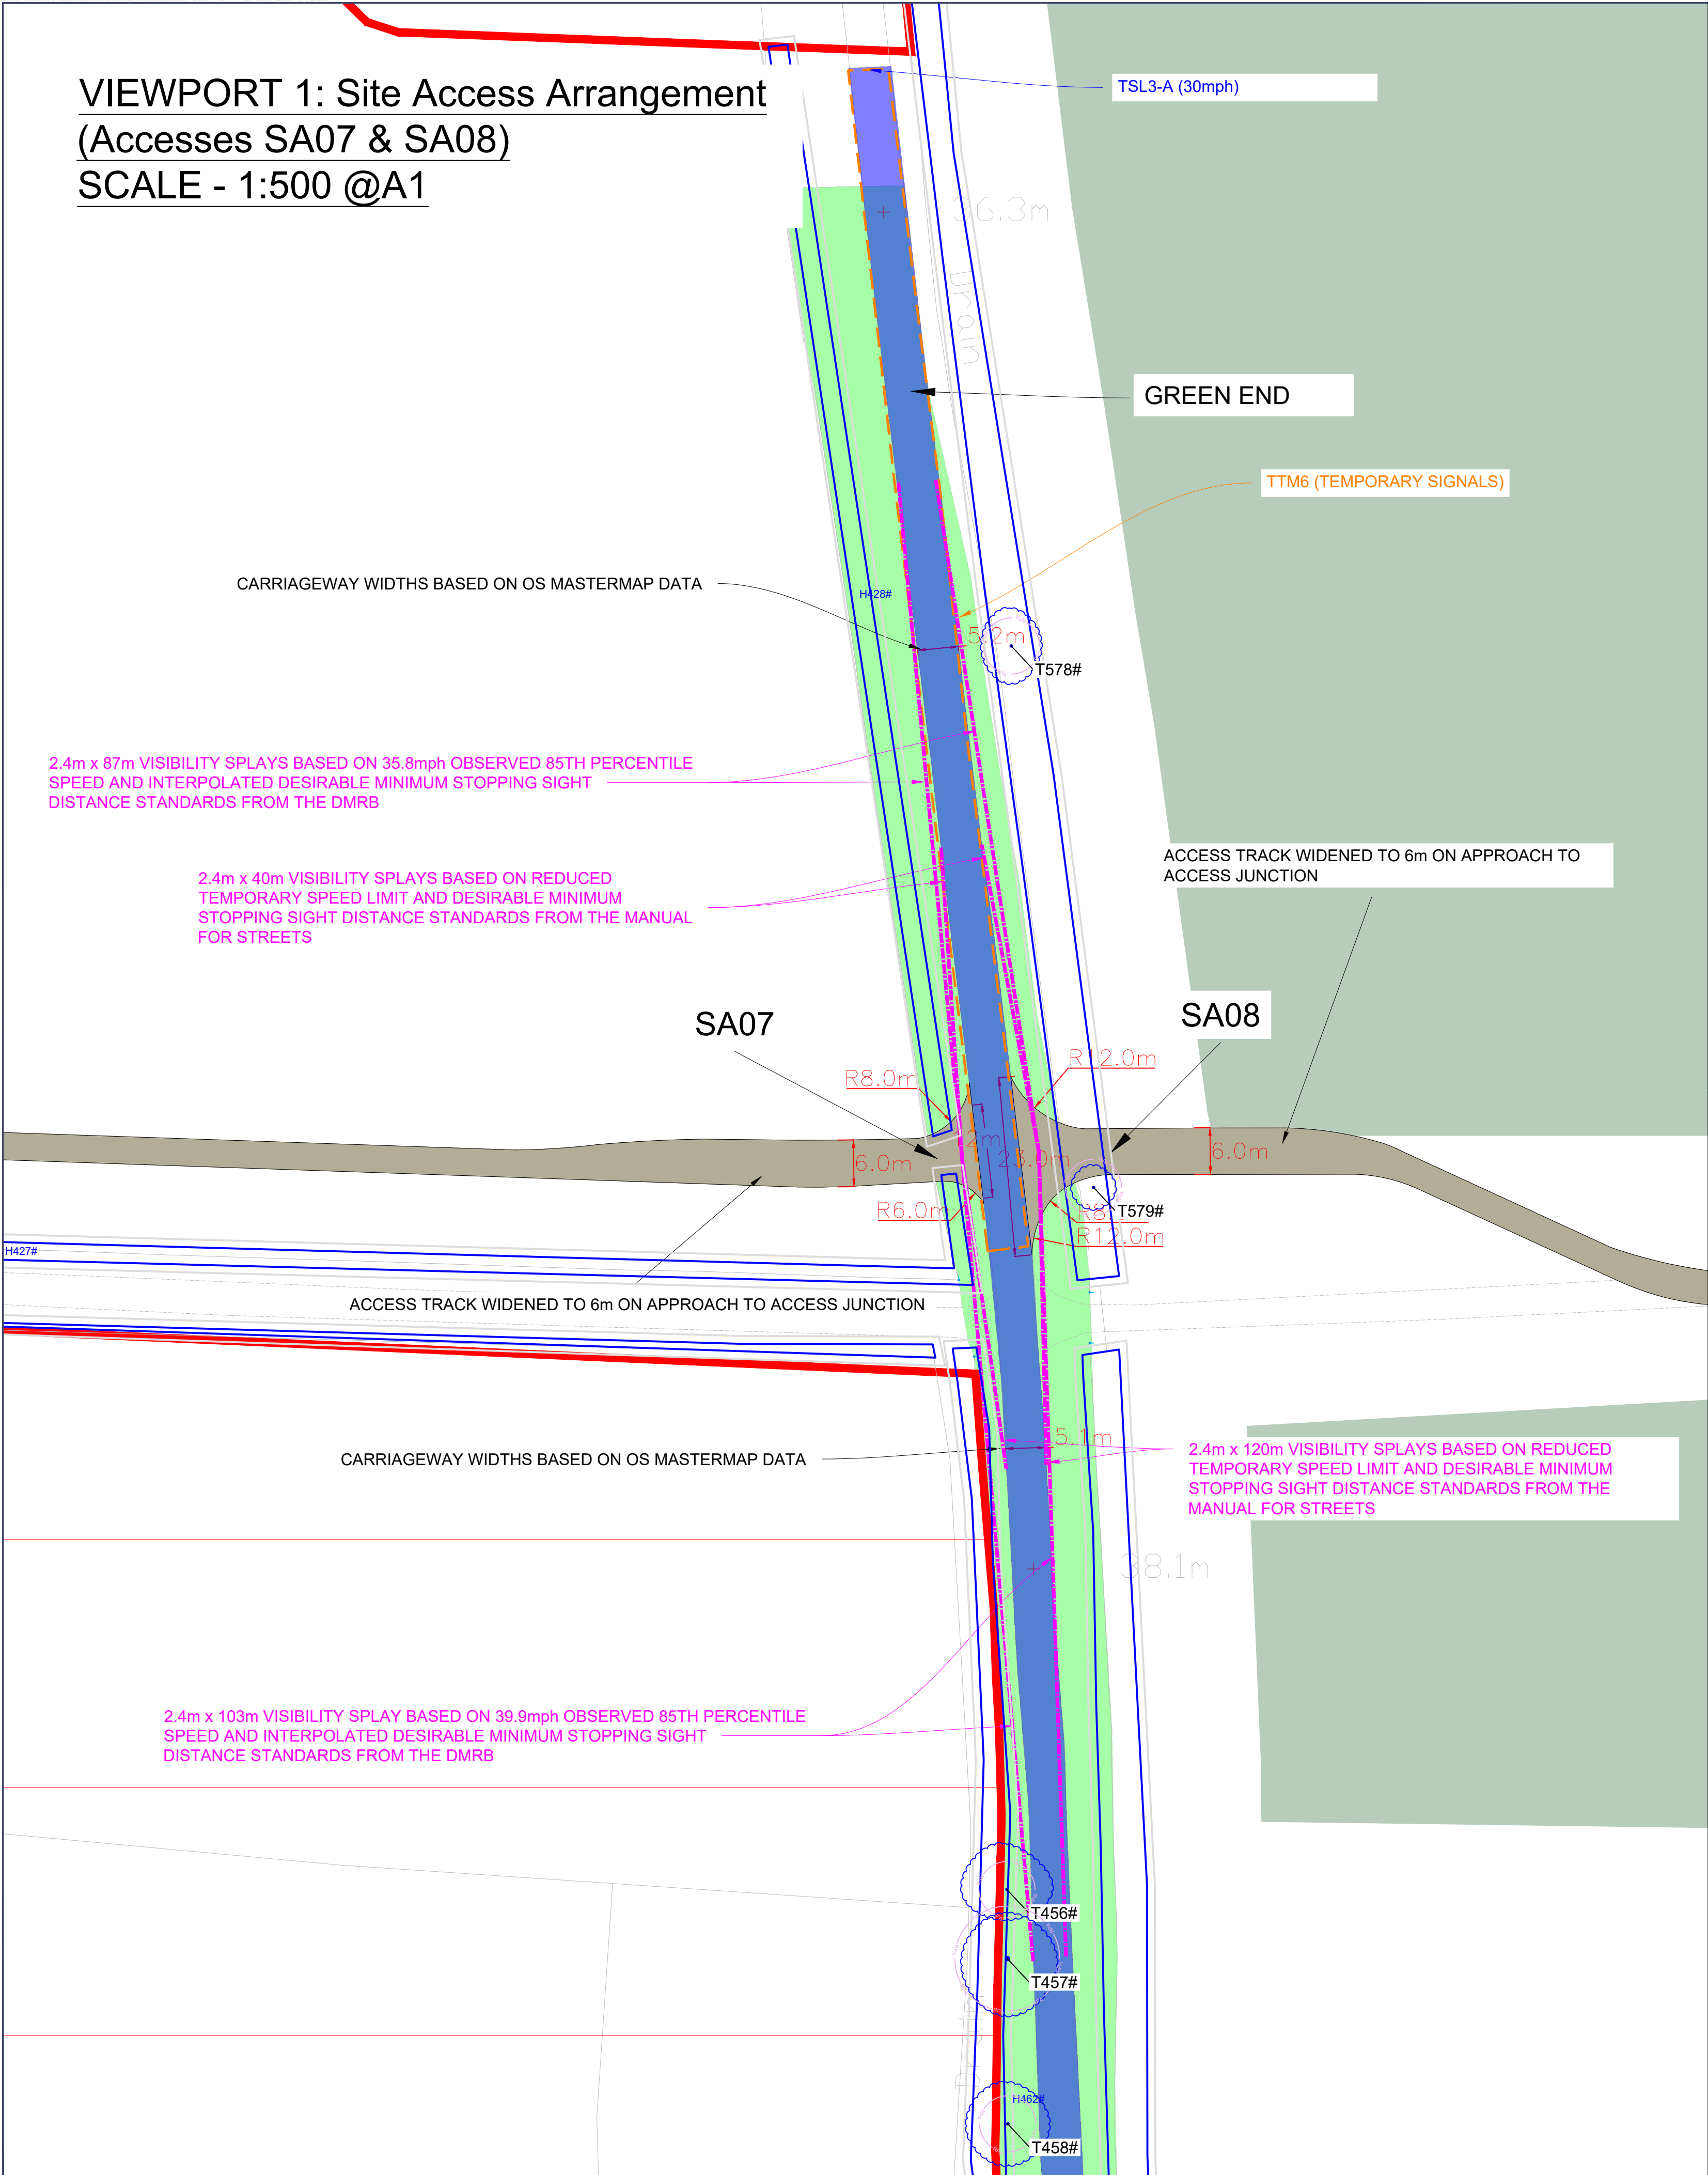
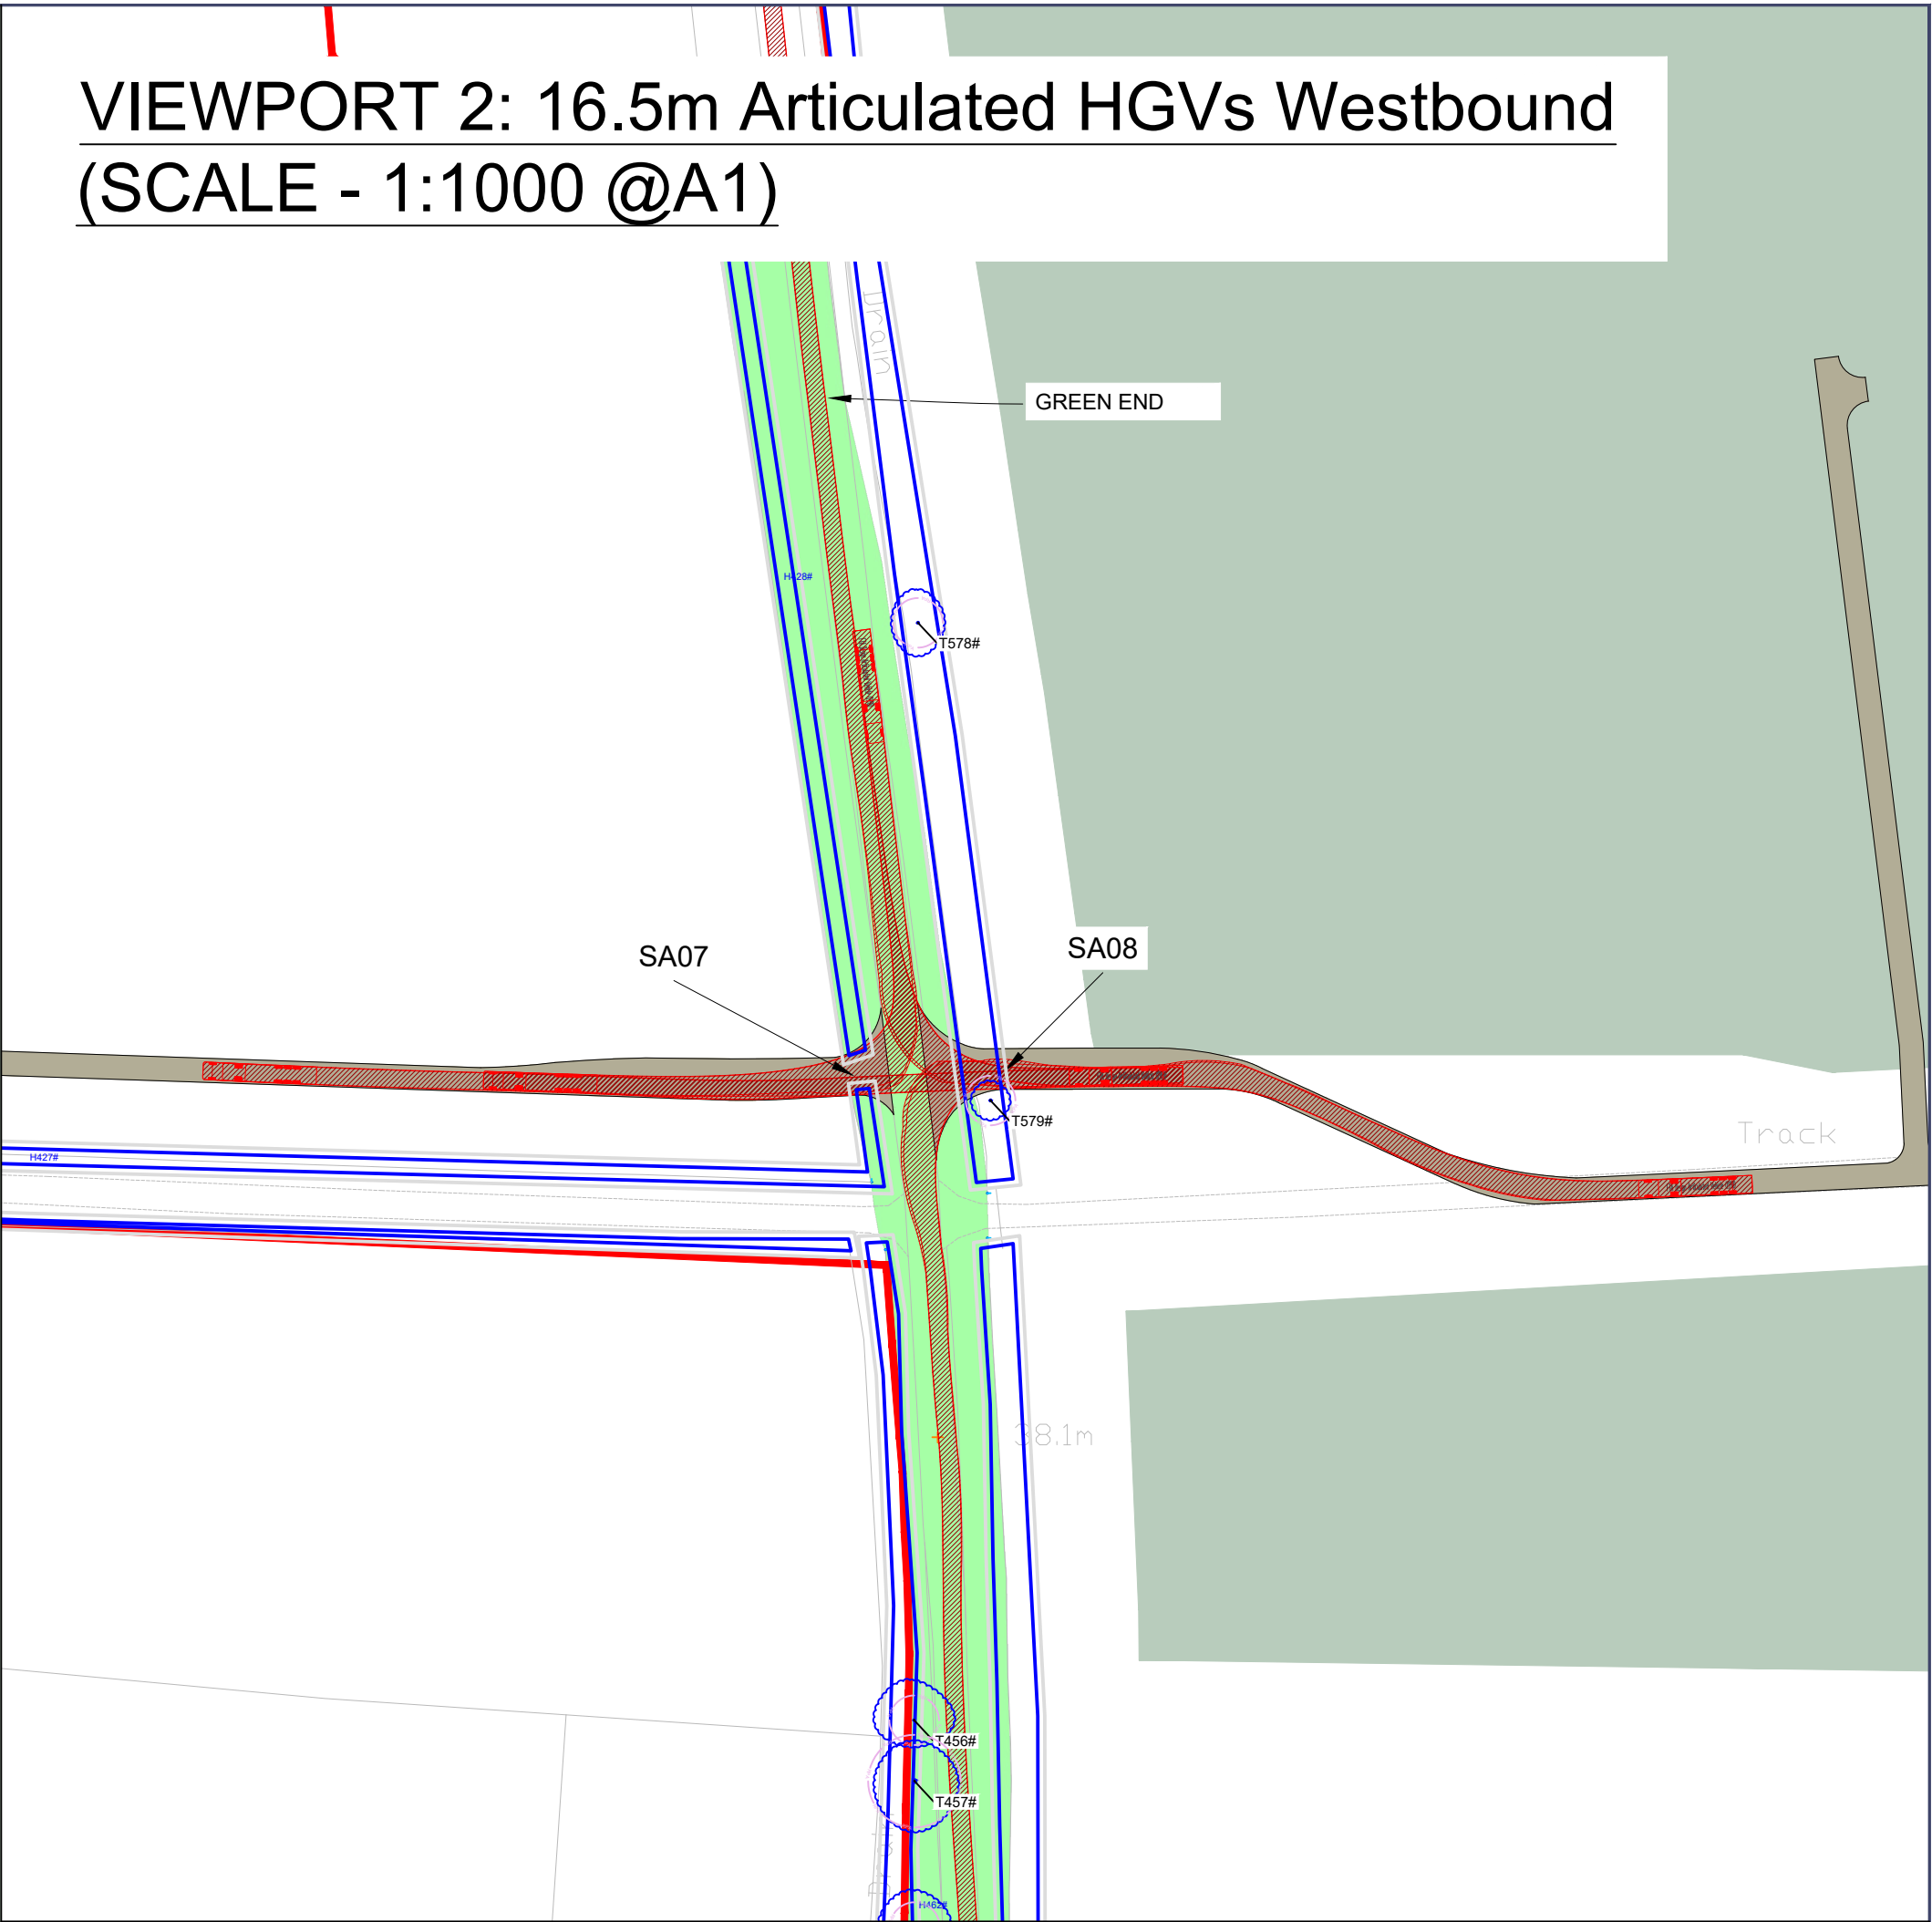
VIEWPORT 1: Site Access Arrangement  
(Accesses SA07 & SA08)  
SCALE - 1:500 @A1

VIEWPORT 2: 16.5m Articulated HGVs Westbound  
(SCALE - 1:1000 @A1)

- 5.1.15 As mentioned earlier, indicative site access designs for each of the accesses described above, including visibility splays and swept path analysis of the largest vehicles that are anticipated to use each access, are shown on Figure 1 to 14 at **Appendix D** of this **outline Construction Traffic Management Plan [EN010141/DR/7.4]**.

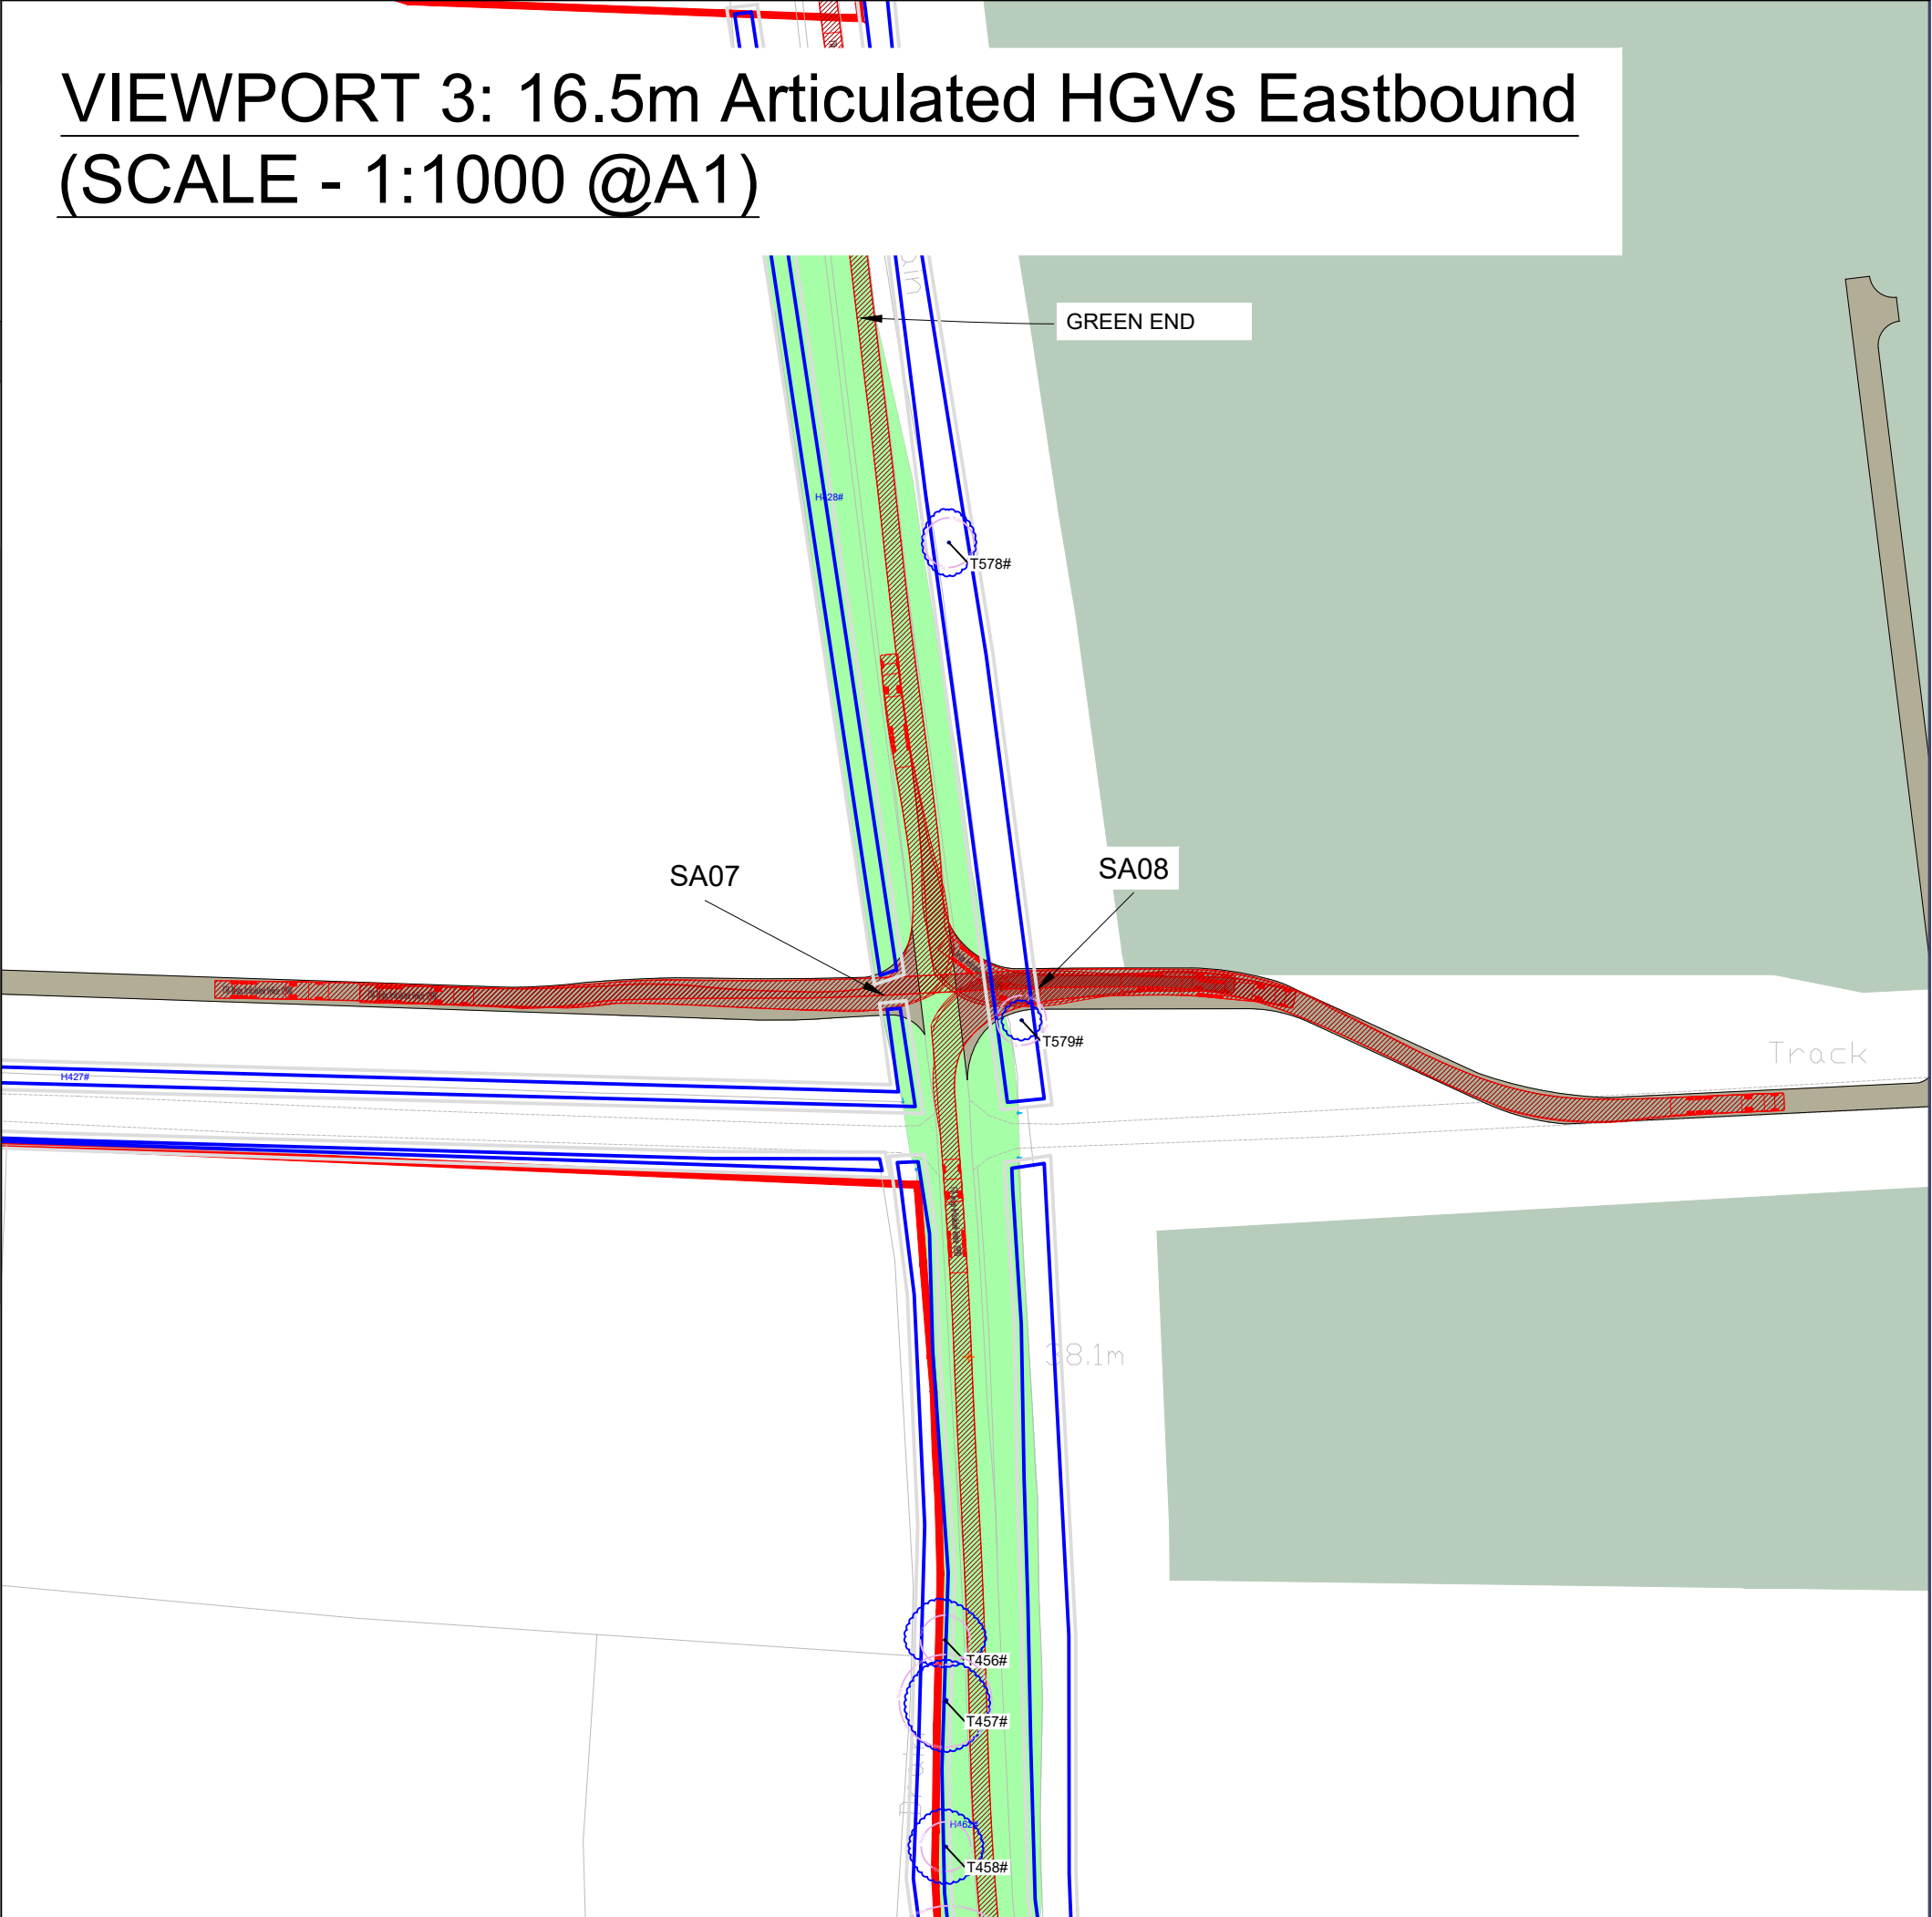
VIEWPORT 3: 16.5m Articulated HGVs Eastbound  
(SCALE - 1:1000 @A1)

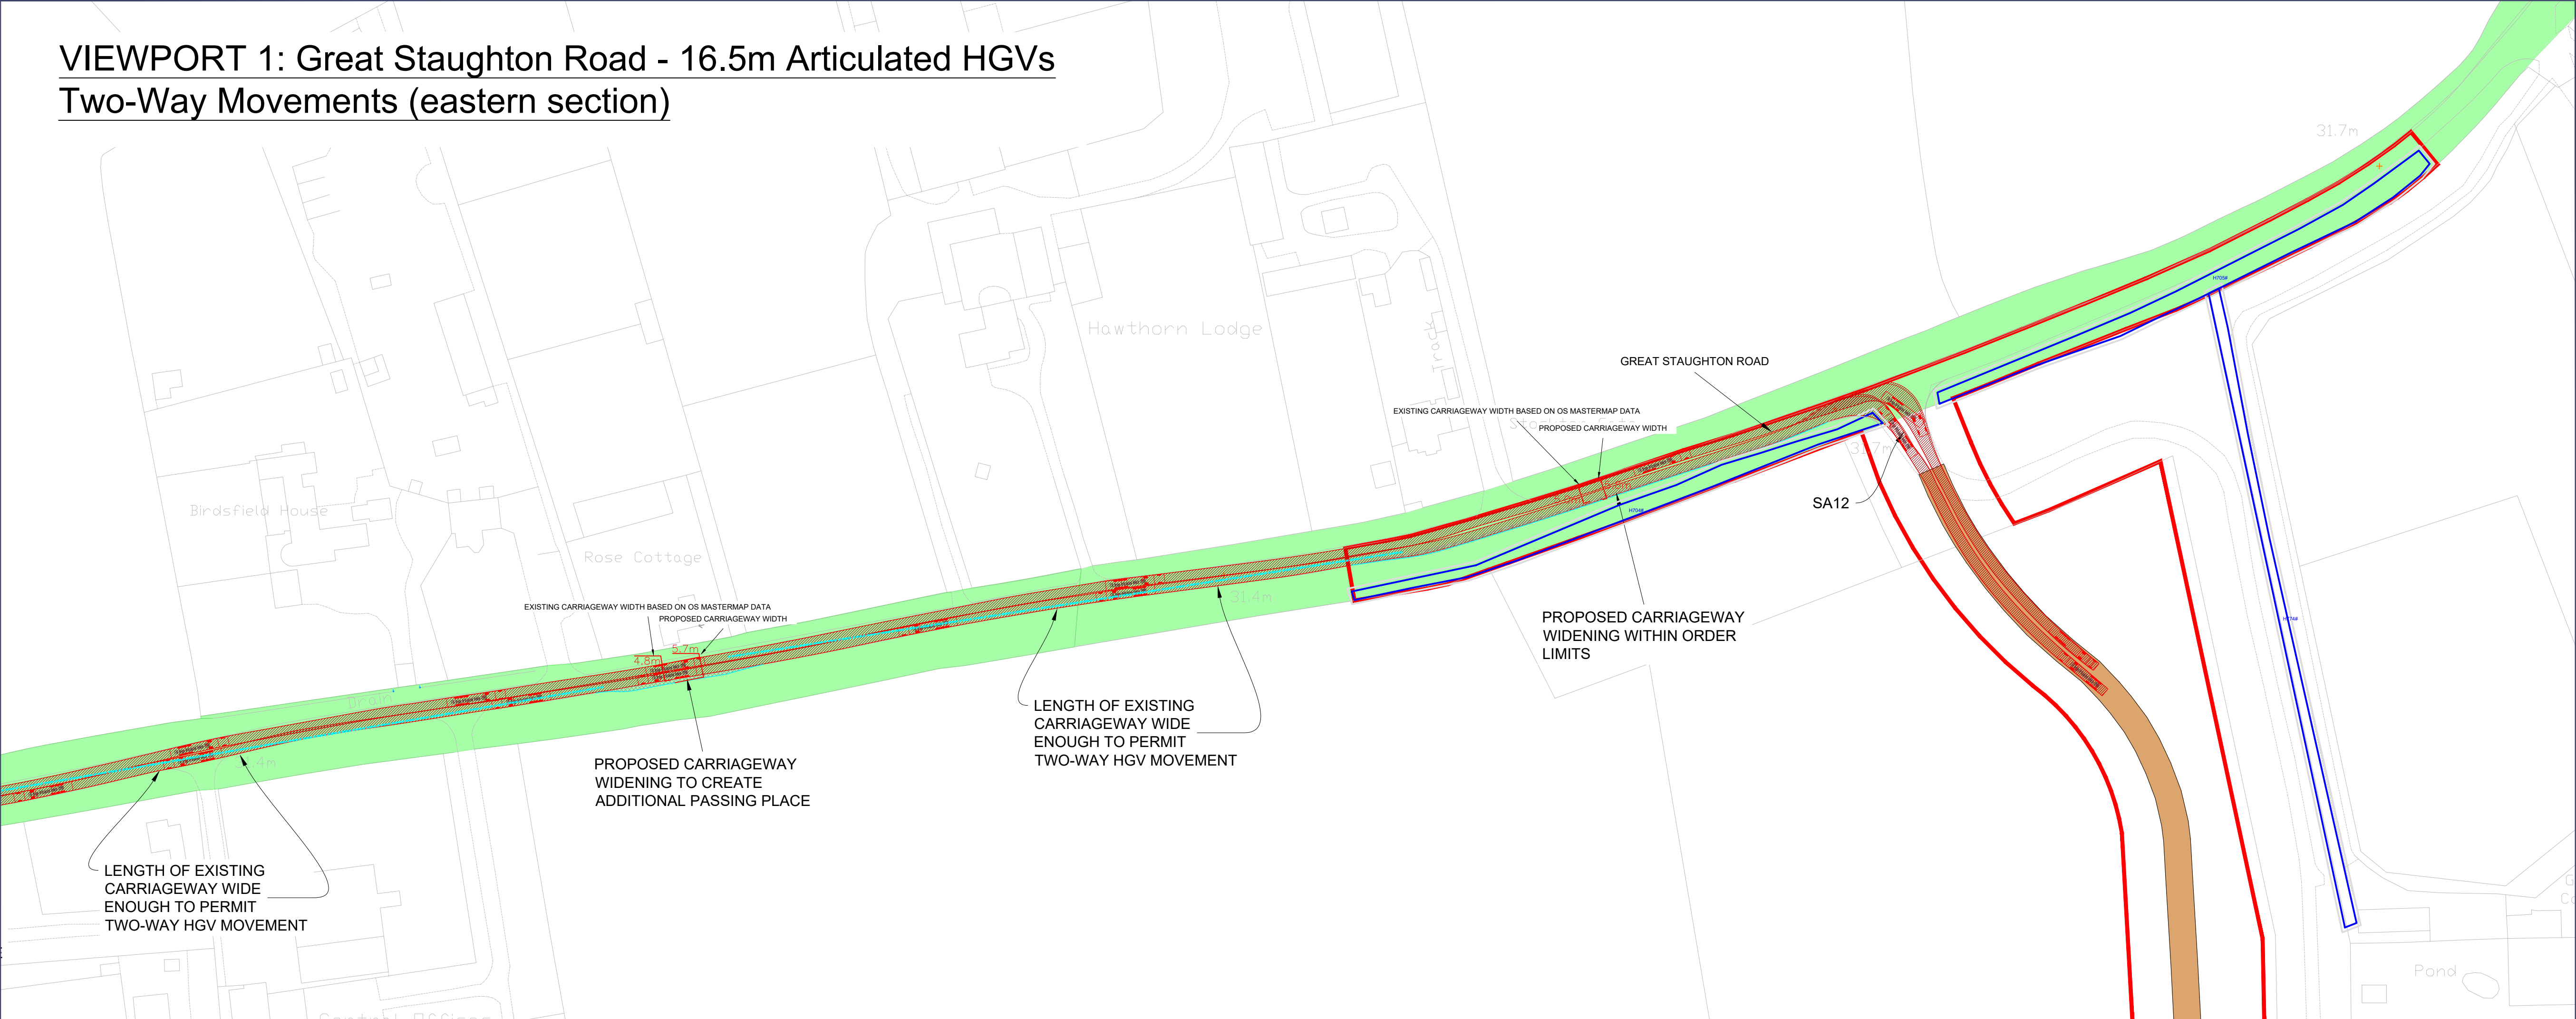
VIEWPORT 1: Great Staughton Road - 16.5m Articulated HGVs  
Two-Way Movements (eastern section)

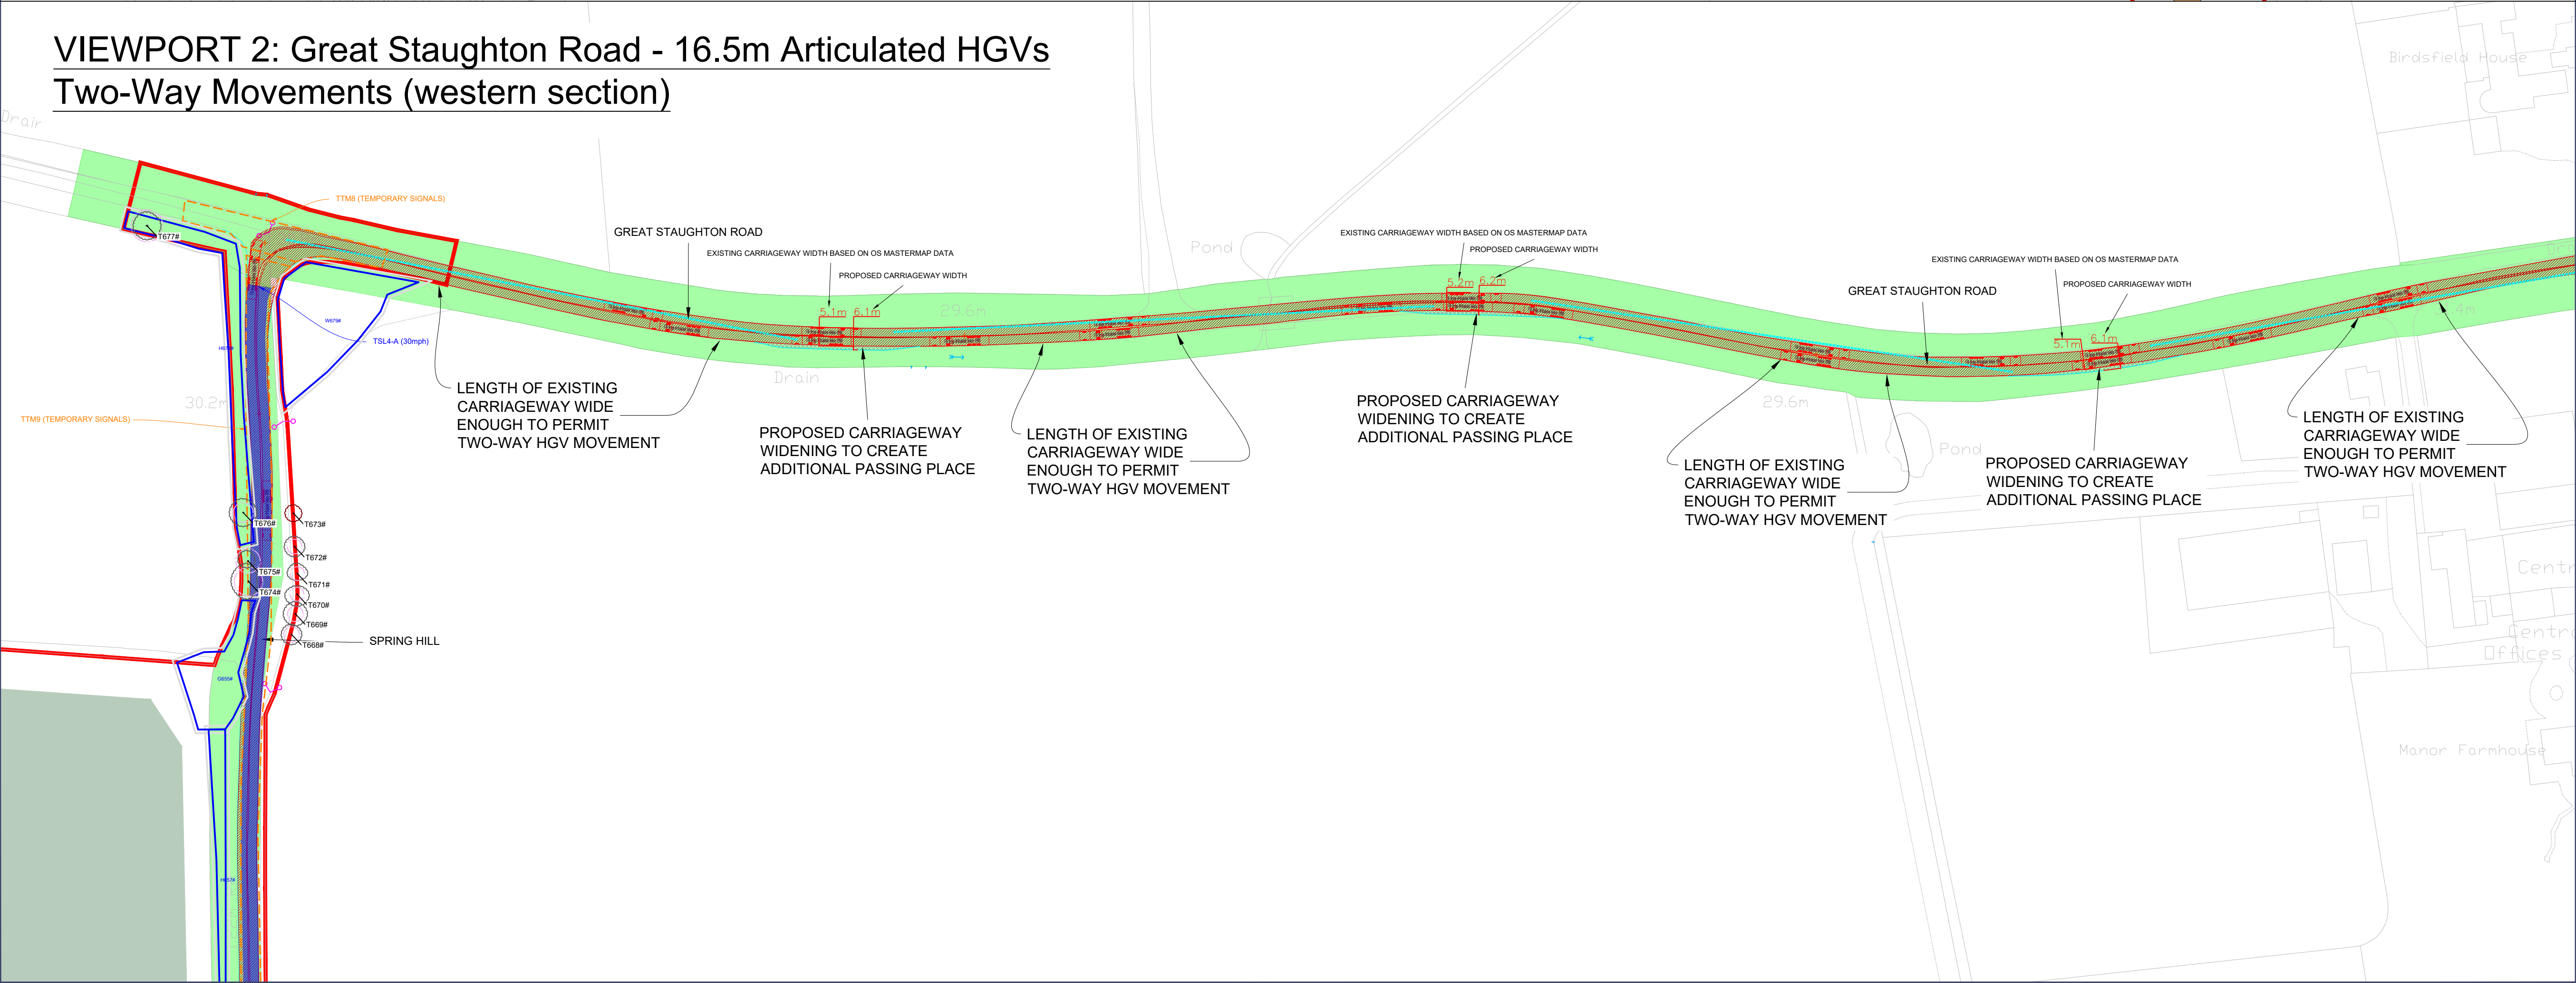
VIEWPORT 2: Great Staughton Road - 16.5m Articulated HGVs  
Two-Way Movements (western section)

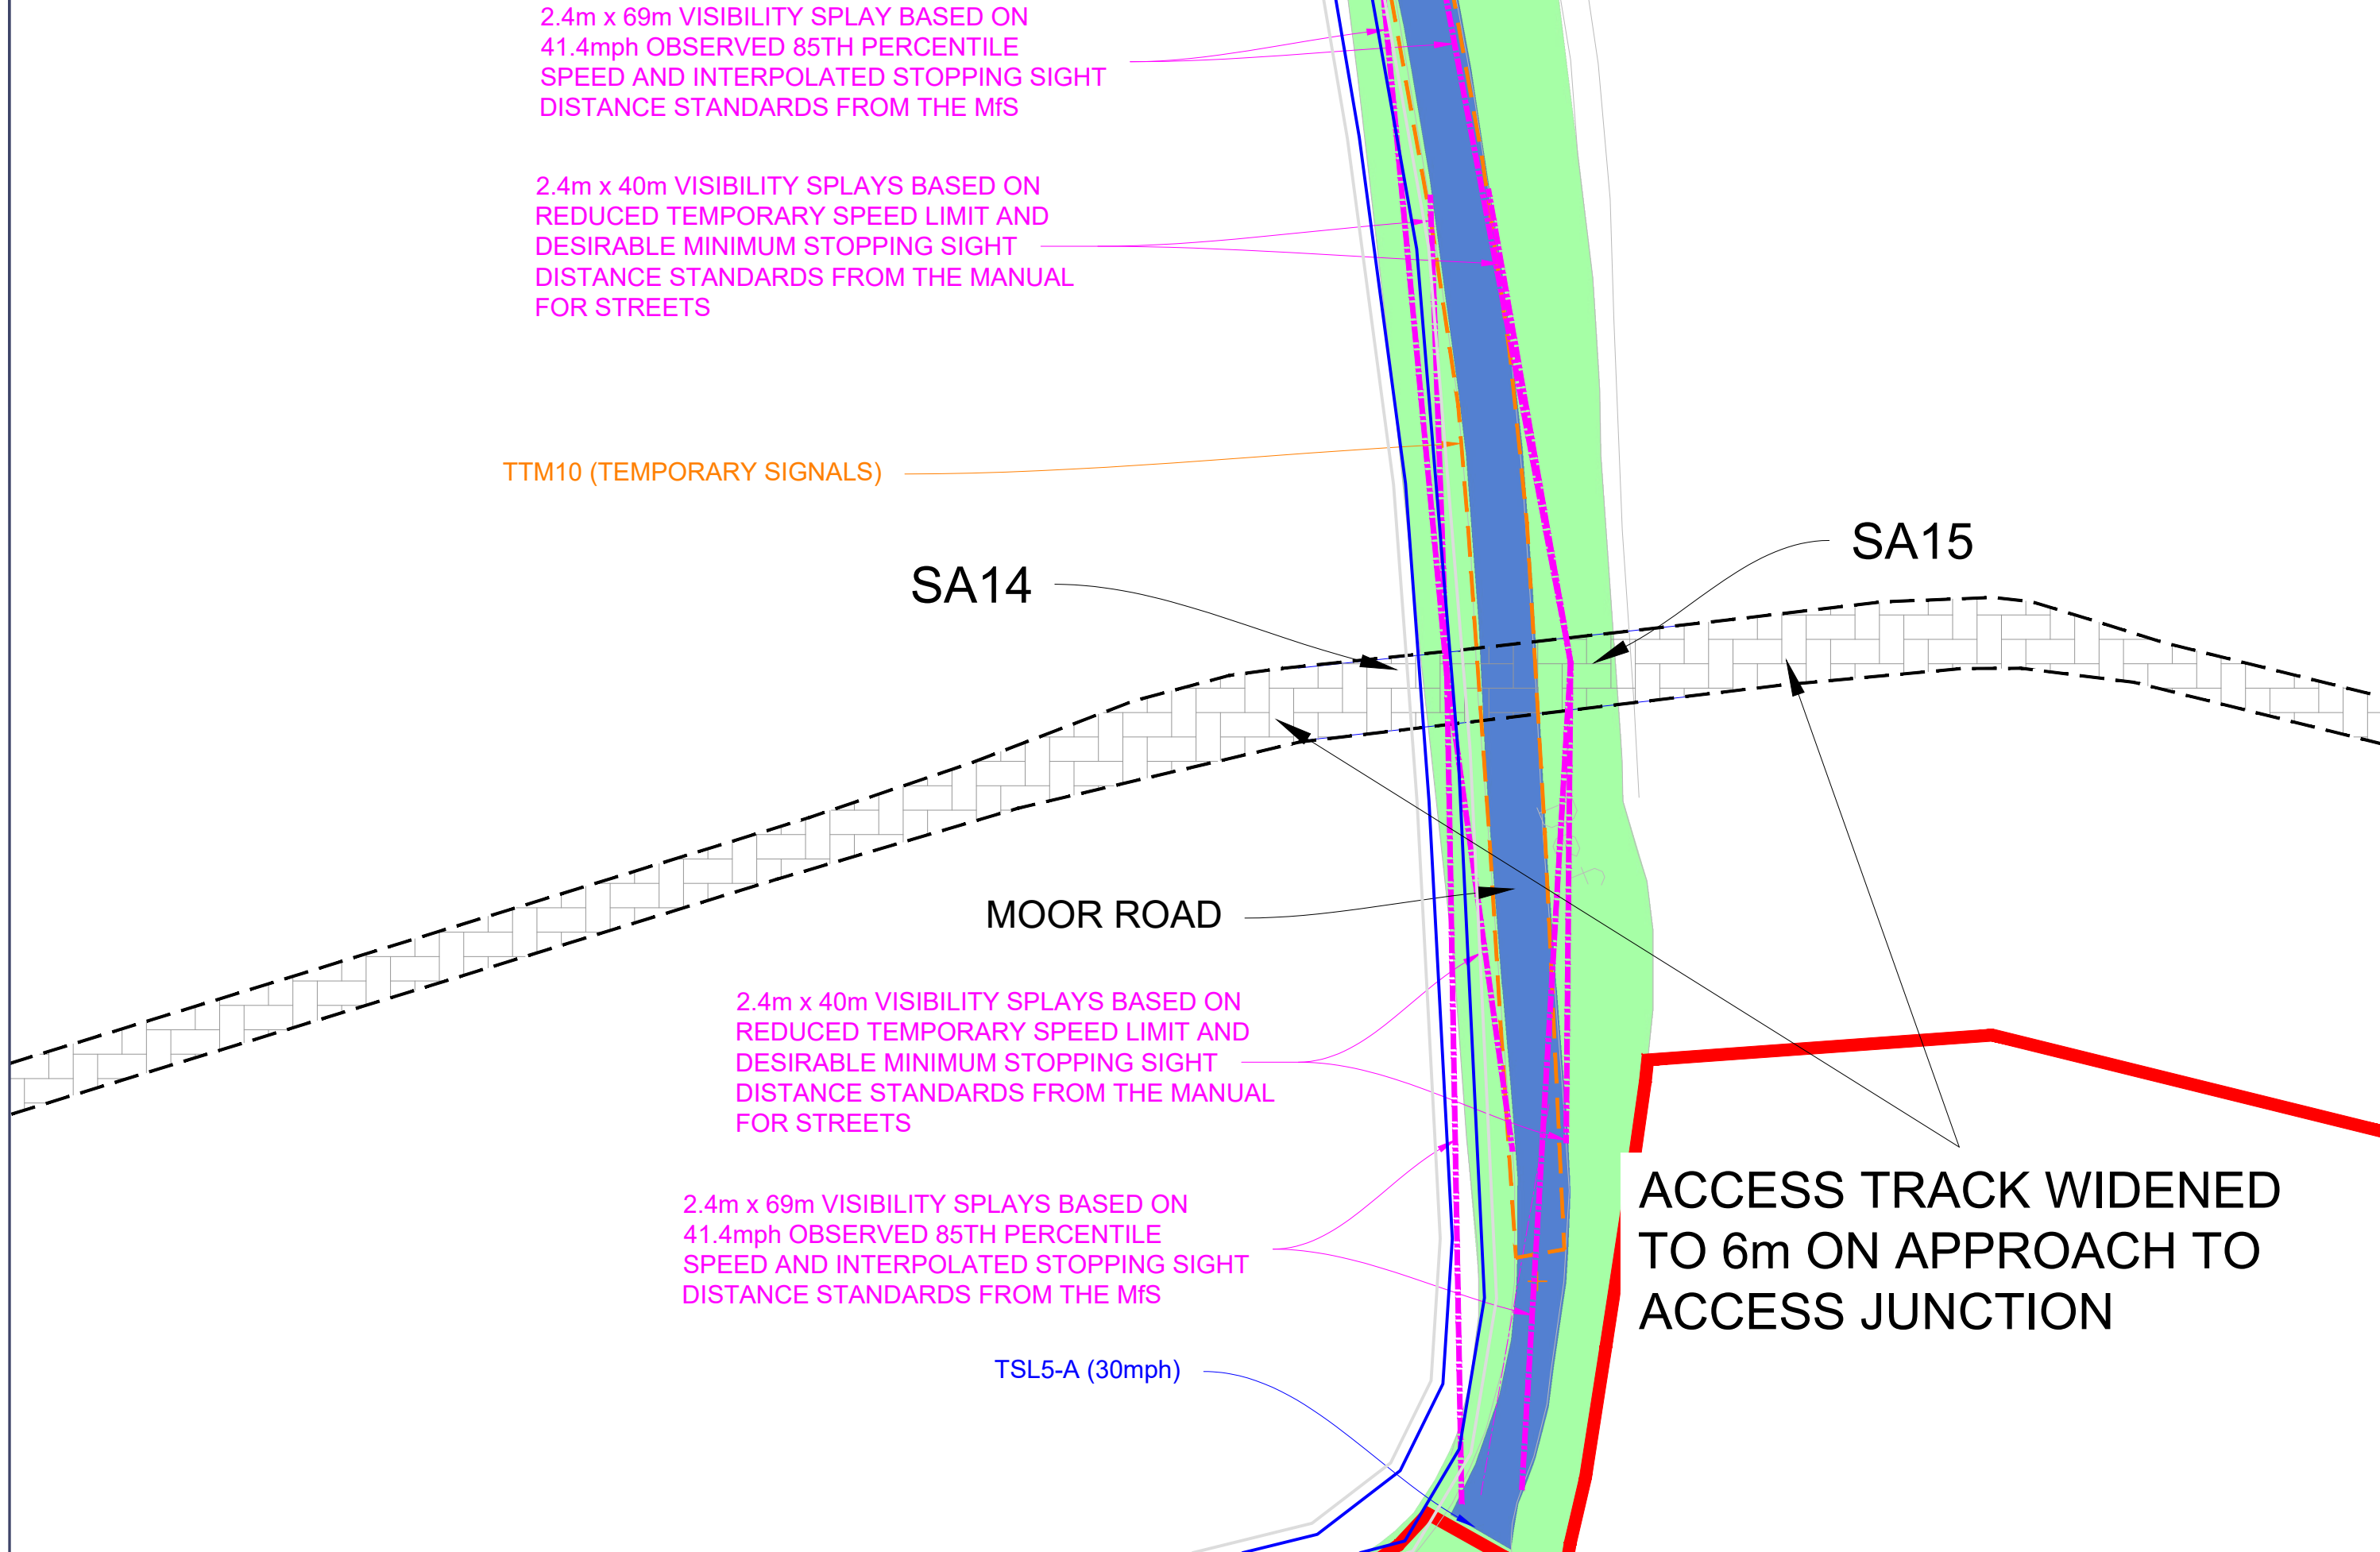
VIEWPORT 1: Site Access Arrangement  
(Accesses SA14 & SA15 - Visibility Splays)
