# EAST PARK ENERGY

EN010141

## Outline Construction Traffic Management Plan

**Document Reference: EN010141/DR/7.4**

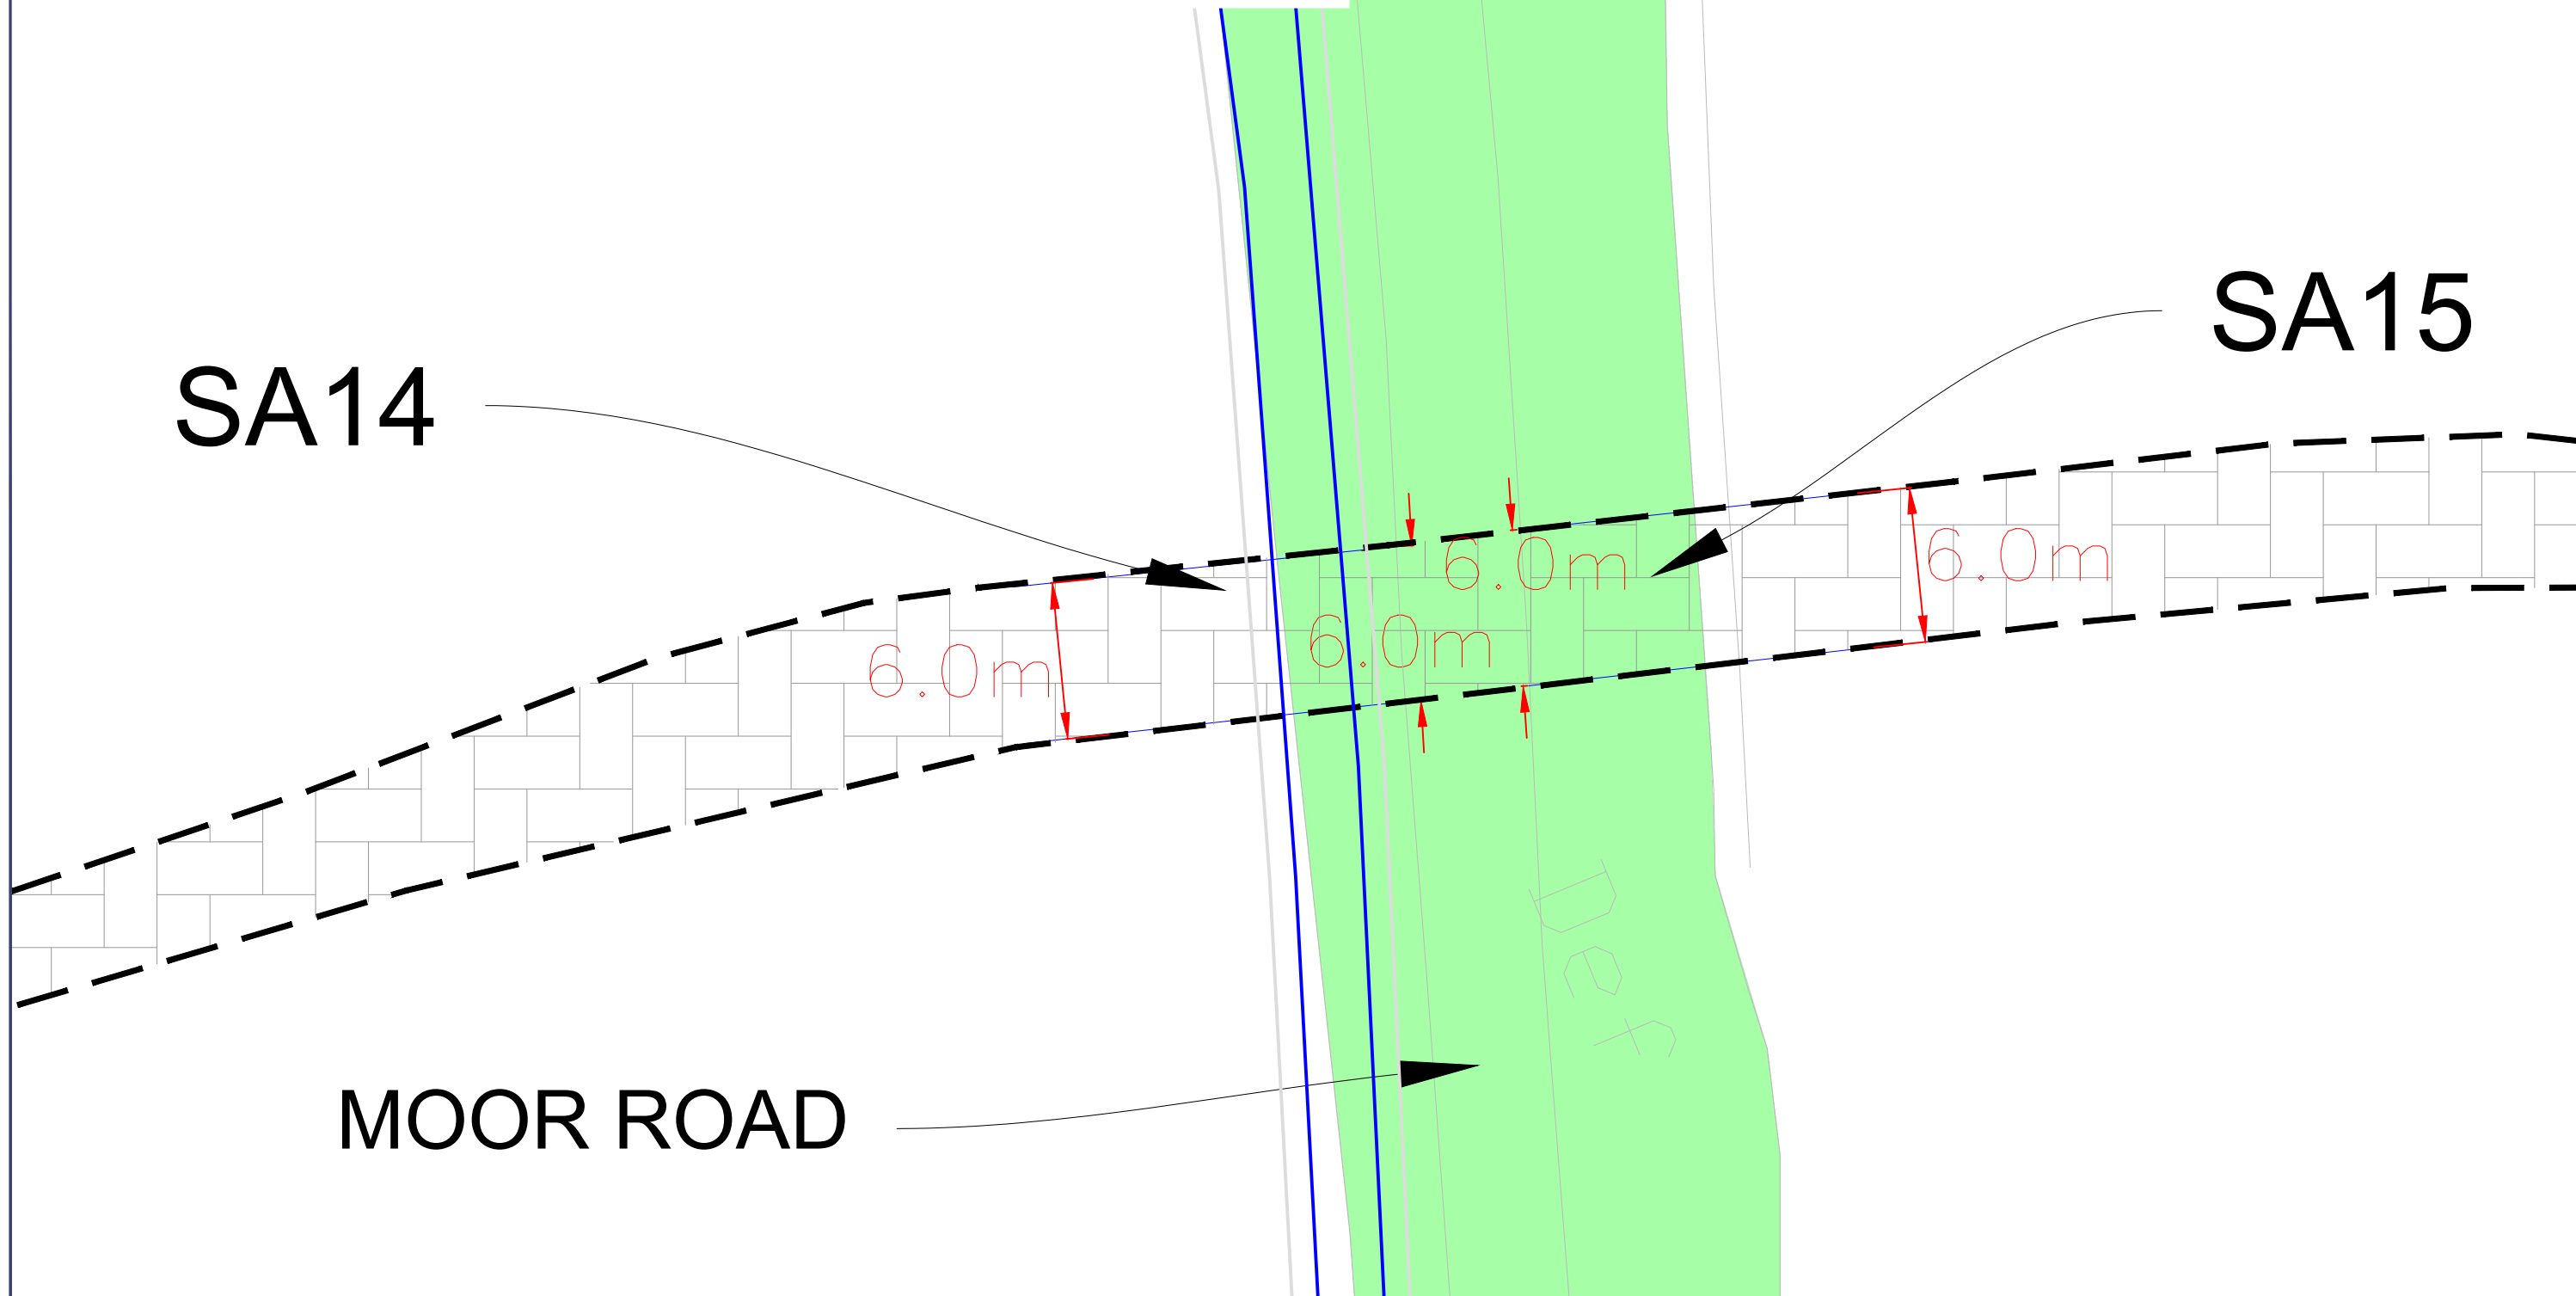
VIEWPORT 2: Site Access Arrangement  
(Accesses SA14 & SA15 - Dimensions)  
SCALE - 1:250 @A1

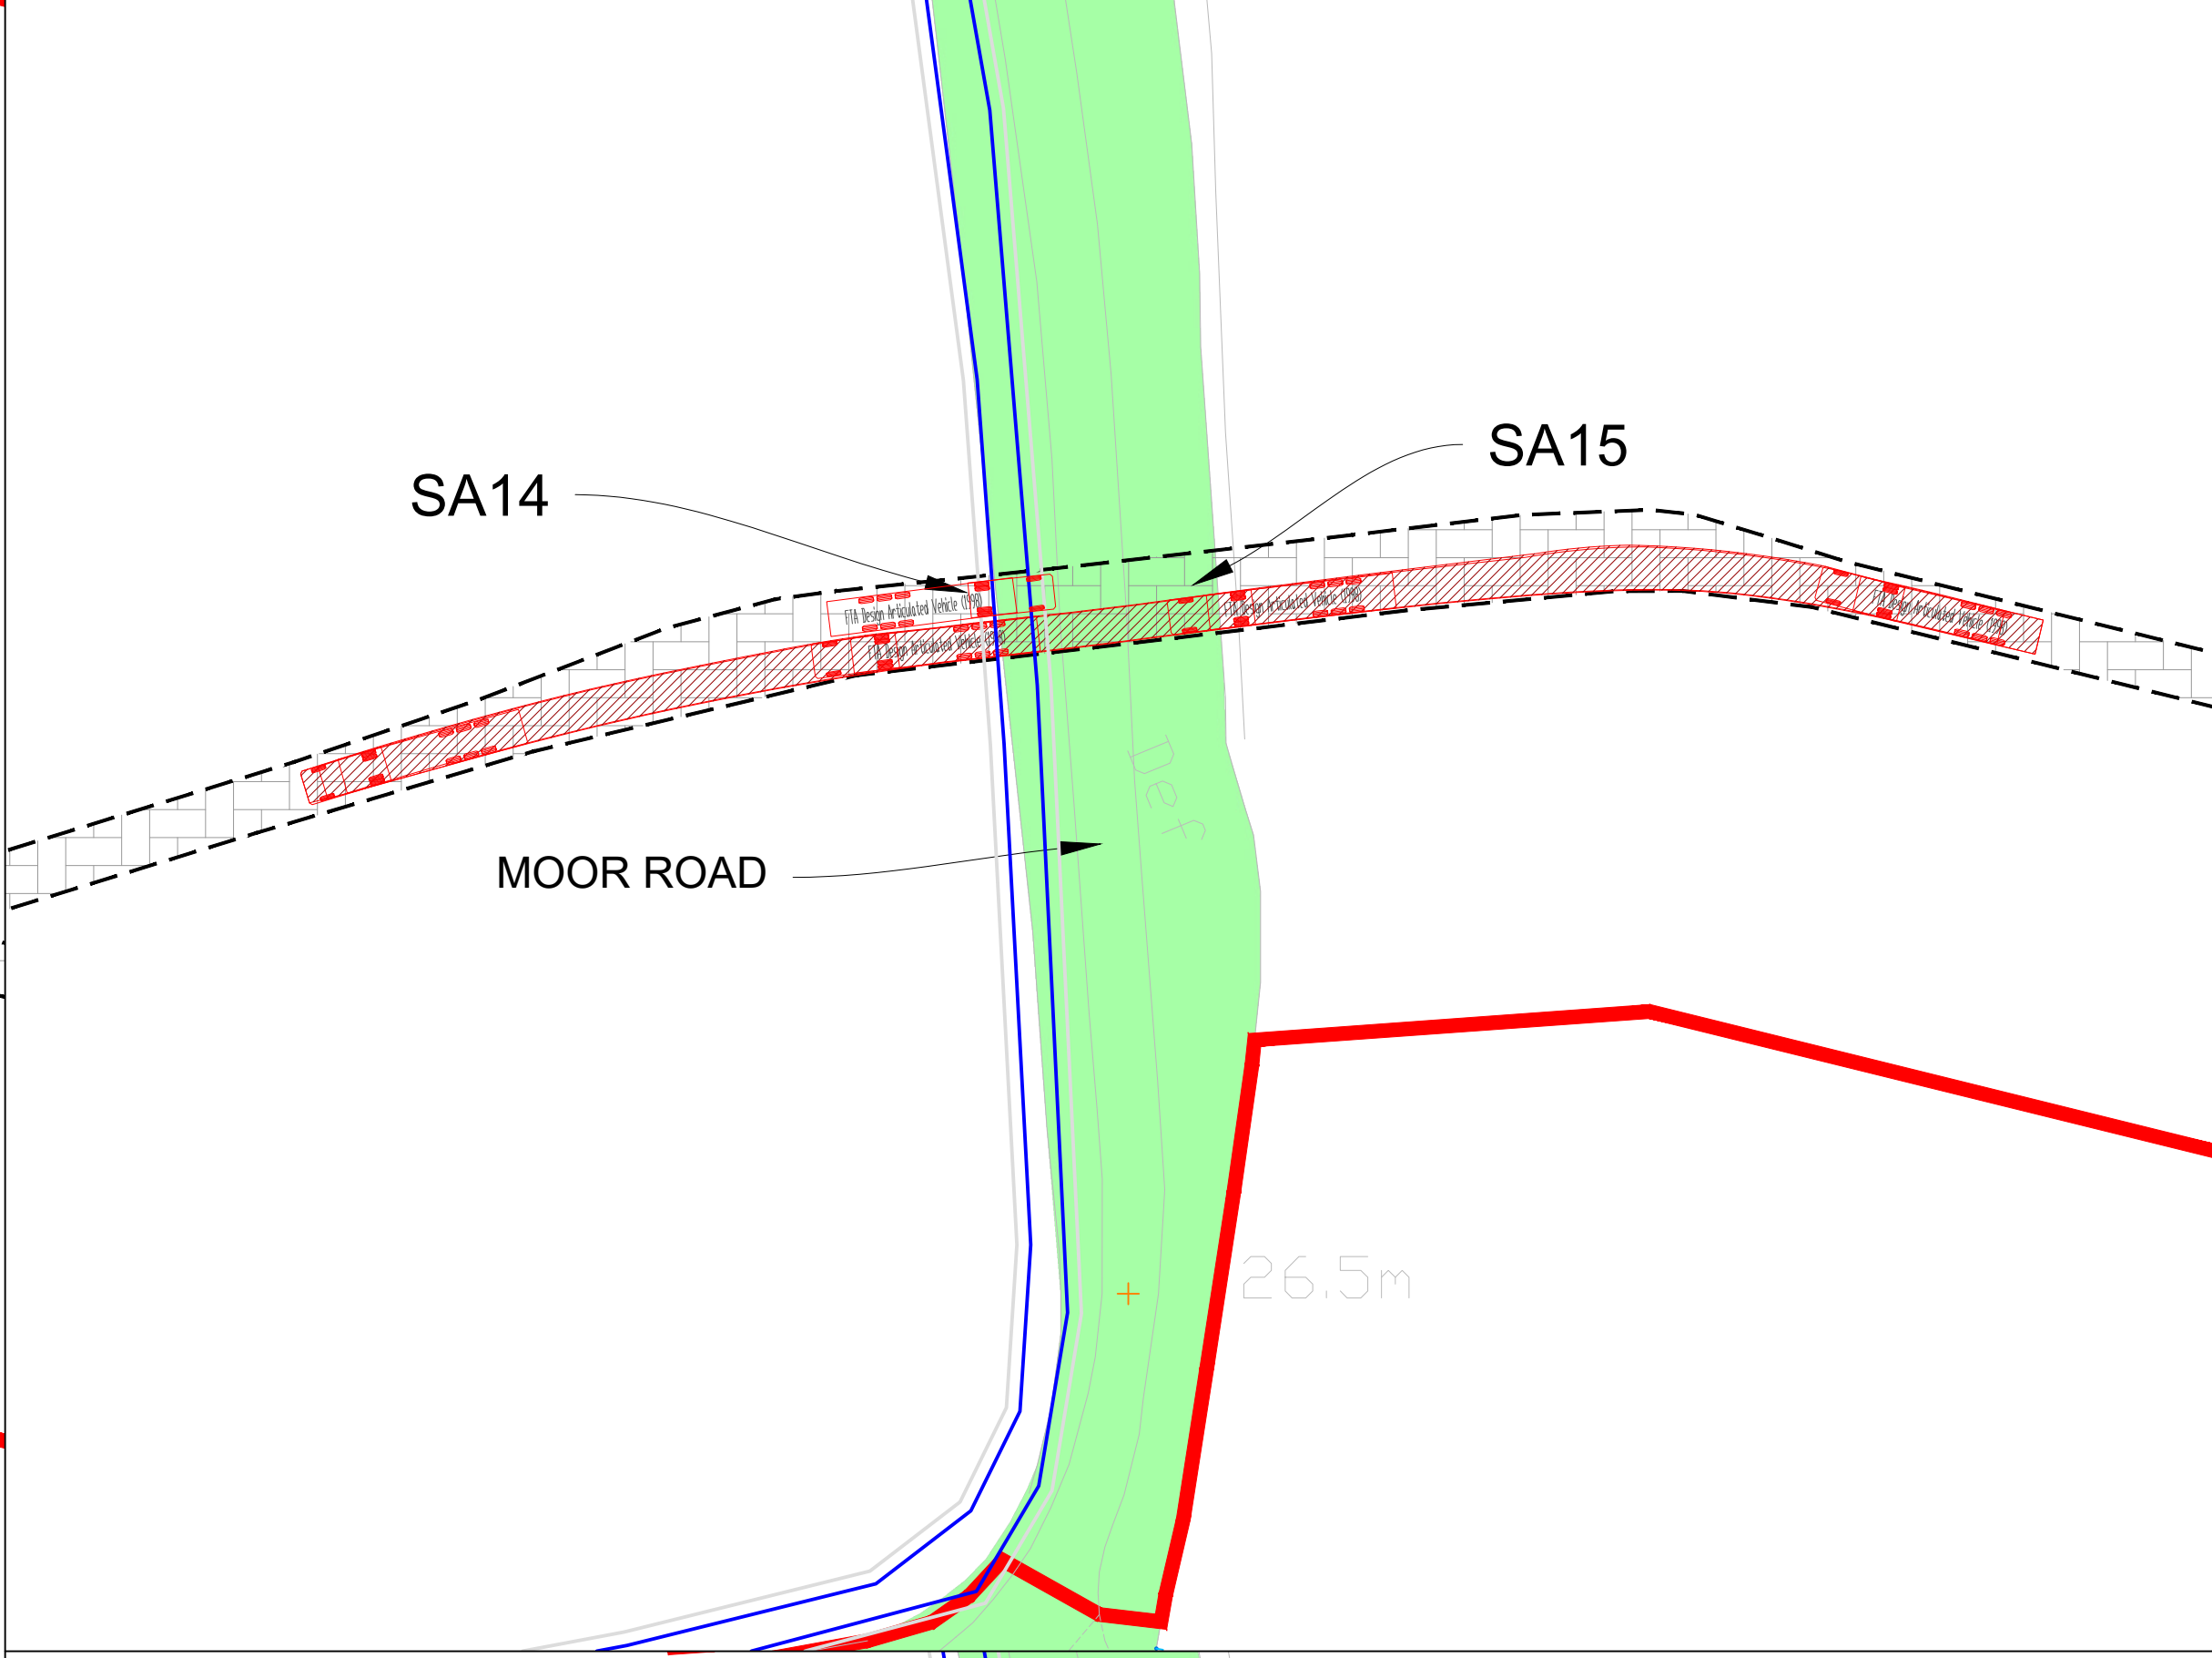
VIEWPORT 3: 16.5m Articulated HGVs Westbound

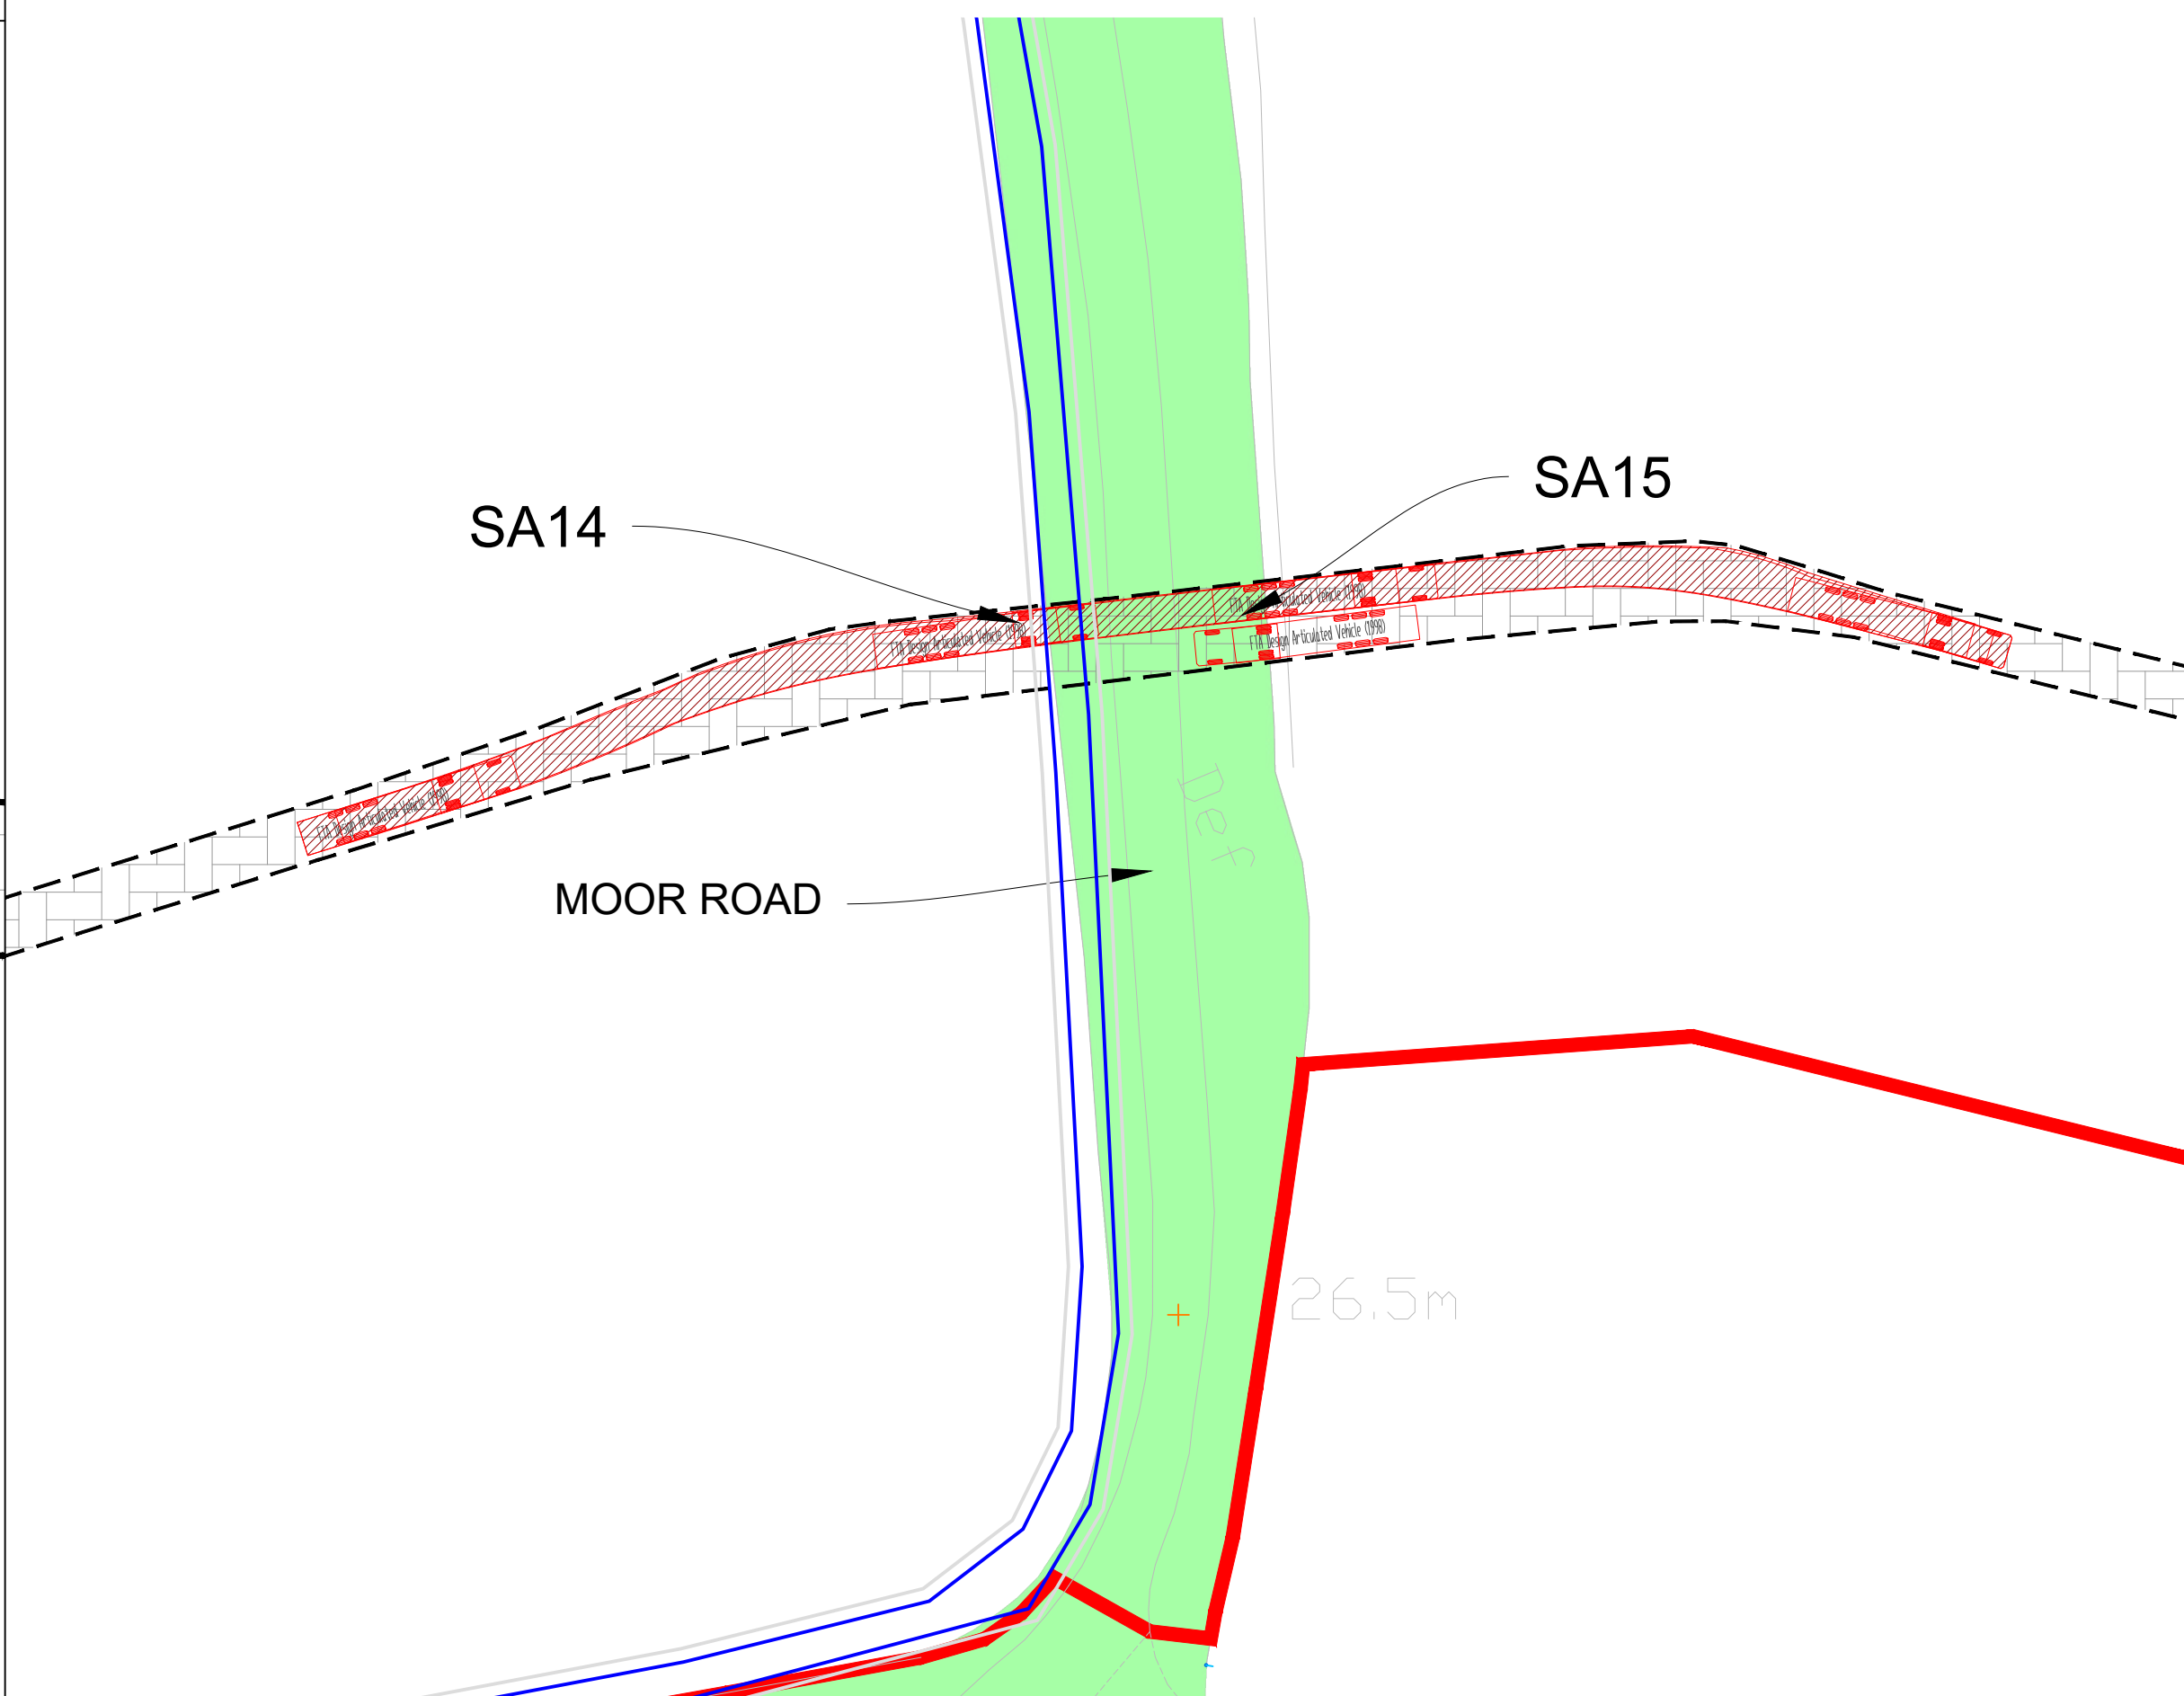
VIEWPORT 4: 16.5m Articulated HGVs Eastbound

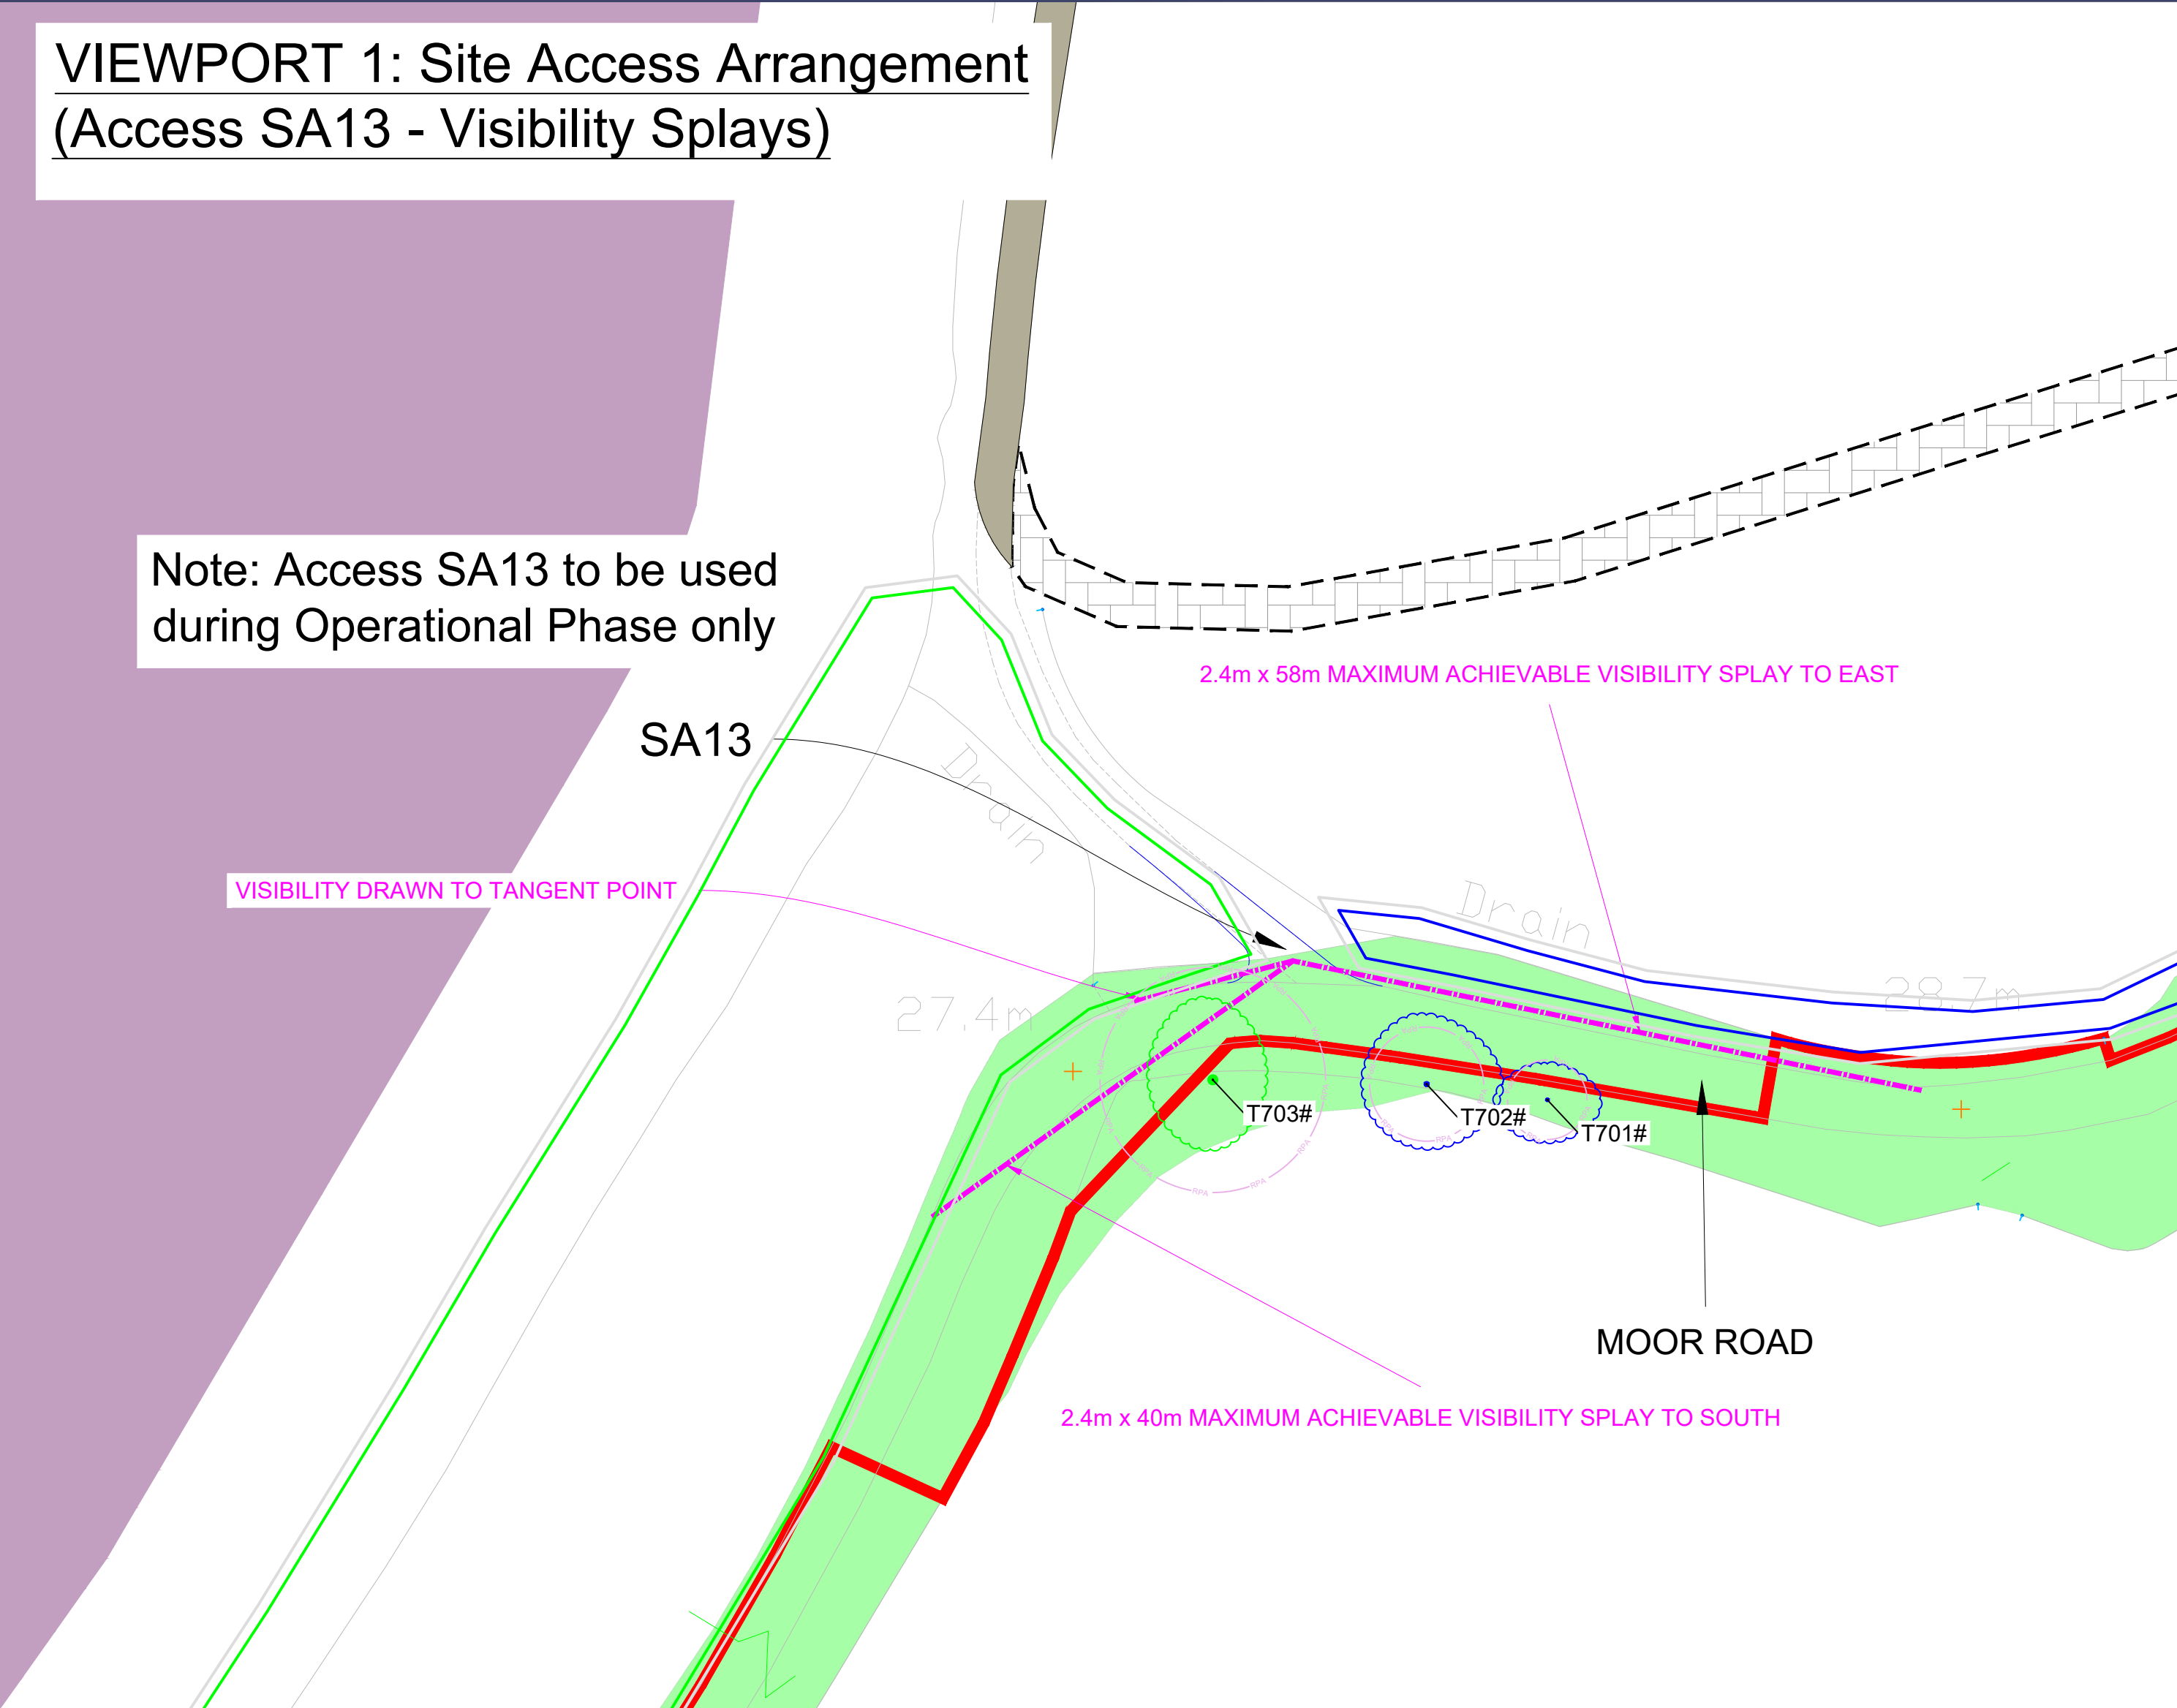
VIEWPORT 1: Site Access Arrangement  
(Access SA13 - Visibility Splays)

Note: Access SA13 to be used  
during Operational Phase only

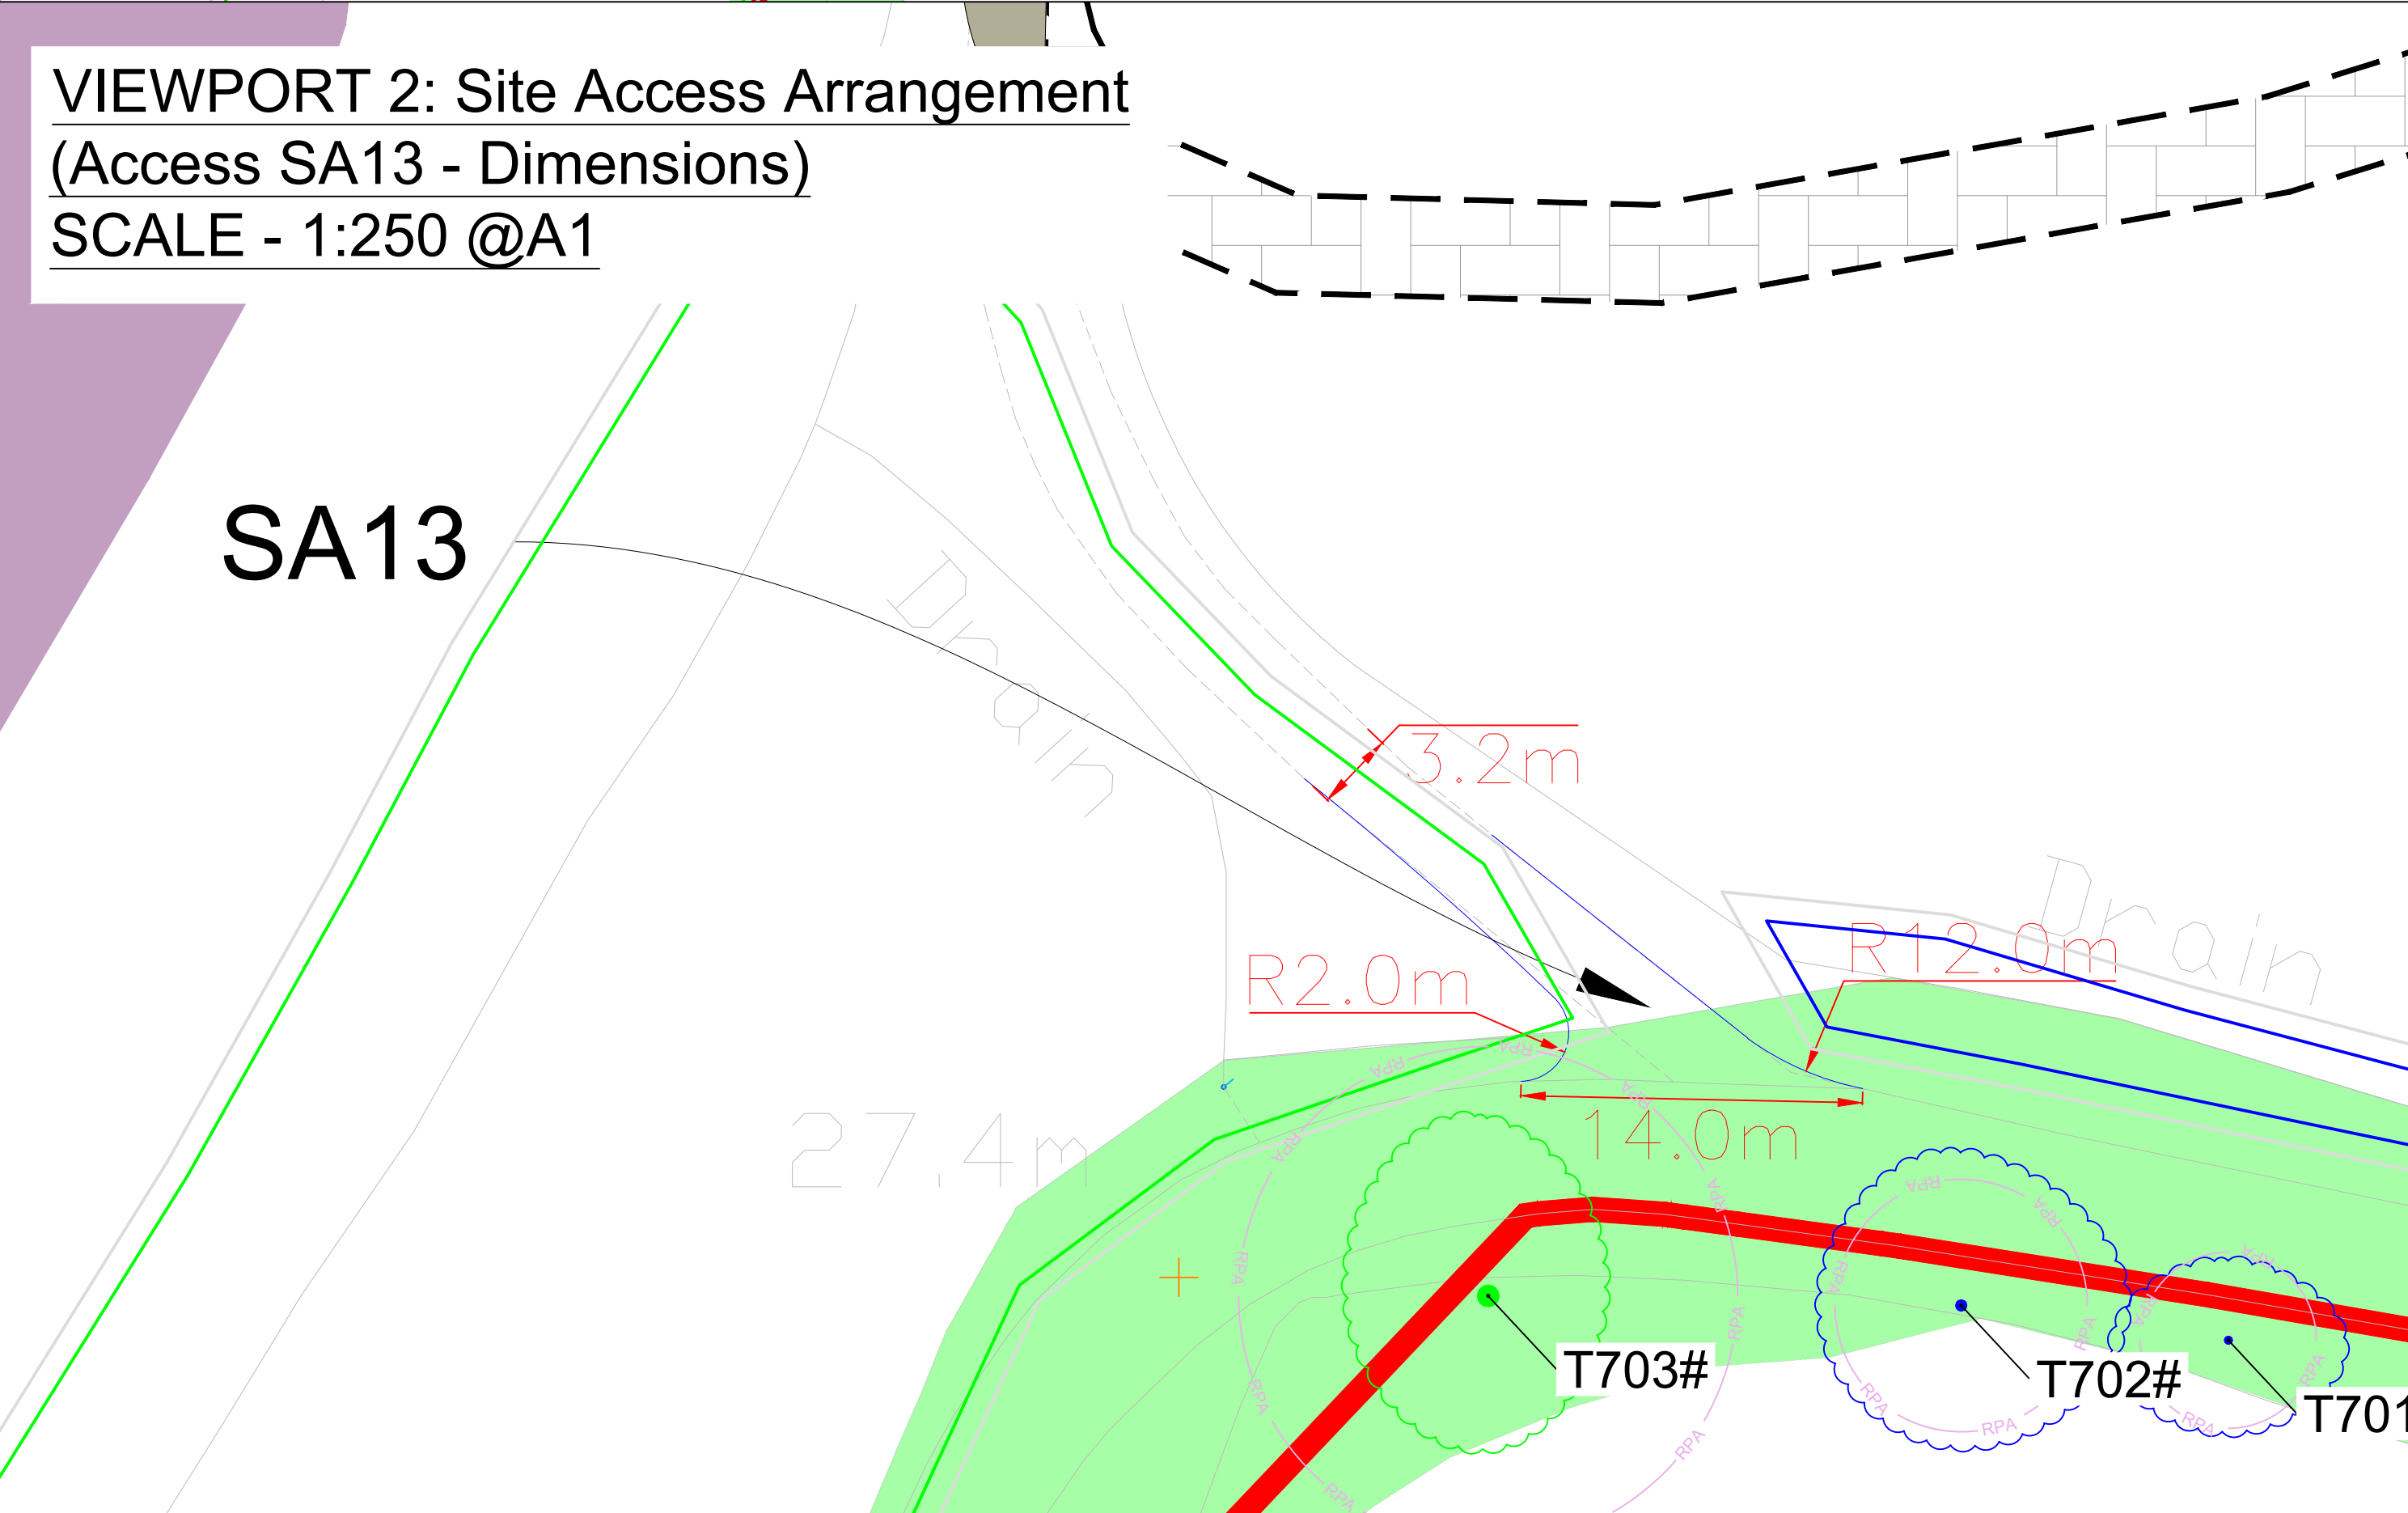
VIEWPORT 2: Site Access Arrangement  
(Access SA13 - Dimensions)  
SCALE - 1:250 @A1

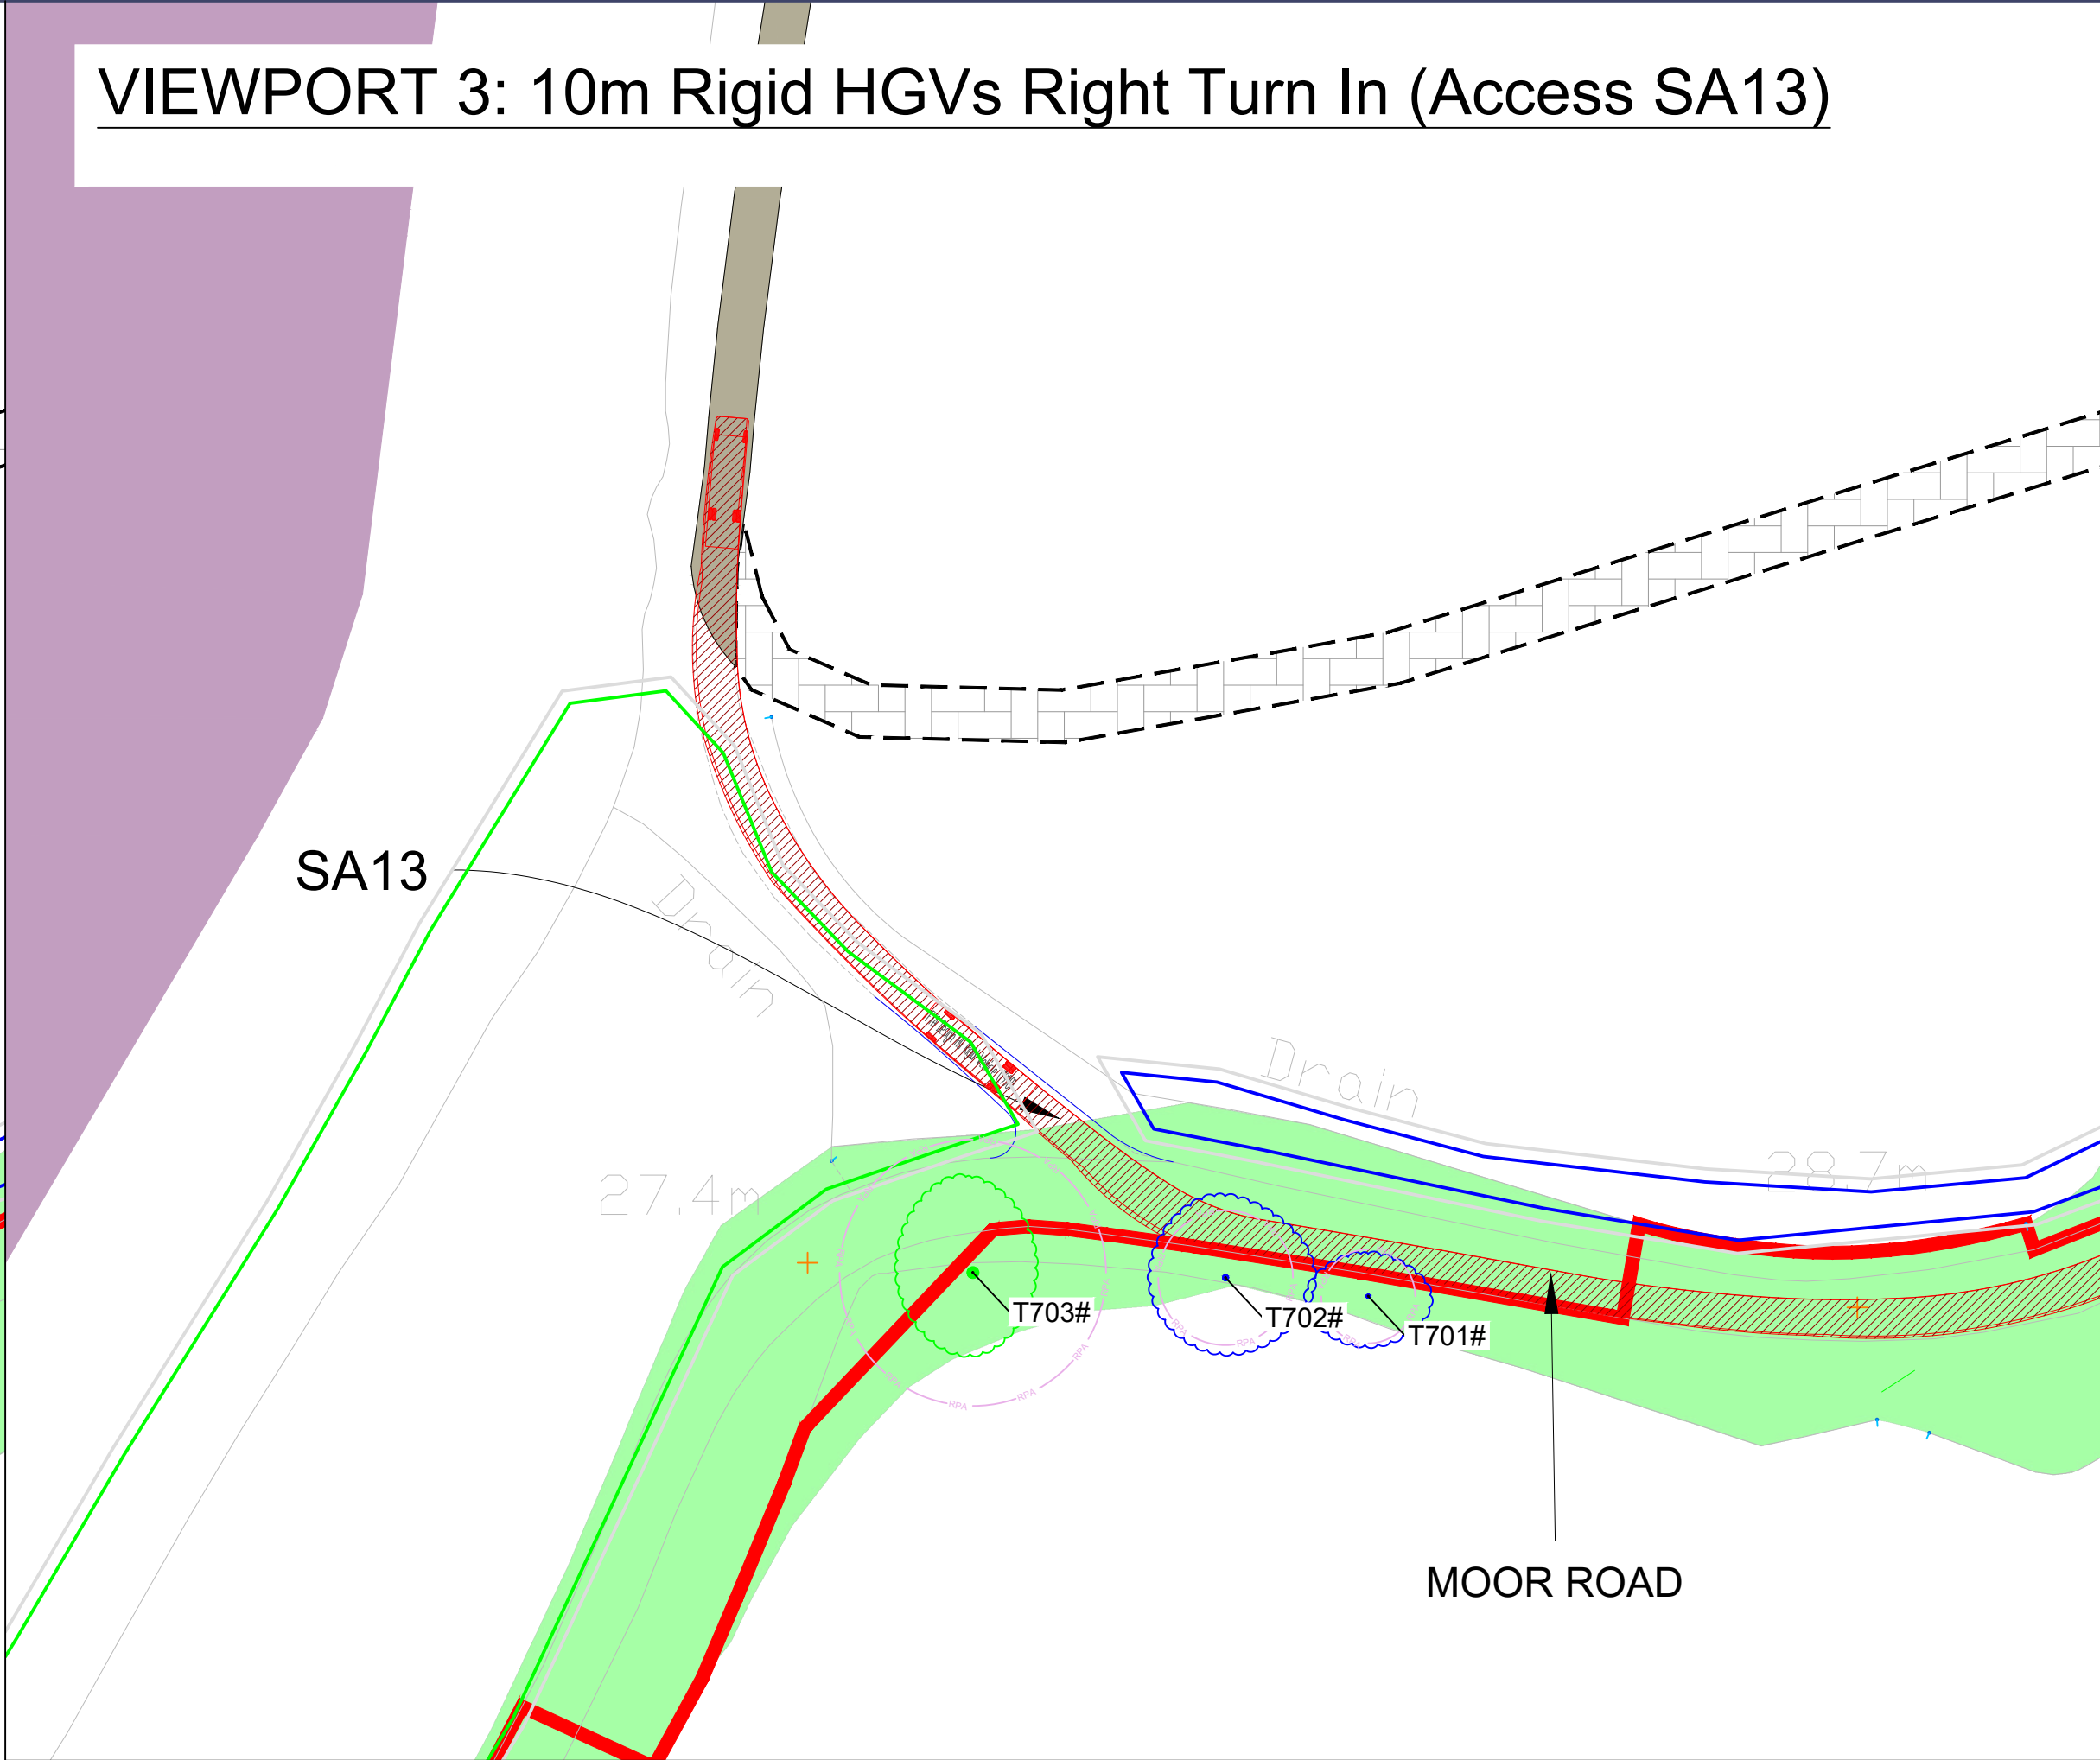
VIEWPORT 3: 10m Rigid HGVs Right Turn In (Access SA13)
