# EAST PARK ENERGY

EN010141

## Outline Construction Traffic Management Plan

**Document Reference: EN010141/DR/7.4**

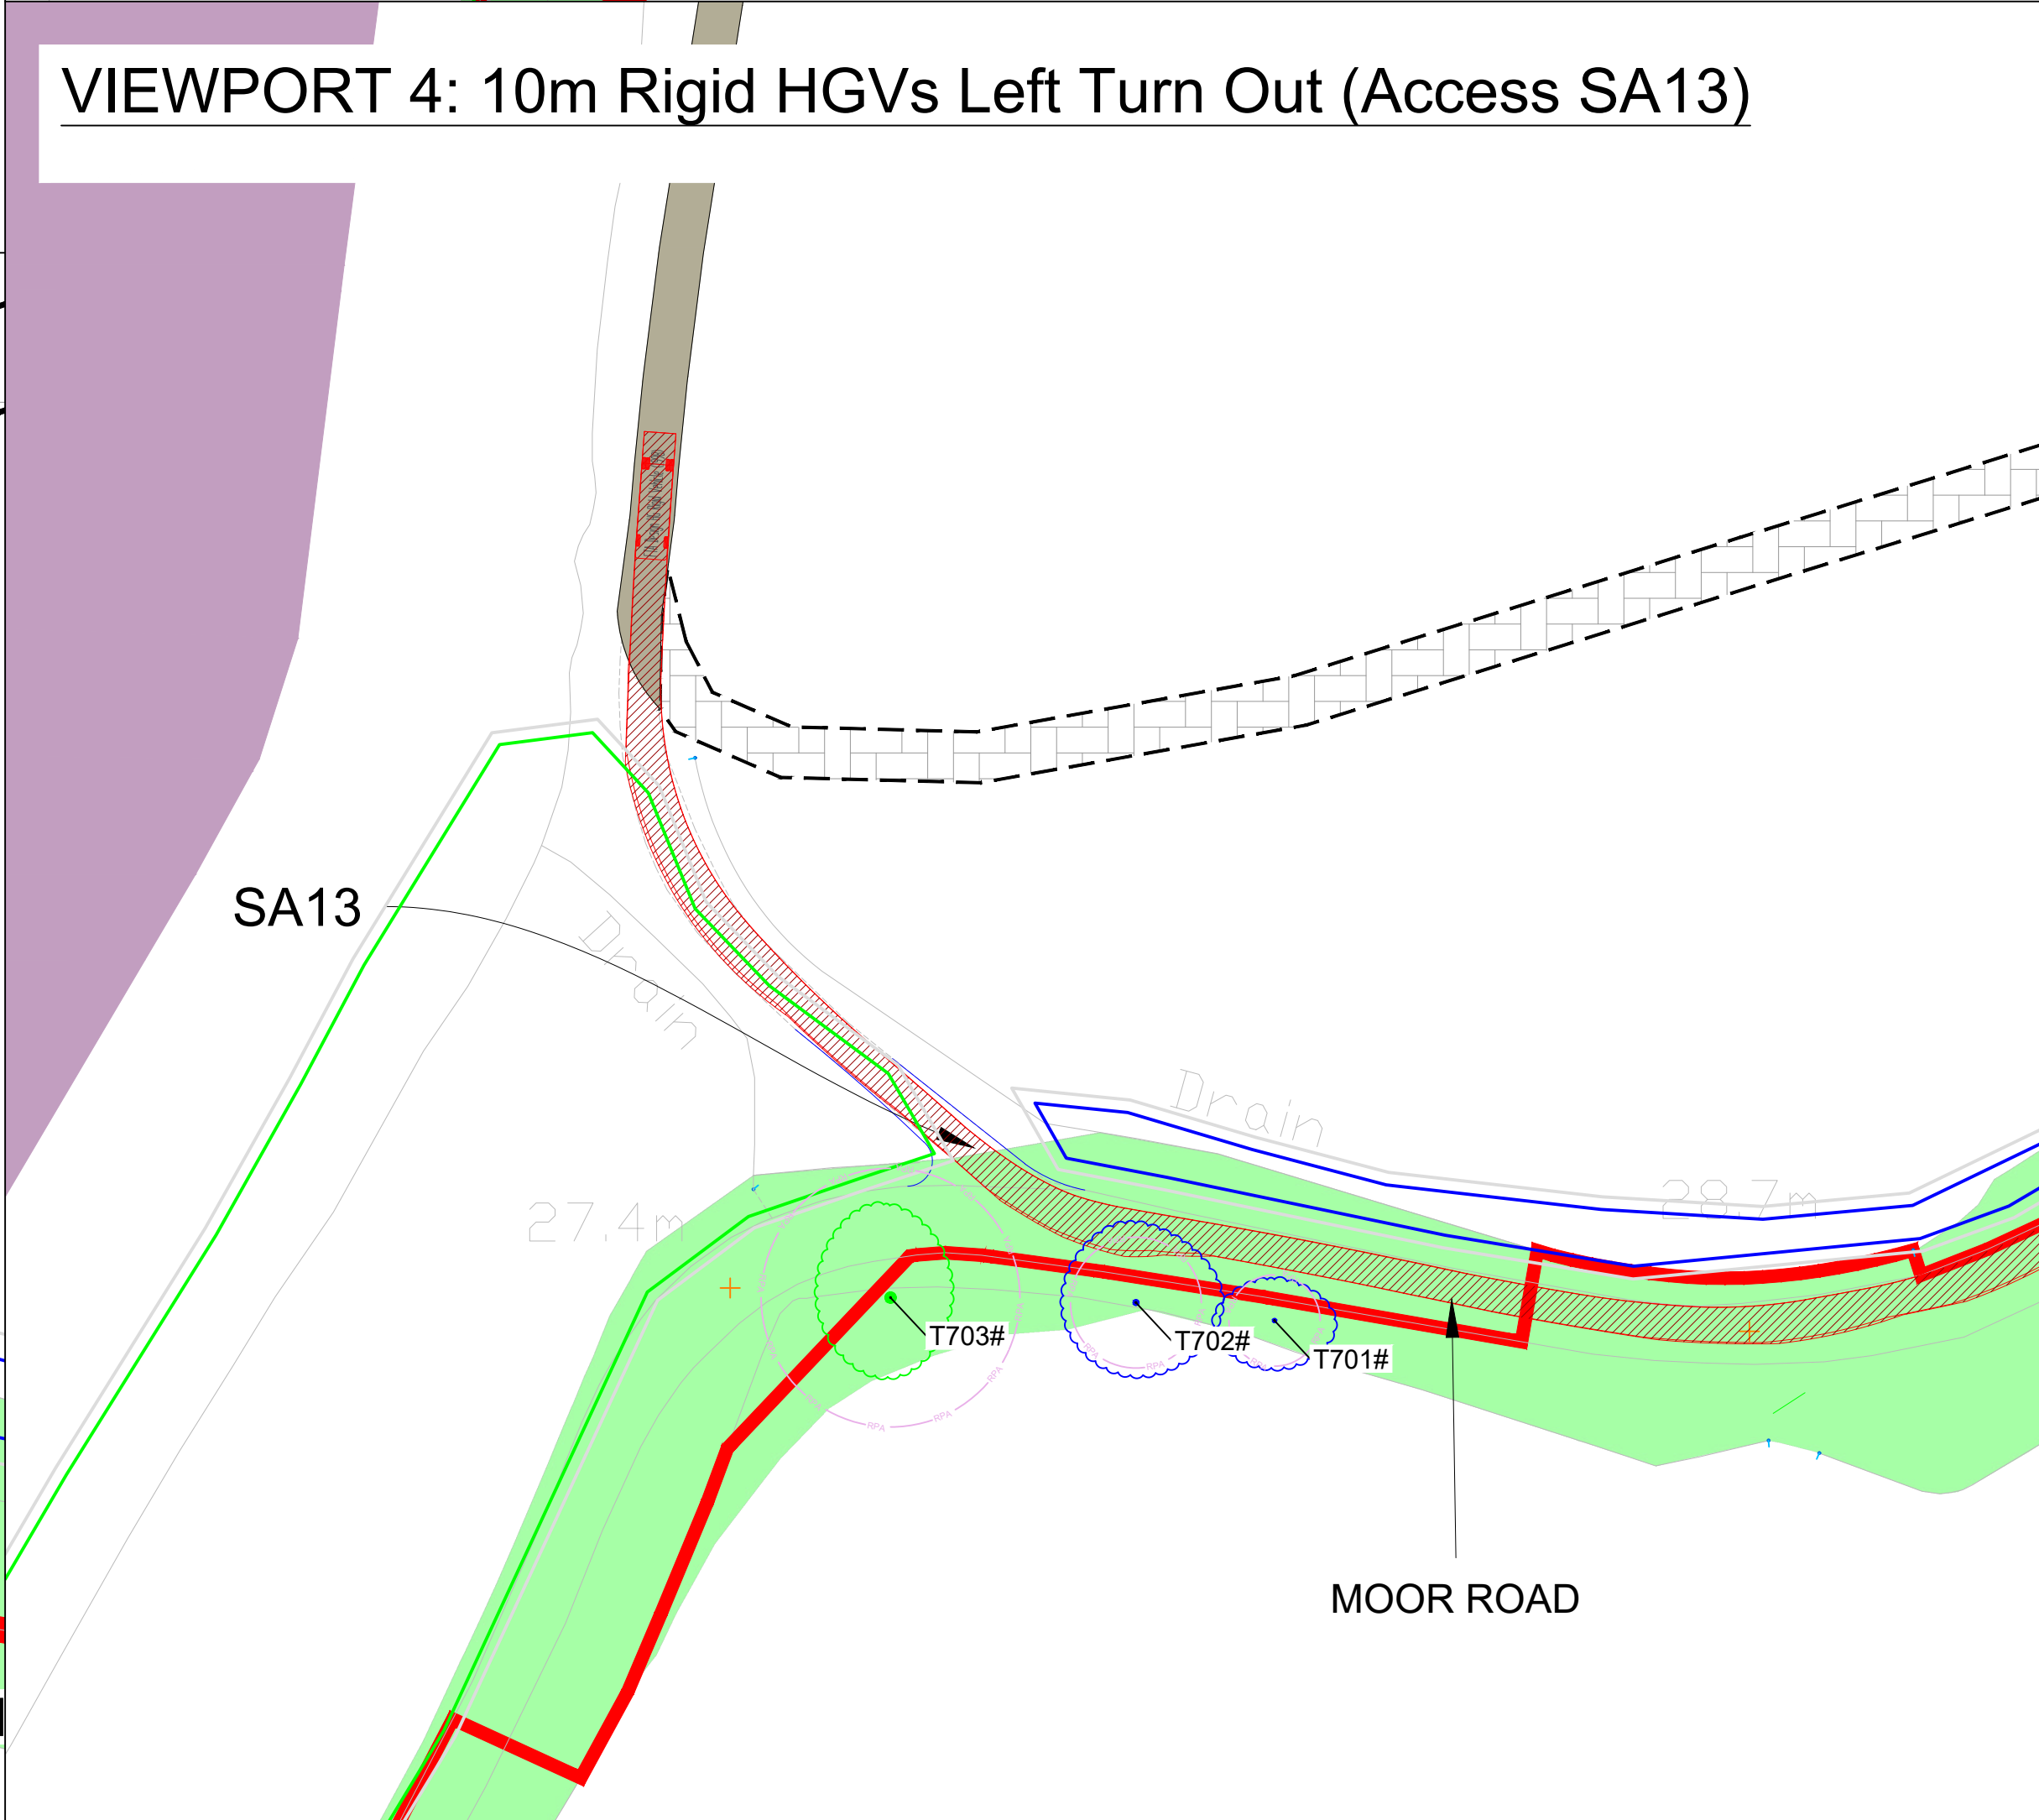
VIEWPORT 4: 10m Rigid HGVs Left Turn Out (Access SA13)
