## APPENDIX E

Sensitivity Tests Output Drawings

Hydraulic Modelling Addendum

Job Name Peartree Hill Solar Farm

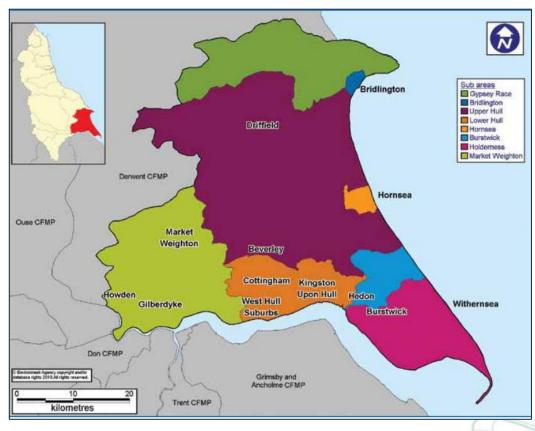
Figure 2-1 CFMP catchment sub-areas

The defences alongside the Humber Estuary fall within Lower Hull catchment sub-area (as shown in **Error! Reference source not found.**). The policy for this area is to "take action to further reduce flood risk".

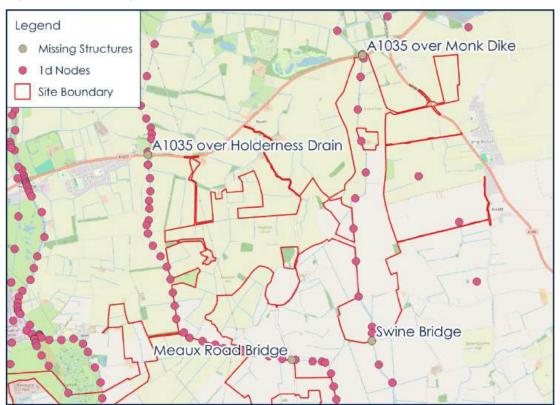
Figure 3-1 Missing Structures

- 3.1.1 The EA model review notes a number of missing structure in vicinity of the site as listed below and shown in Figure 3-1 Missing StructuresFigure 3-1:
  - A1035 bridge over Monk Dike (FM cross section Cat00000)
  - A1035 bridge over Holderness Drain (FM cross section HN43),
  - Swine Road Bridge over Monk Dike (closest FM cross section MK4055), and
  - Meaux Road Bridge over Holderness Drain (FM cross section HN21).

3.1.2 Three of these structures have been added to the model using available data and where information was sparse a conservative approach to the structure definition was taken. The structure at HN21 as it appears to be a clear span structure with the deck approximately 3m above the maximum water level. Structure details definitions are appended to this document.

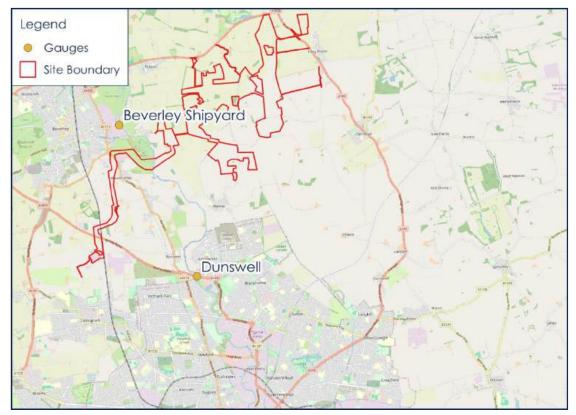
Figure 5-1 Gauge Locations.

The EA model review spreadsheet includes peak water levels for most years for two gauges: Dunswell gauge starting from 2001 and the Beverley Shipyard gauge starting from 1994. The location of the gauges is shown in Figure 5-1.

- 5.1.1 Both of these gauges are located on the River Hull which is heavily tidally influenced and drains a large catchment so the causes of high levels are difficult to apportion. This is complicated by the fact the tidal ingress and fluvial egress are prevented when the Hull Tidal Surge barrier is closed.
- 5.1.2 The levels at Beverly Shipyard which are most relevant for the site vary between 2.99mAOD and 3.89mAOD over the 29 year record and have an average value of 3.54mAOD. When accounting for the predicted sea level rise to 2066 of 0.36m, the peak modelled flood level of 4.06mAOD seems reasonable.
- 5.1.3 The tidal boundary has been subject to sensitivity testing as have the fluvial flows neither of which produce significantly different results.
