Rosefield Solar Farm

Environmental Statement

Volume 4
Appendix 11.1: Preliminary Risk Assessment
(Clean)

EN010158/APP/6.4.2
Revision 2
Deadline 1
March 2026
Rosefield Energyfarm Limited

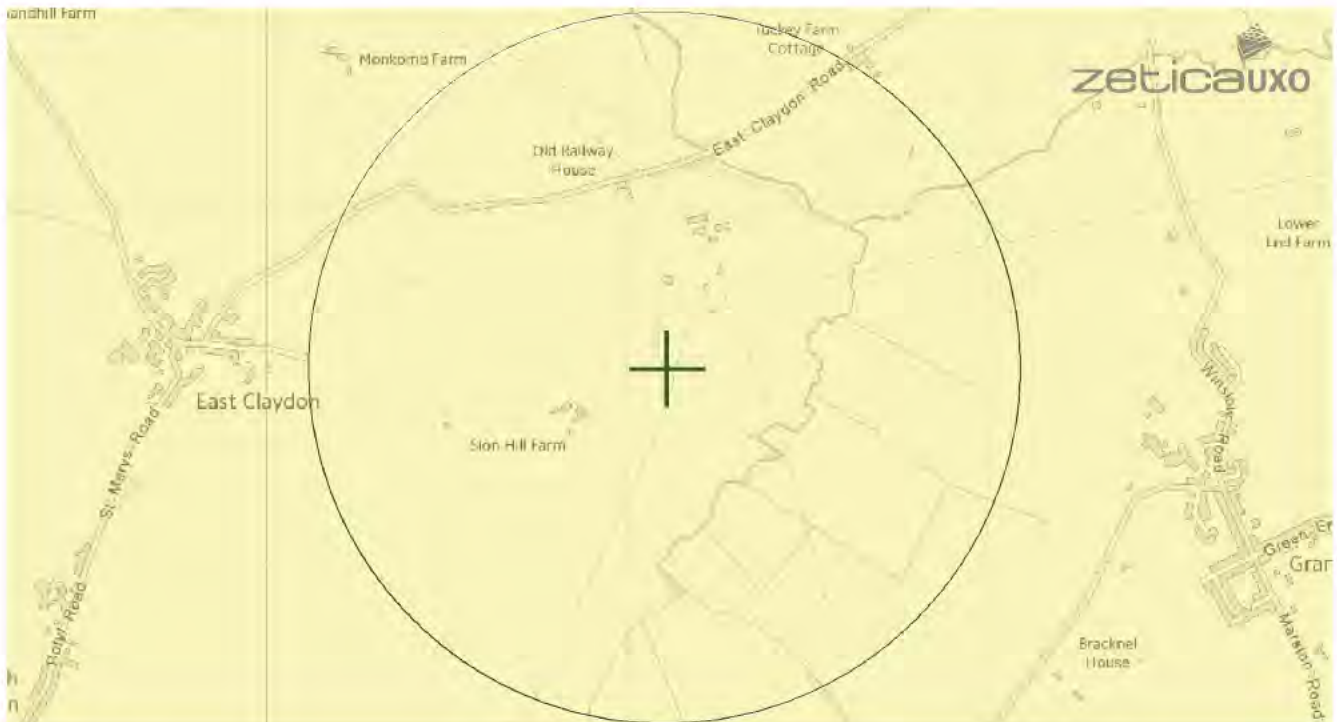
UNEXPLODED BOMB RISK MAP

- High:** Areas indicated as having a bombing density of 50 bombs per 1000acre or higher.
- Moderate:** Areas indicated as having a bombing density of 15 to 49 bombs per 1000acre.
- Low:** Areas indicated as having 15 bombs per 1000acre or less.

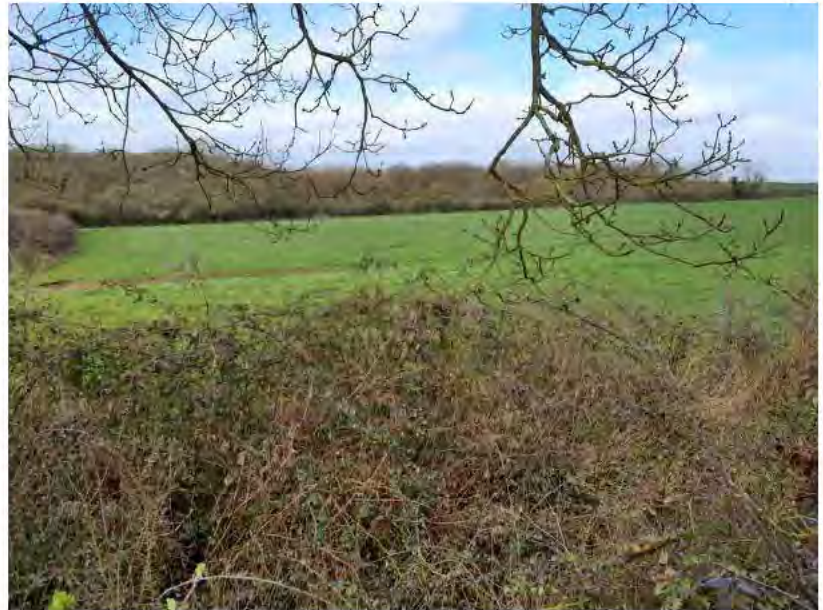
Photo No. 84
Date 26/03/2025

Description
SA5

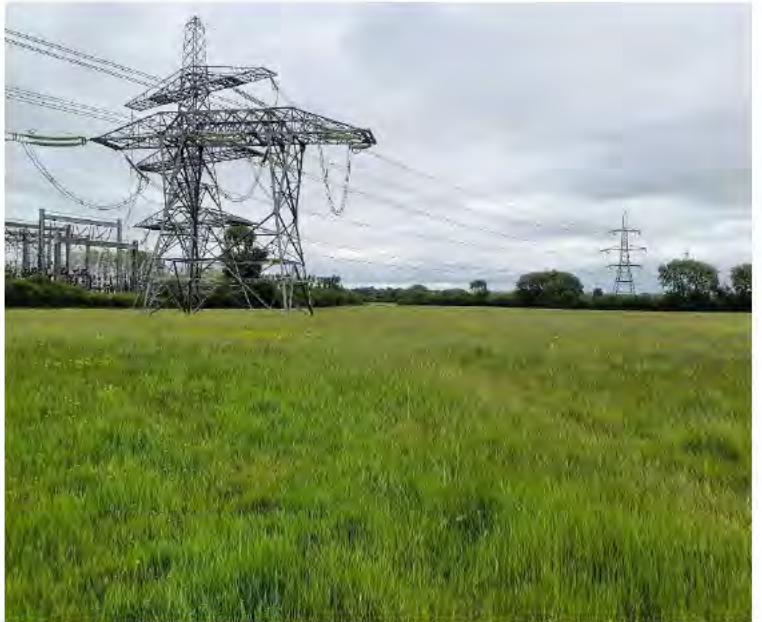
Photo No. 14
Date 23/05/2024 08:43:00

Description
E10

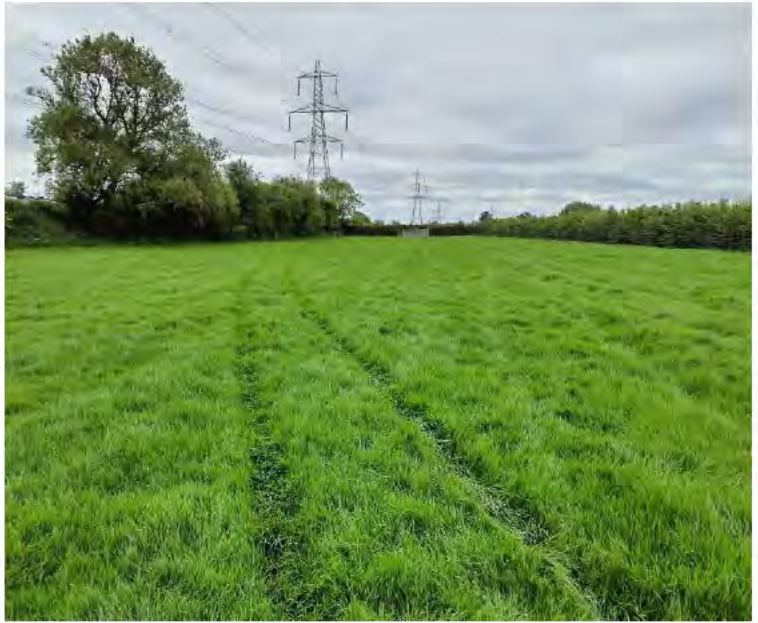
Photo No. 25
Date 23/05/2024 10:43:00

Description
Field SA48, S end
