Rosefield Solar Farm

Environmental Statement

Volume 4
Appendix 11.1: Preliminary Risk Assessment
(Tracked)

EN010158/APP/6.4 2
Revision 2
Deadline 1
September 2025-March 2026
Rosefield Energyfarm Limited

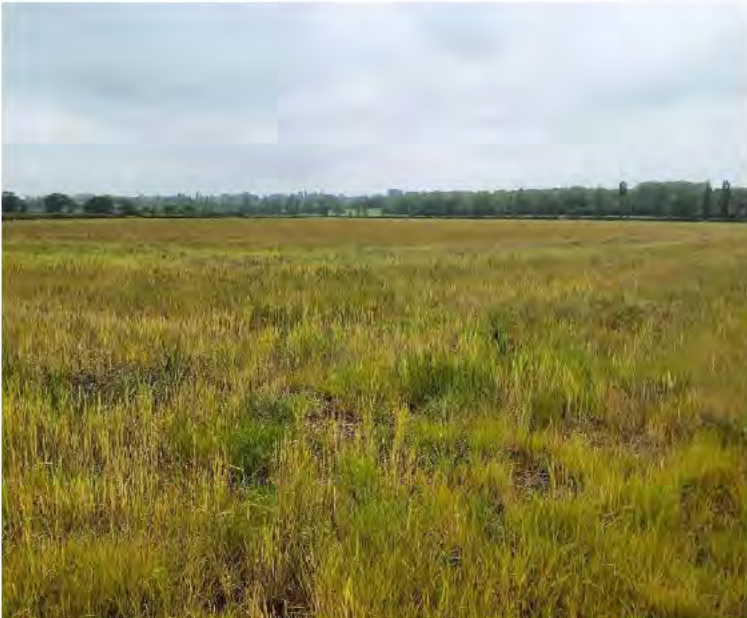
<p>Photo No. 40 Date 21/05/2024 13:12:00</p> <p>Description B19</p> <p>Co-ordinates 51.912435525:-0.974731207</p>

<p>Photo No. 41 Date 21/05/2024 13:21:00</p> <p>Description Below ground water tank in SW corner of B19</p> <p>Co-ordinates 51.910309435:-0.976261053</p>	 
<p>Photo No. 42 Date 21/05/2024 13:21:00</p> <p>Description B19</p> <p>Co-ordinates 51.909047905:-0.973110576</p>

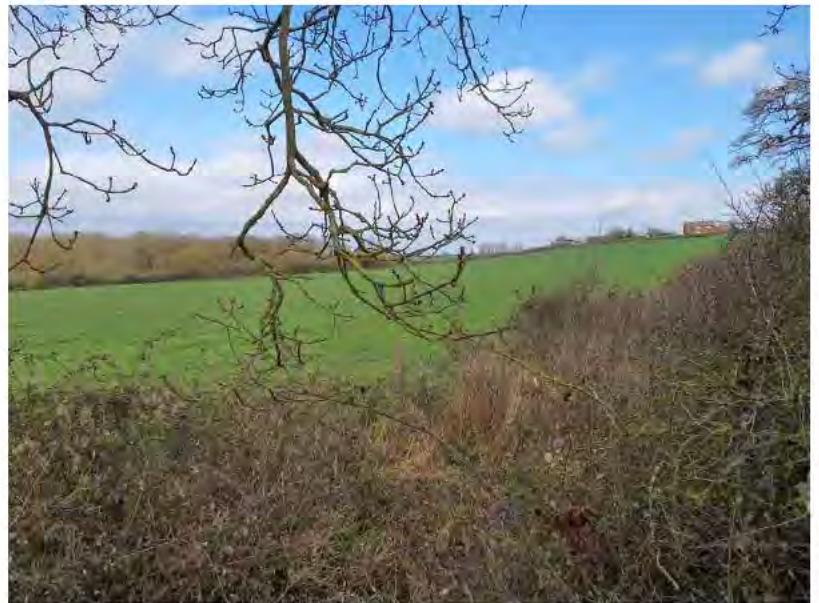
Photo No. 85
Date 26/03/2025

Description
SA5 northern half

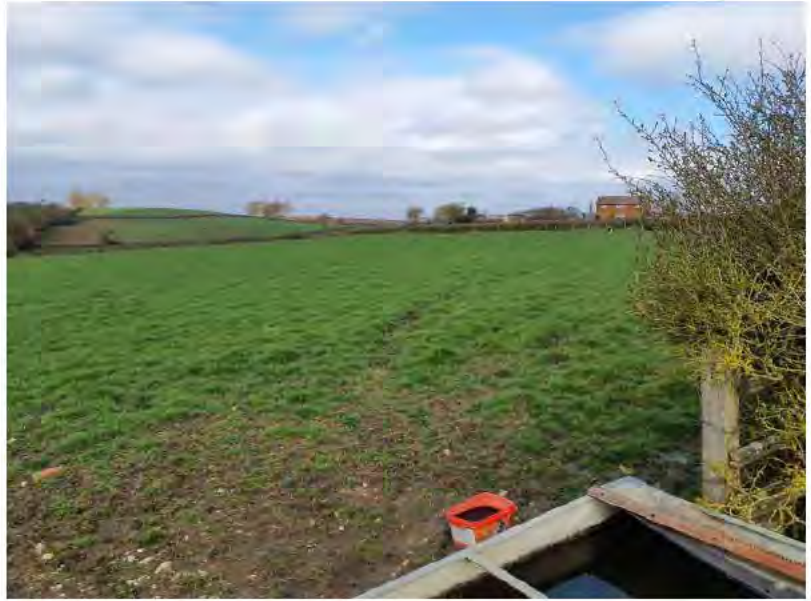
Photo No. 86
Date 26/03/2025

Description
SA5 from access

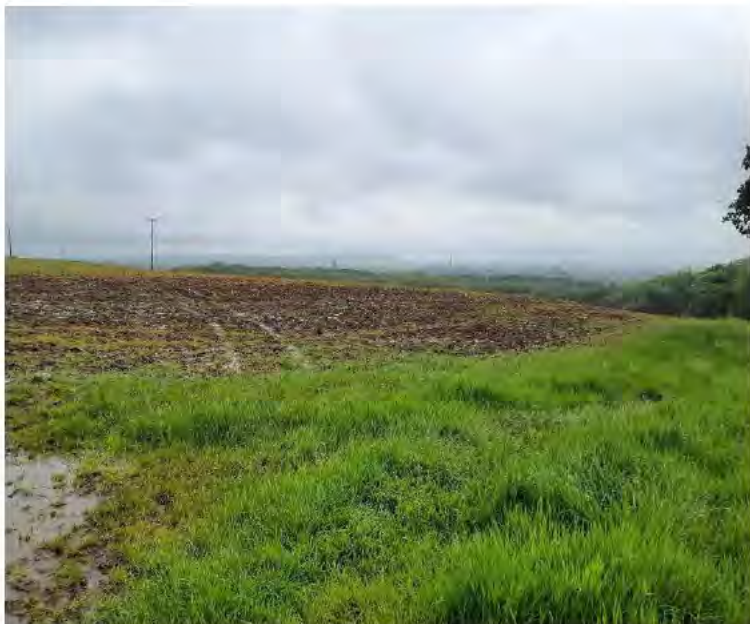
<p>Photo No. 50 Date 22/05/2024 12:55:00</p> <p>Description D30 view SW. Note overhead wires</p> <p>Co-ordinates 51.895970003;-0.957378552</p>

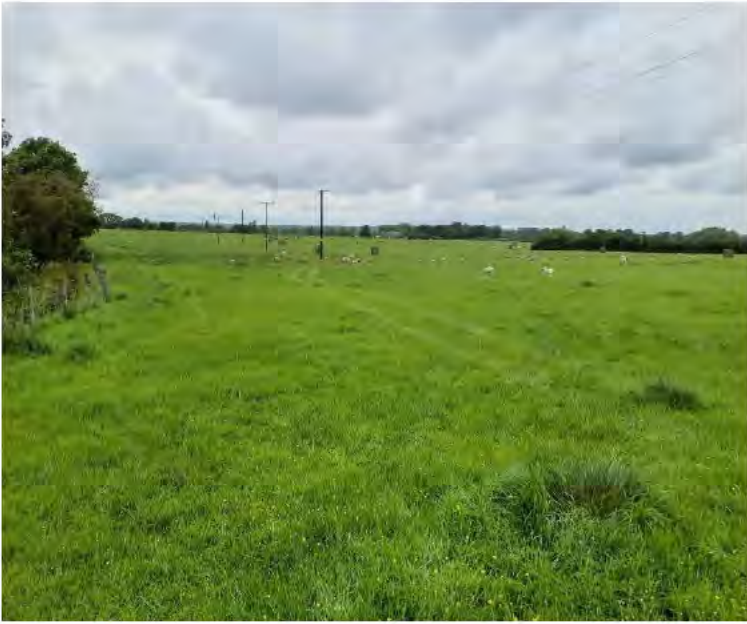
<p>Photo No. 71 Date 26/03/2025</p> <p>Description Penultimate field at east end of cable route between Parcel 1 and Parcel 2</p> <p>Co-ordinates 51° 54' 40.266" N 0° 57' 9.995" W</p>

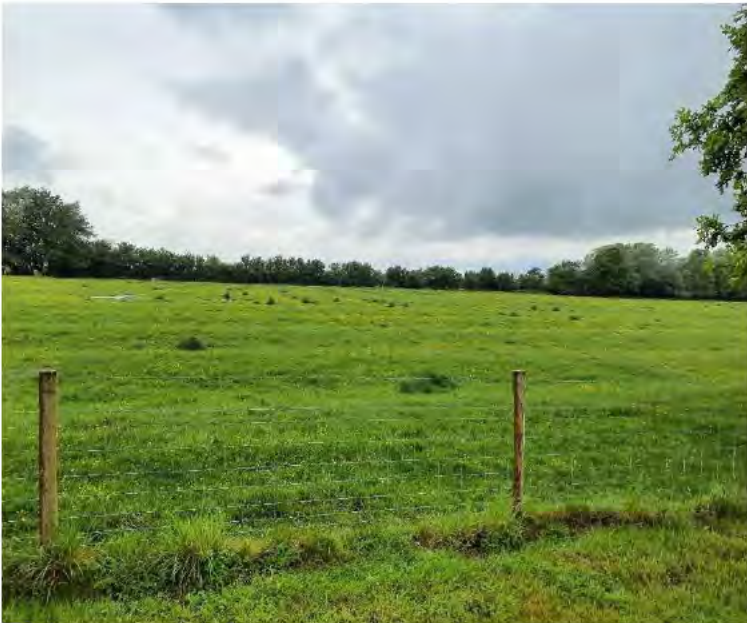
<p>Photo No. 72 Date 26/03/2025</p> <p>Description Last field at east end of cable route between Parcel 1 and Parcel 2</p> <p>Co-ordinates 51° 54' 36.942" N 0° 56' 51.199" W</p>

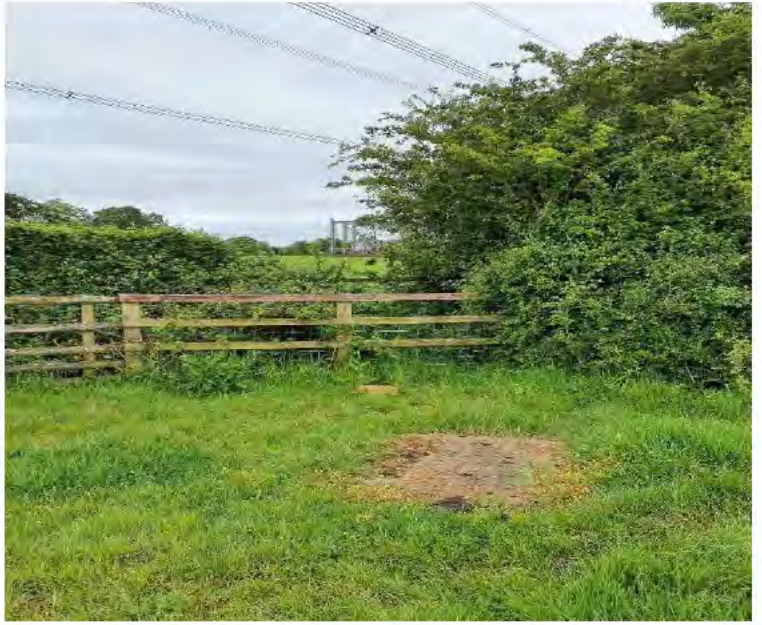
Description
MH cover, N end of E11.
Concrete marker inscribed D900

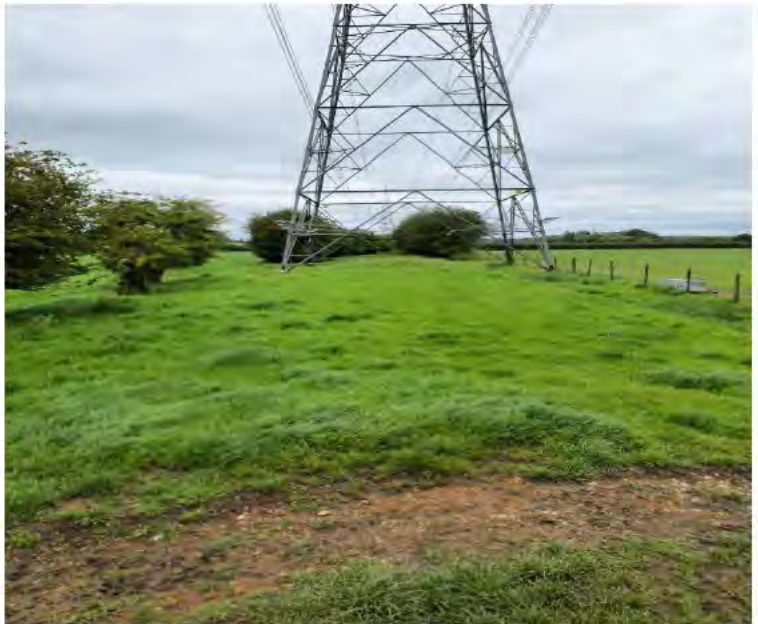
Photo No. 26
Date 23/05/2024 10:45:00

Description
Line of former railway line (SA47). View N from former station
