Rosefield Solar Farm

Environmental Statement

Volume 4
Appendix 7.13: Arboricultural Impact Assessment
(Clean)

EN010158/APP/6.4.2
Revision 2
Deadline 2
April 2026
Rosefield Energyfarm Ltd

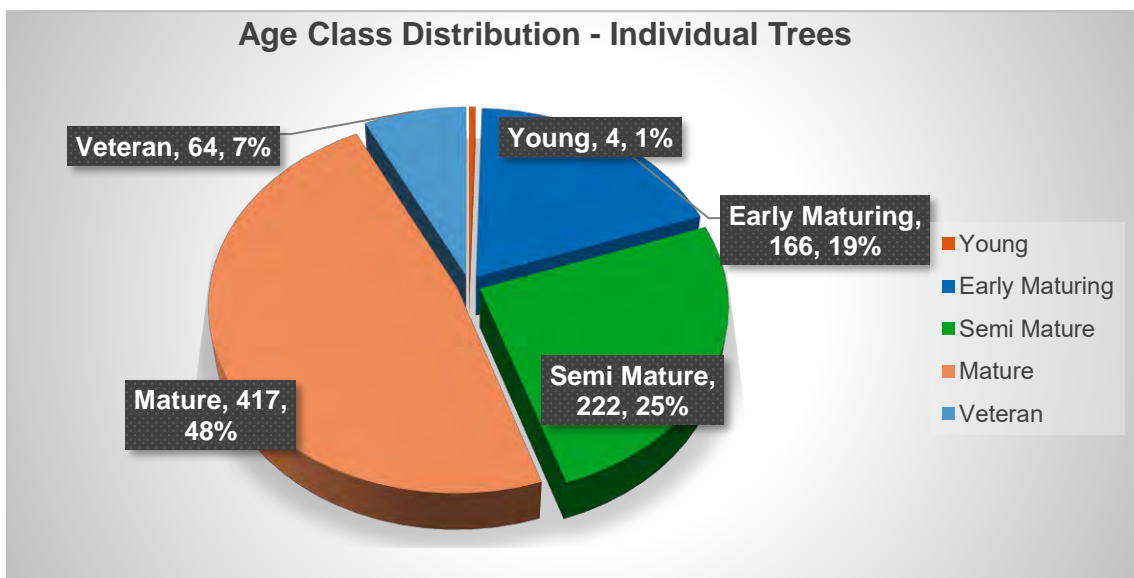
Chart 3 – Age class distribution for individual trees recorded

- 4.1.4. The most frequent species encountered for individual trees were English oak (*Quercus robur*), accounting for around 38% of all individual trees recorded and common ash (*Fraxinus excelsior*), accounting for 35% of individual trees recorded. The distribution of species within the group features recorded also largely reflects the prevalence of these species throughout the Site.
- 4.1.5. The majority of hedgerows comprised common hawthorn (*Crataegus monogyna*) and Blackthorn (*Prunus spinosa*) with Elm (*Ulmus* species) becoming more prevalent toward the east of the Site.
- 4.1.6. The age classes of trees and groups recorded is varied and is shown in **Chart 3** and **4**, with mature trees being the dominant class recorded.
