I wish to add to my written statement.

Insufficient consideration has been given to the history of flooding in Sutton on Trent and Carlton on Trent, and no consideration at all of studies into the impact of solar panels on surface water run-off, particularly the difference between cross-slope and along-slope panel orientation (e.g. <https://onlinelibrary.wiley.com/doi/full/10.1002/hyp.15053>).

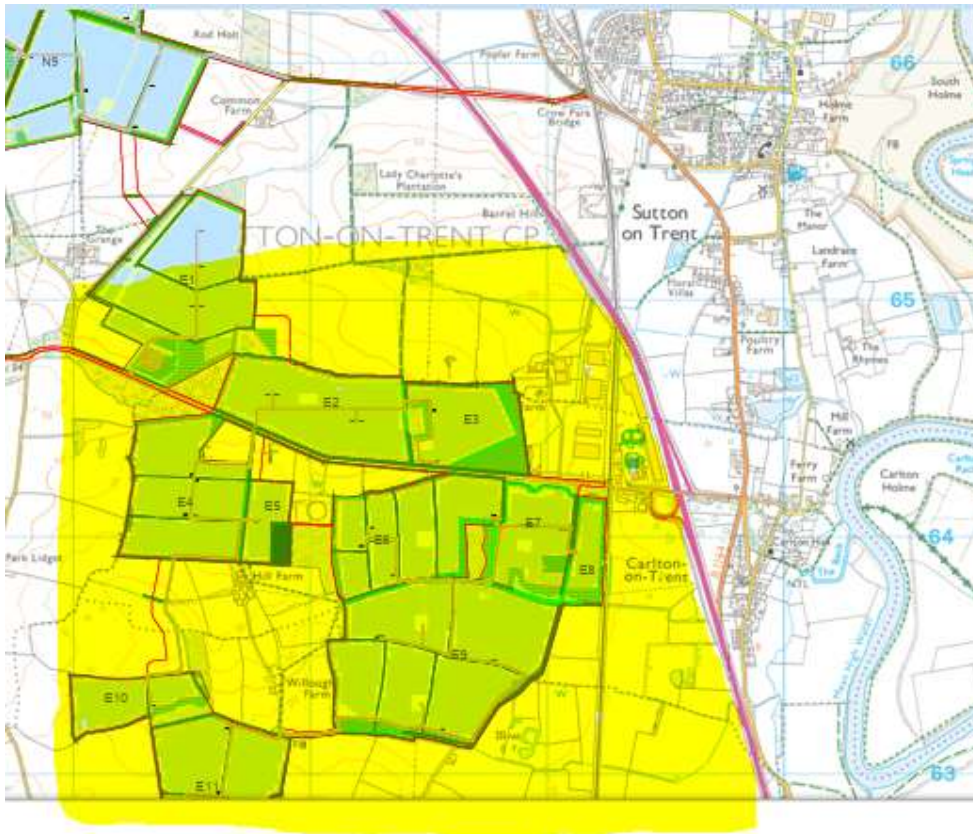
The fields immediately west of Carlton on Trent (highlighted below) drain directly towards the River Trent via Carlton and Sutton villages. Any alteration to these fields **will** directly affect residents of both villages.

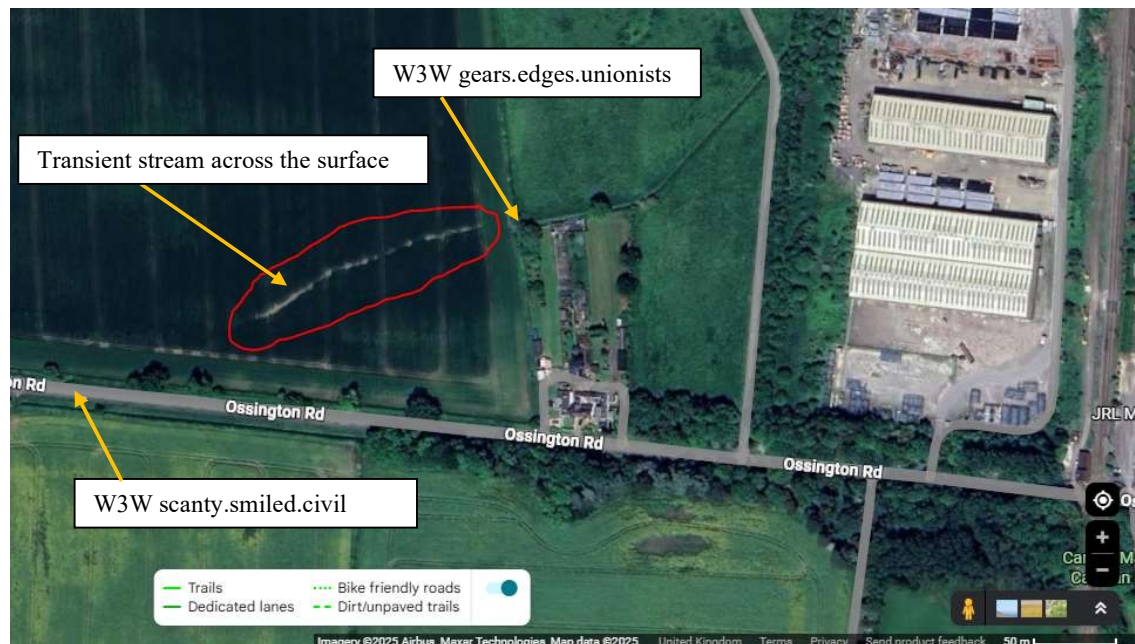
Dykes from several fields converge along Ossington Road. One passes under the road and enters a pipe at what3words scanty.smiled.civil, re-emerging at gears.edges.unionists. A clear erosion channel and transient stream are visible across the field on Google Maps satellite imagery, showing natural concentrated flow. The road regularly floods at scanty.smiled.civil because the pipe capacity is exceeded. Construction activity, heavy plant, and drilling risk damaging this pipe, permanently reducing capacity and increasing both frequency and depth of road flooding.

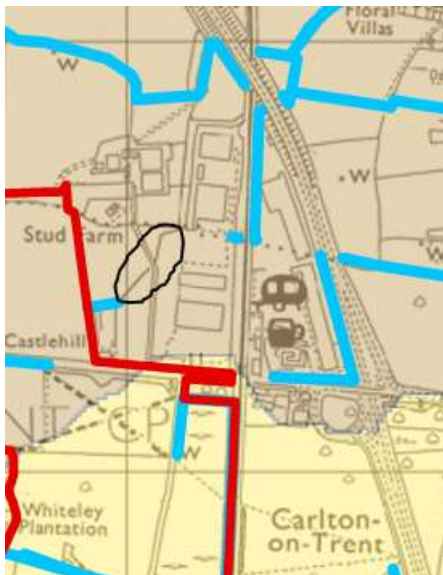
The watercourse mapping (EN010162-000068-GNR\_2.6\_Water Bodies) is incomplete. The dyke continuation identified below is identical in character and function but is not marked. Reliance on desk-top data has clearly led to inaccuracies that undermine the flood risk assessment.

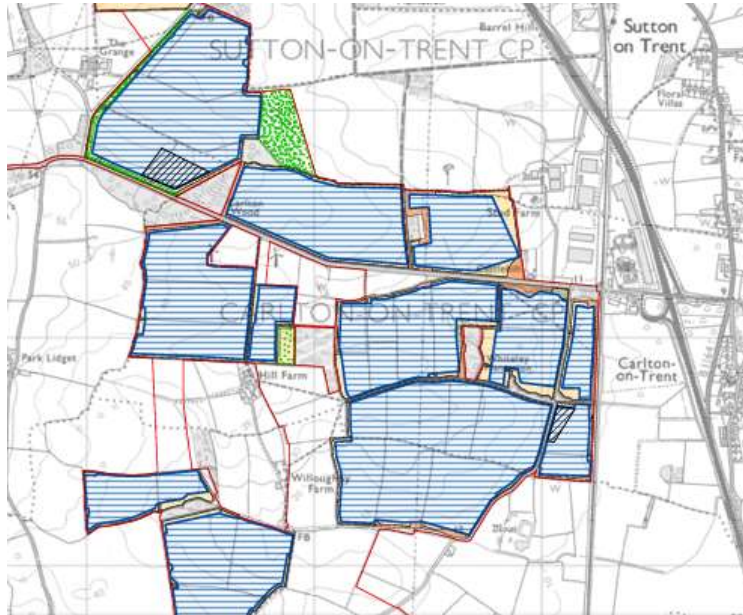
Drawing EN010162-000015-GNR\_5.6 (Design Approach, Part 2 of 4) confirms the vast majority of panels near Carlton are oriented perpendicular to contours. This is one of the most concentrated panel areas in the entire scheme with many adjacent fields covered, magnifying cumulative impact.
