# **Lime Down**

## Solar Park

## **Volume 3, Appendix 11-9: Flood Risk Assessment and Drainage Strategy – Lime Down Cable Route Corridor**

# Appendix 11-9: Flood Risk Assessment and Drainage Strategy – Lime Down Cable Route Corridor

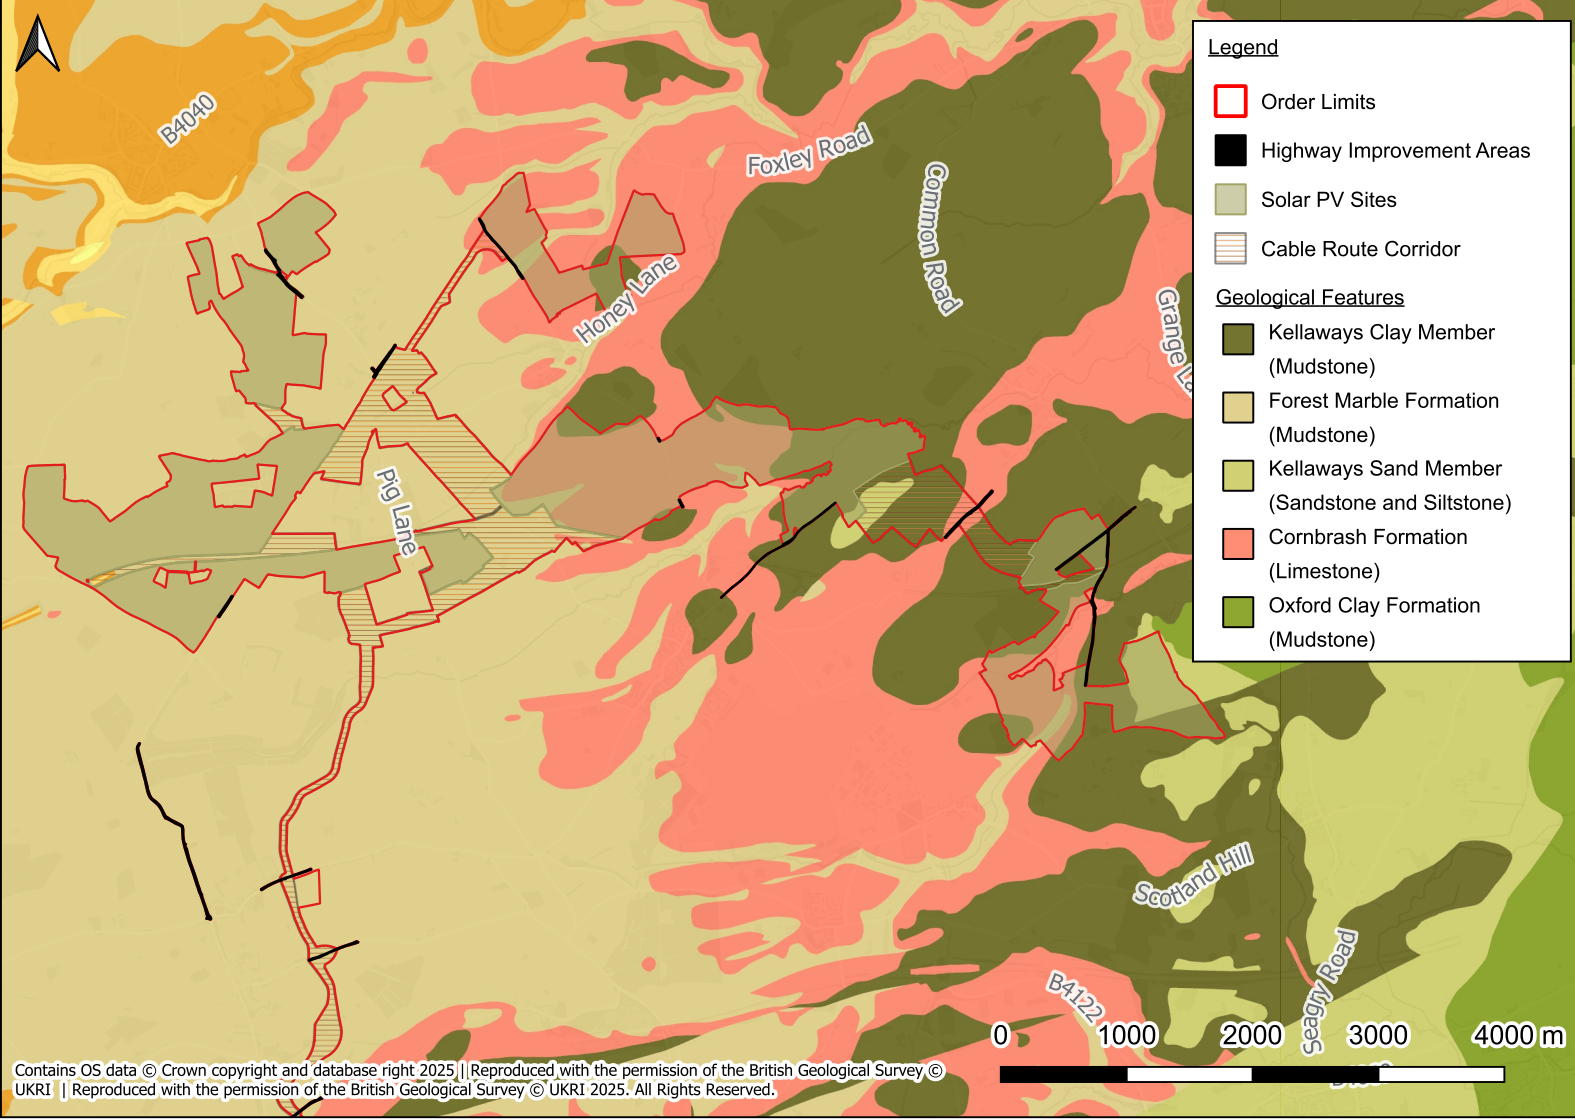
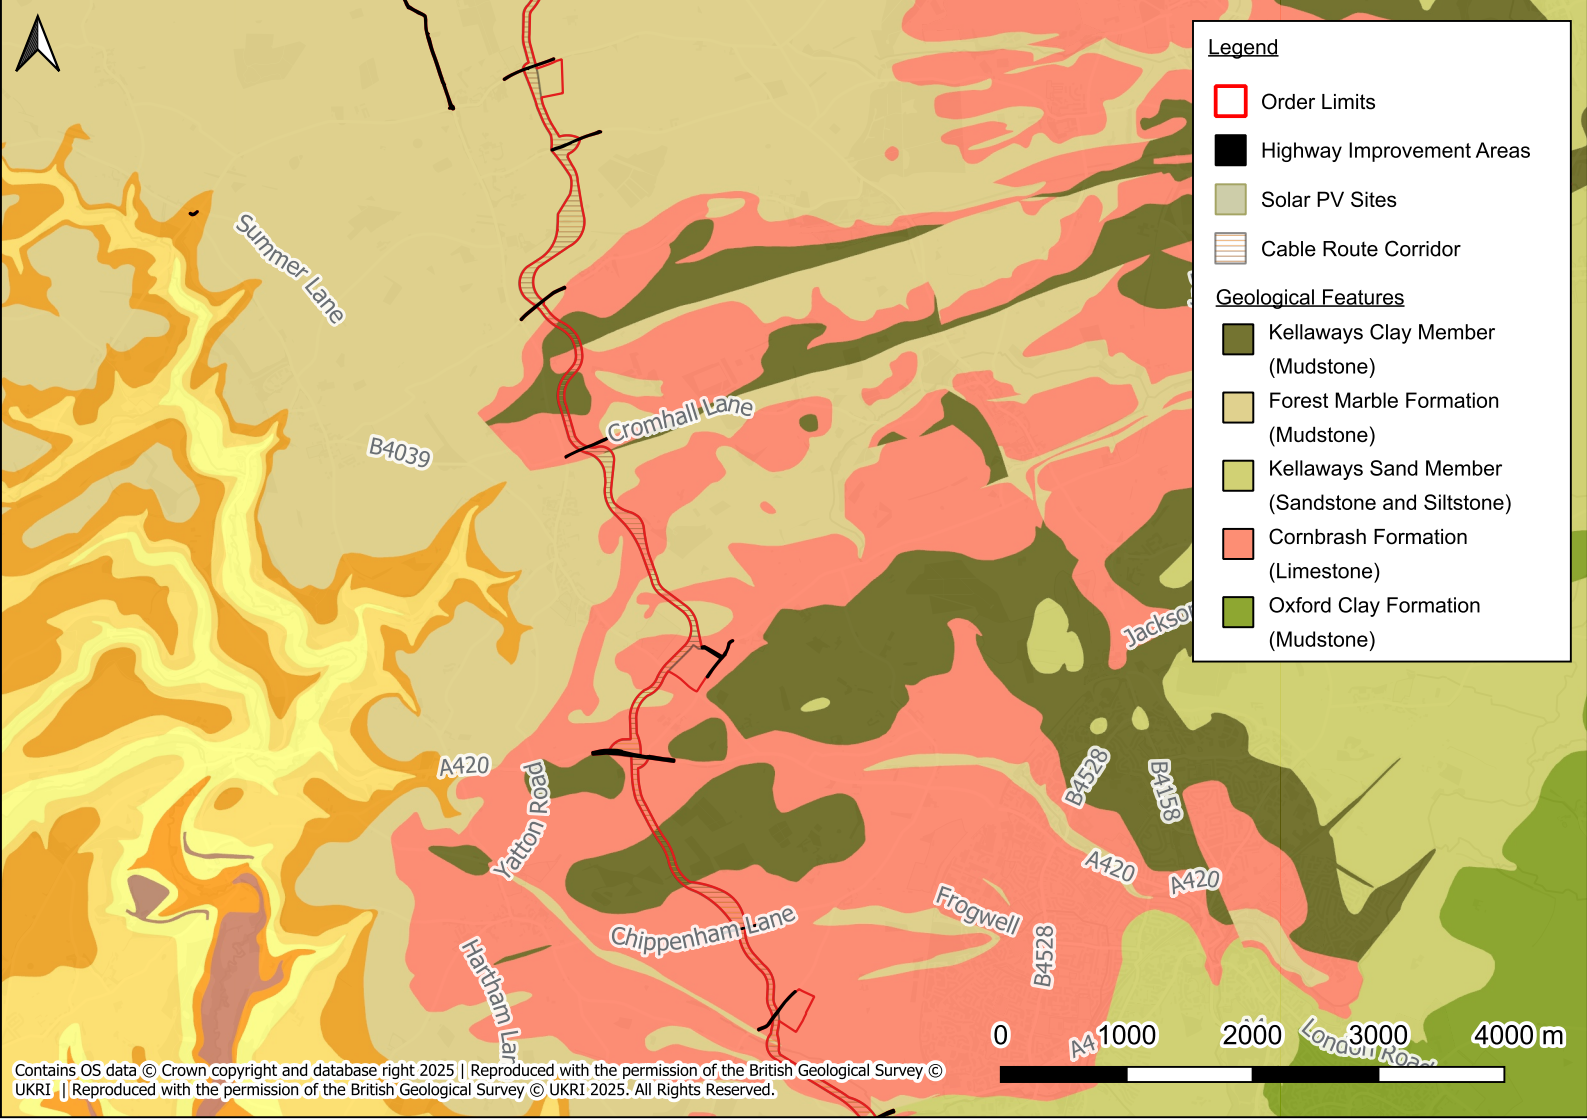
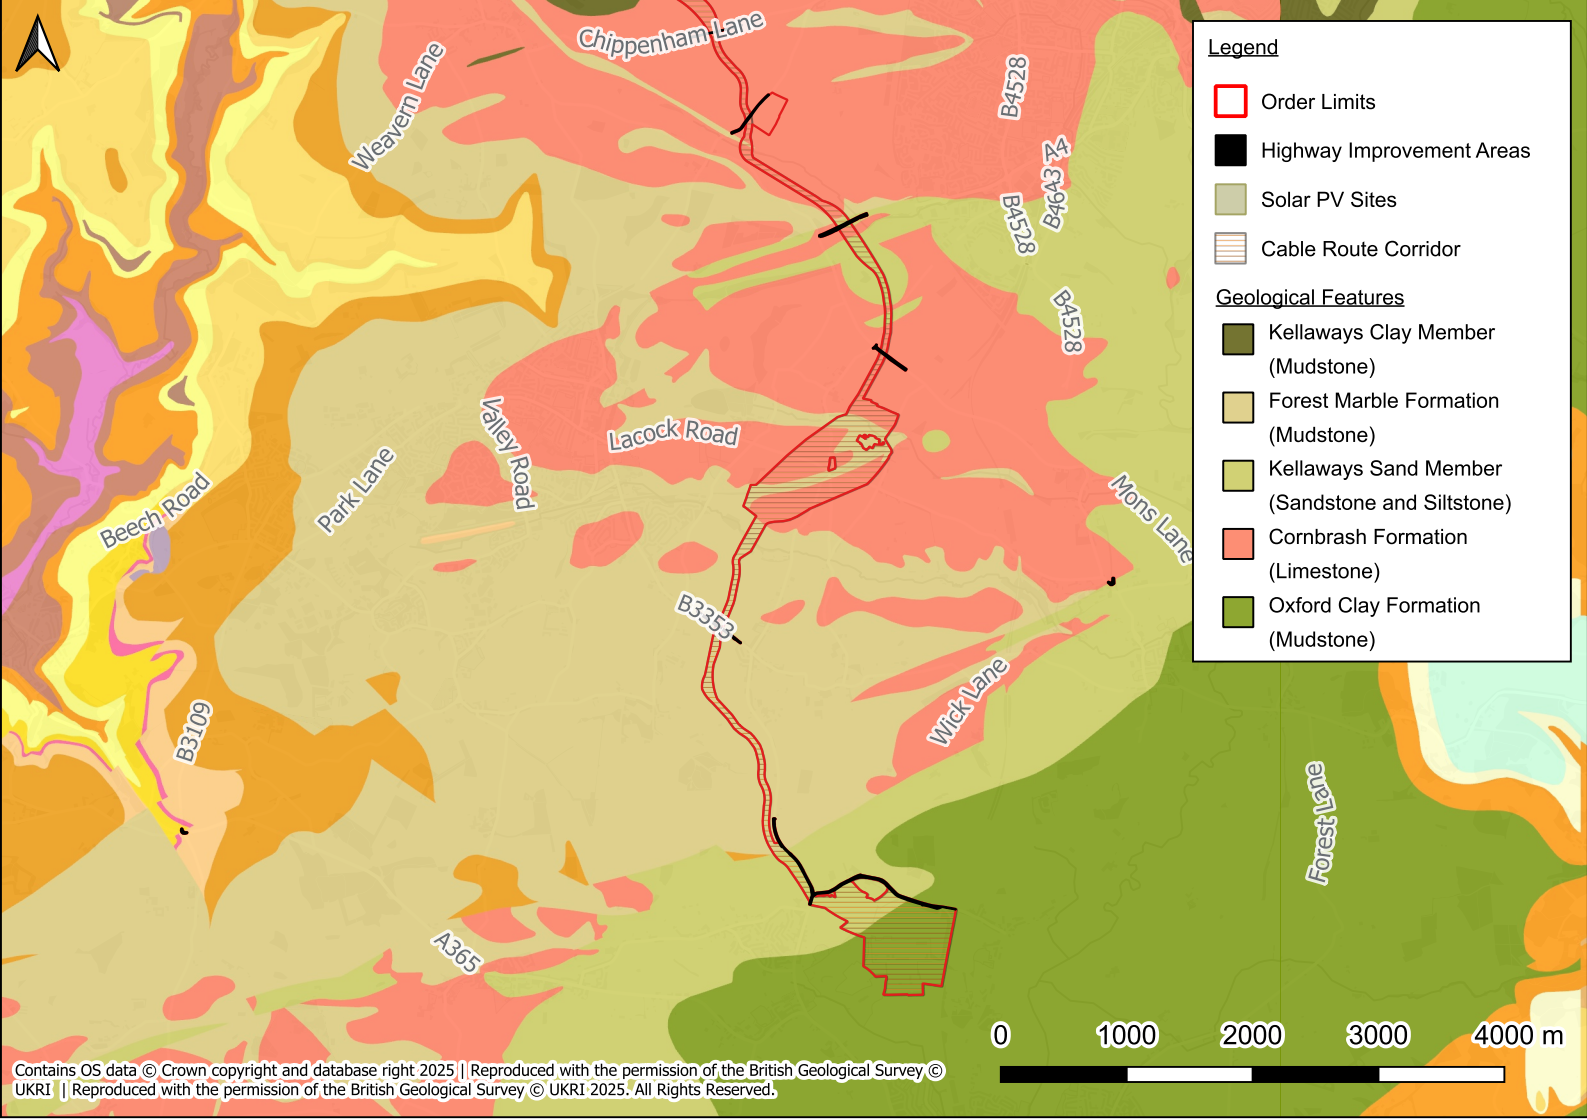
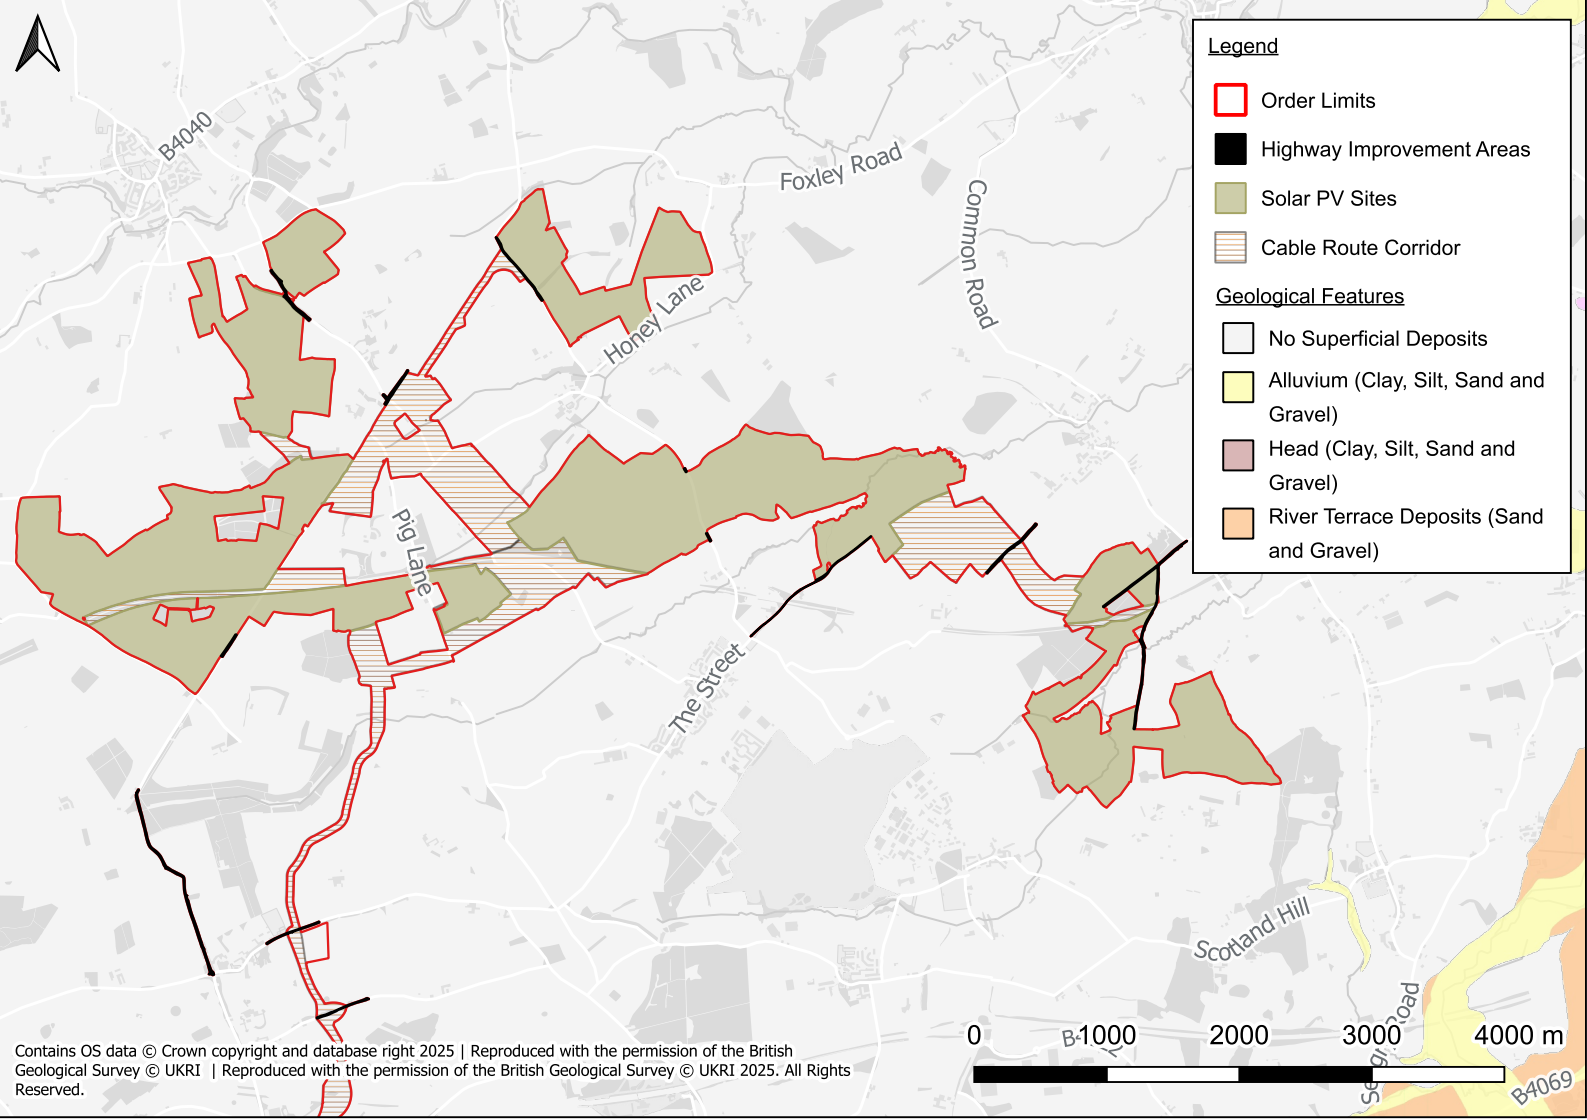
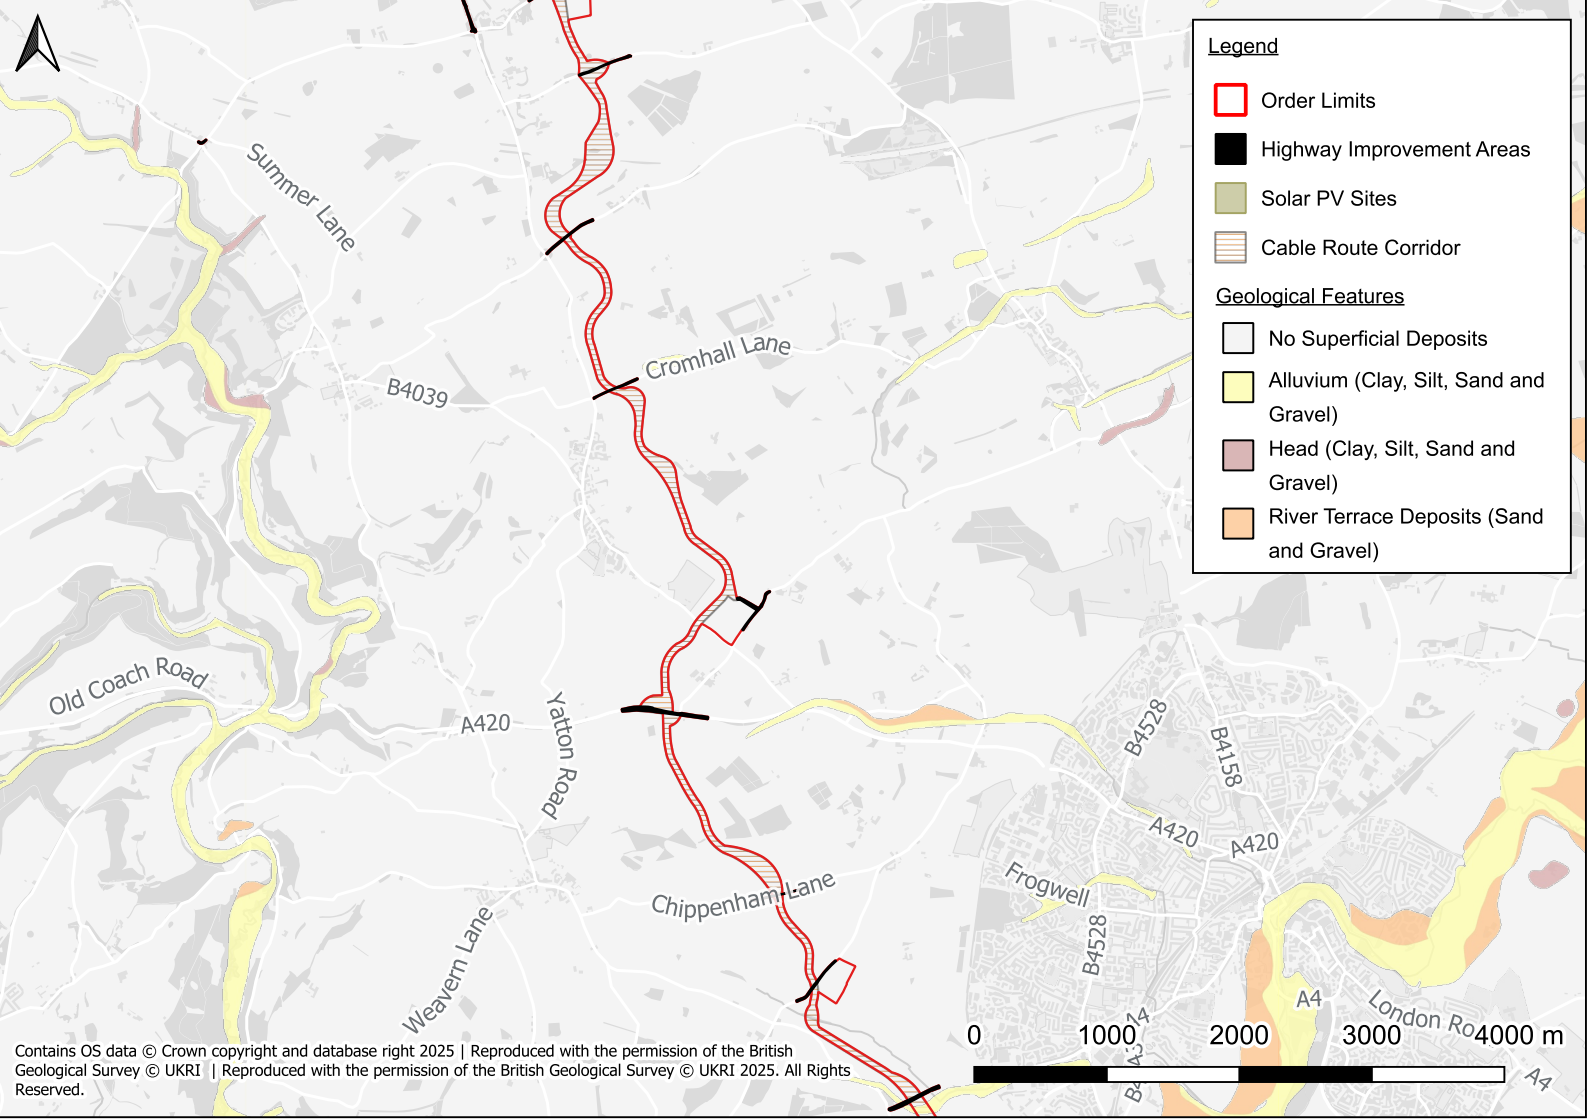
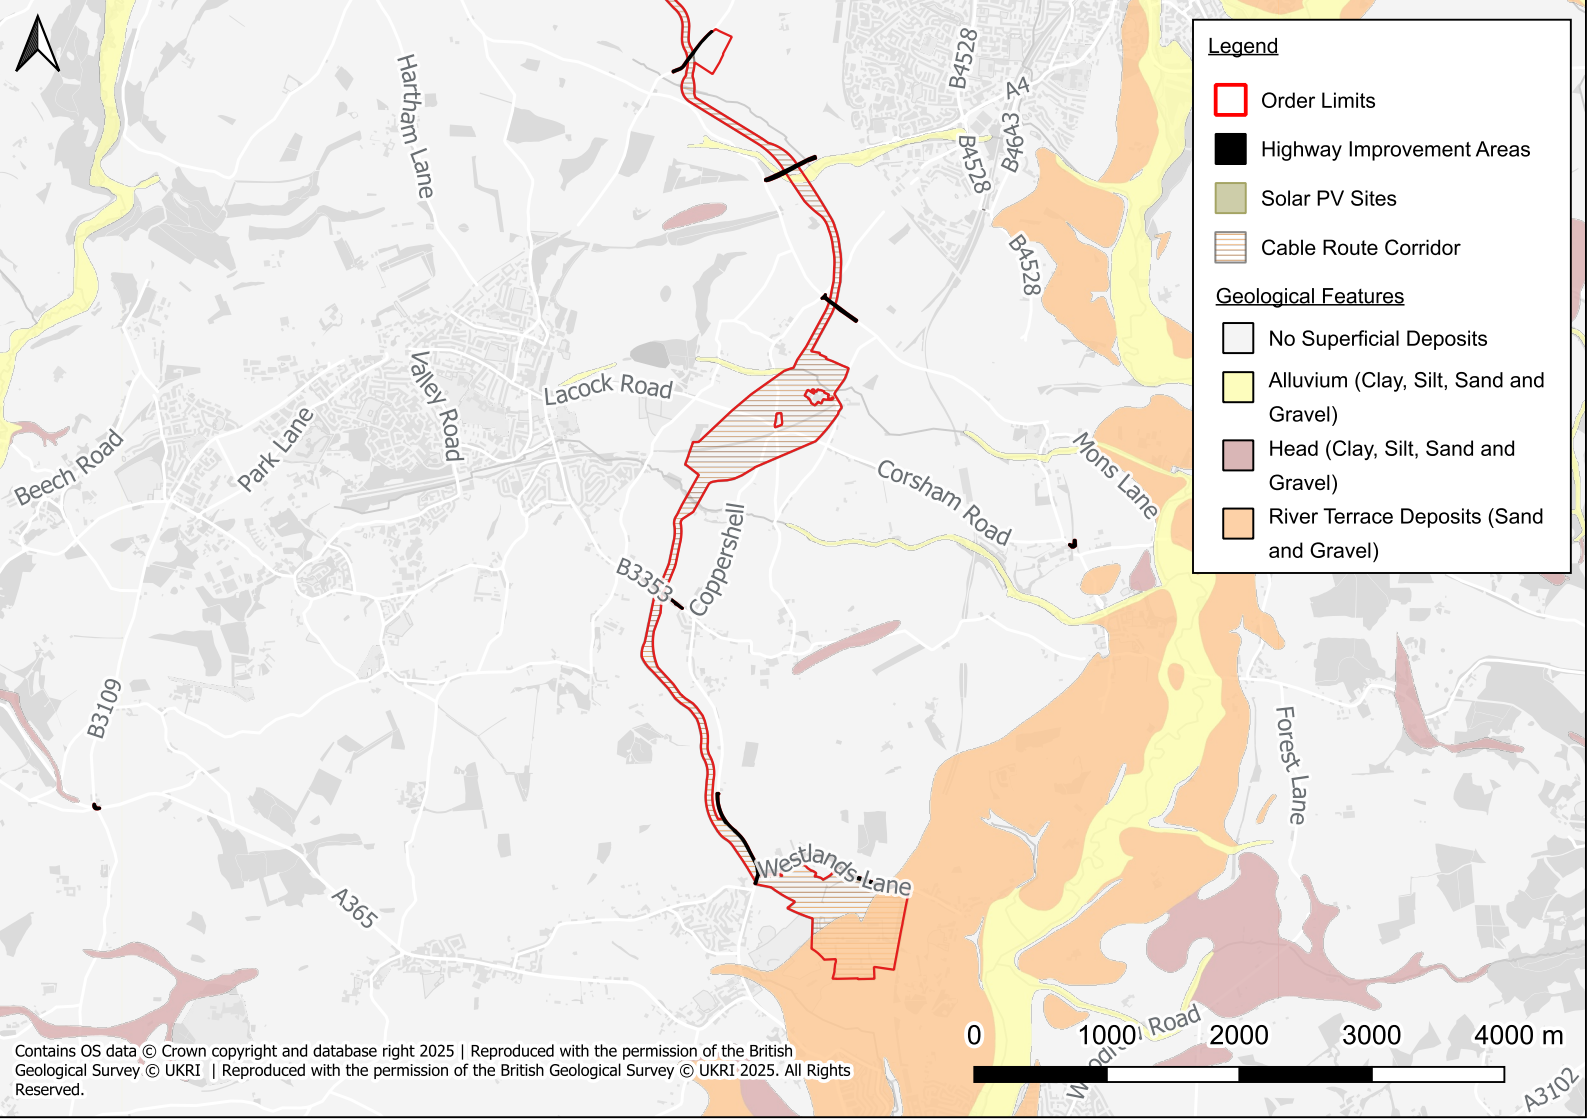
## **Annex B - Cable Route Corridor Geology Maps**

- No Superficial Deposits
- Alluvium (Clay, Silt, Sand and Gravel)
- Head (Clay, Silt, Sand and Gravel)
- River Terrace Deposits (Sand and Gravel)

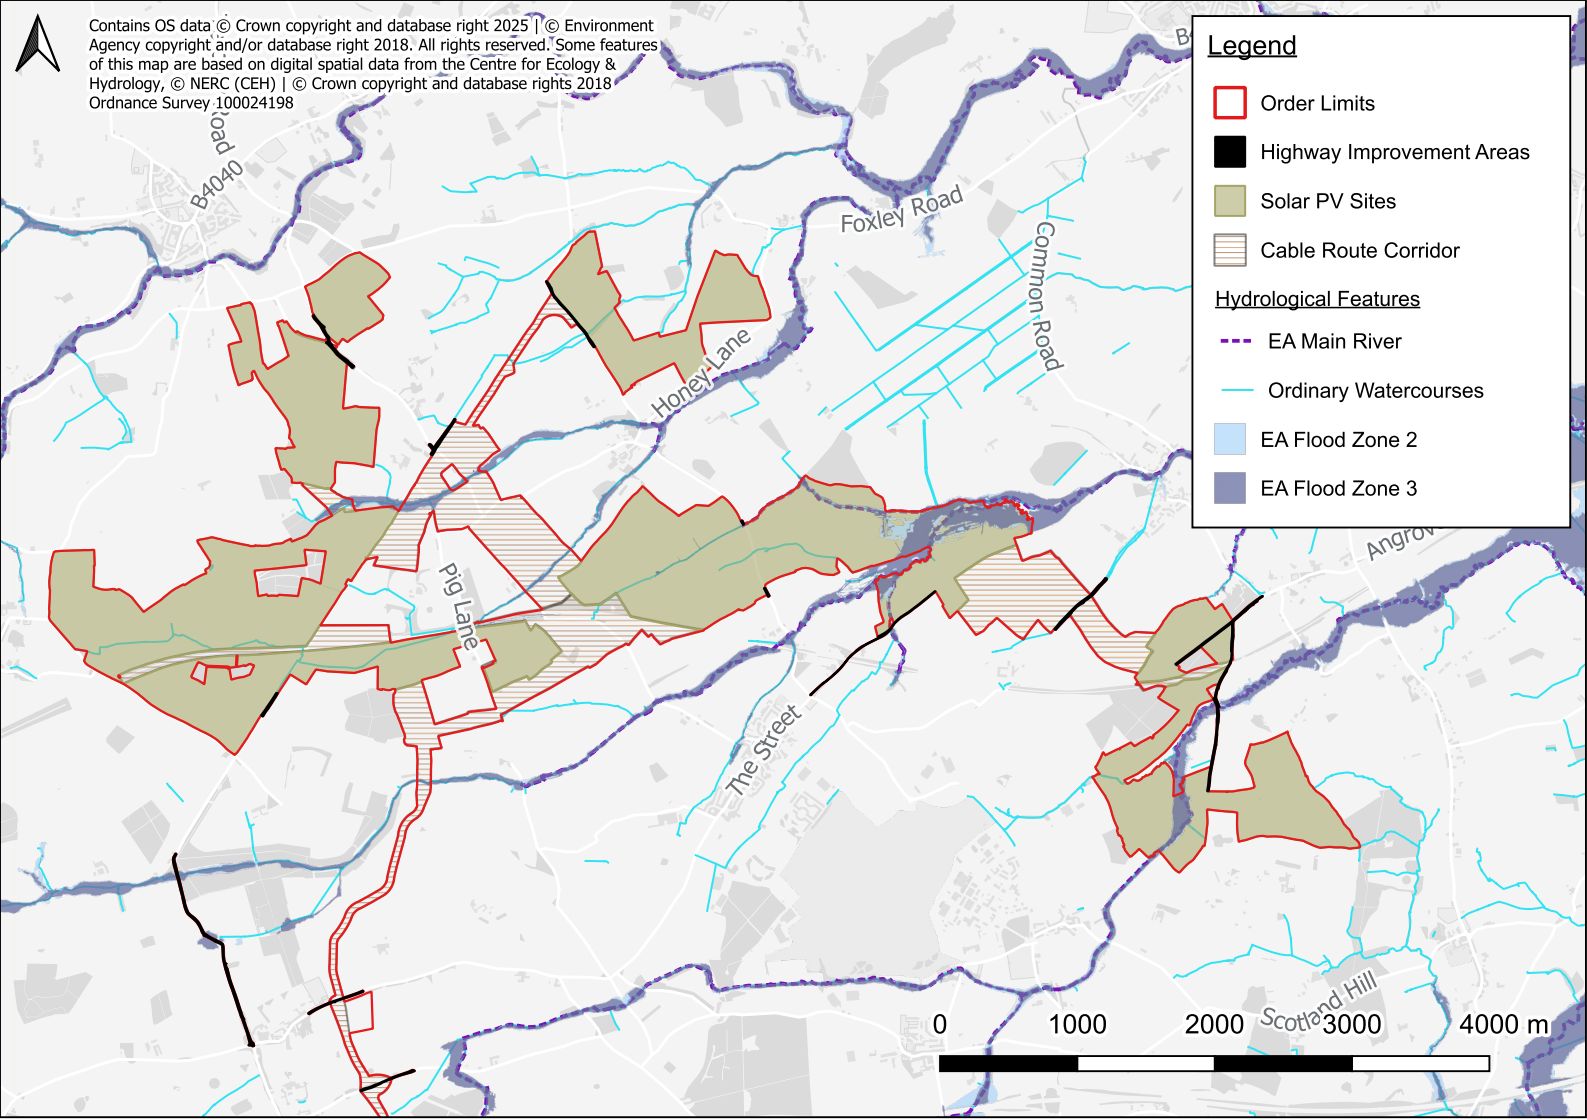
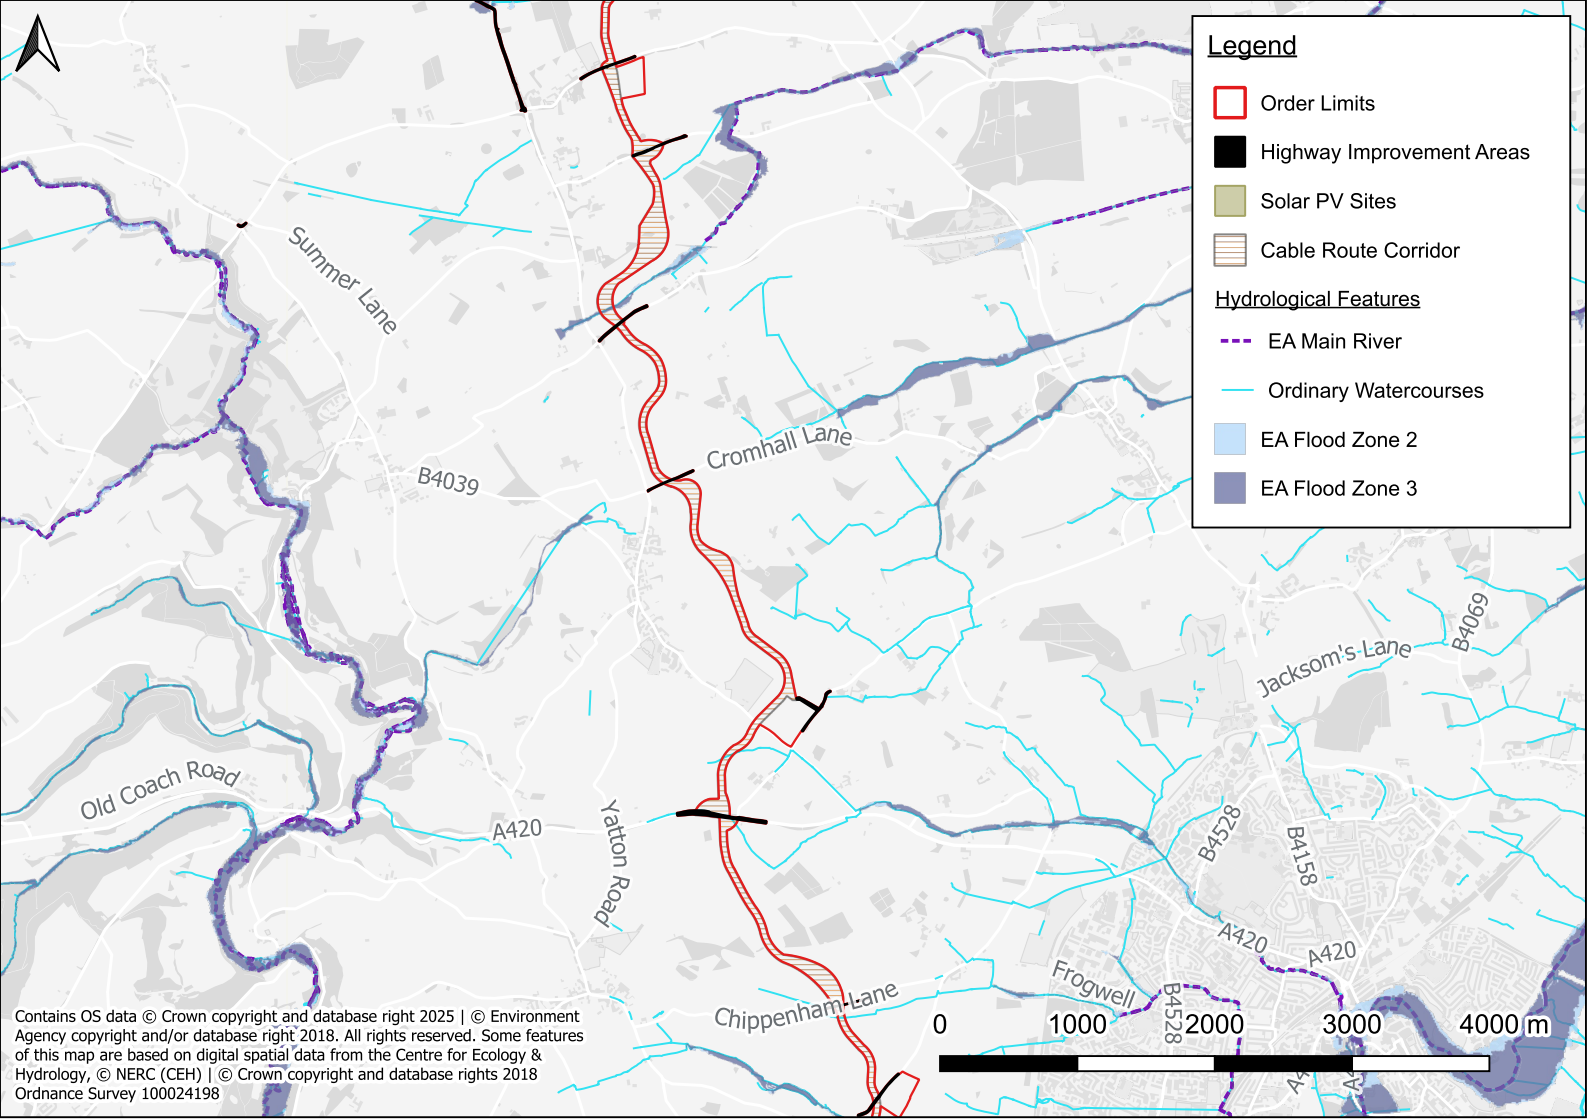
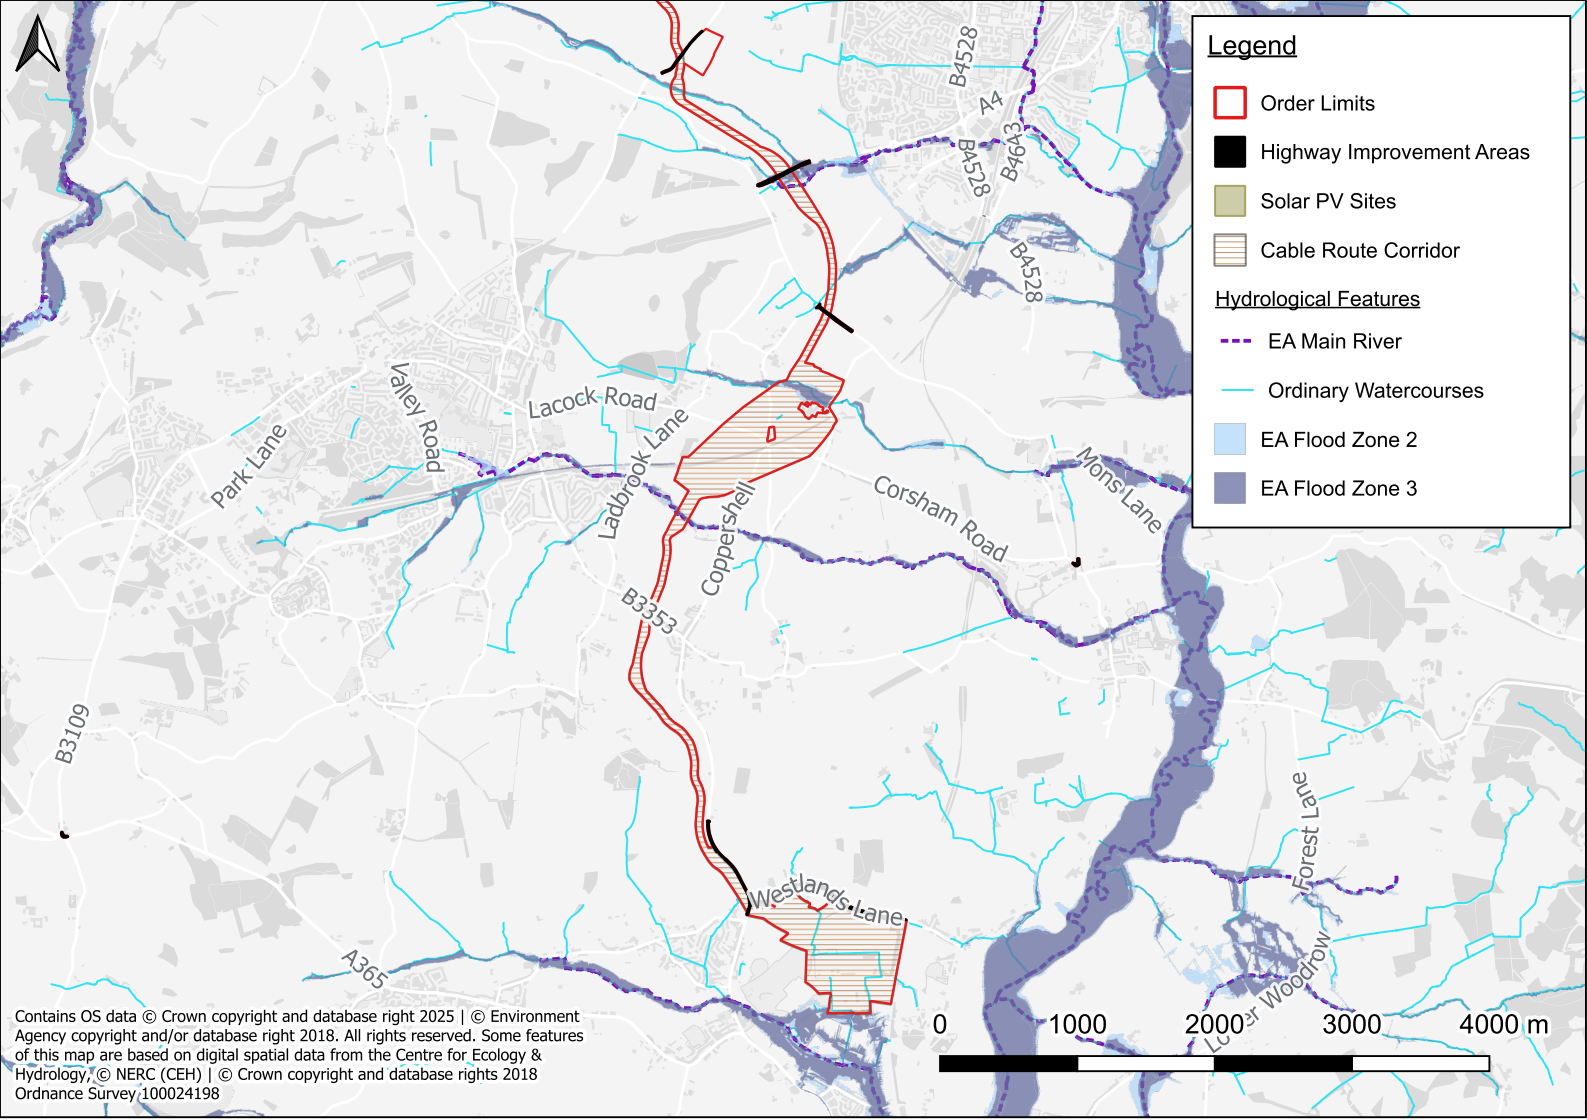
## **Annex C - EA Flood Map for Planning Maps**

- Order Limits
  - Highway Improvement Areas
  - Solar PV Sites
  - Cable Route Corridor
- Hydrological Features
- EA Main River
  - Ordinary Watercourses
  - EA Flood Zone 2
  - EA Flood Zone 3

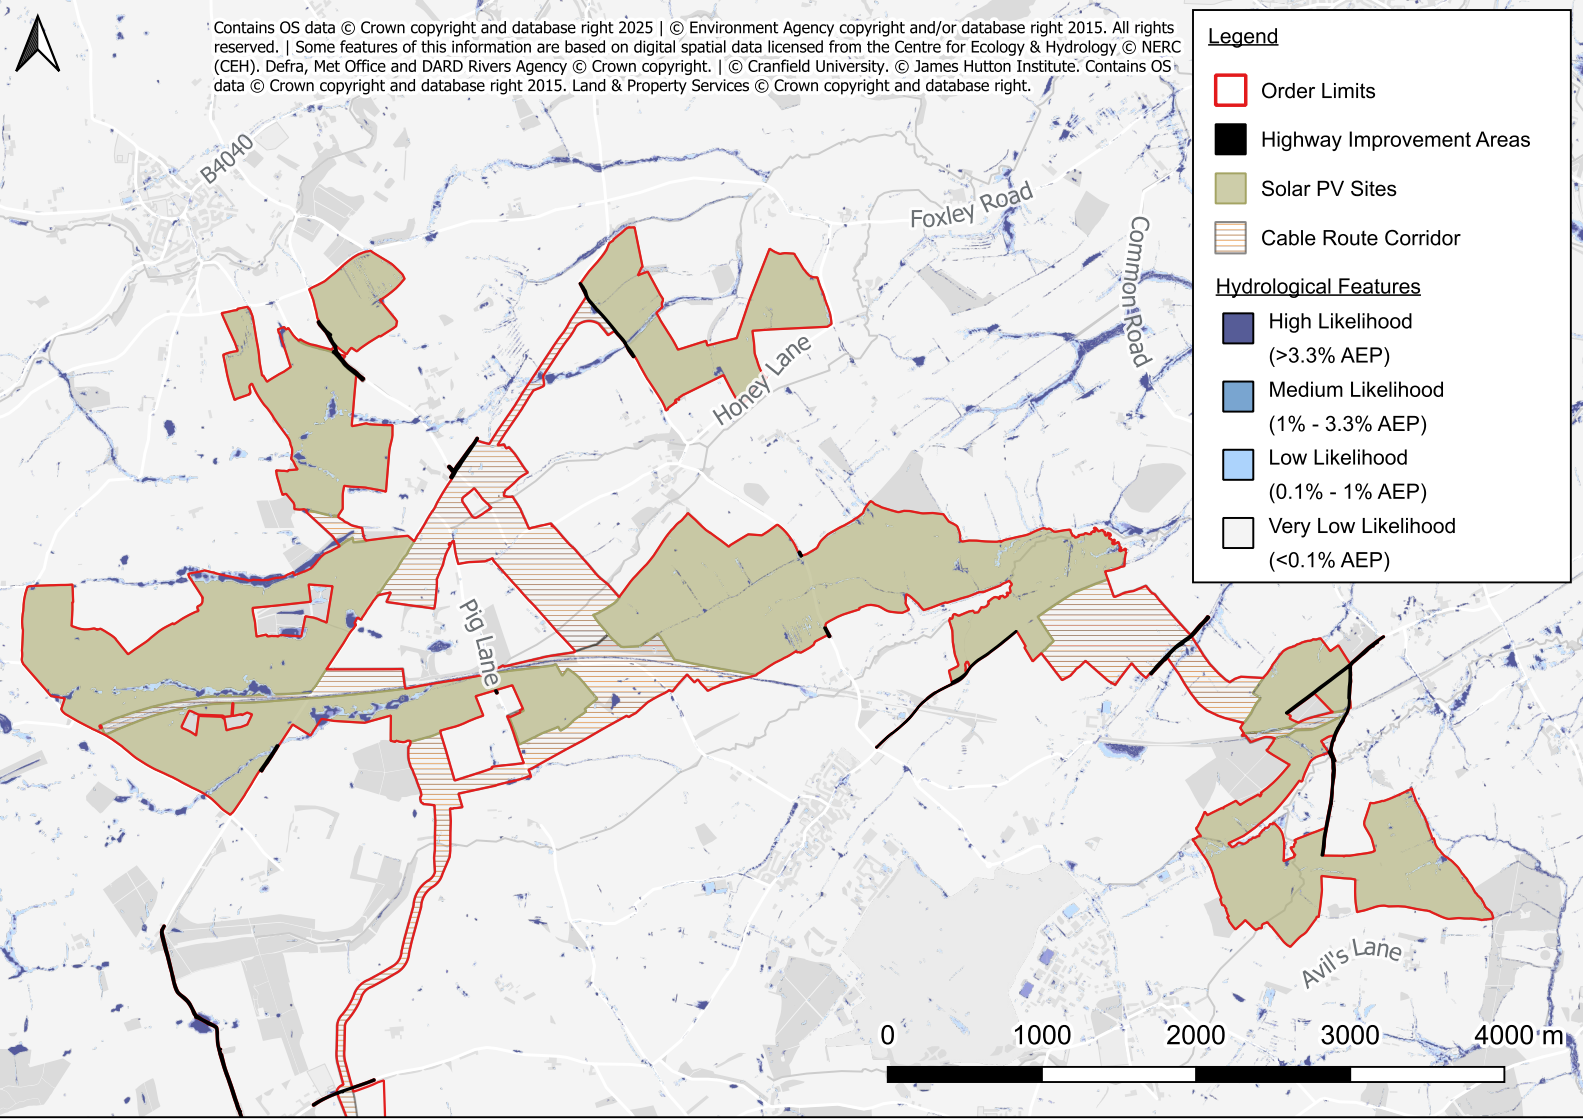
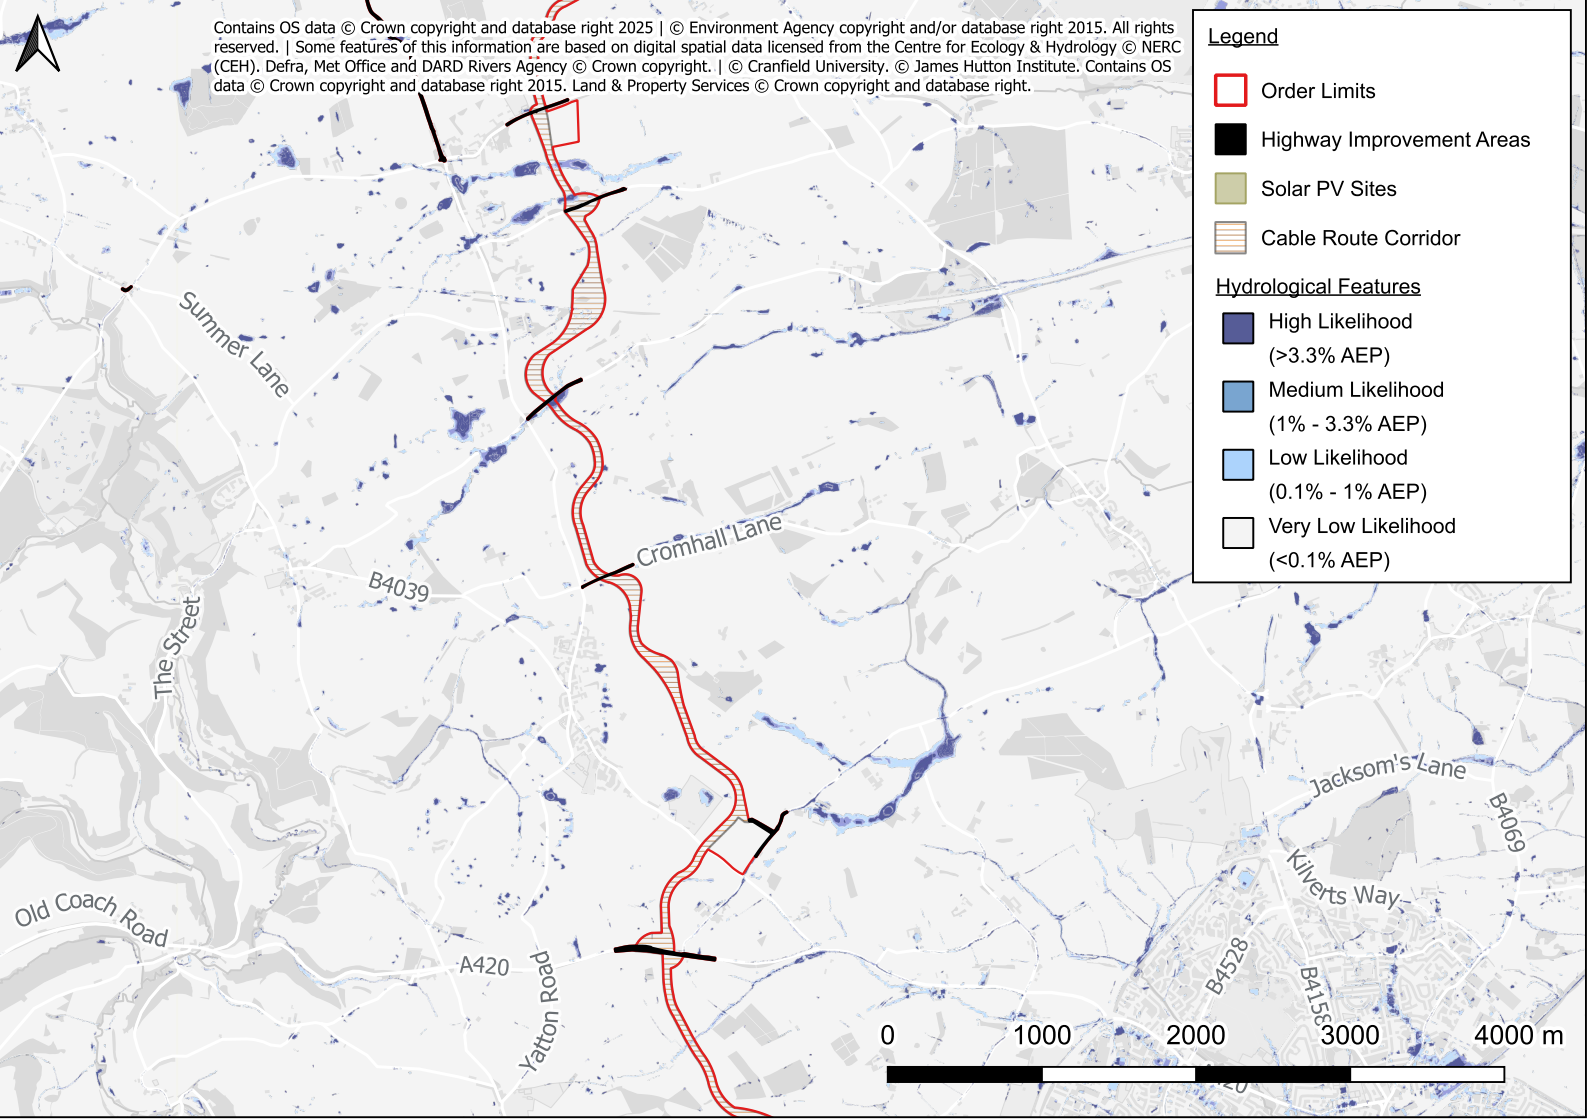
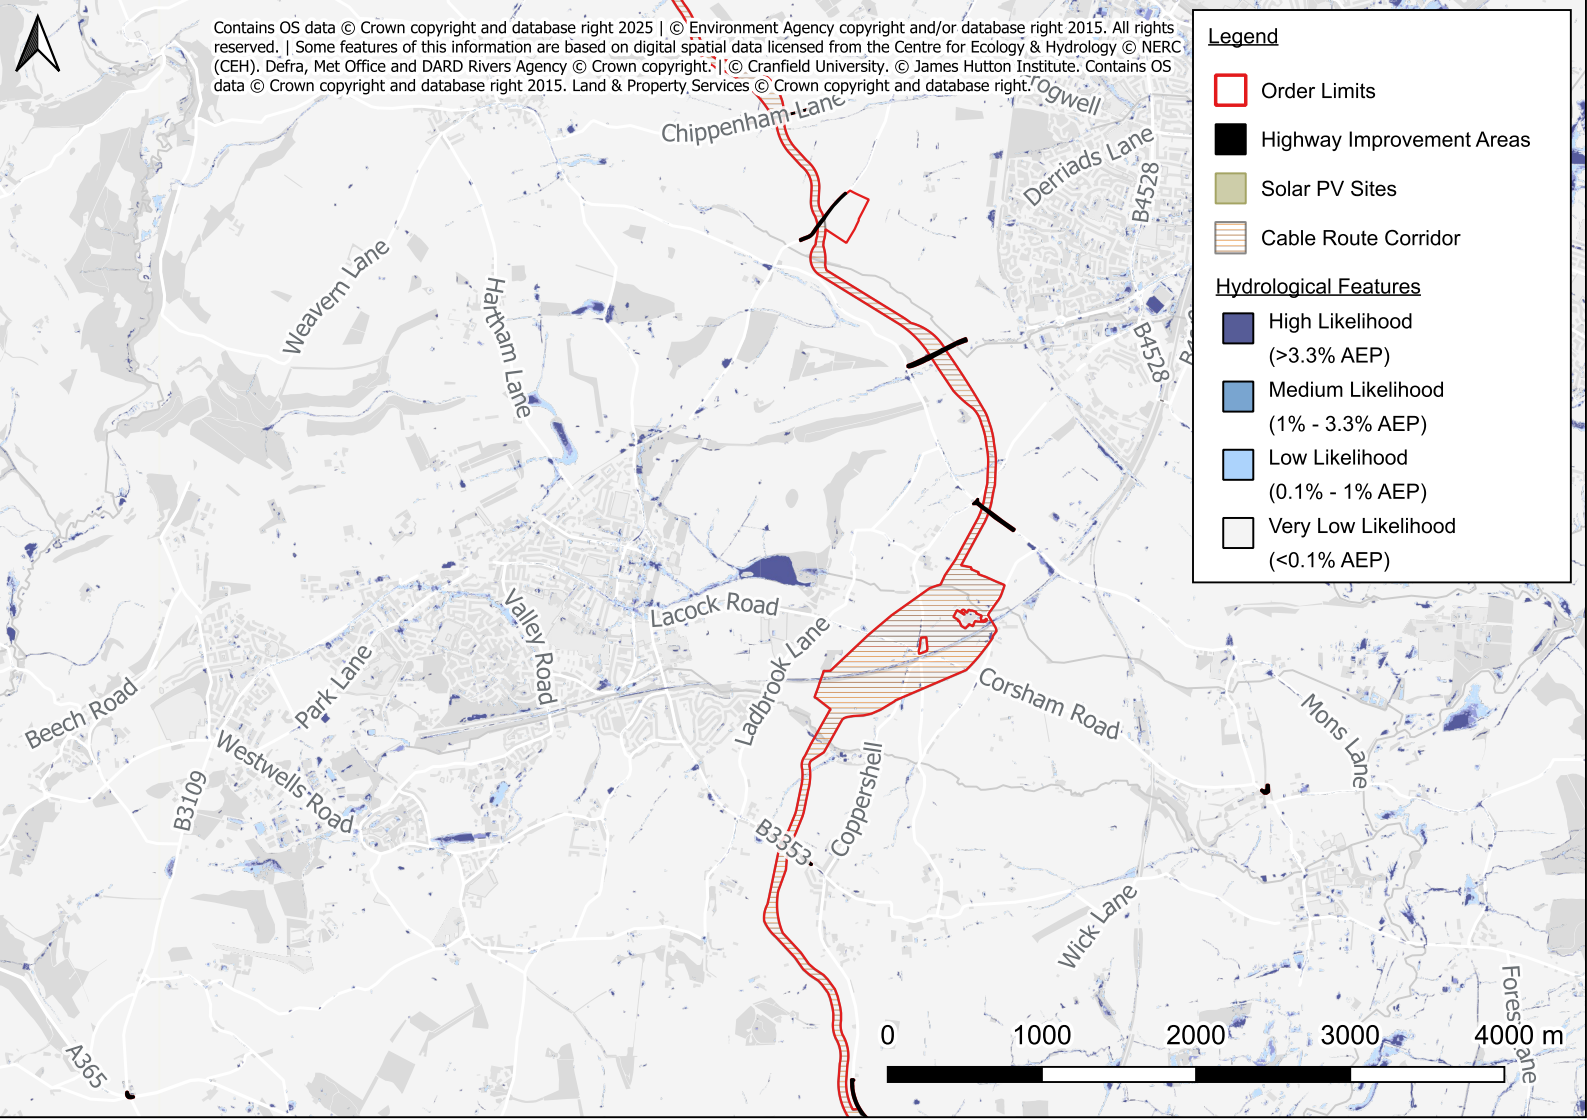
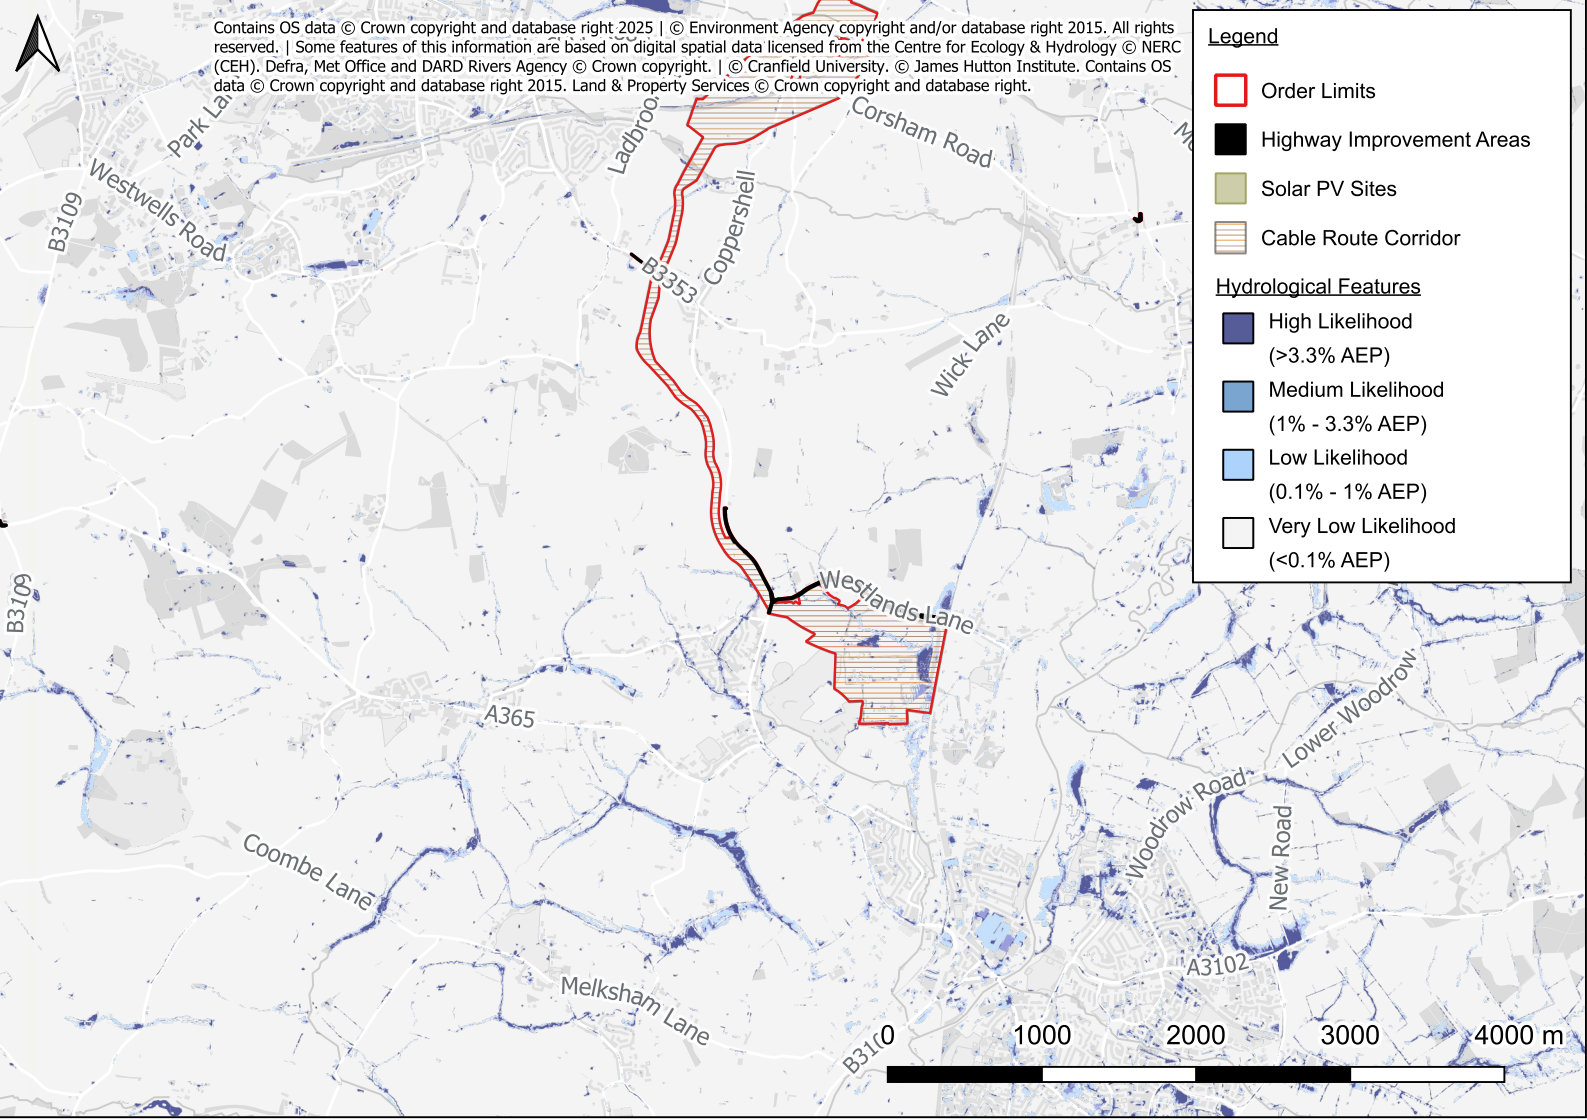
## **Annex E - EA's Long-Term Flood Risk Map (Flood Risk from Surface Water)**

- Order Limits
  - Highway Improvement Areas
  - Solar PV Sites
  - Cable Route Corridor
- ### Hydrological Features
- High Likelihood  
( $>3.3\%$  AEP)
  - Medium Likelihood  
( $1\% - 3.3\%$  AEP)
  - Low Likelihood  
( $0.1\% - 1\%$  AEP)
  - Very Low Likelihood  
( $<0.1\%$  AEP)
