Lime Down

Solar Park

Volume 3, Appendix 11-7: Flood Risk Assessment and Drainage Strategy – Lime Down E1 (Tracked)

Document Reference: APP/6.1

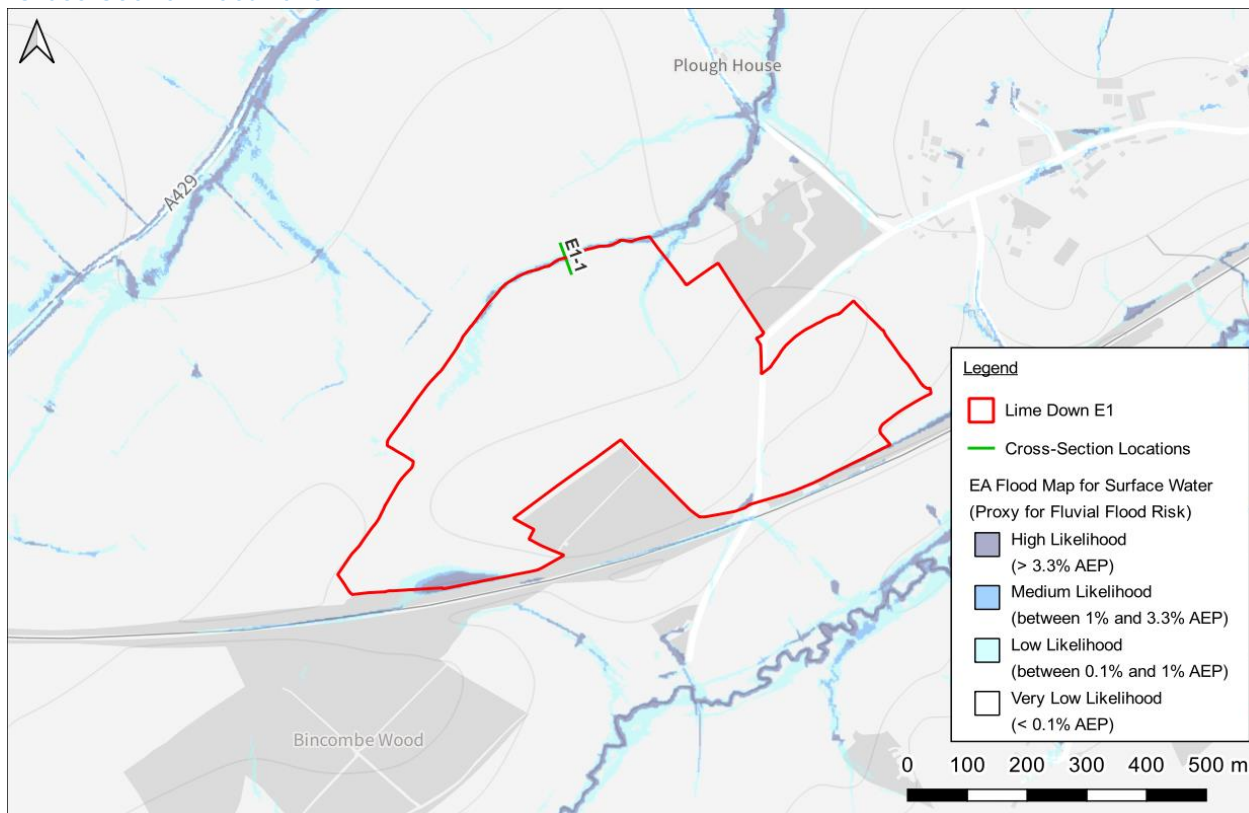
Cross-Section Locations

Cross-sections through the floodplain were extracted from Environment Agency (EA) LiDAR DTM data (flown March 2020) at the locations shown in Figure 1. These cross-sections can be considered representative of the channel and general floodplain adjacent to the site and at the location of the proposed development. The cross-sections were imported into Flood Modeller and the "tabulate cross section properties" tool was utilised to establish the level-flow relationship for the channel and wider floodplain. This tool utilises the Manning's open channel flow equation. Manning's 'n' roughness was set to 0.03s/m^{1/3} for the channel and 0.04s/m^{1/3} for the floodplain. These values were chosen based on Chow (1959)* and aerial imagery. The channel slope was set for each cross-section based on underlying LiDAR.
