Lime Down

Solar Park

Volume 3, Appendix 11-9: Flood Risk

Assessment and Drainage Strategy –

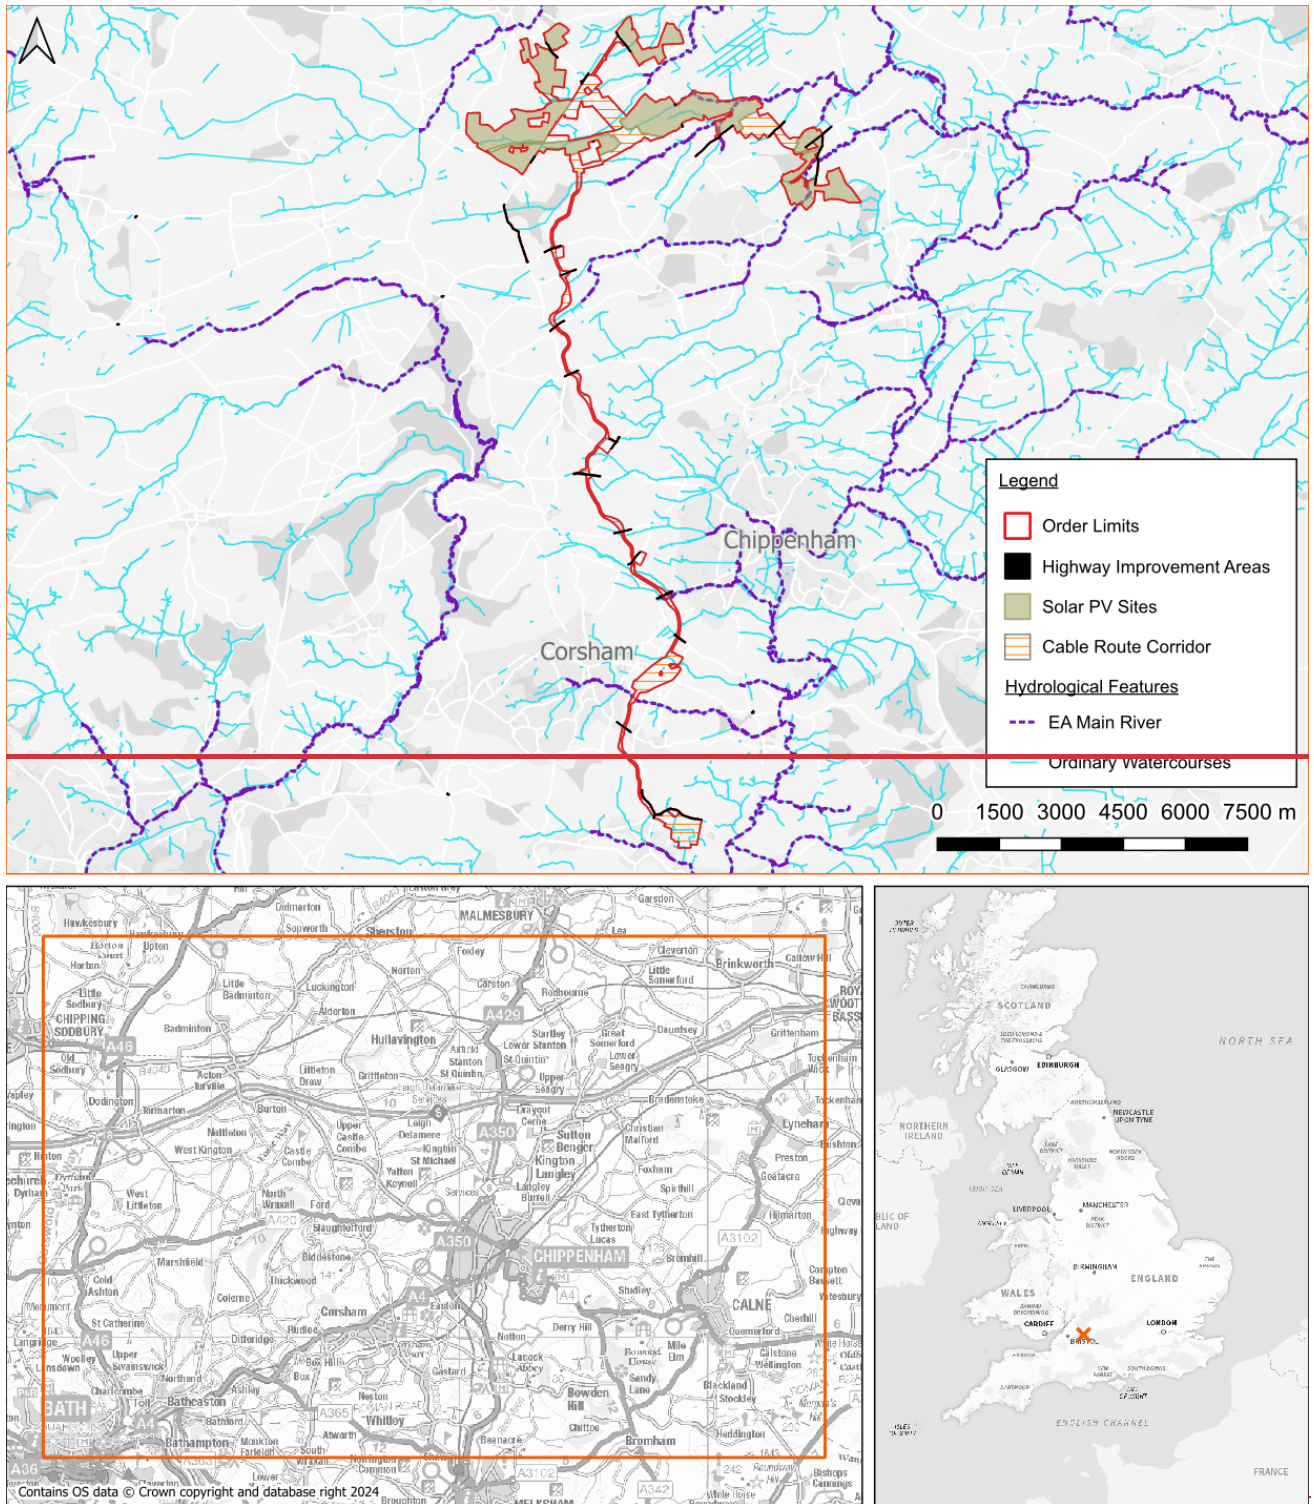
Figure 1: Site Location

1.4.1 The Cable Route Corridor crosses several watercourses which includes; unnamed land drainage ditches, Gauze Brook, Pudding Brook, Bide Brook and South Brook (seen in Figure 1). The named watercourses flow from west to east across the Cable Route Corridor before moving in a southerly direction.

1.2.2 The Cable Route Corridor is situated in the southwest of England, and to the north of Melksham and southwest of Malmesbury
