A1 in Northumberland: Morpeth to Ellingham

Scheme Number: TR010059

Preliminary Bat Roost Assessment Verification Survey Report

January 2021

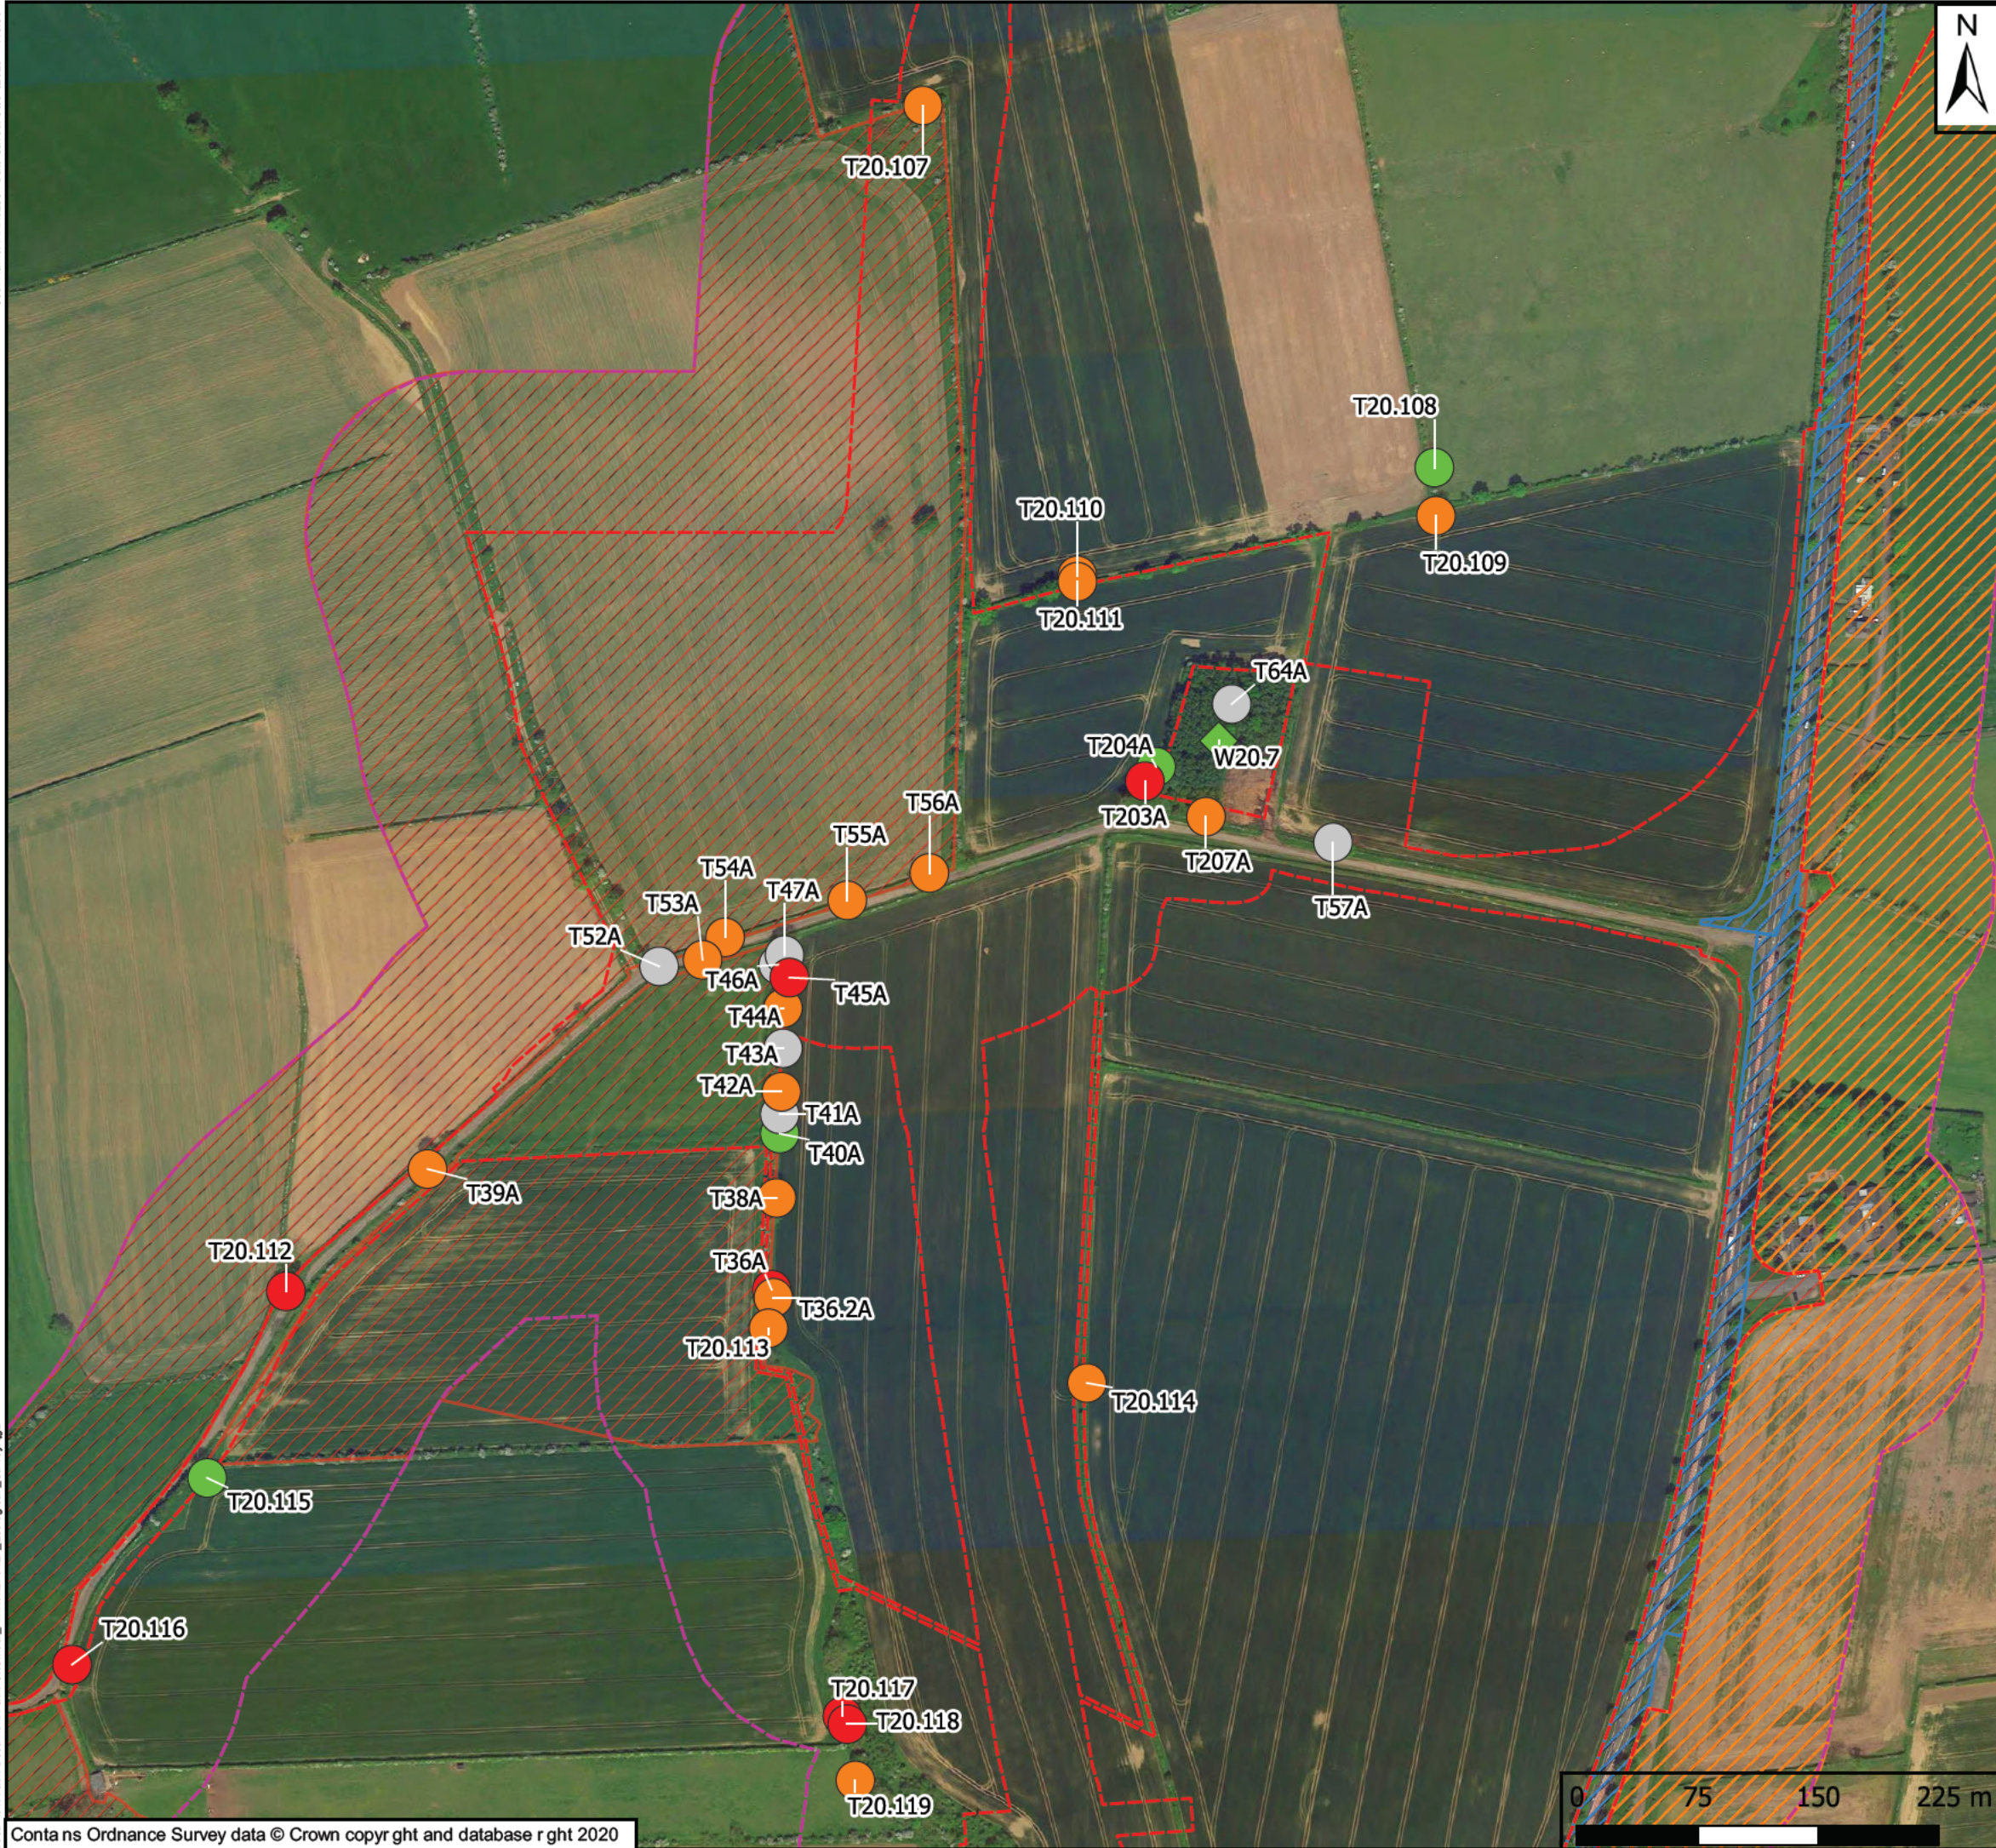
Drawing title
FIGURE 2-4 - PRELIMINARY BAT ROOST ASSESSMENT -
2020 VERIFICATION SURVEYS RESULTS

Order Limits		Trees
	Survey Area		Woodlands
	No Access	Bat Roost Suitability	
	Restricted/partial access		High
	Scoped out of Survey Area		Moderate
			Low
			Negligible
Survey Features			
	Buildings

- 2.1.4. The locations of assessed buildings, trees and woodland are presented in **Figure 2-1** to **2-12**.

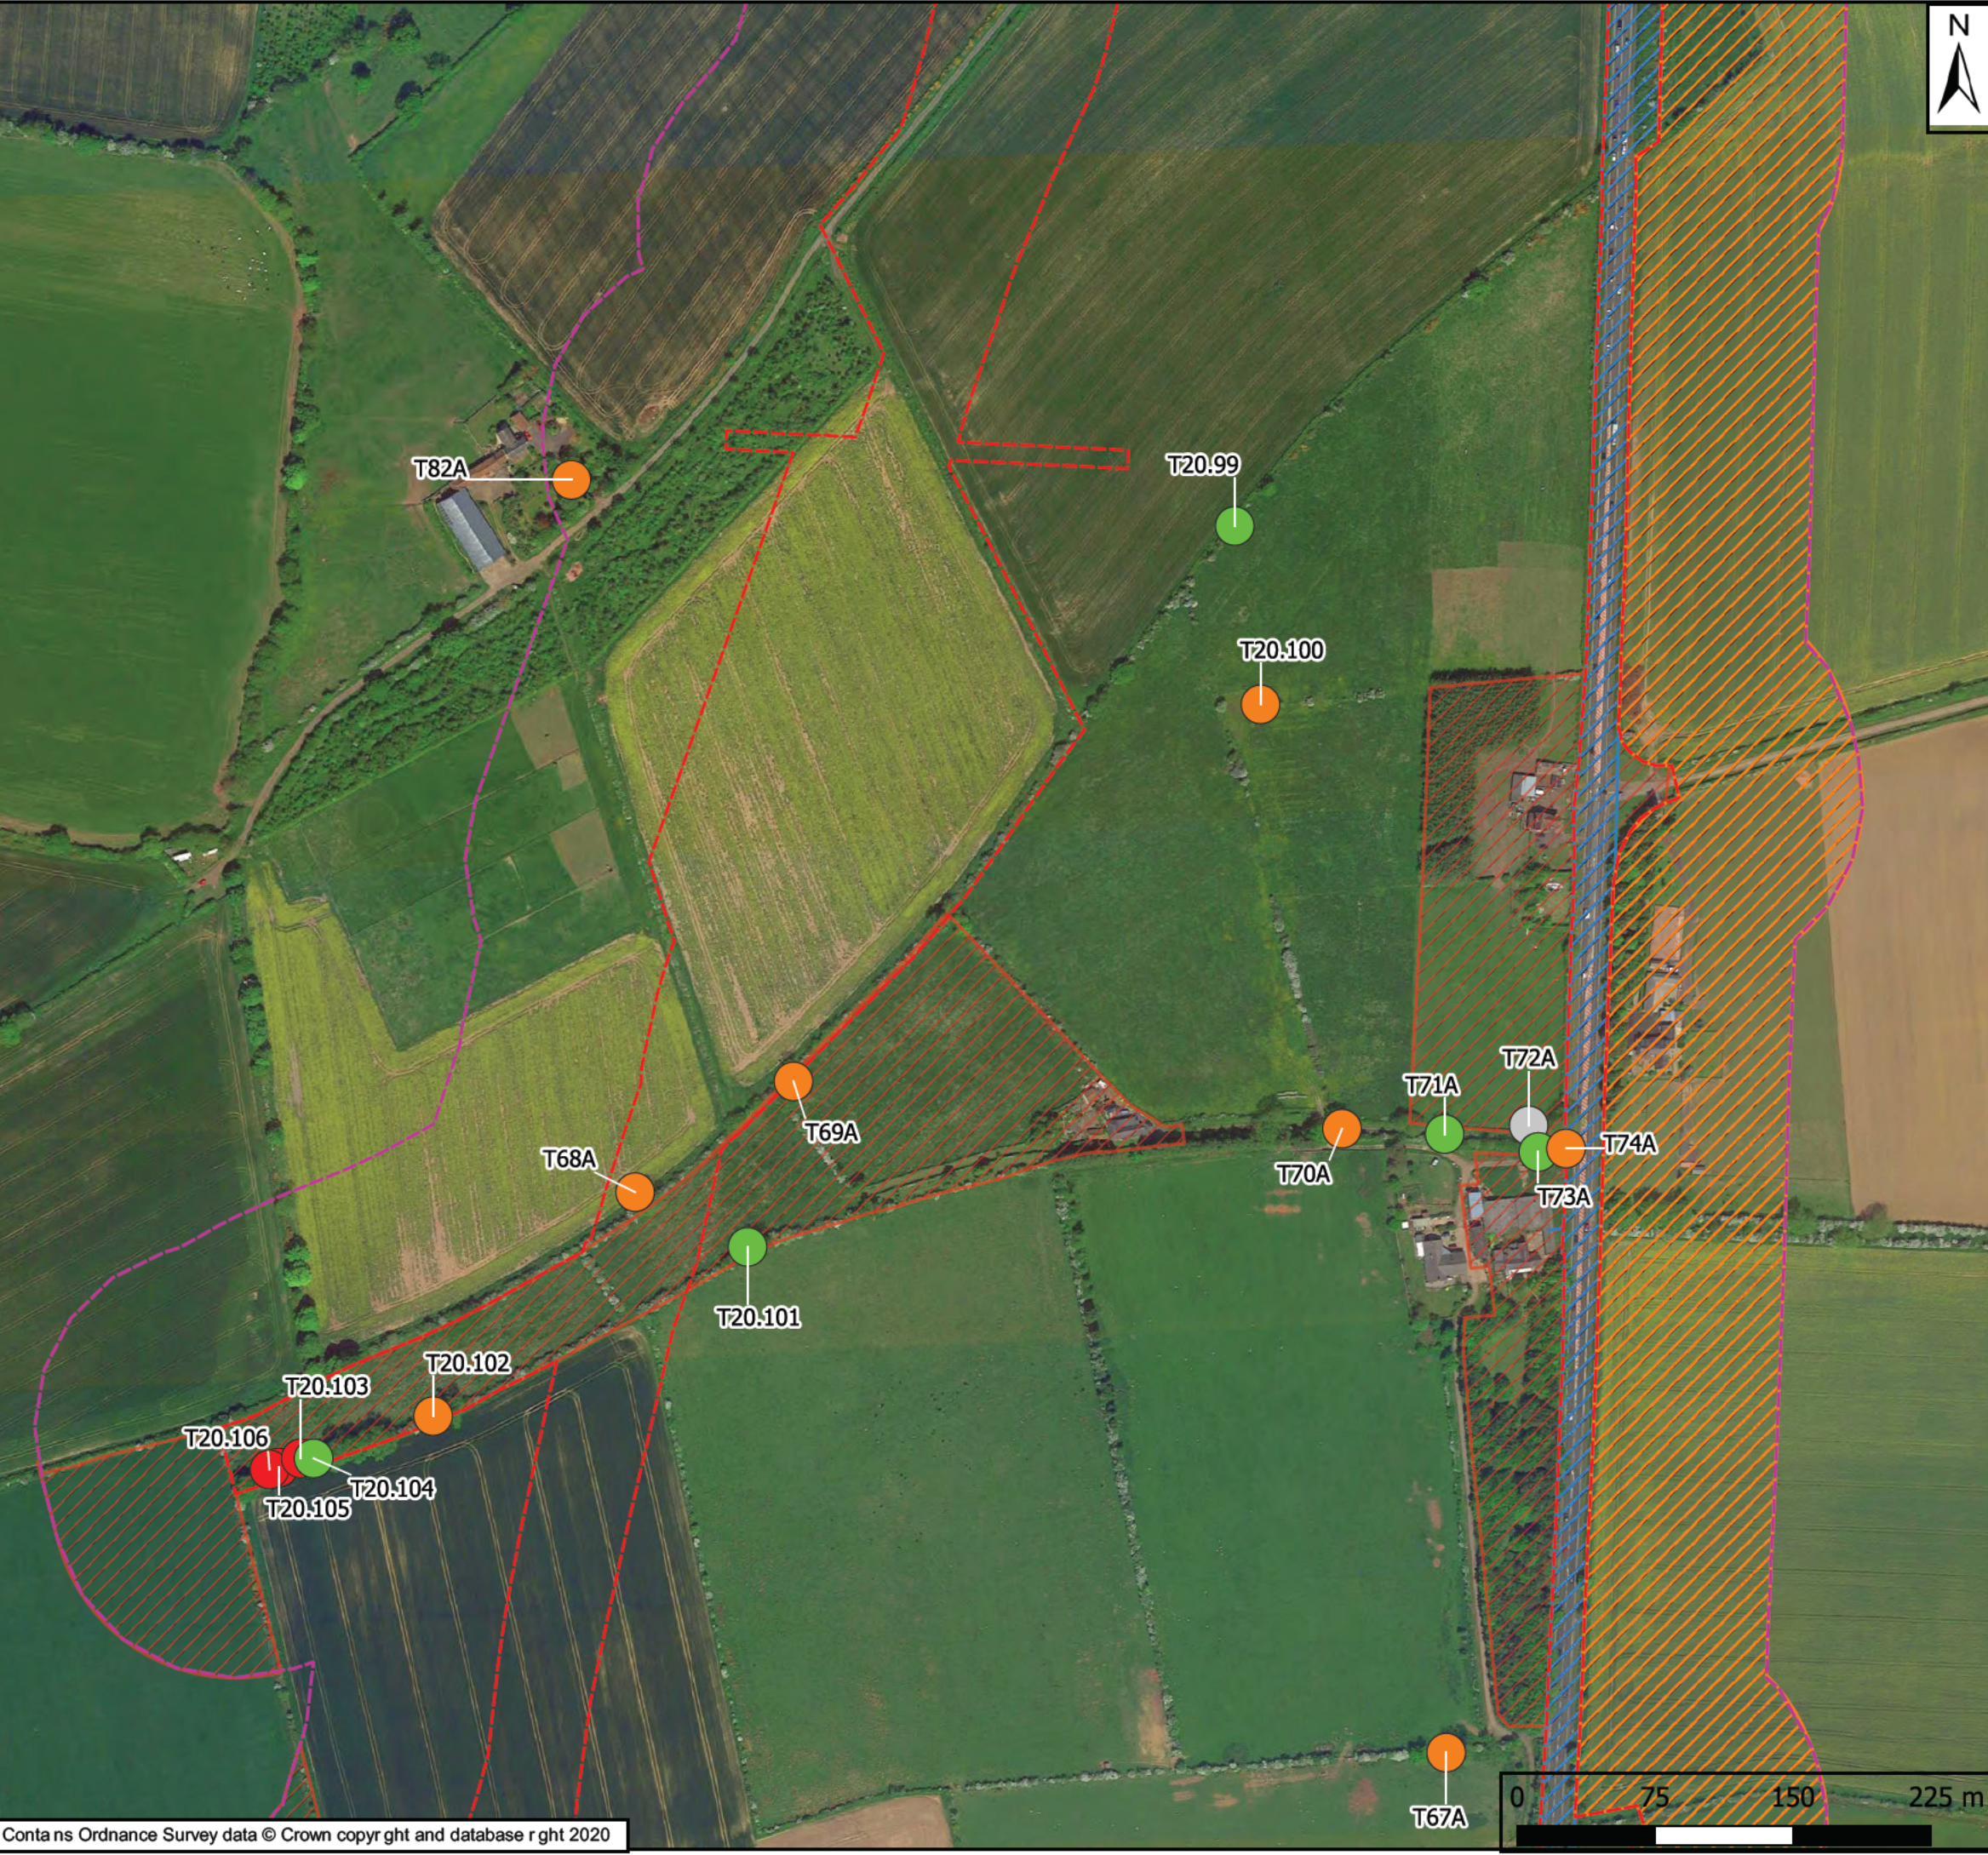
Drawing title
FIGURE 2-5 - PRELIMINARY BAT ROOST ASSESSMENT -
2020 VERIFICATION SURVEYS RESULTS

- Order Limits
- Survey Area
- No Access
- Restricted/partial access
- Scoped out of Survey Area
