The A46 Newark Bypass Development Consent Order 202[x]

Responses to any further information requested by the ExA for deadline 5

Regulation Number:	5(2)(q)		
Planning Inspectorate Scheme Reference	TR010065		
Application Document Reference	7.65		
Author:	A46 Newark Bypass Project Team, National Highways

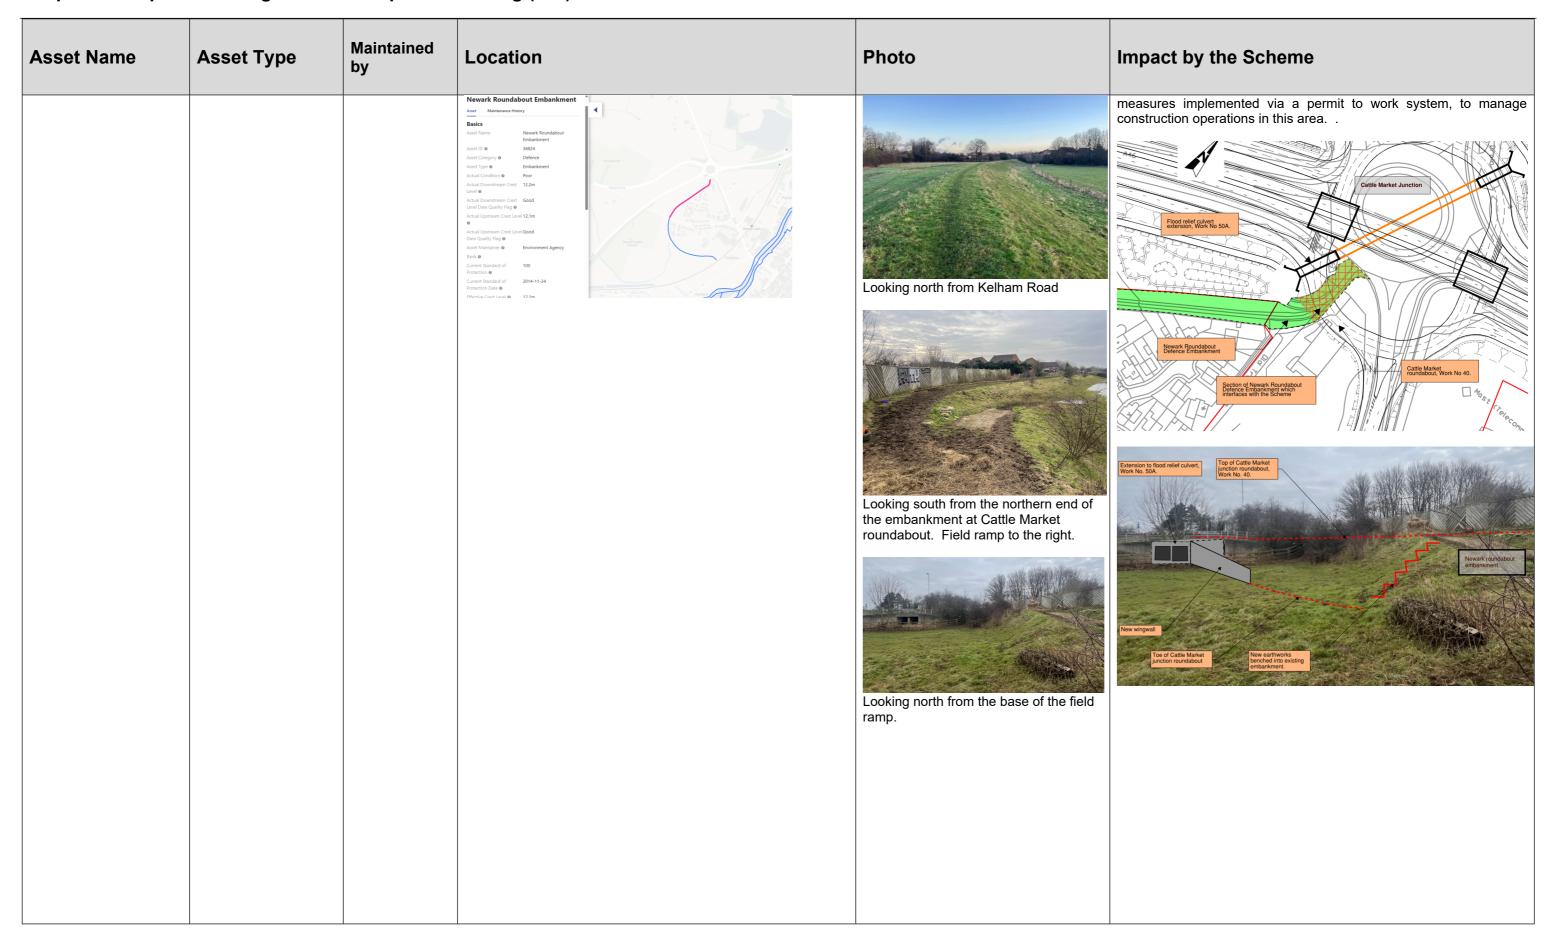
Newark Roundabout Embankment	Defence Embankment	Environment Agency			The Scheme interfaces with the northern end of the defence embankment for approximately 43m (refer to hatched section in the drawing below). The embankment in this location is retained and incorporated within the embankment for the widened Cattle Market roundabout. The new earthworks will be benched into the existing embankment to create a homogenous earthworks element. The new roundabout is higher than the defence embankment and will not be lowering the existing structure. The defence embankment will be identified on the construction drawings as an existing hazard item, with control
