East Anglia TWO Offshore Windfarm

East Anglia TWO and East Anglia ONE North Offshore Windfarm Export Cable Route Archaeological assessment of geophysical data

Environmental Statement Volume 3

Archaeological Assessment of Geophysical Data

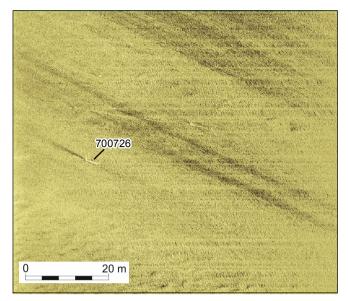
Sidescan sonar image of bright reflector 700726, measuring 2.0 x 1.7 x 0.1 m

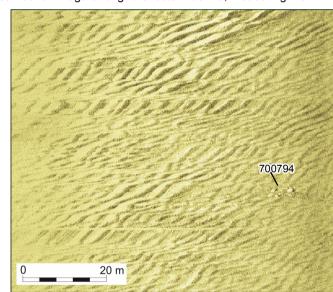
Sidescan sonar image of debris field 700794, measuring 22.2 x 7.8 x 0.3 m

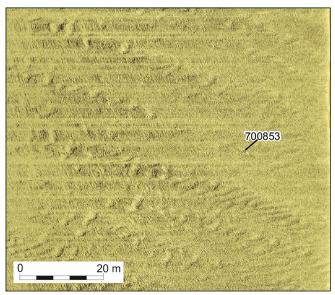
Sidescan sonar image of debris item 700853, measuring 1.5 x 0.8 x 0.0 m

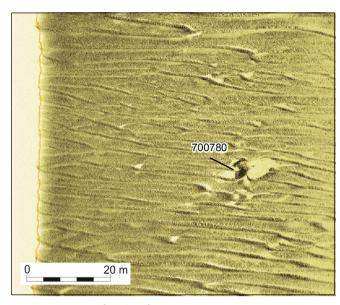
Sidescan sonar image of dark reflector 700780, measuring 14.5 x 4.8 x 1.4 m

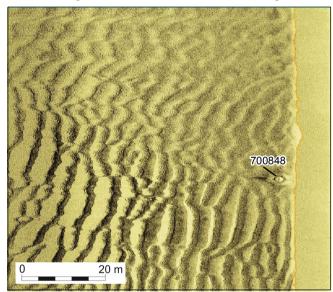
Sidescan sonar image of debris item 700848, measuring 4.0 x 3.0 x 0.4 m

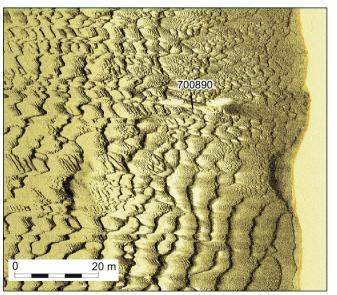
Sidescan sonar image of seabed disturbance 700890, measuring 18.1 x 12.7 x 0.8 m

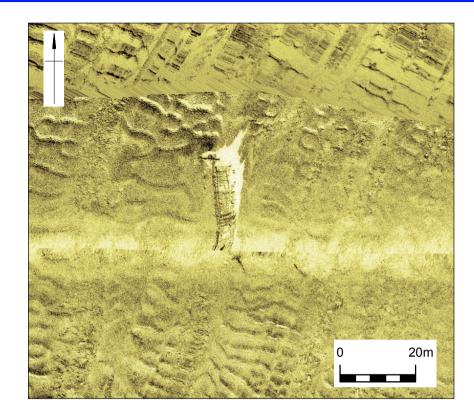
Sidescan sonar image of **70641**, 25.0 m x 8.0 m x 2.8 m

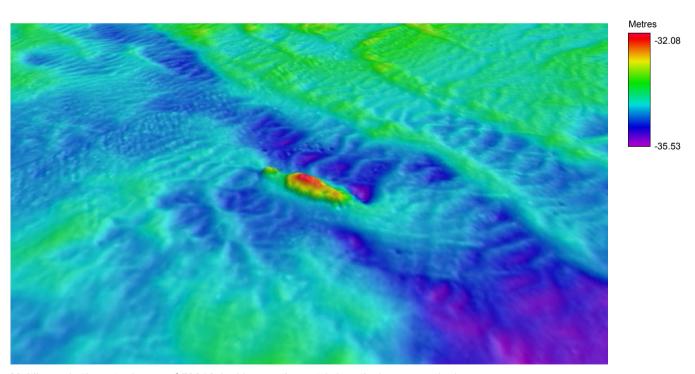
Multibeam bathymetry image of **70641**, looking south-west (x1 vertical exaggeration)

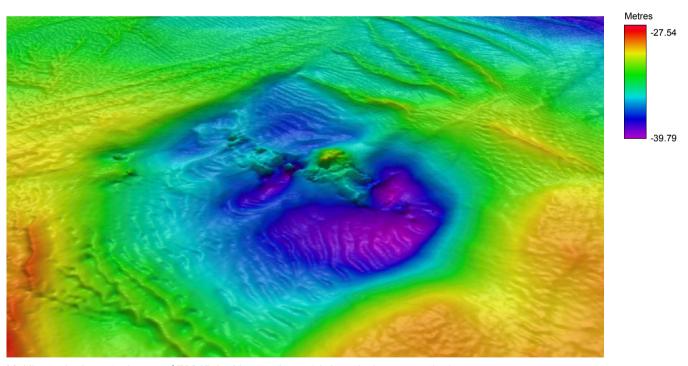
Multibeam bathymetry image of **70645**, looking north-west (x1 vertical exaggeration)

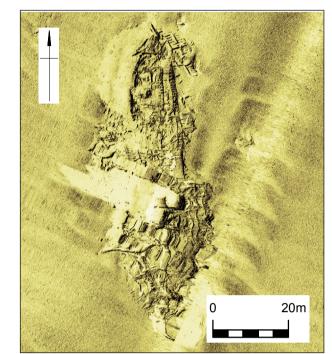
| Location | | 407392 E, 5782532 N Area ECR |
|---|---|--|
| Extent of Survival | | The Jim had two boilers, a single shaft and a triple expansion engine of 99 NHP. It was sunk on passage from Goole to Dieppe in 1941. The circumstances surrounding the loss are unclear. The UKHO (10313) records that the wreck was first recorded in this position in 2015. It was observed as upright and fully collapsed, with plating collapsing outwards. The two boilers were also identified. Further surveys in 2016 and 2017 showed the wreck in one piece and identified an orientation of 177/357° and a scour length of 142 m. The wreck appears upright and fairly compact but deteriorated, with minimal |

Sidescan sonar image of **700218**, 85.7 m x 46.9 m x 2.5 m

bedforms. The MBES data show the wreck as a collection of mounds and features with relief, generally orientated approximately north to south. The *Jim* was a steamship built in 1908 by J. Crown & Sons Ltd., it was sunk on passage from Goole to Dieppe on 31 October 1941 with the circumstances of loss unclear, but it is assumed to either have been sunk by a German midget submarine or by a sea mine. The wreck was first recorded in this position in 2015, with subsequent surveys confirming the location in 2016 and 2017. The wreck appears upright and fairly compact but deteriorated, with minimal superstructure remaining. There appears to be a slight dispersal of debris still within close proximity over an area of flat seabed; there is potential for some burial of items.

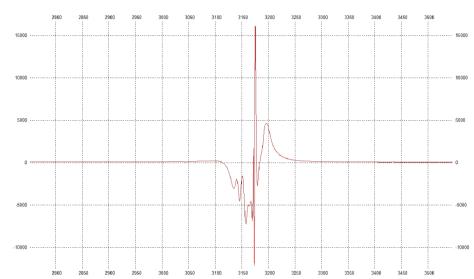
Magnetic profile of 700218, measuring of 31,220 nT

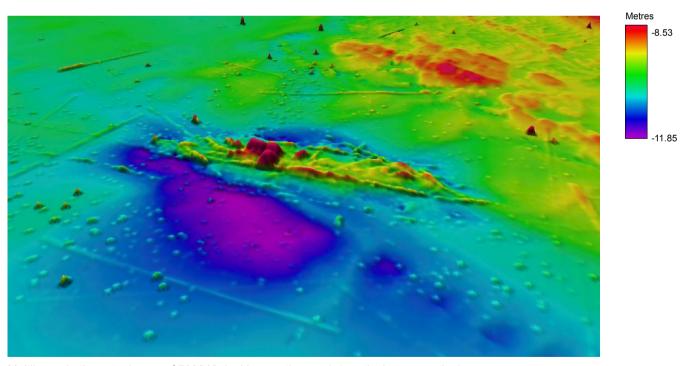
Multibeam bathymetry image of 700218, looking south-west (x1 vertical exaggeration)

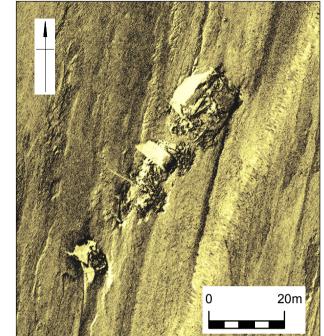
| Location | | 410382 E, 5785290 N Area ECR |
|---|---|--|
| Extent of Survival | | The <i>Mangara</i> had one boiler and a triple expansion engine of 149 HP with a single shaft. It was lost in 1915 en route from Bilbao to West Hartlepool with a cargo of 2400 tons of iron ore, torpedoed with the loss of eleven men. The UKHO (10325) records that the position of the wreck has been known since 1917. A survey in 1985 observed the wreck orientated 030/210° and the hull broken in two. Two surveys in 2017 indicted the wreck was almost entirely buried. The wreck appears upright and dispersed. It is very degraded, although still with considerable height, and occasionally buried indicating potential for some debris dispersal. The magnetic anomaly for this wreck has a magnitude of 9,392 nT and contains multiple peaks, suggesting partial ferrous construction or else dispersal of ferrous cargo. |

Sidescan sonar image of 700244, $72.4 \text{ m} \times 20.8 \text{ m} \times 2.3 \text{ m}$

- 4.2.8 Feature **700244** (Wreck Sheet 4) is a large broken up known wreck of the *Mangara* (UKHO 10325), measuring 72.1 x 20.8 x 2.3 m in the geophysical data, with an associated magnetic anomaly of 9,392 nT, located amongst an area of rough and uneven seabed. The MBES data show the wreck as a collection of two to three mounds and features with relief, generally orientated approximately north-east to south-west. The *Mangara*, an 1821-ton steamship built by A. Stephen & Sons, was torpedoed by UB-16 on the 28 July 1915 *en* route from Bilbao to West Hartlepool with a cargo of 2400 tons of iron ore. The wreck was first recorded in this position in 1917, with subsequent surveys confirming the location in 1985 and 2017. The wreck appears upright and dispersed. It is very degraded, although still with considerable height, and occasionally buried indicating potential for some debris dispersal.

| ID | Class | Easting | Northing | Archaeological discrimination | Length (m) | Width (m) | Height (m) | Magnetic Amplitude (nT) | Description | Report Reference | External references |
|---|---|---|---|---|---|---|---|---|---|---|---|
| 700244 | Wreck | 410382 | 5785290 | A1 | 72.4 | 20.8 | 2.3 | 9392 | A very large and dispersed wreck orientated in a northeast to southwest direction and possibly broken into two pieces. A large number of distinct dark reflector objects are visible with significant height, angular objects and linear pieces are discernible in the wreckage. The wreck is situated on a rough and uneven area of the seabed and outcropping geology. The wreck appears to be very degraded though still with significant height. In the MBES data the wreck is visible as an alignment of uneven mounds, there appear to be a number of small but deep depressions around the edge of the wreck up to 3 m deep. There is a possible boiler visible in the centre of the wreck standing at 2.3 m. There is a very large magnetic anomaly associated with this vessel indicating a possible ferrous construction or cargo. This wreck is recorded in the UKHO database as the <i>Mangara</i> steamship that was sunk in 1915 by the torpedo by the UB-16, its cargo is record as being 2400 tons or iron ore. The original vessel dimensions are 79.2 x 11.3 x 5.2 m. | 117810 | UKHO 10325 |

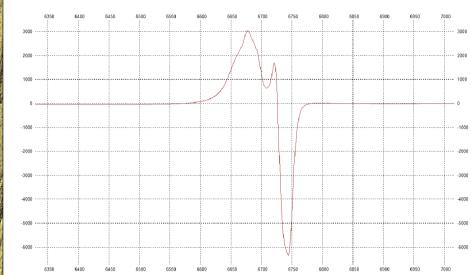
Magnetic profile of 700244, measuring of 9392 nT

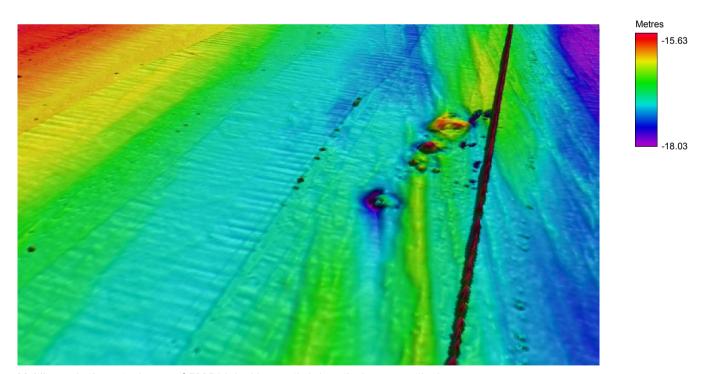
Multibeam bathymetry image of **700244**, looking north (x1 vertical exaggeration)

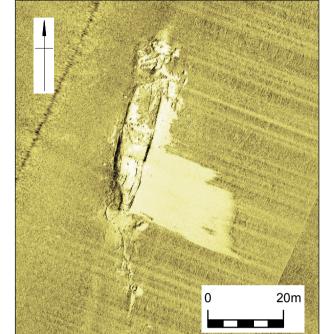
| Location | | 413082 E, 5787765 N | Area | ECR |
|--|---|---|---|--|
| Extent of Survival | | The Alastair had one boiler, a Additional aft machinery was ship was lost in 1915 due sink The UKHO (10331) records the location in 1966 and further started wreck as having an orientation buried. The wreck is upright as largel likely the bow. A few minor rethe hull outline on the surroum mainly confined to the superstate associated magnetic signal no clear spread of debris. | single shaft triple estability by Clyne Mitch cling quickly, with the mat the wreck was idurveyed in 1985. An of 014/194° and an of 014/194° and an of 014/194° and and the flectors (such as 70 ding seabed which tructure. This is suppose the suppose of the properties of the suppose of the properties of the suppose of the properties of | dell & Co., Aberdeen. The eloss of seven lives. Identified by sonar at this survey in 2016 identified the is largely intact and partially ally collapsed at one end, 00254) are visible outside suggests debris items are prorted by the character of |

Sidescan sonar image of **700255**, 53.4 m x 17.2 m x 5.9 m

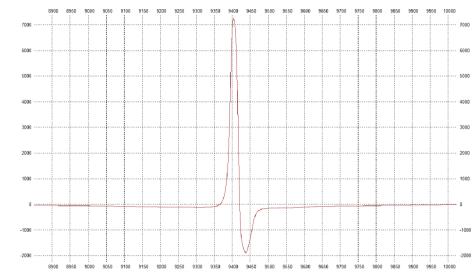
Magnetic profile of 700255, measuring of 9152 nT

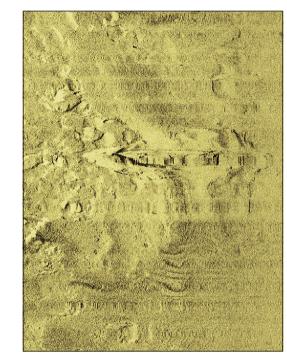
| | | 408286 E, 5783069 N | Area | ECR |
|---|---|---|---|--|
| Extent of Survival | | with a height of 1.4 m and a With the wreck being of low survival is hard to confirm. either buried or still within t | y a geophysica Observed dime an orientation v relief and pai There is no cle the main struct ts a small vess | al survey in 2016 and ensions were 29.1 x 17.7 m of 120/300°. rtially buried the extent of ear debris field, indicating cure. The clean magnetic sel of ferrous construction or |

Sidescan sonar image of **700262**, 25.0 m x 8.0 m x 0.8 m

| ID | Class | Easting | Northing | Archaeological discrimination | Length (m) | Width (m) | Height (m) | Magnetic Amplitude (nT) | Description | Report Reference | External references |
|---|---|---|---|---|---|---|---|---|---|---|---|
| 700262 | Wreck | 408286 | 5783060 | A1 | 25.0 | 8.0 | 0.8 | 228 | An outline of a medium sized wreck with no discernible height which suggests that potentially the structure is poorly degraded or is buried by sediment. The wreck has been identified in an area of bed forms which may also mask its extent. The wreck has some possible associated scour, approximately 25 x 23 m, and is orientated in a north-west to south-east direction on the seabed. It is to be noted that the area includes some seabed disturbances nearby, no clear items of debris have been identified. In the MBES data the hull of the vessel is clearly distinguished with some possible faint internal structures still standing, though this is unclear, and the wreck has low relief. There is a large magnetic anomaly associated with this wreck indicating a ferrous construction or cargo. This is recorded in the UKHO database as an unknown wreck (UKHO 87913) identified by geophysical survey in 2016. | 117810 | UKHO 87913 |

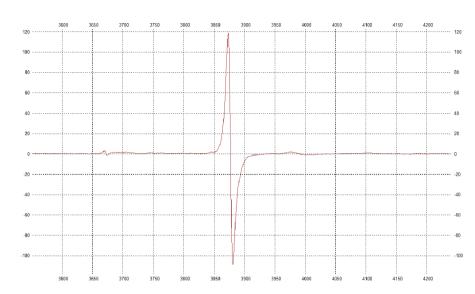
Magnetic profile of 700262, measuring of 228 nT

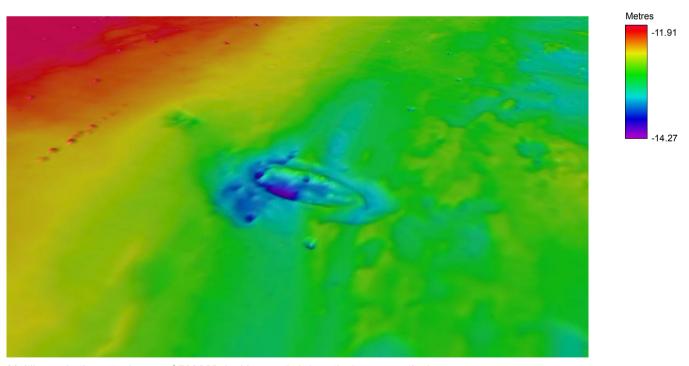
Multibeam bathymetry image of 700262, looking north (x1 vertical exaggeration)

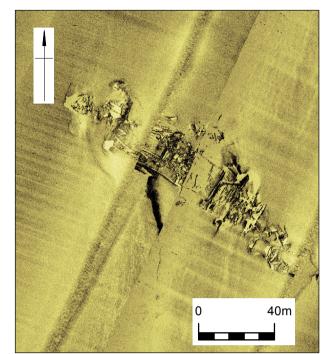
| Location | | 411648E, 5783222N Area ECR | |
|---|---|---|--|
| Extent of | Survival | The <i>Magdapur</i> was powered by a 1147 HP turbine with a single shaft and two boilers. It was lost en route from South Shields to Southampton, sinking after breaking in two due to a mine strike, with the loss of six lives. The UKHO (10321) records that the wreck was identified by sonar at his location in 1962. A further survey in 1972 described the wreck as completely pulverised with only steel found. No parts except engine room components were identified and the lie of the vessel was not clear. A sonar survey in 1985 showed considerable dispersion and a further survey in 2017 found the wreck lying at 124/304° orientation, partially buried and broken. The wreck is upright and largely intact but broken, some bow and stern collapse is visible. Only a few reflectors are visible outside the hull outline on the surrounding seabed which suggests most debris items are confined to the superstructure. This inference is supported by the character of the associated magnetic signature, which is a clear, smooth dipole of magnitude 21.605 nT. | |

Sidescan sonar image of **700591**, 162.0 m x 40.0 m x 4.1 m

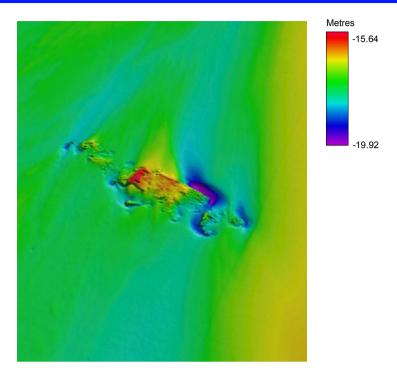
Multibeam bathymetry image of **700591**, looking south (x1 vertical exaggeration)

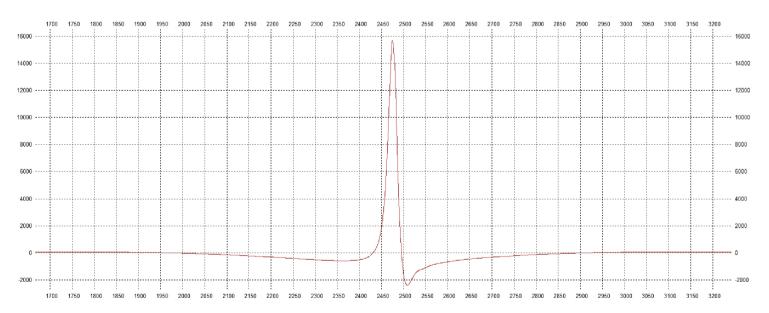
Magnetic profile of 700591, measuring of 21,605 nT

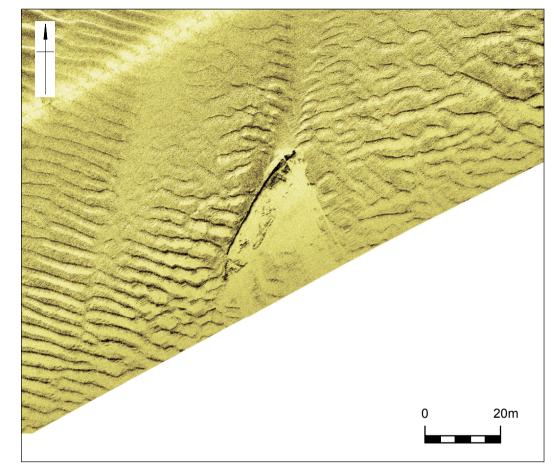
| Location | | 416532 E, 5790383 N | Area | ECR |
|--|---|--|---|---|
| Extent of Survival Sunk by a mine laid by U-6 (3 rd September 1916) The Mascotte had two boilers, a single shaft and a compound expansion engine. It was sunk on passage from Rotterdam to in 1916, with the loss on one life. The UKHO (10338) records that the wreck was first recorded 1916, with the general position identified in 1977 by the skipp Michelle Louisa. It was observed, and the bell removed, in 1977 The position was confirmed during survey in 1993 and swept 2001. Subsequent surveys in 2016 showed the wreck as inta partially buried, the position was updated with a note of orien 027/207°. The wreck appears upright and compact, with clear superstrue Any debris may be buried, but none is current seen around the wreck site. | | and a compound om Rotterdam to Leith as first recorded in 1977 by the skipper of removed, in 1991. 1993 and swept clear in the wreck as intact and a note of orientation of clear superstructure. | | |

Sidescan sonar image of **700786**, 41.1 m x 8.3 m x 2.3 m

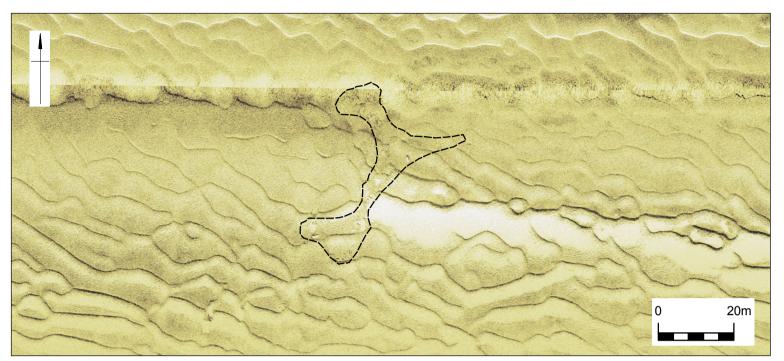
| Location | | 429622E, 5797407N Area ECR |
|---|---|---|
| Extent of S | urvival | Debris appears to be associated with an unidentified wreck (UKHO 10674). The wreck was located in 1982 by HMS Bulldog. Dimension are stated in the UKHO data as 35.5 m x 5.6 m x 4.1 m, laying approximately east to west across, and almost completely buried by, a north to south bedform. It was not located during mine hunting in 1997. During the 2010 East Coast REC survey the wreck was recorded buried by an east to west sand wave, aligned north to south and without apparent structure or debris. This indicated the wreck is regularly covered and uncovered by the mobile sediments, indicating debris may be well scattered within the recent sediments. The wreck is still unconfirmed if intact as no structure is seen at this time. Only a debris field can be identified in the current data, which consists of a number of small items. The main body of the wreck is likely to either be partially buried or widely distributed if not intact due to the presence of mobile sediment bedforms. |

Sidescan sonar image of **70639**, 46.6 m x 6.1 m x 0.4 m

- Feature **70639** (Wreck Sheet 9) is an area of debris that appears linked to an unknown 4.2.13 wreck (UKHO 10674), measuring 46.6 x 6.1 x 0.4 m in the geophysical data, located in an area of mobile bedforms. Due to the magnetometer line spacing in this section, it is not possible to confirm whether the feature is comprised ferrous material. The MBES data does not show the distributed debris amongst the bedform. It is to be noted that there is an area of outcropping bedrock approximately 140 m north of the UKHO location, orientated approximately north to south, perpendicular to the bedform crest. There are a number of small debris items also associated but located separately to the main debris field, 700822-4. The wreck was located in 1982 by HMS Bulldog and was noted to be almost completely buried. It was not located during mine hunting in 1997. During a survey in 2010, the wreck was recorded as buried by an east to west sand wave, aligned north to south and without apparent structure or debris. This indicated the wreck is regularly covered and uncovered by the mobile sediments. The wreck extent and status are still unconfirmed as no structure is seen at this time. Only a debris field can be identified in the current data. The main body of the wreck is likely to either be partially buried or widely distributed if not intact due to the presence of mobile sediment bedforms.

- 5.2.4 For the four debris fields, one (70639) was recommended an AEZ of 100 m as the location of the wreck itself was not identified and debris was identified amongst the bedforms. Two (700257 and 700835) were recommended an AEZs of 50 m; one (700257) as a possible wreck with an unconfirmed spread of debris, the second as a large collection of associated wreck debris. One (700258) was recommended an AEZ of 15 m as associated to a larger area of debris.

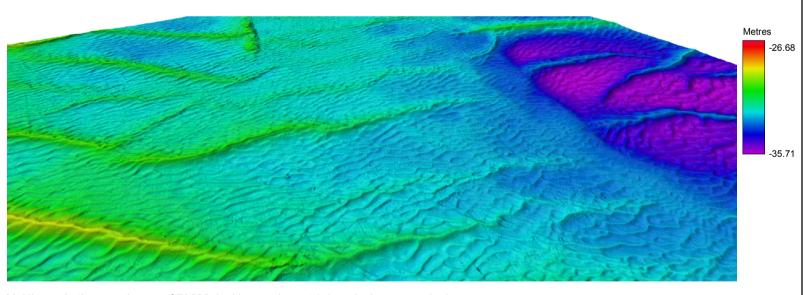
Multibeam bathymetry image of **70639**, looking north-east (x1 vertical exaggeration)

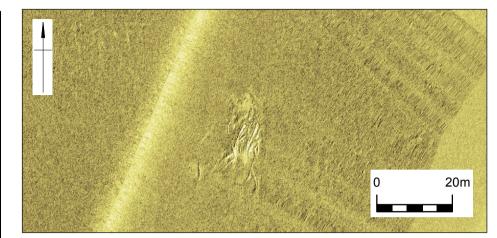
Sidescan sonar image of **700257**, 40.0 m x 19.0 m x 0.5 m

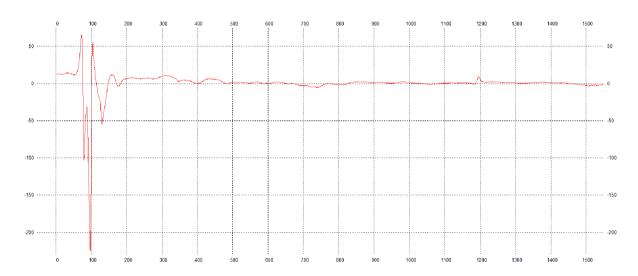
Magnetic profile of 700257, measuring of 290 nT

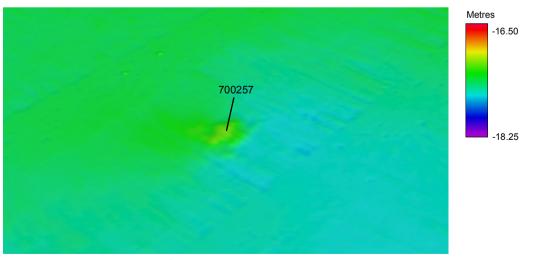
Multibeam bathymetry image of **700257**, looking south-east (x1 vertical exaggeration)

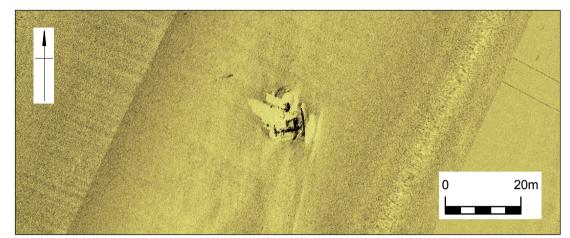
| Location | | 411428 E, 5783615 N Area ECR | | |
|---|---|--|--|--|
| Extent of Survival | | The seabed feature has no associated UKHO record, however the feature's structure and associated magnetic anomaly suggests a possible unknown undocumented wreck site or associated debris. Items appear to be contained, with no apparent spread of debris field however, there is potential for burial. Unclear of full extent of feature. | | |

Sidescan sonar image of **700590**, 13.3 m x 13.1 m x 1.6 m

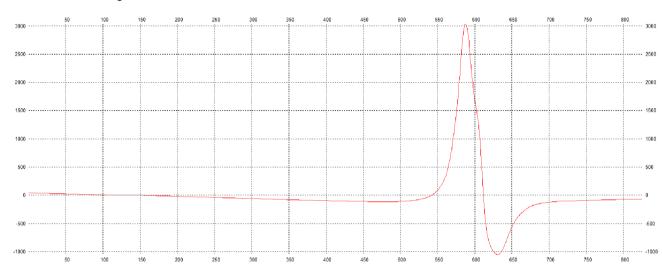
Magnetic profile of 700590, measuring of 4091 nT

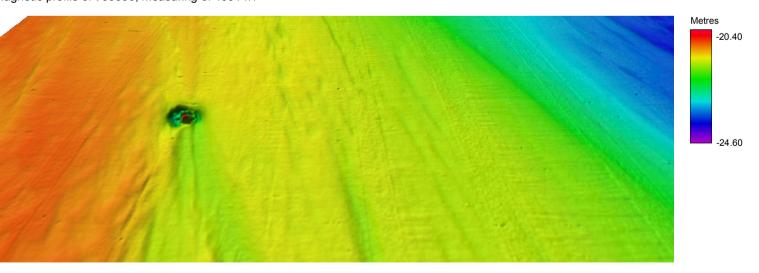
Multibeam bathymetry image of **700590**, looking south-eastt (x1 vertical exaggeration)

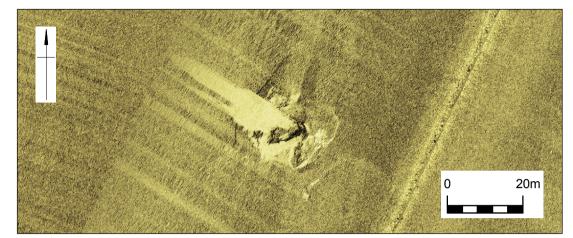
Sidescan sonar image of **700605**, 10.0 m x 6.9 m x 4.9 m

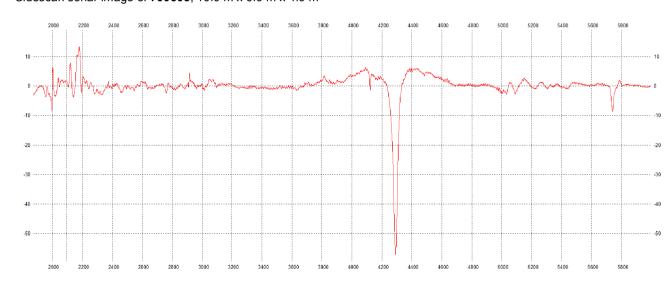
Magnetic profile of 700605, measuring of 60 nT

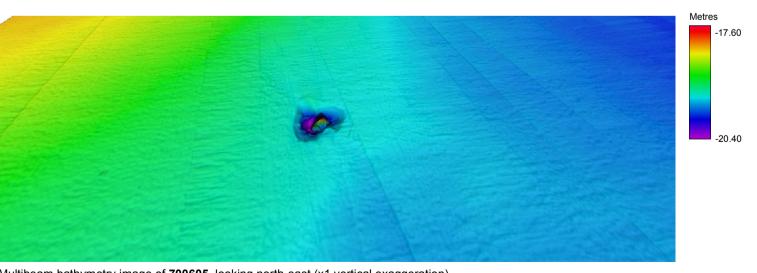
Multibeam bathymetry image of **700605**, looking north-east (x1 vertical exaggeration)
