# **East Anglia TWO Offshore Windfarm**

## **Appendix 20.5**

### **Geomorphological Baseline**

#### **Environmental Statement Volume 3**

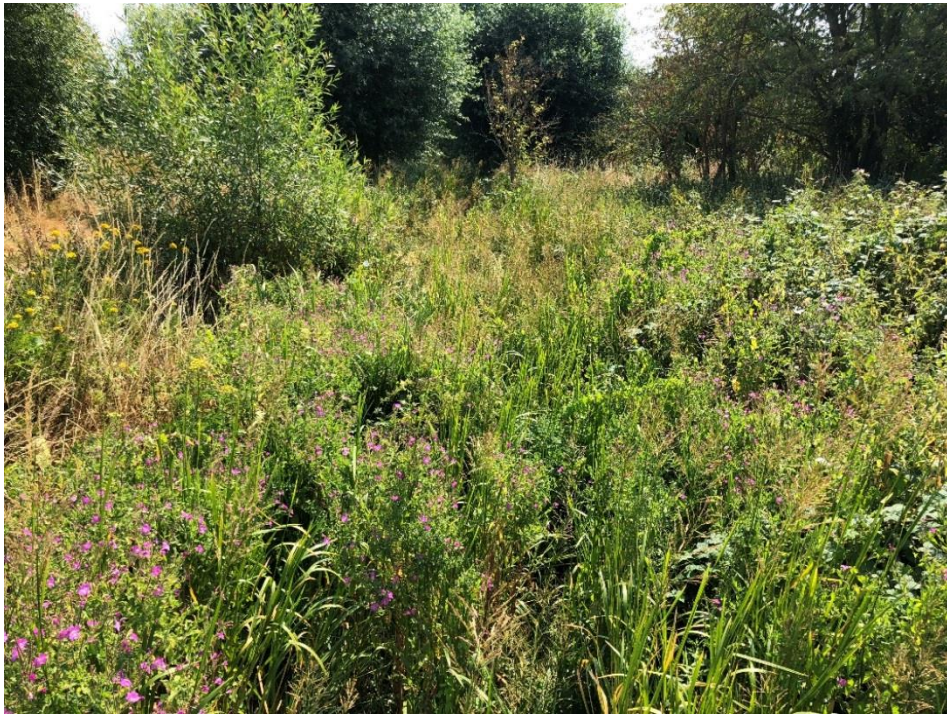
| Parameter | Main characteristics |
|---|---|
| Substrate conditions | The channel bed was obscured by extensive vegetation growth at the time of the survey ( <b>Plate A20.1</b> ). |
| In-channel and riparian vegetation | The channel was dominated by extensive vegetation growth (including reeds) at the time of the survey ( <b>Plate A20.1</b> ). |
| Character photograph | <p><b>Plate A20.1 Extensive Vegetation Growth in Dry, Shallow Channel</b></p> |

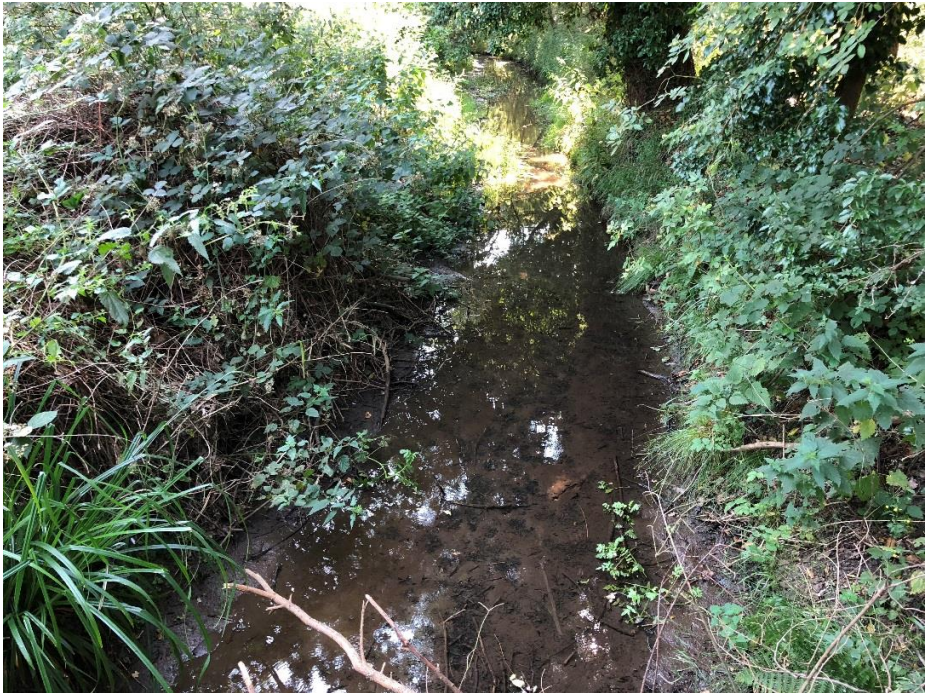
| Parameter | Main characteristics |
|---|---|
| Channel form | The banks are low, steep to near-vertical, and composed of fine sediment that appears to be cohesive ( <b>Plate A20.2</b> ). The banks are largely stable, although some undercutting of the bank toe was apparent in parts of the reach. |
| Substrate conditions | The bed is comprised of fine sediment (e.g. silts and fine sands) ( <b>Plate A20.2</b> ). Extensive fine sedimentation was evident in the channel margins, alongside partially vegetated silt bars. |
| Character photograph | <p><b>Plate A20.2 Low-Energy Flows in Silt-Bed Channel</b></p> |

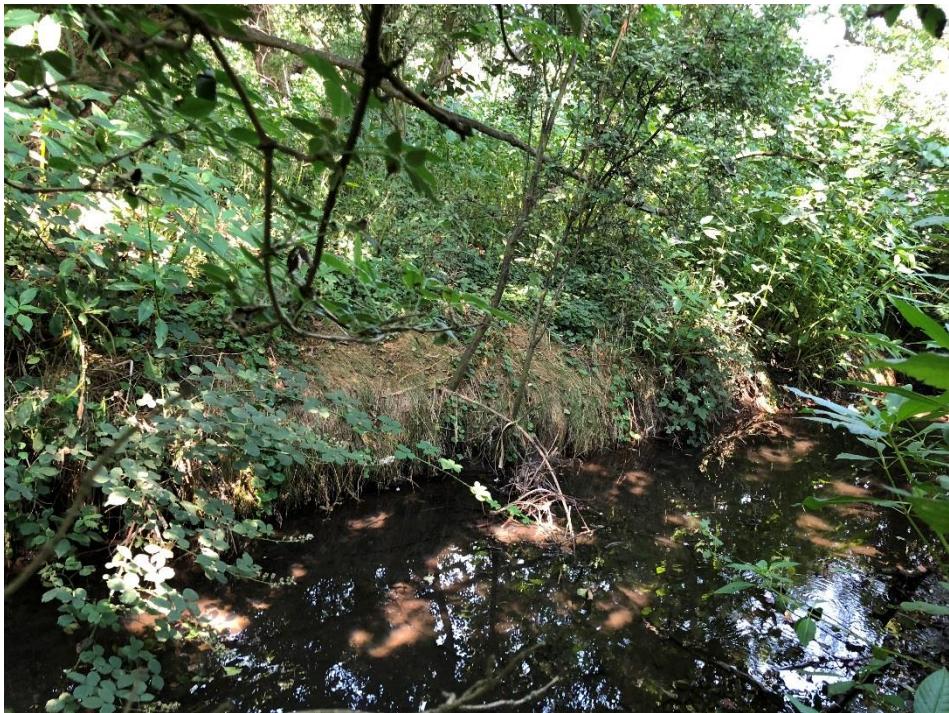
| Parameter | Main characteristics |
|---|---|
| Channel form | The banks are shallow and steep, and are much lower than in the upstream reach. They are largely stable and well-vegetated, although evidence of toe scour was observed in parts of the reach. The channel is very uniform, with limited geomorphological diversity ( <b>Plate A20.3</b> ). |
| In-channel and riparian vegetation | Extensive areas of in-channel vegetation growth are interspersed with reaches with clear open water were observed during the survey ( <b>Plate A20.3</b> and <b>Plate A20.5</b> ). Considerable vegetation growth was apparent in the riparian zone, including Himalayan balsam ( <i>Impatiens glandulifera</i> ) at the upstream end of the reach, near the proposed crossing point. |

| Parameter | Main characteristics |
|---|---|
| Character photograph | <p><b>Plate A20.3 Wide, Shallow Silt-Bed Channel with Low Energy Glide Flows</b></p> <p><b>Plate A20.4 Locally Wide Floodplain with Dense Riparian Vegetation Growth</b></p> |

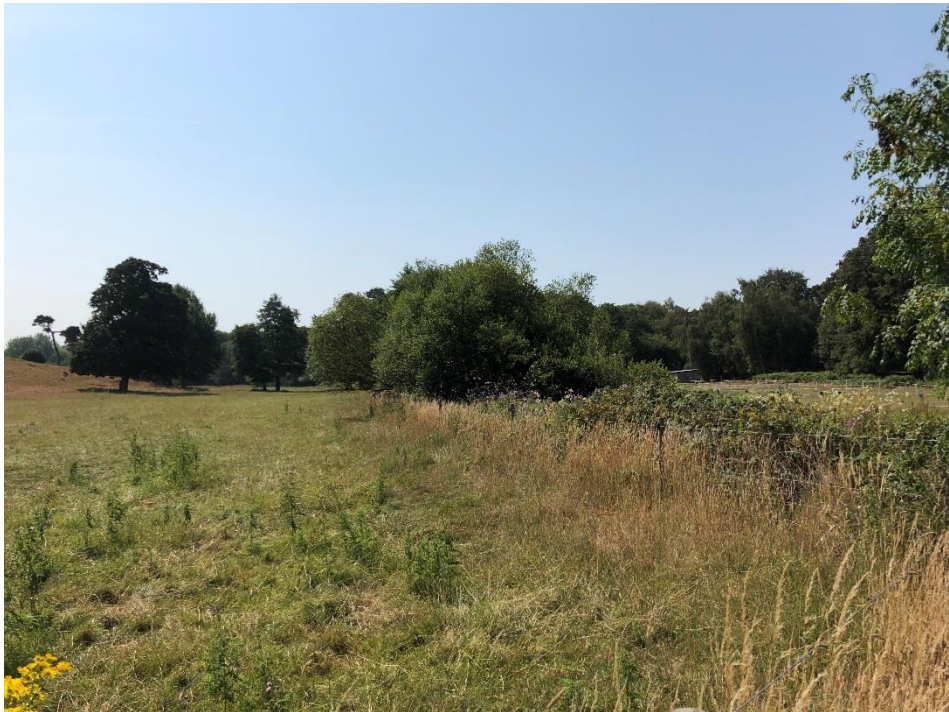
| Parameter | Main characteristics |
|---|---|
| Floodplain characteristics | In the upstream end of the reach, the floodplain is wider than in upstream reaches, and dominated by grazing land and areas of woodland ( <b>Plate A20.4</b> ). The floodplain is drained by an extensive ditch system which is well connected with the main river channel. The floodplain becomes much wider at the downstream end of the reach, where the channel flows through floodplain wetlands (The Fens). |

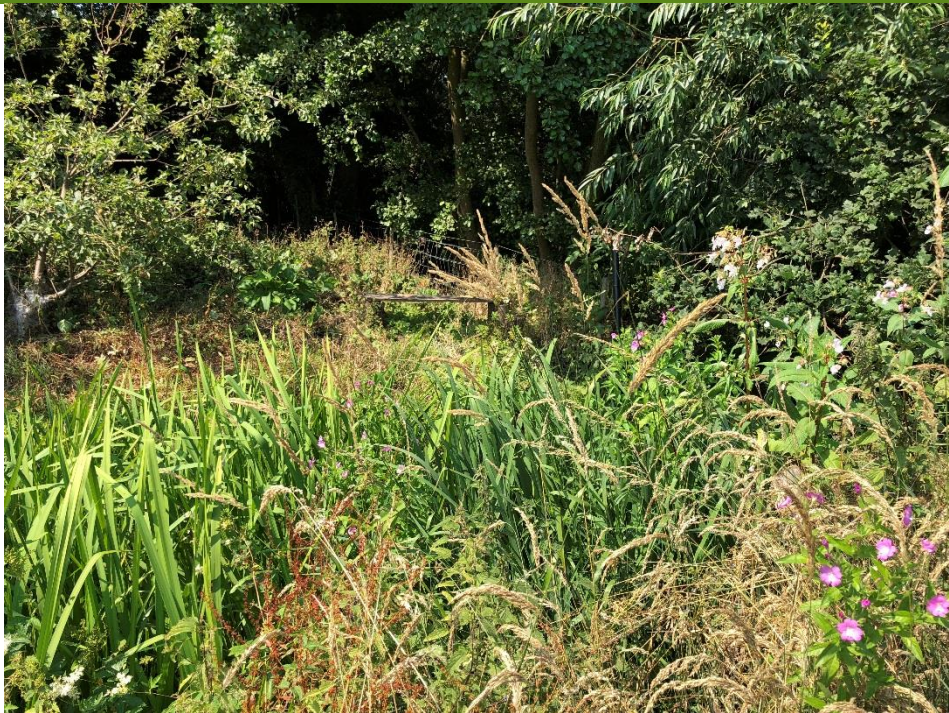
| Parameter | Main characteristics |
|---|---|
| | <p><b>Plate A20.5 Extensive Growth of In-Channel Vegetation in Parts of the Reach</b></p> |

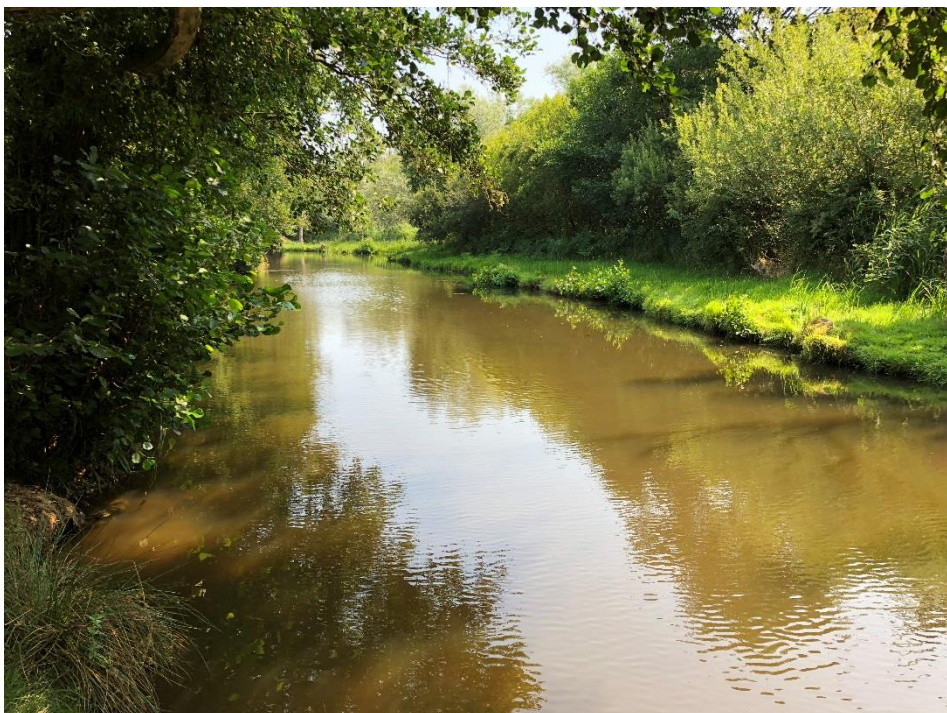
| Parameter | Main characteristics |
|---|---|
| Channel form | The wide, open channel has very shallow, stable, steep to near-vertical banks ( <b>Plate A20.6</b> ). There is a weir located towards the upstream end of the reach, which raises water levels to supply The Meare. |
| Flow conditions | Flow conditions were dominated by uniform, low energy glides ( <b>Plate A20.6</b> ). The reach upstream of the weir is impounded. The water was highly turbid at the time of the survey. |

| Parameter | Main characteristics |
|---|---|
| Character photograph | <p><b>Plate A20.6 Wide, Shallow Channel with Low Energy Glide Flows</b></p> |
