# Norfolk Vanguard Offshore Wind Farm

### Cable Constructability Assessment

## CABLE CONSTRUCTABILITY ASSESSMENT

GMSL DOC REFERENCE 2210-GMSL-G-RD-0001\_01

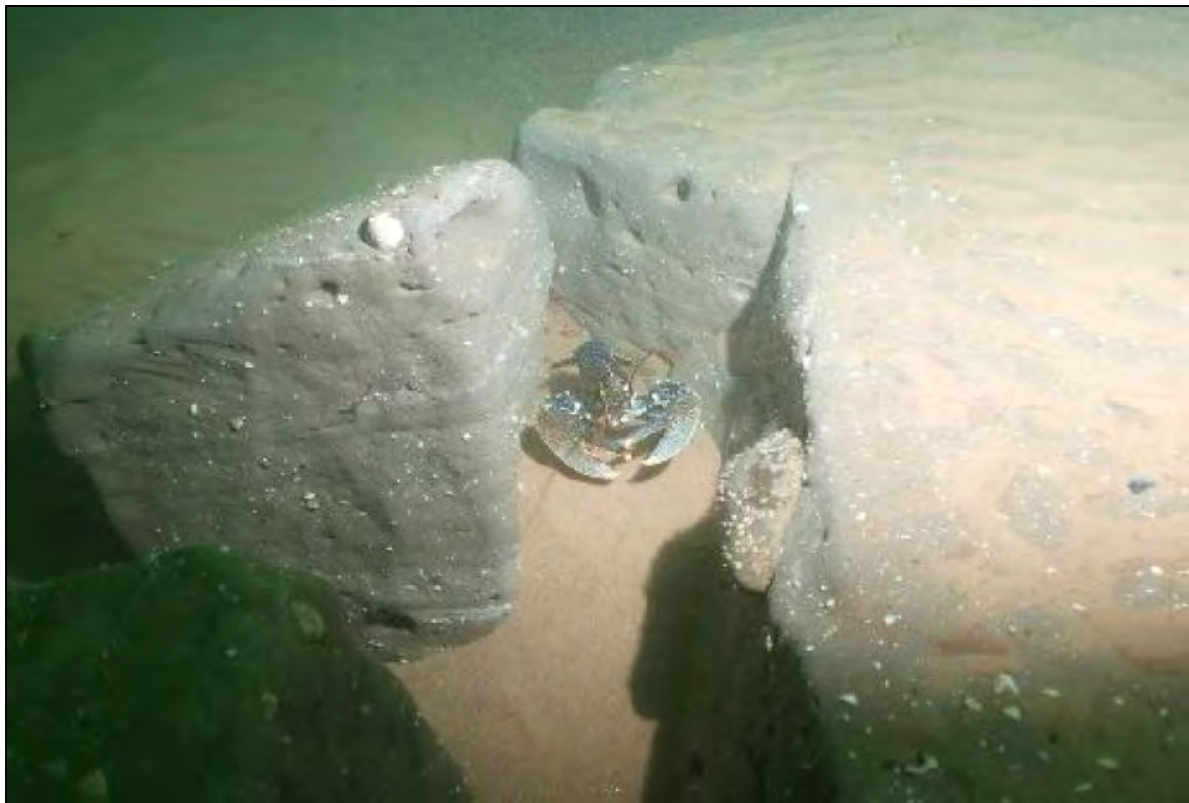
**Figure 24 Highly consolidated clays at the seabed in Norfolk (Seasearch)**

Further north, diver surveys a few hundred metres offshore of the Norfolk coast have reported finding highly consolidated clays exposed at the seabed which fractures into blocks (Figure 24). It is likely that this extends further south, possibly into the northern export cable corridor landing zone near to Bacton. As this area remains unmapped by the BGS (Figure 22) it is not presently possible to confirm this hypothesis.
