# Norfolk Vanguard Offshore Wind Farm

### Coastal Erosion Study

Document Reference: PB4476-005-0043

## **Norfolk Vanguard Coastal Erosion Study**

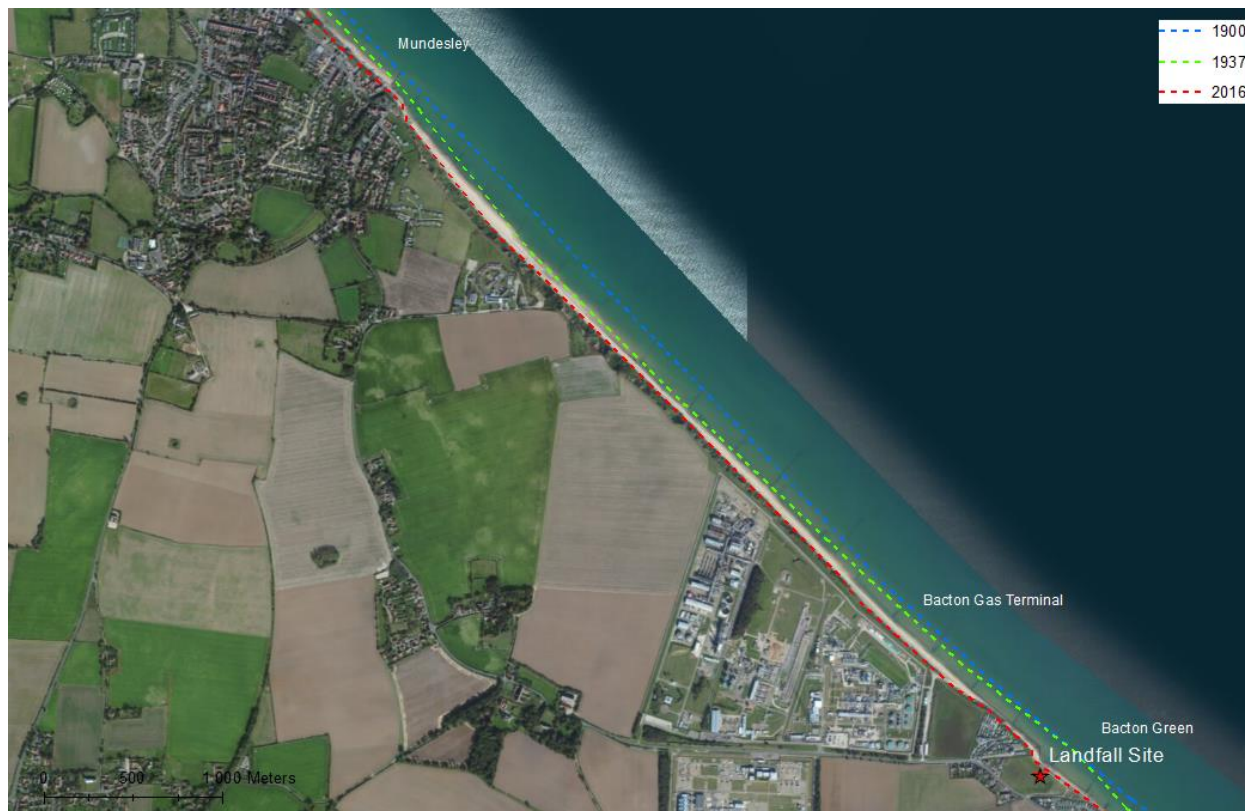
Figure 2-2: Cliff Top evolution between Mundesley and Bacton

The cliffs at Mundesley are sandier and better drained compared to the cliffs to the north. Erosion of the cliffs is generally a gradual process, but with small scale recession events resulting in 1 to 5 metres of erosion per event. The cliff top evolution between Mundesley and Bacton between 1900 and 2016 is presented in Figure 2-2. This has been derived by Royal HaskoningDHV by plotting cliff top lines from historical mapping sourced from National Library of Scotland. Annual cliff top retreat between Mundesley

and Bacton has been estimated at approximately 1.1 - 4.5 metres per year for 1900-1937. For 1937 to 2016 retreat has been estimated at approximately 0.65 – 1.2 metres per year.

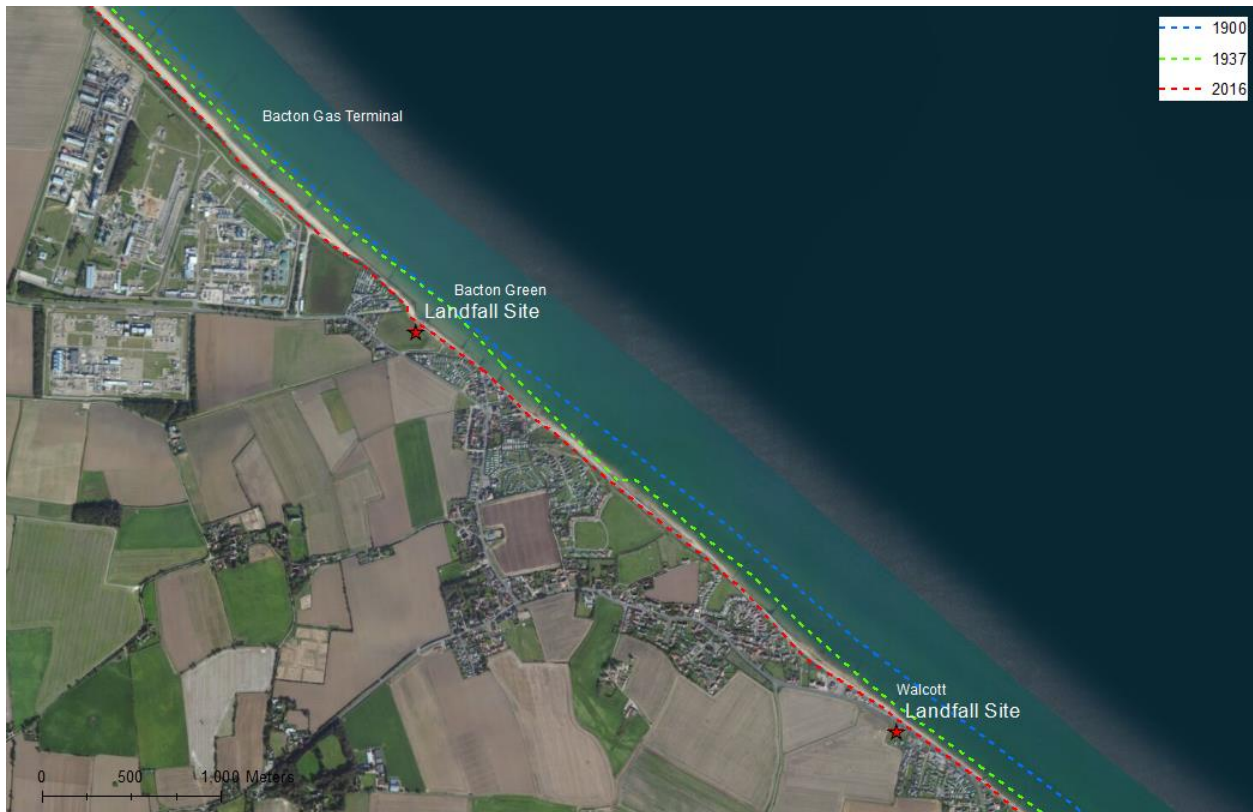
Figure 2-3: Cliff top evolution between Bacton and Walcott

The evolution of the cliff top between Bacton and Walcott has been mapped at three distinct dates; 1900 which predates the construction of the sea defences and that of the Gas Terminal, 1937 and 2016 as presented in Figure 2-3. This has been derived by Royal HaskoningDHV by plotting cliff top lines from historical mapping sourced from the National Library of Scotland. Annual cliff top retreat along Bacton has been estimated at 0.5 – 1.35 metres per year for 1900-1937. For 1937 to 2016 retreat has been estimated at approximately 1.3 – 1.7 metres per year. Annual cliff top retreat along Walcott has been

estimated at approximately 3.1 – 3.8 metres per year for 1900-1937. For 1937 to 2016 retreat has been estimated at 1.0 – 1.2 metres per year.

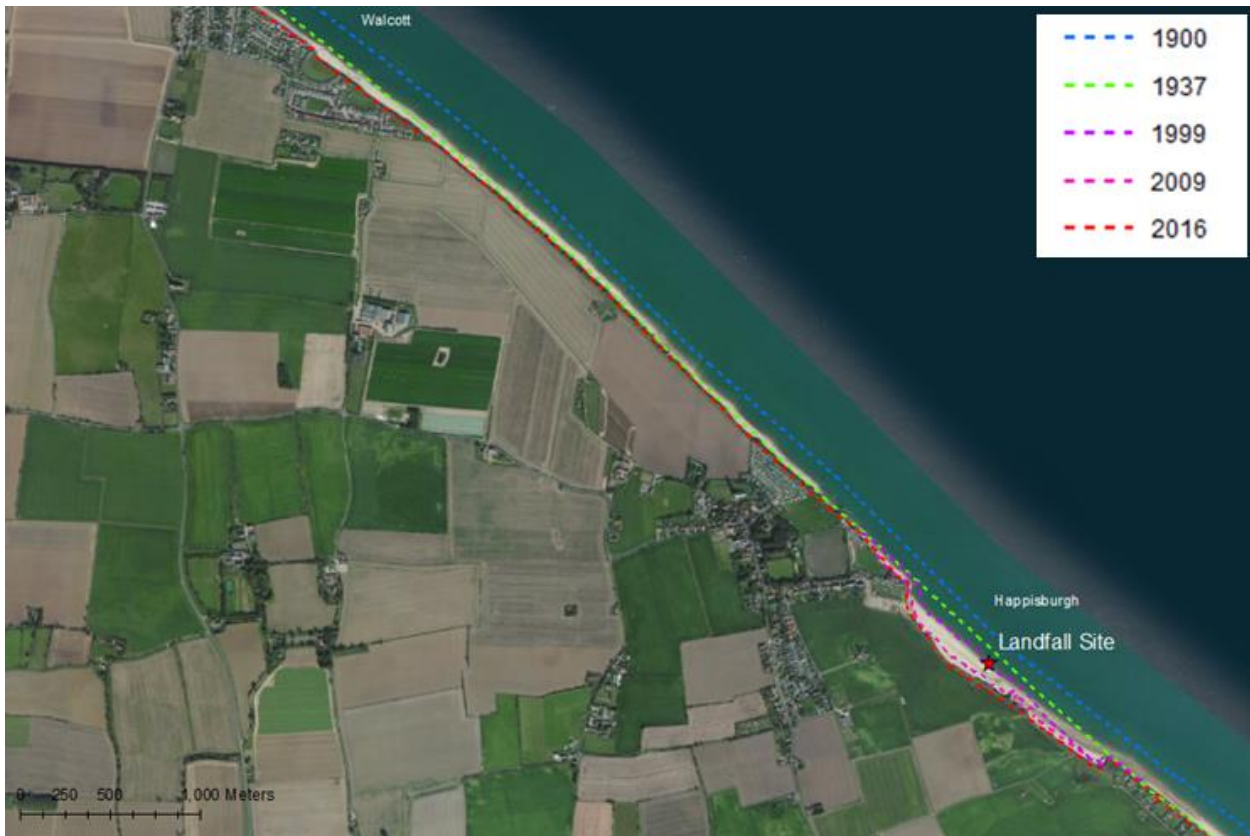
*Figure 2-4: Cliff erosion between Happisburgh and Cart Gap*

Figure 2-4 presents the shoreline evolution along Happisburgh (This has been derived by Royal HaskoningDHV by plotting cliff top lines from historical mapping sourced from the National Library of Scotland) and Figure 2-5 presents aerial photography of recent cliff erosion events from 2001, 2010 and 2014 reflecting the cliff retreat following the failure of the defences. The cliffs at Happisburgh are retreating primarily in response to wave undercutting. The shoreline has shown a history of net retreat and pre-

defence maps (1900 – 1937) show the average erosion rate varied between 0.4 – 2.1 metres per year. An analysis of post-defence erosion rates (1937 – 1999) concluded that erosion rates varied between 0.4 (north of the landfall site) – 0.8 metres per year. Since 1999 the shoreline has shown a higher rate of erosion along the landfall site in response to the failure of existing defences with erosion of up to 10 metres per year. Cliff top analysis for year 2017 shows a negligible change in cliff top retreat, however this cannot be taken as a sign for retreat rates slowing down, but more that retreat is variable.

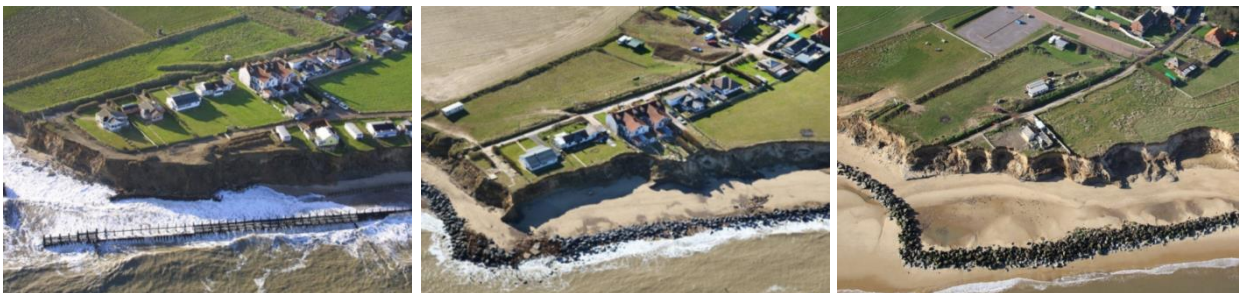
*Figure 2-5: Cliff erosion along Happisburgh– 2001, 2010 and 2014.*

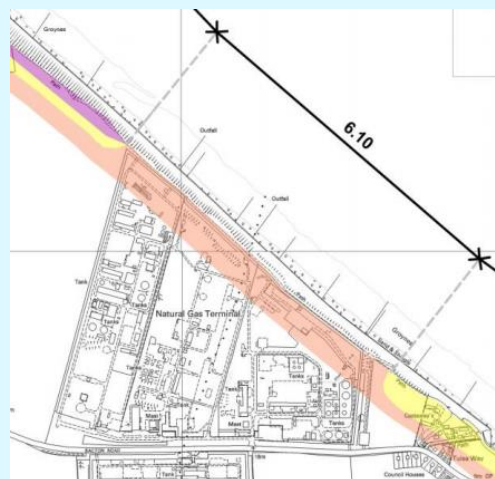
**Bacton Gas Terminal – SMP Policy Unit 6.10**
**Defence History**

1960s: Timber breastwork and groynes constructed at northern end.

Low, unconsolidated cliffs, between 5-10m high

**Planned Coastal Defence Work** It is likely that in 2018 a mega-nourishment scheme (referred to as Sandscaping) will be implemented, which will minimise the chance of erosion up to the end of the Terminal's economic life. Temporary erosion protection works are currently being constructed to bridge the period until implementation of the Sandscaping solution.

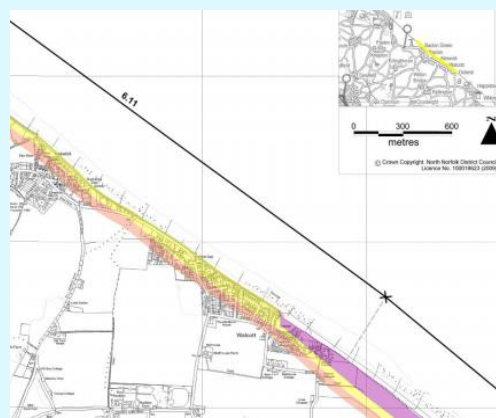
**Bacton, Walcott and Ostend – SMP Policy Unit 6.11**
**Defence History**

1954: Concrete wall and apron with steel piled toe constructed along much of section. Timber groynes also constructed along section.

Unconsolidated till cliffs which drop down to beach level at Walcott, creating a short gap in the line of cliffs that run from Cromer to Happisburgh.

There is very little permanent backshore along this shoreline, and in places no backshore is present. The beach rests on a clay platform and occasionally this is exposed and subject to marine erosion.

| <p><b>Planned Coastal Defence Work</b></p> <p>The Sandscaping mega-nourishment, likely to be implemented at the Bacton Terminal in 2018, may involve direct placement of sediment on the Bacton Green frontage, and would lead to natural sediment supply over time to the Bacton Green and Walcott frontages, reducing the exposure and increasing the residual life of the defences.</p> | |

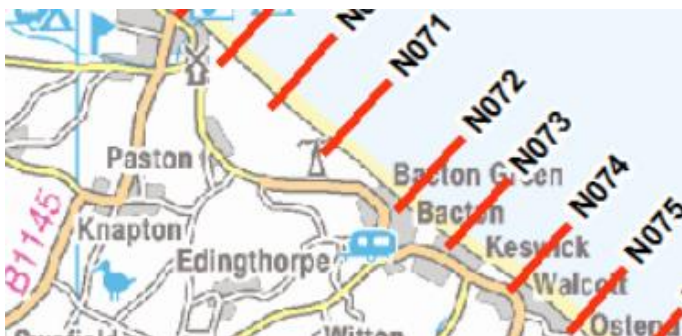
Figure 2-11: Location of known beach profiles surveyed along Bacton to Walcott

The profiles of interest along Walcott are N074 and N075 as presented in Figure 2-11.

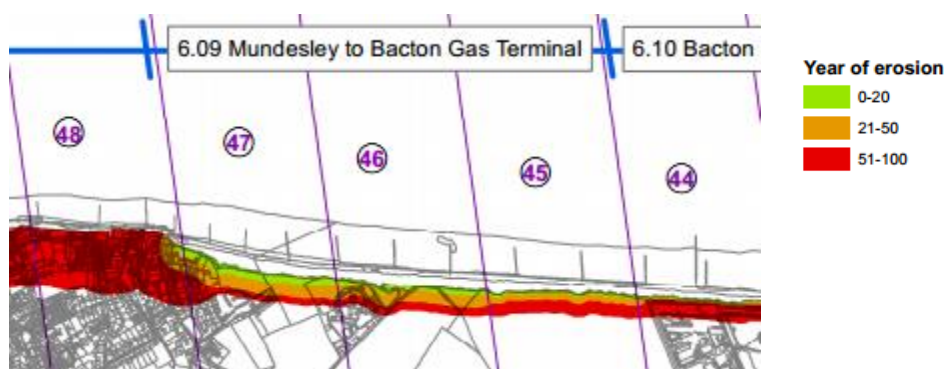
Figure 3-2: Mundesley to Bacton Gas Terminal Indicative Erosion Zones from the Cromer to Winterton Ness Coastal Management Study - SMP Policy 6 Management

management scenario. Figure 3-2 presents the indicative erosion zones for year 0 – 20, 21 – 50 and 51 – 100 based on the existing SMP management scenario from the Cromer to Winterton Ness Coastal Management Study (2013).

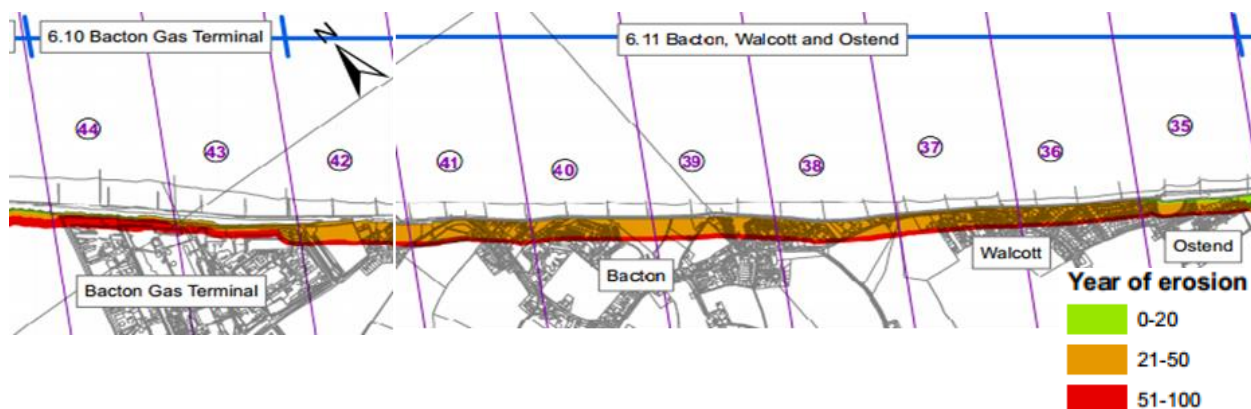
Figure 3-4: Bacton and Walcott Indicative Erosion Zones from the Cromer to Winterton Ness Coastal Management Study - SMP Policy 6 Management
