# Sunnica Solar Farm: Newmarket Road/ Site Access Junction

Stage 1 Road Safety Audit

Sunnica Energy

Project number: 60589004

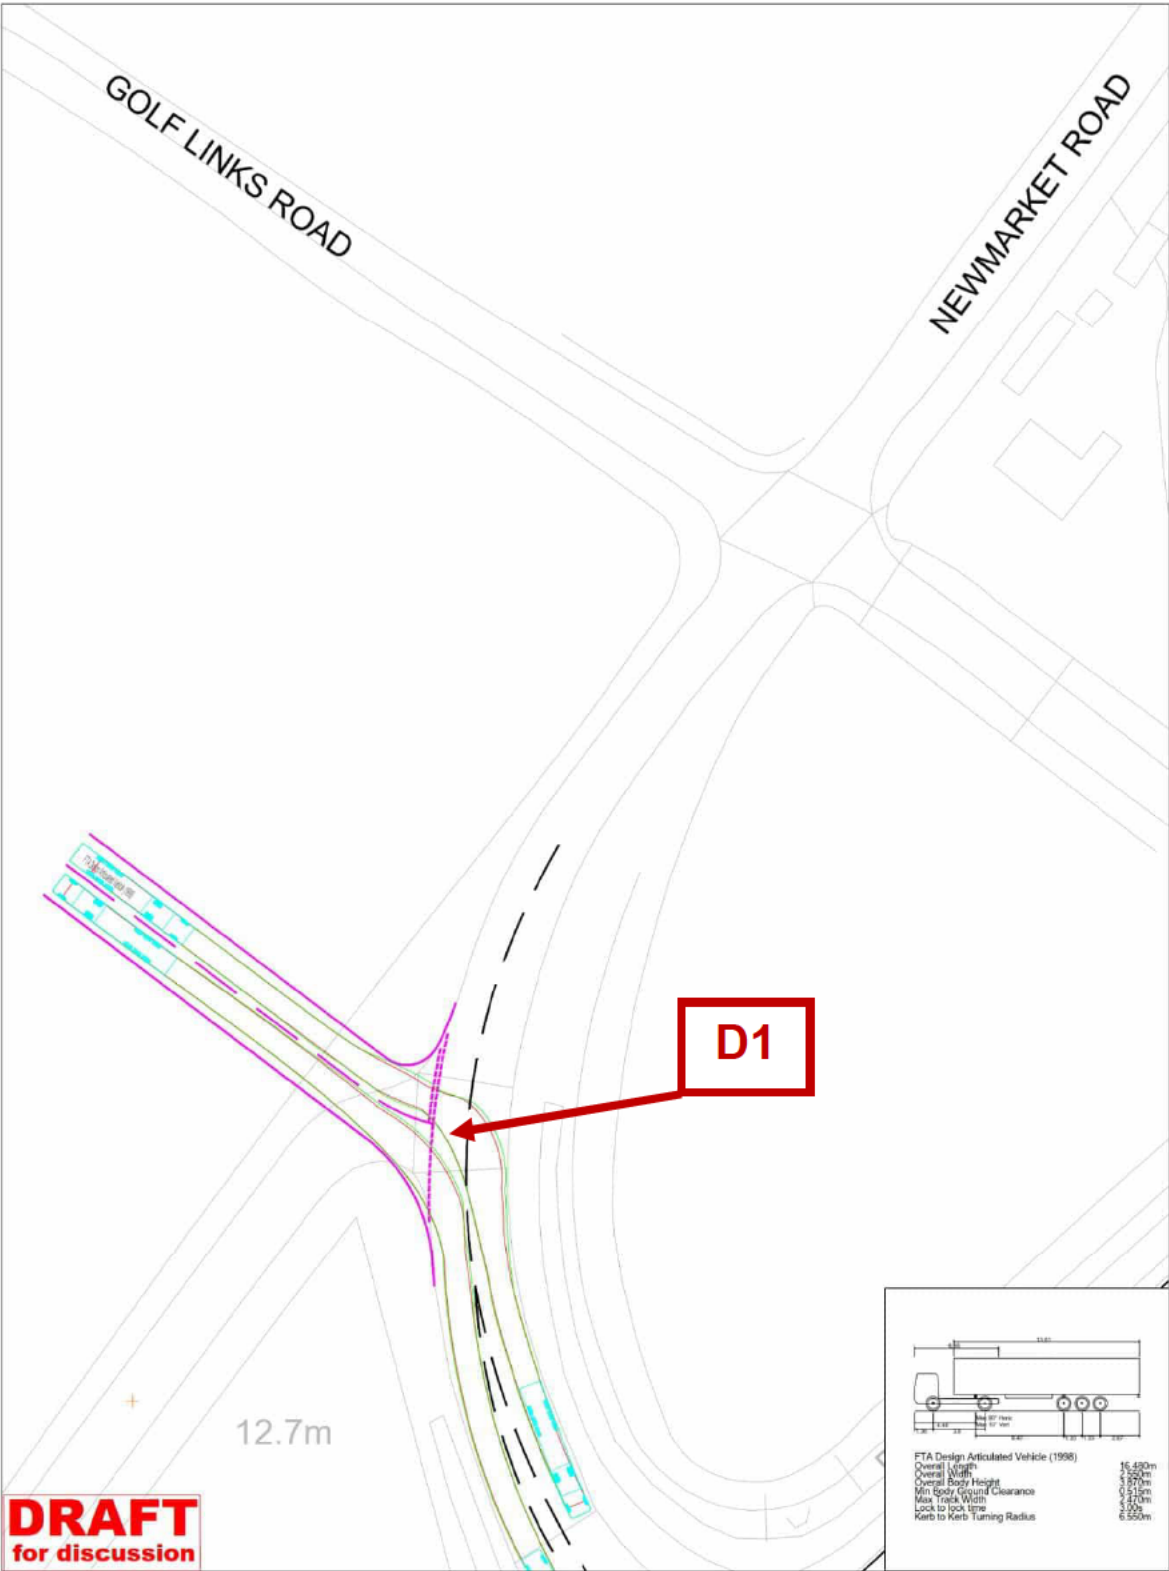
# Appendix B Locations of Problems

**Location:** Proposed construction access junction.

**Drawing:** TRA\_003\_Golf\_Links\_Road\_Option\_2

**Summary:** Slow moving HGVs turning right from access may be at risk of being struck by northbound vehicles on Newmarket Road.

The proposed construction access is located close to the A11(T) junction. Construction vehicles turning right out of the site will do so relatively slowly and vehicles heading north on Newmarket Road, having turned from the A11 may collide with the slow turning construction vehicles.

Although it is acknowledged that the RSA brief states that warning signs are proposed along Newmarket Road warning motorists of the site access and HGVs turning, it is recommended that, at detailed design stage, a suitable clear warning signage strategy is designed (and reviewed as part of the Stage 2 Road Safety Audit) to ensure that drivers joining Newmarket Road from the A11 are aware of the construction access and potential for slow turning vehicles ahead. It is advised that the signage is provided as a 'gateway' on entry to Newmarket Road so that it is clearly seen by both right turning and left turning traffic from the A11.
