# EAST PARK ENERGY

## Outline Construction Traffic Management Plan

**Document Reference: EN010141/DR/7.4**

**September 2026**

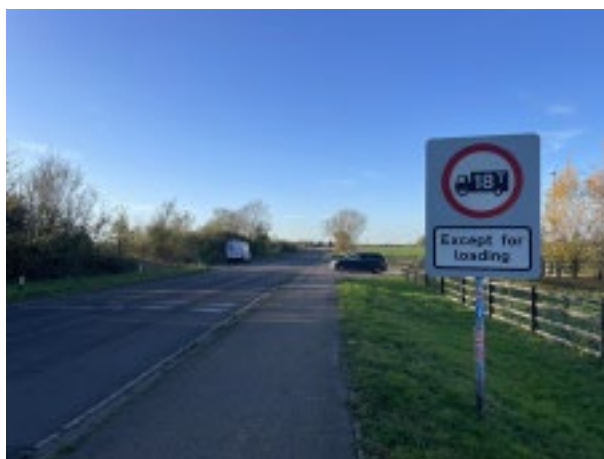
**Photograph 4 - (OS Grid Ref: TL 17187 61297)**

Vehicle moves away from camera. Travel through environmental 18Te weight limit restrictions is permitted under the agreed Special Order.

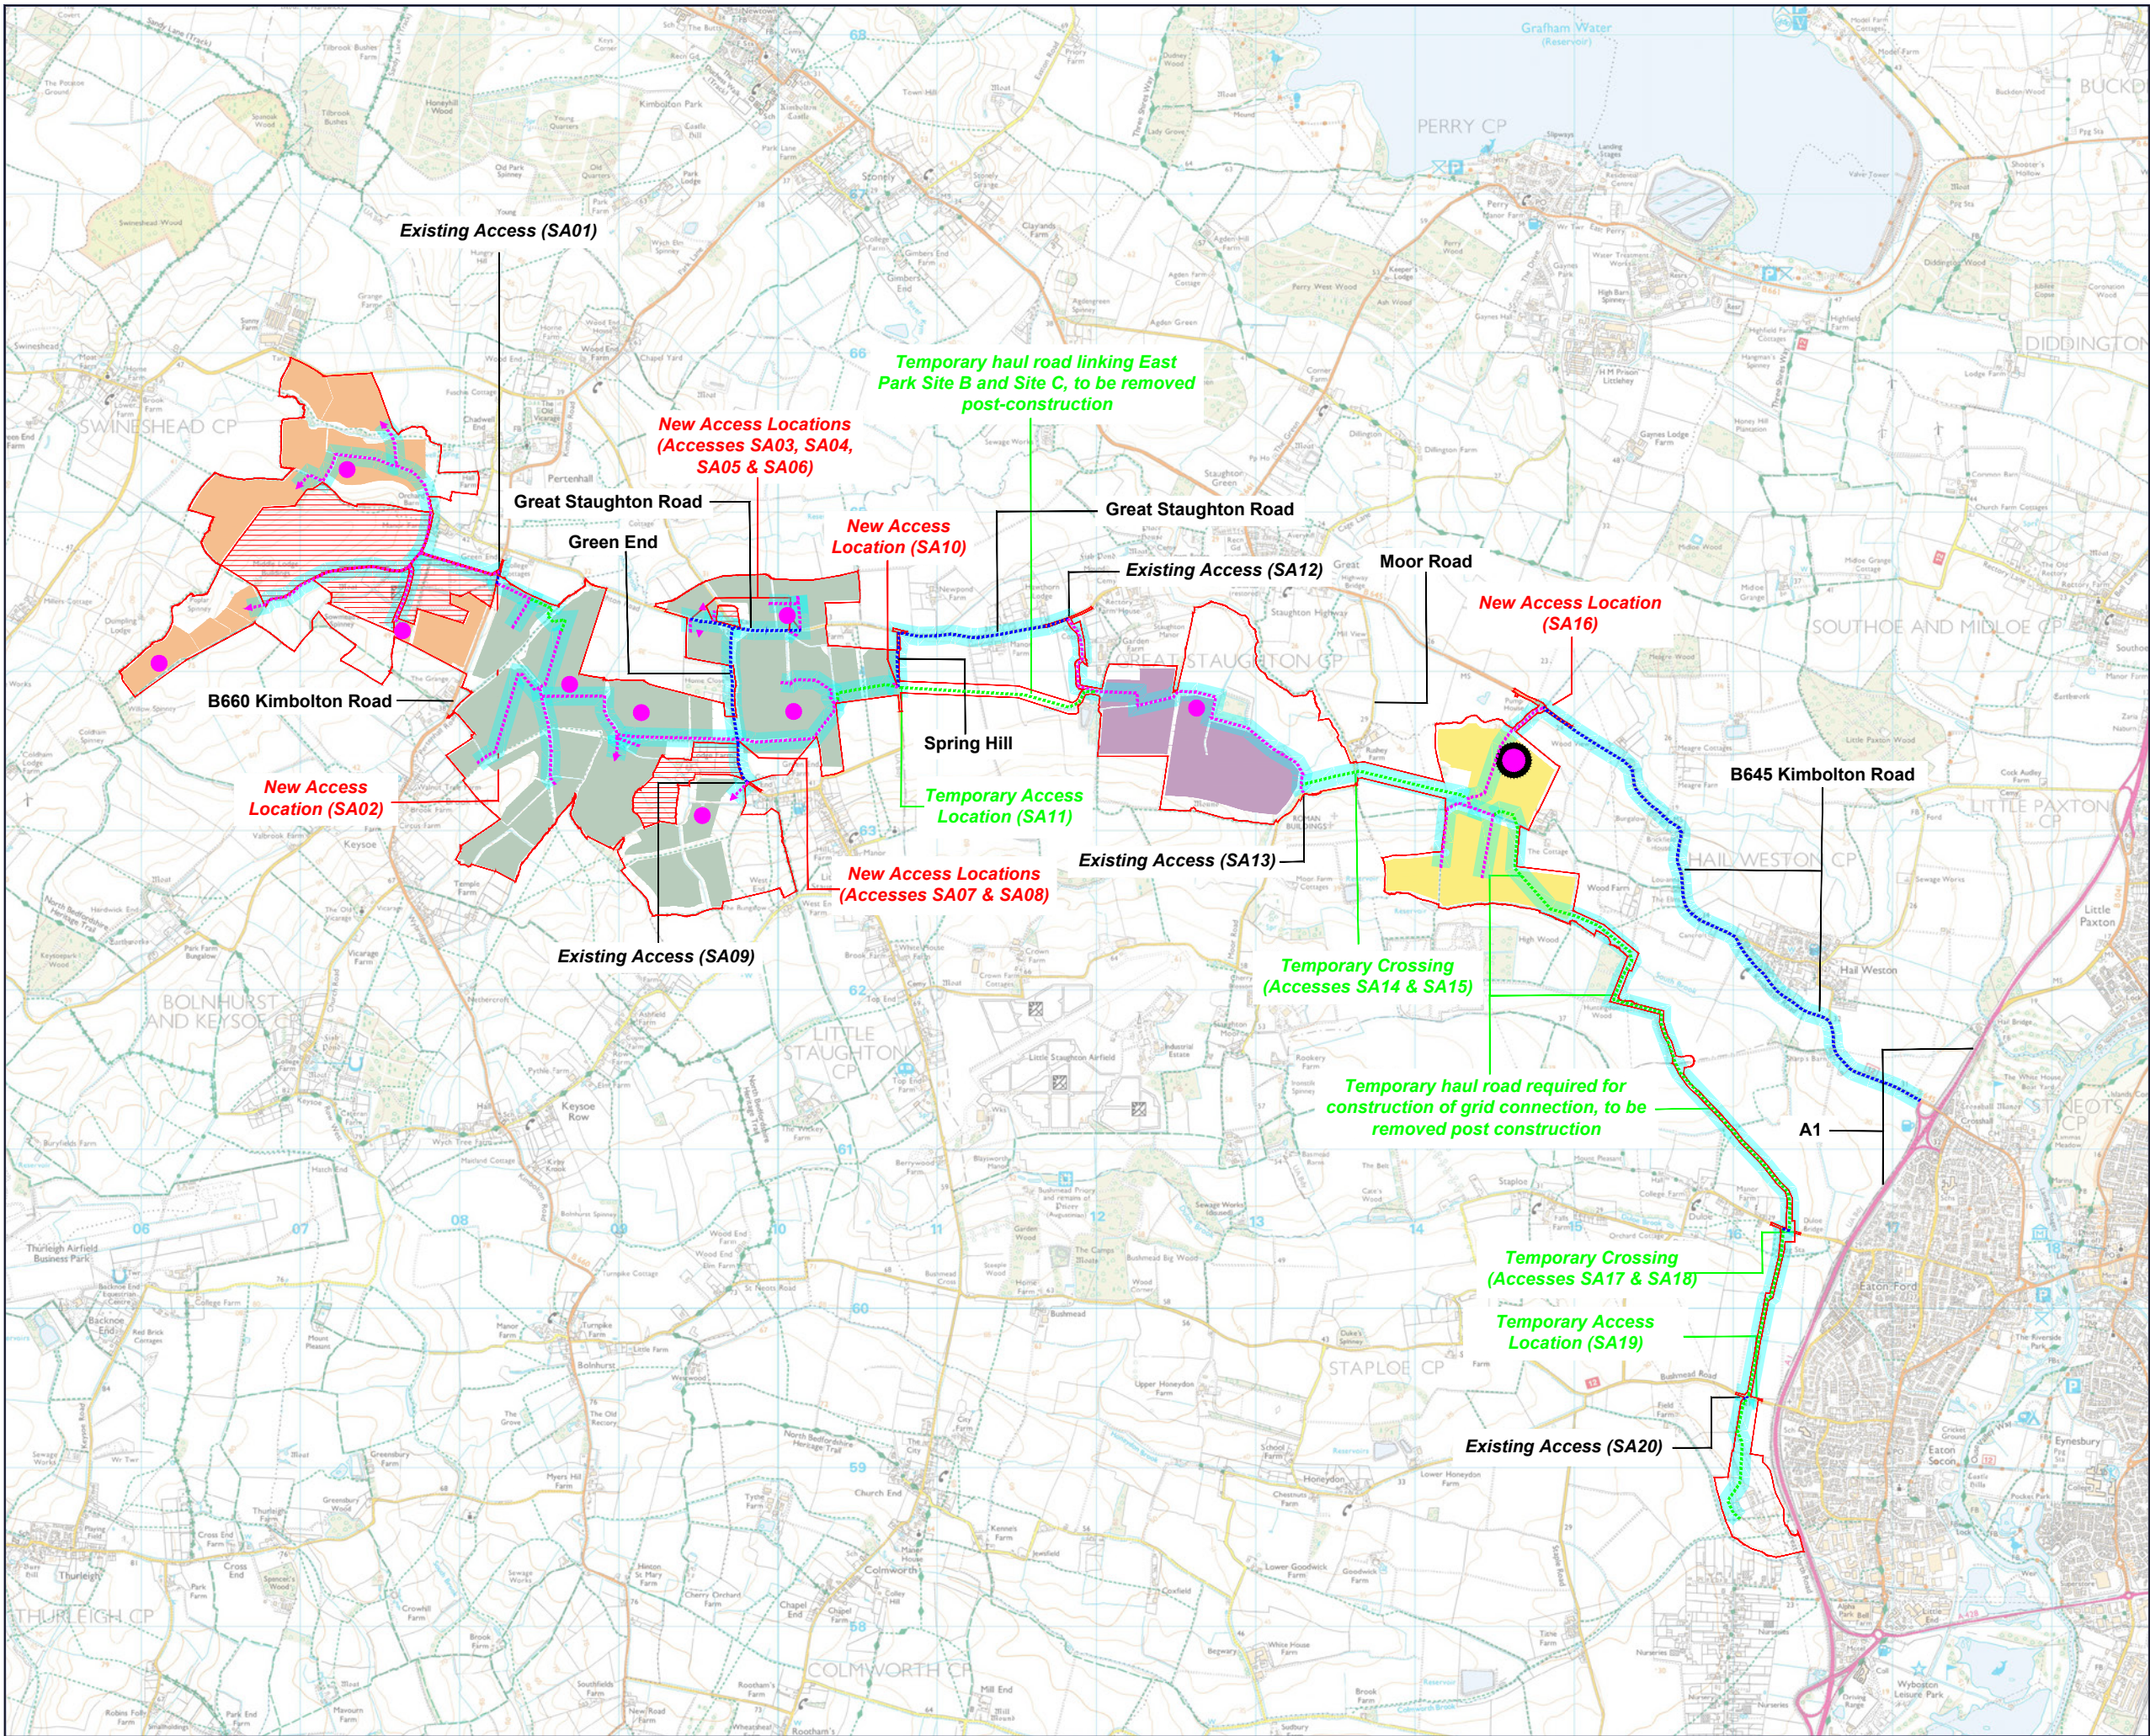
## **APPENDIX C: PROPOSED CONSTRUCTION ACCESS STRATEGY**

- Order Limits
- Land Excluded from Order Limits
- East Park Site D
- East Park Site C
- East Park Site B
- East Park Site A
- HGV Delivery Route
- Construction access utilising section of existing public highway
- Indicative construction access utilising existing access tracks or proposed new access tracks internal to the site, and which would be retained post-construction
- Indicative temporary access tracks (haul roads) required to install cabling and the grid connection that will be implemented at the start of the construction phase to keep construction traffic off local roads as far as possible. To be removed post construction
- Main construction compound
- Satellite construction compound

**Note:** The full extent of construction access tracks internal to the site are illustrated in ES Vol 3 Figure 2-5 Indicative Construction Access and Compounds Plan (APP-125)

- 5.1.14 The identified construction access routes described above represent the only permitted routes to be used by construction HGVs. These routes are illustrated in the Proposed Construction Access Strategy plan included as Figure 15 in **Appendix C** of this **outline Construction Traffic Management Plan [EN010141/DR/7.4]**. All other routes not illustrated on the Proposed Construction Access Strategy plan are to be treated as restricted routes. Any construction HGVs found to be using restricted routes would be considered to be in breach of the CTMP.

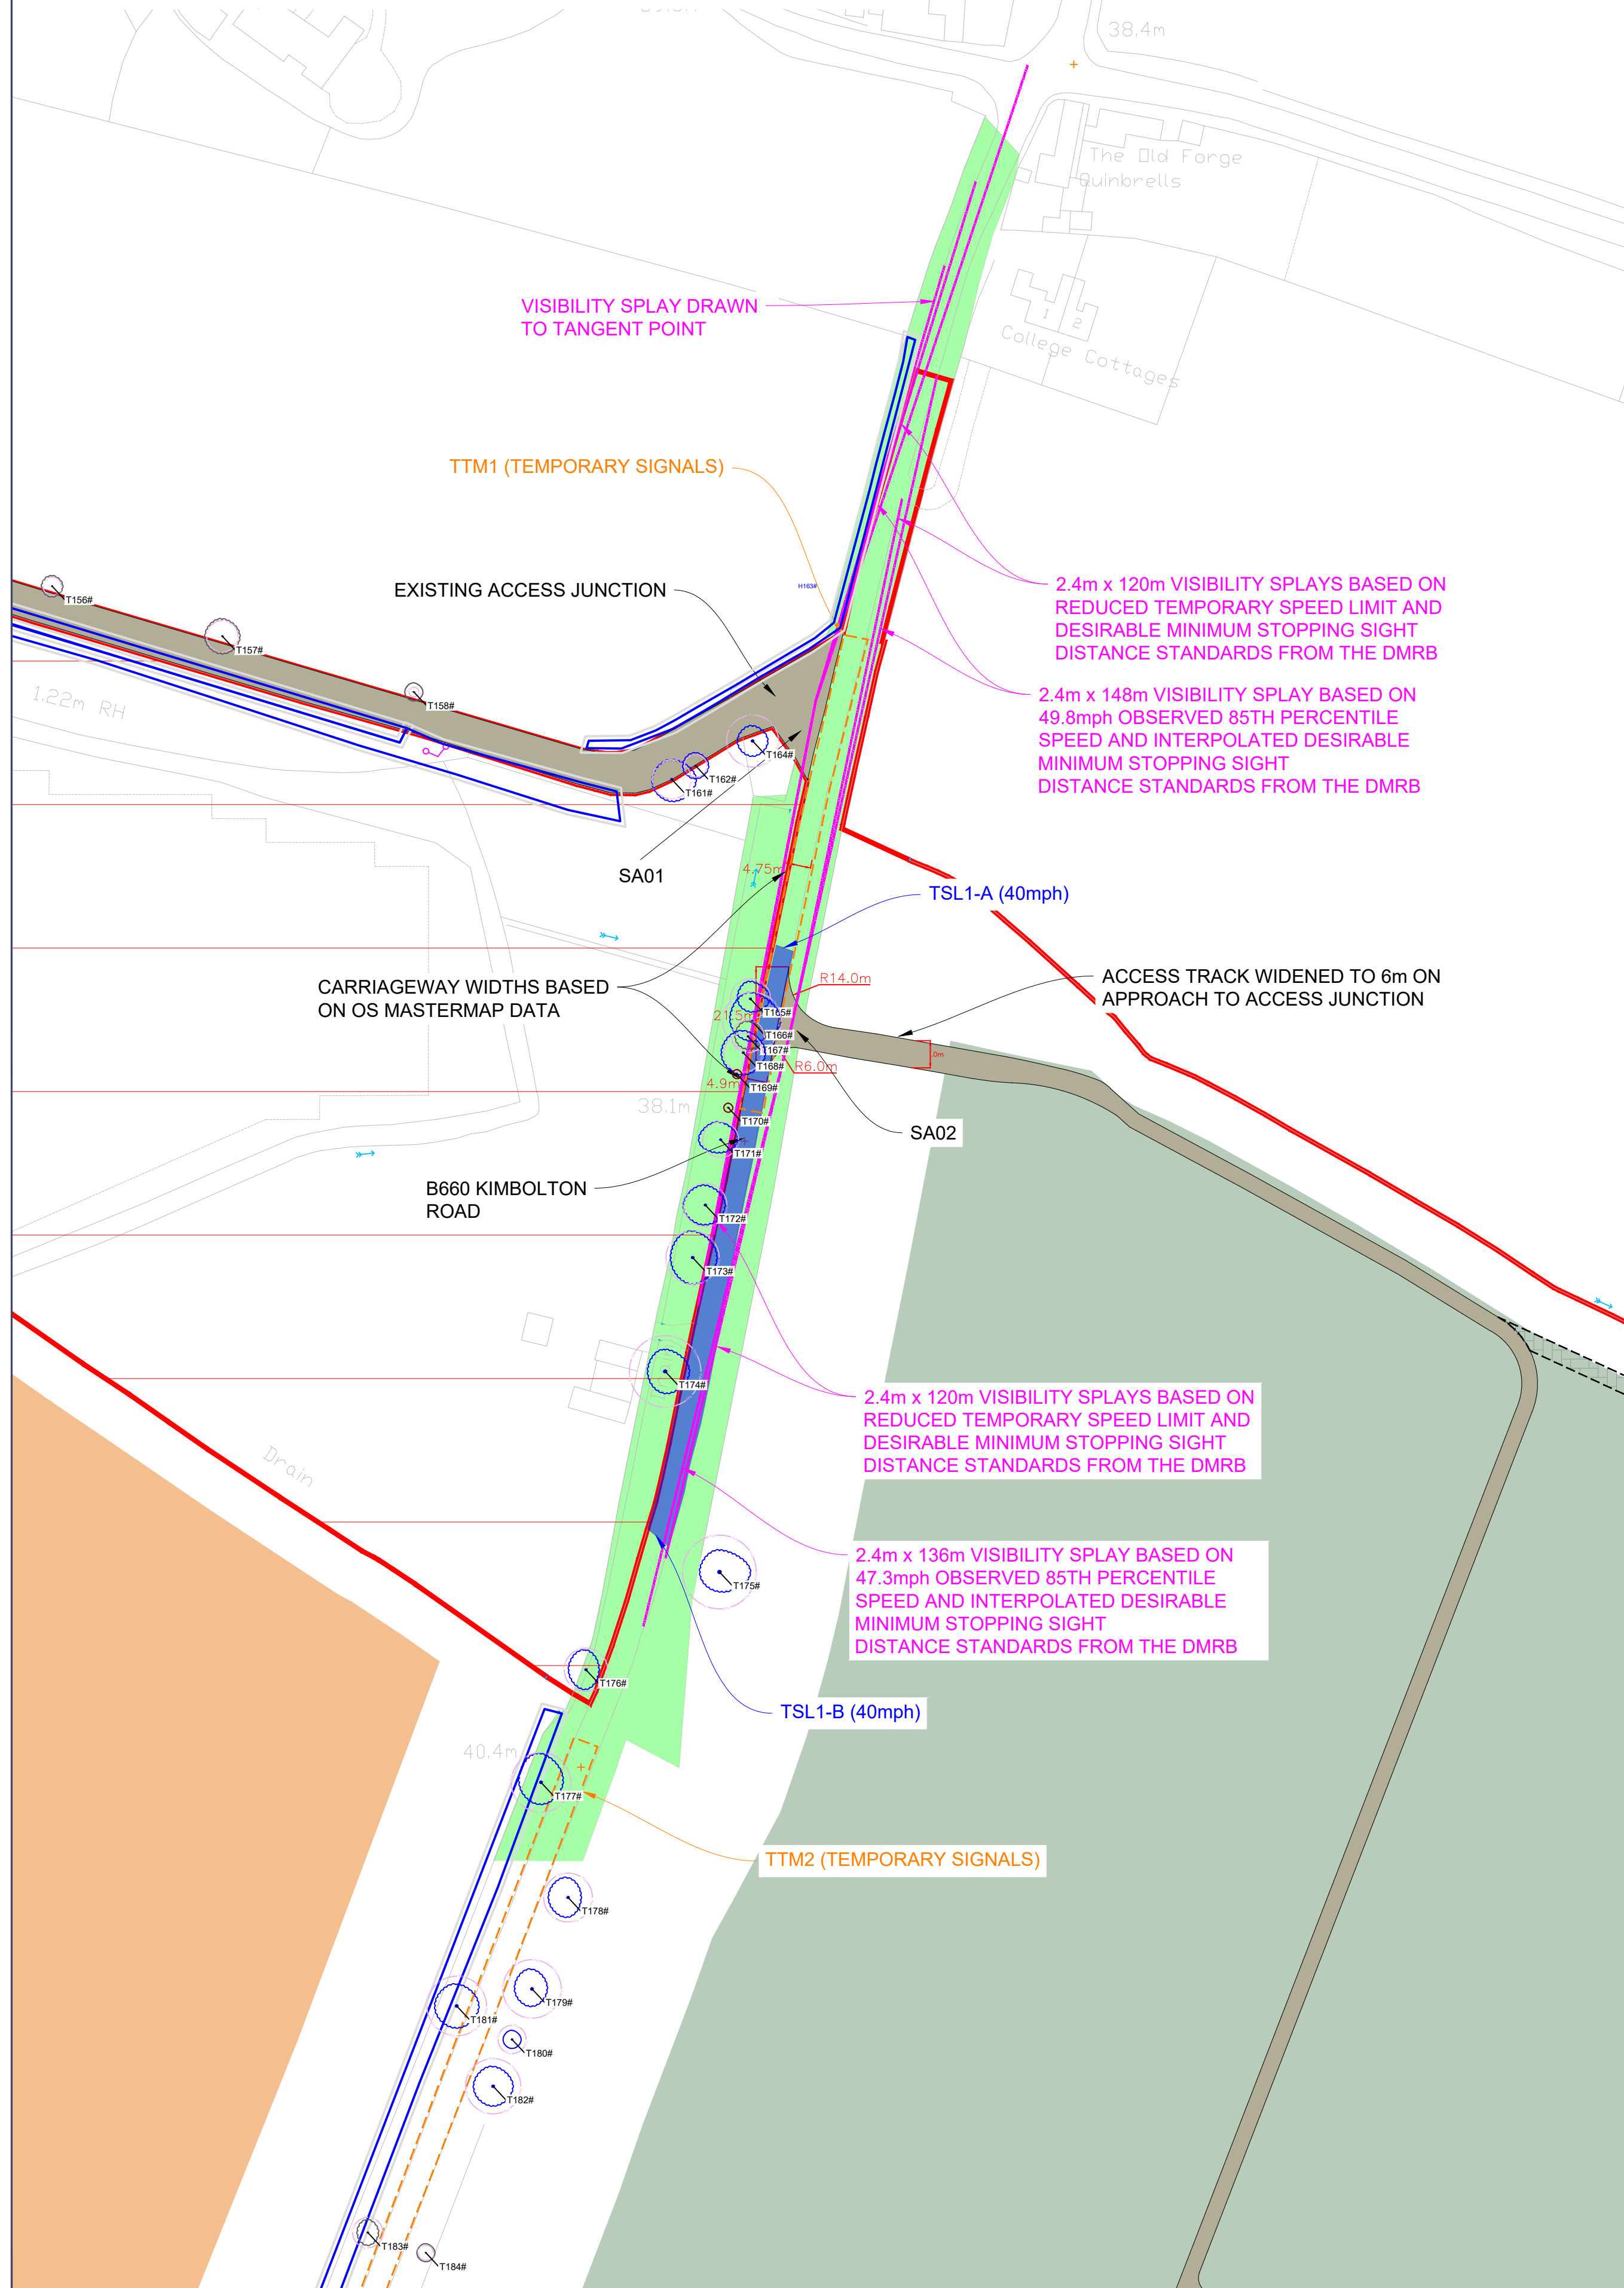
VIEWPORT 1: Site Access Arrangement  
(Access SA01 & SA02)  
SCALE - 1:1000 @A1

- 5.4.2 Visibility splays at each of the proposed new Site accesses, including those accesses which will comprise the upgrade of an existing field access, have been determined based on the guidance and standards set out in the DMRB. For completeness, visibility splays based on the observed traffic speeds / posted speed limits, as well as the temporary reduced speed limits, are shown on Figures 1 to 14 in **Appendix D**.

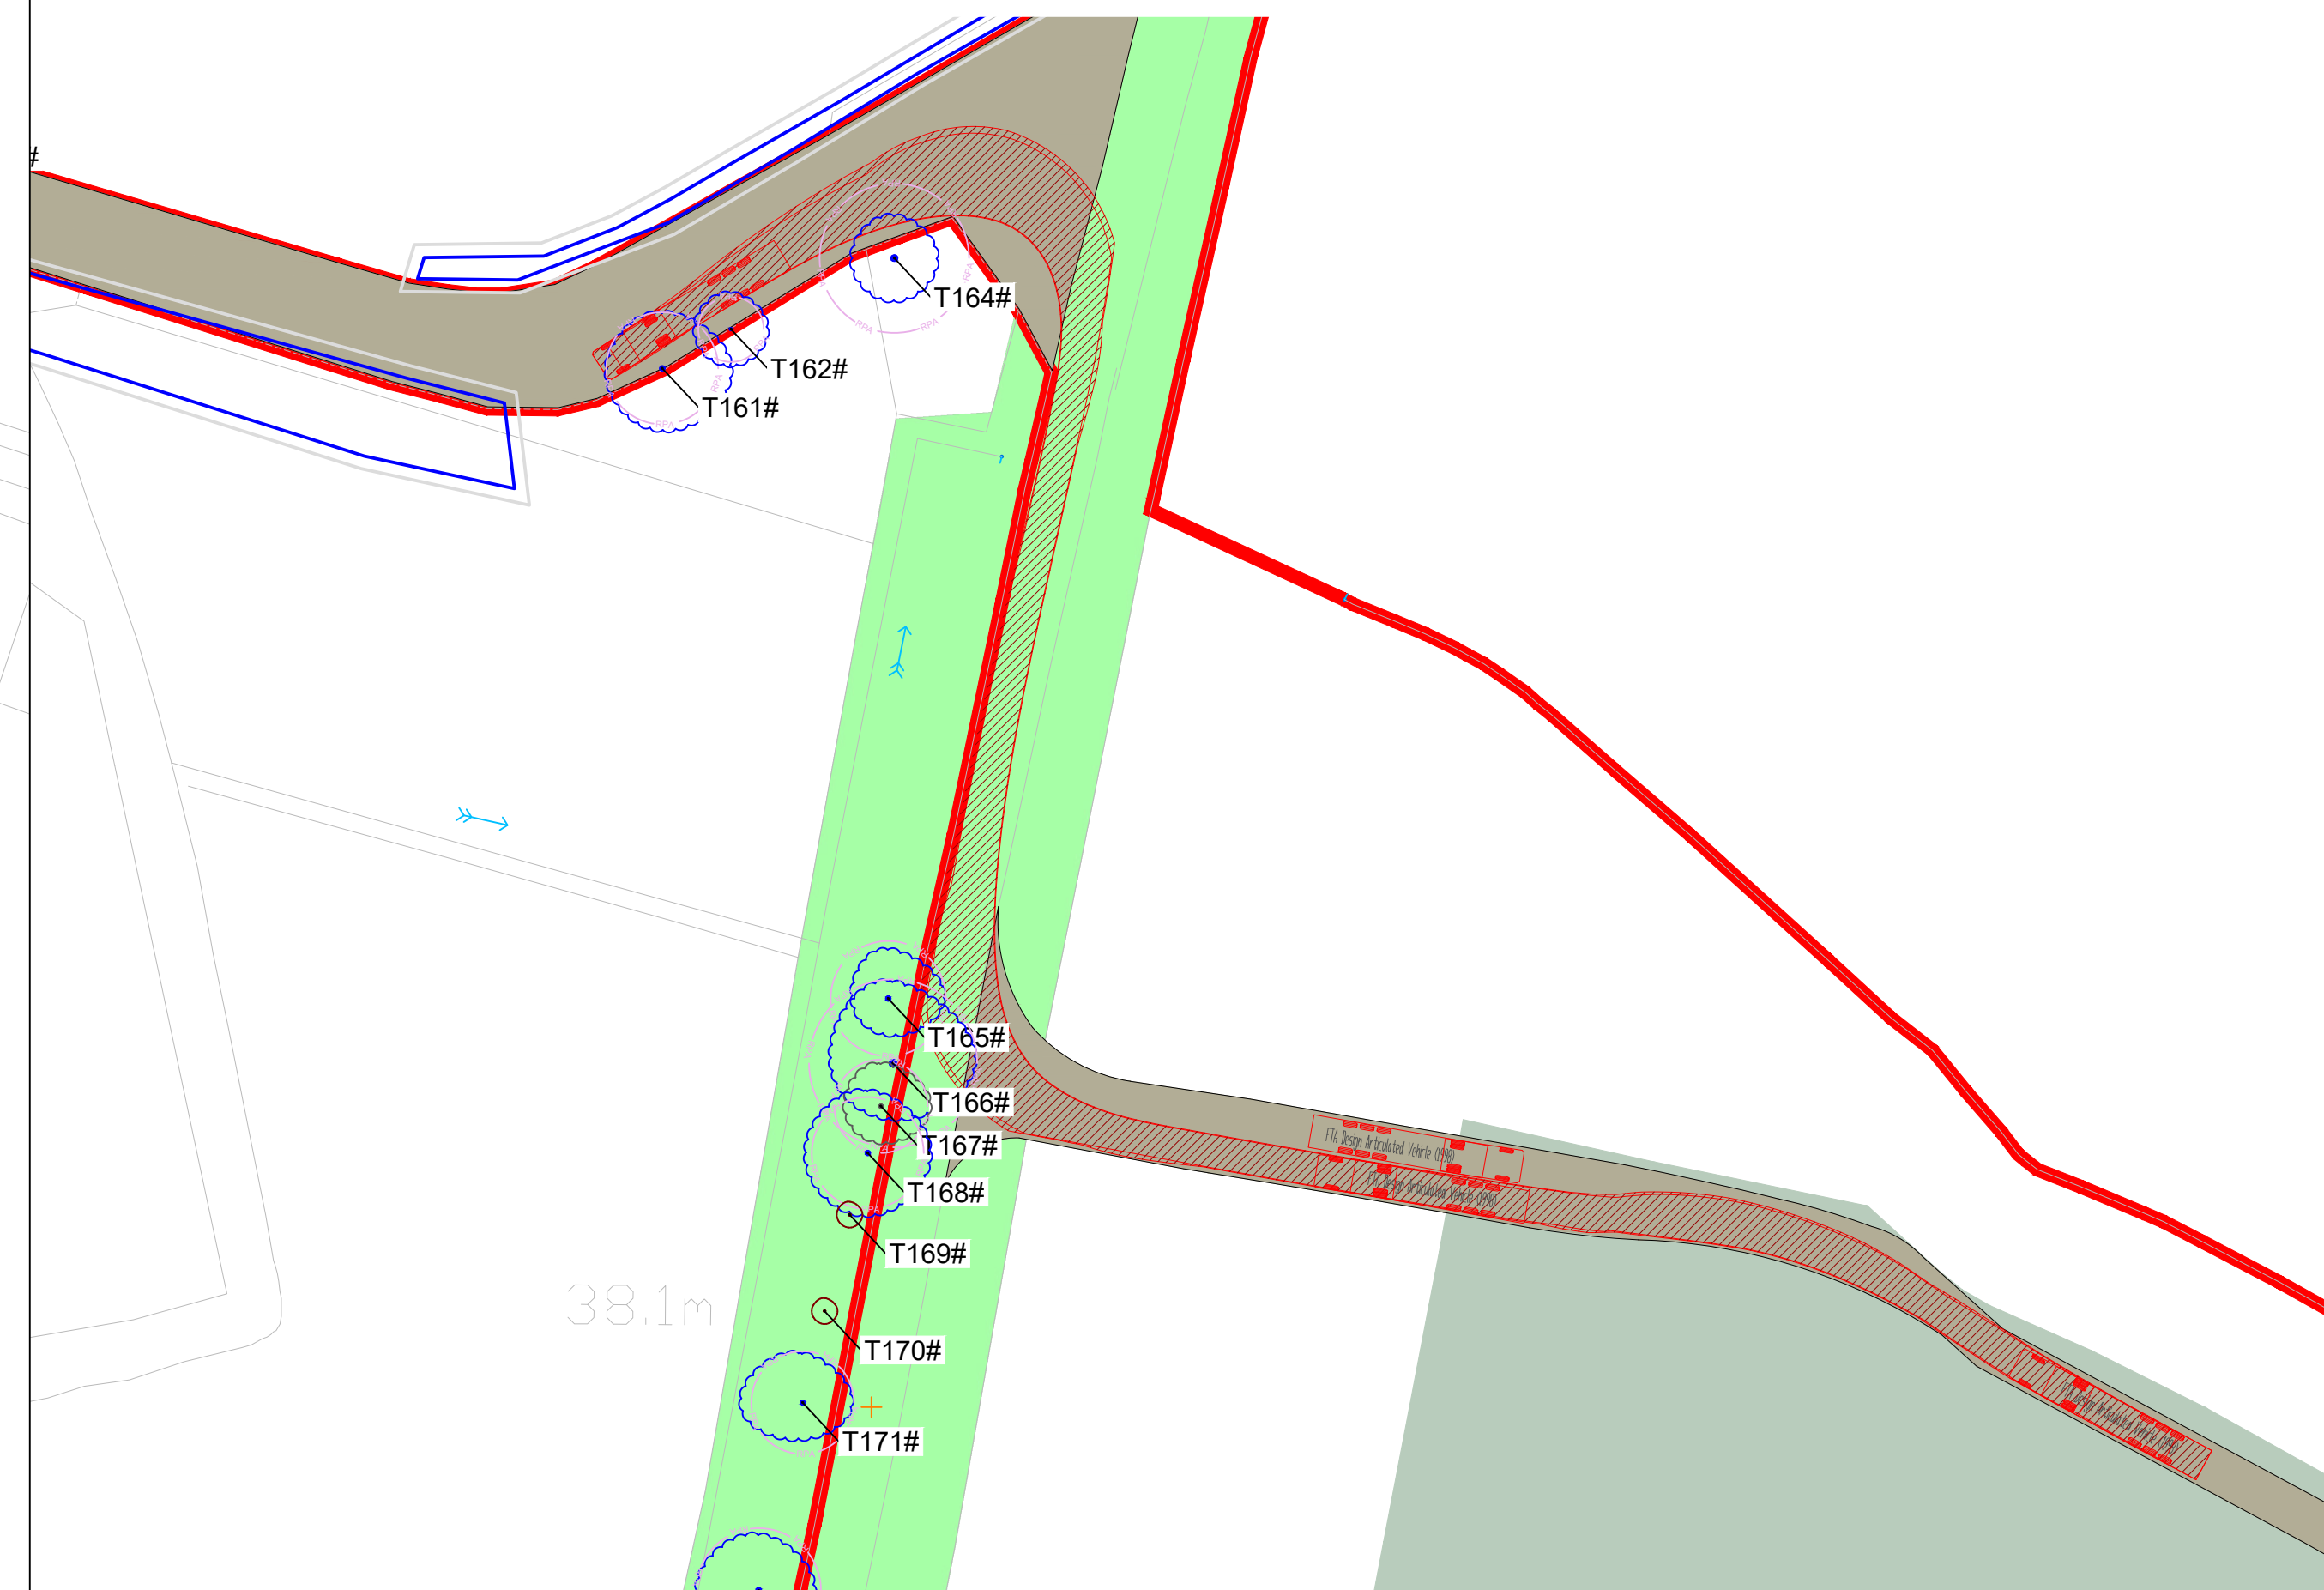
VIEWPORT 2: 16.5m Articulated HGVs Westbound  
(SCALE - 1:500 @A1)

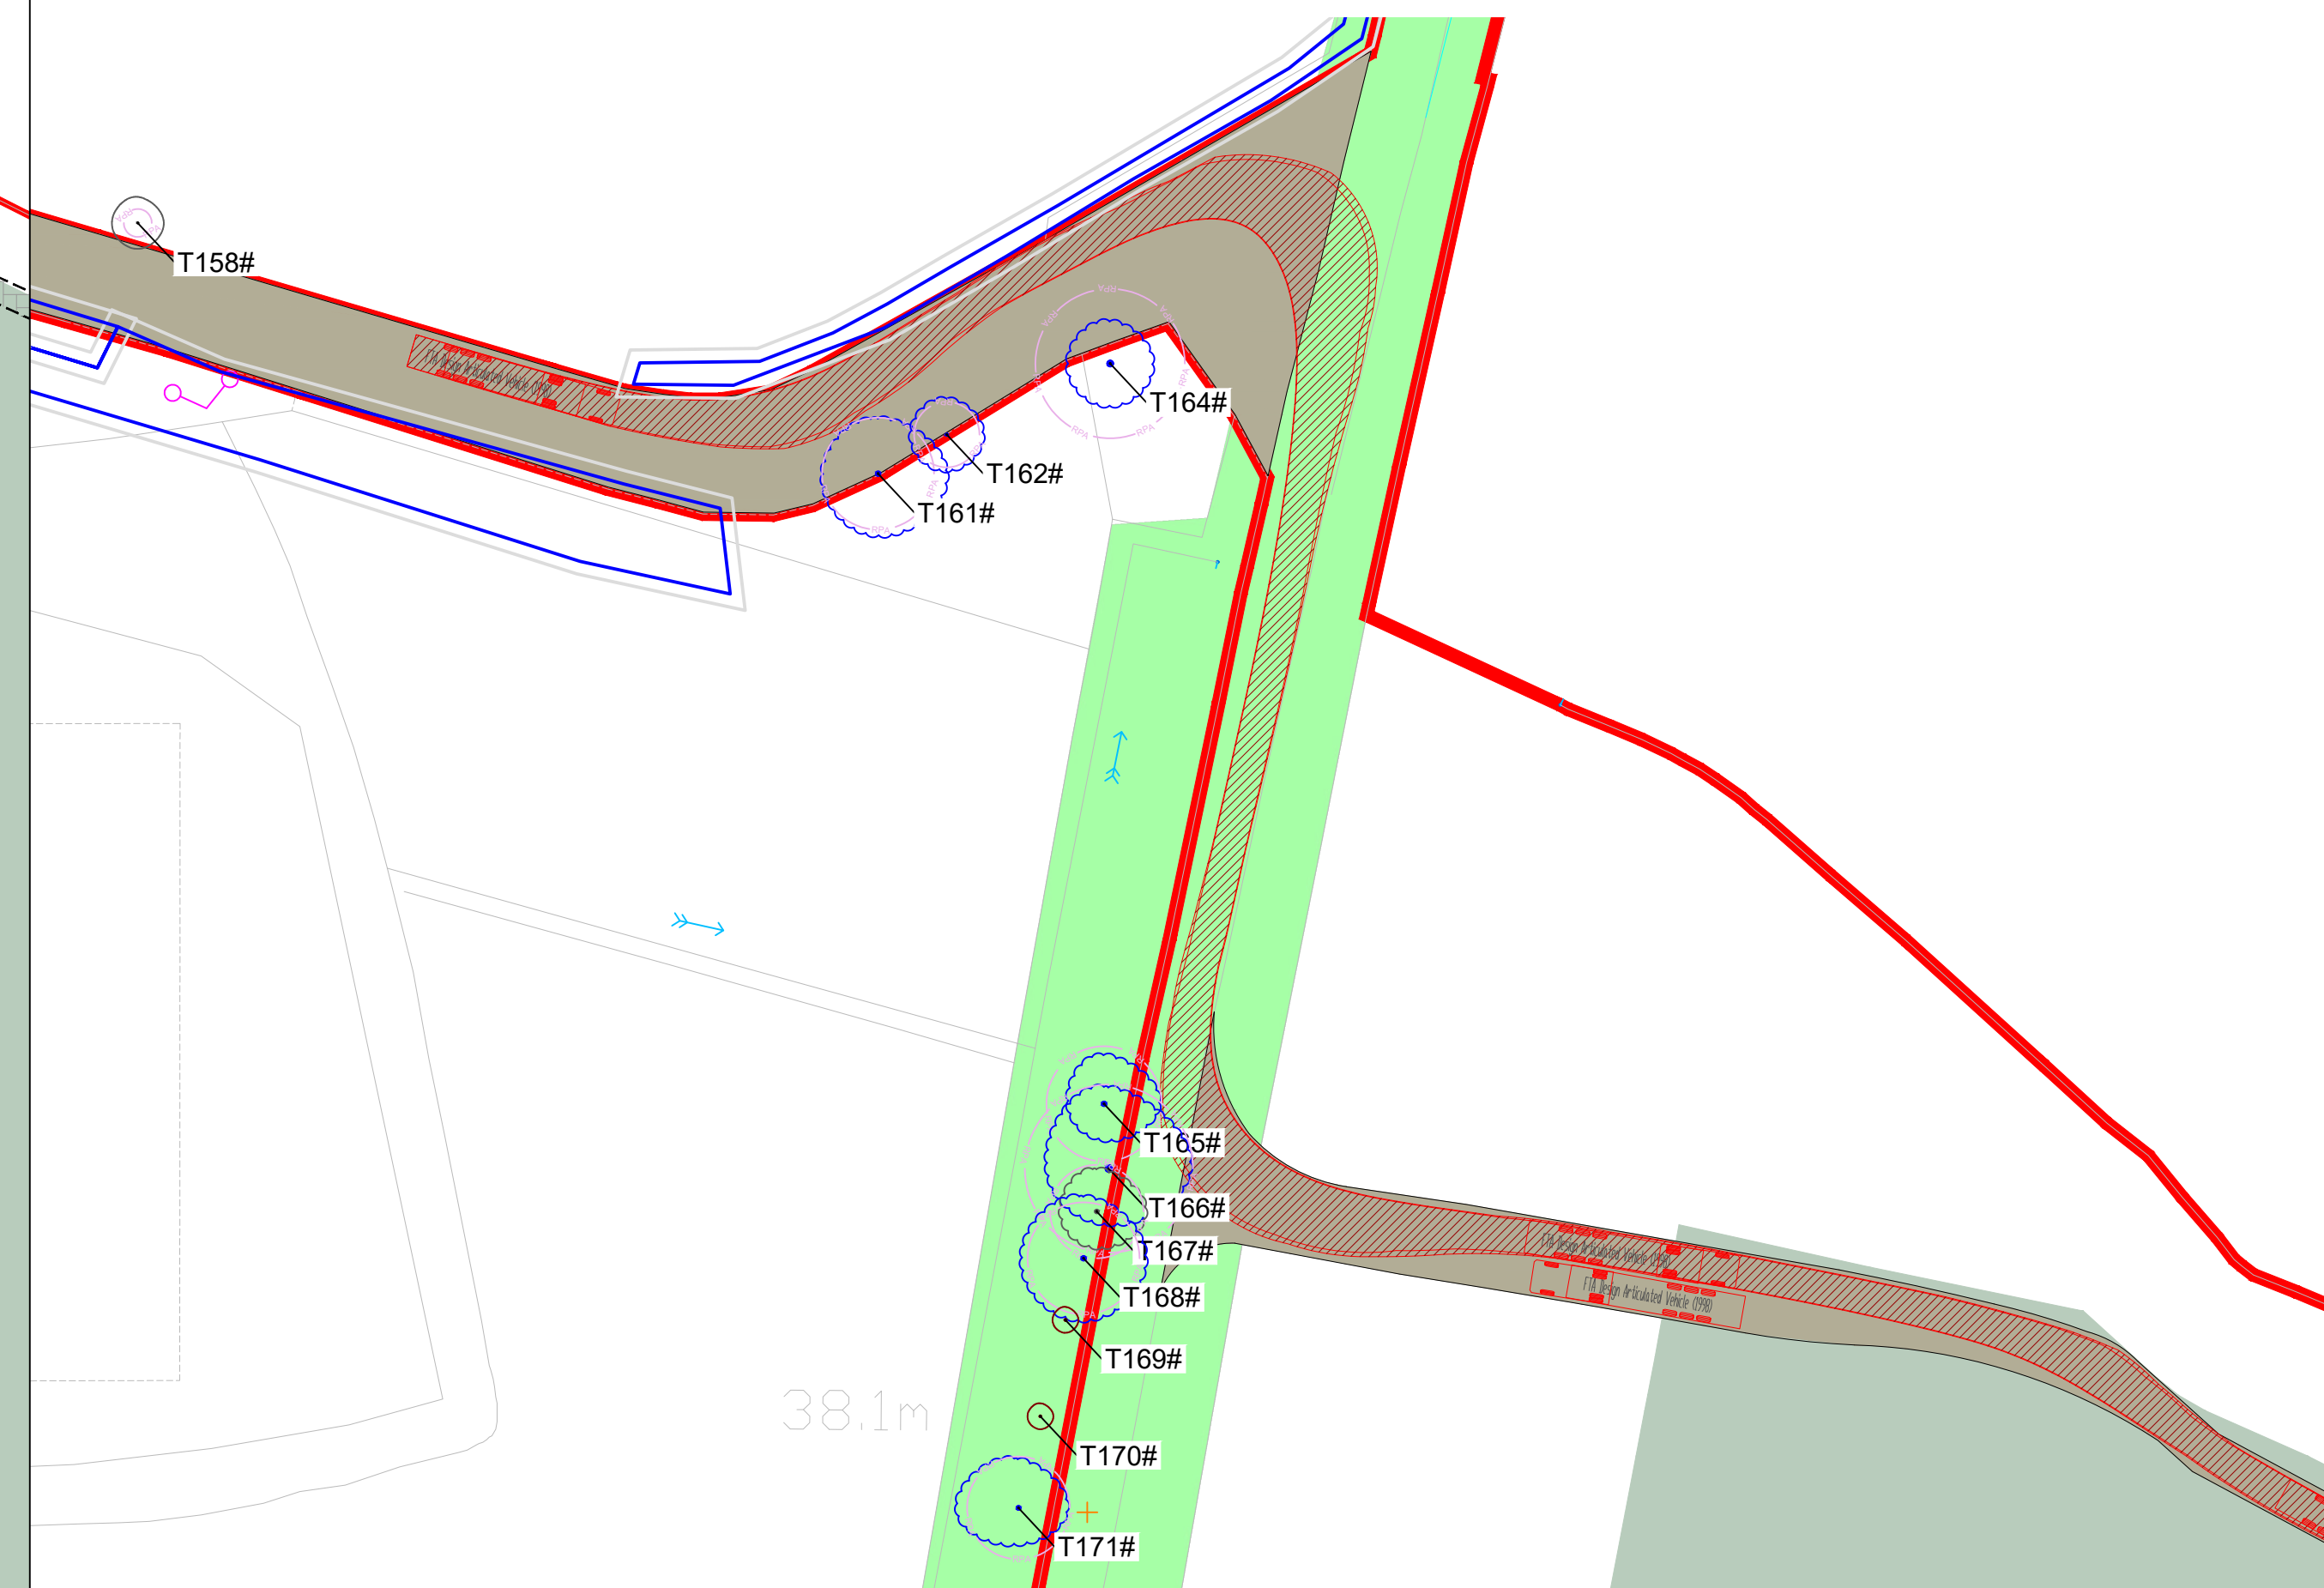
VIEWPORT 3: 16.5m Articulated HGVs Eastbound  
(SCALE - 1:500 @A1)

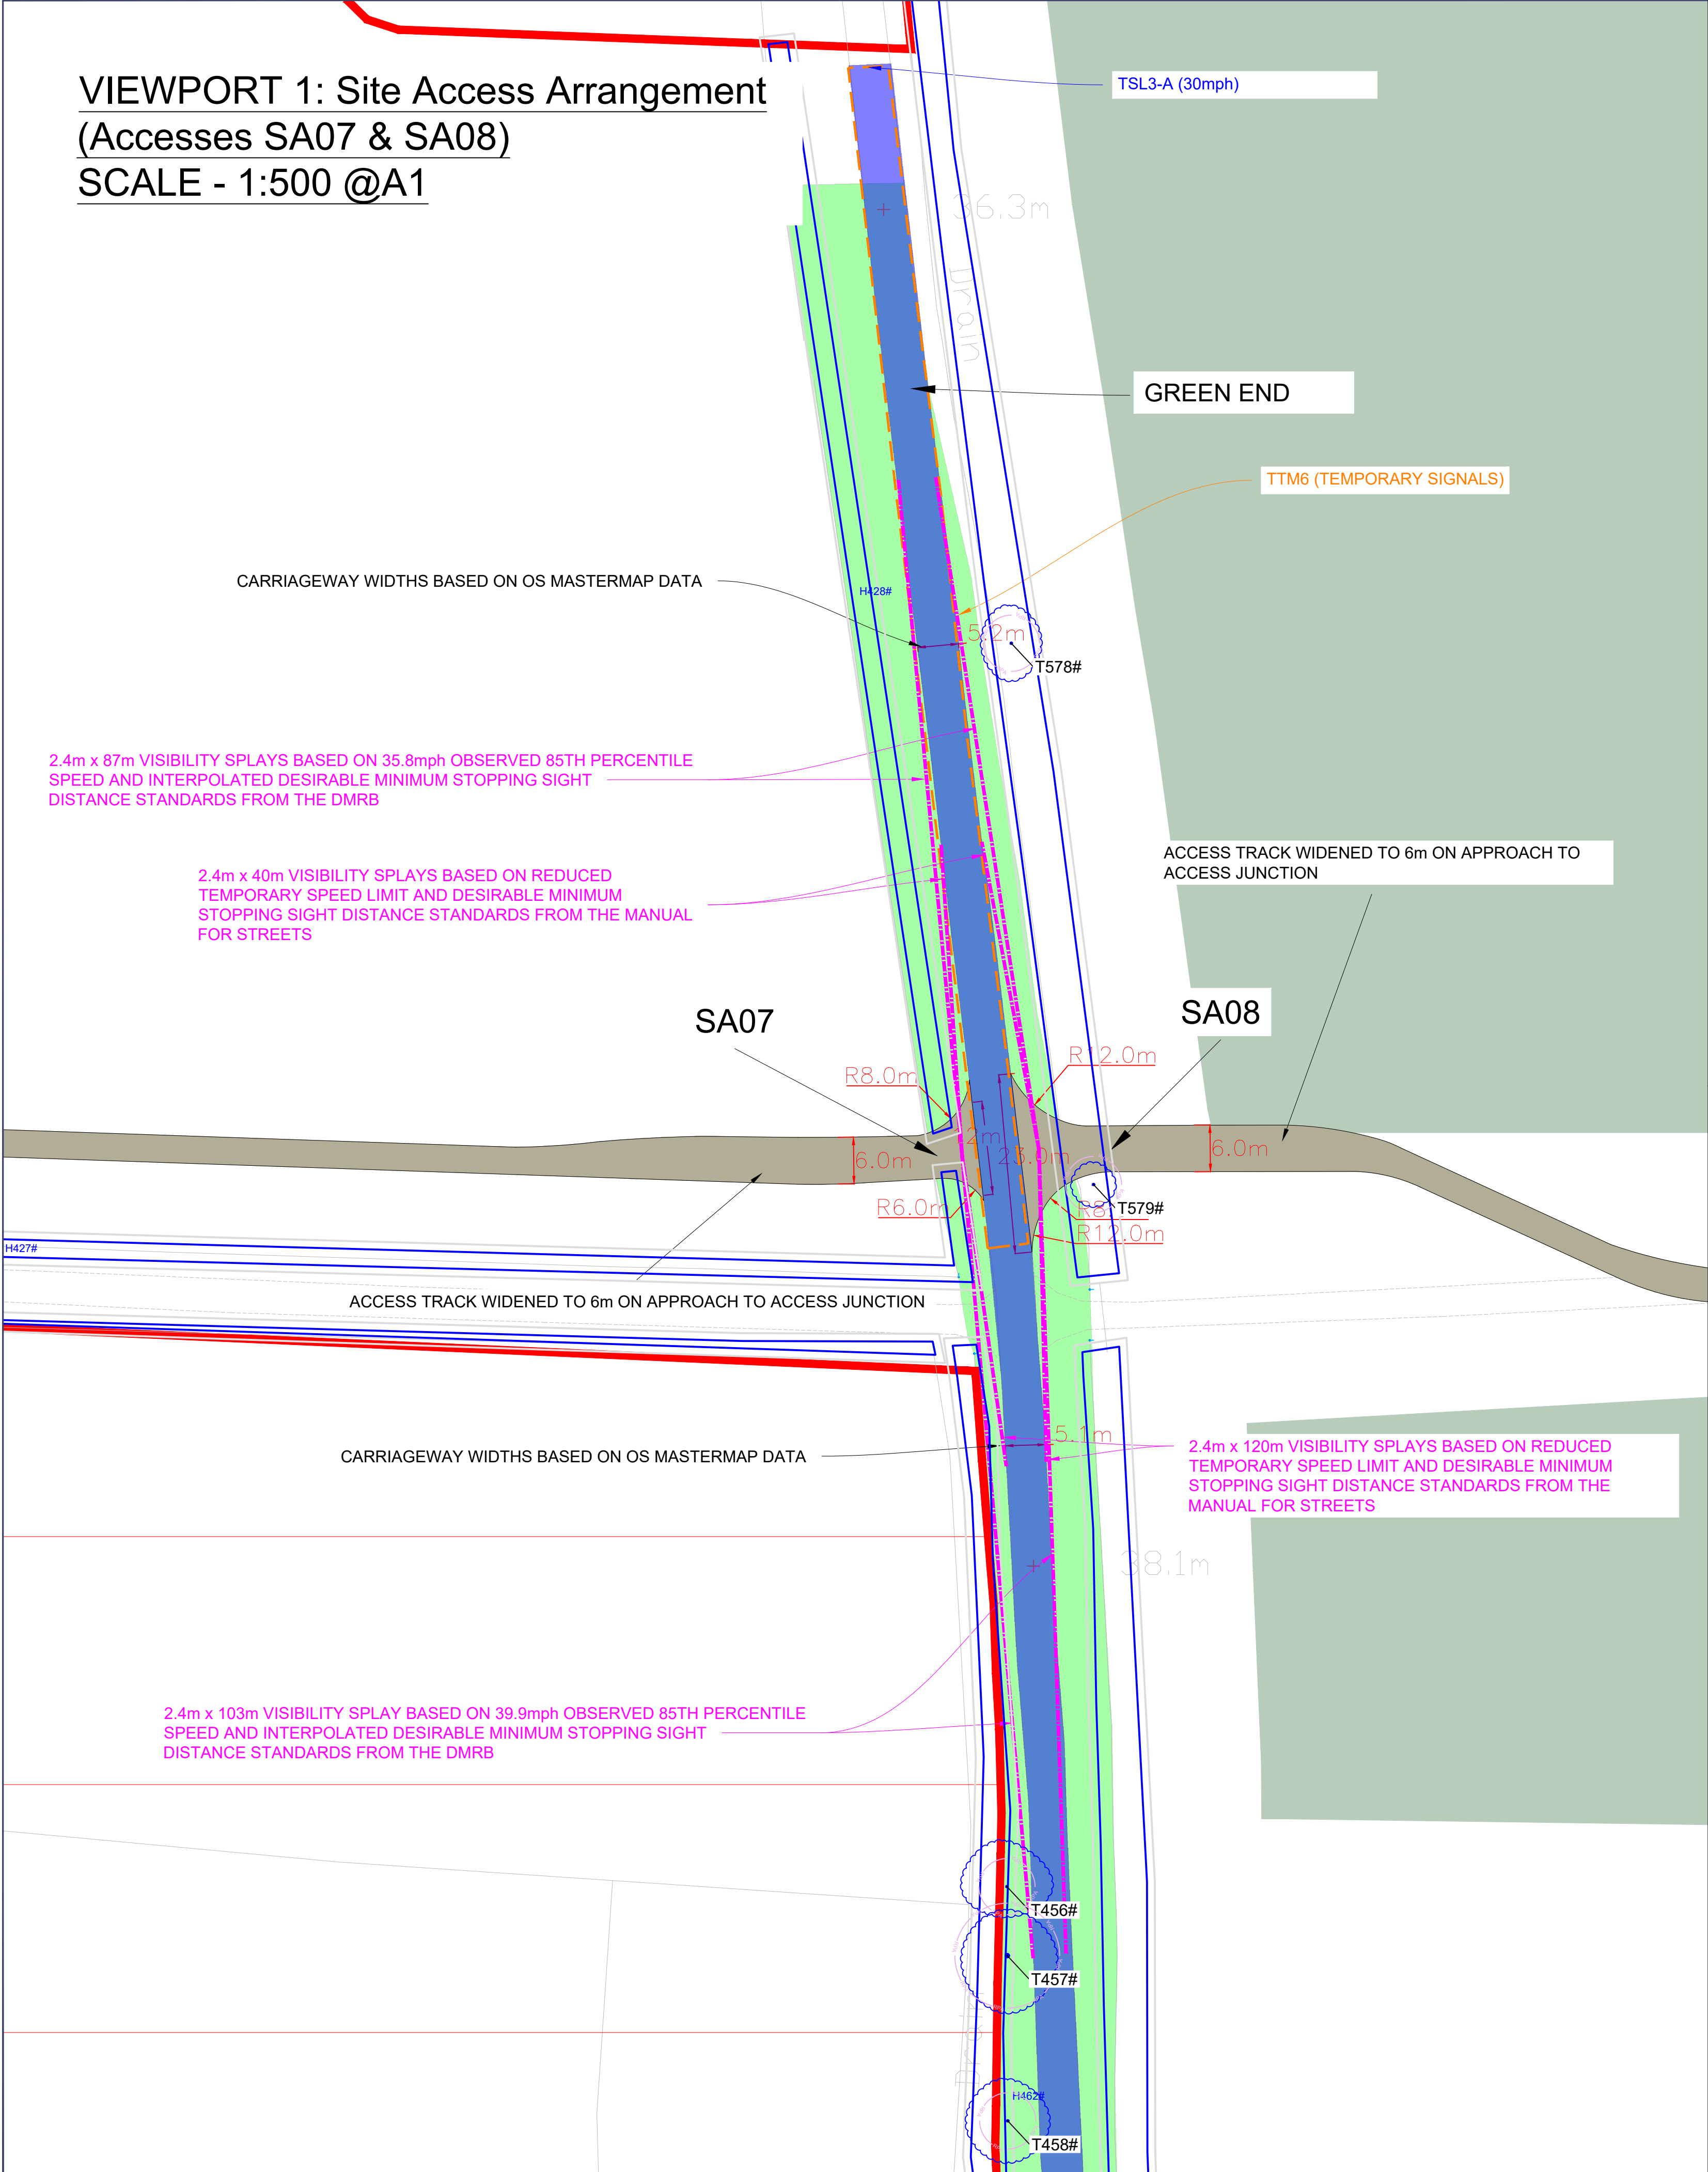
VIEWPORT 1: Site Access Arrangement  
(Accesses SA07 & SA08)  
SCALE - 1:500 @A1
